Interim Reclamation and Stormwater Inspection

Date: 01/13/2023

Operator: IMPETRO RESOURCES LLC - 10690

Location ID: 312277

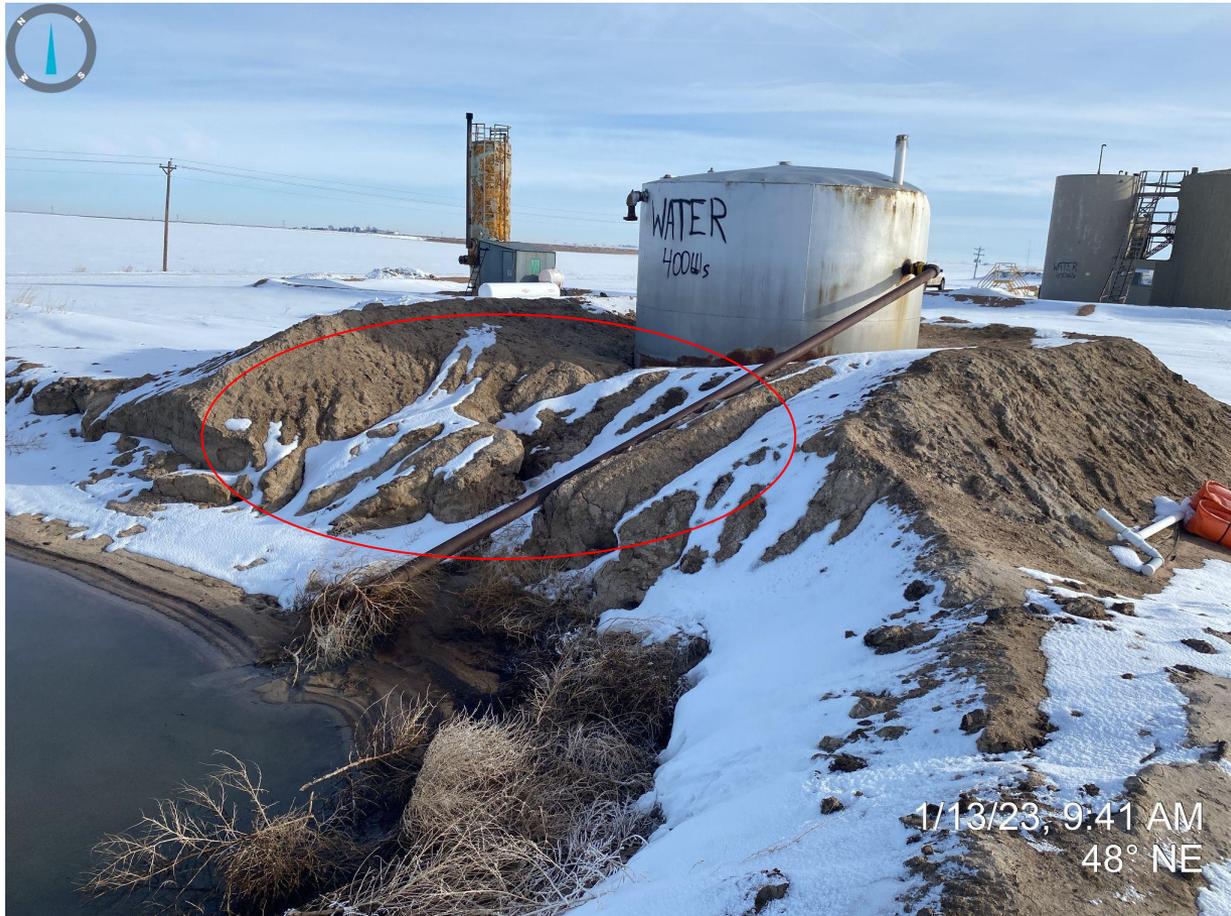
Photo 1. Facing northeast near the produced water tank. Photo illustrates the the western earthen berm has been breached with evidence of rill and gully erosion.

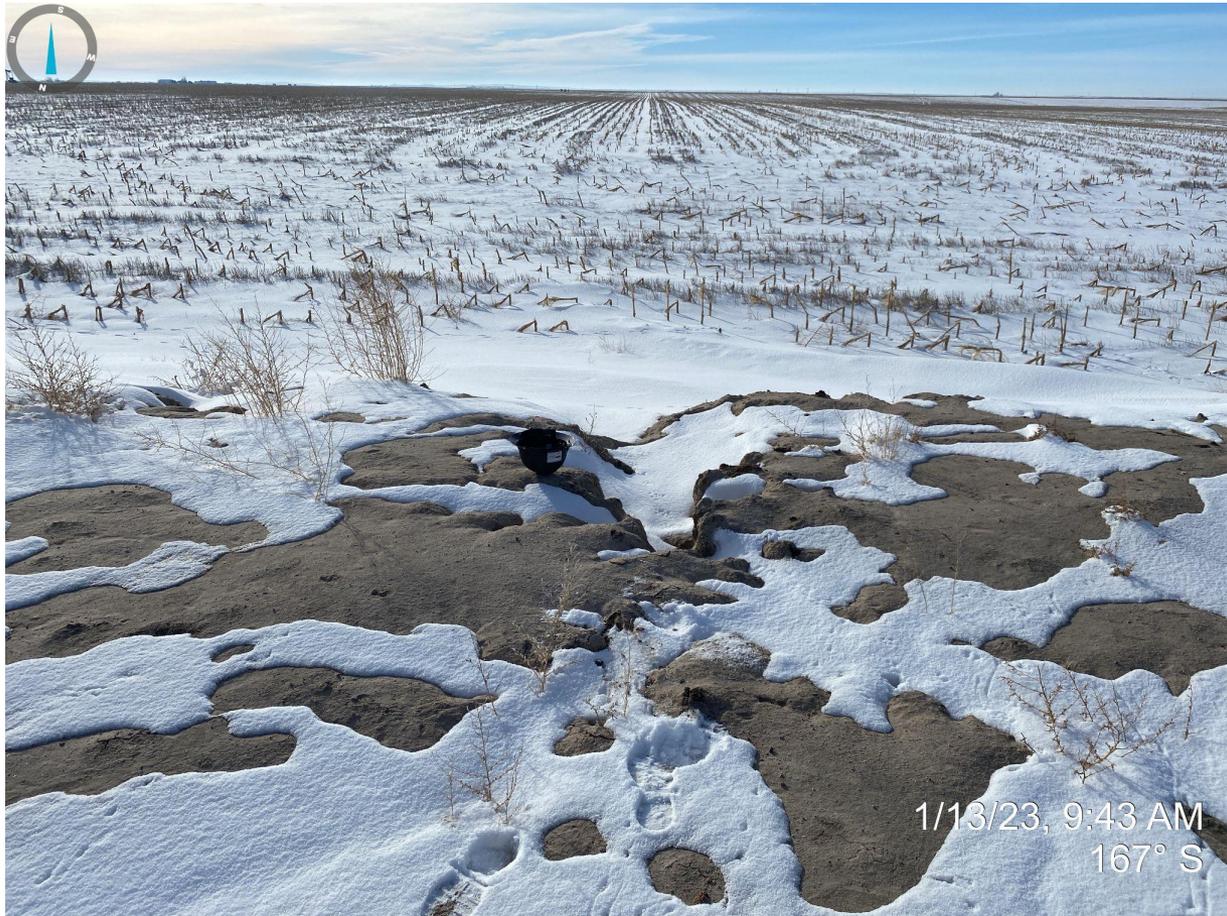
Photo 2. Facing south on the southern pit wall. Photo illustrates gully erosion (approx. 3' wide) on the exterior pit wall. A future inspection will be conducted to evaluate the off-location conditions as snow cover blocked view during this inspection.

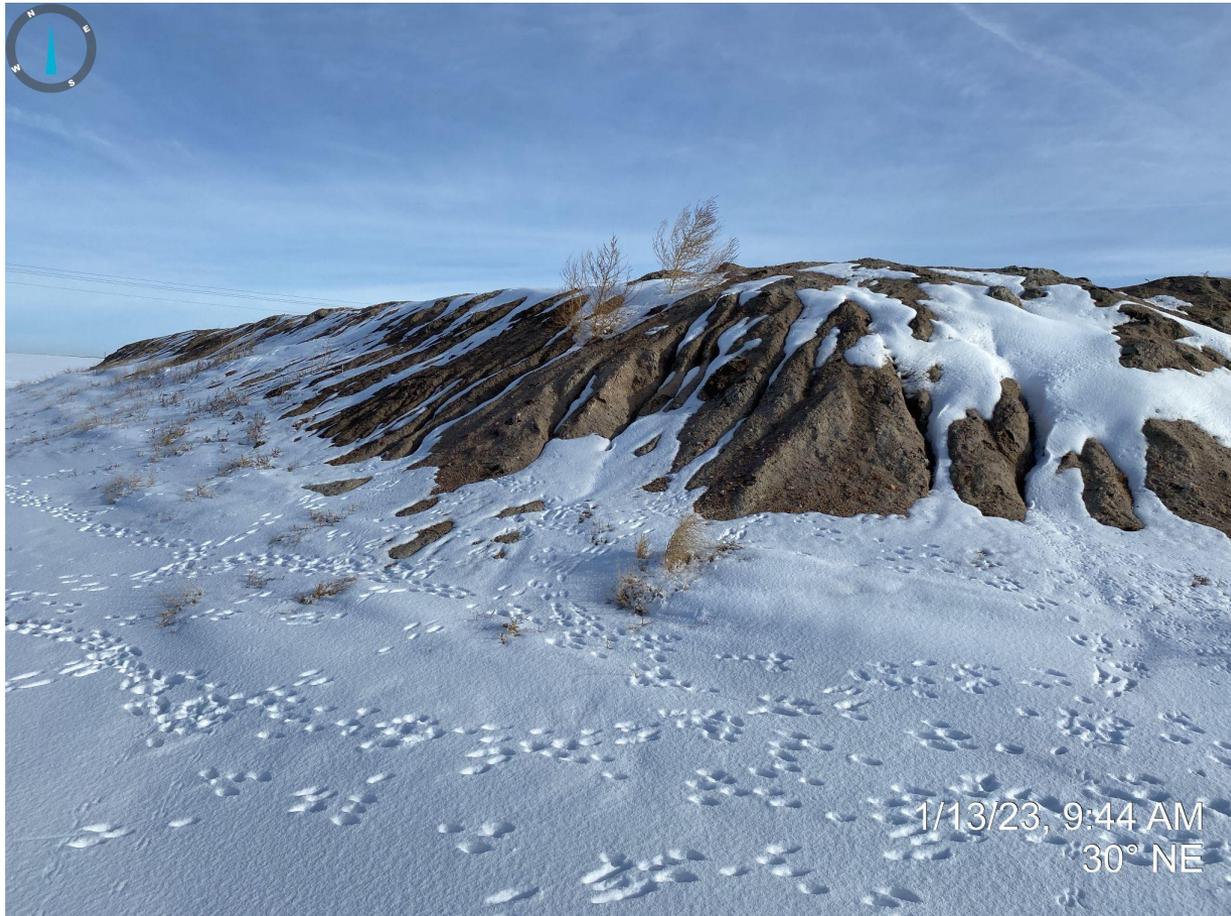
Photo 3. Facing northeast at the southwest corner of the produced water pit. See comments in Photo 2.

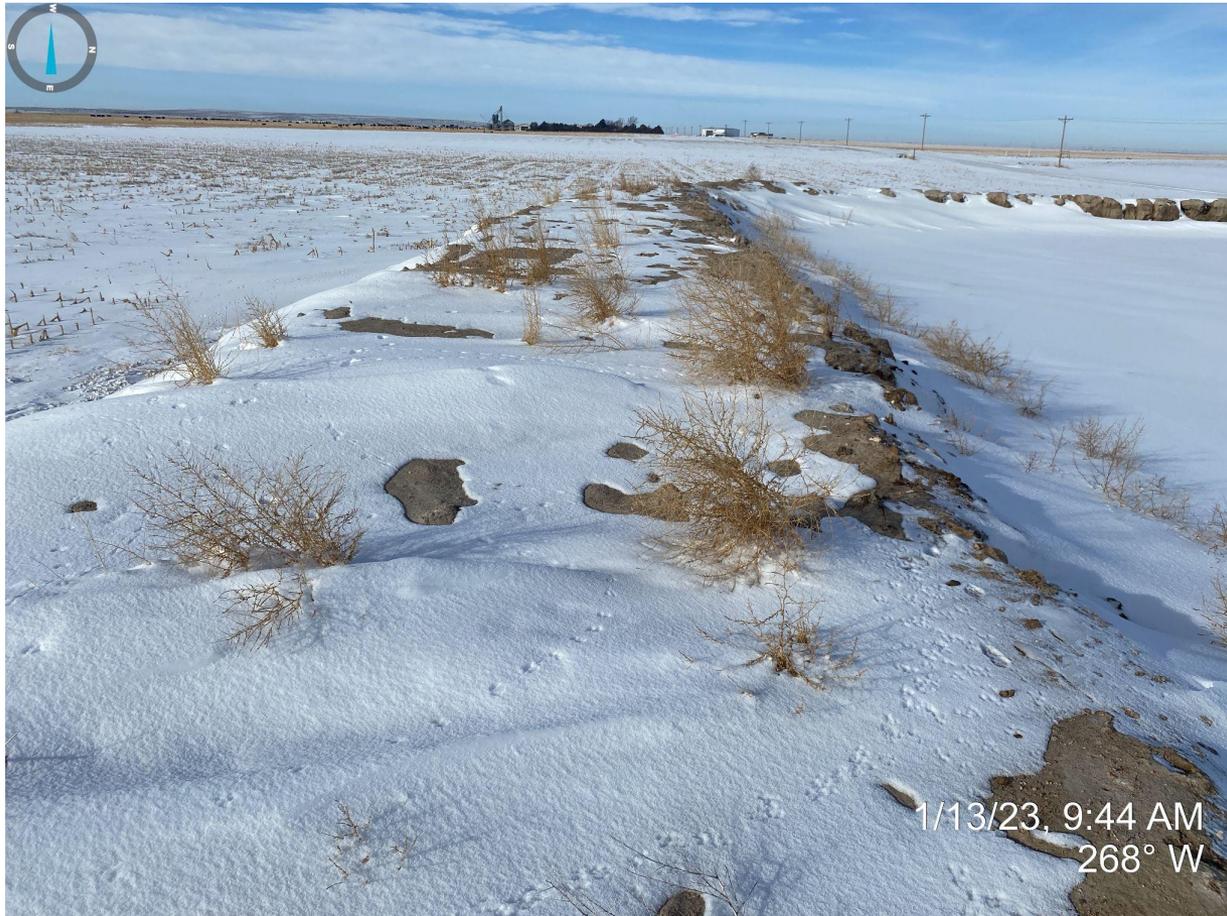
Photo 4. Facing west from the western portion of the pit. Undesirable weedy vegetation was observed throughout the location and needs to be managed as it is now considered debris.

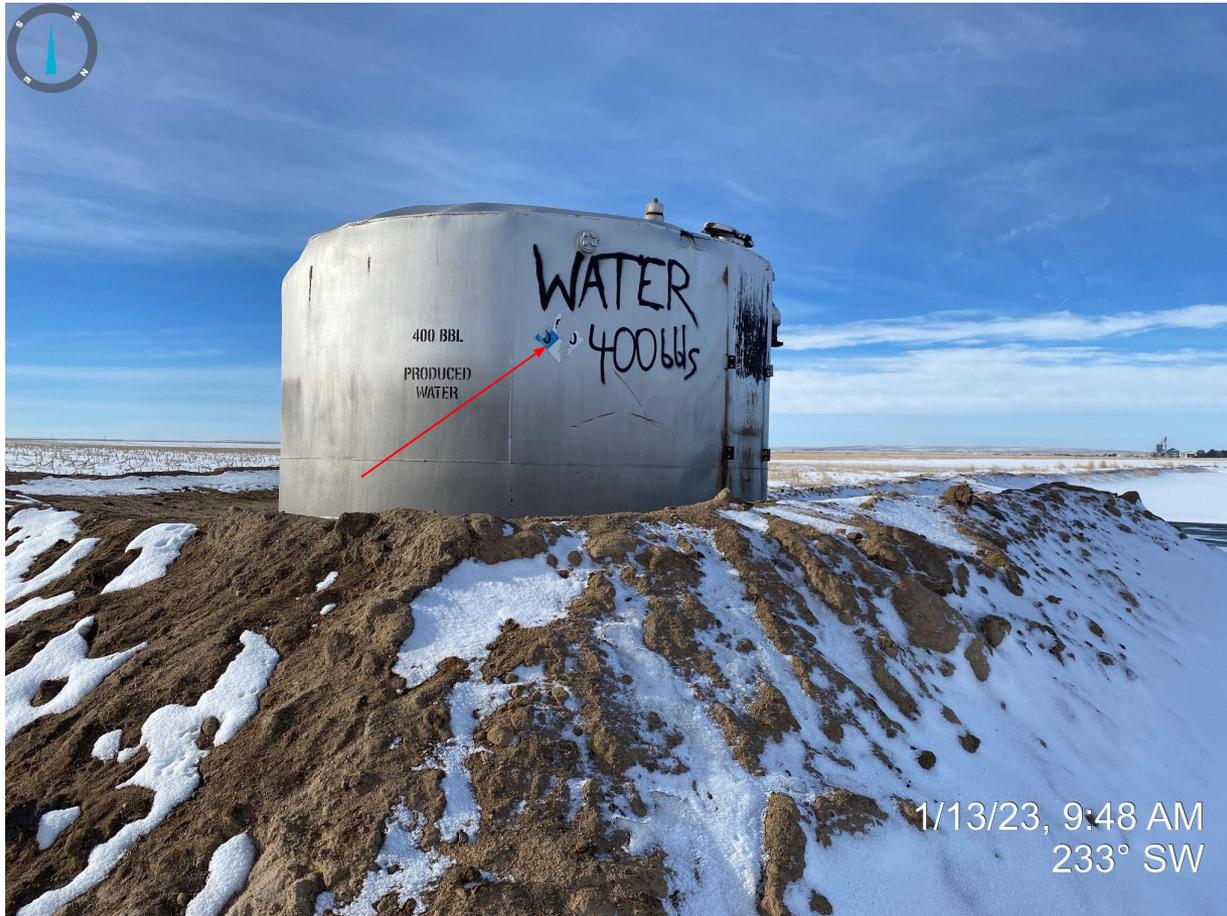
Photo 5. Facing southwest at the produced water tank. NFPA placards are inadequate and need to be replaced/installed.

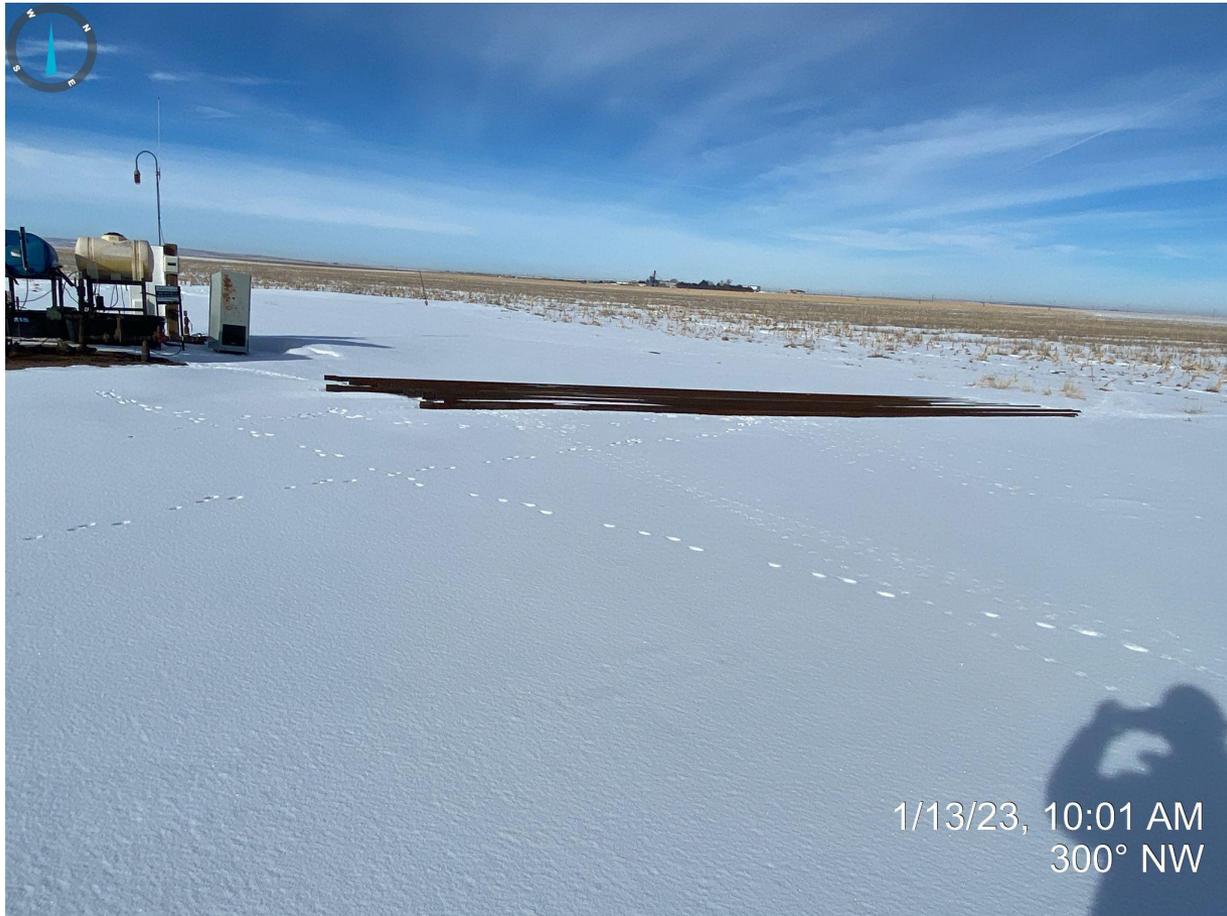
Photo 6. Facing northwest at the wellhead. Unused equipment is being stored on site and needs to be removed.

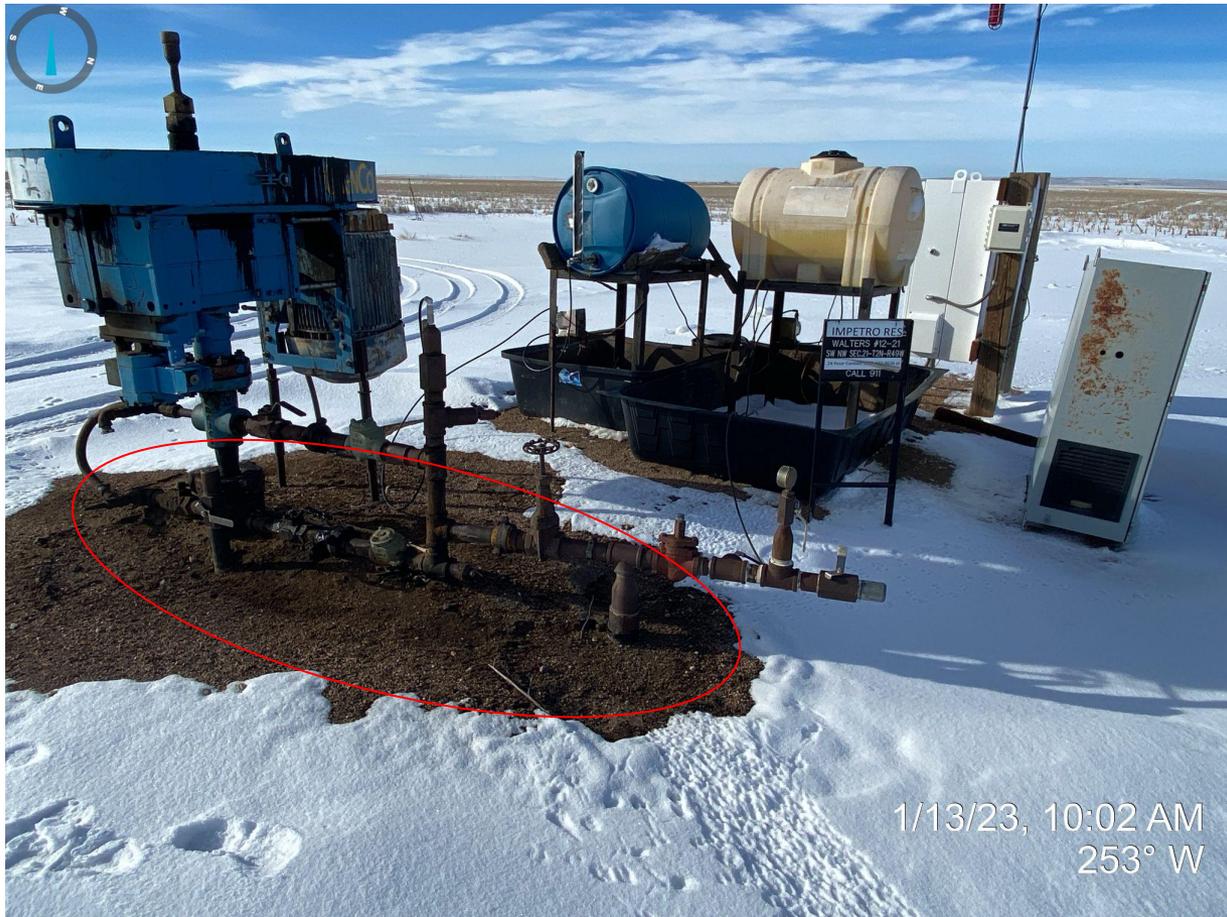
Photo 7. Facing west near the wellhead. Photo illustrates oily stained soil that needs to be properly removed.

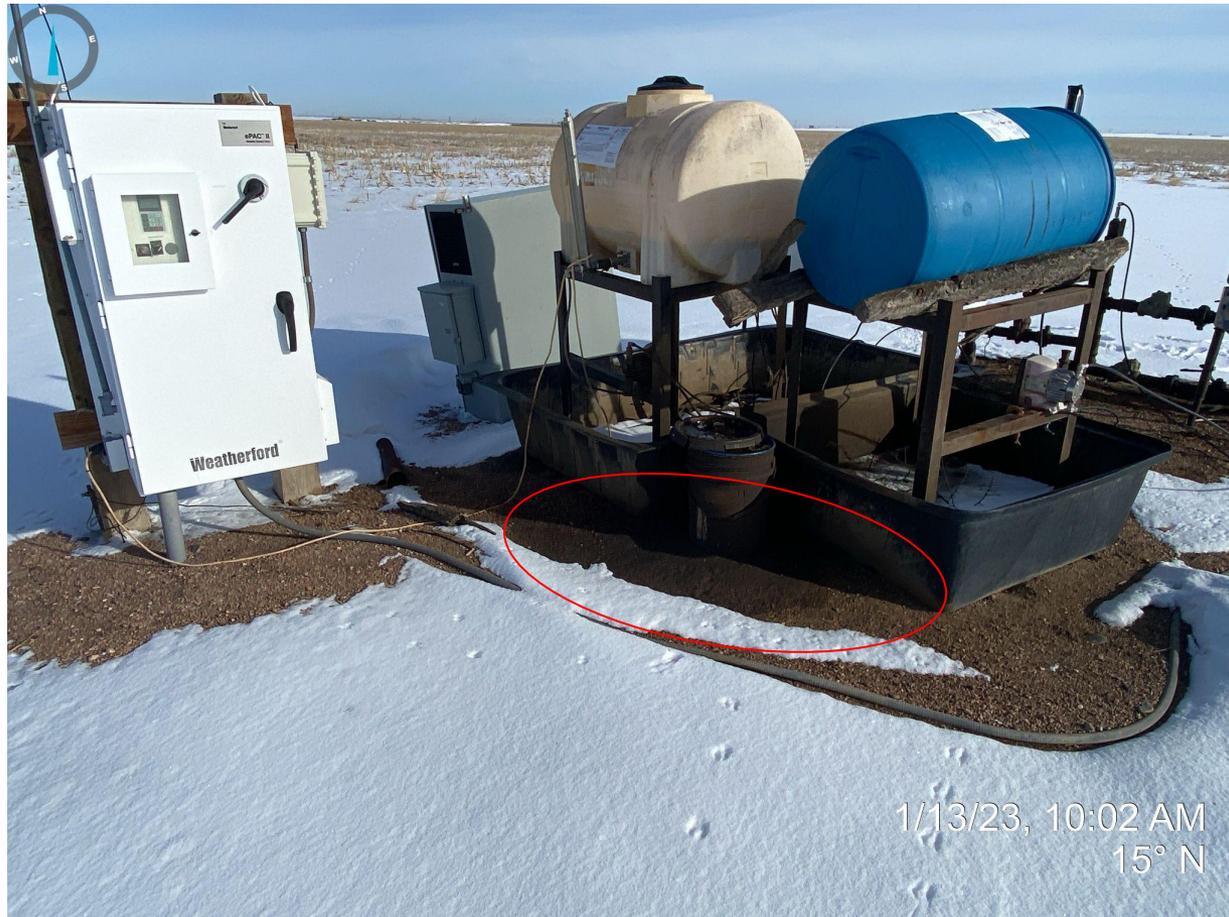
Photo 8. Facing north at wellhead. See comments in Photo 7.
