Interim Reclamation and Stormwater Inspection

Operator: IMPETRO RESOURCES LLC - 10690

Location ID: 317093

Inspection Photos
Location Name: Stennett
Location ID: 317093

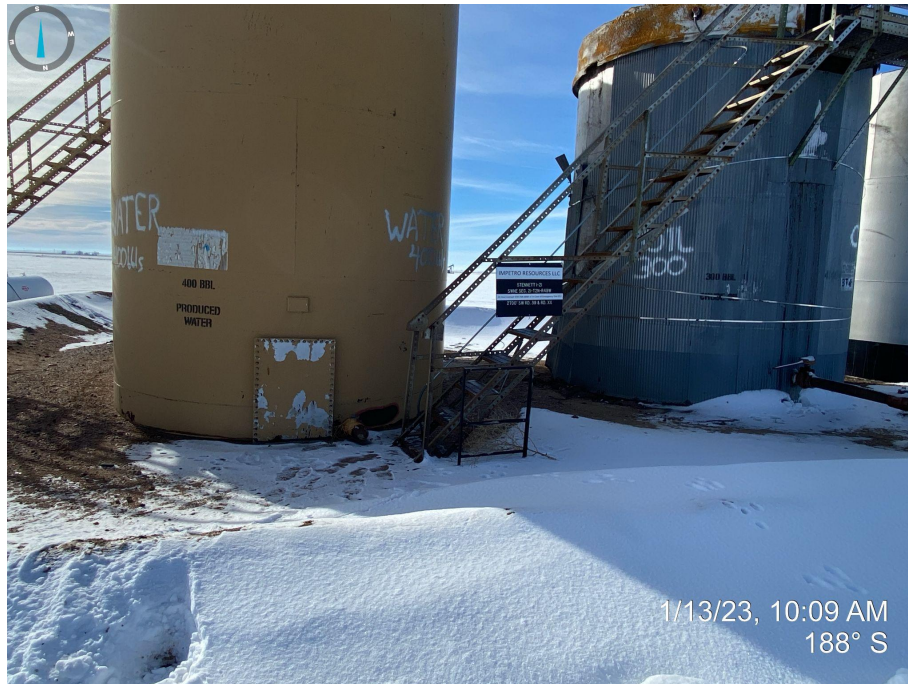
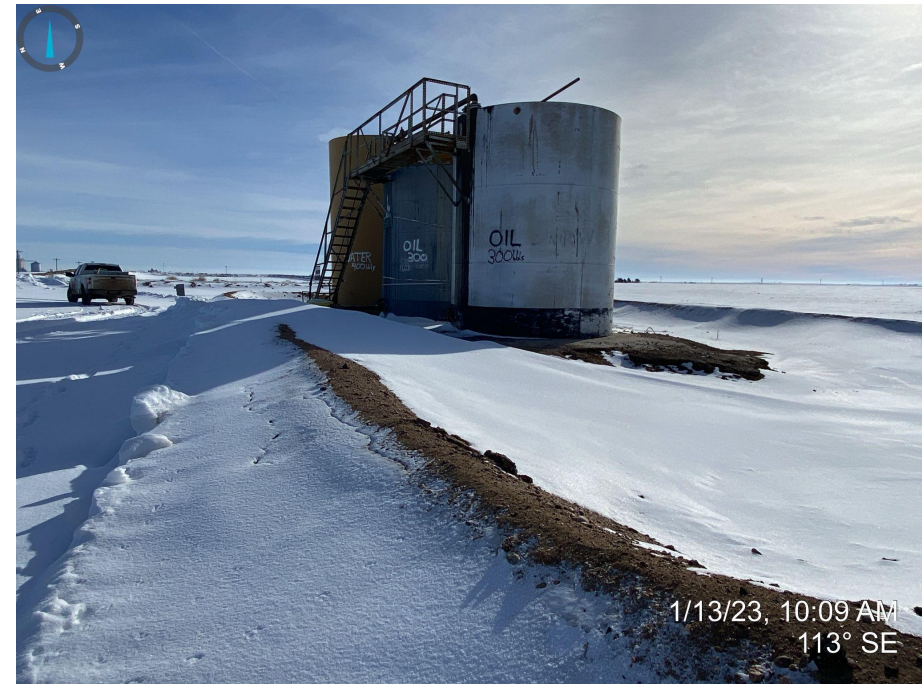
Photos 1 & 2. Facing south and southeast at tank battery. NFPA placards are missing and or not legible.

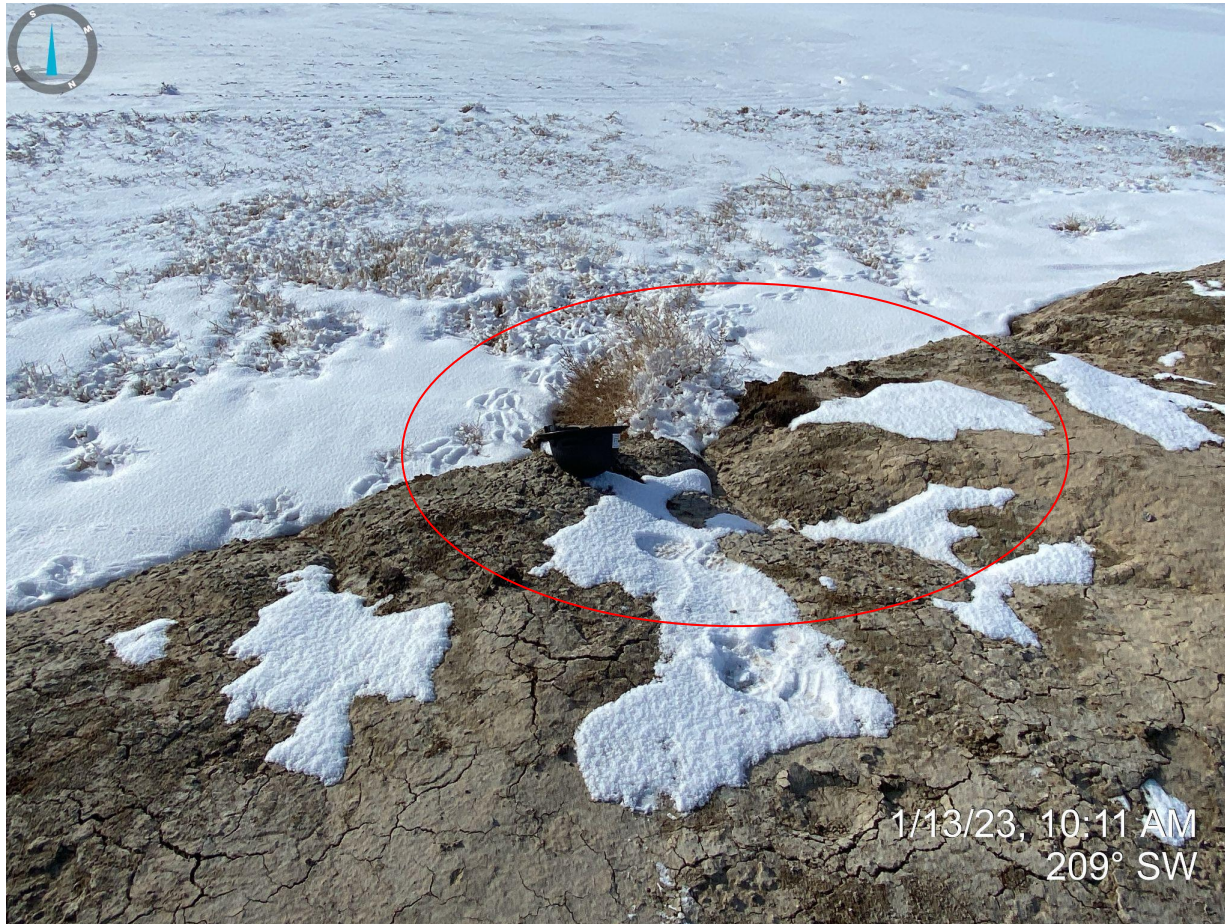
Photo 3. Facing southwest from southern pit wall. Photo illustrates gully erosion on pit wall with hard hat for scale.

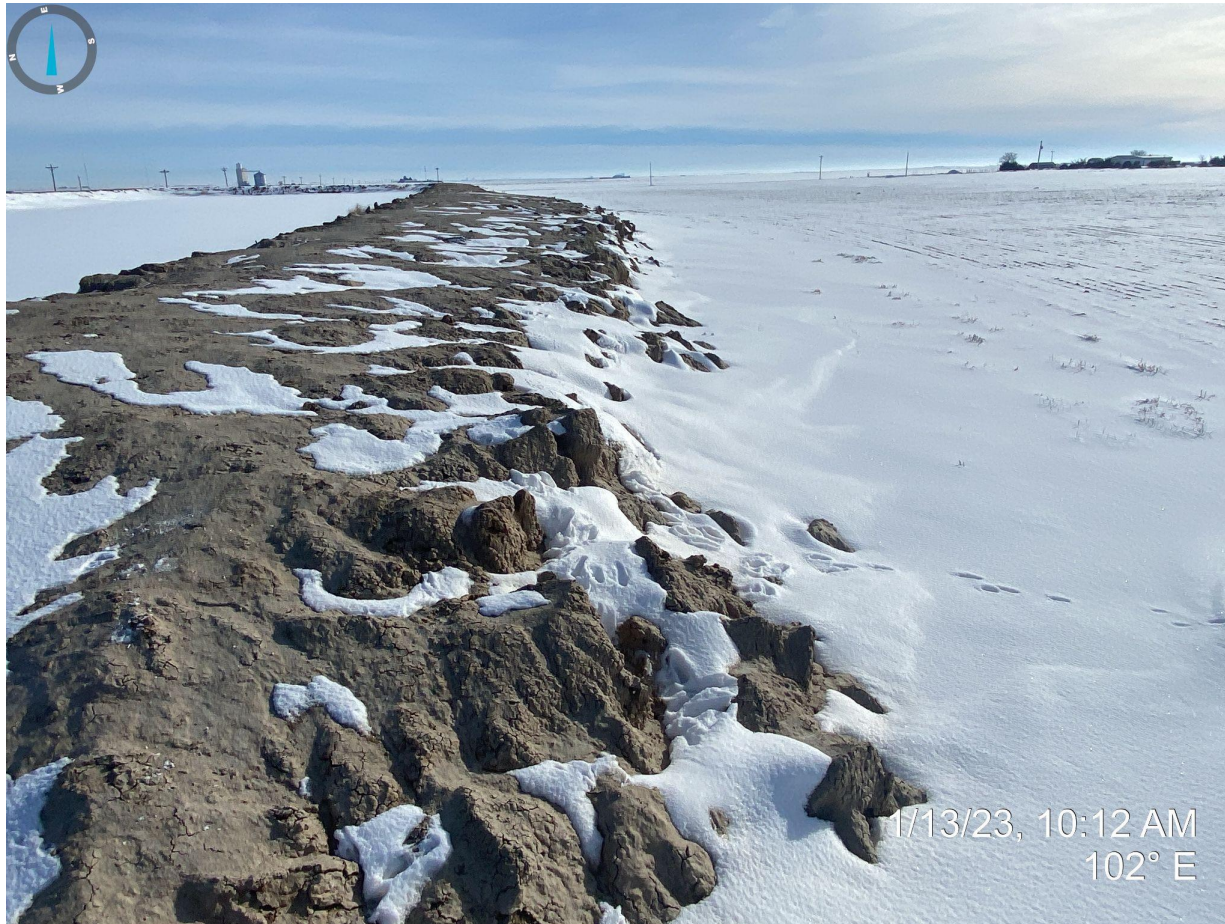
Photo 4. Facing east from the southern pit wall. Photo illustrates unconsolidated material comprising the walls with evidence of rill and gully erosion. Snow cover is obstructing view of adjacent ground and a follow-up inspection will be constructed at a later date to assess site conditions.

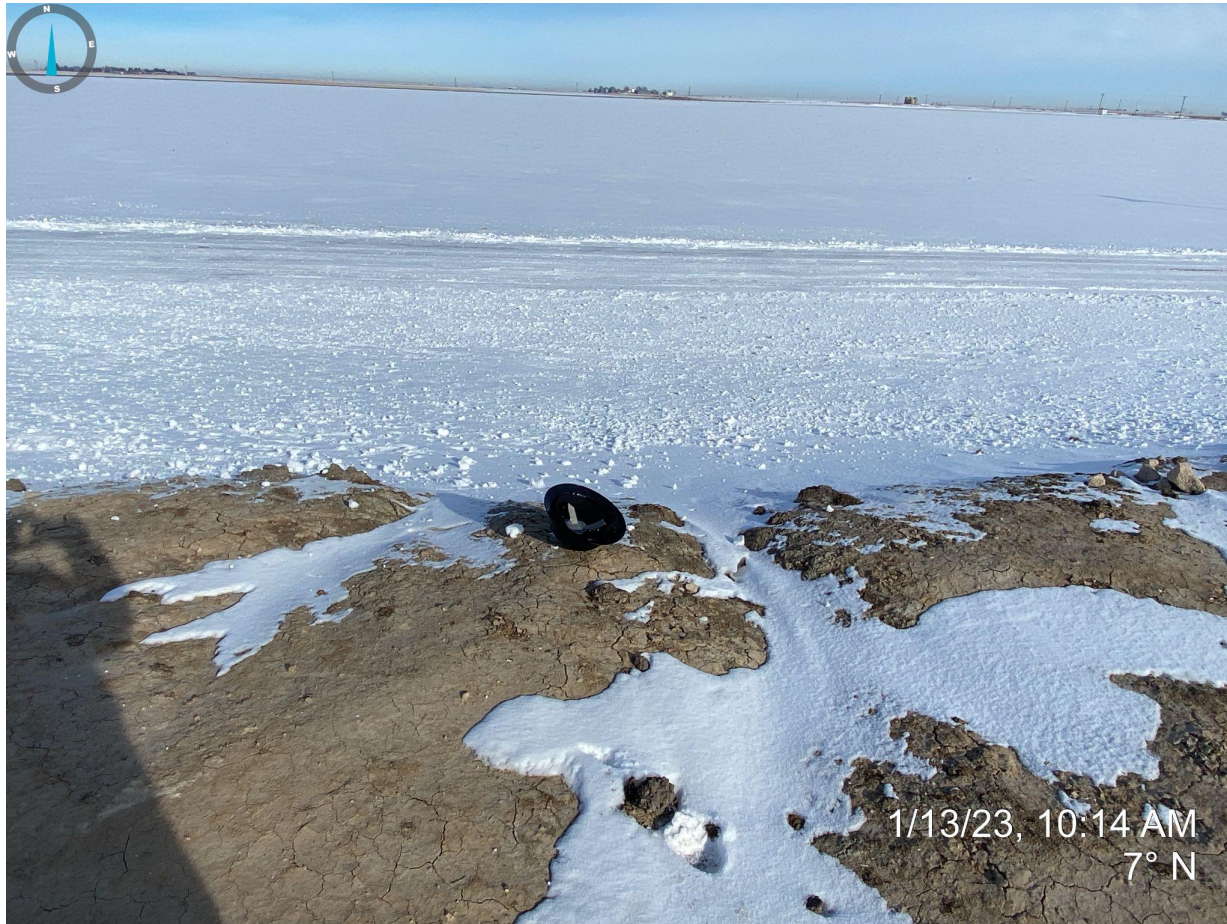
Photo 5. Facing north from the northern pit wall. See comments in Photos 3 & 4.

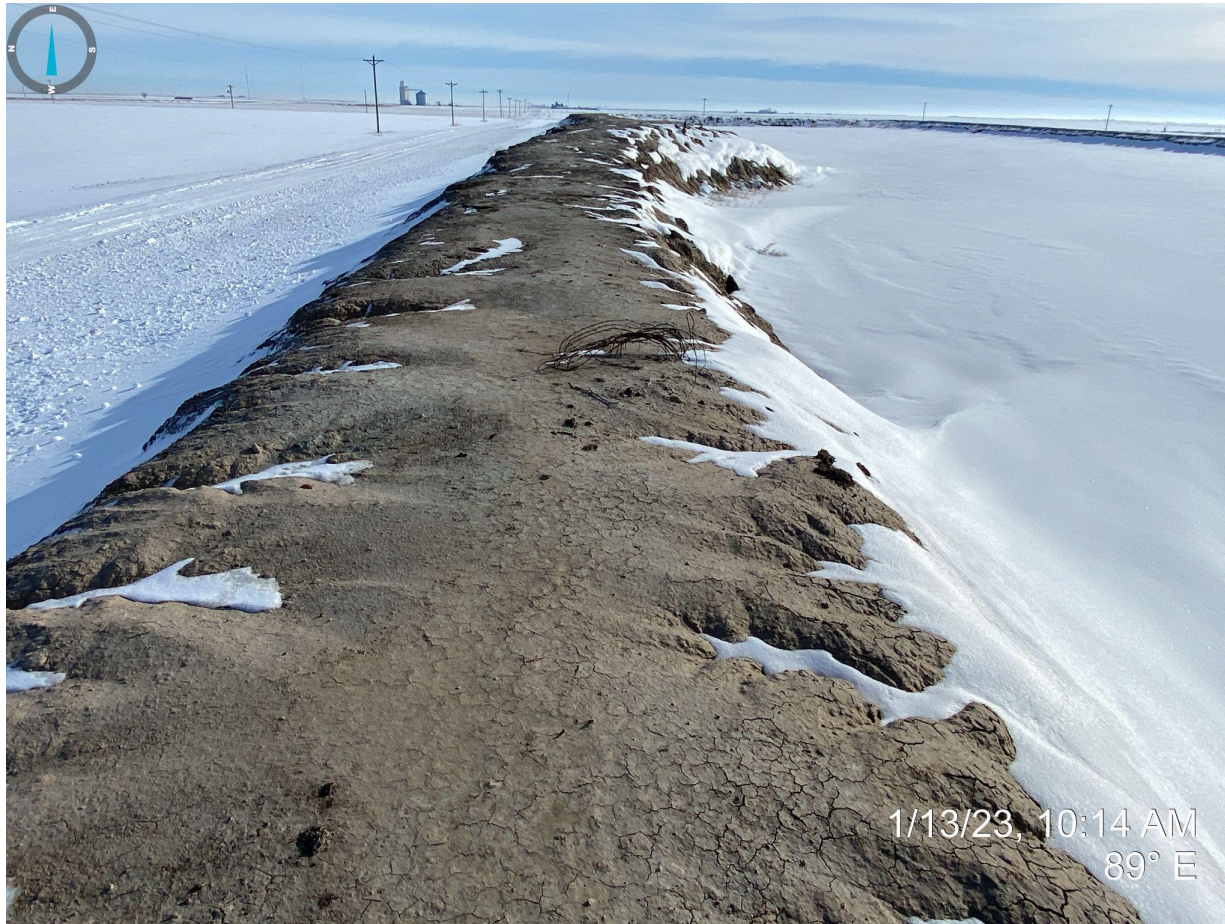
Photo 6 . Facing east from the northern pit wall. Photo illustrates rill and gully erosion occurring on both the interior and exterior walls.

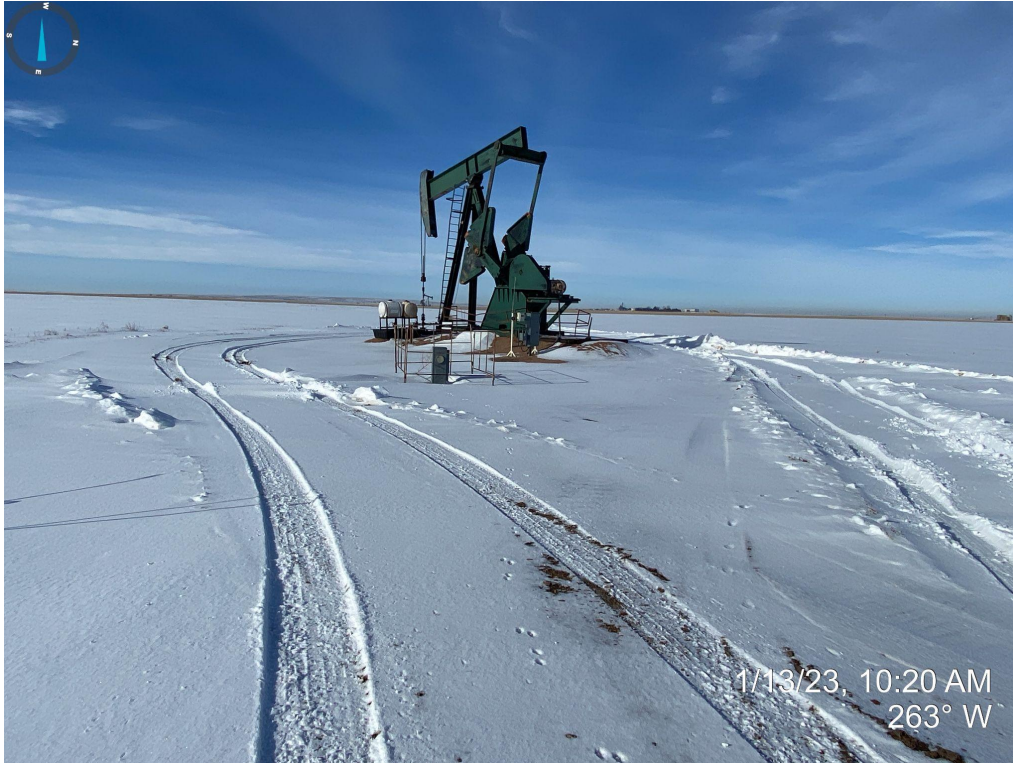
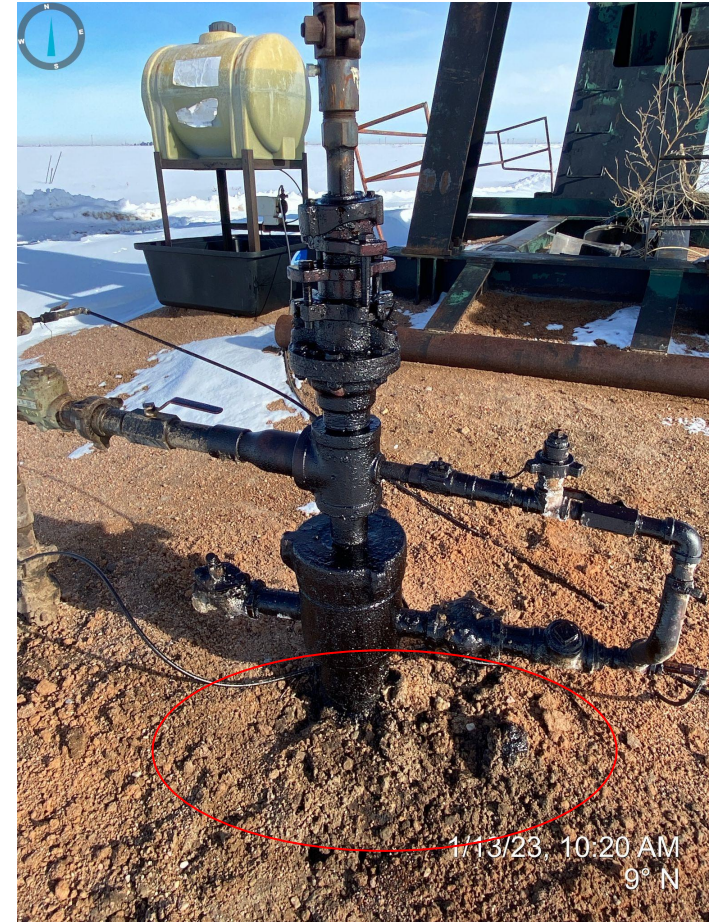
Photos 7 & 8. Facing west and north from the wellhead/pump jack. Photo illustrates a leaking wellhead at fittings and polishing rod. Stained soil (outlined in red) will need to be removed.
