Interim Reclamation and Stormwater Inspection

Operator: IMPETRO RESOURCES LLC - 10690

Location ID: 317278

Inspection Document #: 696105686

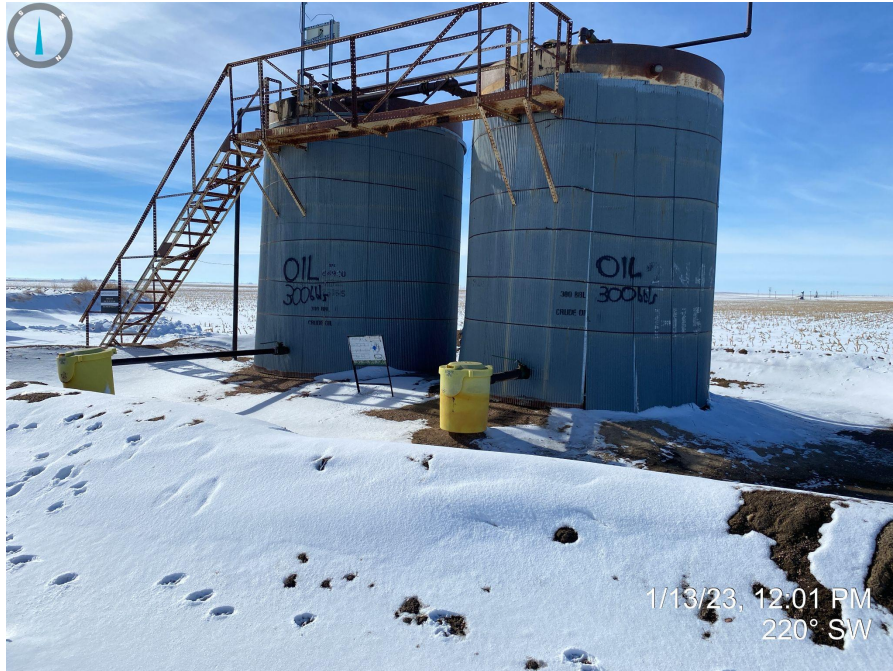
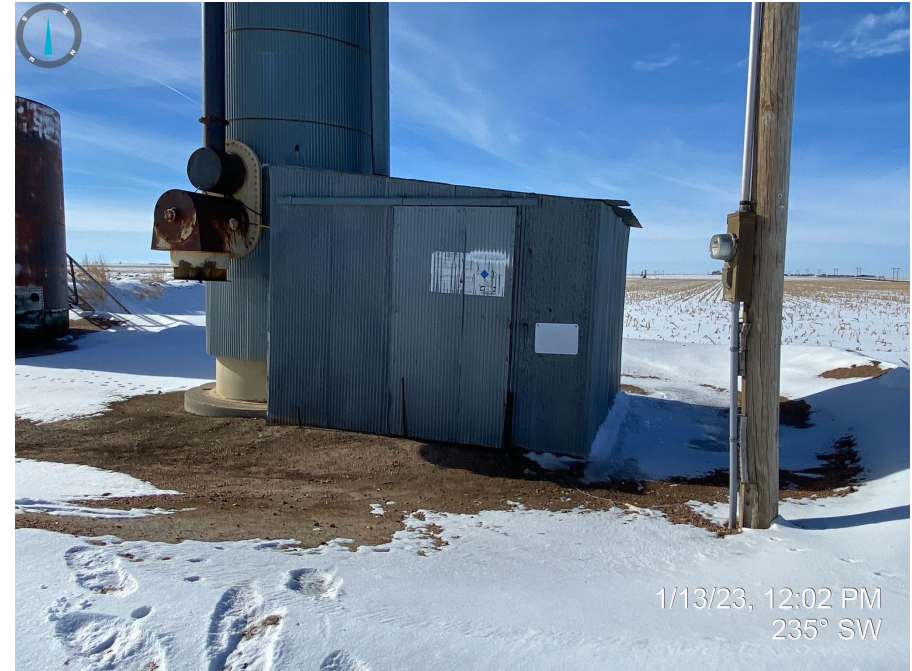
Photos 1 & 2. Facing southwest towards tanks. NFPA placards are either missing or not legible and need to be repaired/installed.

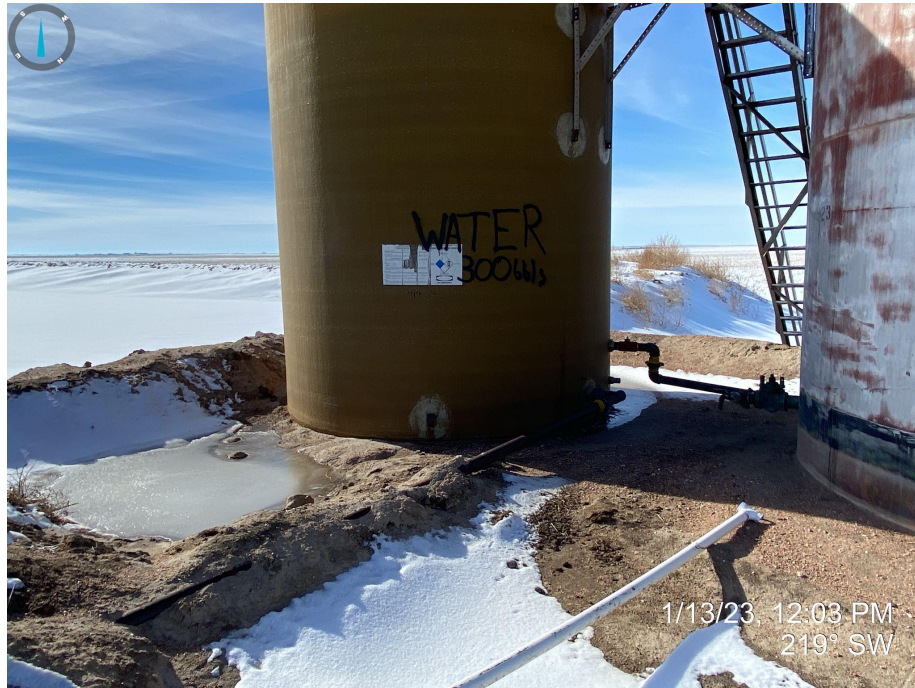
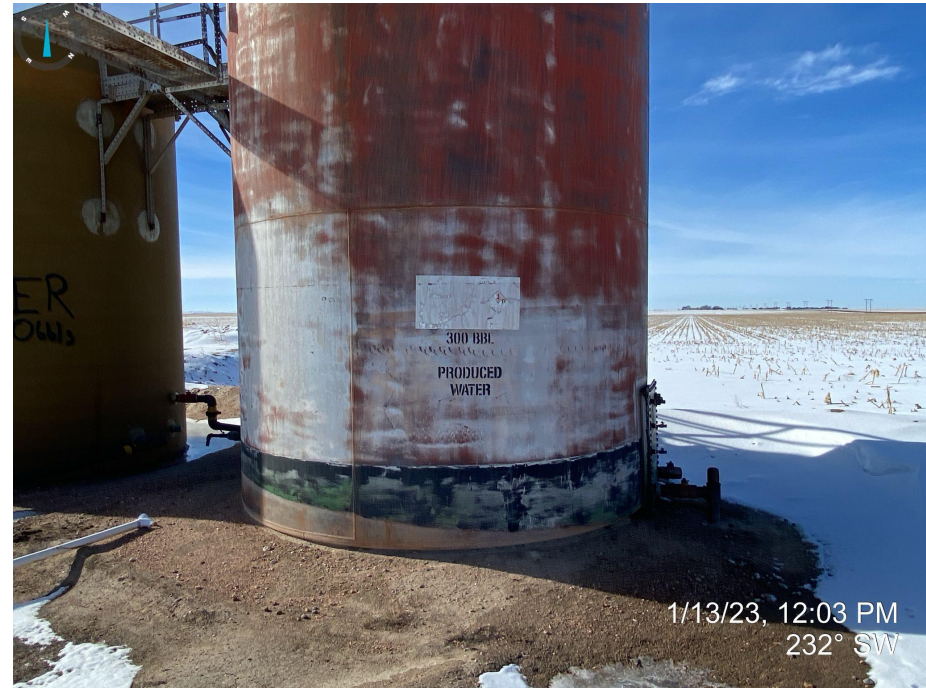
Photos 3 & 4. Facing southwest at produced water tanks. NFPA placards are either missing or not legible (e.g. cracked, peeling, faded) and need to be replaced.

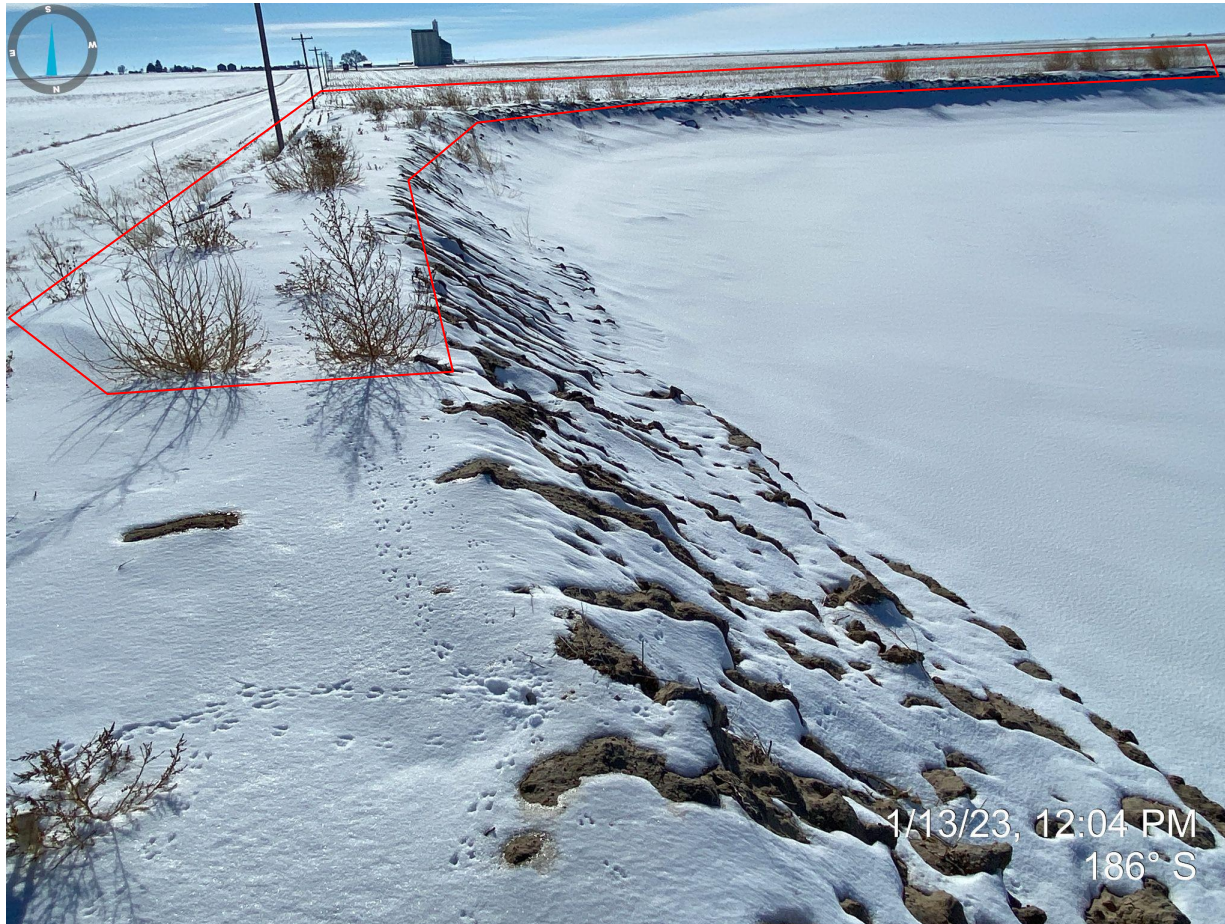
Photo 5. Facing south from the eastern pit wall. Photo illustrates rill erosion and unconsolidated material comprising the interior walls; e.g. not stabilized. Also pictured, undesirable weedy vegetation (e.g. kochia and russian thistle) that is considered debris and needs to be removed and managed for in the future.

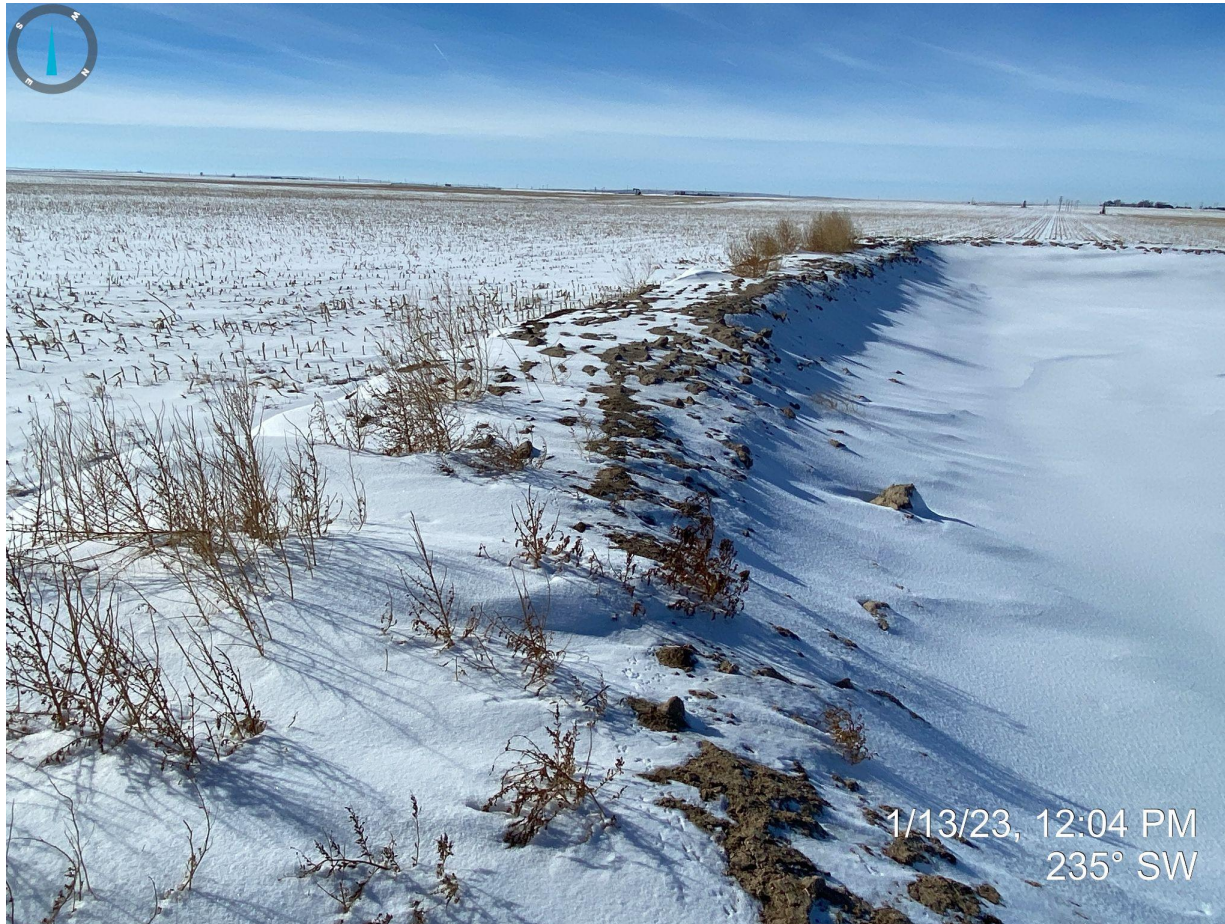
Photo 6. Facing southwest from southeast corner of pit. See comments in Photo 5.

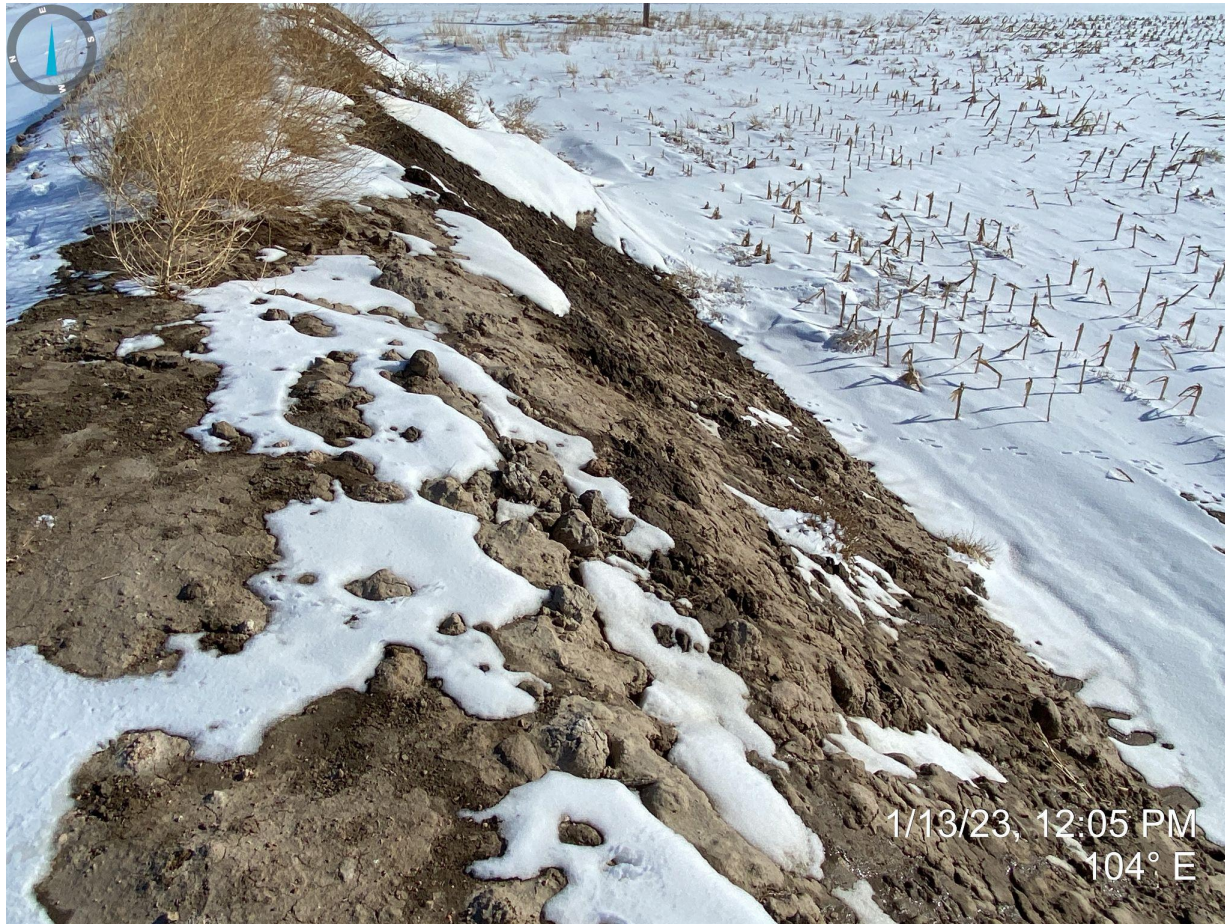
Photo 7. Facing east from southern pit wall. Photo illustrates the pit wall is unstabilized with evidence of rill erosion and unconsolidated material. These walls need to be repaired/stabilized to prevent further erosion from migrating off location.

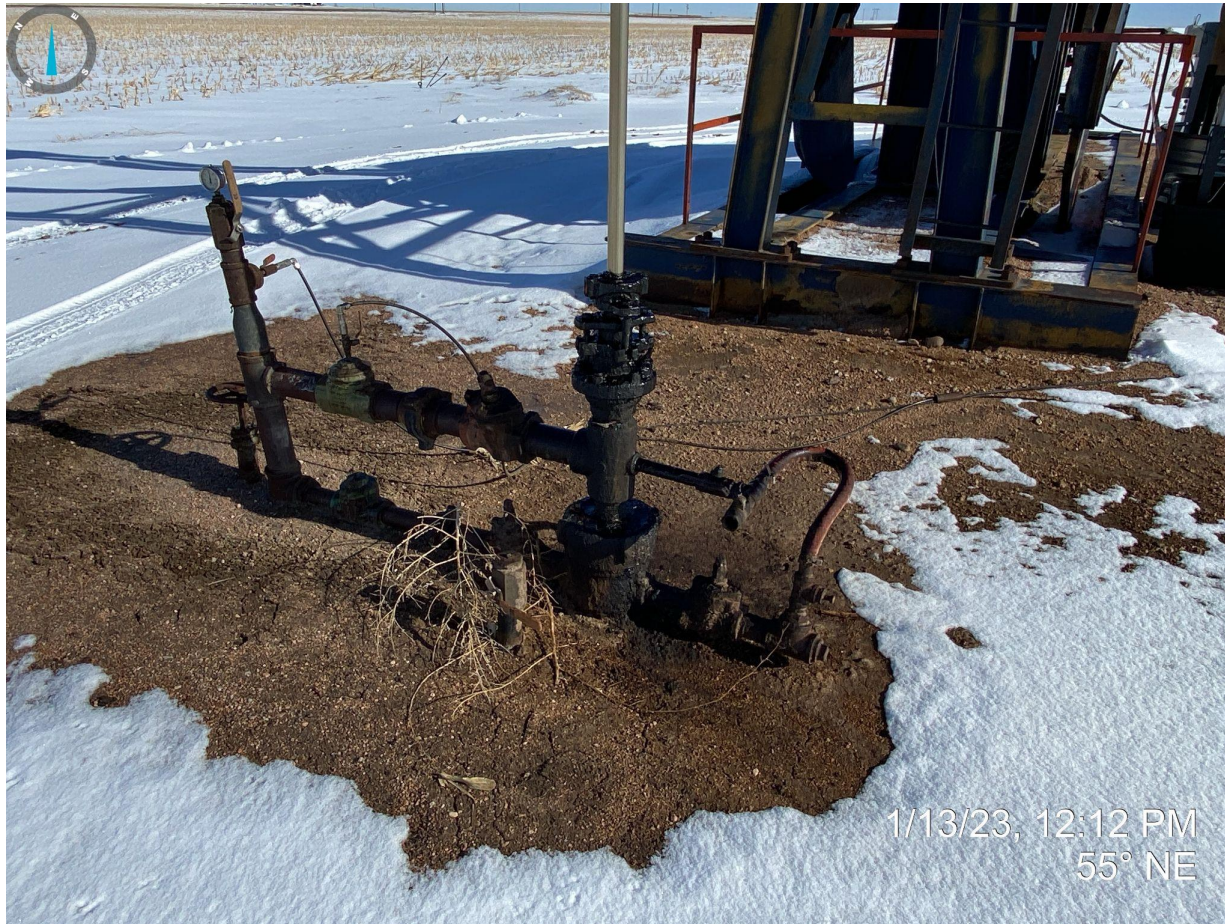
Photo 8. Facing northeast from wellhead. Photo illustrates oil stained soil around wellhead that needs to be properly cleaned and disposed of.
