Interim Reclamation and Stormwater Inspection

Date: 01/09/2023

Operator: IMPETRO RESOURCES LLC - 10690

Location ID: 317256

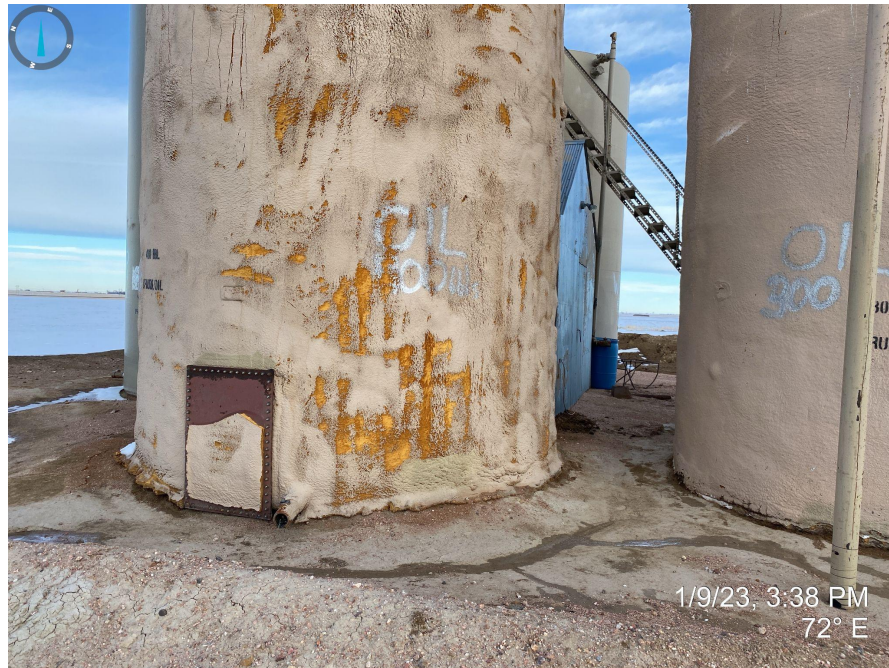
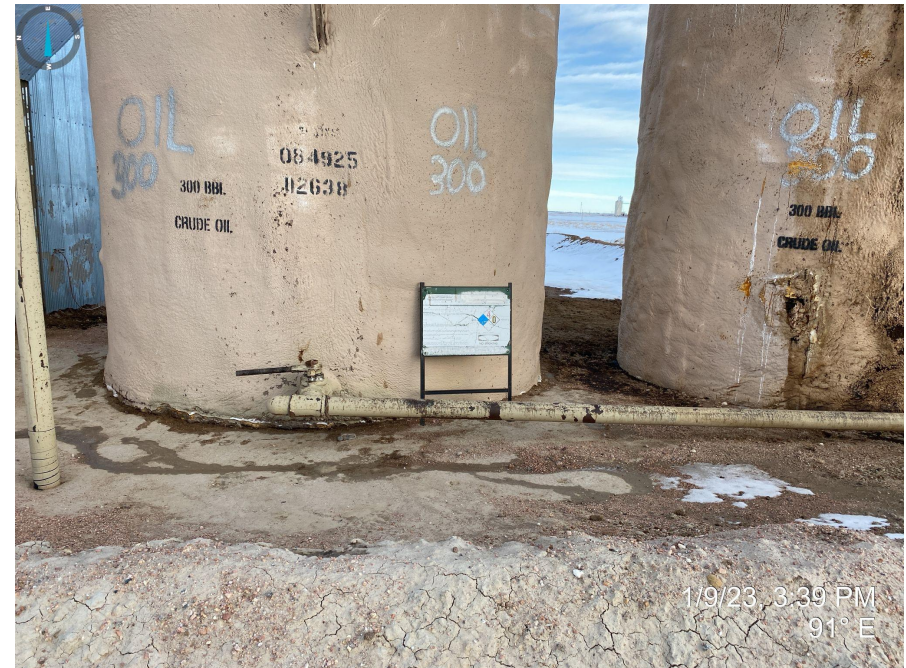
Photos 1 & 2. Facing east at the tank battery location. NFPA placards are either missing or not legible and need to be installed on all tanks.

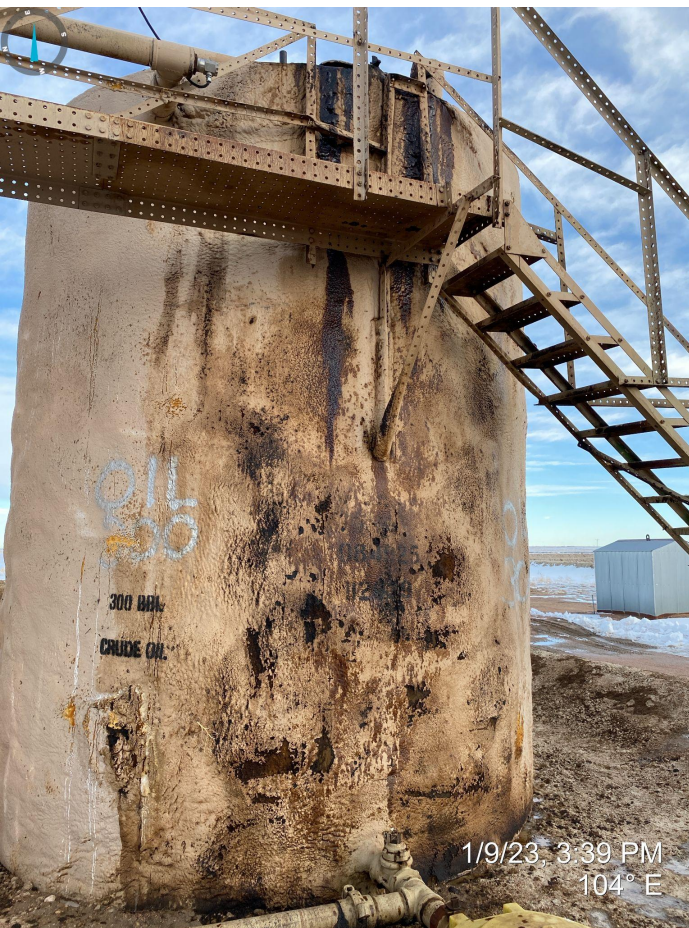
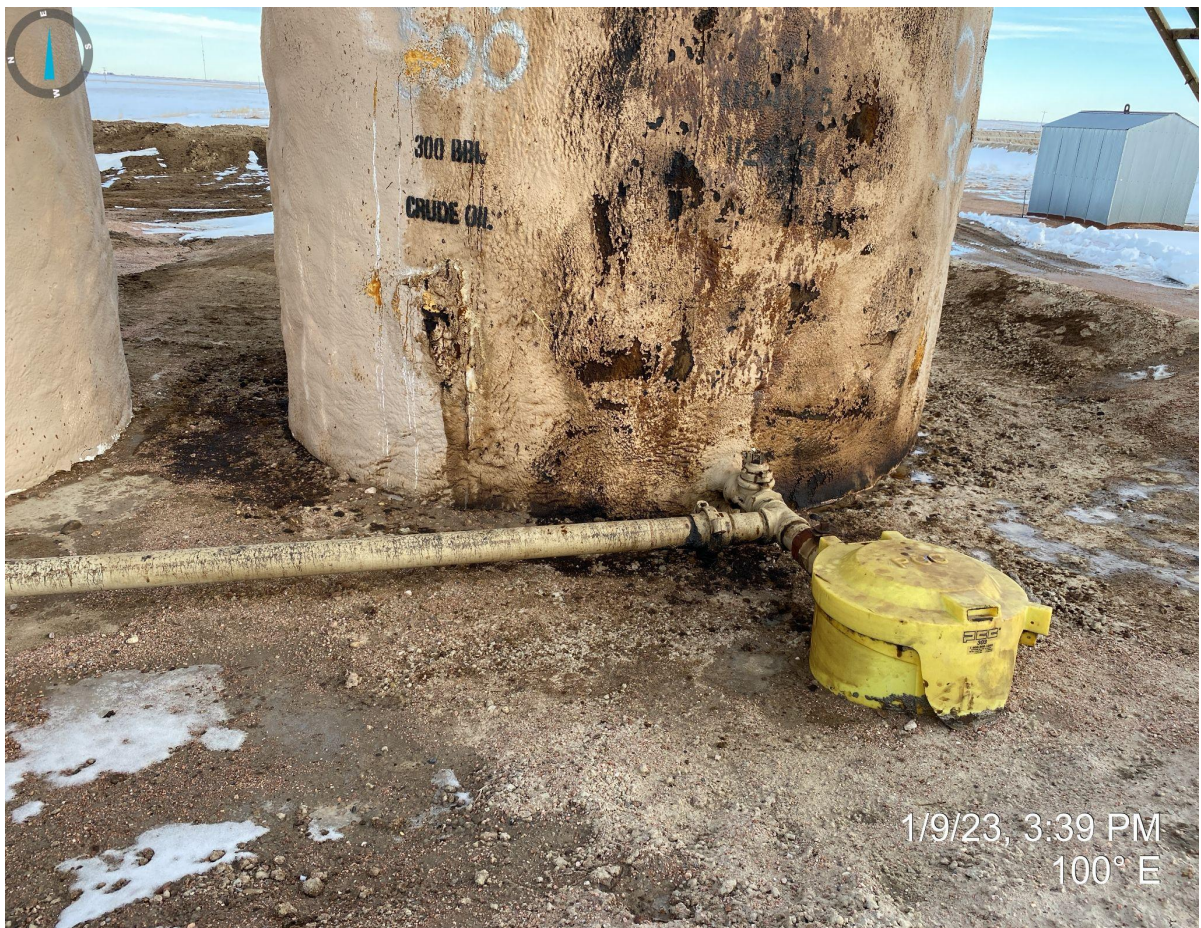
Photos 3 & 4. Facing east at tank battery. Photos illustrates crude oil spill appearing to come from the top of the tank near the thief hatch. Also pictured, oil stained soil around the bottom of the tank.

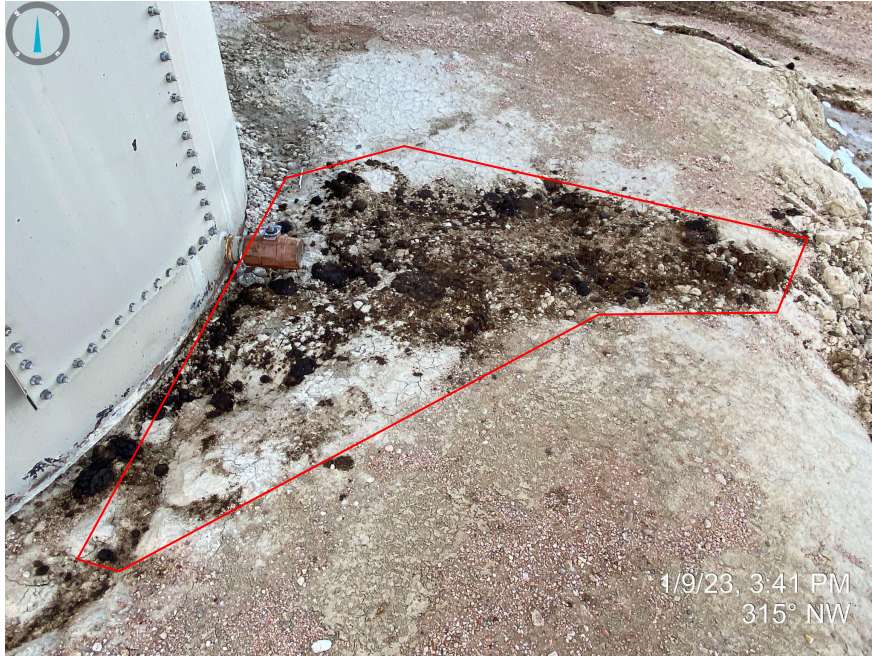
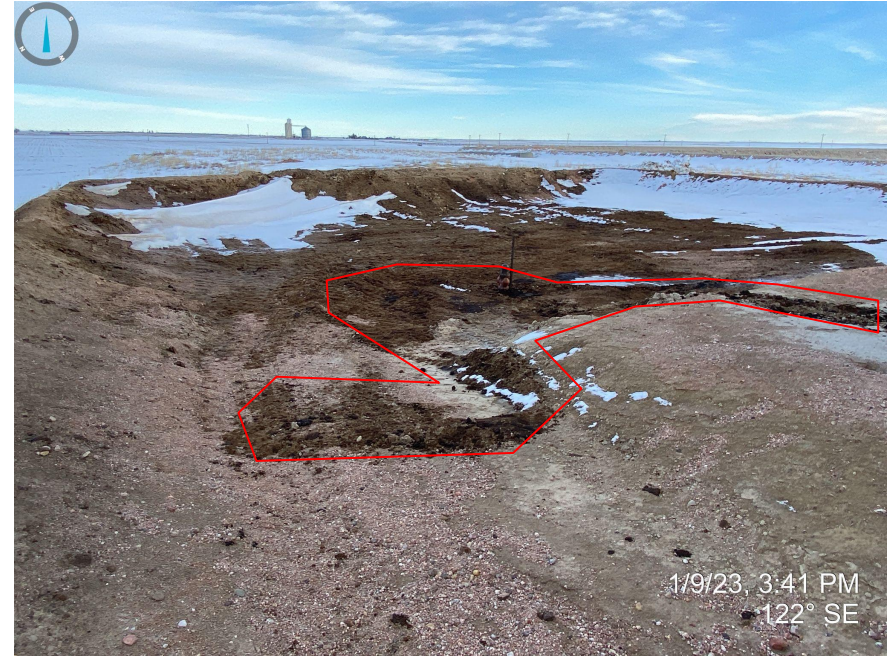
Photos 5 & 6. Facing northwest and east from the eastern side of the tank batteries. Photo illustrates oil stained soils that need to be properly removed and disposed of.

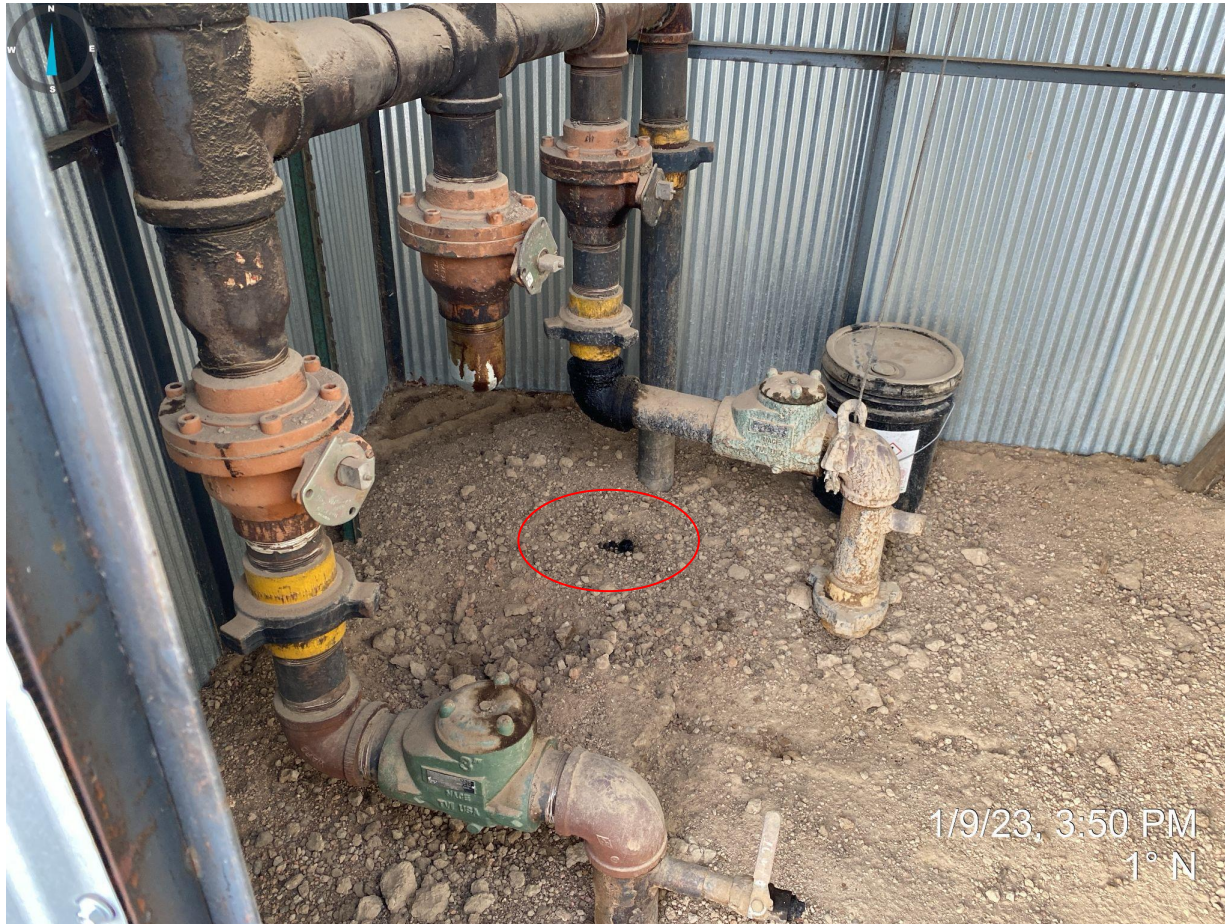
Photo 7. Facing north from inside of shed, north of skim pit. Photo illustrates oil stained soils coming from a leaky fitting.

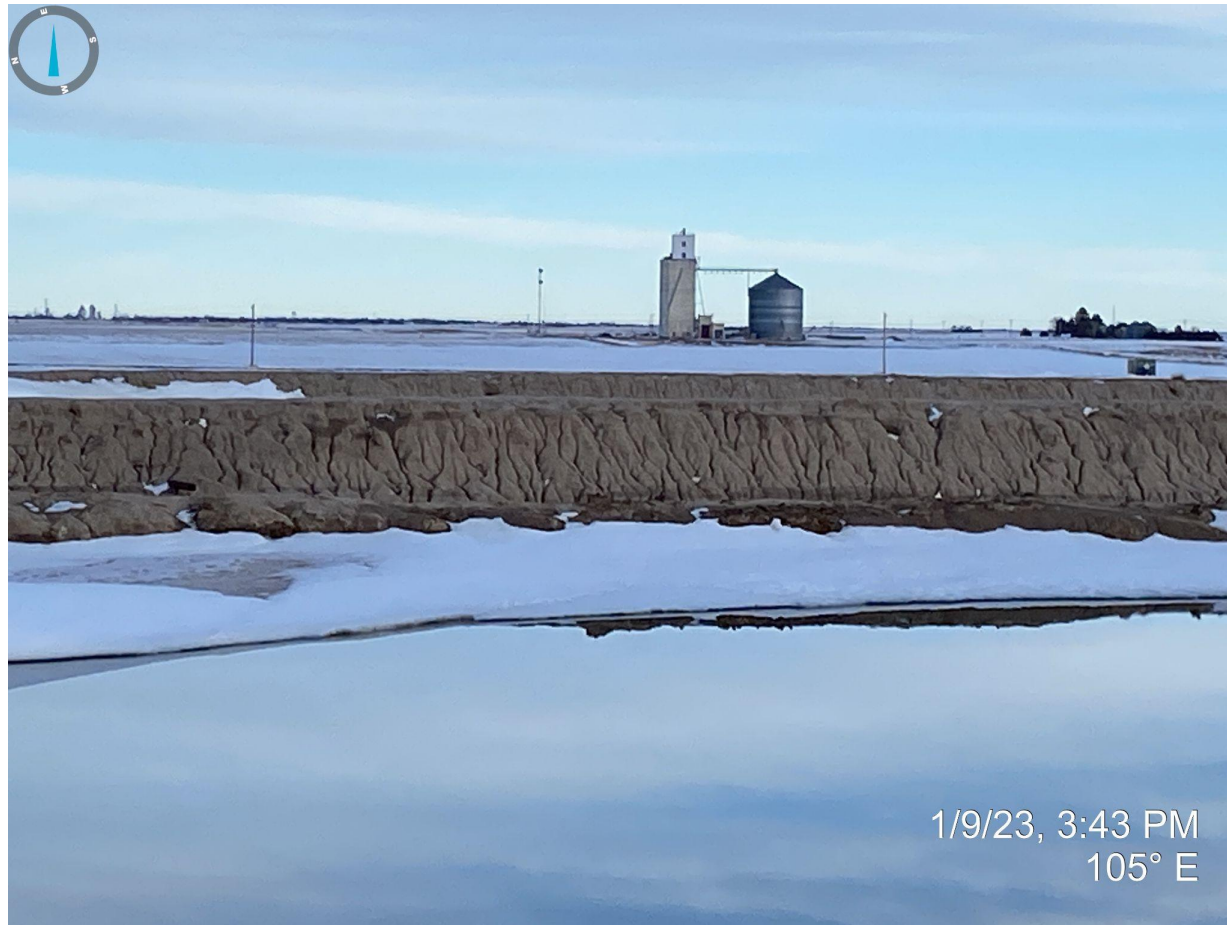
Photo 8. Facing east from skim pit. Photo illustrates rill erosion occurring on the interior pit wall; these walls are not stabilized as the material is unconsolidated.

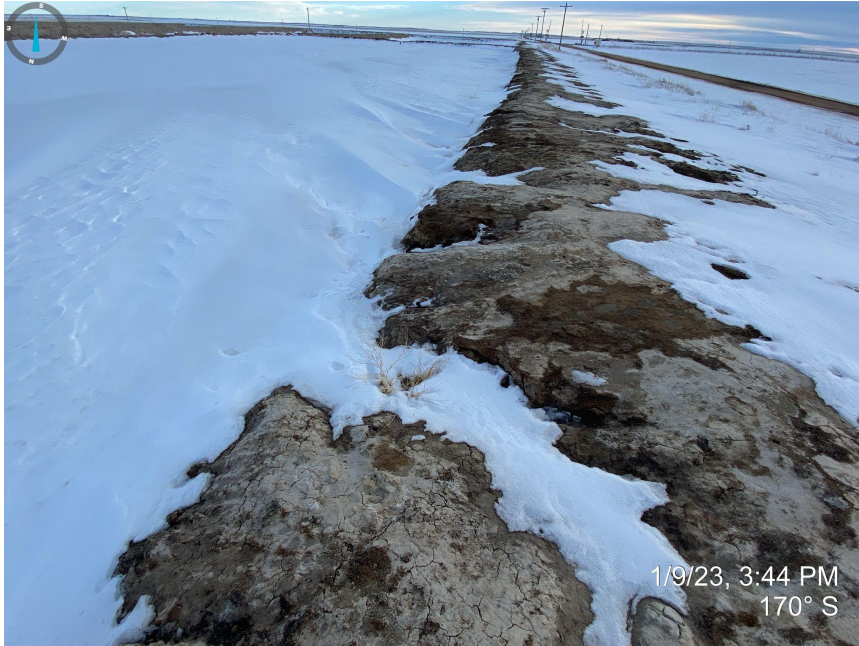
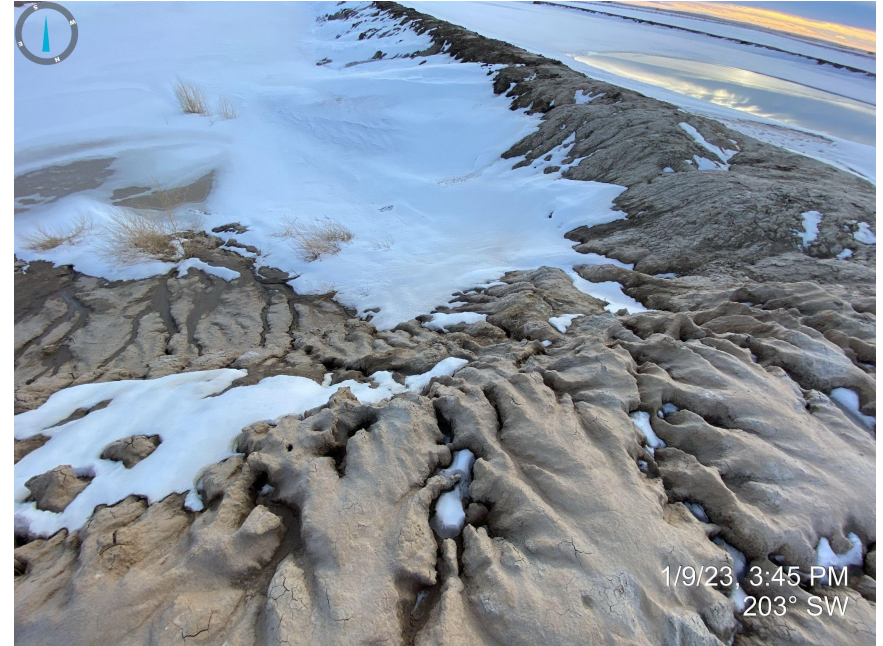
Photos 9 & 10. Facing south and southwest from northern portion of the pit facilities. See comments in Photo 8.

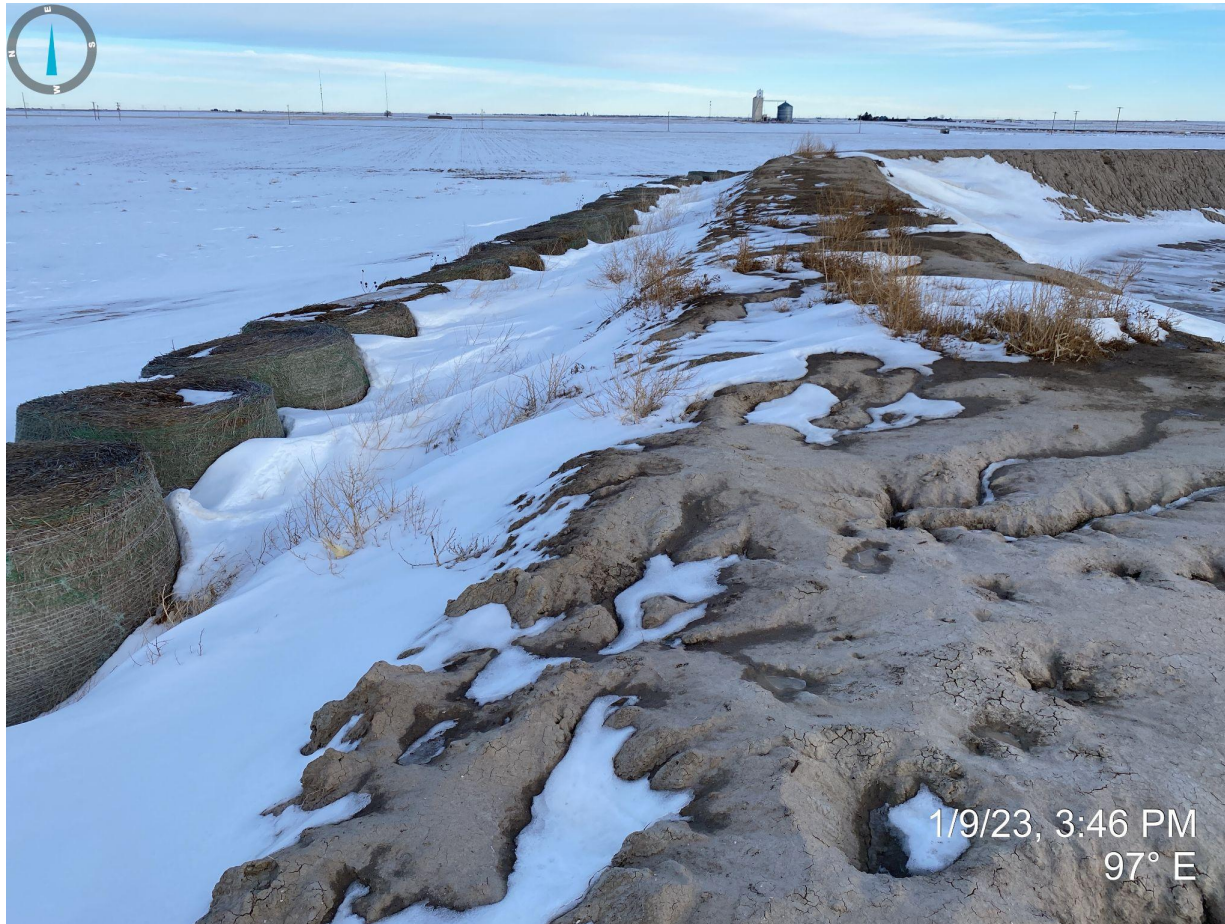
Photo 11. Facing east from the northeastern corner of pit. Photo illustrates undesirable weedy vegetation (e.g. russian thistle and kochia); this is now considered debris and needs to be removed.
