# Inspection Photos

January 13, 2023

Operator: Caerus Piceance LLC - #10456

Location Name: SHAEFFER-67S93W/12SENW

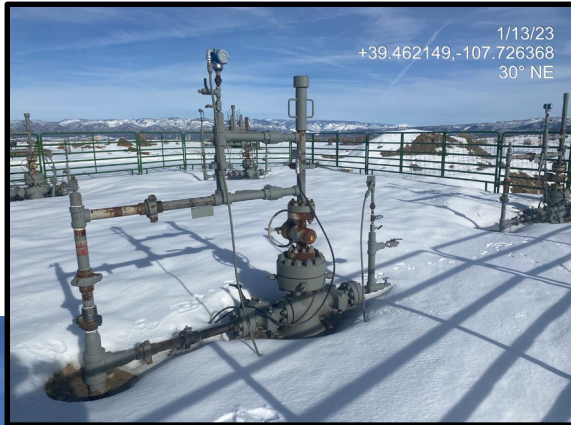
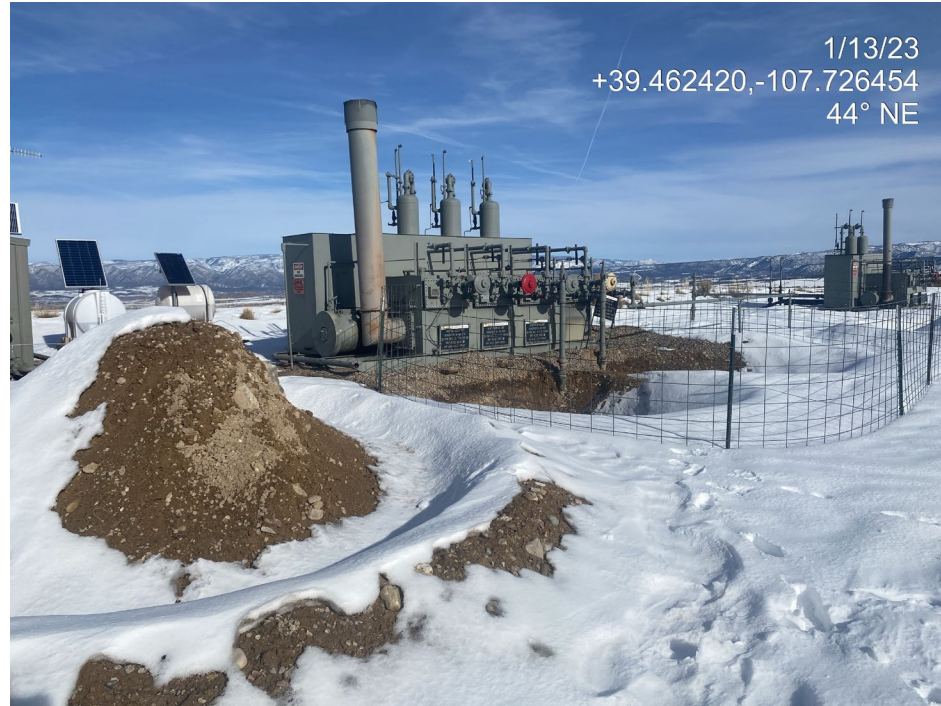
Photo 1. Photos show production areas.

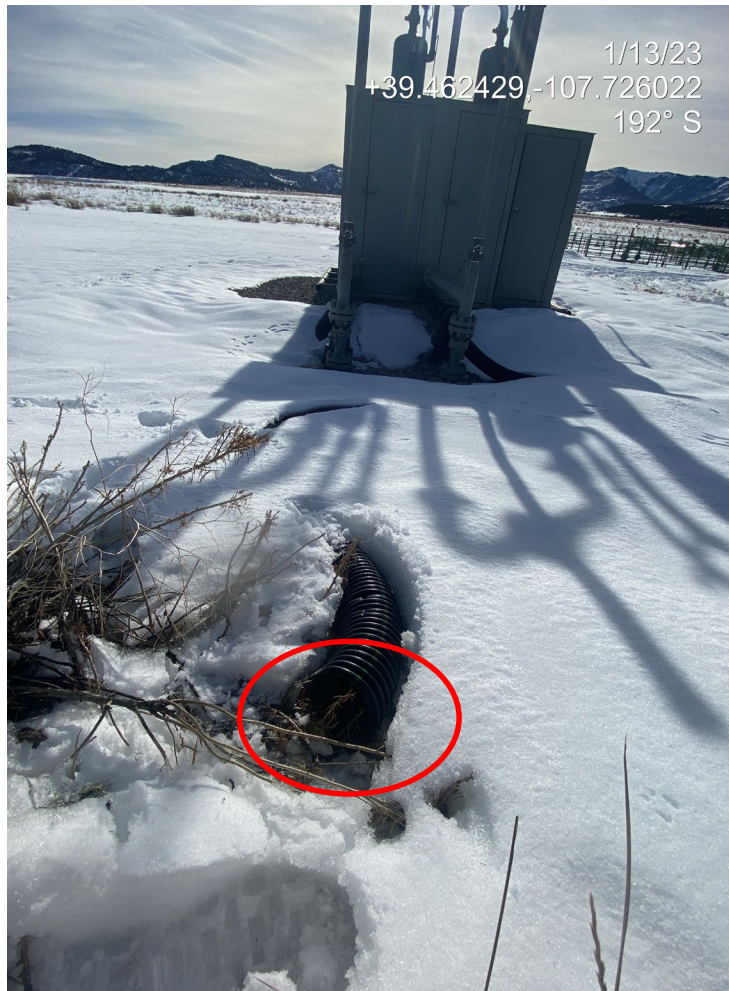
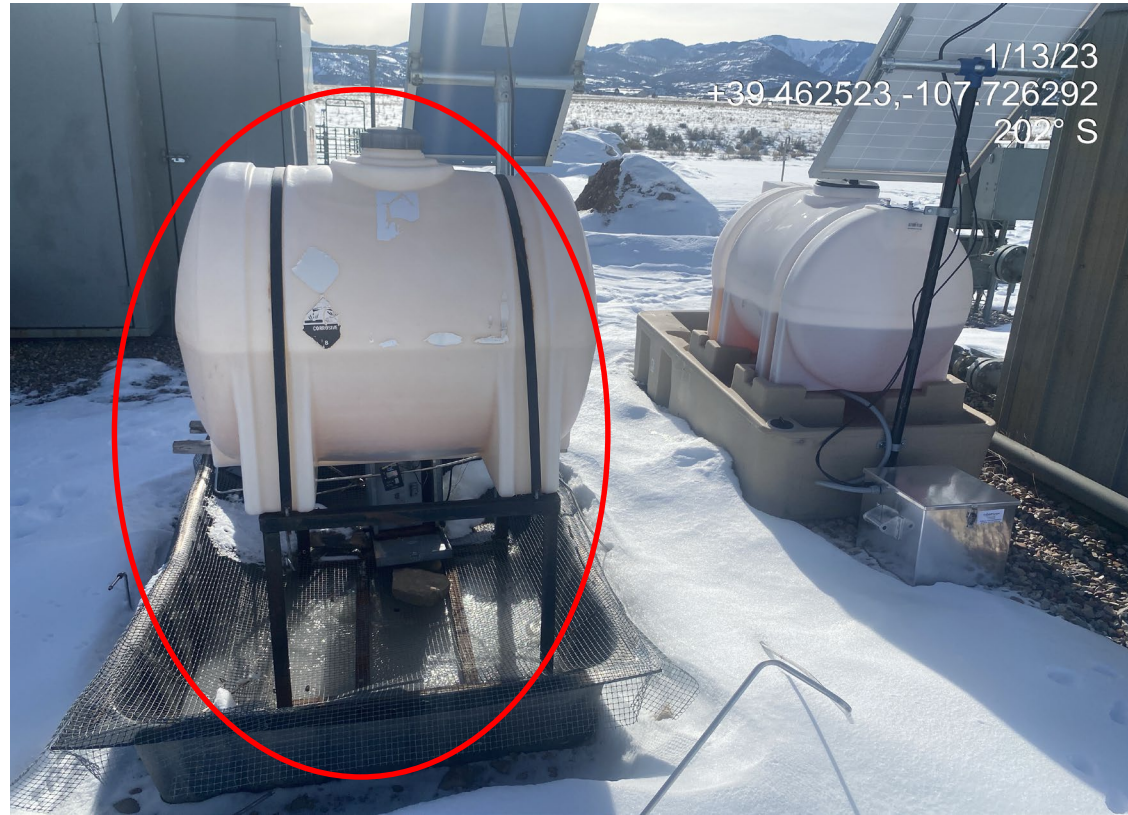
**Photo 2.** Photos show open ended piping at separators (left), an unused chemical tank (right).

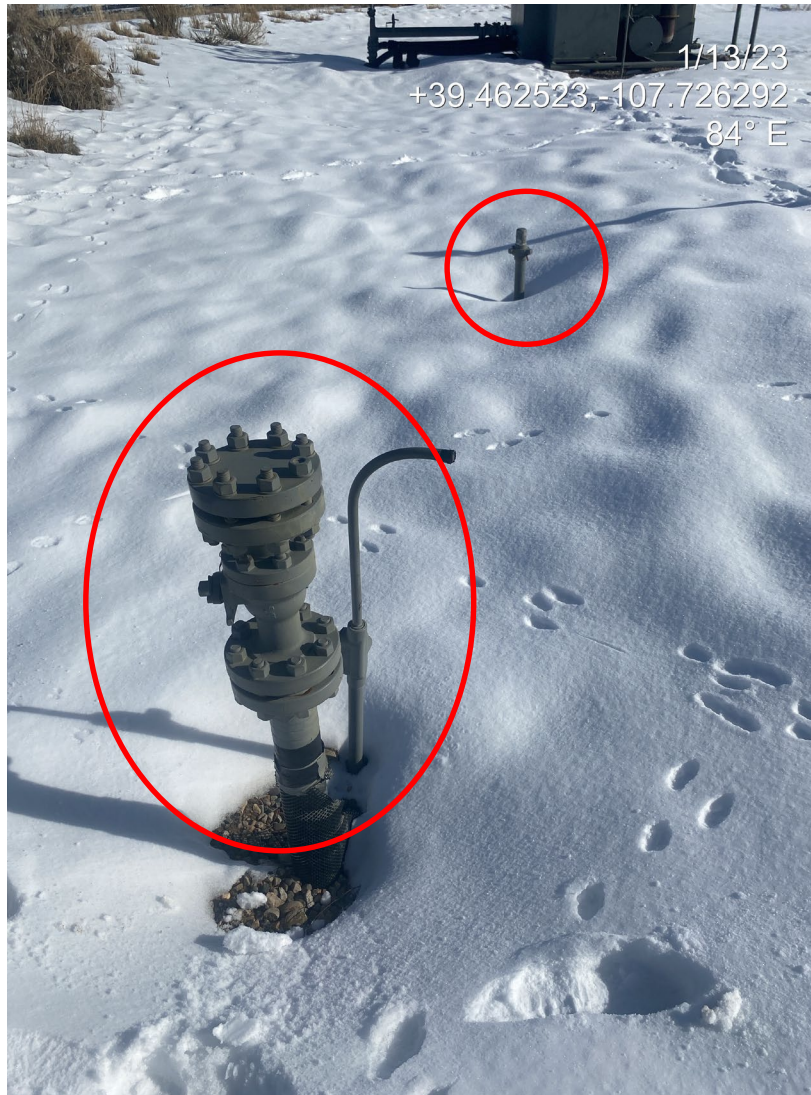
**Photo 3.** Photo shows two (2) risers which appear to be associated with plugged and abandoned well API #045-10452. Unused equipment must be removed.

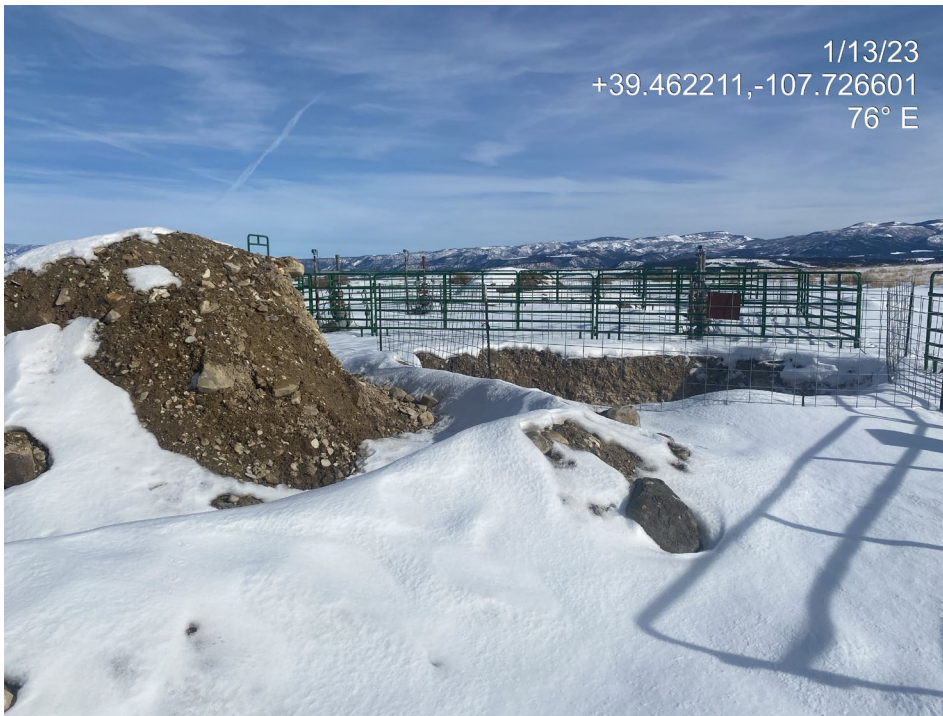
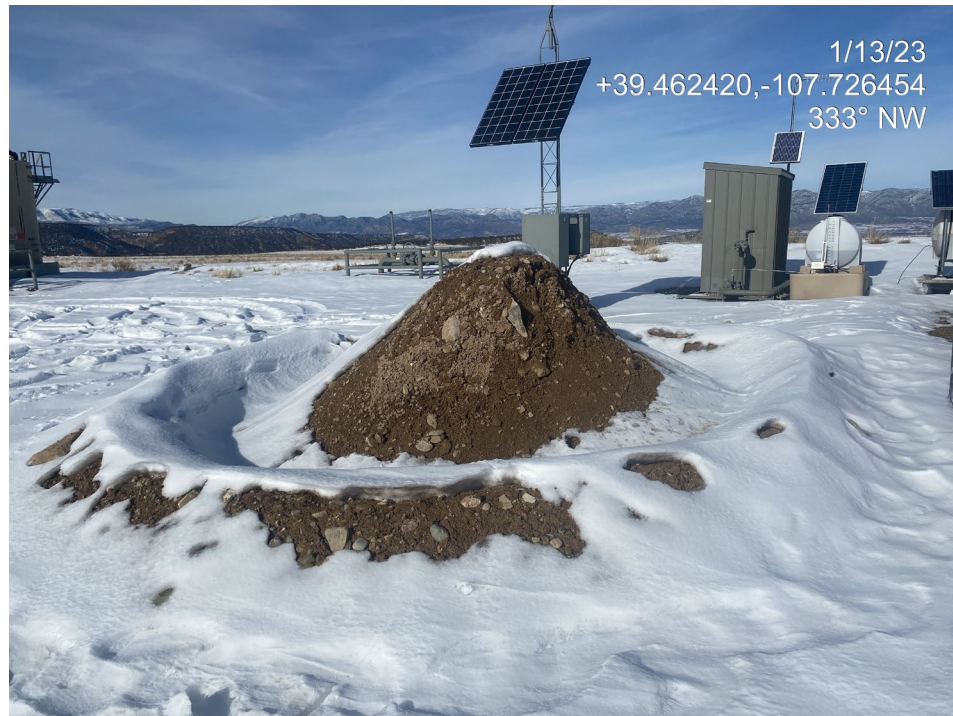
**Photo 4.** Photos show stockpiled soil associated with plugged and abandoned well API #045-09128 (left) and the associated separator and flowline (right) excavations. Perimeter control berm does not appear properly compacted. Soils are loose, and susceptible to wind and water erosion and may act as a sediment source.

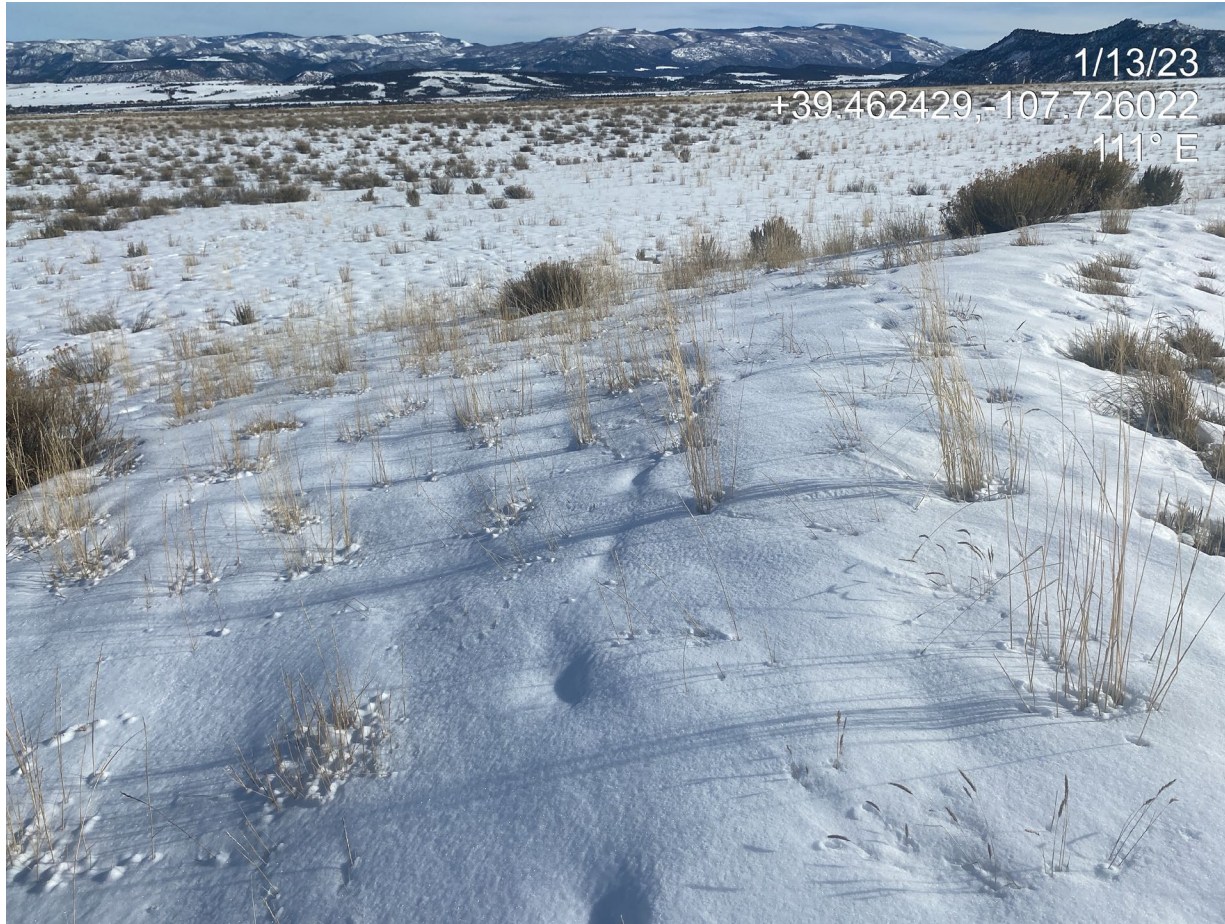
**Photo 5.** Photo shows an example of location interim areas. Introduced perennial grasses appear established.
