Construction and Stormwater Inspection

January 17, 2023

Operator: ENERPLUS RESOURCES (USA) CORPORATION - #10177

Location ID: 478120

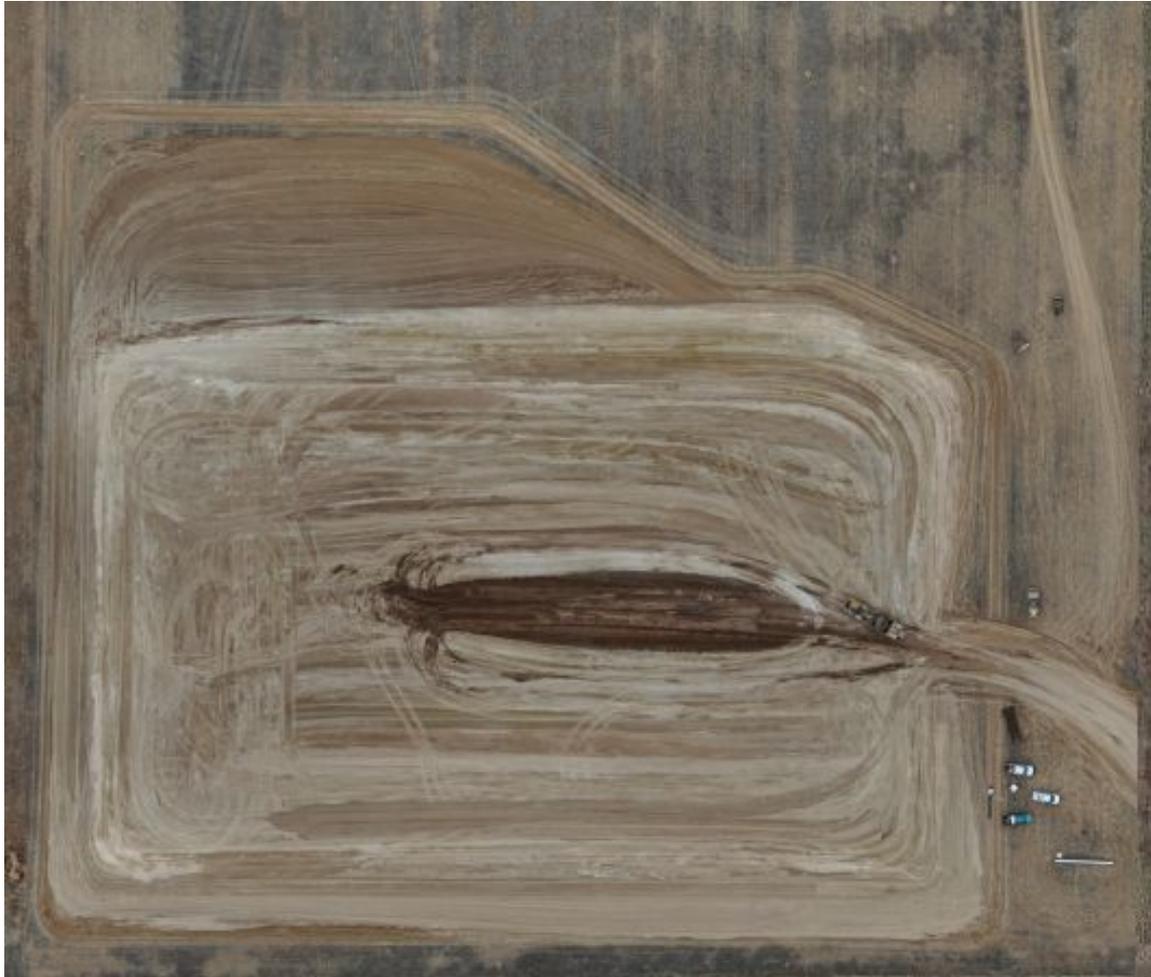
Photo 1. COGCC drone imagery illustrates the location and a disturbance area of 7.95 acres. The stockpile observed in the central location is topsoil from the access road being salvaged. Note- Operator was utilizing a temporary access road north of the location that was not permitted but is owned by Enerplus. See next photo for additional details.

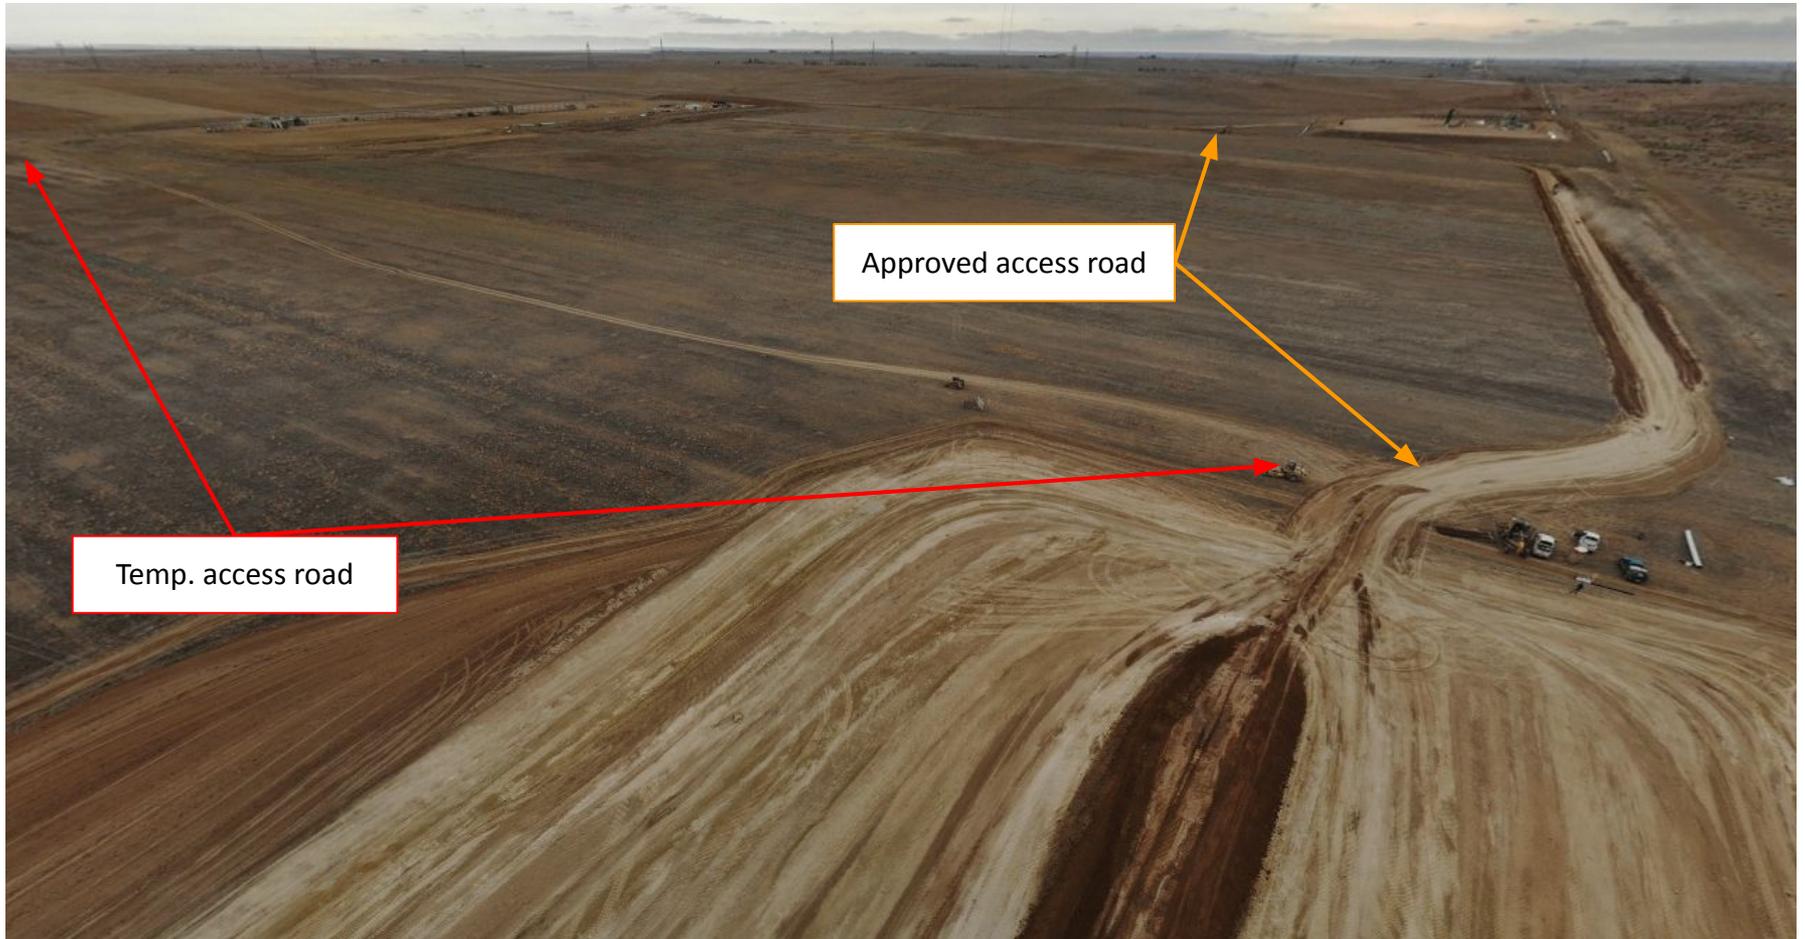
Photo 2. COGCC drone imagery illustrates the temporary access road north of the location that was not permitted and the approved access road.

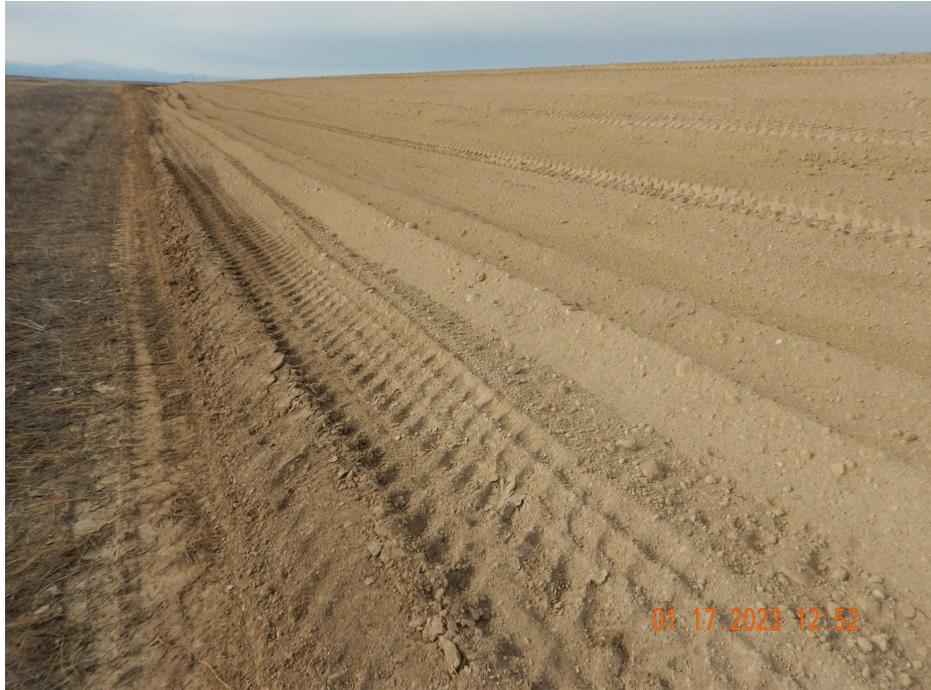
Photo 3. Photo taken from the southern location, facing West. Photo illustrates the fill slope material has filled in the temporary stormwater ditch and berm BMP. Note- Operator appears to be constructing a detention pond or detention berm along the southern location per Weld County standards.

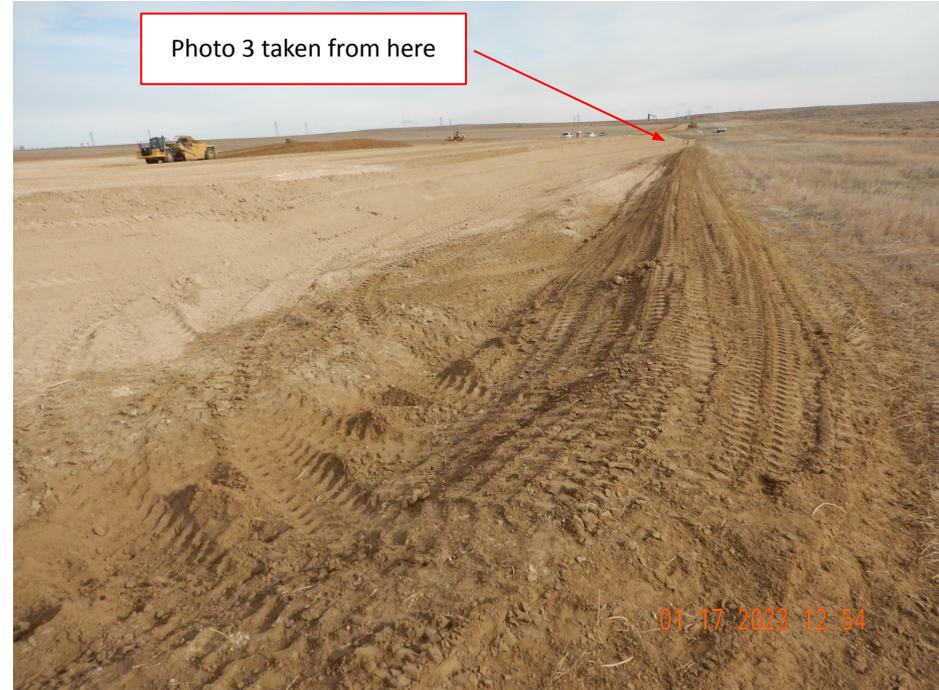
Photo 4. Photo taken from the southwestern location, facing East. Photo illustrates the temporary stormwater ditch and berm BMP without fill slope material.

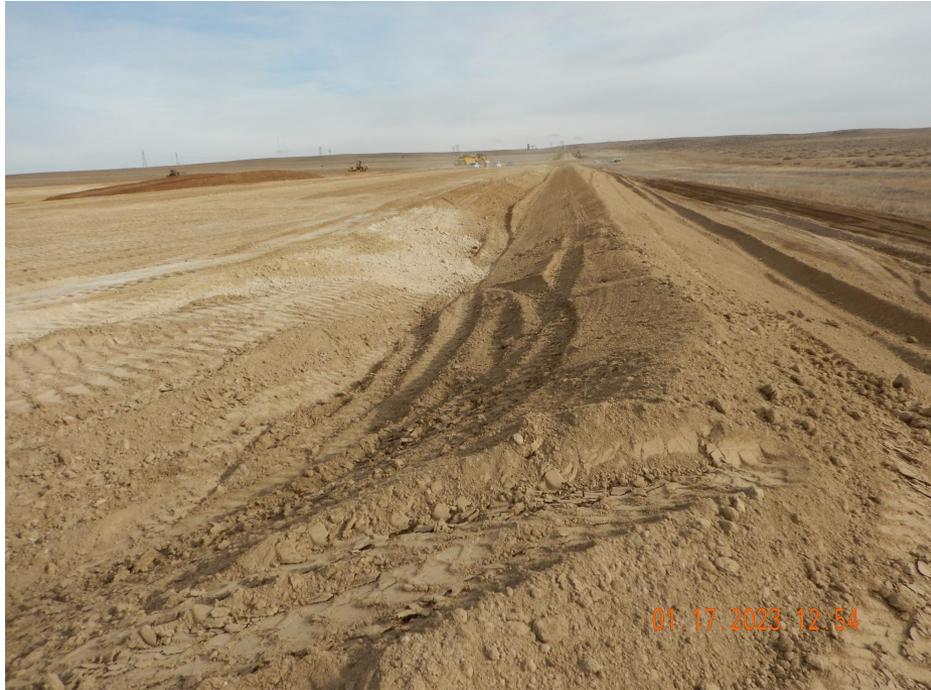
Photo 5. Photo taken from the southwestern location, facing East. Photo illustrates what appears to be the start of construction for the detention pond or detention berm.

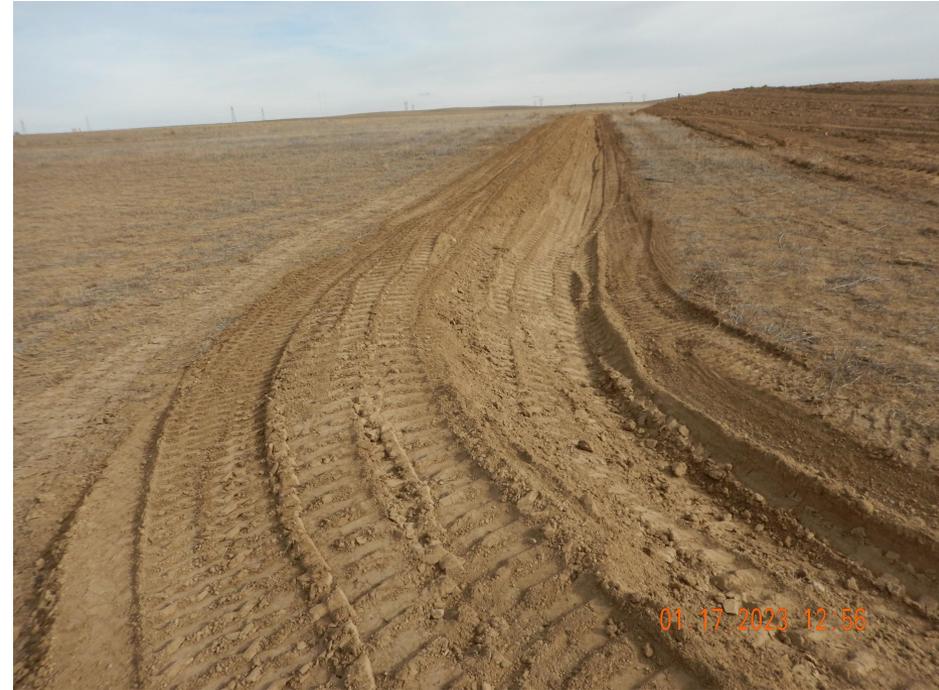
Photo 6. Photo taken from the northwestern location, facing East. Photo illustrates the temporary stormwater ditch and berm BMP and the topsoil stockpile.

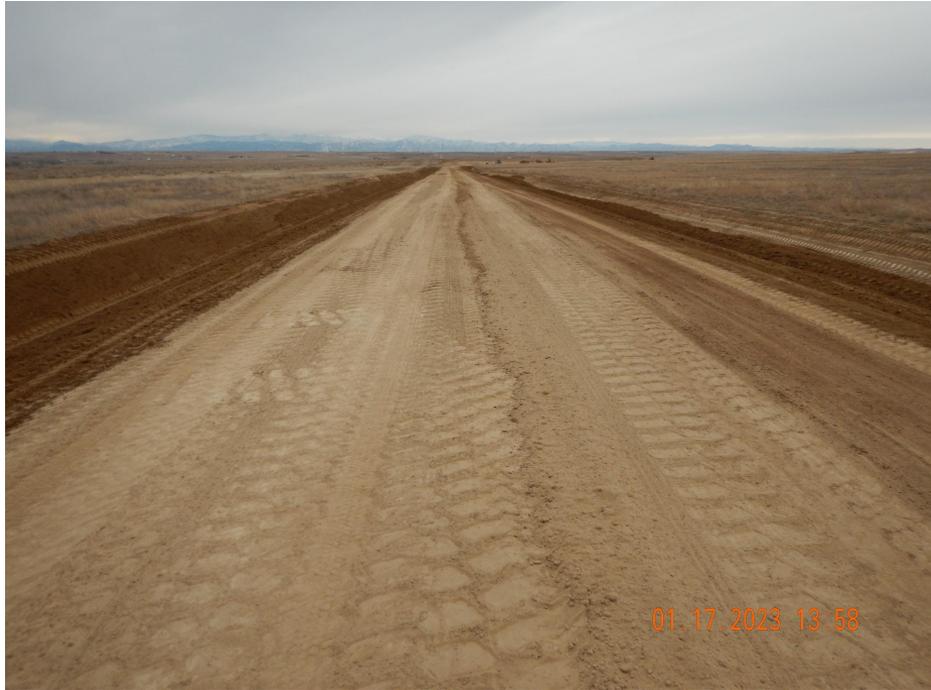
Photo 7. Photo taken from a portion of the access road, facing West. Photo illustrates the Operator is stockpiling/applying topsoil to an approximate depth of 6" along the ditch area of the access road to facilitate final reclamation.

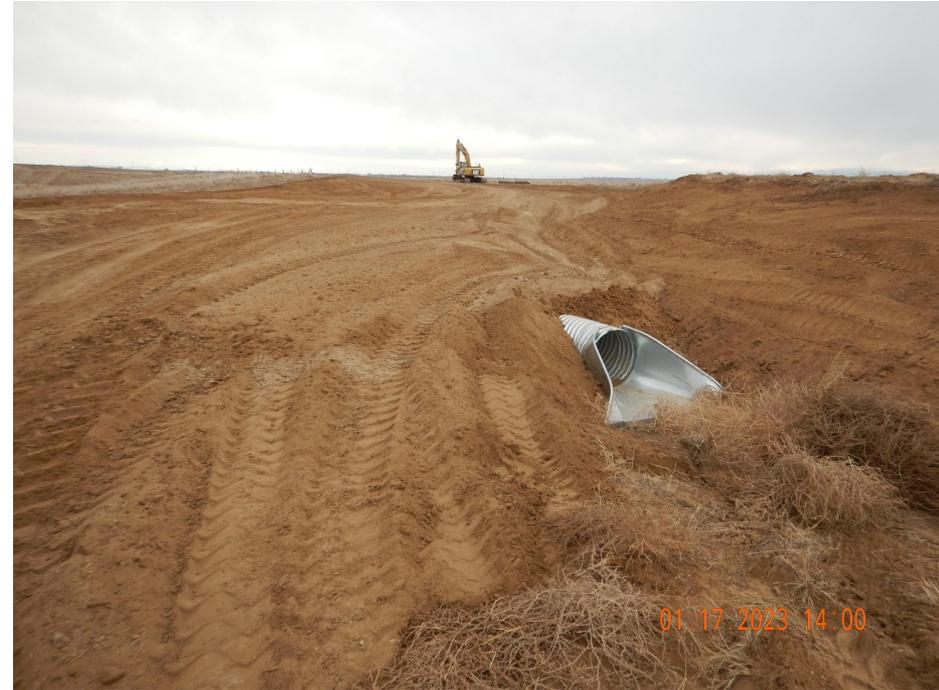
Photo 8. Photo taken from the entrance of the approved access road, facing South. Operator is in process of constructing the access road and completing the culvert installation.
