Inspection Photos

API: 043-06122

Operator: JAVERNICK OIL

Inspection Date: 1/24/2023

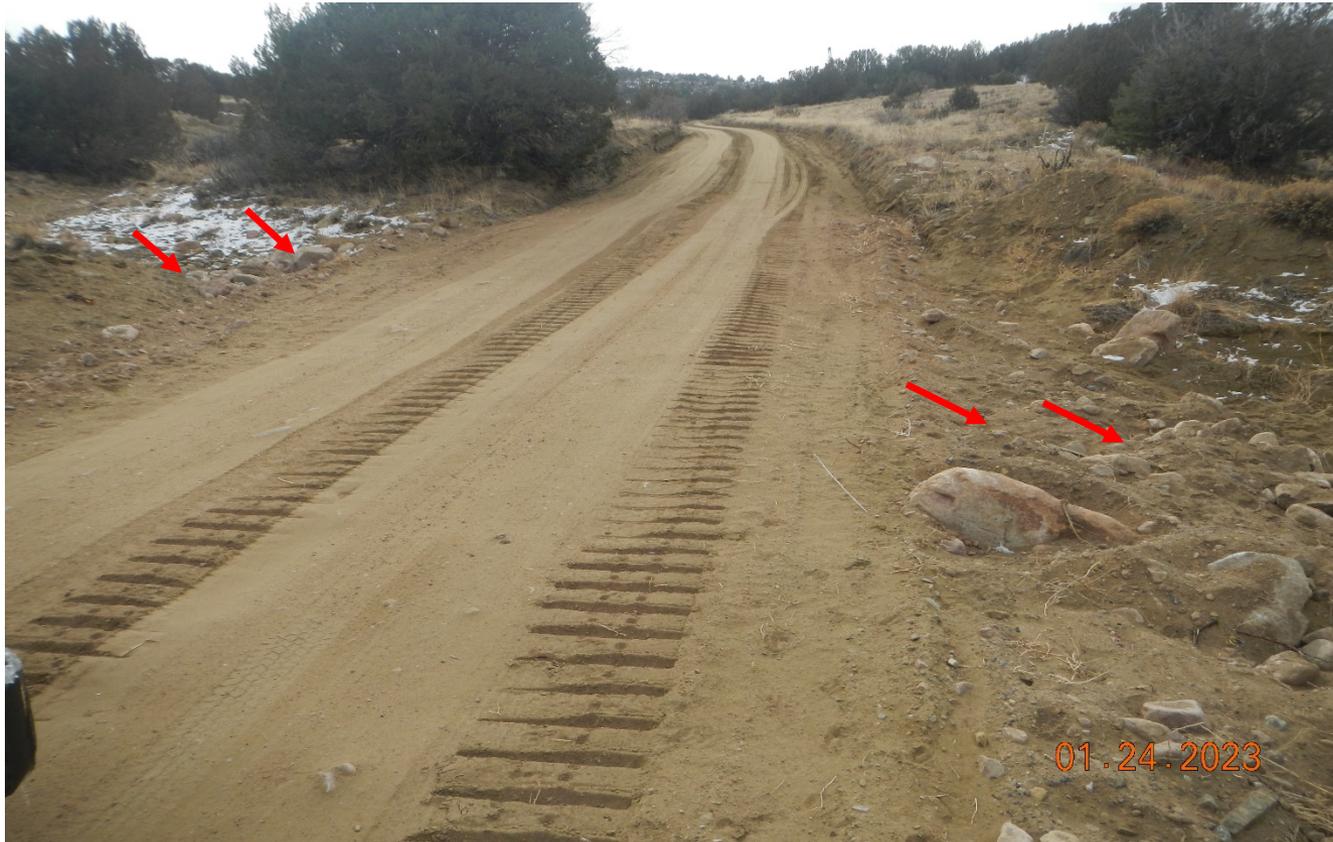
Photo 1. Facing southeast long the access road. This drainage crossing must have BMP's installed to accommodate seasonal storm event to prevent material from washing out. BMP may include culvert, rip/rap, ect. Previous corrective action not completed. Red line shows direction of drainage flow.

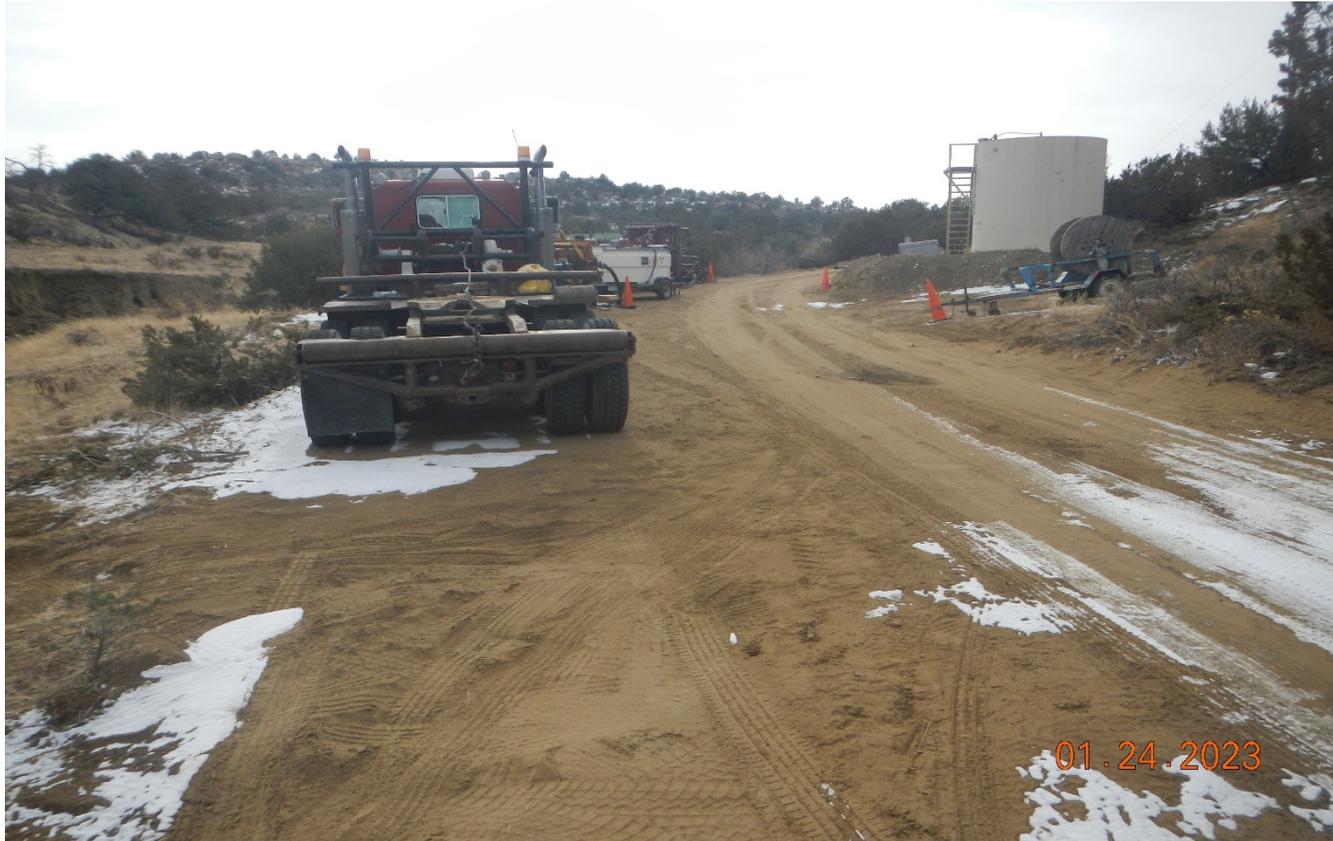
Photo 1. Facing southeast long the access road at the tank battery site. Soils were pushed out in this area toward the drainage and no BMP's along down gradient perimeter. Drilling equipment is being stored in this area.

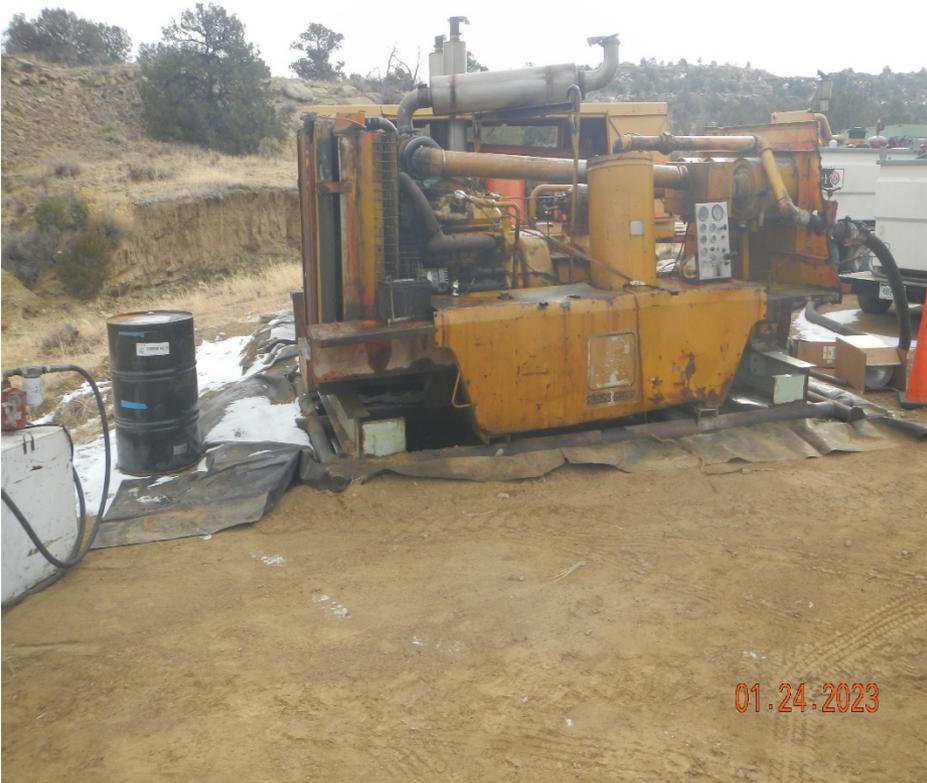
Photo 3. There are multiple equipment leaking oil. There is plastic matting however it does not cover the area well and has no containment.

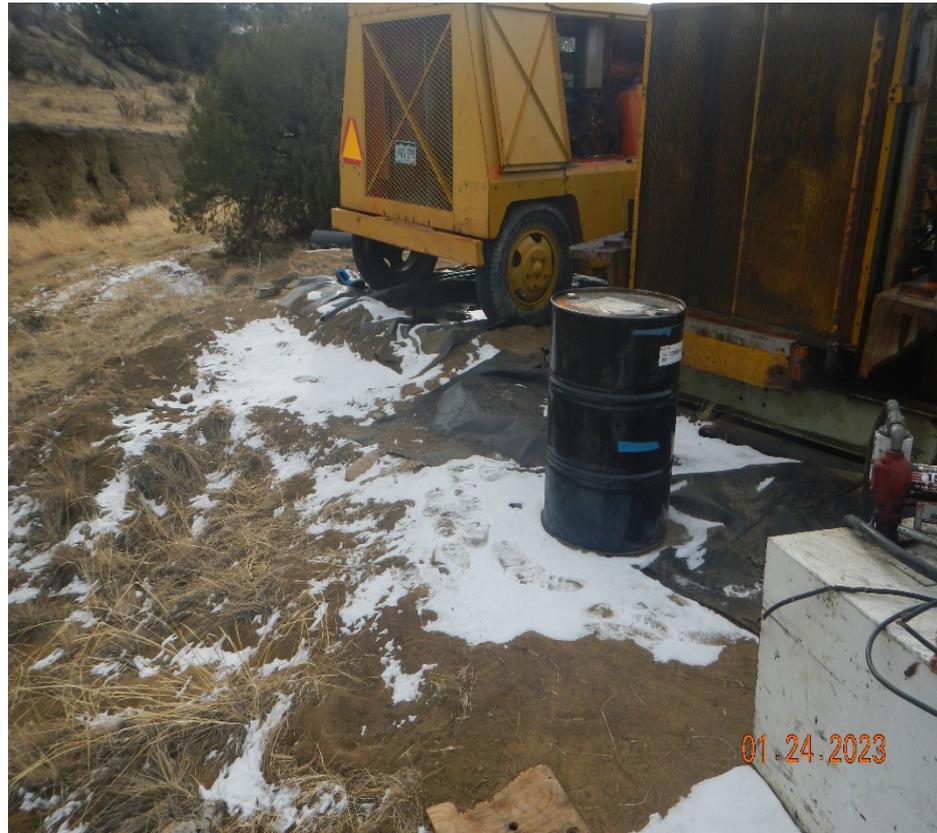
Photo 4. There is no down gradient perimeter controls toward the drainage in the left side of photo. This equipment is leaking fluids shown in the next two photos.

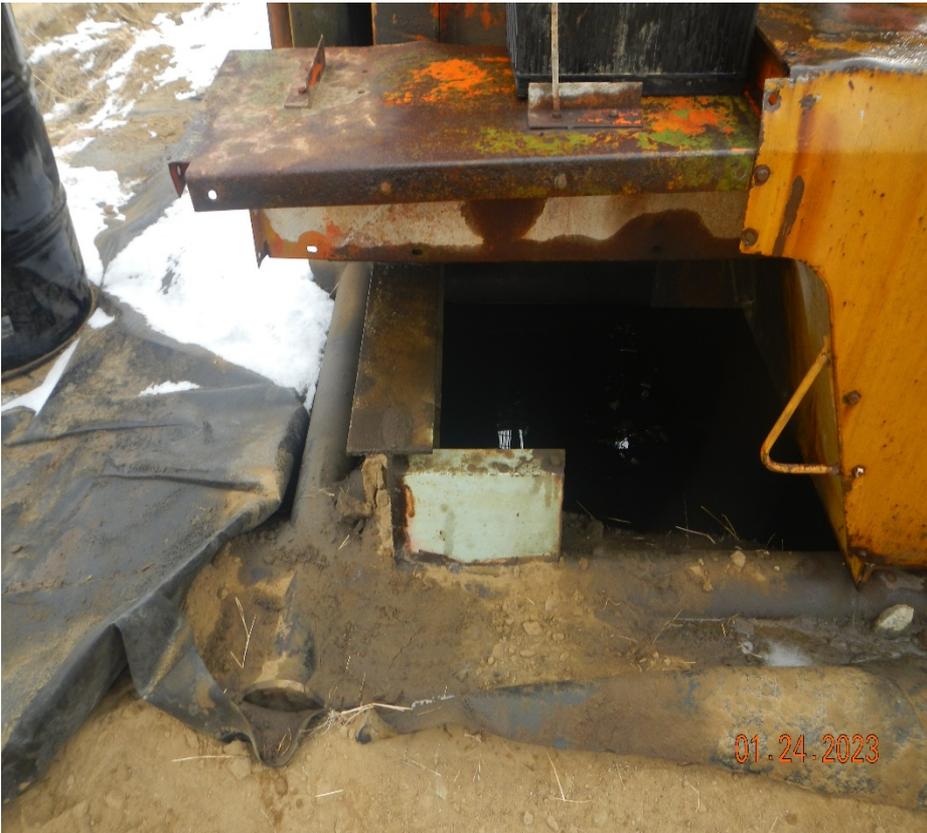
Photo 5. There is oily fluid in tis engine skid which is not contained and needs to be cleaned up immediately.

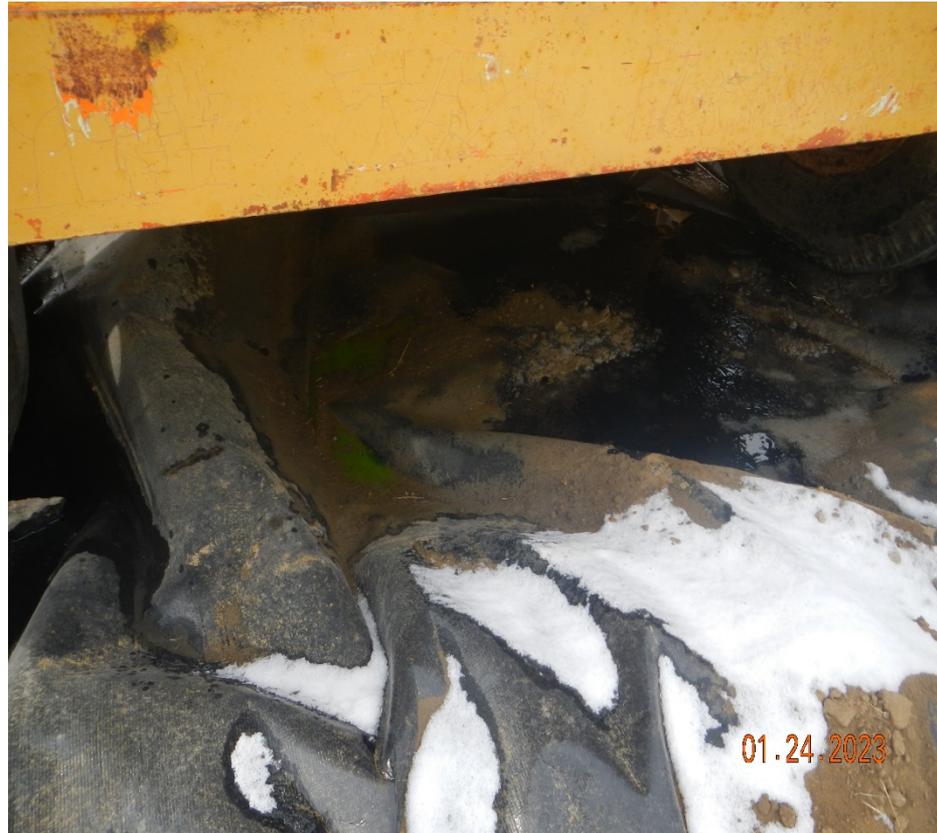
Photo 6. There is oily fluid and anitfreeze underneath this equipment that is not contained and needs to be cleaned up immediately.

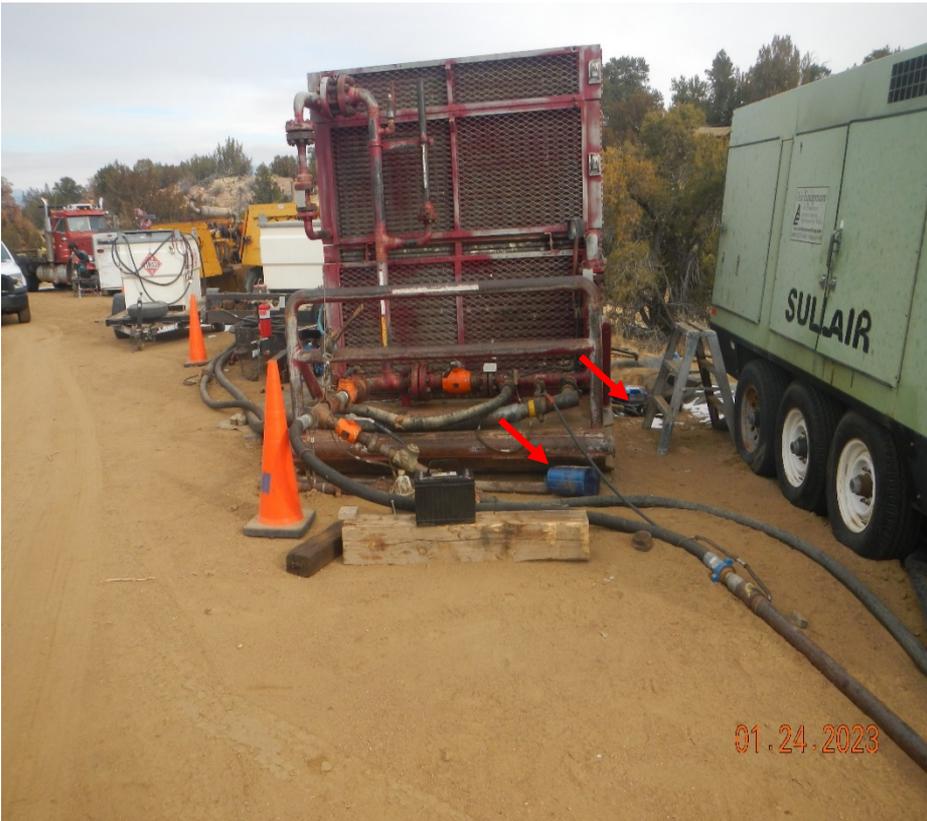
Photo 7. There are numerous buckets and container laying on the ground and not properly stored.

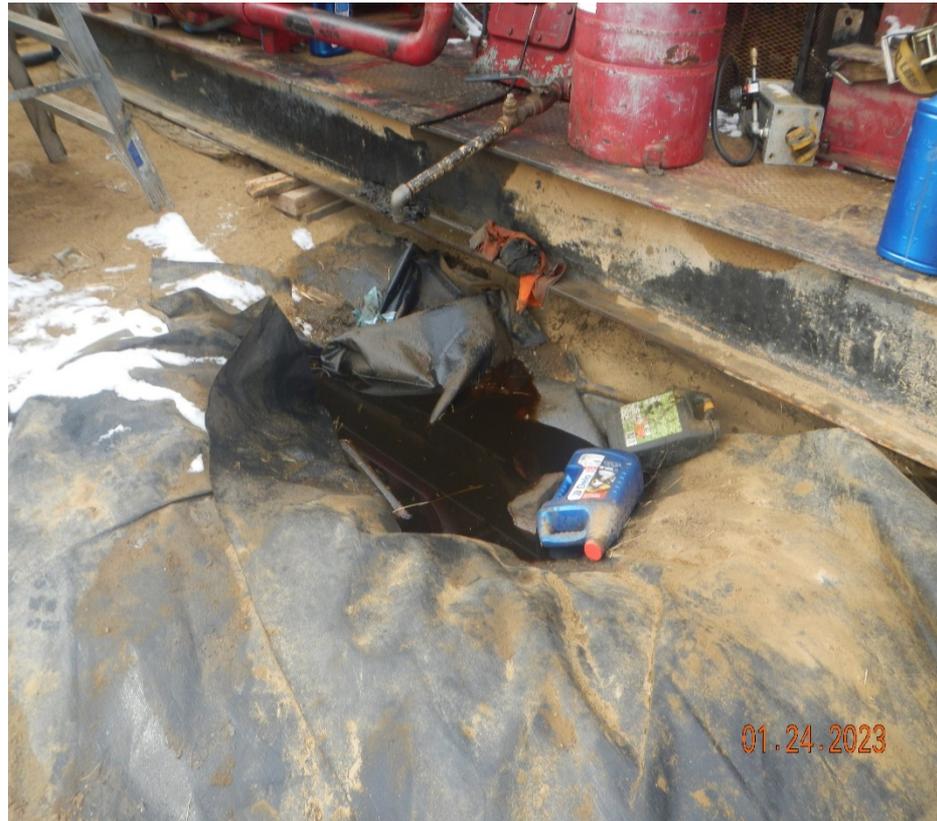
Photo 8. There is oil leaking out of this engine skid which is not contained and containers laying on the ground.

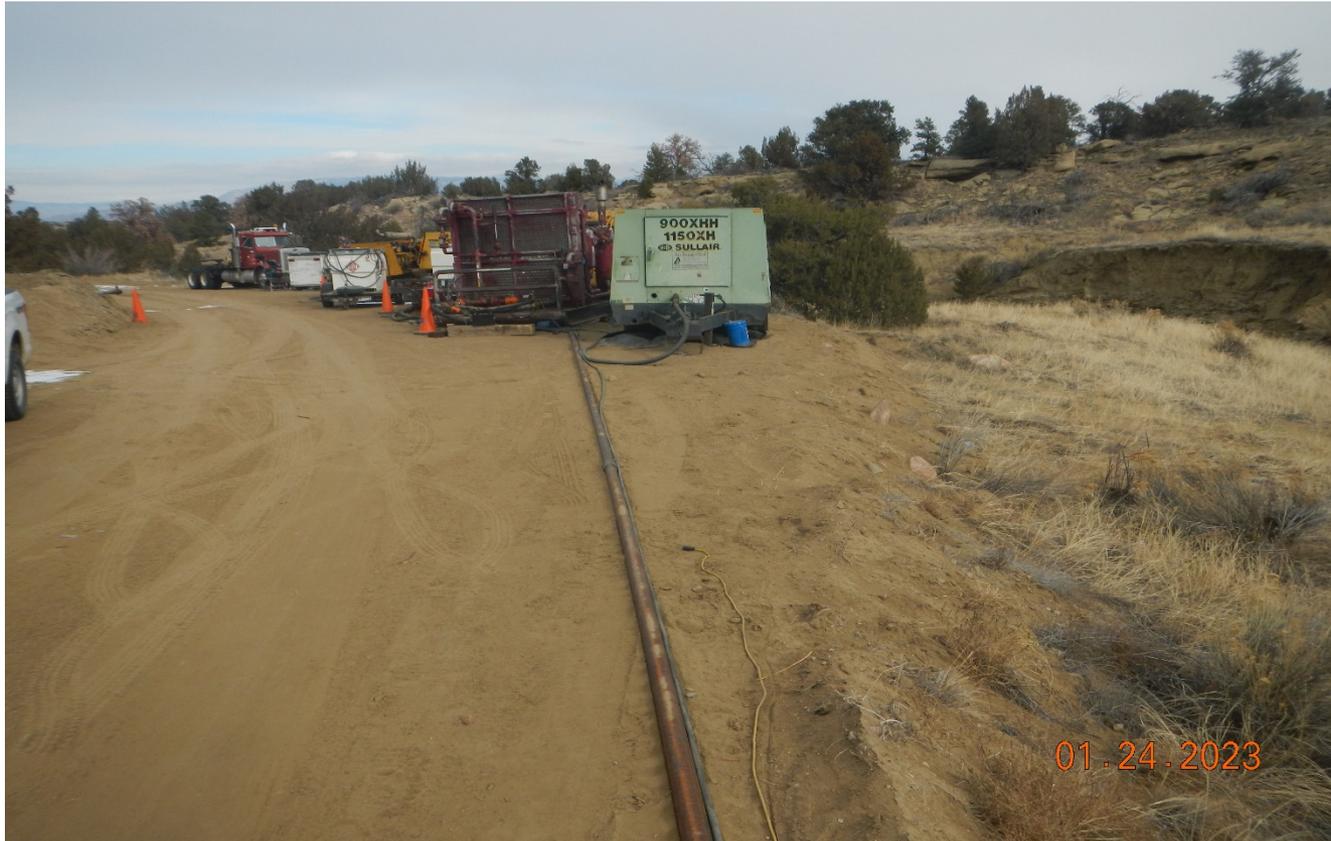
Photo 9. Facing north at the tank battery site where equipment is being stored. There are no perimeter controls down gradient toward the stream drainage at right side of photo which previous inspection also cited.

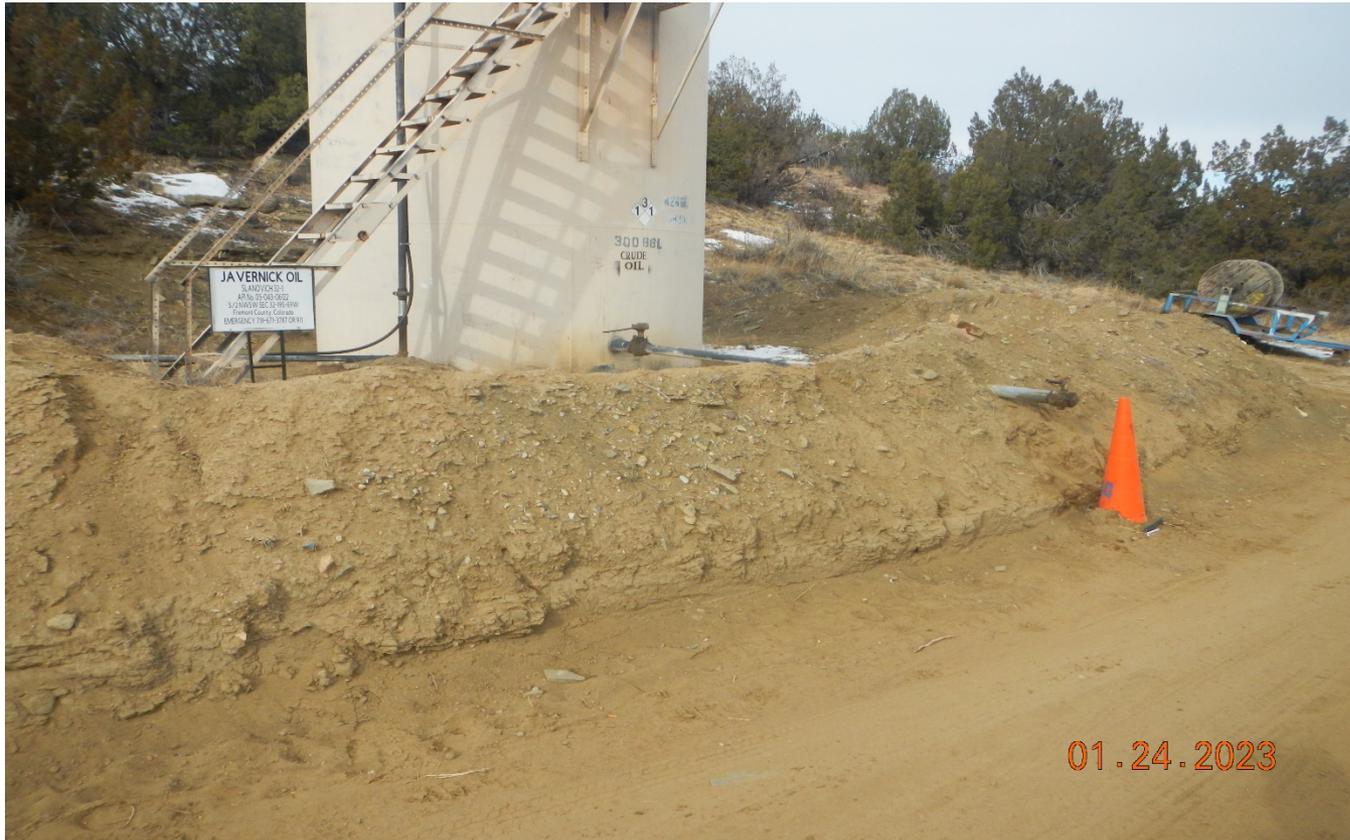
Photo 10. Facing toward the tank battery. There is still stained soils at the berm where the orange cone is located.

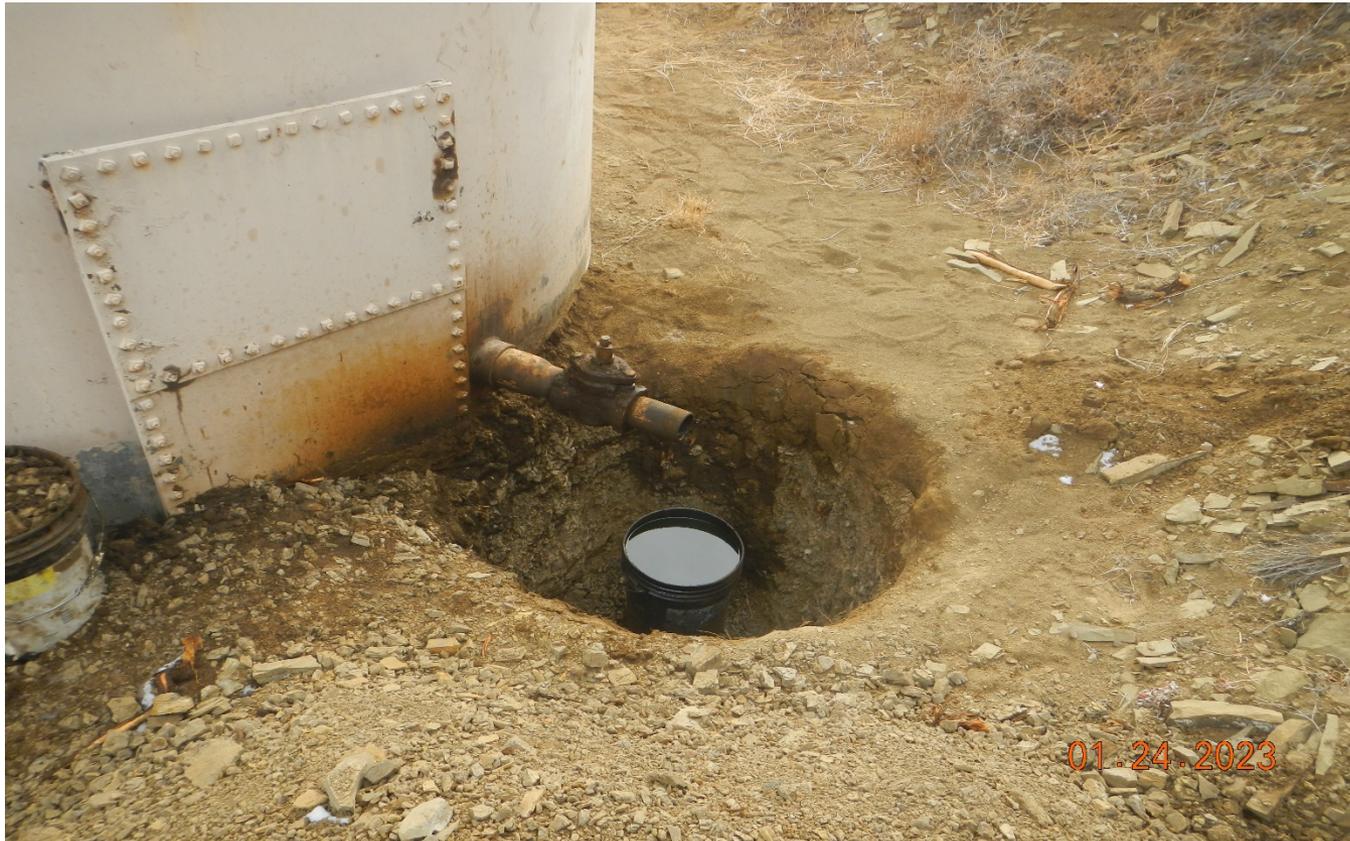
Photo 11. There is a dripping leak at the backside valve and the 5 gallon bucket is filled with oil. There is oil stained soils underneath the tank. Tank may need to be removed to cleanout the contaminated soils. This needs to be cleaned up immediately.

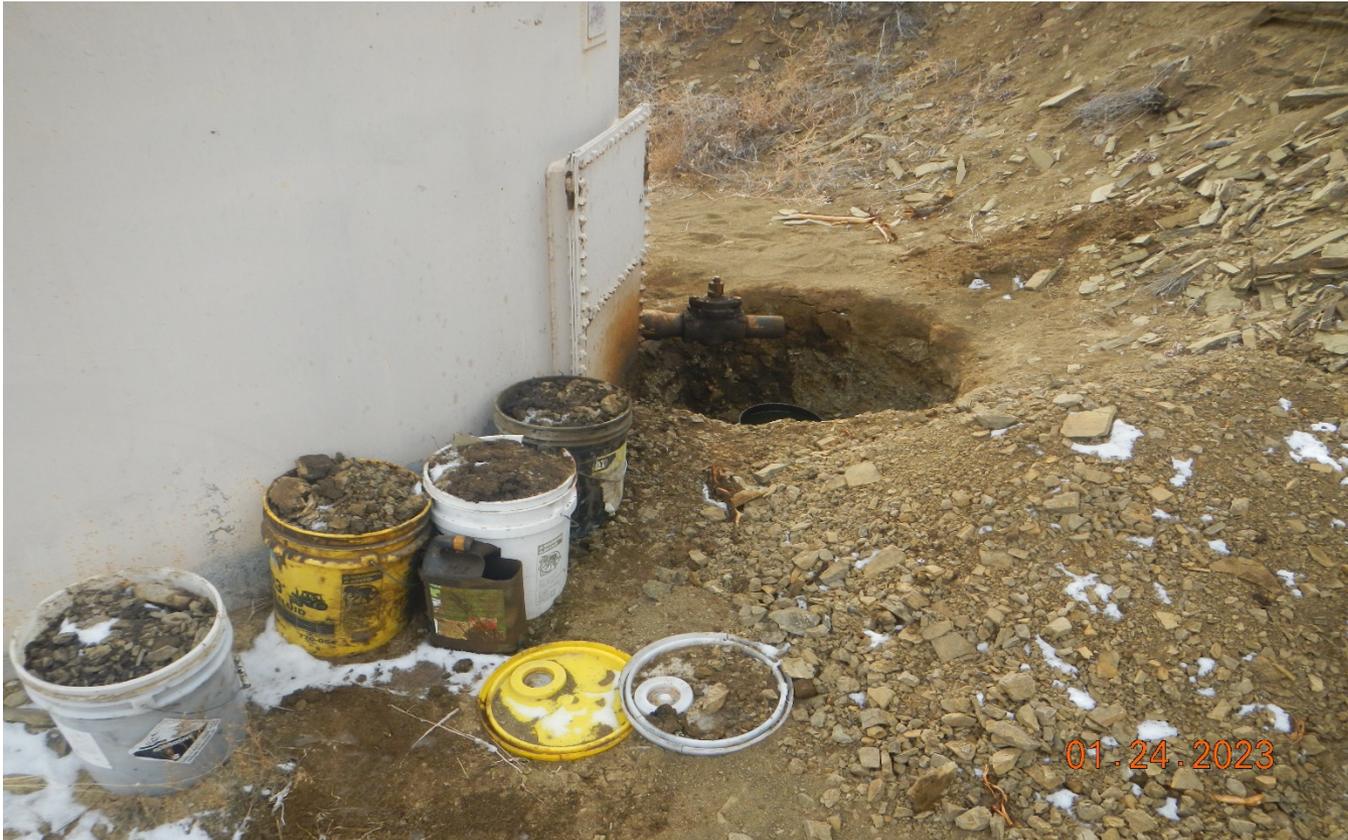
Photo 12. There are buckets of oily soils where it was excavated underneath the valve however the tank will likely need to be removed for further excavation.

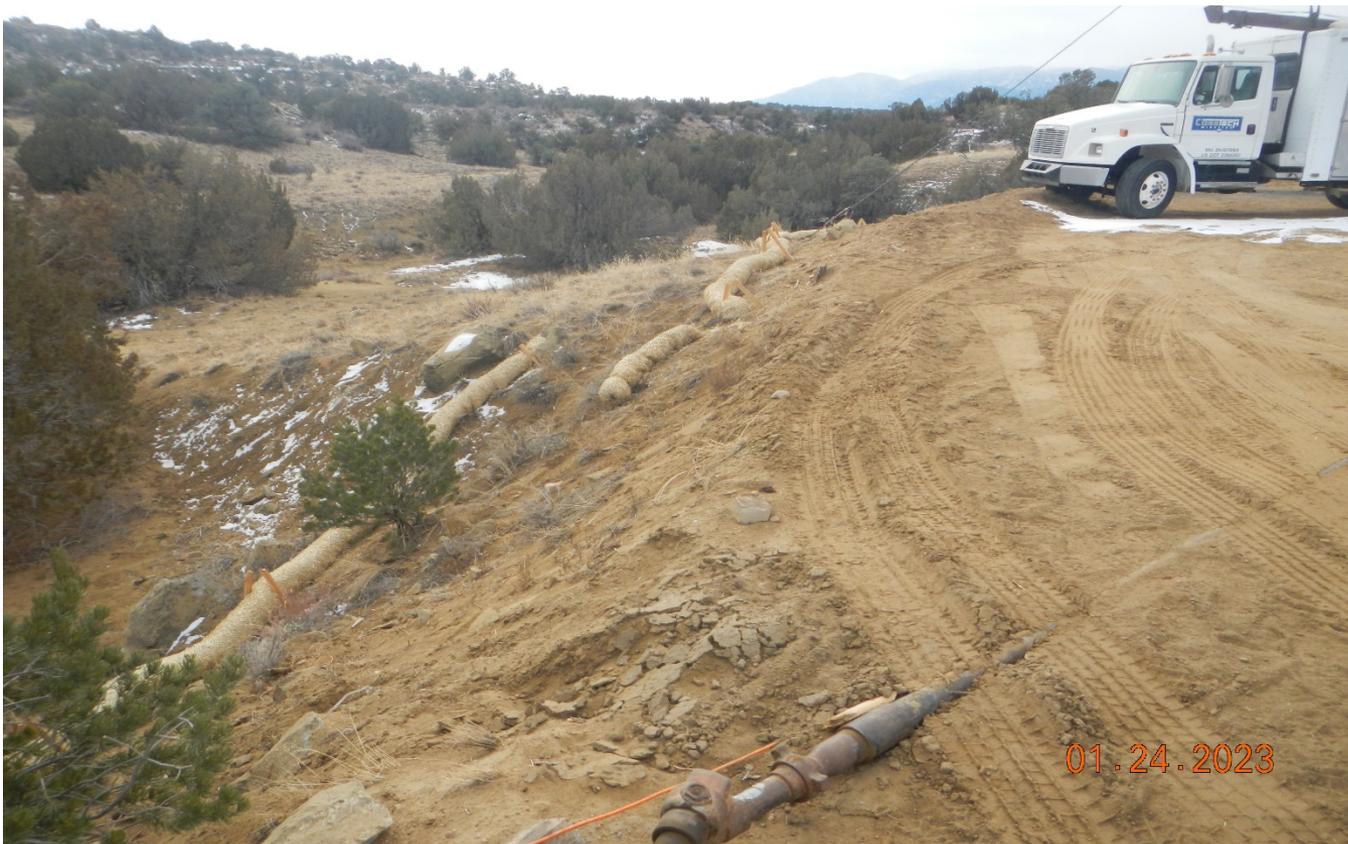
Photo 14. Facing southeast along the fill slope of the pad. There are wattles installed however they are not properly installed per good engineering practice. Wattles are not properly positioned, trenched, or staked down.

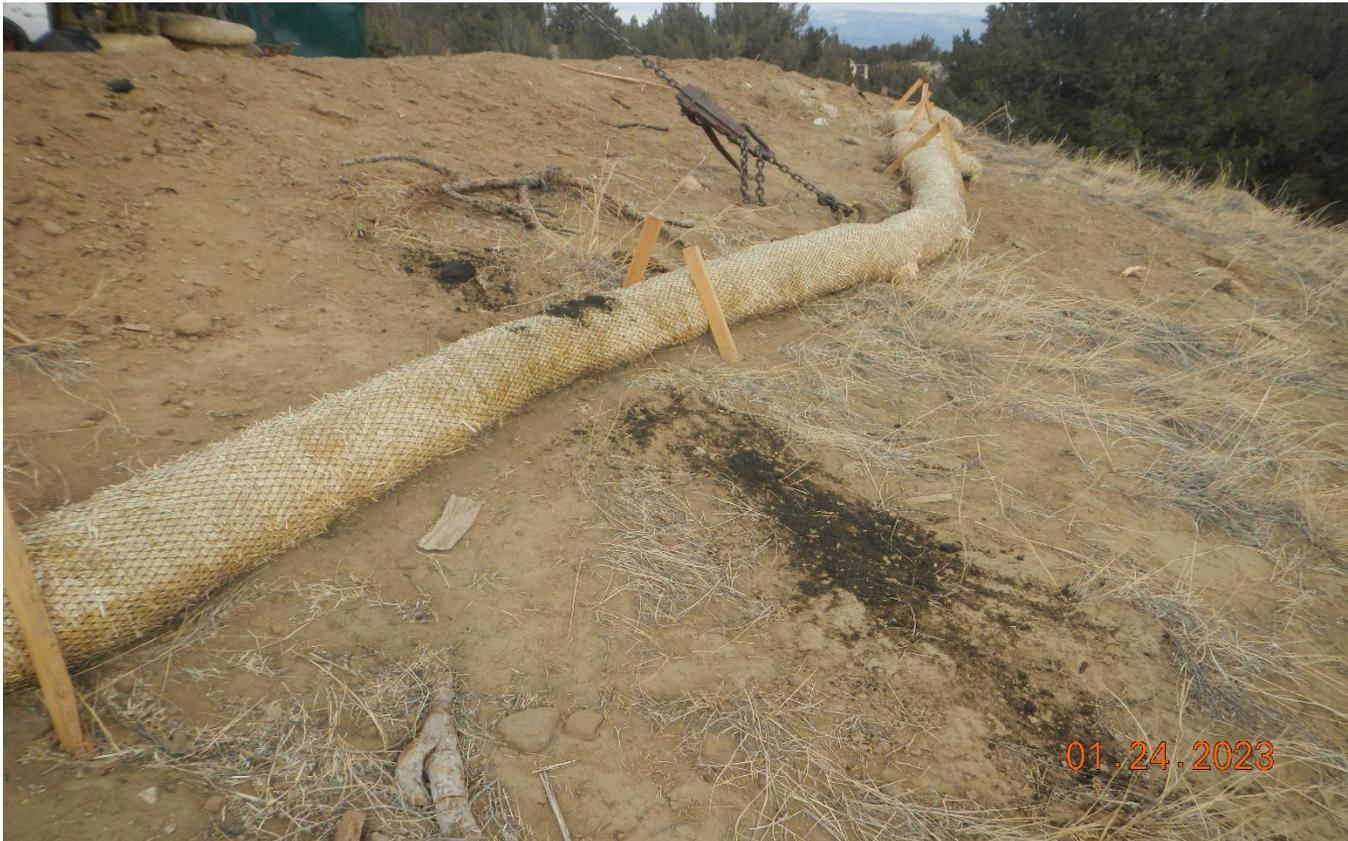
Photo 15. Facing northwest at the east side of location. There is oil staining in this area outside of the wattles. Oil stained soils need to be cleaned up.

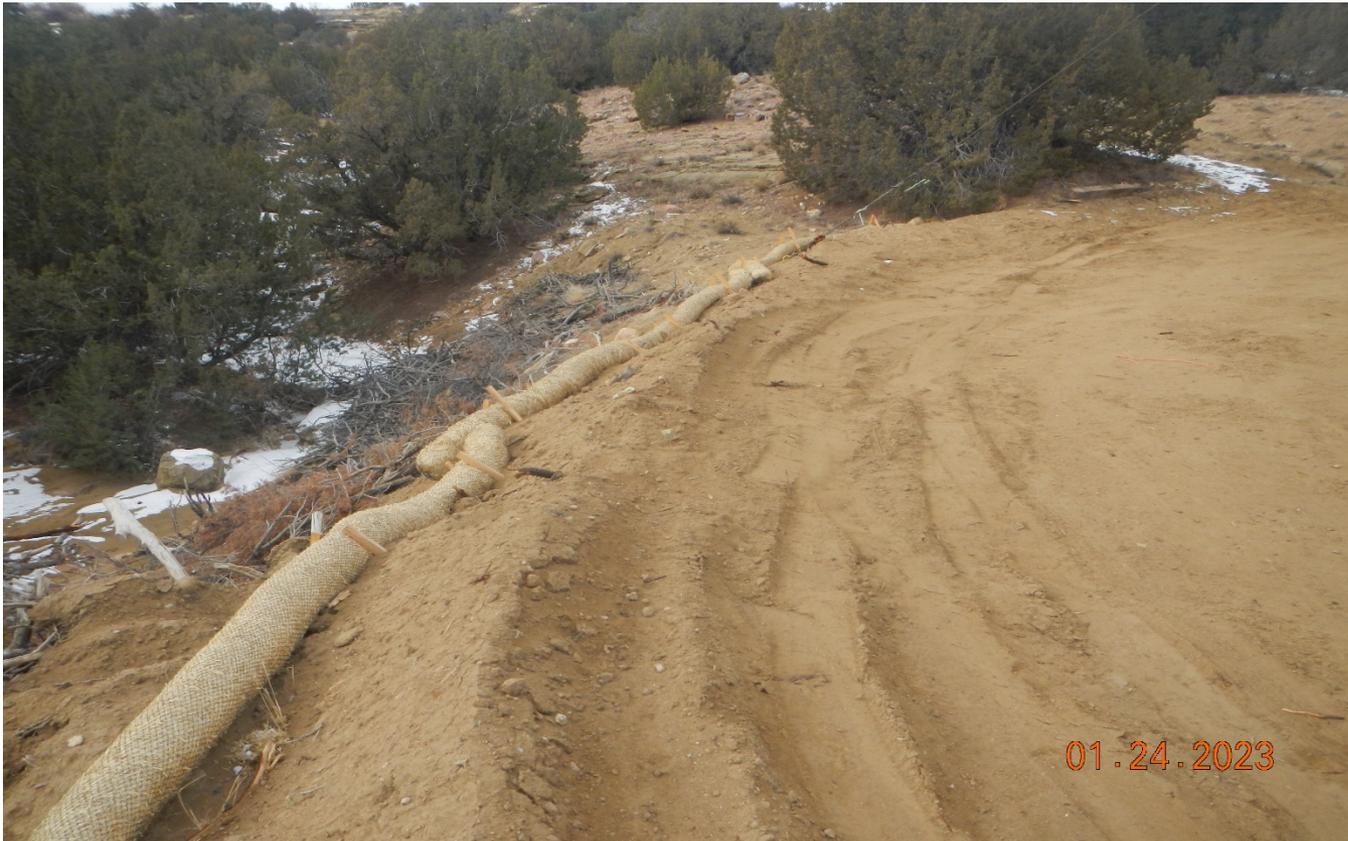
Photo 16. The wattle installed at the southern perimeter should have been positioned at the bottom of the slope to contain all loose soils that were pushed out and disturbed.

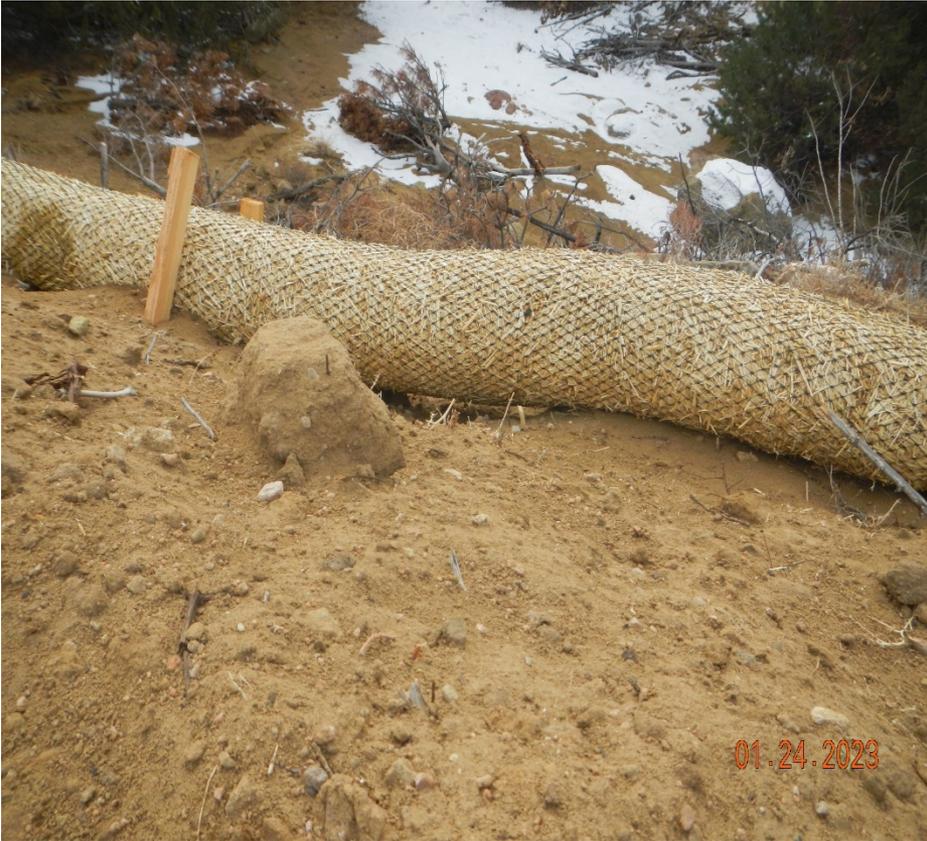
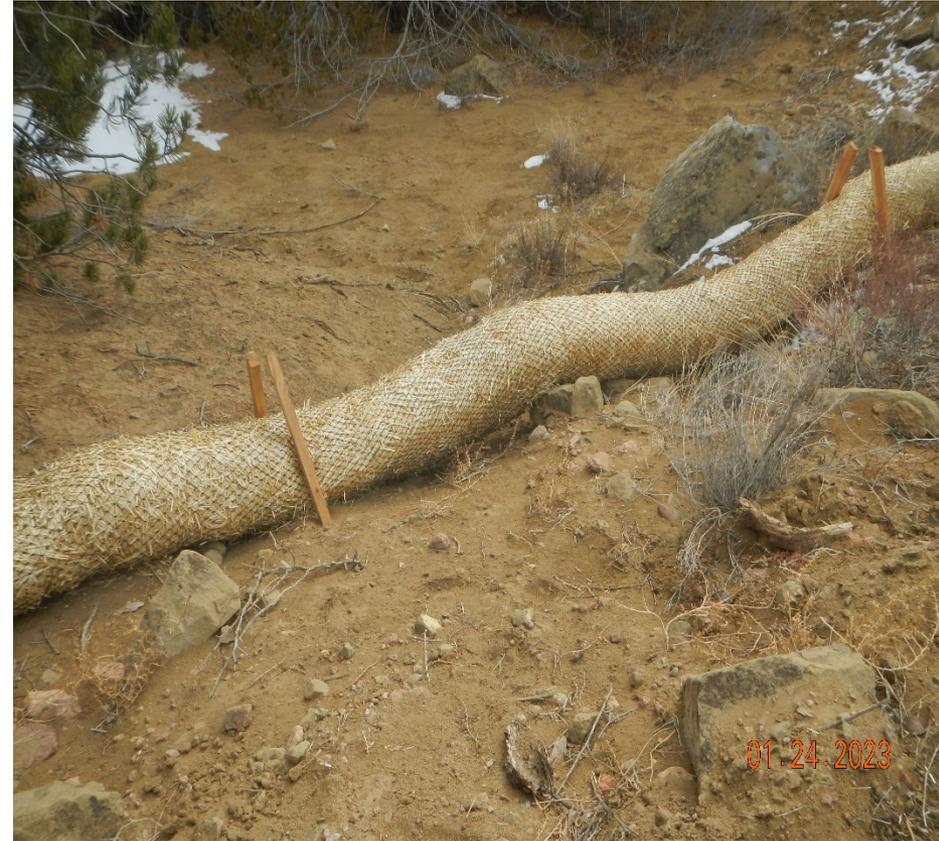
Photo 17 & 18. There is daylight underneath the wattles which shows in- proper installation. Wattles need to be trenched in and pack so stormwater wont undercut the wattles.

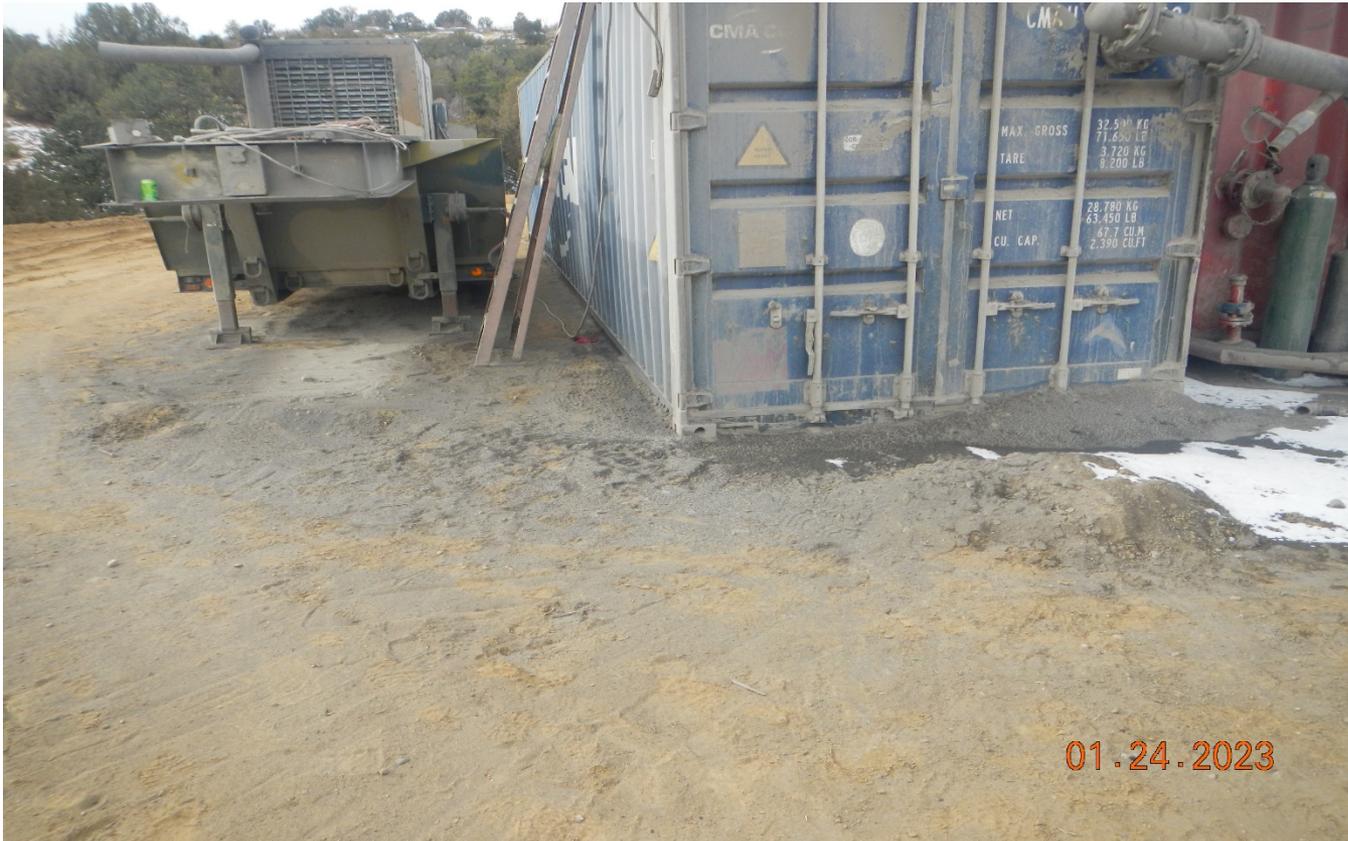
Photo 19. There is drill cuttings on the surface not properly stored and contained.

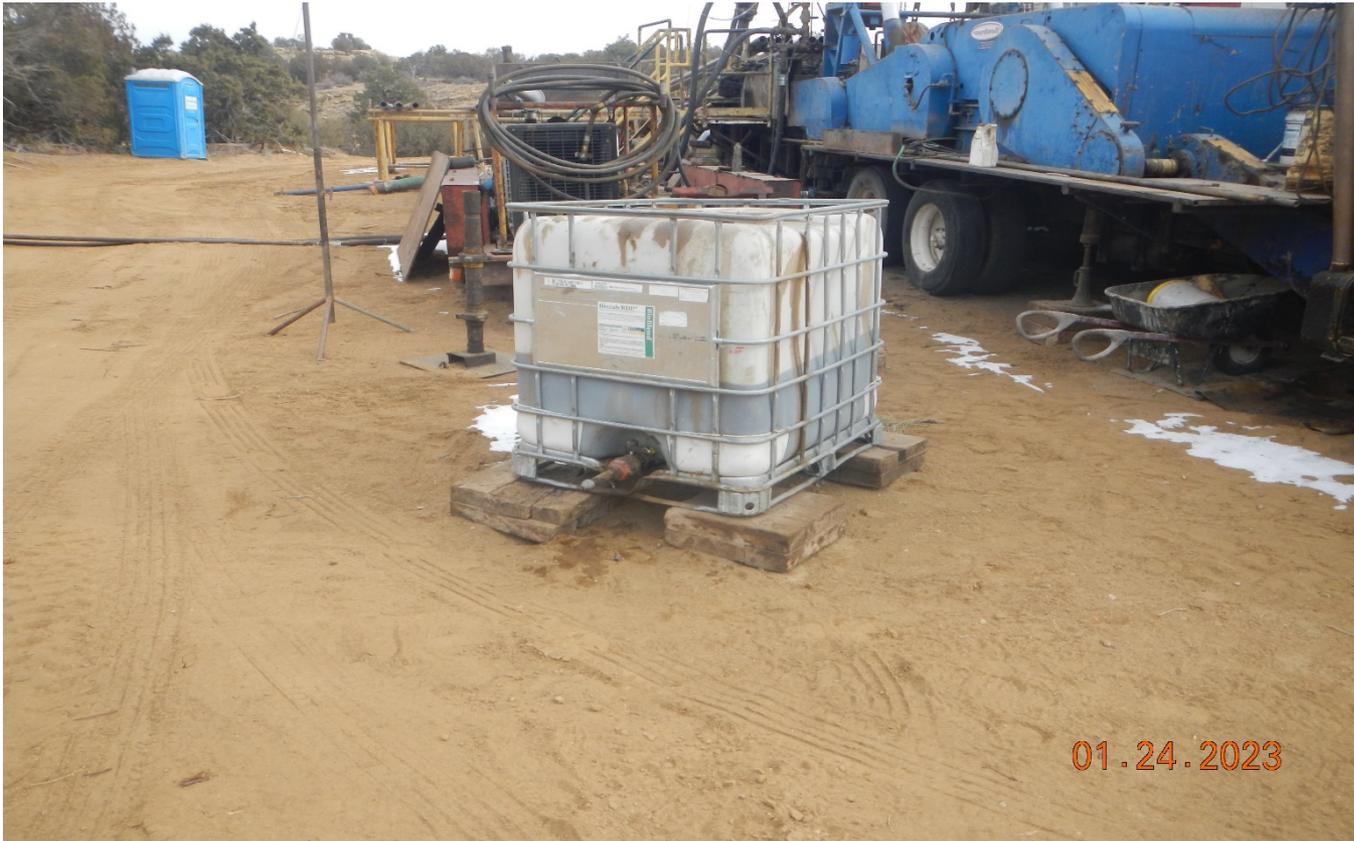
Photo 20. There is stained soils at the outlet of this oil container which is not properly stored.

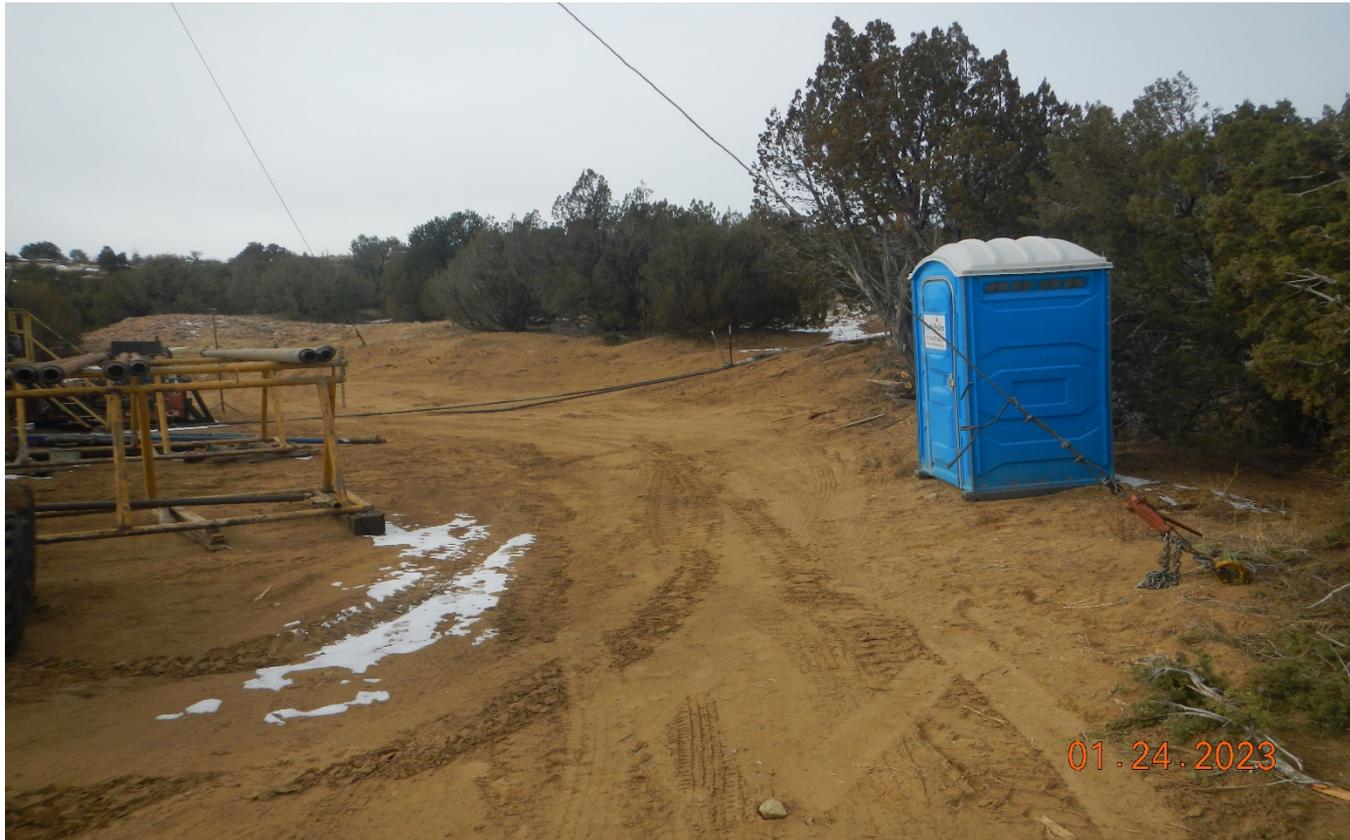
Photo 21. Facing southwest at the location. The portable outhouse was not staked down and could fall over. There are no run-on stormwater controls along the west side of the location.
