Tank Battery Closure Checklist

Site Name & COGCC Facility Number	Seltzer Farm-61S67W / 3SENW
Remediation Project #	24010

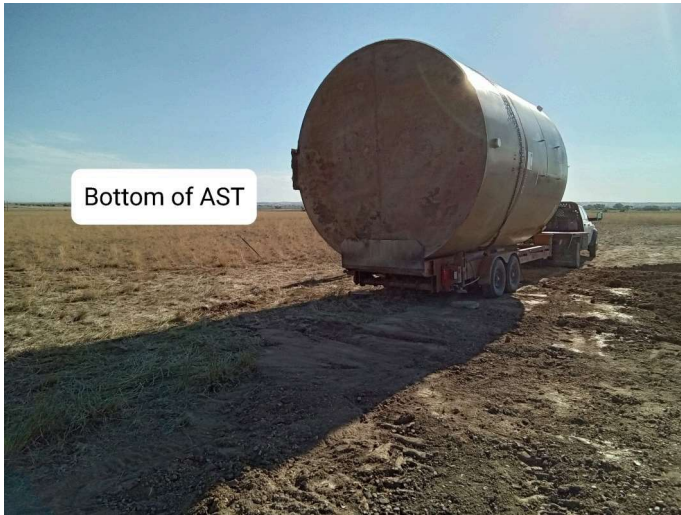
R1 - P1

Bottom of AST

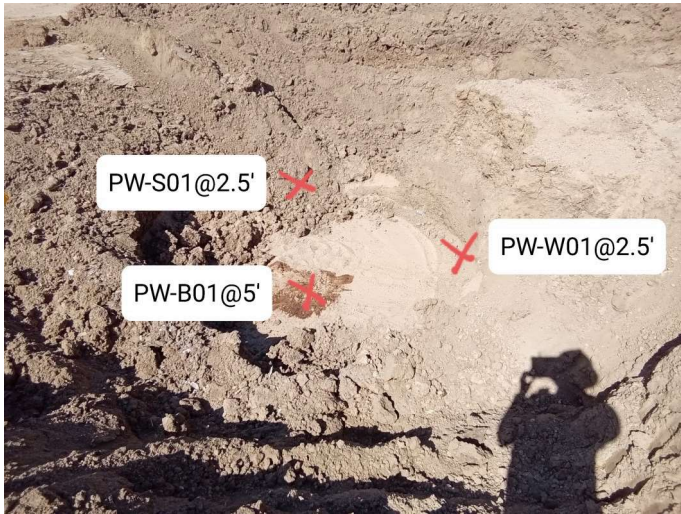
R3 - P1

General Condition of Site	Good condition
USCS Soil Type	Clay / Clay
Estimated Depth to Groundwater	<20'
Hydrocarbon Impacted Soils / Spills	Hydrocarbon impacted soil identified at PW-B01@5' via laboratory analysis.
Salt Crusted Soils or Impacted Vegetation	None observed
