Construction and Stormwater Inspection

January 17, 2023

Operator: Verdad Resources LLC, #10651

Location ID: 483467

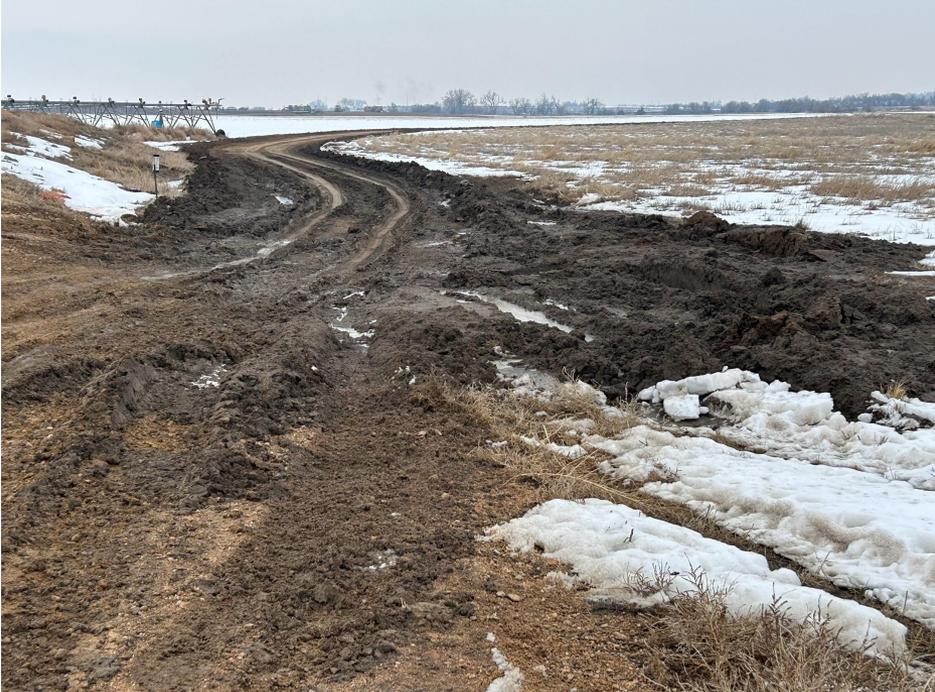
Photo 1. Photo taken from the entrance of location, facing East. Photo illustrates the access point to the location, the PVC pipe holding the Form 2A. Operator has yet to salvage topsoil but plans to. No observed tracking device on location.

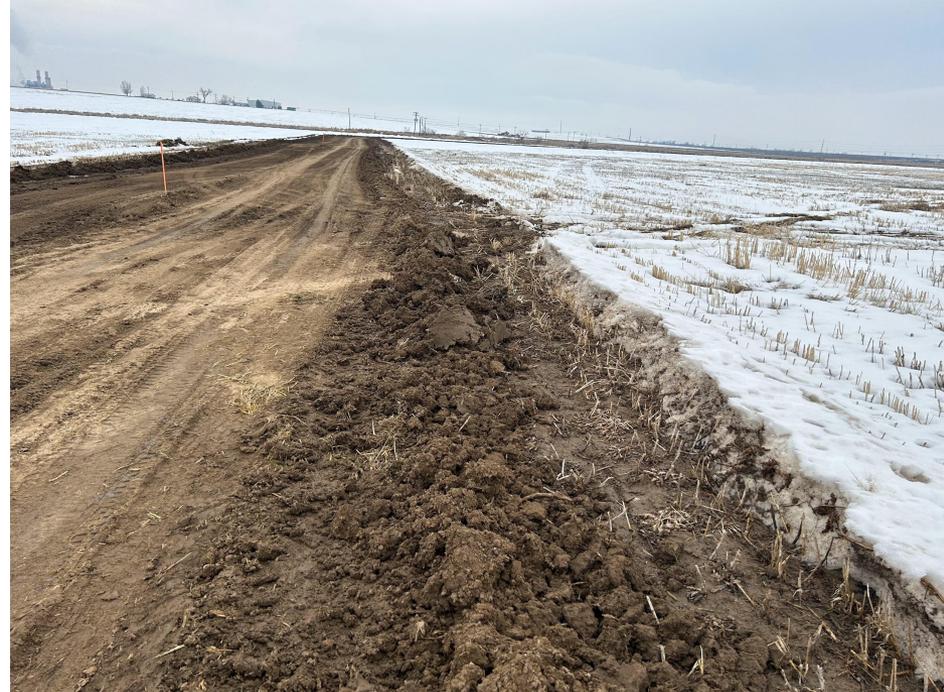
Photo 2. Photo taken from from a portion of the access road, topsoil windrowed, will be salvaged and stockpiled on location.

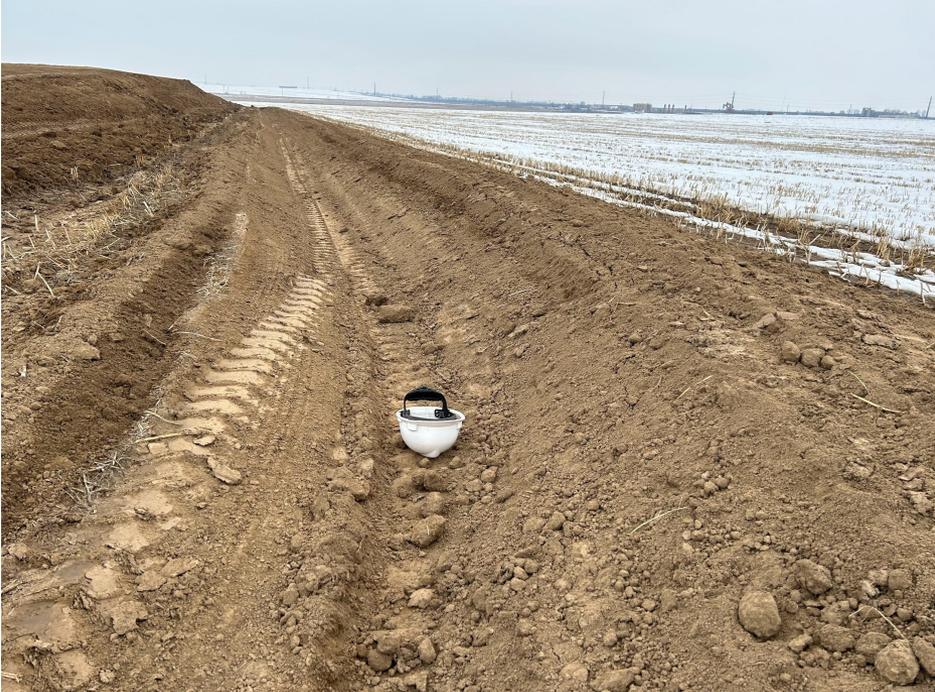
Photo 3. Photo taken from the western perimeter of location, facing south. Photo illustrates a berm and ditch BMP installed around the perimeter of the location.

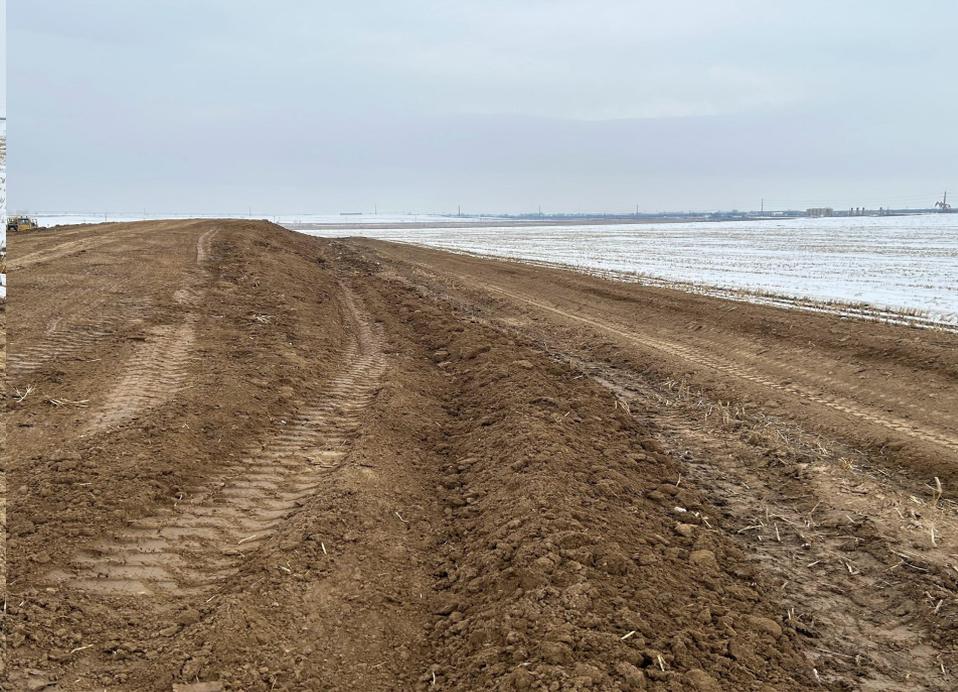
Photo 4. Photo taken from the topsoil stockpile on location. Stockpile is unconsolidated and shall be stabilized, per rule 1002c.

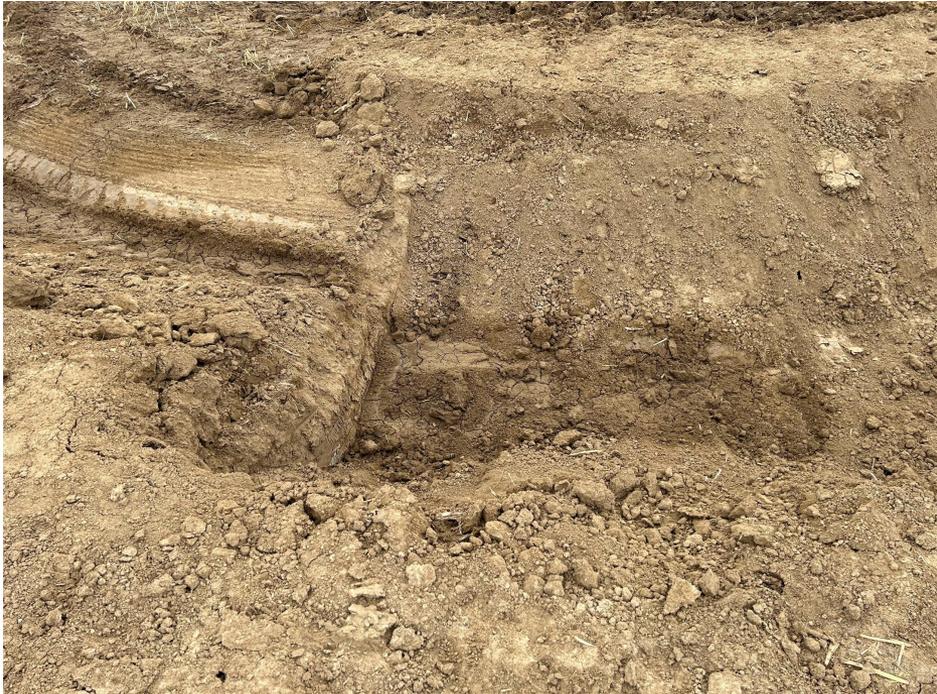
Photo 5. Photo taken of a sediment trap on location. . Photo illustrates the BMP is under construction but appears to be undersized to accommodate the size of the disturbance.

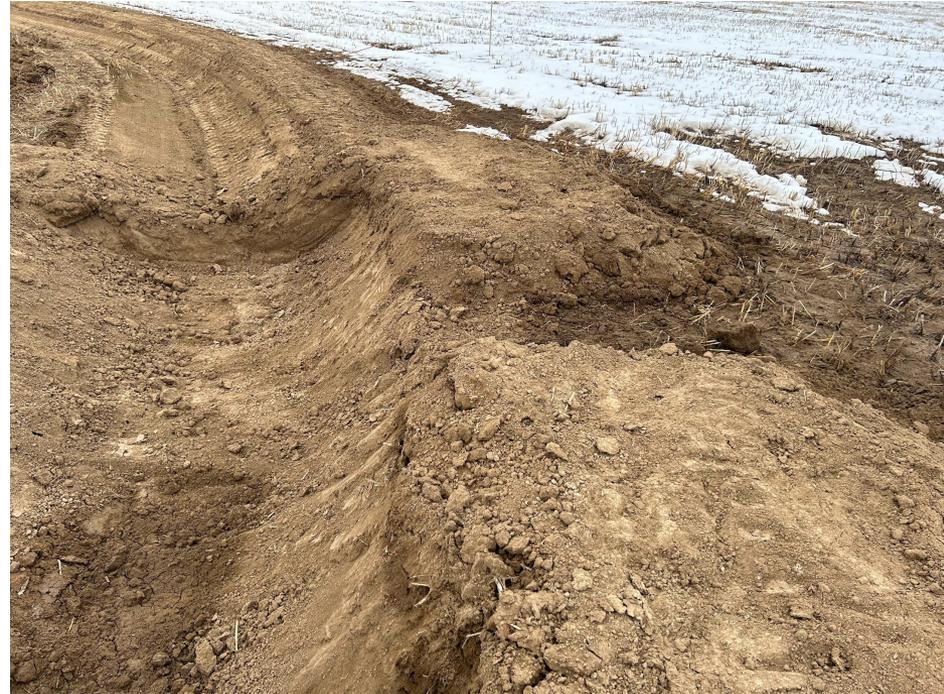
Photo 6. Photo taken of a sediment trap on location. See comments under photo 5.

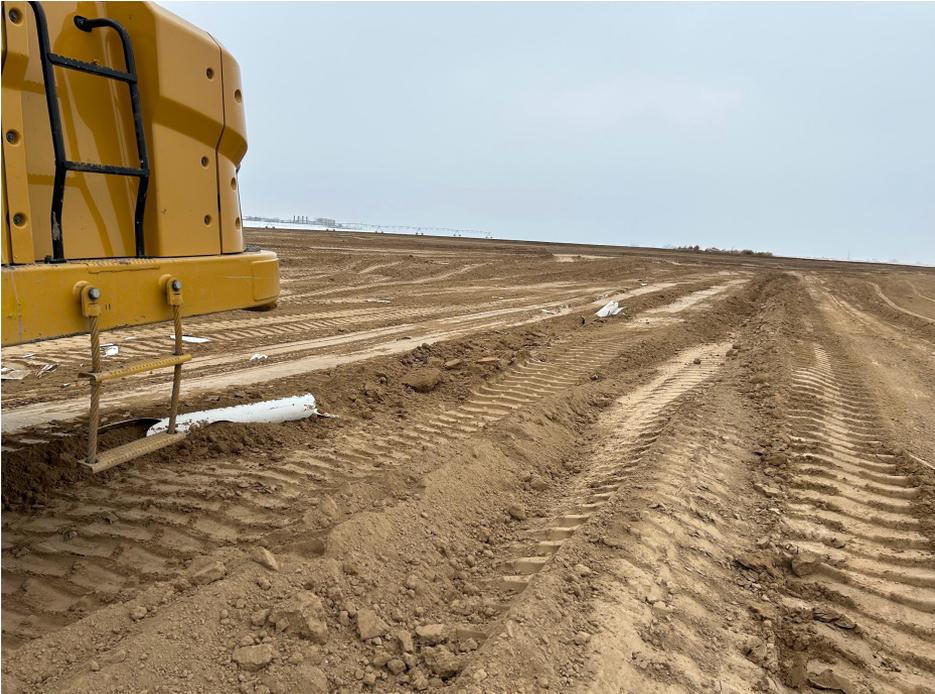
Photo 7. Photo taken from the eastern location. Photo illustrates debris/broken pipe that should be removed.

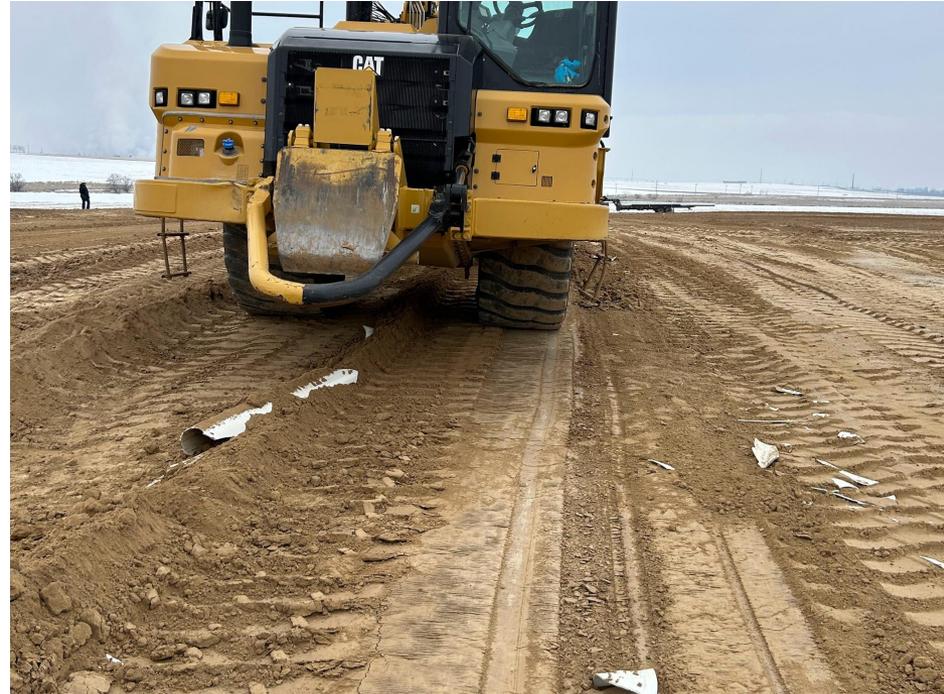
Photo 8. Photo taken from the eastern location. see comments under photo 7.
