Construction and Stormwater Inspection

Operator: ST CROIX OPERATING INC - 81490

Location ID: 474453

Inspection Document #: 696105713

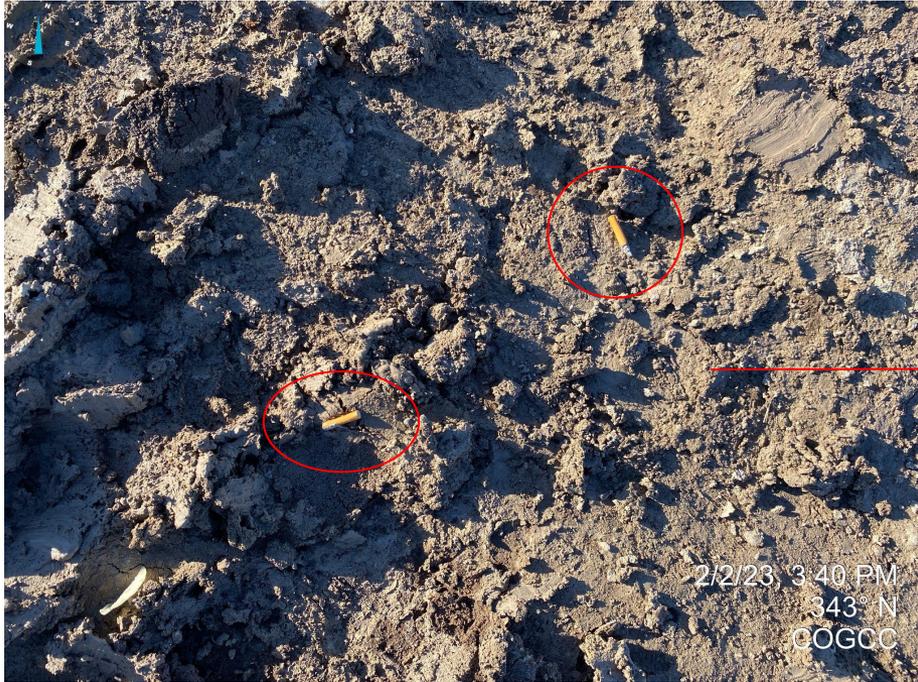
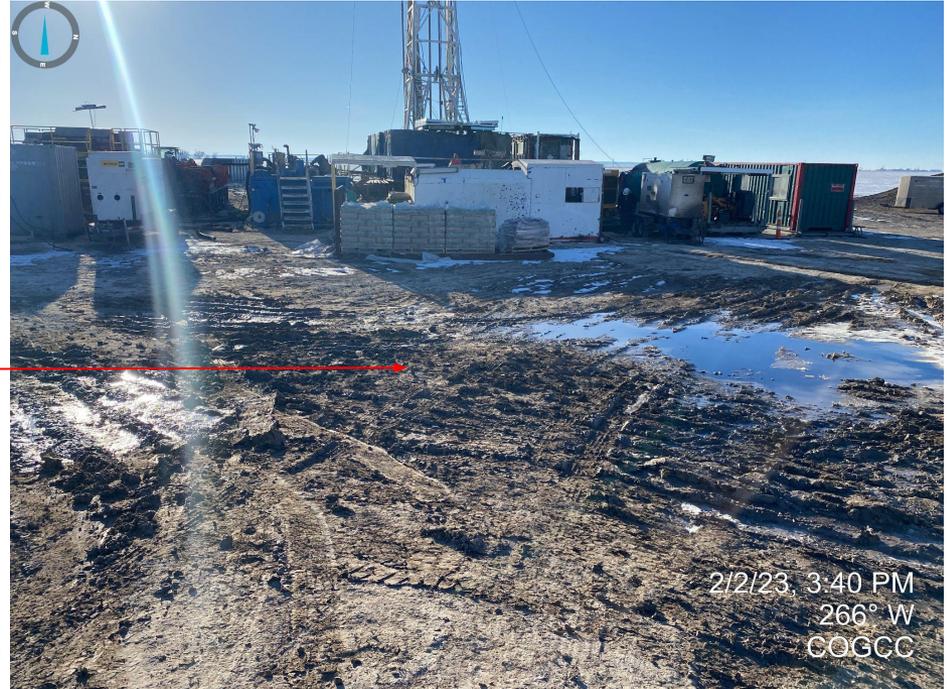
Photos 1 & 2. Cigarette butts observed near the location's entrance which is not compliant with Rules 610.f or 610.g.

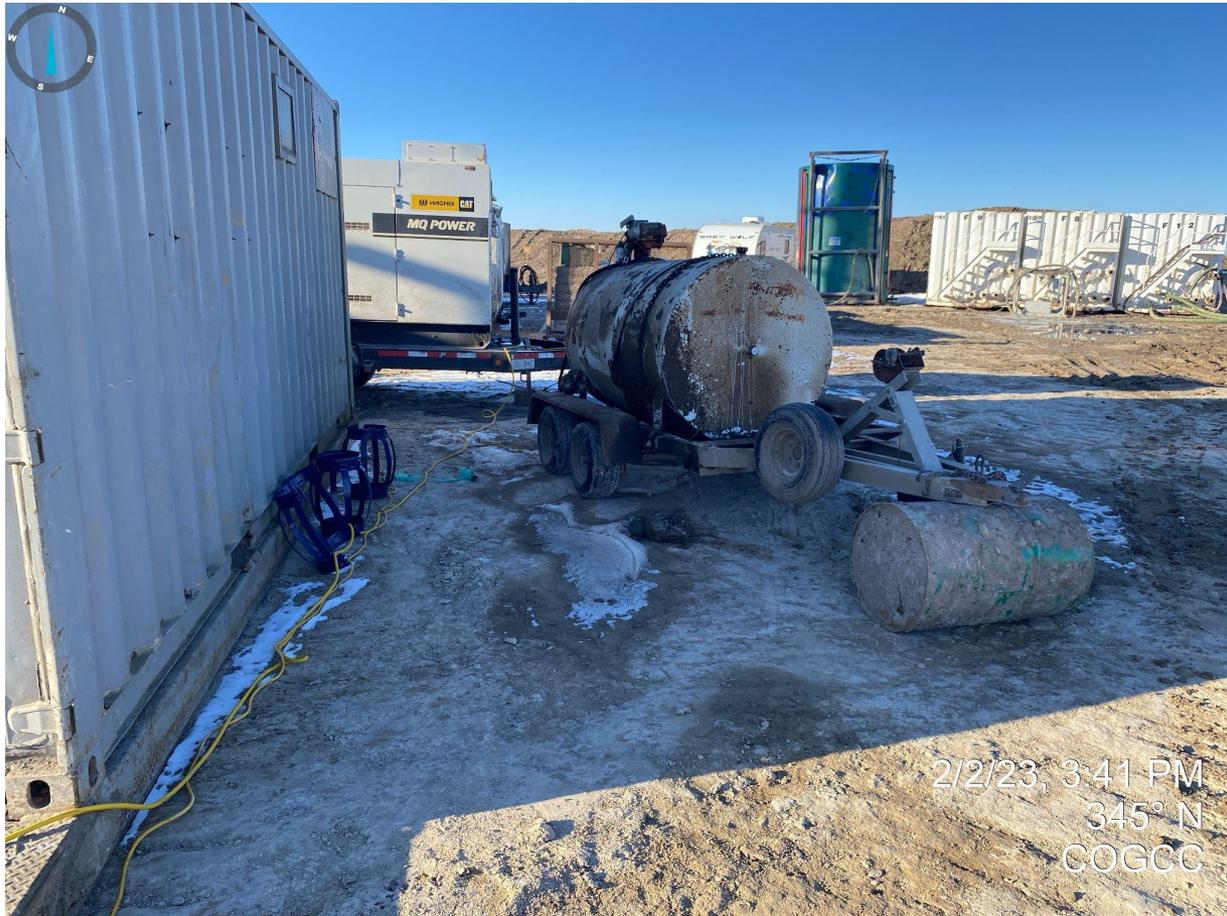
Photo 3. Facing north near the drill rig. Diesel tank does not have a secondary containment and is not in compliance with Rule 1002.f.(2)B.

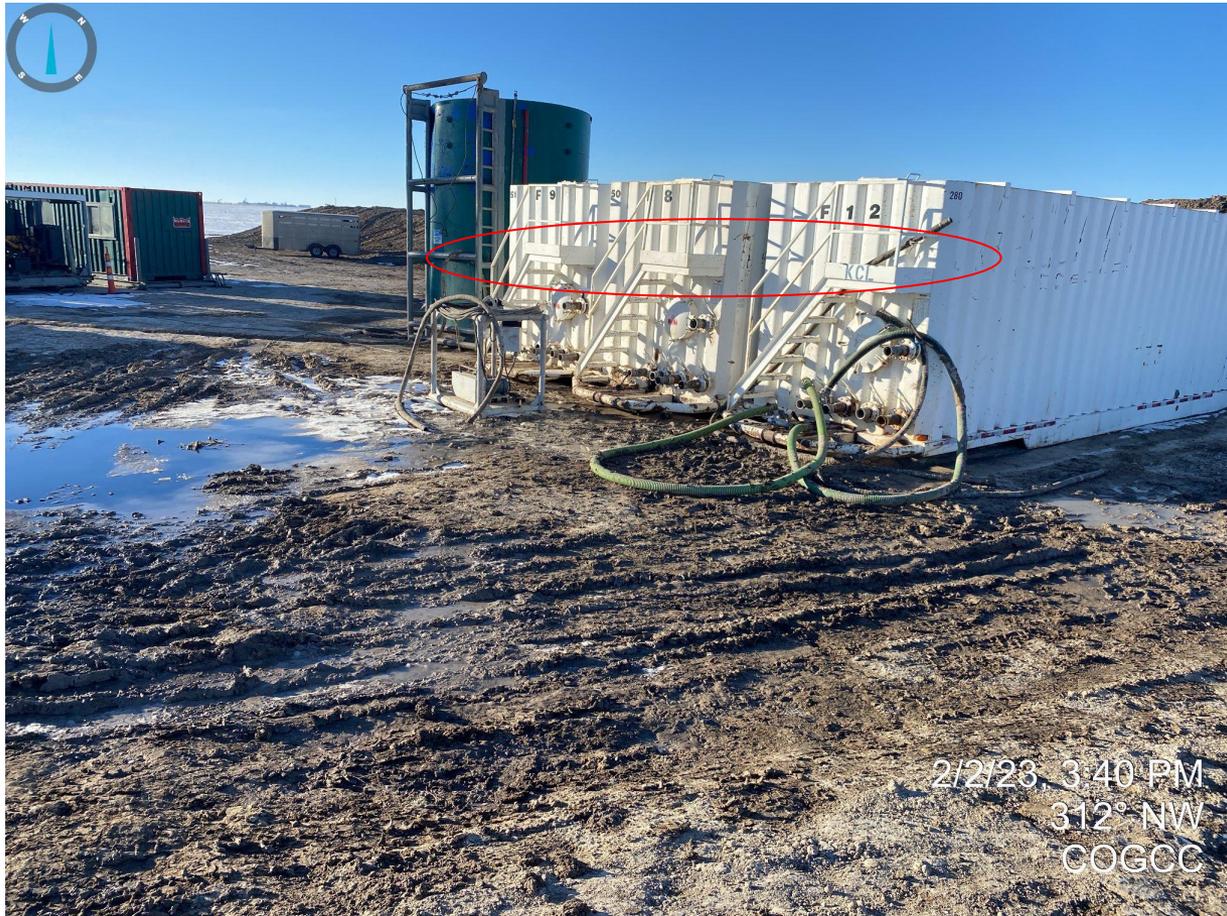
Photo 4. Facing northwest near the entrance. Tanks do not have adequate labels/NFPA placards.

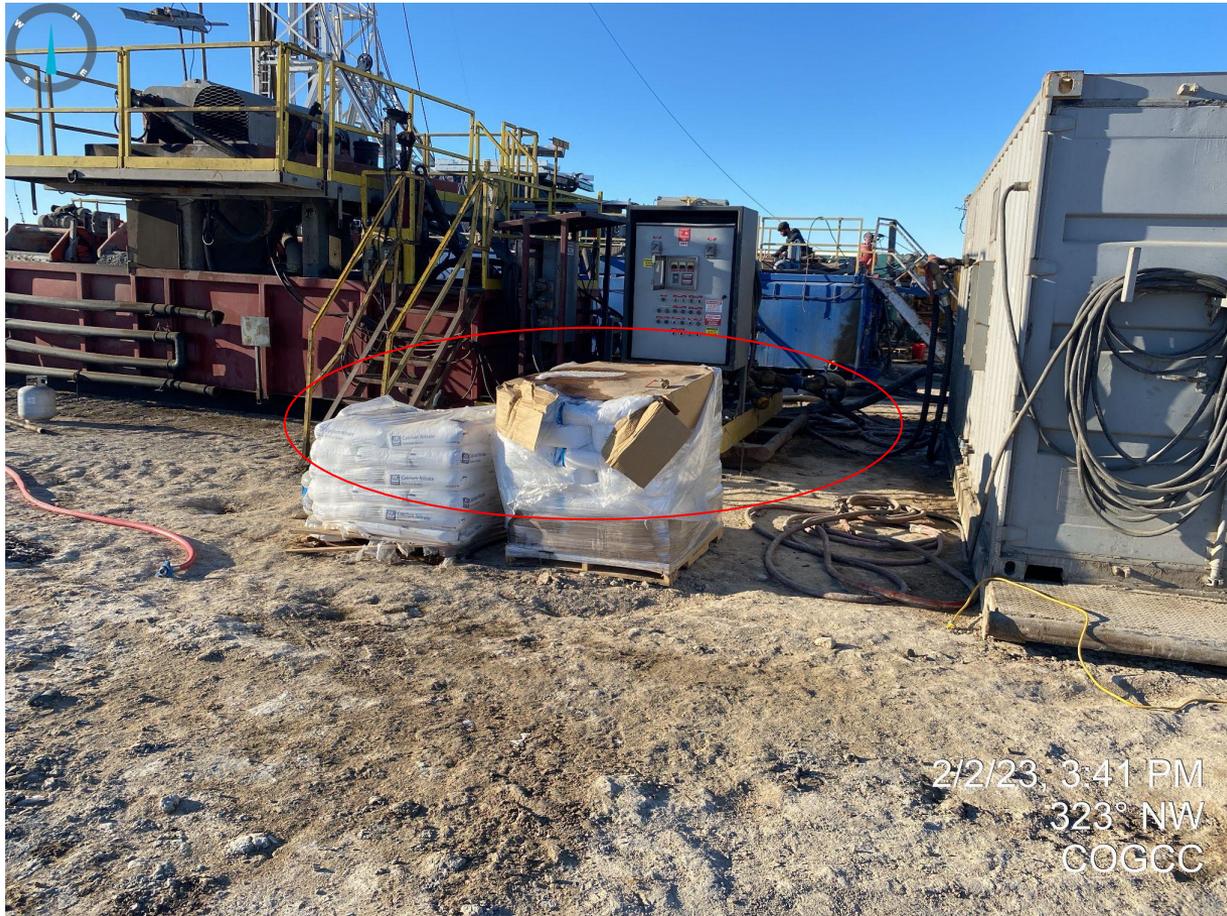
Photo 5. Facing northwest near drill rig. Photo illustrates that materials do not have adequate covering to minimize contact with precipitation or stormwater and are not in compliance with Rule 1002.f.(2)A.

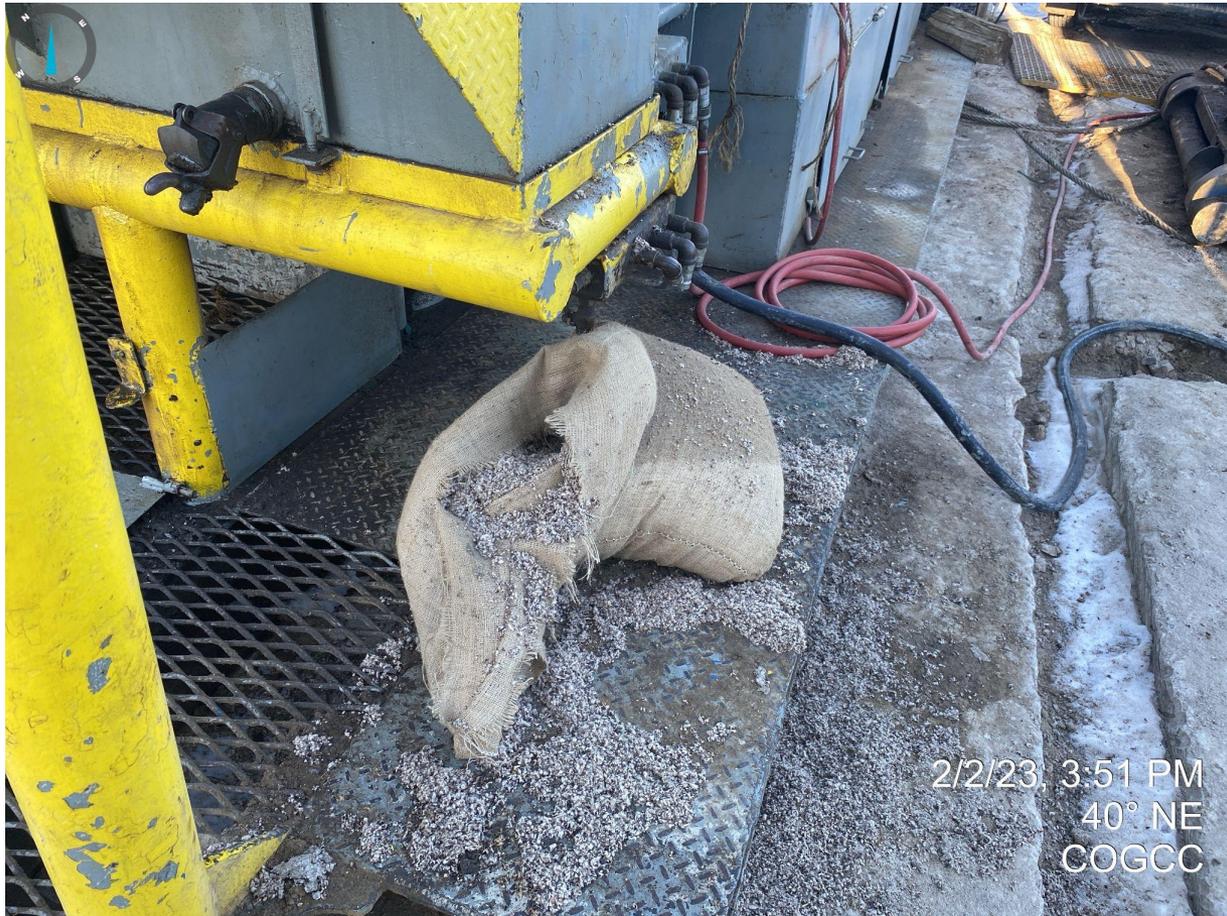
Photo 6. Facing northeast near drill rig. Photo illustrates that materials do not have adequate covering to minimize contact with precipitation or stormwater and are not in compliance with Rule 1002.f.(2)A.

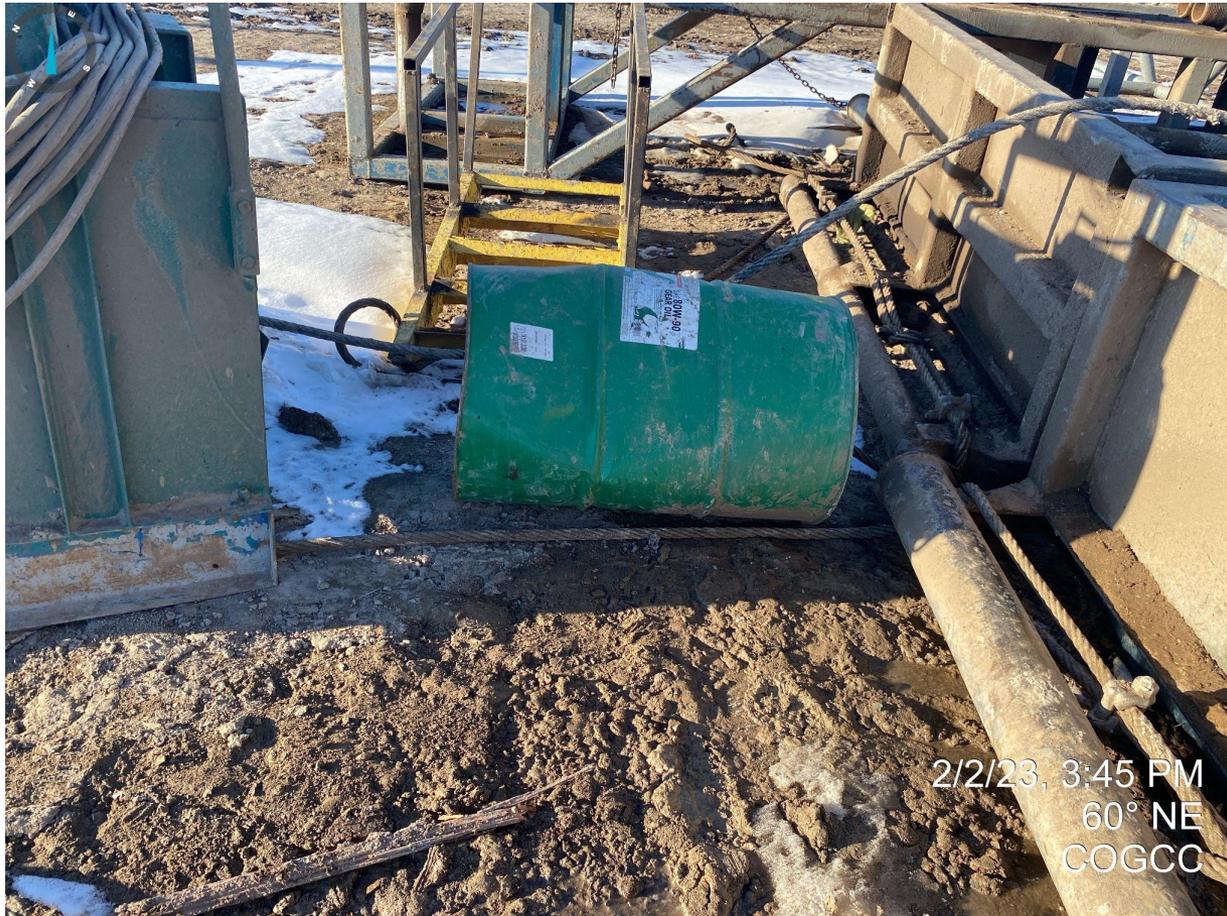
Photo 7. Facing northeast near the drill rig. Photo illustrates barrel that was tipped over, not placed in a secondary containment, and is not in compliance with Rule 1002.f.(2)B.

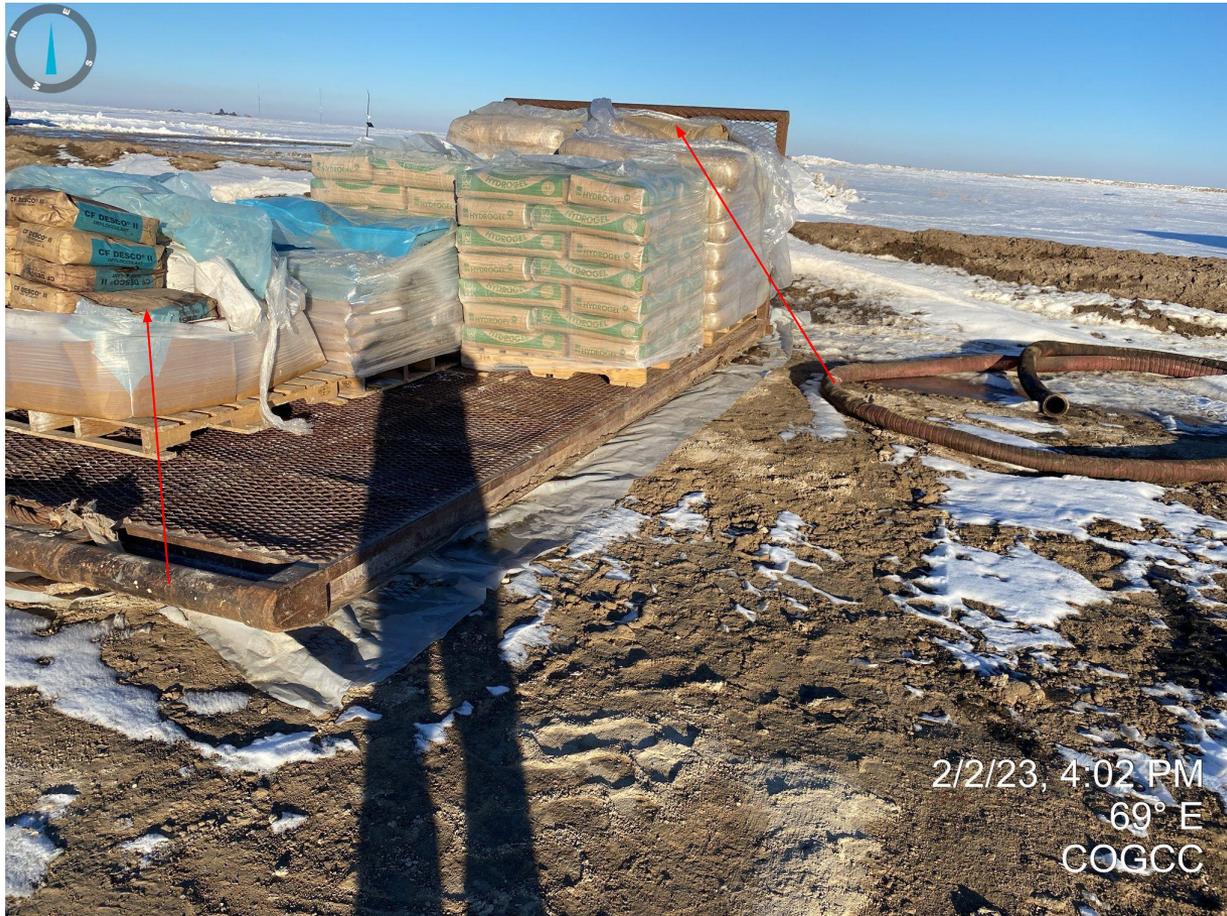
Photo 8. Facing east from the eastern portion of the location. Photo illustrates that materials do not have adequate covering to minimize contact with precipitation or stormwater and are not in compliance with Rule 1002.f.(2)A.

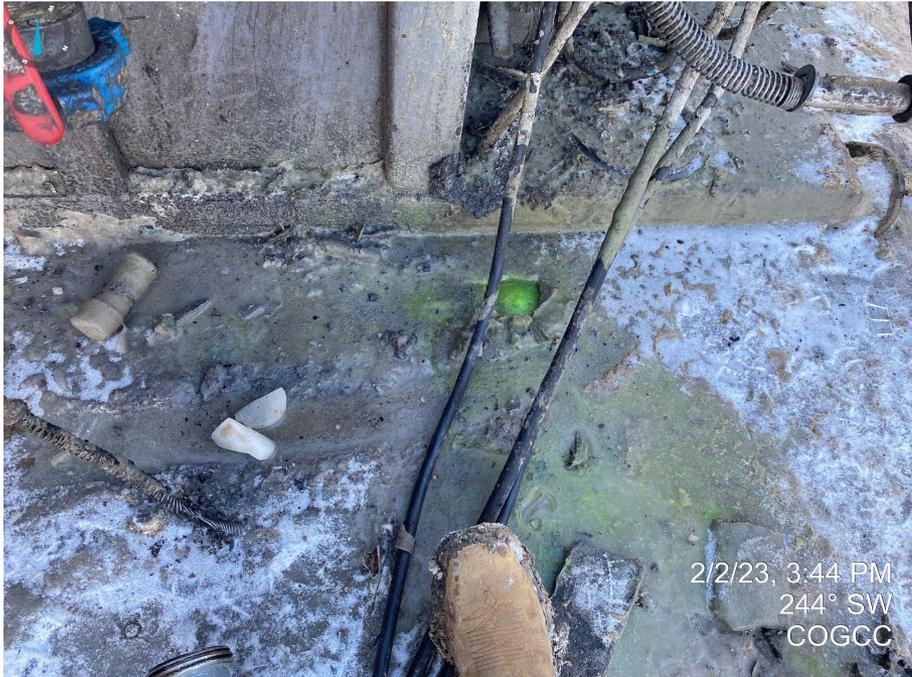
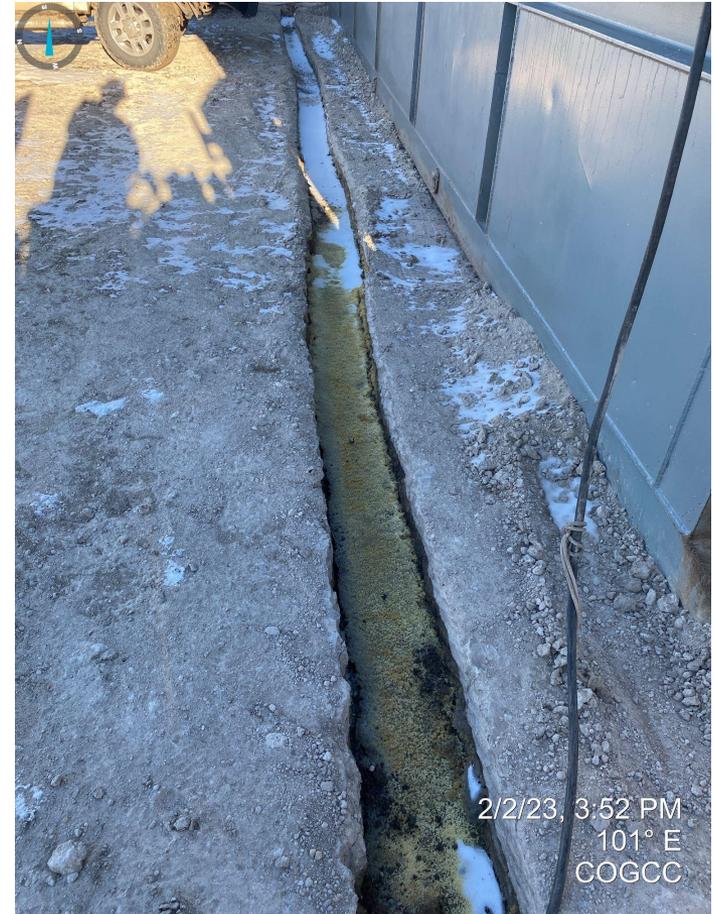
Photos 9 & 10. Close up photos taken from drill rig area, identifying localized spills of unknown materials. These will need to be cleaned up per Rule 1002.f.(2)D.

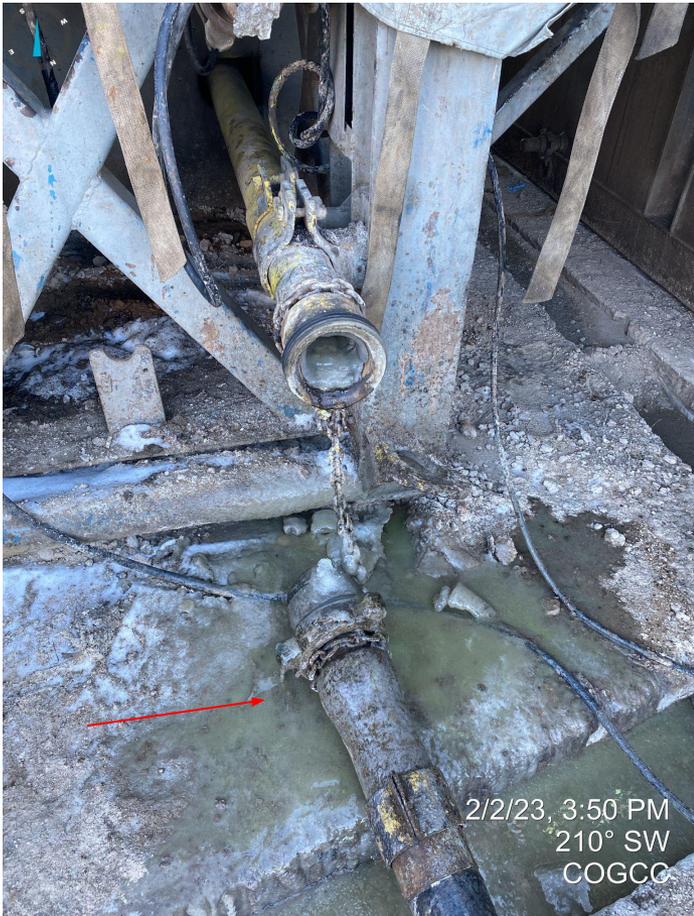
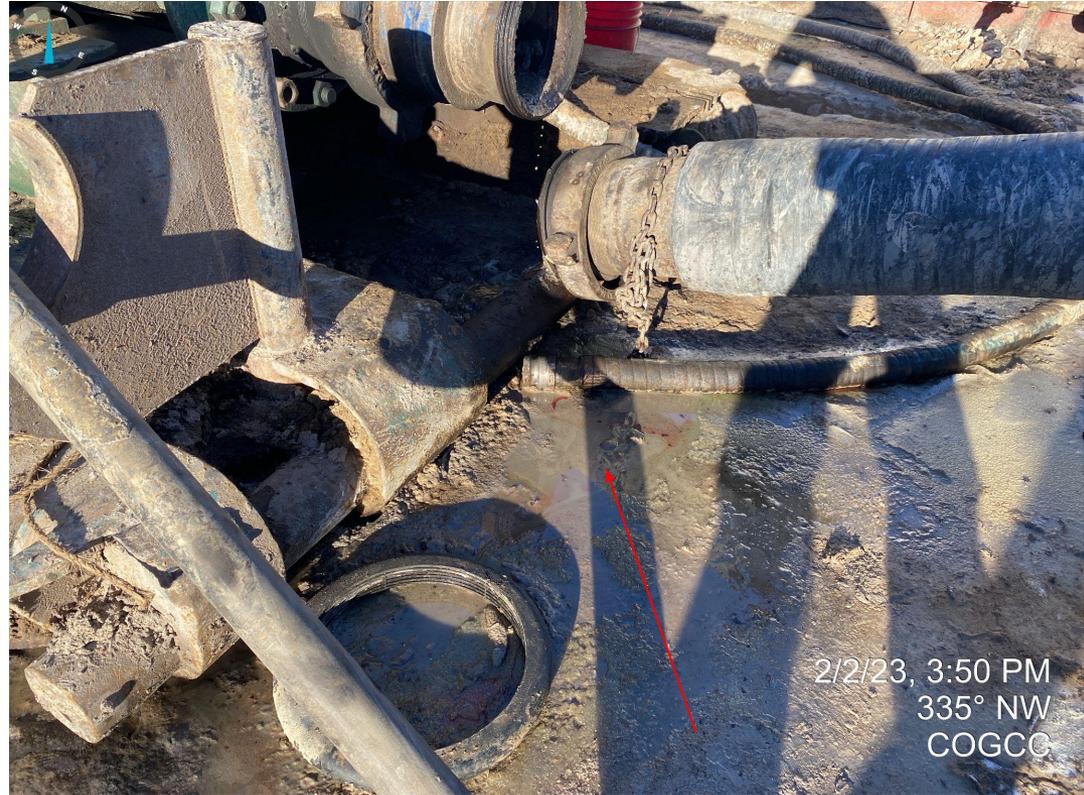
Photos 11 & 12. Close up photos taken from drill rig area, identifying localized spills of unknown materials. These will need to be cleaned up per Rule 1002.f.(2)D.

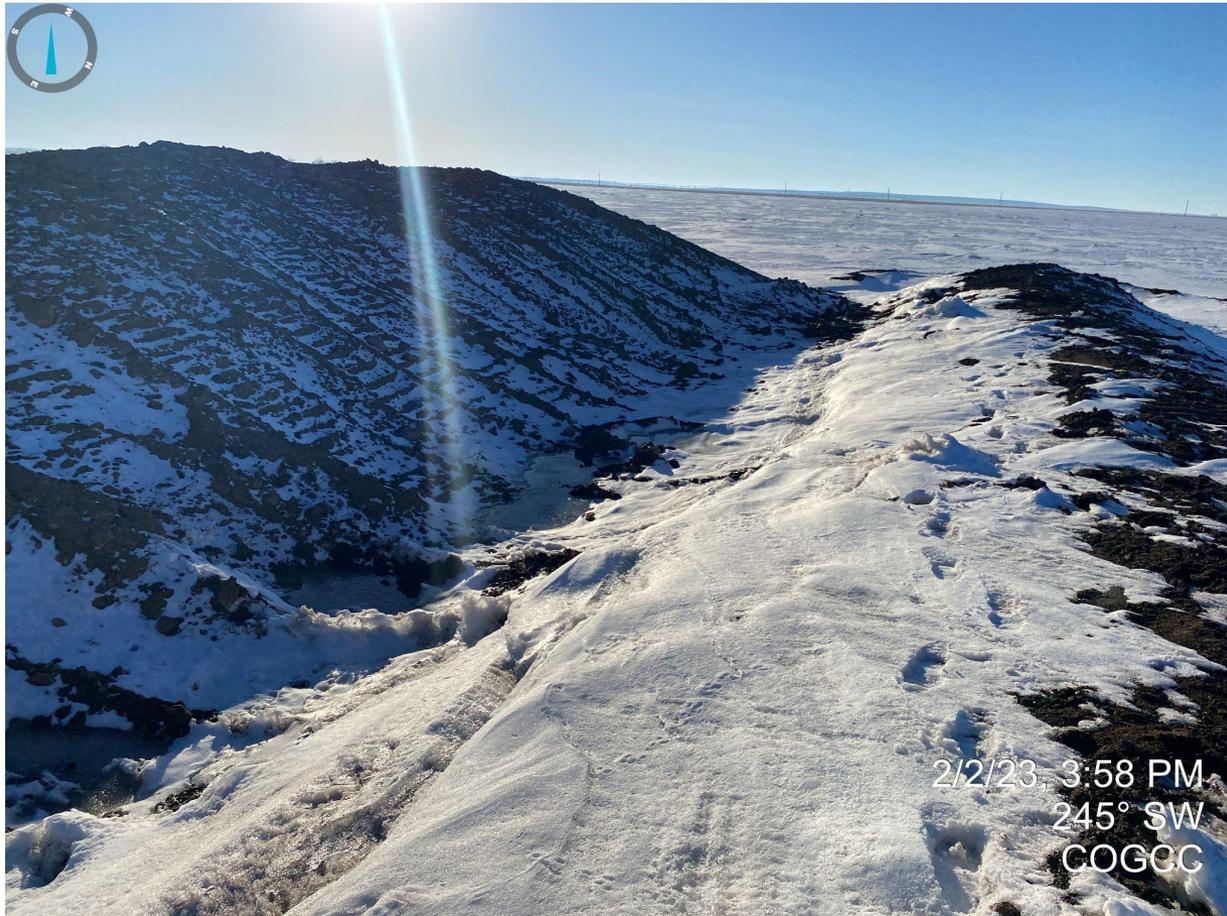
Photo 13. Facing southwest from the topsoil stockpiles. Photo illustrates that topsoil stockpiles have been temporarily stabilized with equipment tracking.

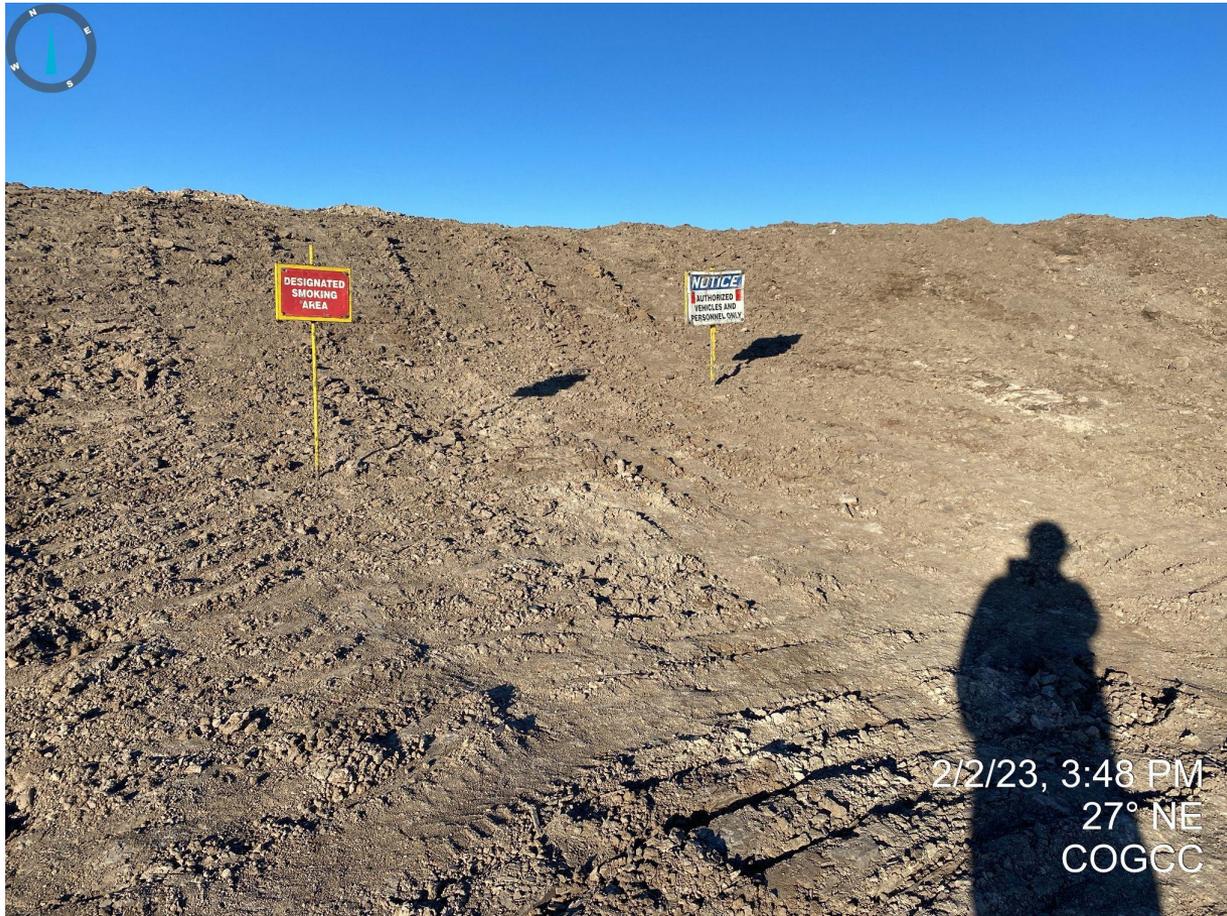
Photo 14. Facing northeast from topsoil stockpiles. See comments in Photo 13.

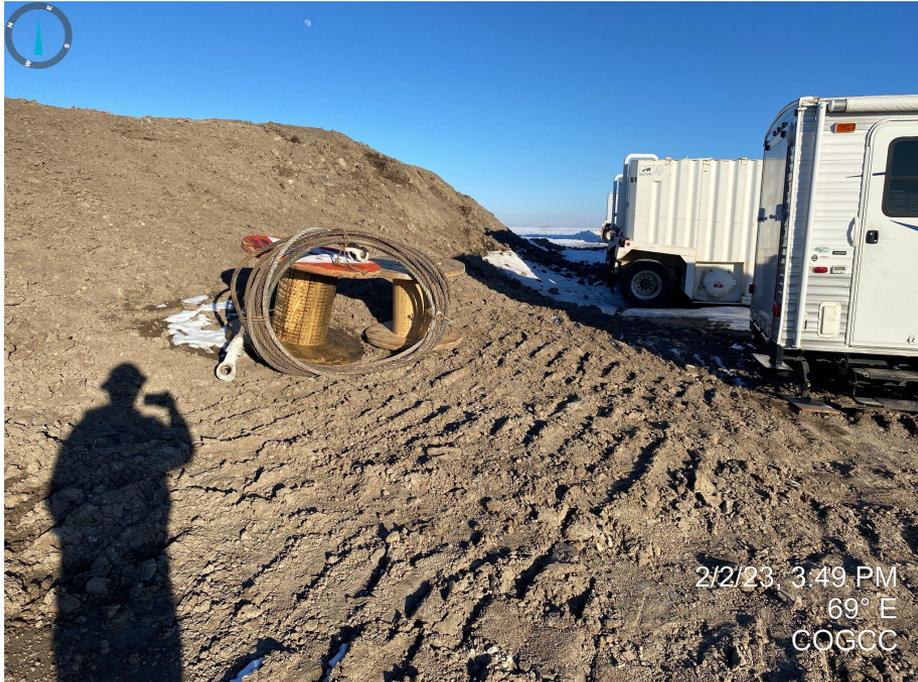
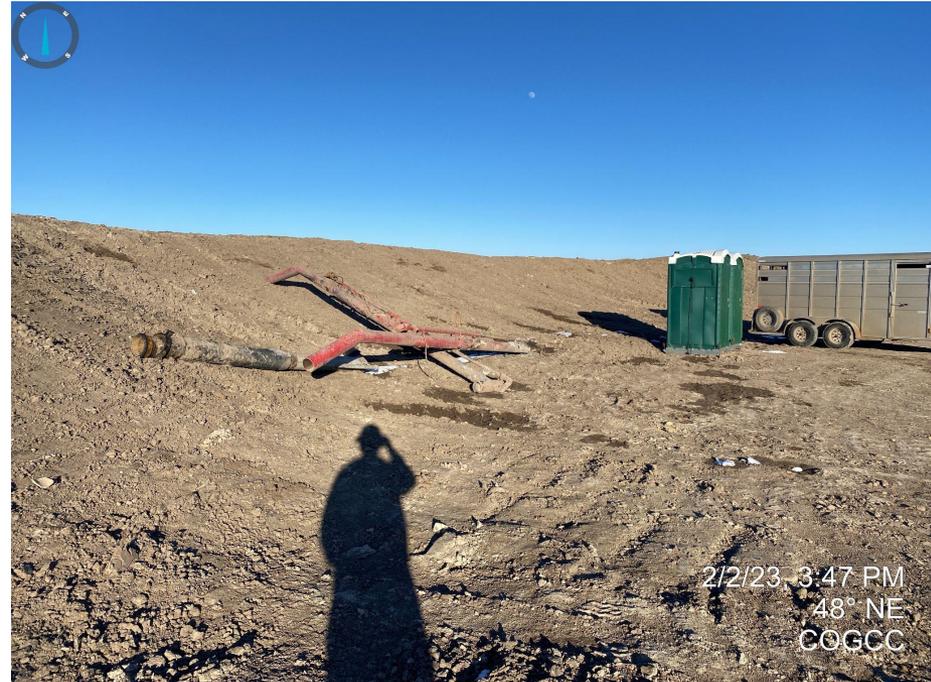
Photos 15 & 16. Facing east and northeast from the topsoil stockpiles. Photos illustrate that equipment is being stored on the topsoil stockpiles and needs to be moved and stored in a different location.

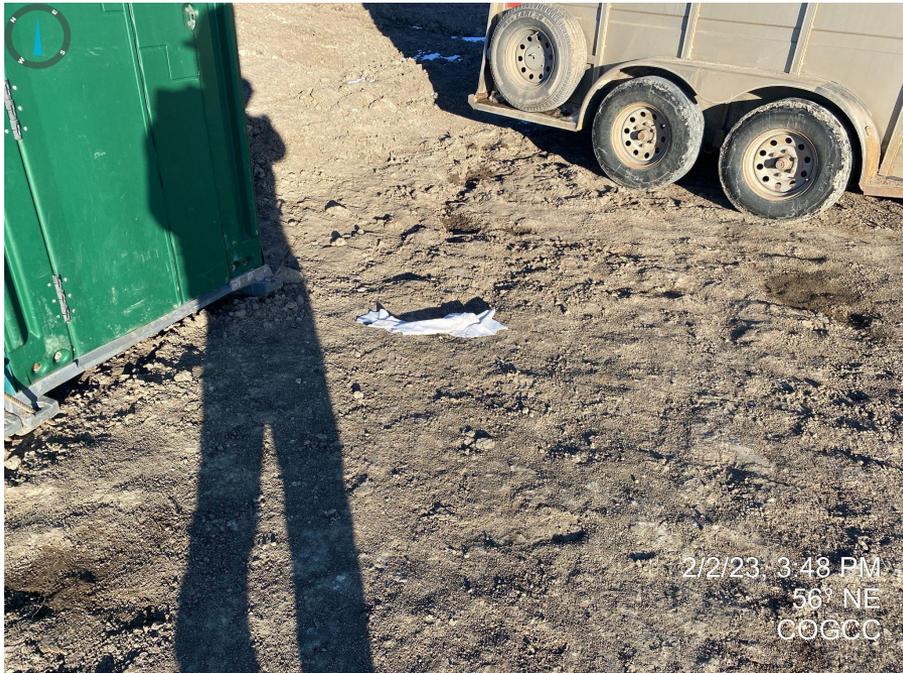
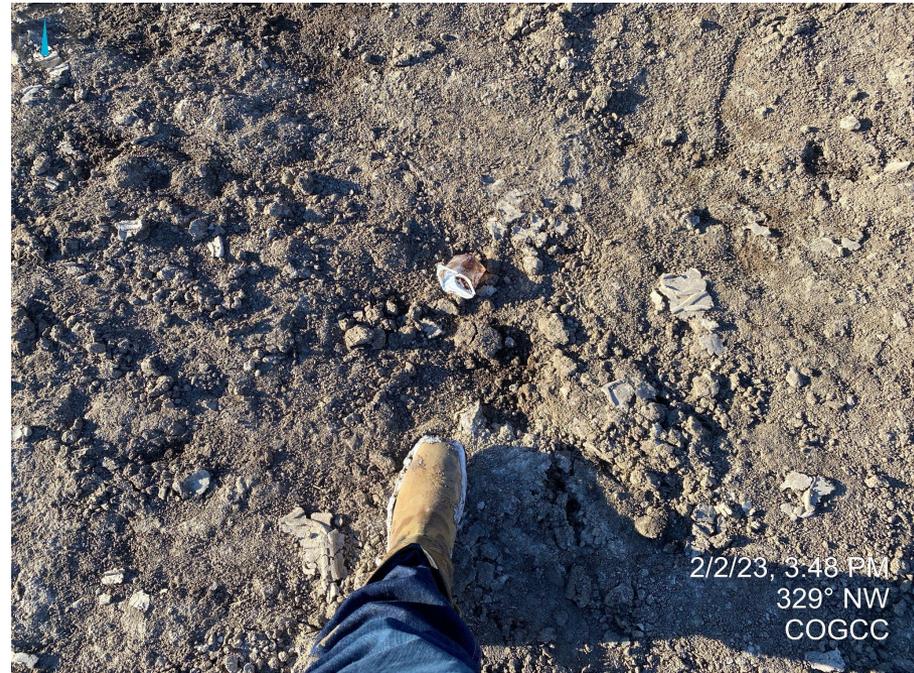
Photos 17 & 18. Close up photos near the topsoil stockpiles illustrating trash that was observed on location.

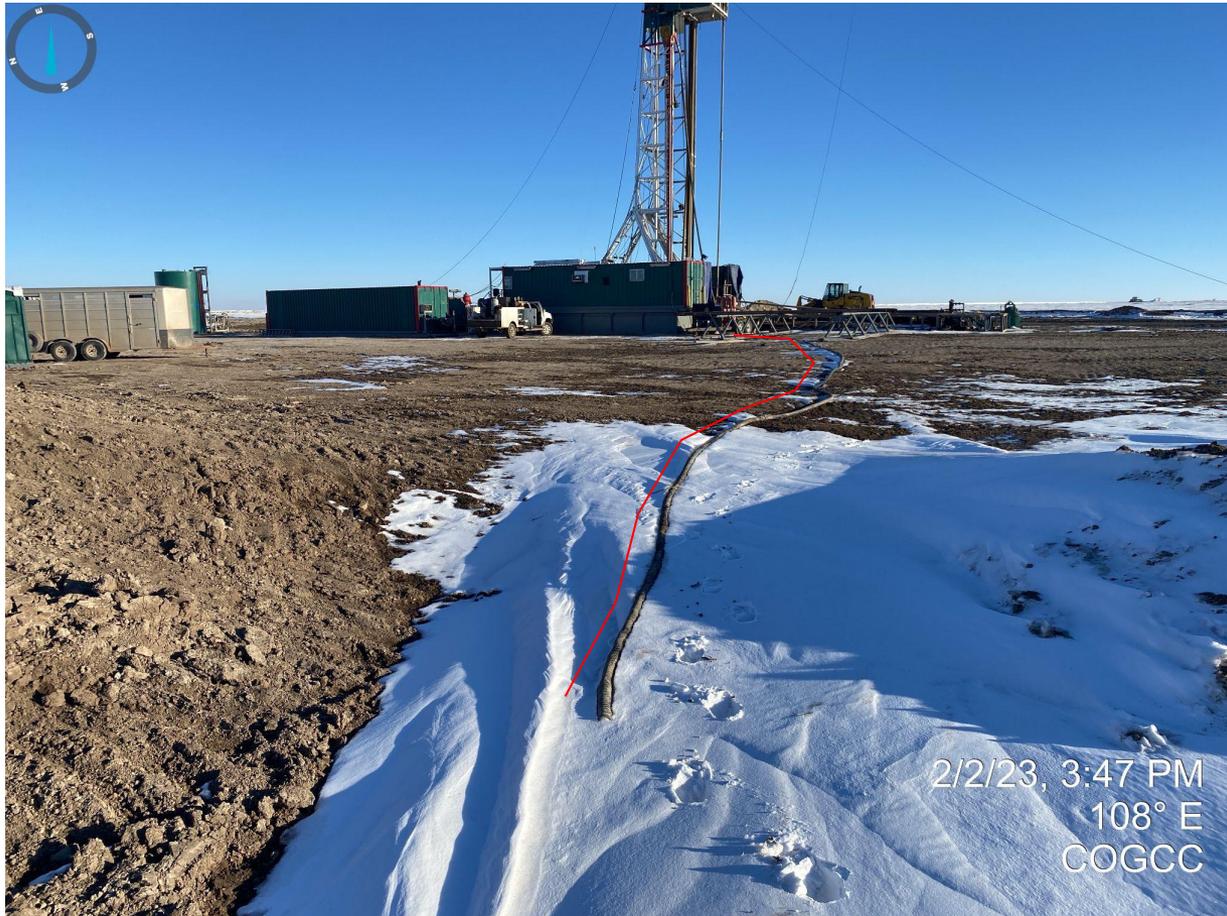
Photo 19. Facing east near the sediment trap on the northwest corner of the location. Red line indicates a line originating from the drill rig. On site crew members were unable to verify what the line was being used for. This is not in compliance with 1002.f.(2)B as materials should not be discharged into the stormwater BMPs (e.g. ditch or sediment trap).

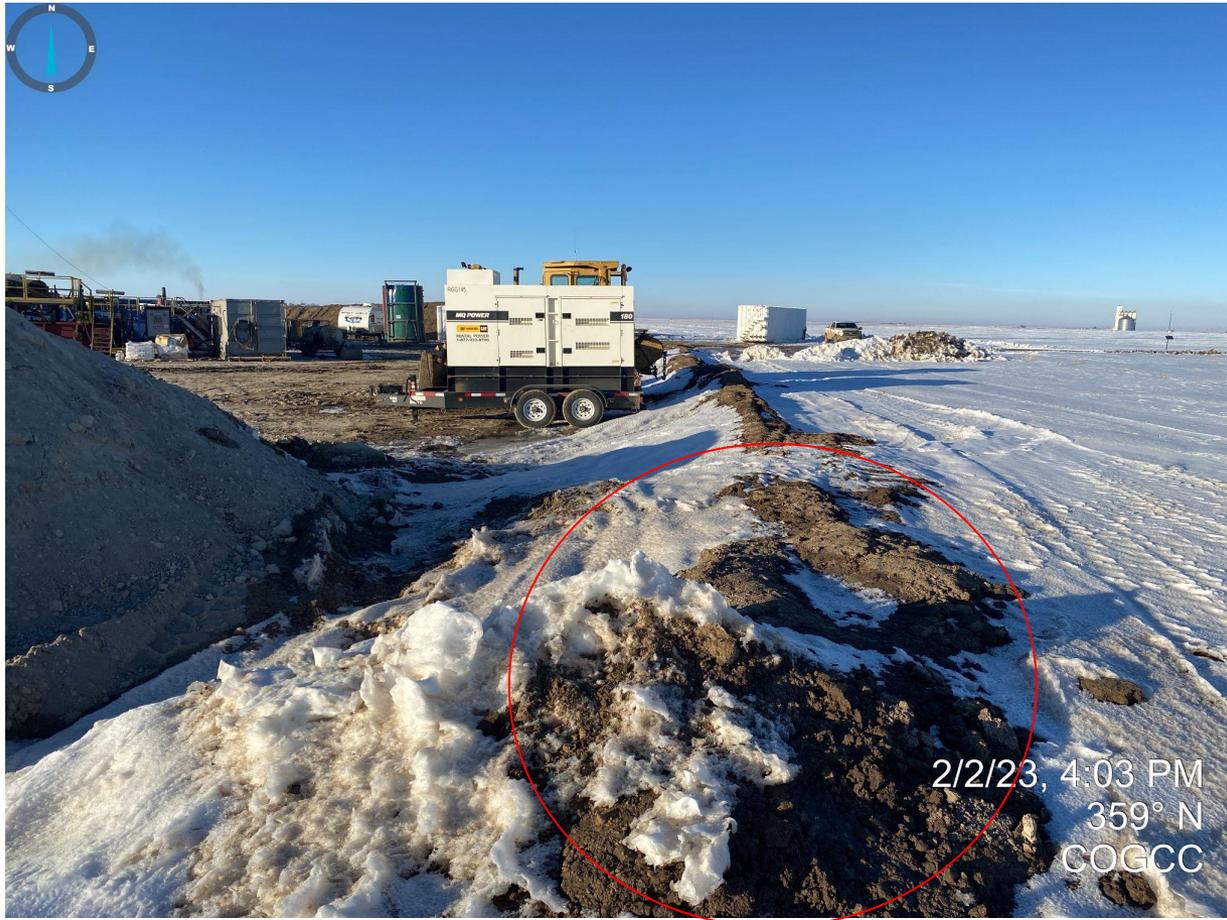
Photo 20. Facing north from the southeast corner of the location. Photo illustrates that the berm BMP is still comprised of unconsolidated material and is not in compliance with Rule 1002. Staff acknowledges that the weather and snow cover are preventing maintenance; maintenance will need to be performed as weather permits.

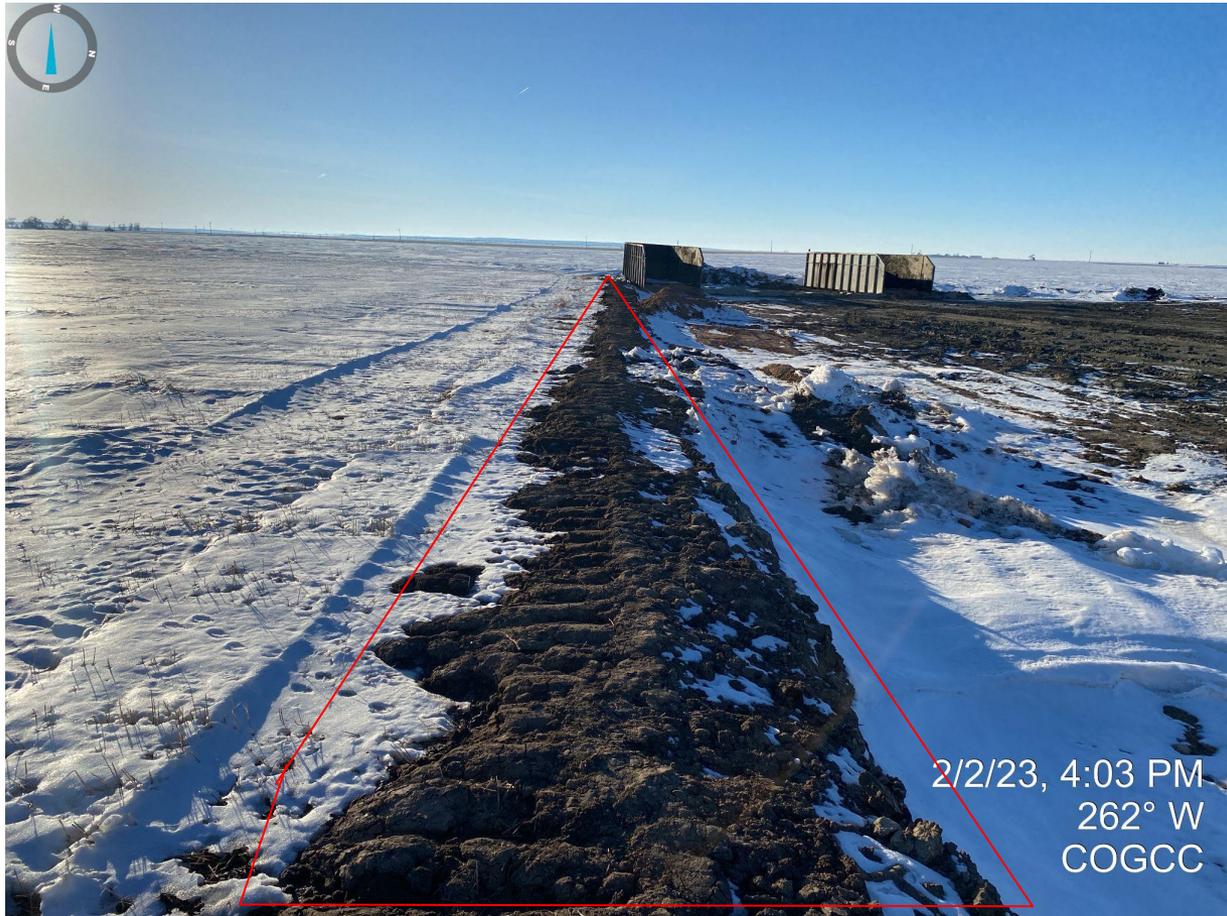
Photo 21. Facing west from the southeast corner of the location; see comments in Photo 20.

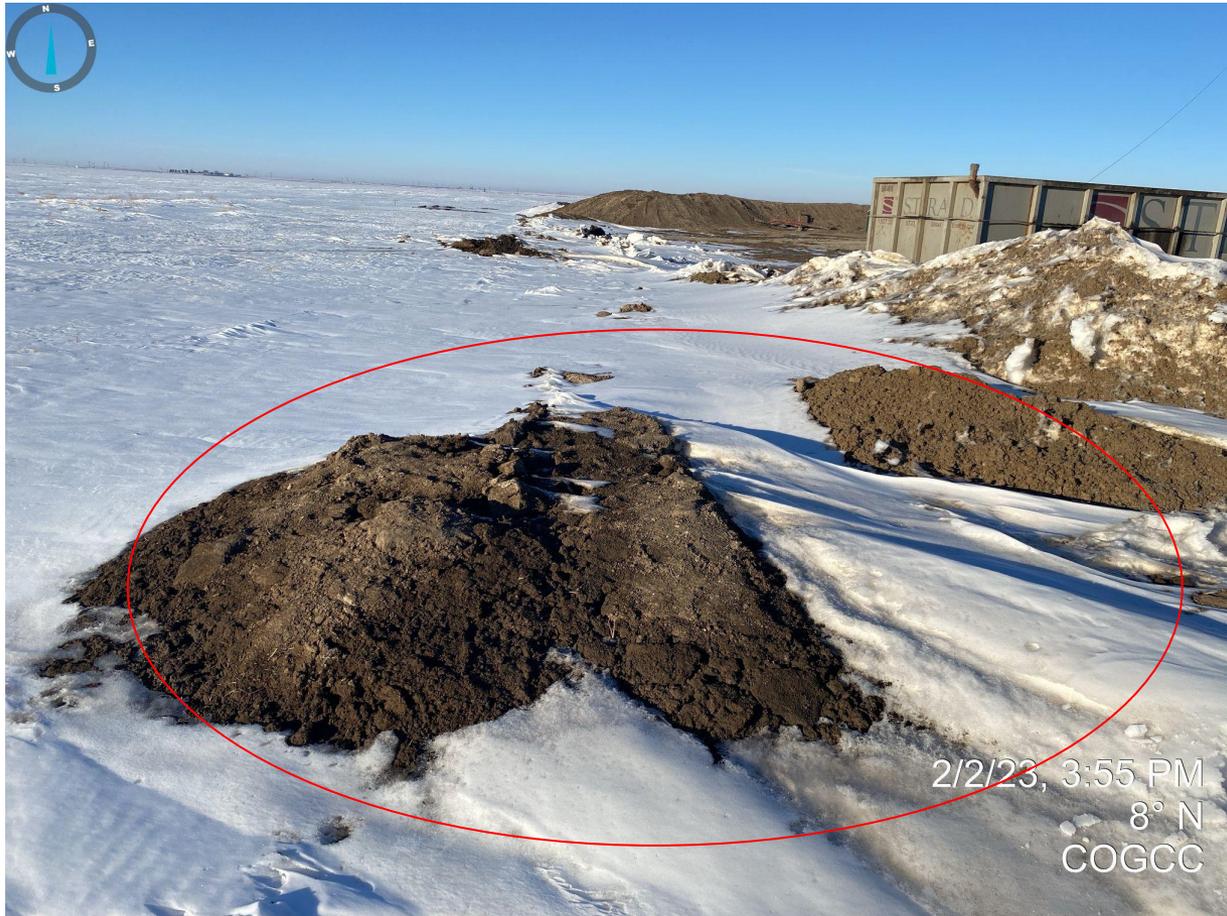
Photo 22. Facing north from the southwest corner of the location; see comments in Photo 20.

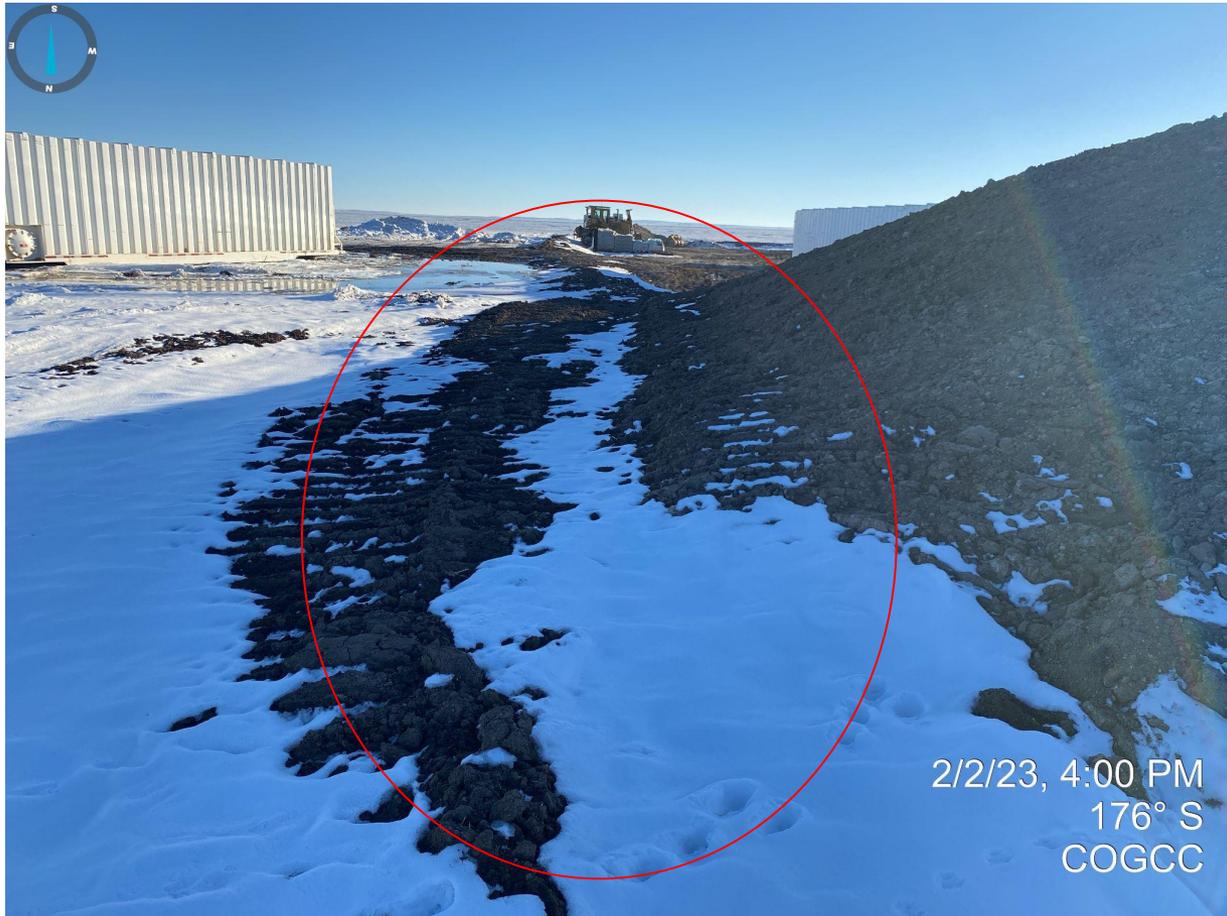
Photo 23. Facing south from the northeast corner of the location, near the topsoil stockpile; see comments in Photo 20.
