Final Reclamation and Stormwater Inspection

Date: 02/02/2023

Operator: ST CROIX OPERATING INC - 81490

Location ID: 482780

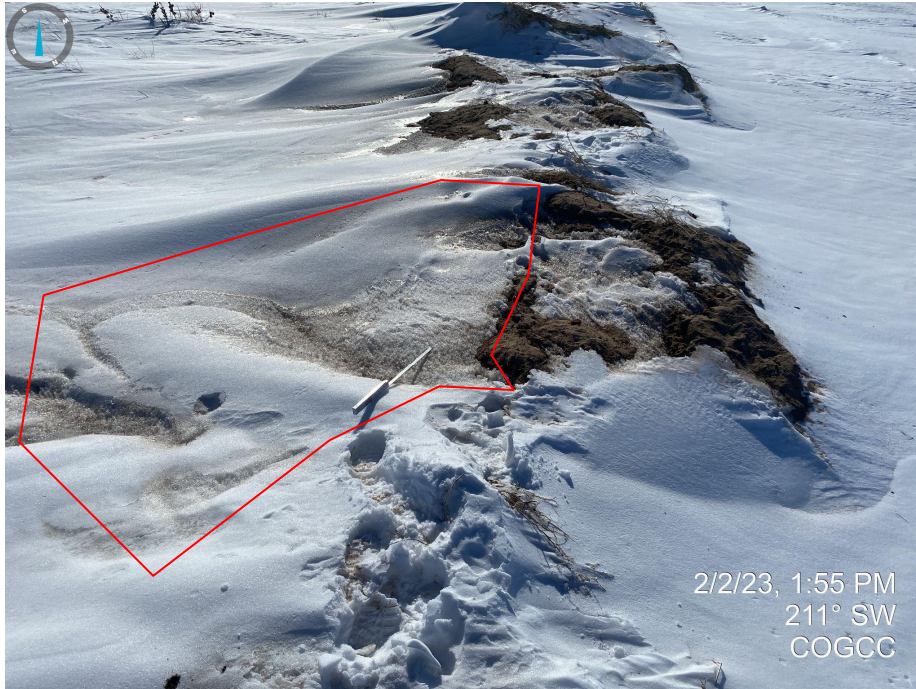
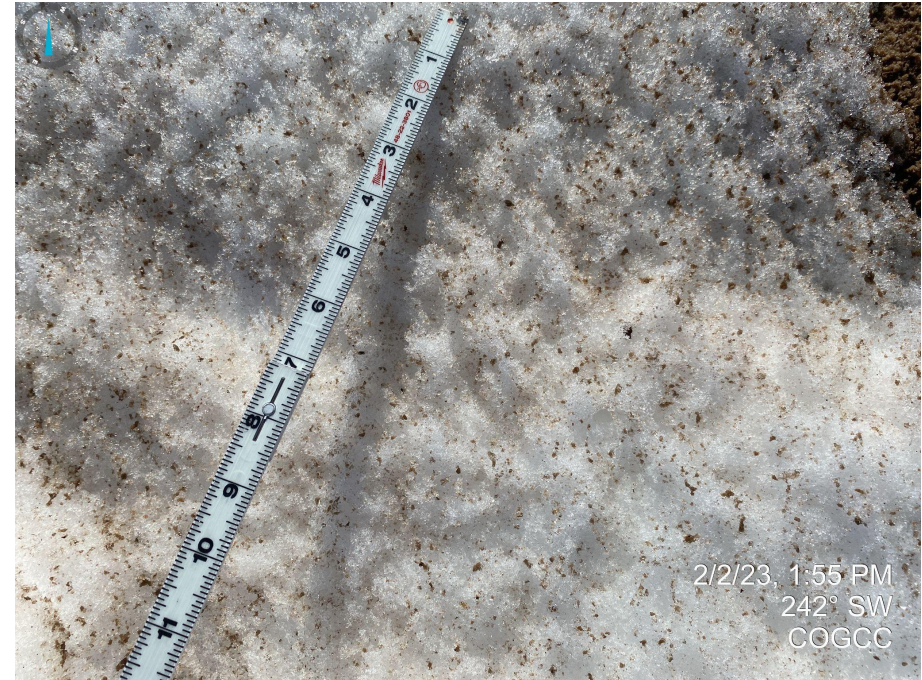
Photos 1 & 2. Facing southwest near the location's entrance. Photos illustrate that topsoil stockpiles stored along the access road are comprised of unconsolidated material and not properly stabilized against wind erosion. Evidence of soil/dust on snow.

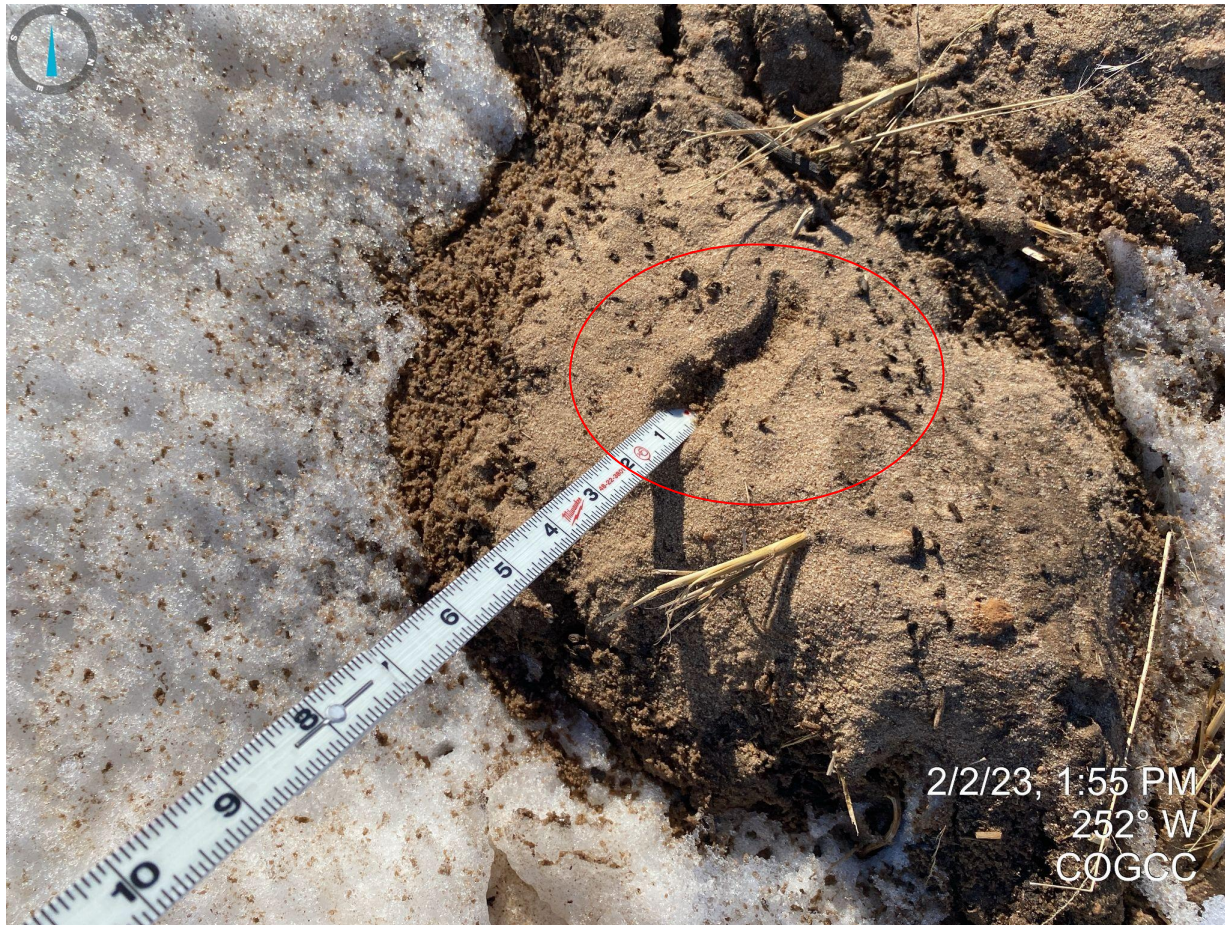
Photo 3. Close up photo from topsoil stockpiles near the location's access road. Photo illustrates that soils are not frozen and thus not properly protected from wind erosion.

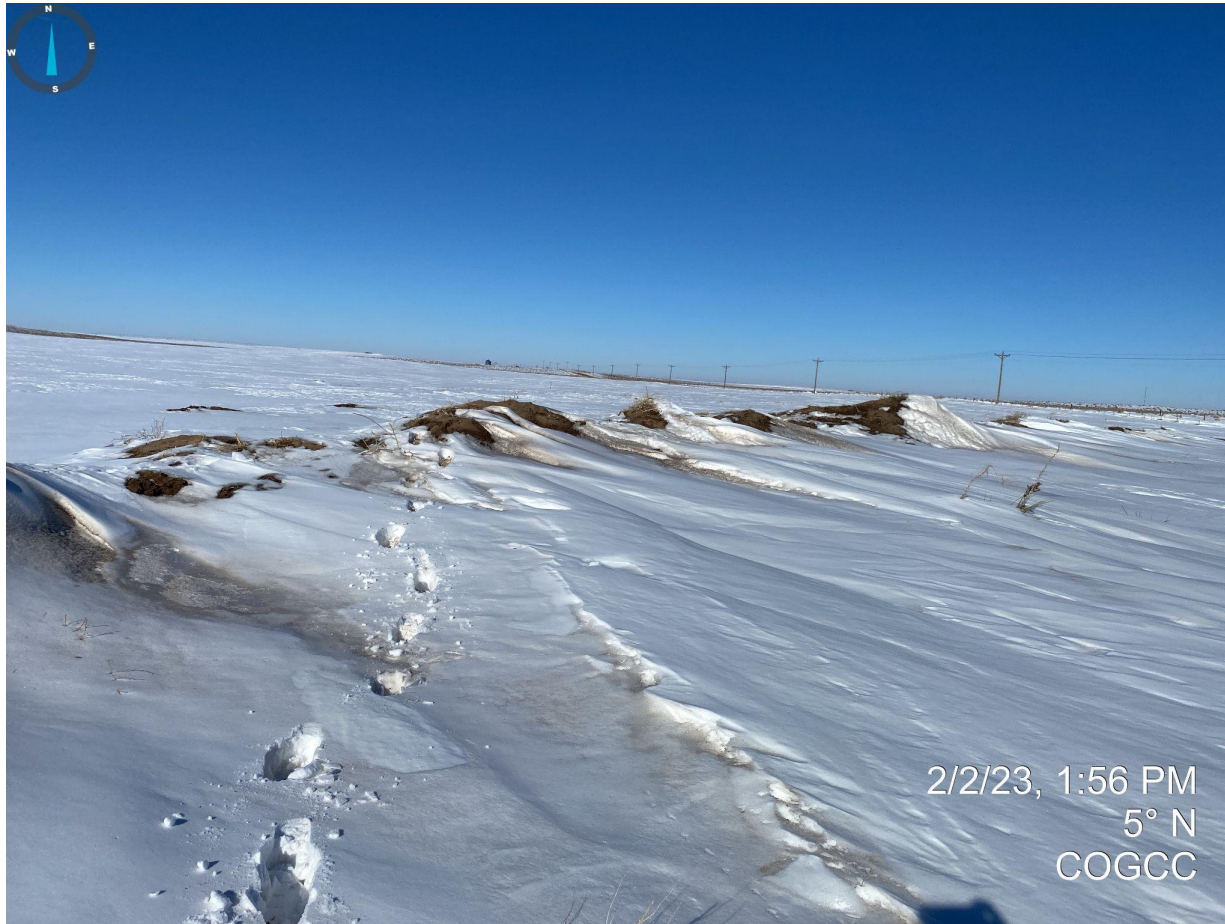
Photo 4. Facing north from the location's access road. See comments in Photos 1-3.

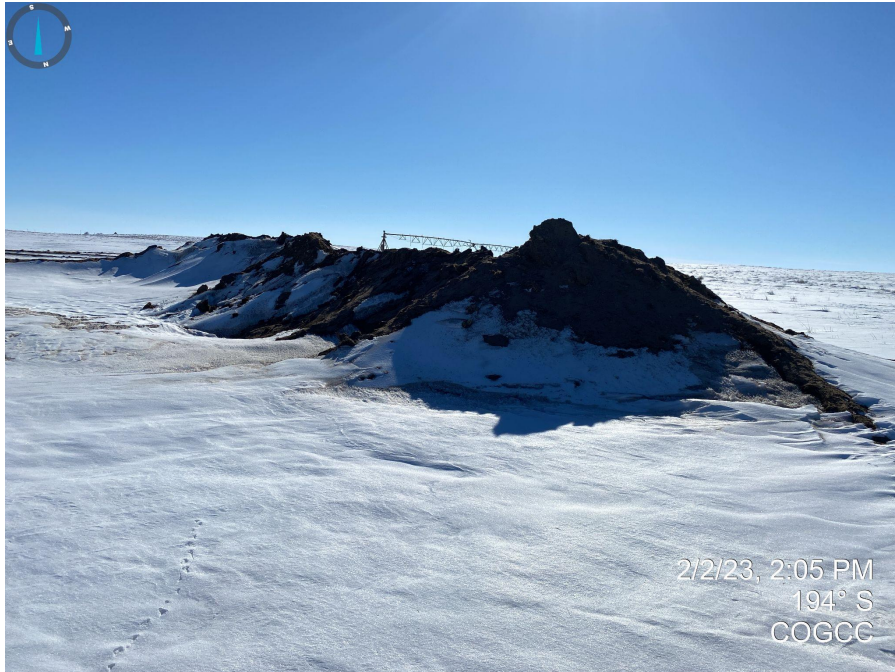
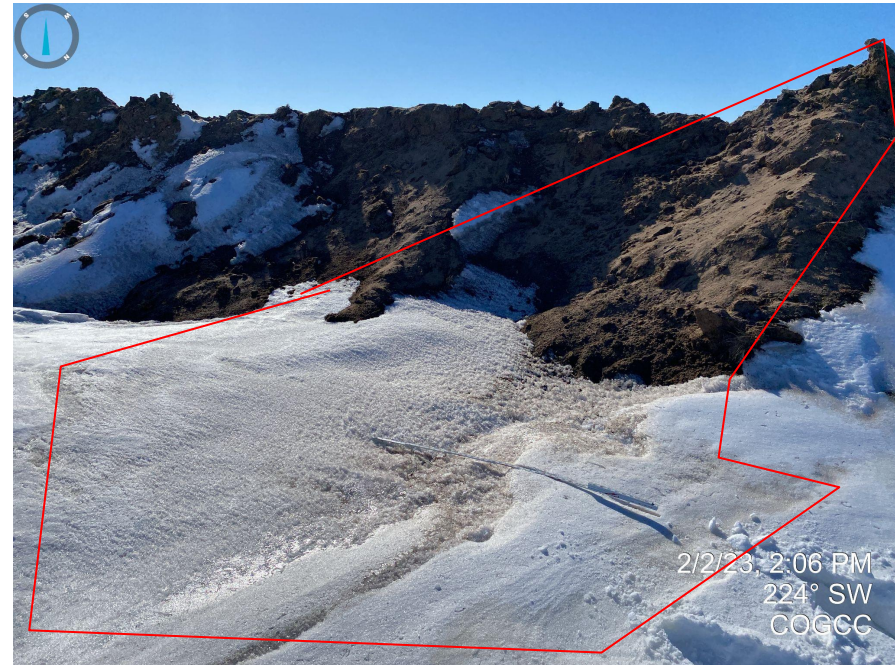
Photos 5 & 6. Facing south and southwest at the location. Photos illustrate that topsoil stockpiles are not properly stabilized and are unconsolidated with evidence of wind erosion (e.g. soil/dust blown onto snow).

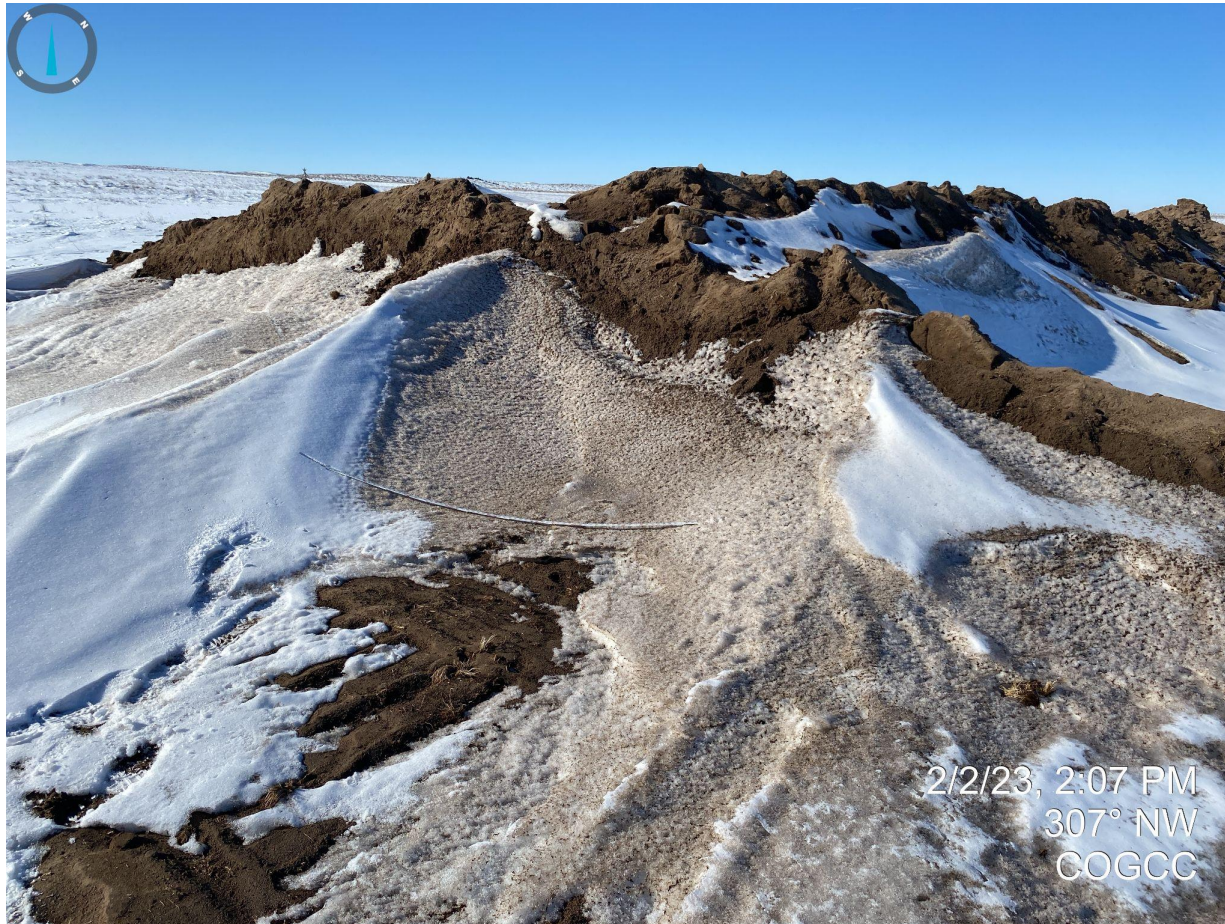
Photo 7. Facing northwest at one of the topsoil stockpiles. See comments in Photos 5 & 6.

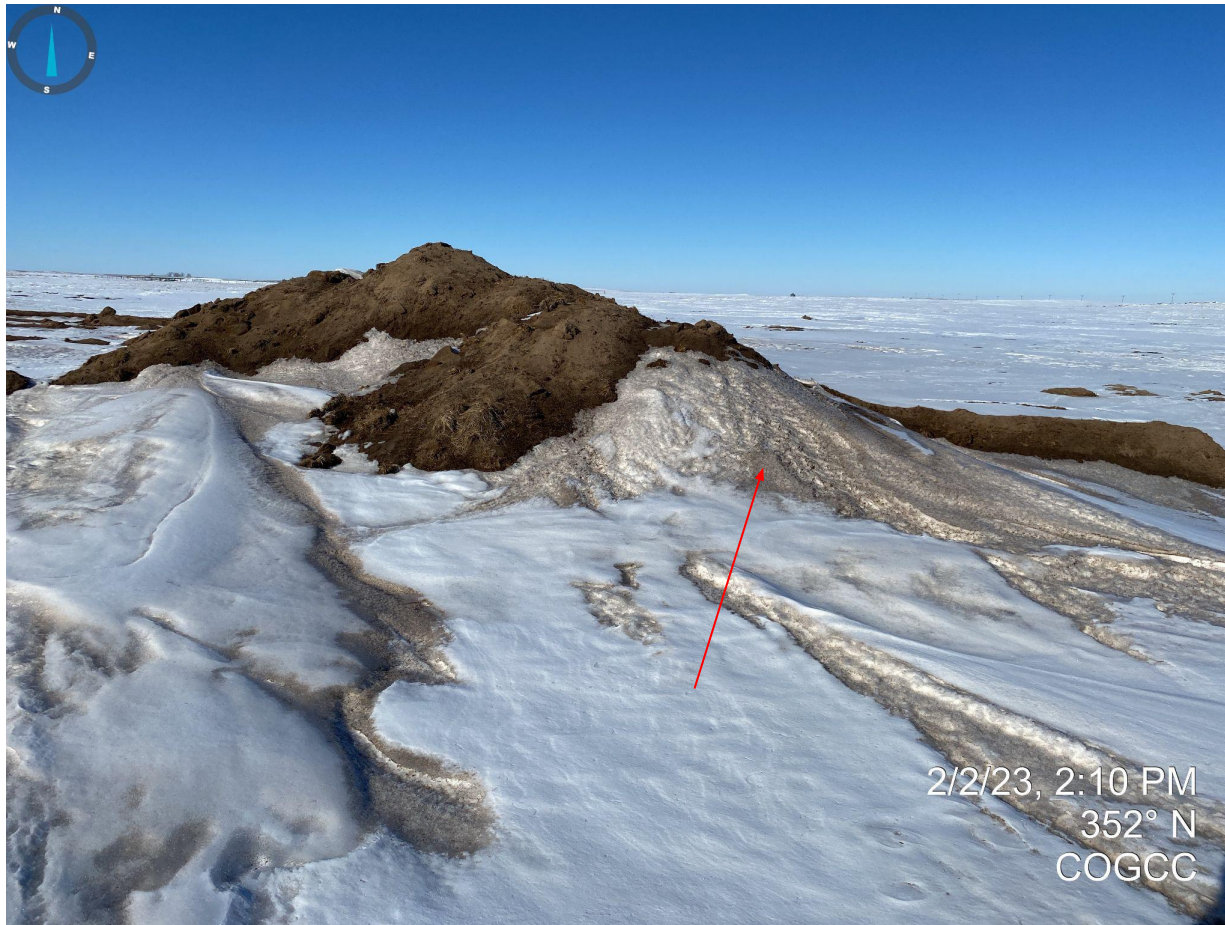
Photo 8. Facing north from the center portion of the location. See comments in Photos 5 & 6.

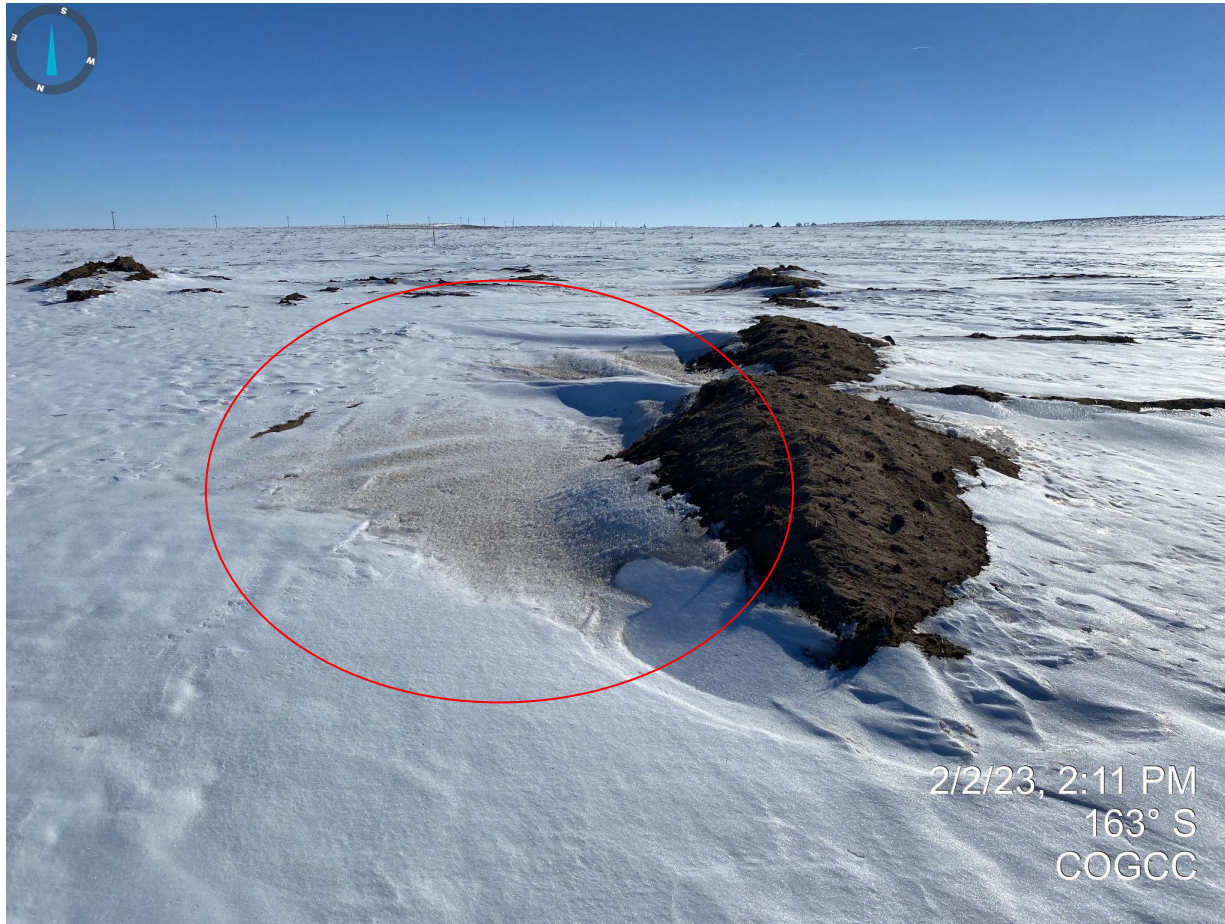
Photo 9. Facing south from the eastern portion of the location. See comments in Photos 5 & 6.

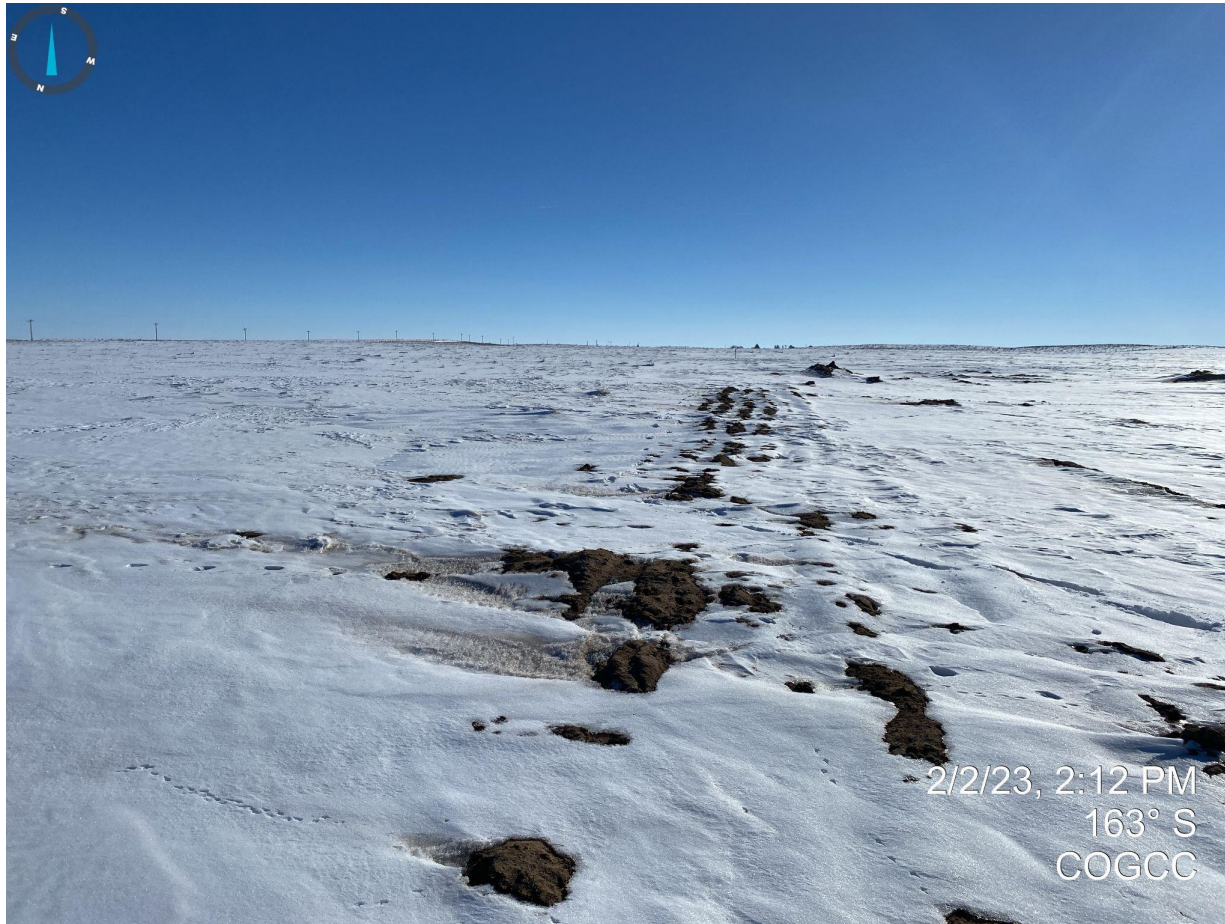
Photo 10. Facing south from the eastern boundary of the location. No stormwater BMPs were observed along this eastern boundary that would prevent sediment laden storm water from exiting off location. Surface roughening alone is not an adequate BMP; photo illustrates a rough grade or till that is not contiguous throughout the eastern boundary.

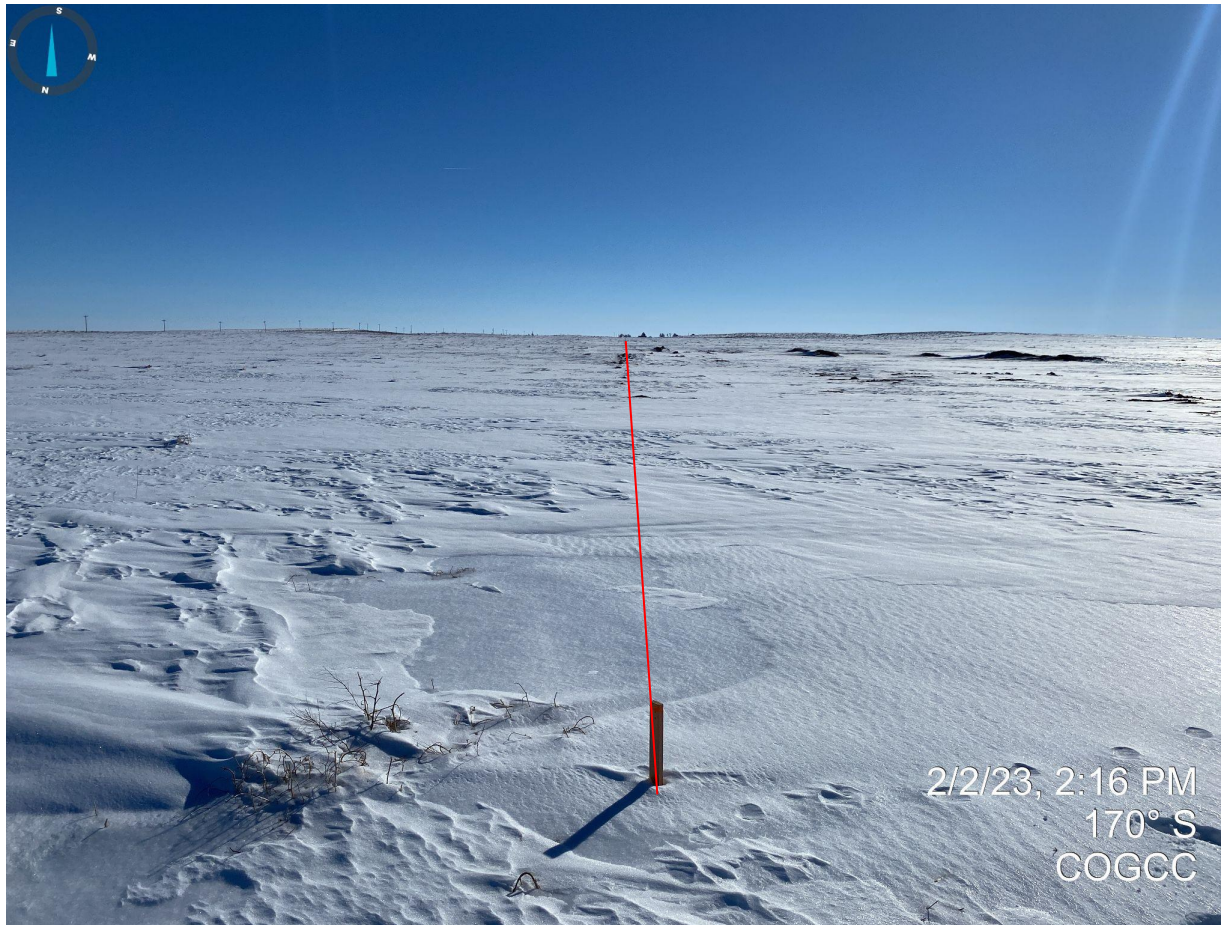
Photo 11. Facing south at the northeast corner of the disturbance area. See comments in Photo 10. Red line is drawn from t-post at southeast corner to the northeast corner, or the eastern boundary of the disturbance area.

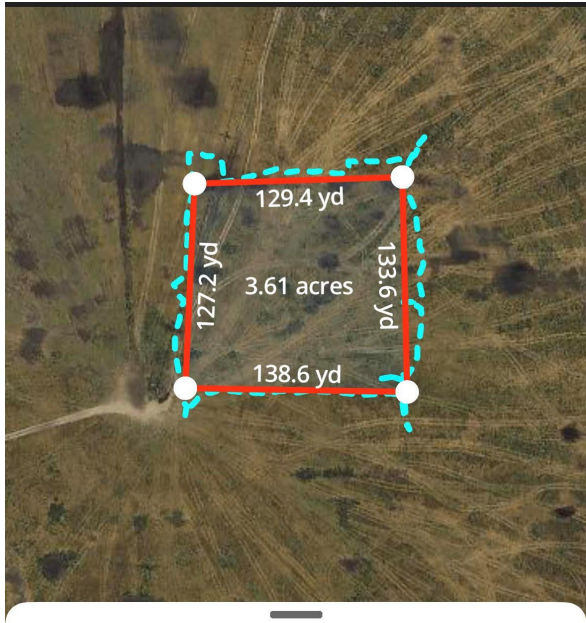
Photos 12 & 13. Photo 12 (left) illustrates field collected disturbance area (in blue line) obtained from OnX mapping and an approximate area (red line/box) used for topsoil calculation to a depth of 12" (A and AC horizons). North/south lines were averaged in feet (~390') as were east/west lines (~402') for an approximate disturbance area of 3.6 acres. Red outline in Photo 13 (right) illustrates how much topsoil should have been salvaged during the construction phase of this location; blue box indicates how much topsoil Operator states was salvaged (1,667 cubic yard) based on a 300'x300' pad to a depth of 6" (see FIRR Doc #403302335).
