Interim Reclamation and Stormwater Inspection

February 7, 2023

Operator: PDC ENERGY INC - 69175

Location ID: 433548

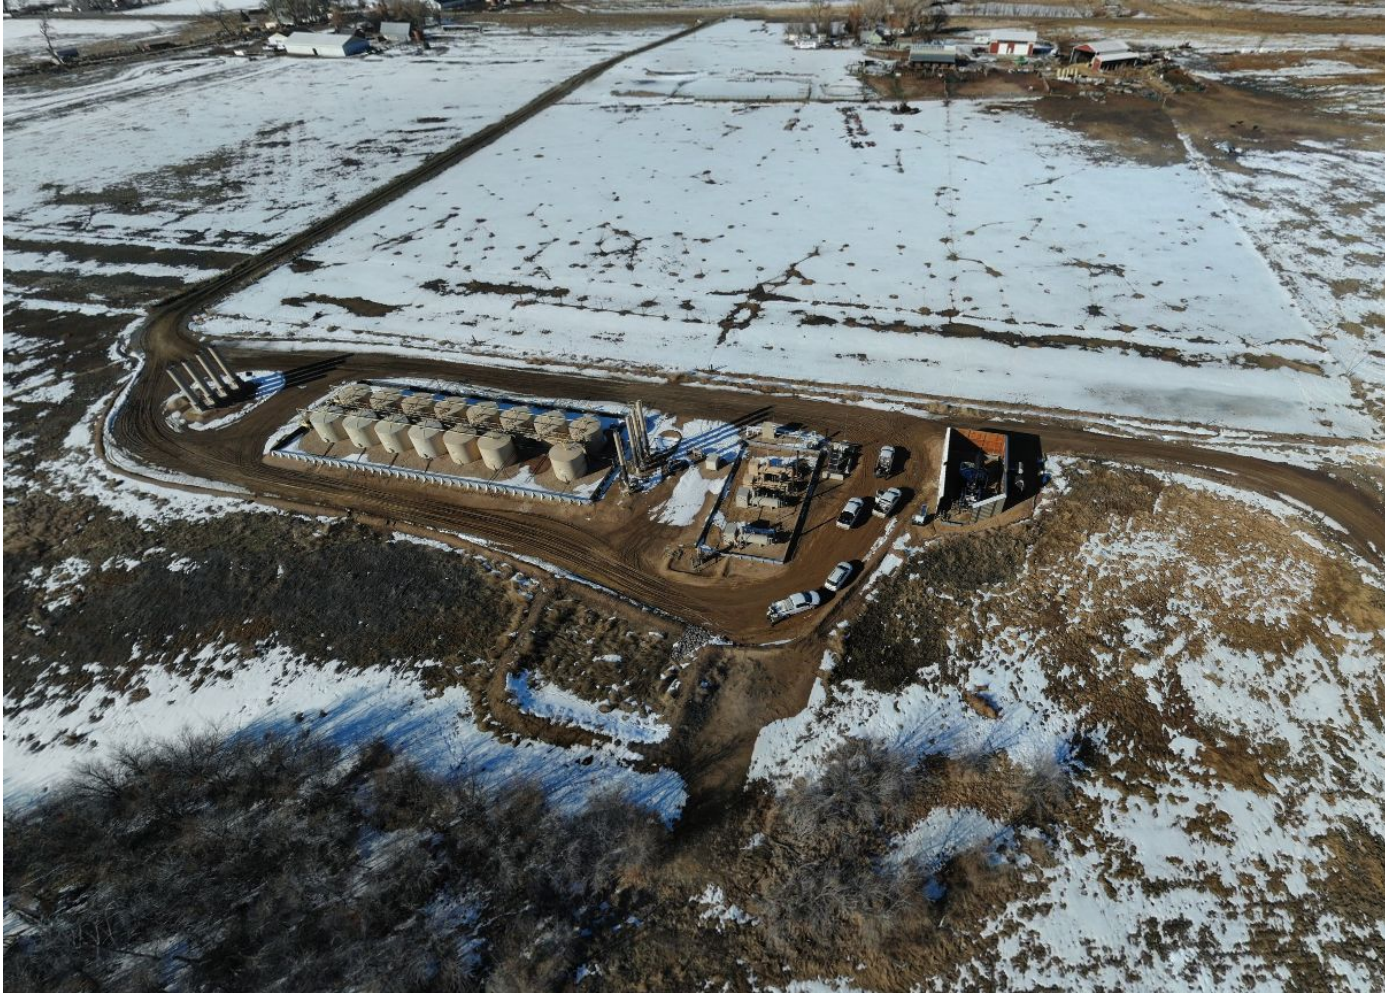
Photo 1. Drone aerial imagery from February 7, 2023 illustrates the Phelps facility and portions of the flowline area. COGCC observed stormwater while active snowmelt was occurring. Stormwater from the location is not being directed into the sediment trap and it appears only $\frac{1}{3}$ of the facility might be directing stormwater to the sediment trap.

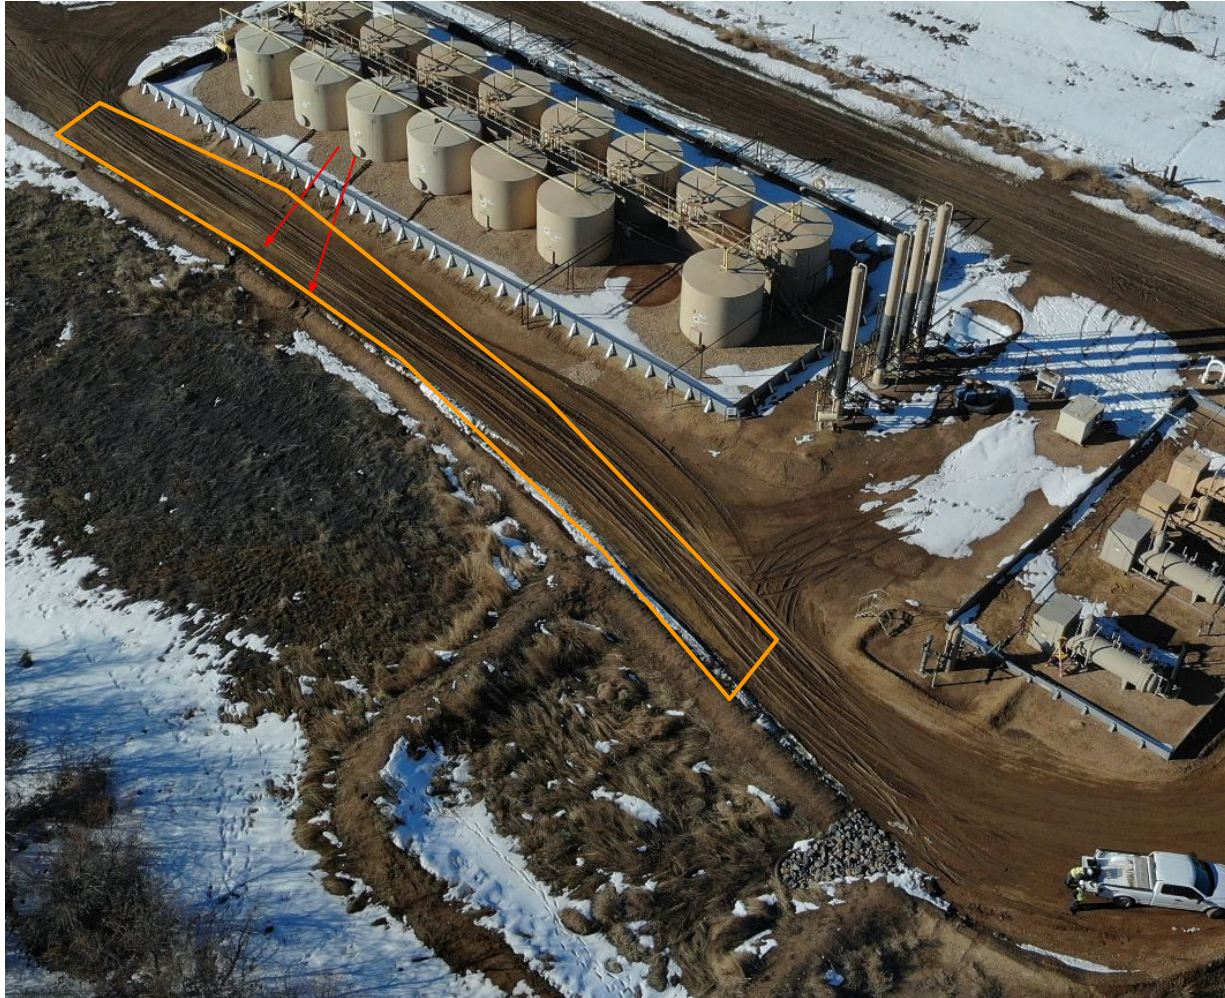
Photo 2. Drone aerial imagery from February 7, 2023 illustrates the earthen berm has failed and sediment laden stormwater is discharging off location. It appears that the other $\frac{2}{3}$ of the location is pooling along the southern earthen berm which is not being directed into the inlet of the sediment trap.

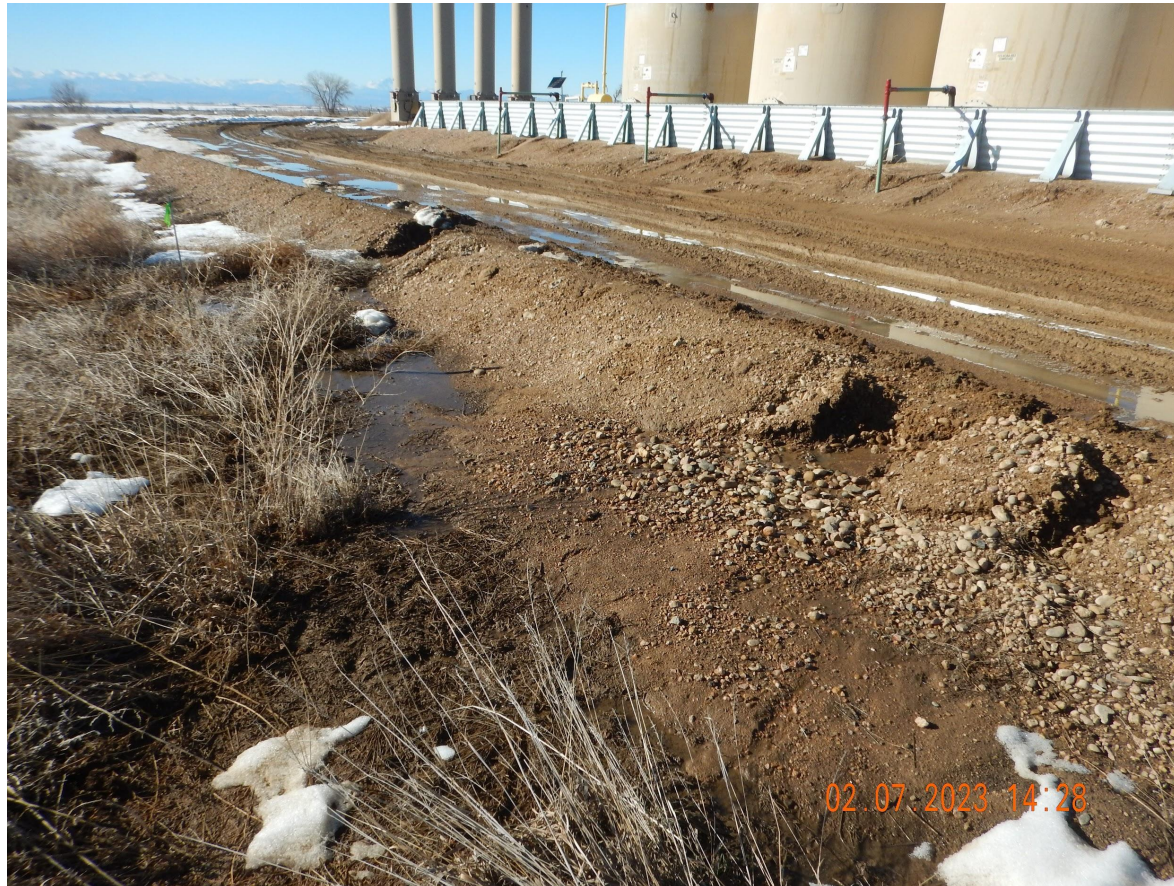
Photo 3. Photo taken from the failed earthen berm, facing West. See comments under Photo 2.

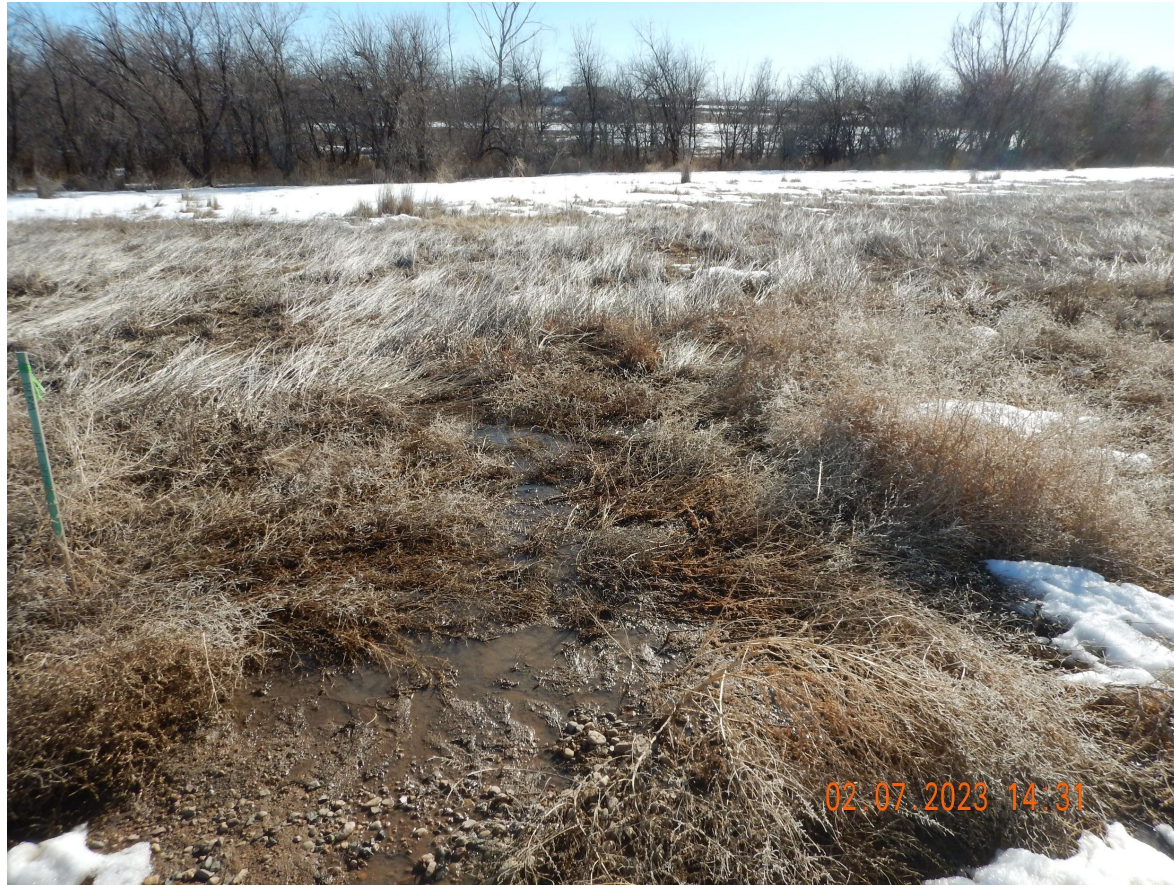
Photo 4. Photo taken from the failed earthen berm, facing South. See comments under Photo 2.

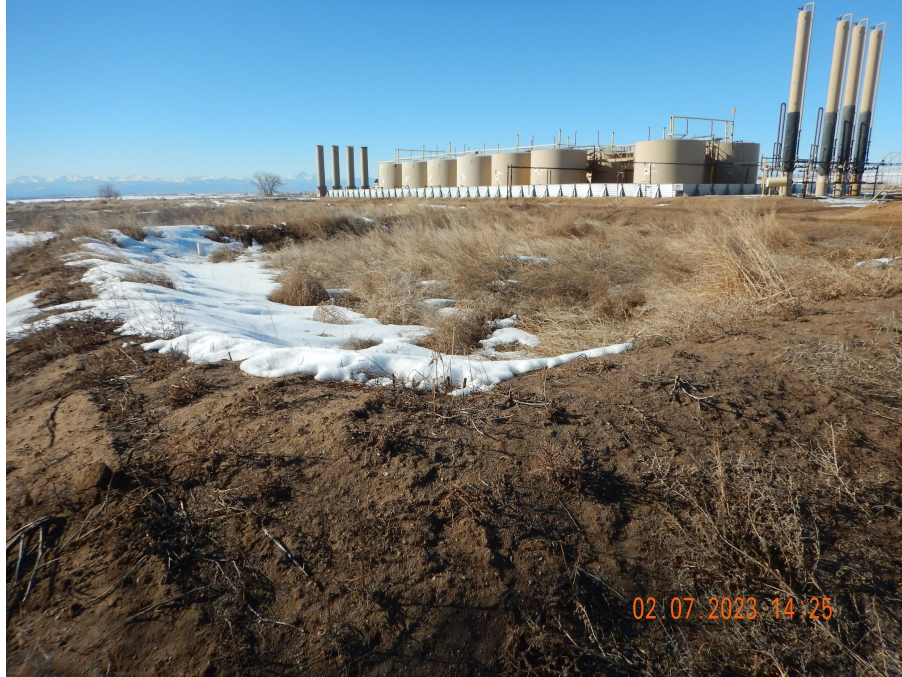
Photo 5. Photo taken from the sediment trap, facing West. Photo illustrates unmanaged weeds within the sediment trap.

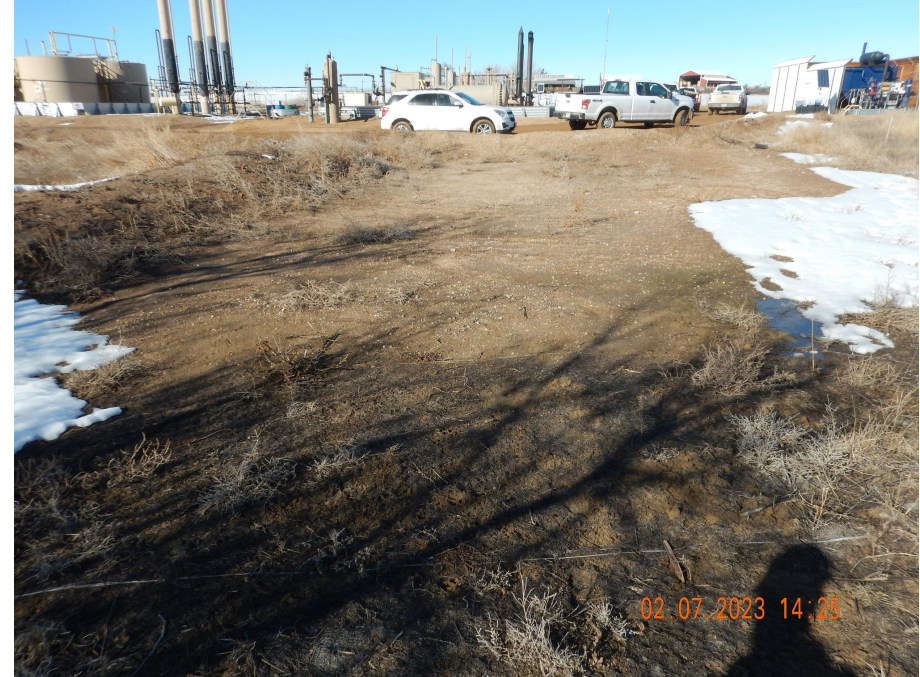
Photo 6. Photo taken from a portion of the flowline, facing North. Photo illustrates bare soil with no vegetation to stabilize the area. Erosion control blankets were previously used within the flowline area but are no longer functioning.

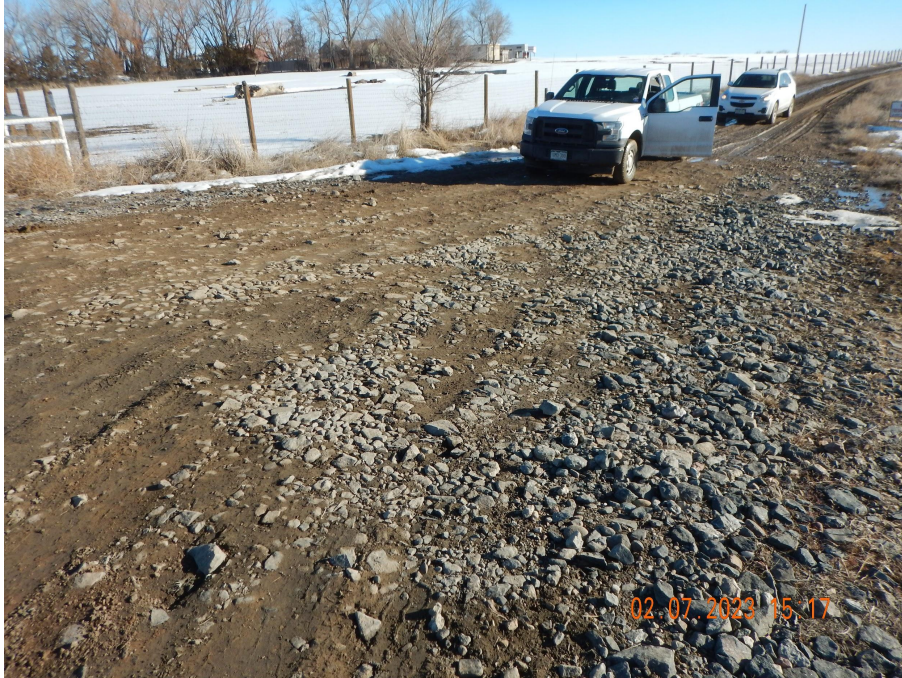
Photo 7. Photo taken from the entrance of location, facing South. Photo illustrates the vehicle tracking device BMP is in need of maintenance. At the time of this inspection, there was no track out observed.

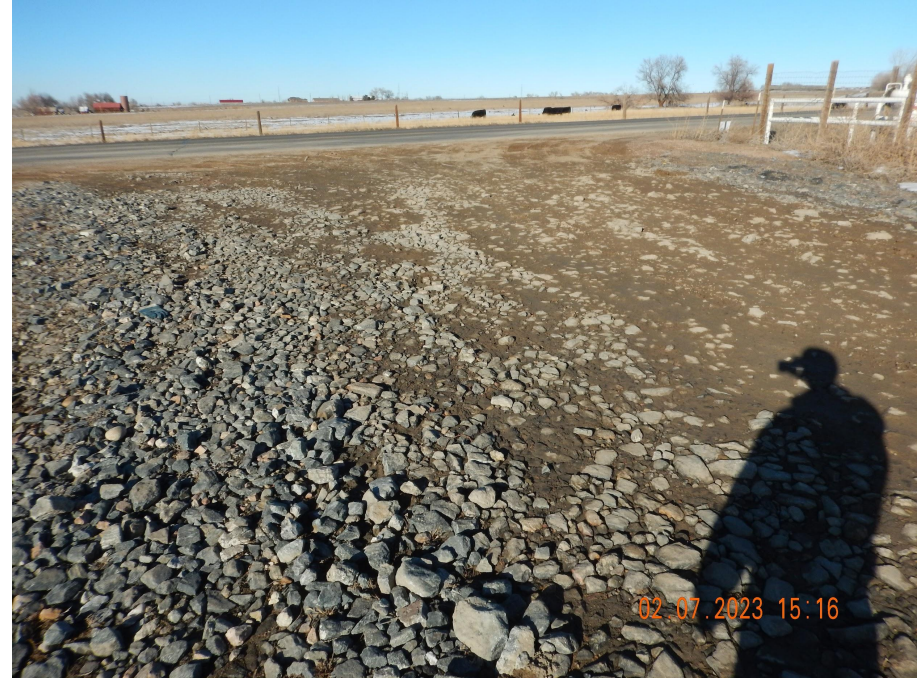
Photo 8. Photo taken from the entrance of location, facing North. See comments under Photo 7.
