## Inspection Photos

Location Name: CAERUS PICEANCE LLC Federal /35-16H (ON1).

Location ID: 334468

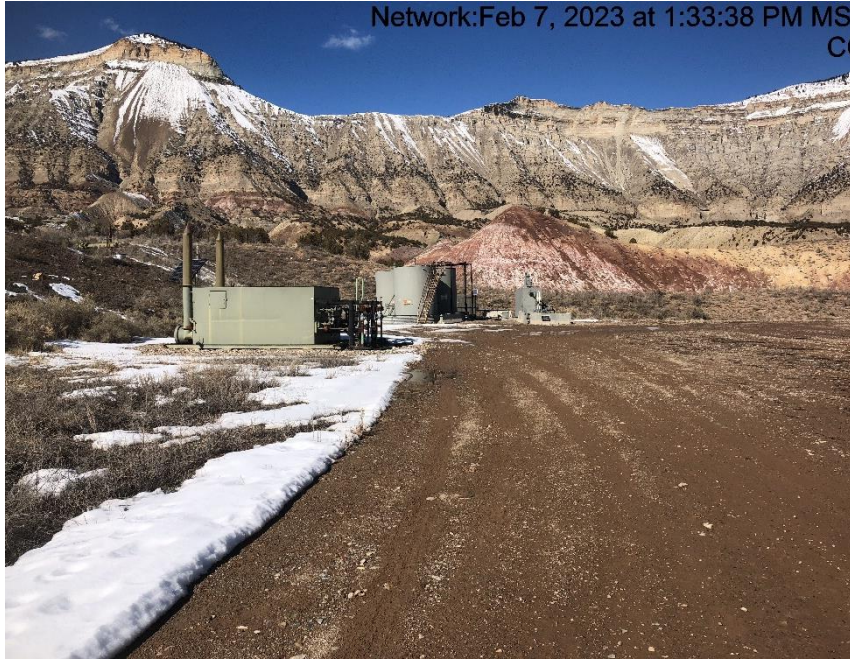
Photo #8922 From entrance to location.

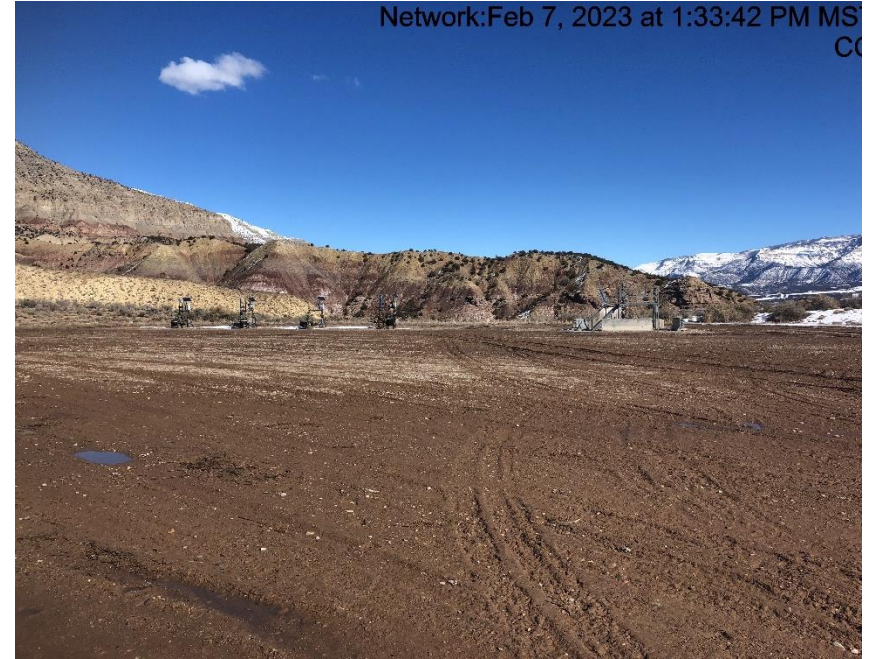
Photo #8923 From entrance to location

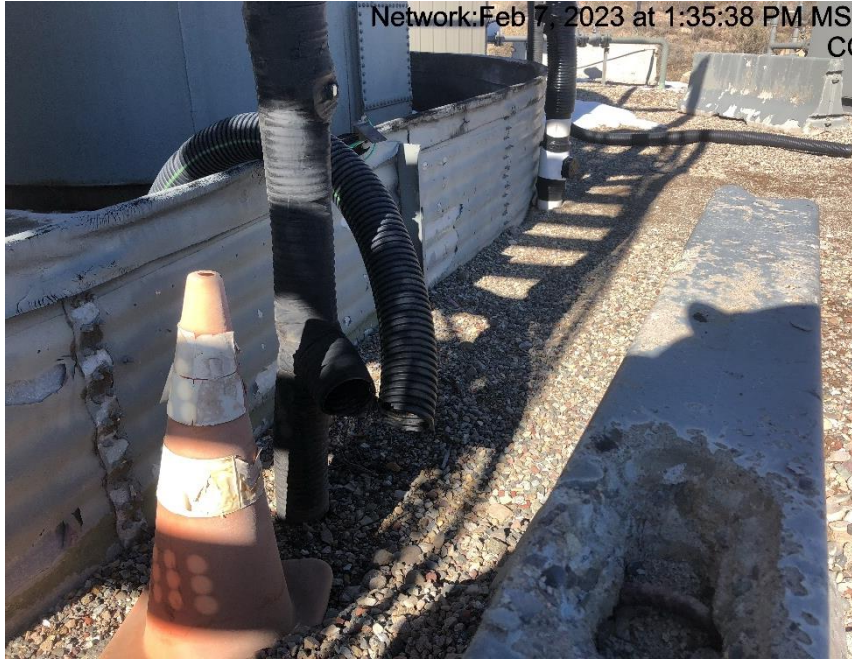
Photo #8925 Flow line heating insulation open ended.

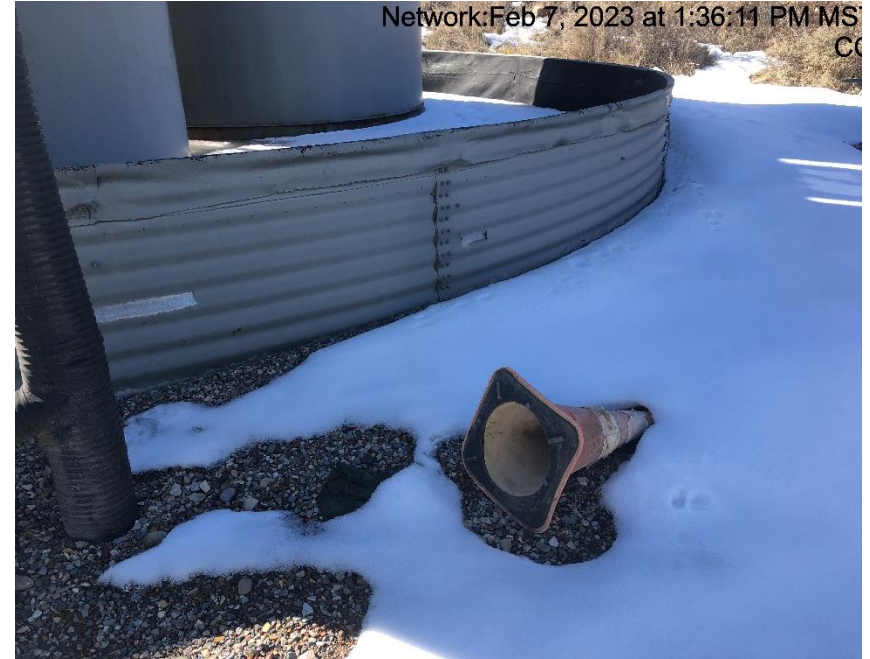
Photo #8927 Multiple places with debris on location.

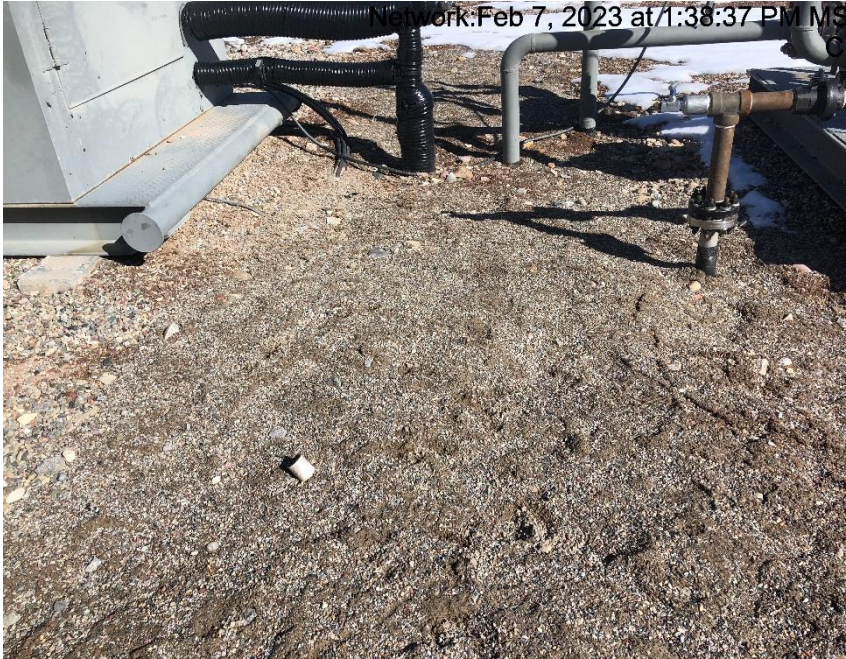
**Photo #8930 Multiple places with debris on location.**

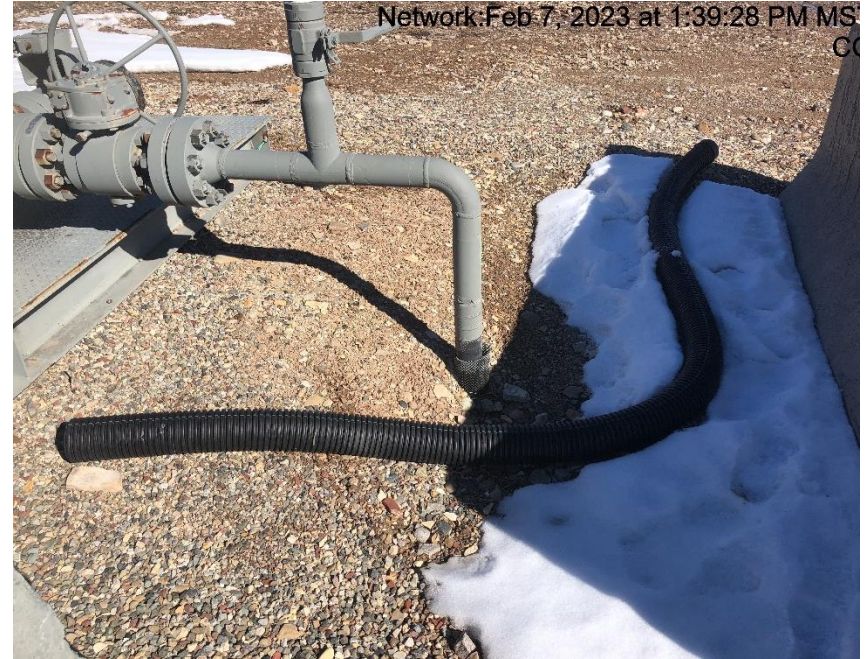
**Photo #8932 Multiple places with debris on location.**

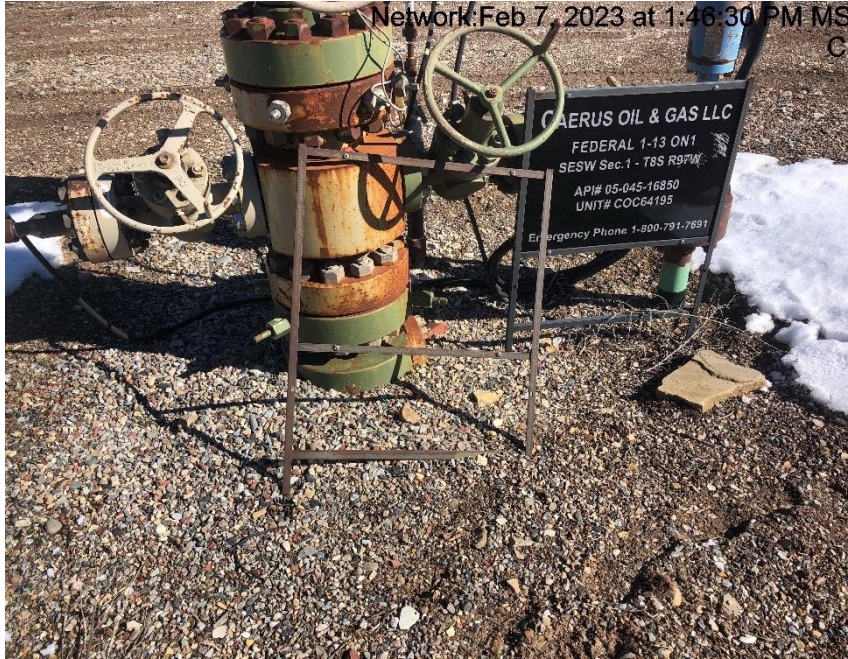
**Photo #8943 Multiple places with debris on location.**

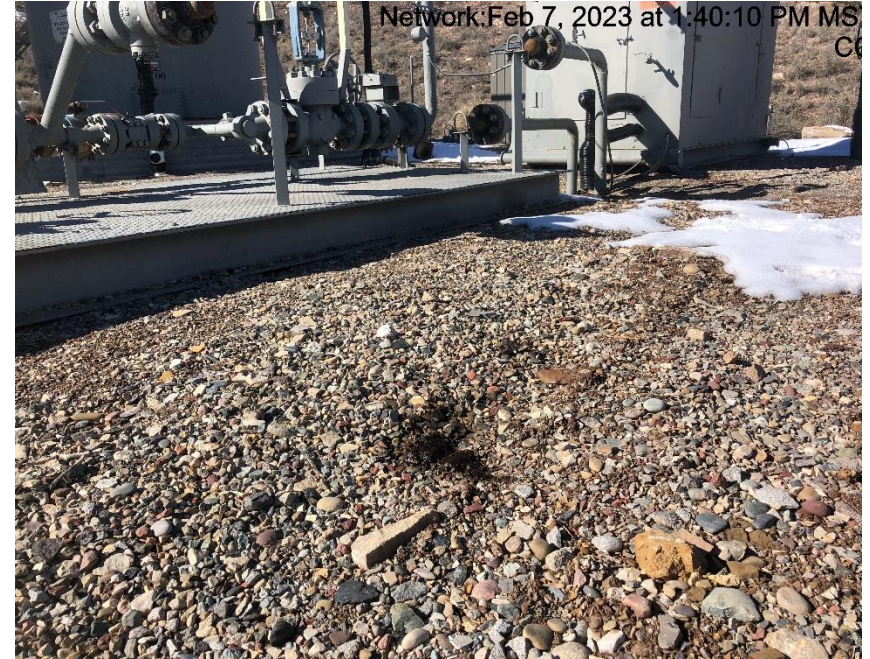
**Photo #8934 Stained soil and gravel.**

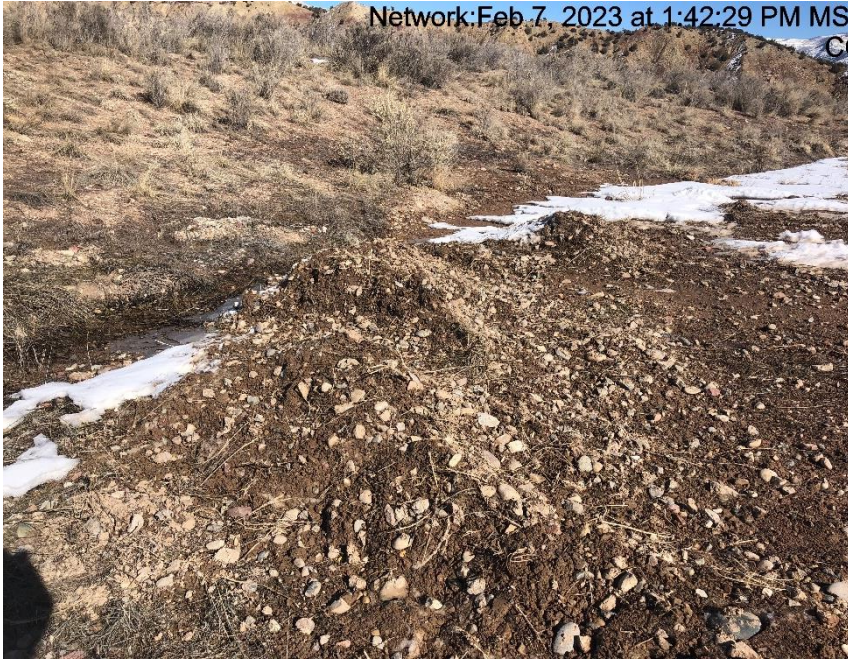
**Photo #8936** Sediment has been transported into ditch.

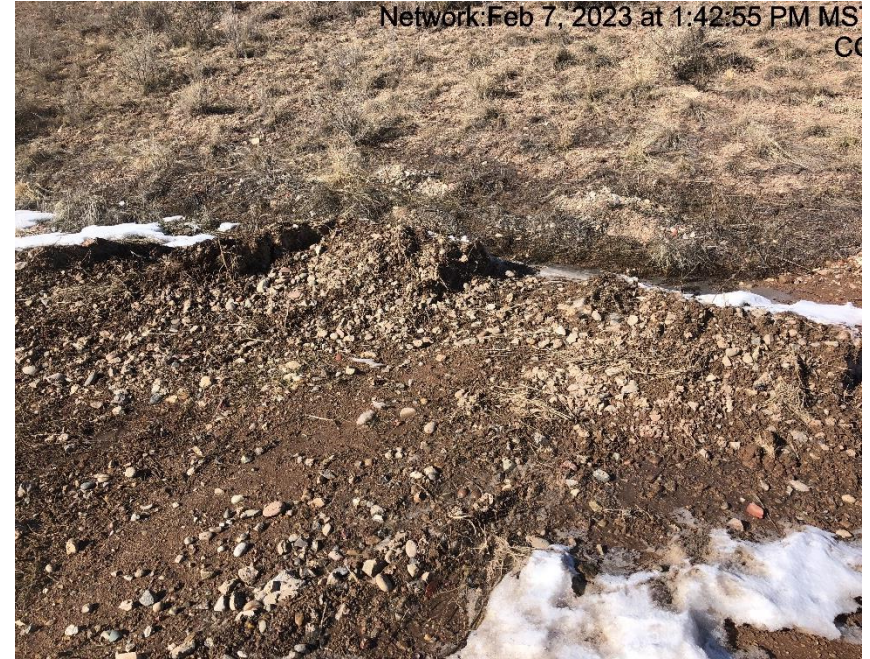
**Photo #8937** Sediment has been transported into ditch.

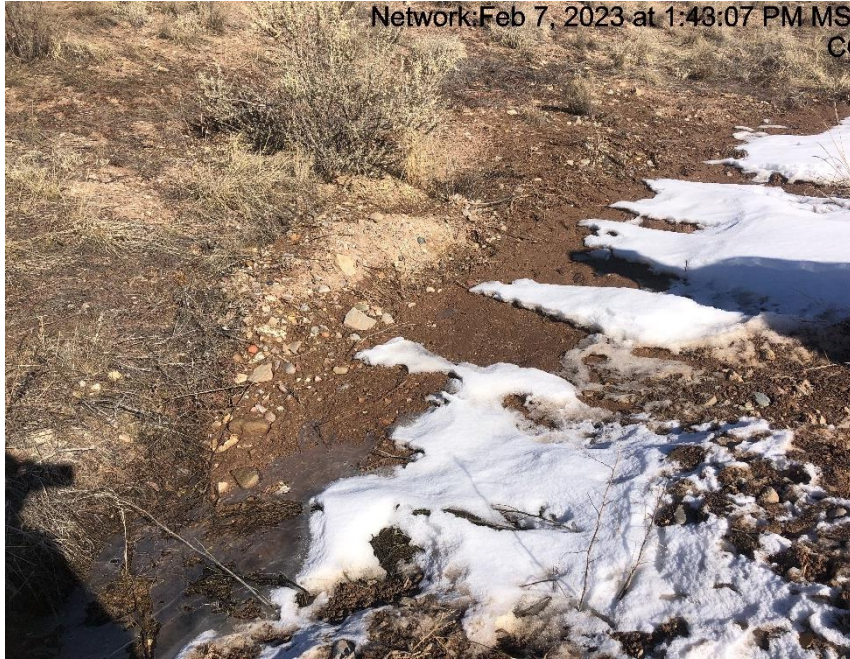
Photo #8939 Sediment migration in ditch.

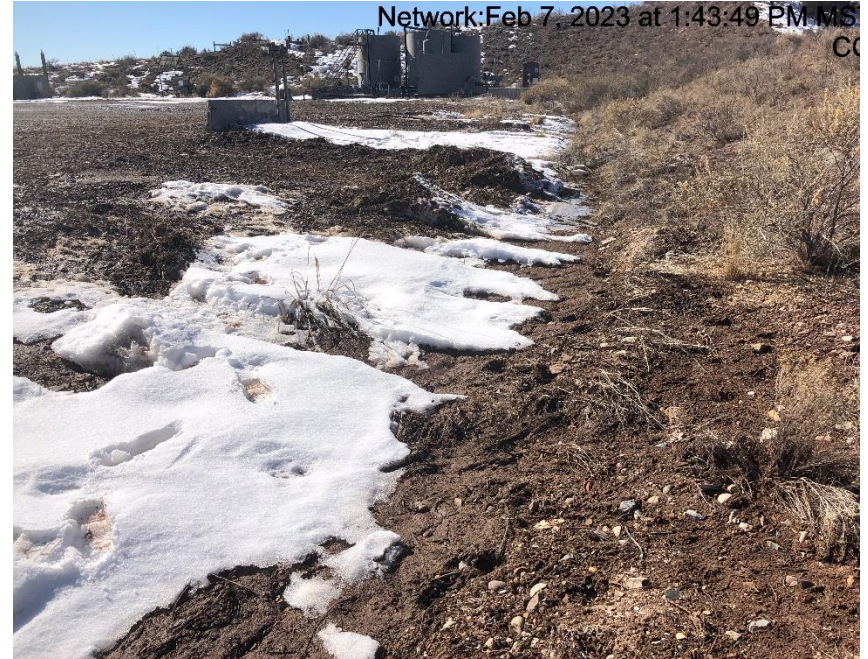
Photo #8940 Sediment migration in ditch.
