## Inspection Photos

Location Name: CAERUS PICEANCE LLC FEDERAL-68S97W /12SWNE

Location ID: 324378

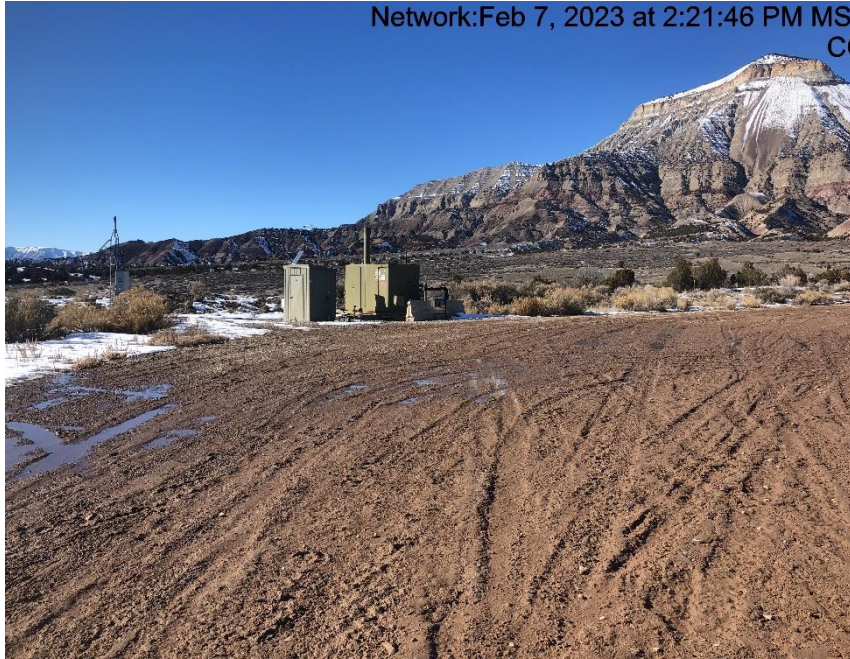
Photo #8944 From entrance to location.

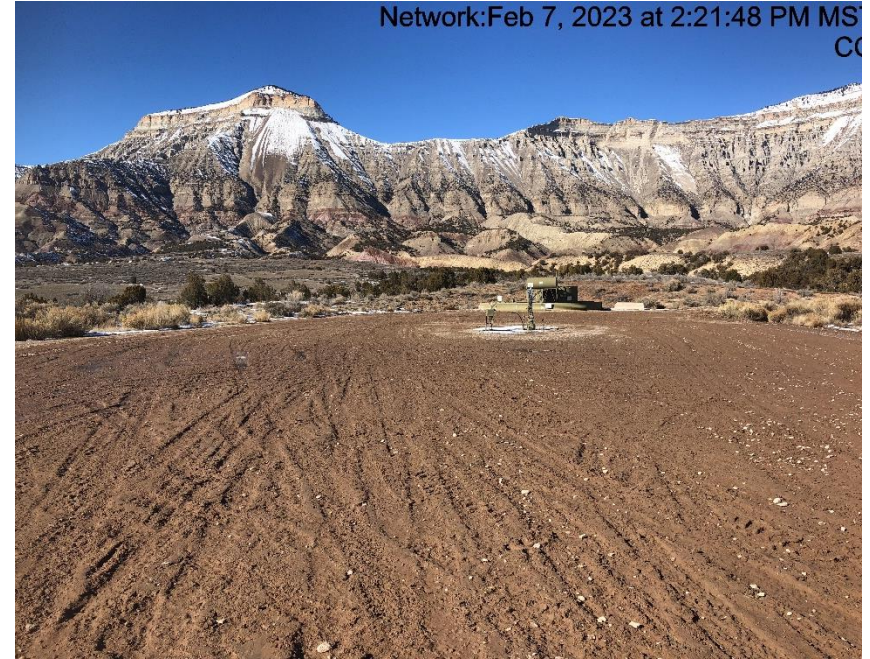
Photo #8945 From entrance to location

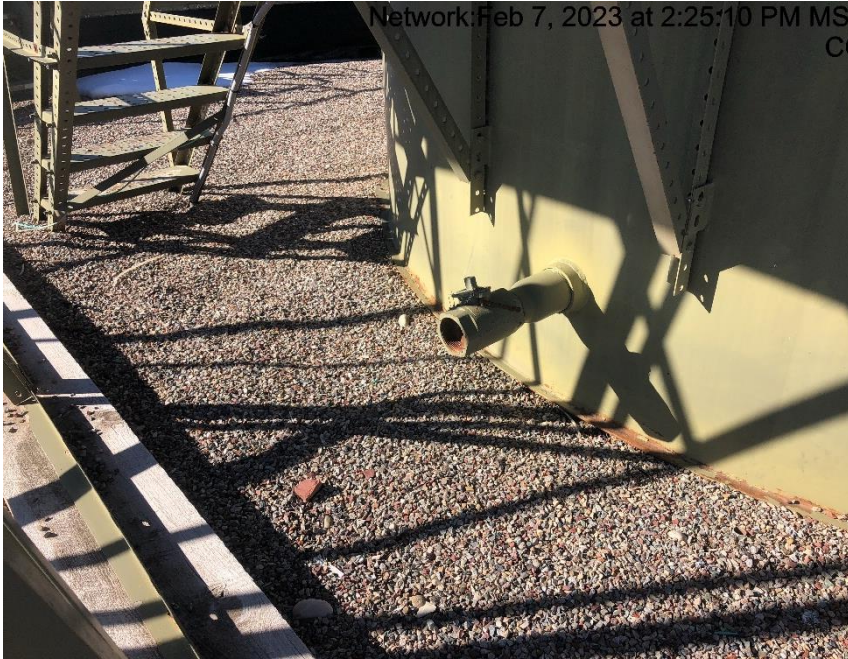
Photo #8946 Loadline open ended.

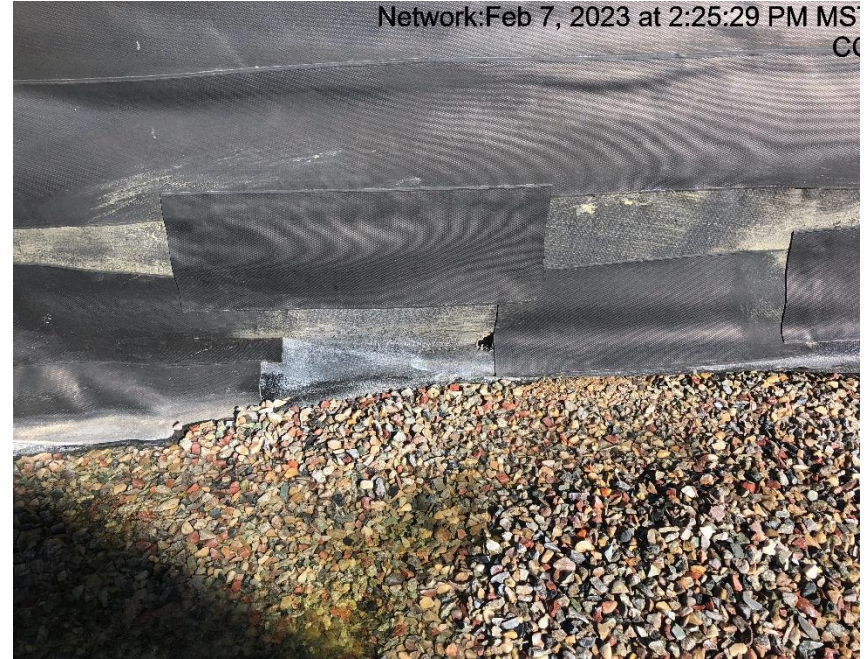
Photo #8947 Multiple holes in secondary containment.

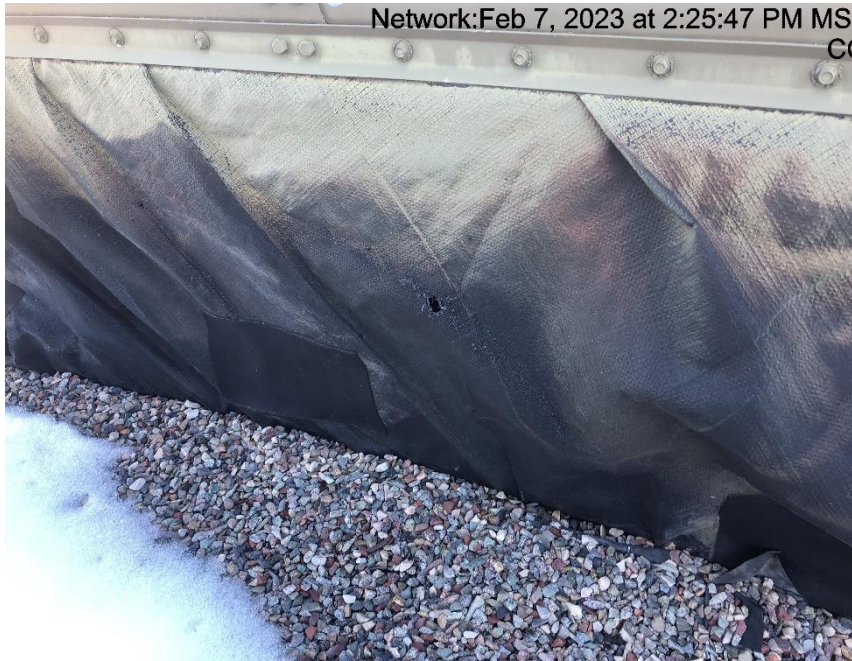
**Photo #8948 Multiple holes in secondary containment.**

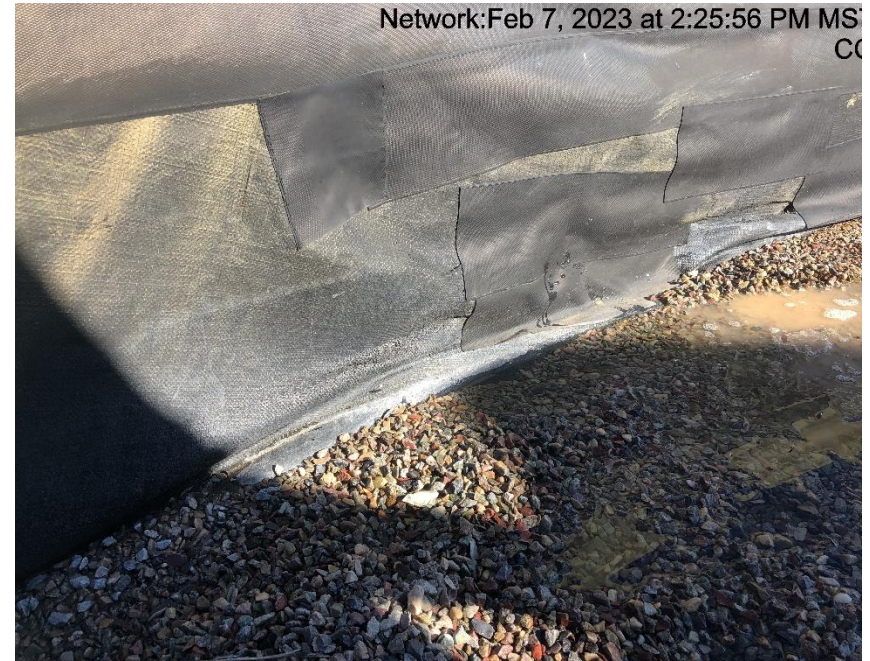
**Photo #8949 Multiple holes in secondary containment.**

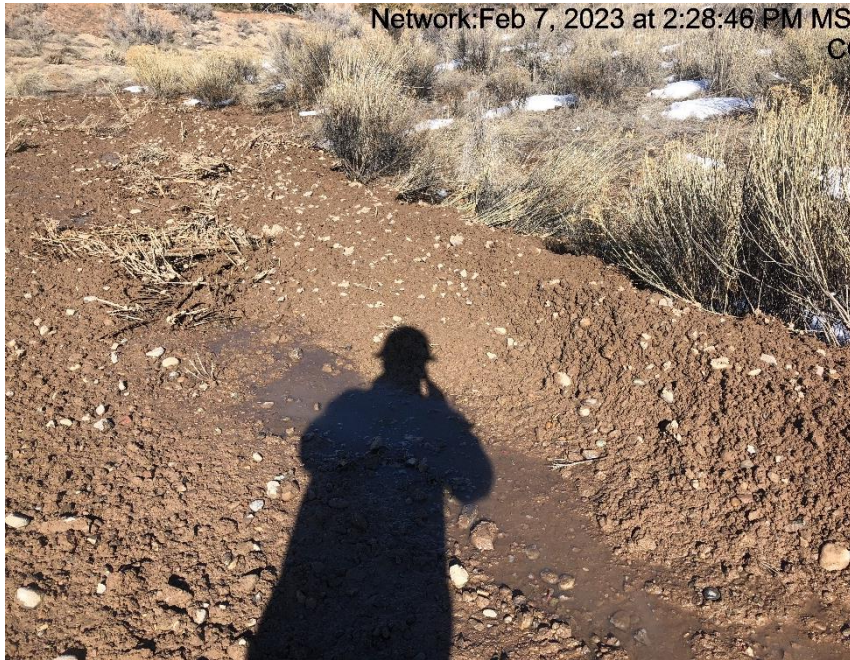
**Photo #8950** Sediment has been transported in to reclamation area.

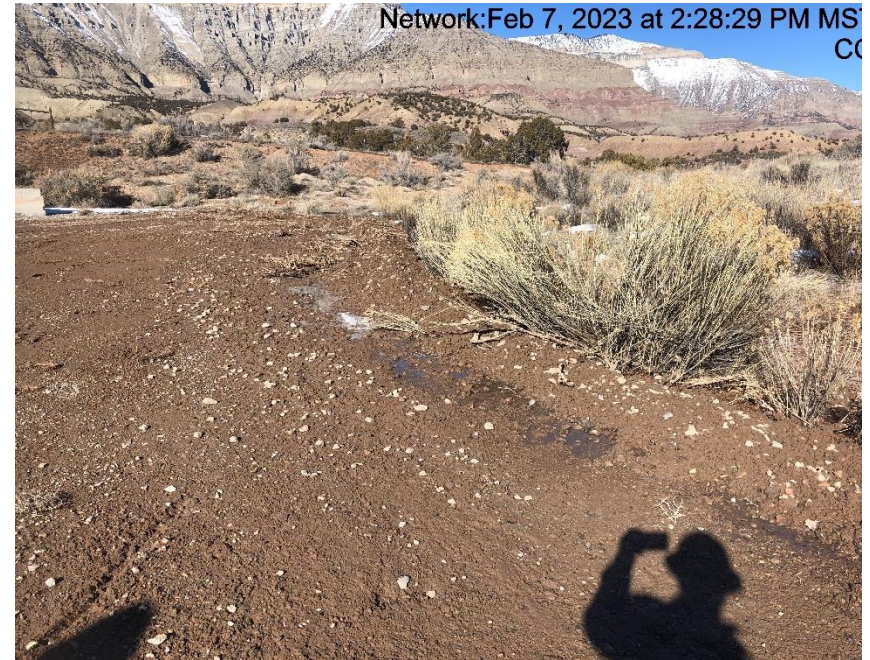
**Photo #8951** Sediment has been transported in to reclamation area.

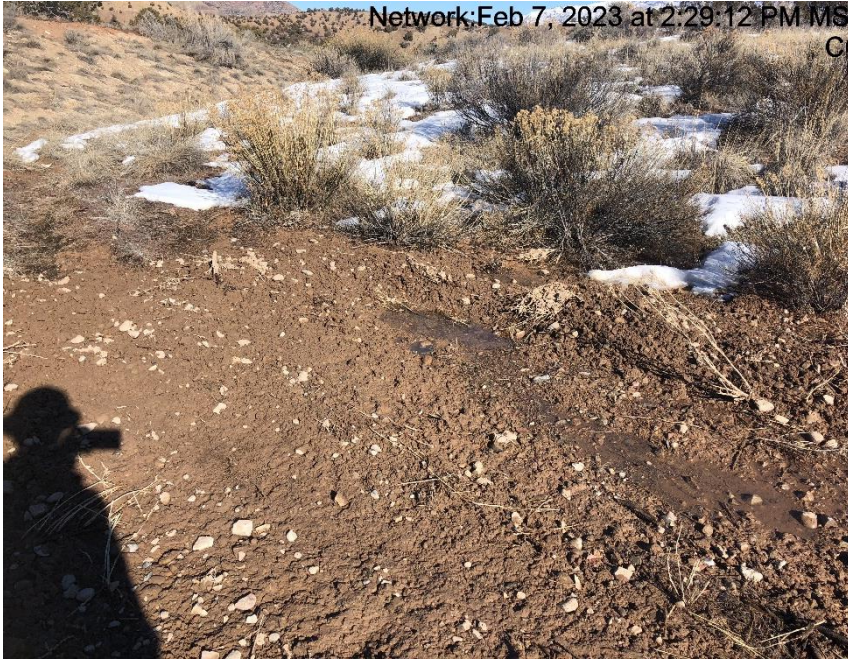
**Photo #8954 Sediment is choking off vegetation.**
