Operator: Highpoint Operating Corporation

Location Name: Esterling 44-33H

Loc ID: 428695

Inspection: 696304645

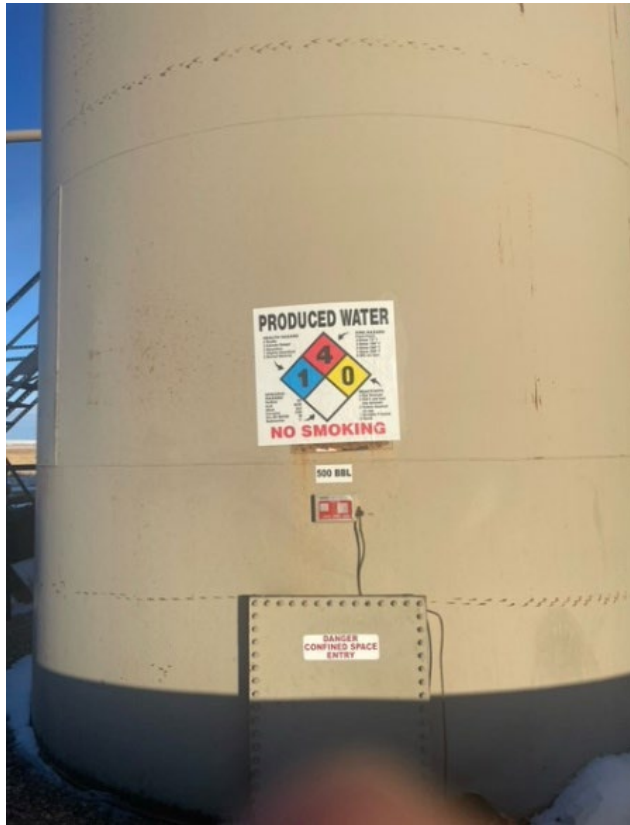
Exhibit A

CA: North Produced Water Tank is missing Labels - NFPA, Content and Capacity; Drain Pit at Compressor is missing Capacity Label.
Install sign to comply with Rule 605.h.

CA Resolution: Installed NFPA, content and capacity labels in accordance with Rule 605.h. (See Exhibit A) The capacity label on the drill pit compressor was installed in accordance with Rule 605.h. (See Exhibit B)
