Operator: Extraction Oil & Gas, Inc.
Location Name: ALMA 1S-66-2524
Loc ID: 449925
Inspection: 709400008

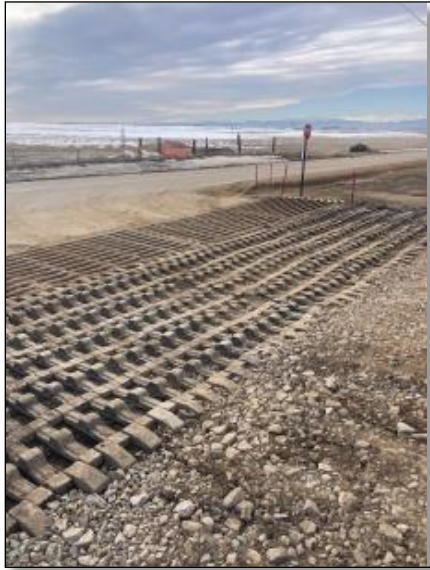
Exhibit A

CA: Tracking pad not adequately maintained to prevent track of material offsite. Refer to inspection photos for documentation.
Corrective Action Maintain vehicle tracking BMPs on the oil and gas location to comply with rule 1002.f. (2)F

CA Resolution: Tracking pads at entrance were cleaned and are now in compliance with rule 1002.f. (2)F.

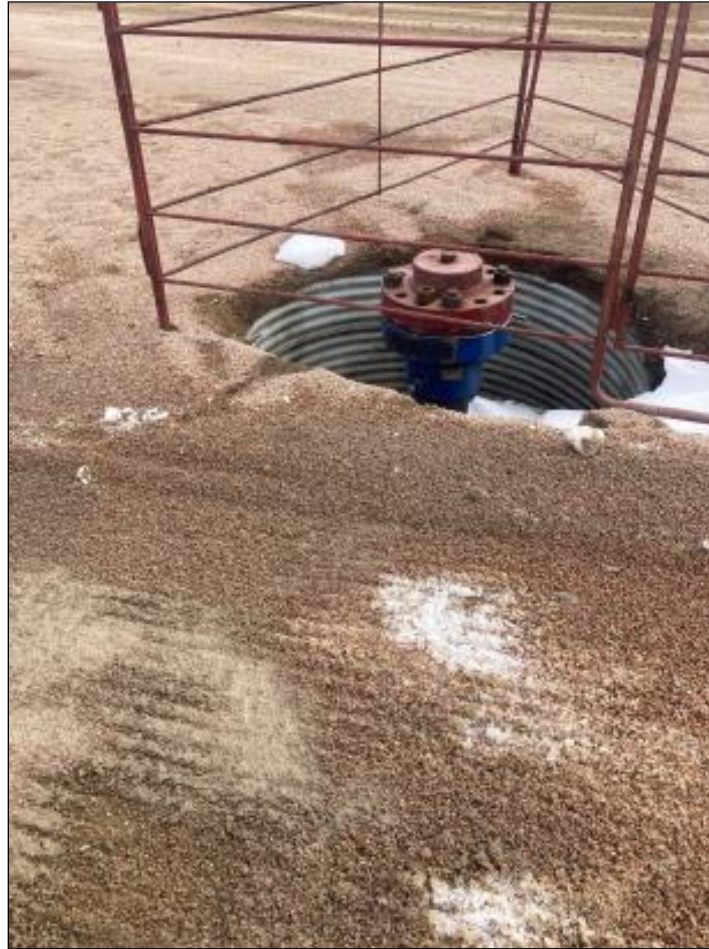
Exhibit A

CA: During this inspection, a hole/boring/subsidence (See photos) was observed immediately adjacent to well head. There was nothing on site to indicate an open excavation or provide warning or safety protections for both humans and wildlife. Operator shall immediately ensure operations are safe and will properly install safety controls for the observed hole/boring/subsidence pursuant to Rule 602.c.

CA Resolution: Hole next to wellhead was backfilled. This location is now in compliance with Rule 602. c.

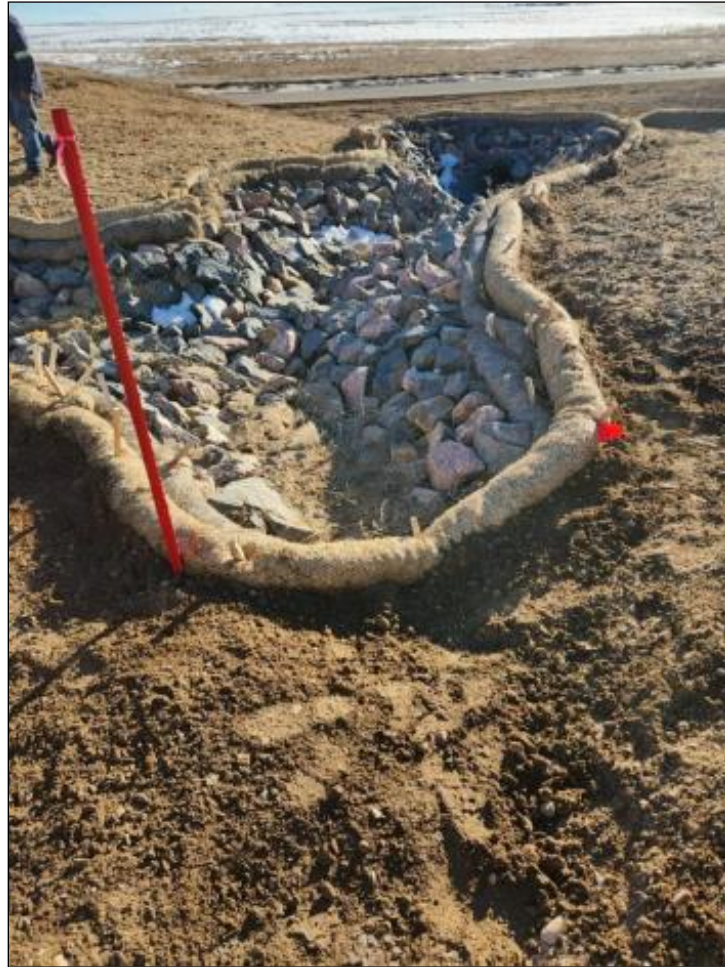
Exhibit A

CA: This location does not comply with Rule 1002.f. During this inspection it was observed that stormwater has undercut the straw wattles near one of the sediment traps. Additionally, several straw wattles were observed to be degraded, covered with material, and not in proper functioning order. See additional comments in lease road section under summary and location for vehicle track out. Refer to attached inspection photos for documentation. Immediately install or repair required BMPs per Rule 1002.f. in accordance with good engineering practices.

CA Resolution: The straw wattles were dressed up and supplemented in the SW corner location. Location is now in compliance with Rule 1002.f.
