Interim Reclamation and Stormwater Inspection

Operator: RED HAWK PETROLEUM LLC - 10503

Location ID: 430662

Inspection Photos
Location Name: Waves 1H
Location ID: 430662

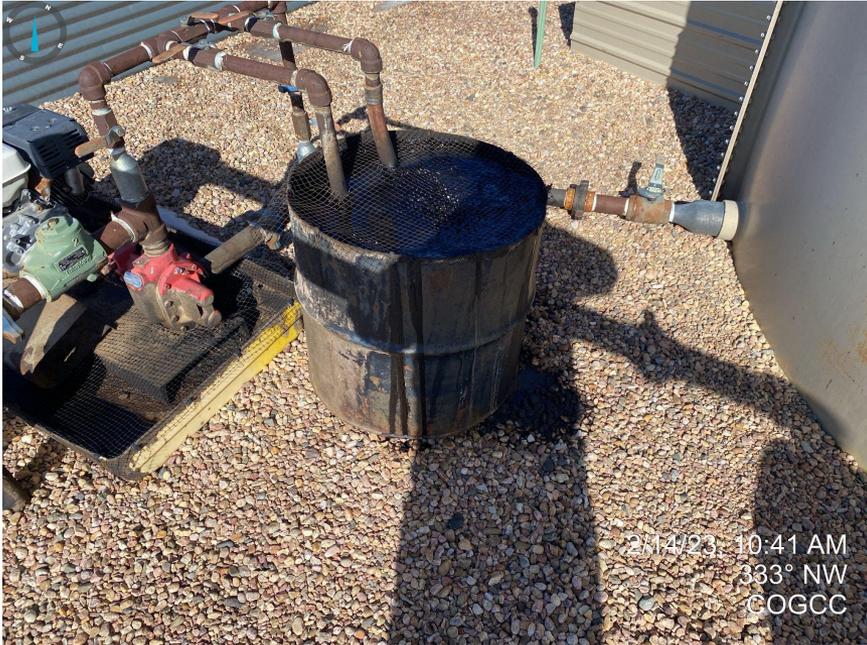
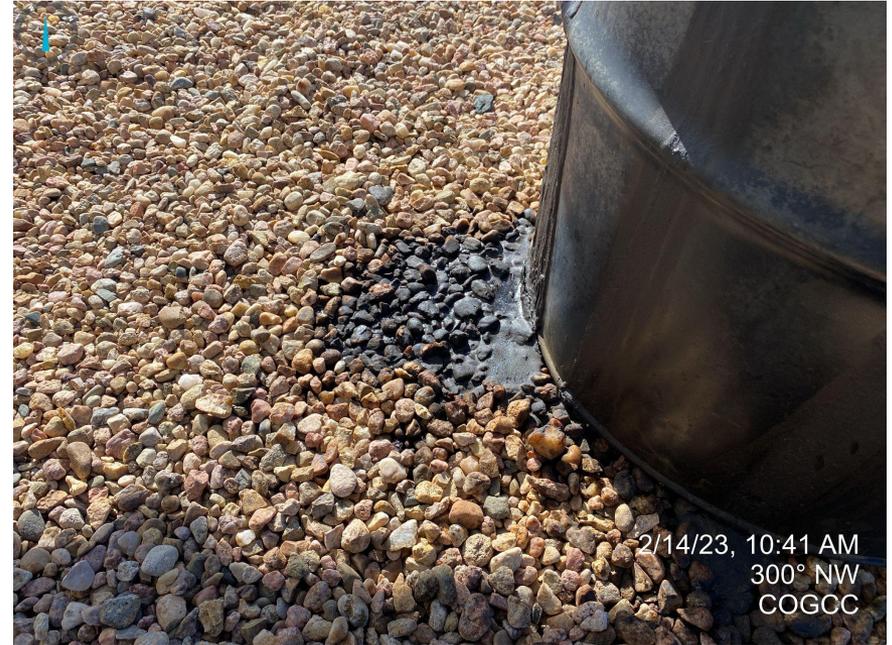
Photos 1 & 2. Facing northwest from inside of the tank battery containment. Photos illustrates an apparent leak originating from bucket/drum and staining the soil underneath.

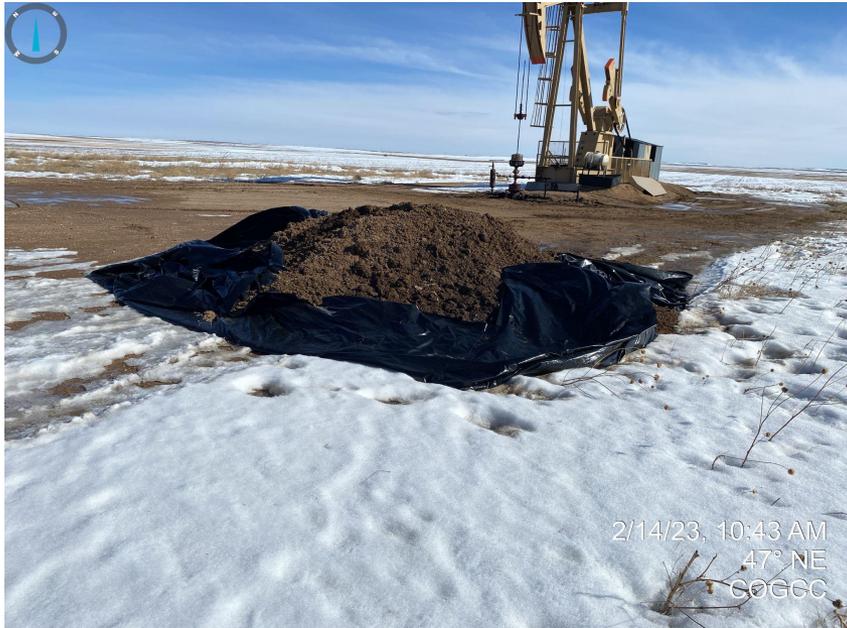
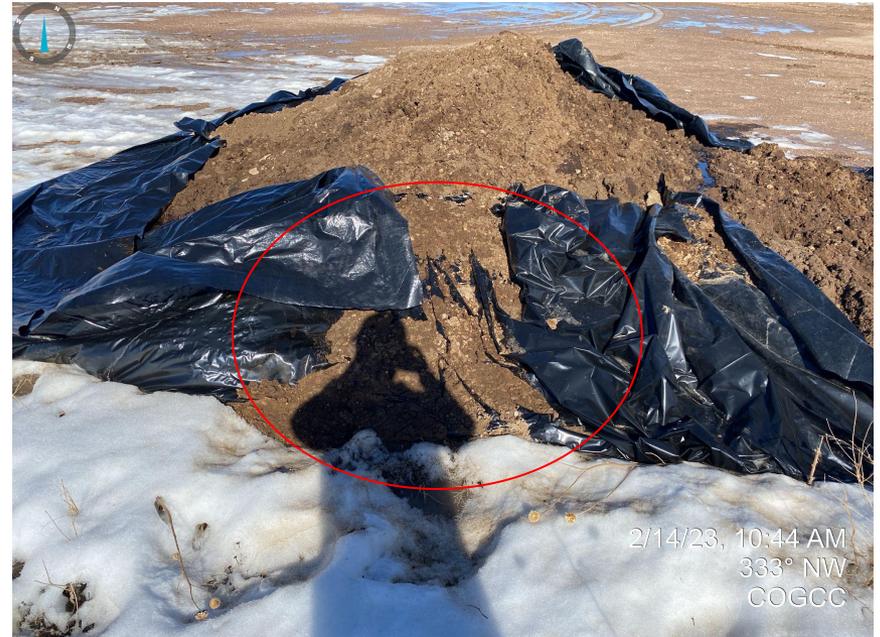
Photos 3 & 4. Facing northeast and northwest from the center portion of the location. Photos illustrate stockpiled material without and labels or signage and the absence of BMPs to prevent material from migrating outside of plastic liner (e.g. no earthen berm).

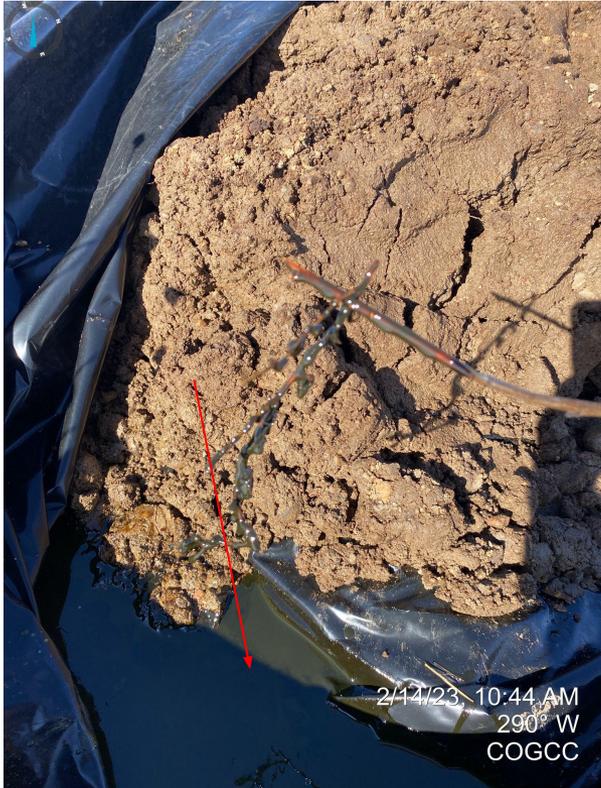
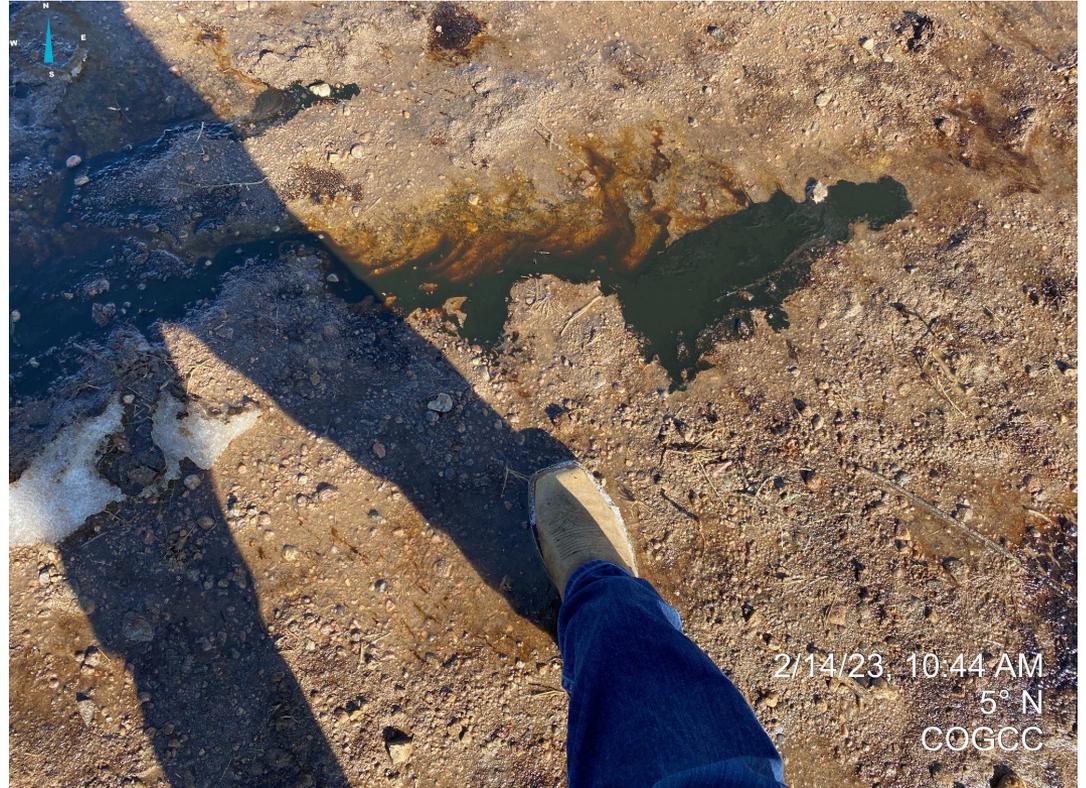
Photos 5 & 6. Close up photos illustrating pooling crude oil (left) and crude oil outside of the plastic liner.

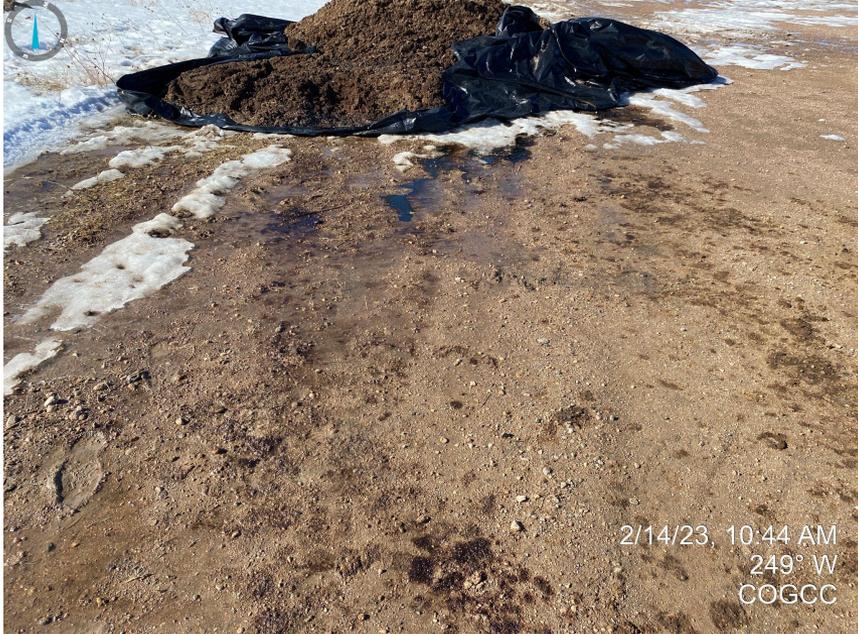
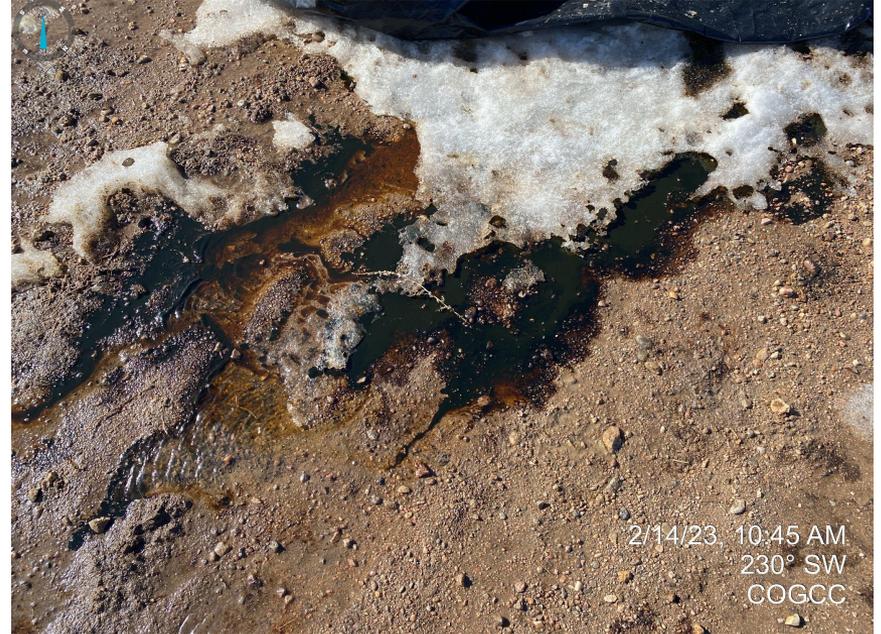
Photos 7 & 8. Facing west and southwest at stockpiled material; see comments in Photos 5 & 6.

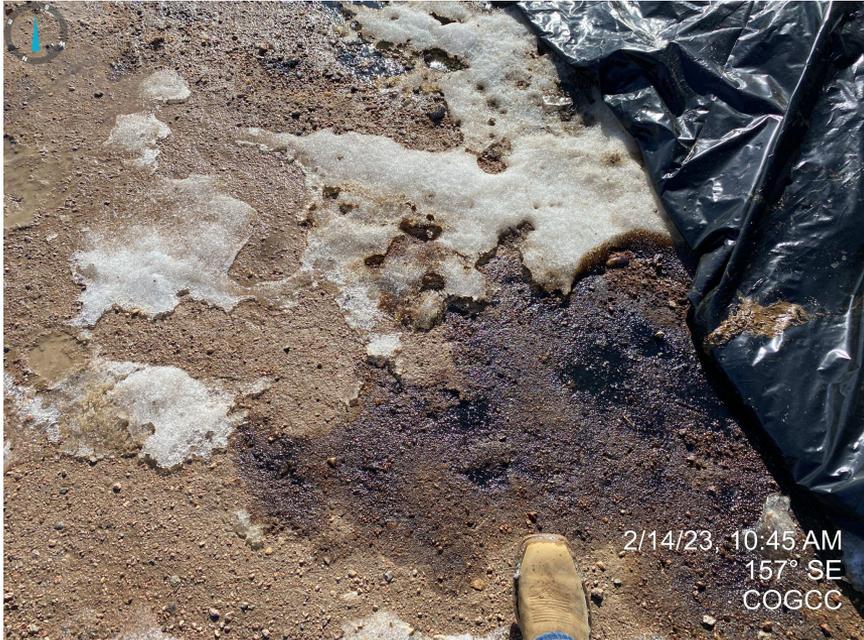
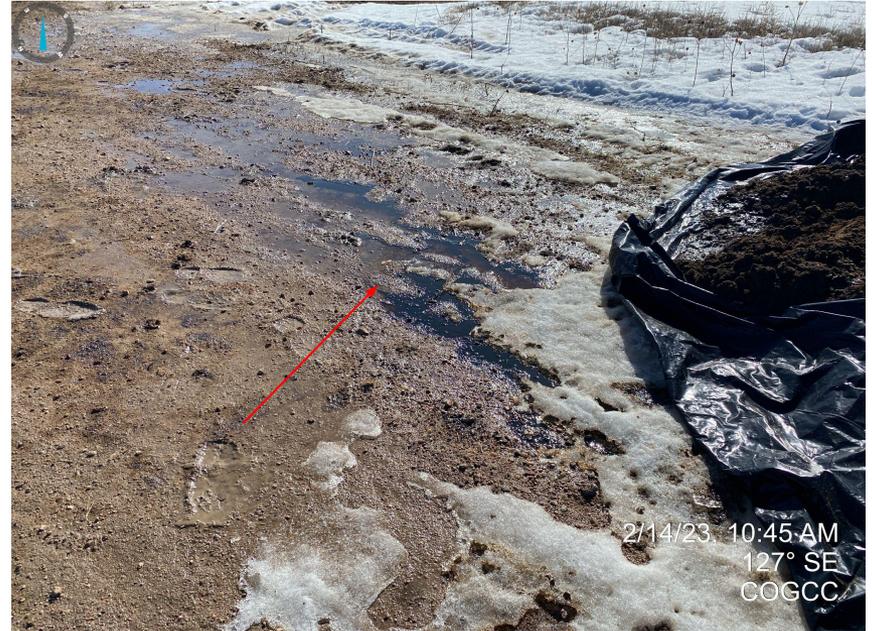
Photos 9 & 10. Facing southeast at stockpiled material; see comments in Photos 5 & 6.

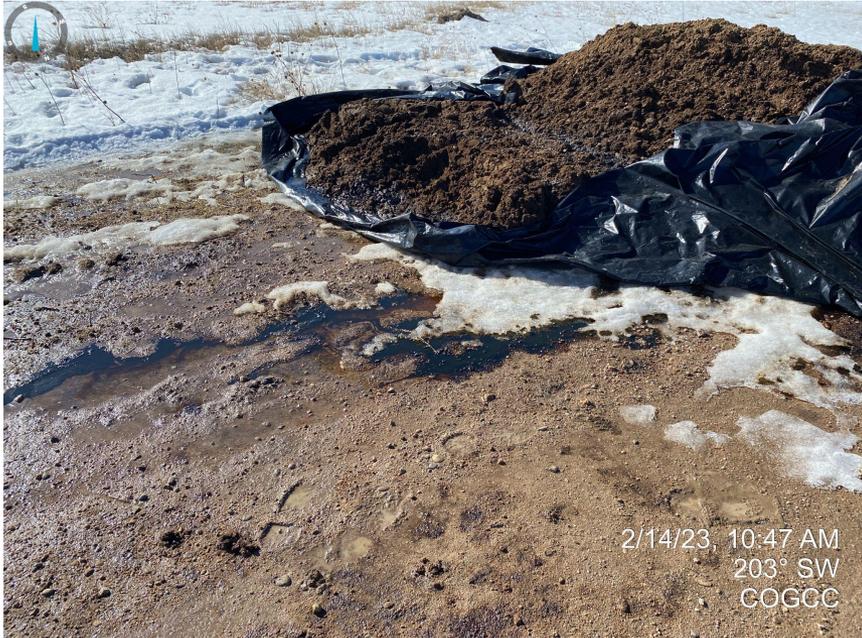
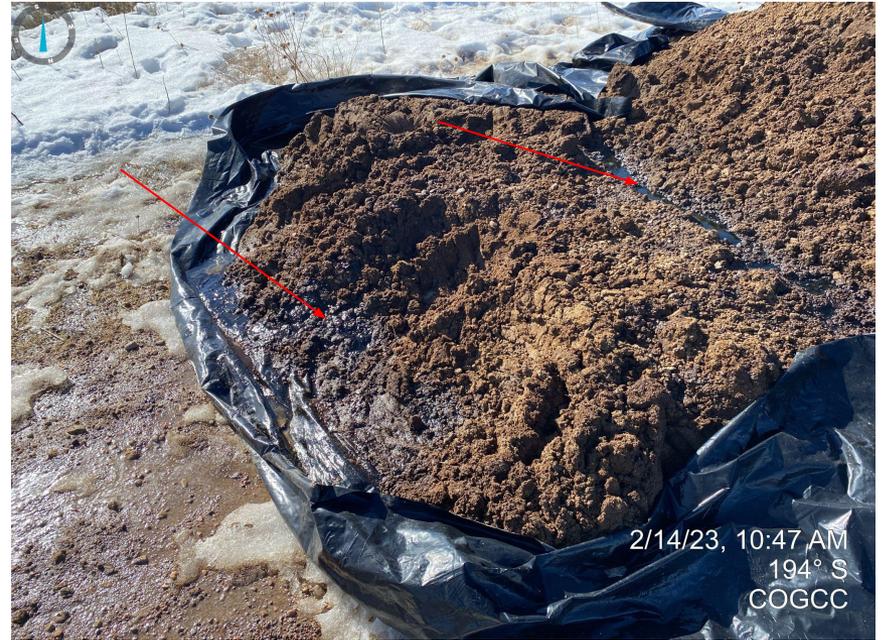
Photos 11 & 12. Facing southwest and south at stockpiled material; see comments in Photos 5 & 6.

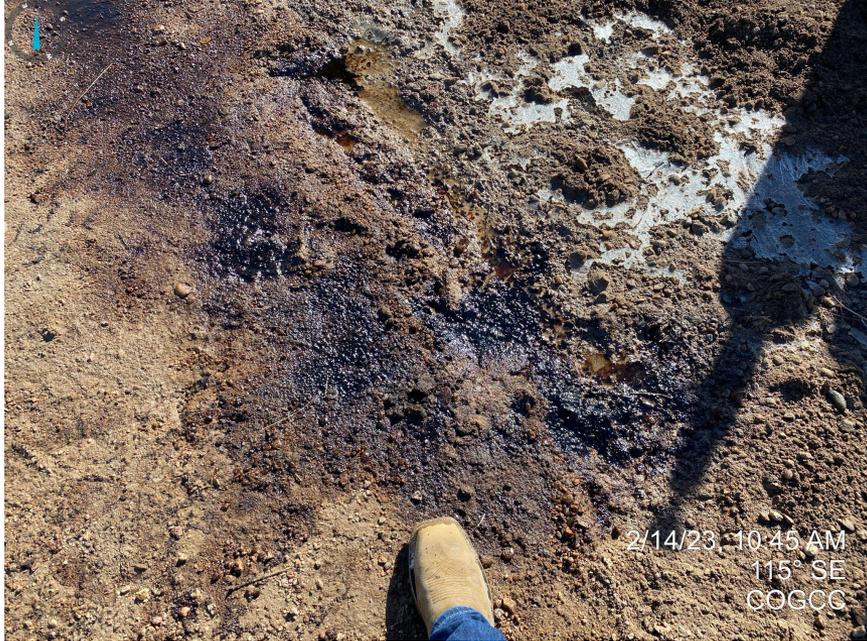
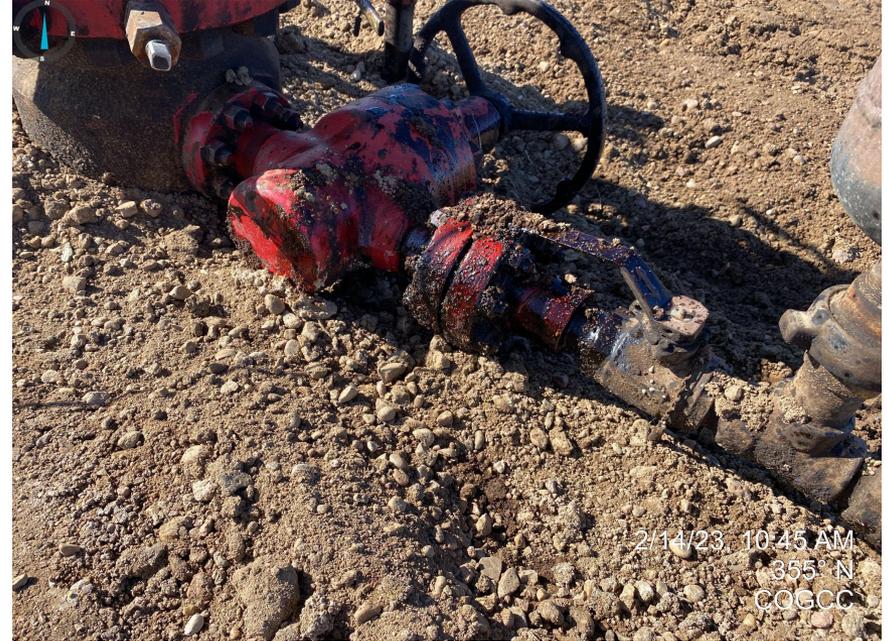
Photos 13 & 14. Close up photos near the wellhead and pump jack. Crude oil was observed from the stockpiled material leading to the well head; presence of crude oil was observed on piping as well.

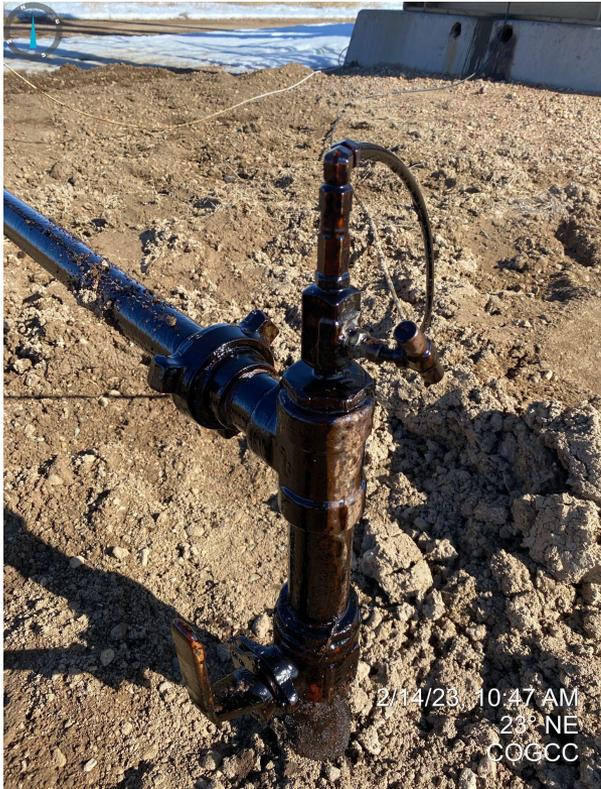
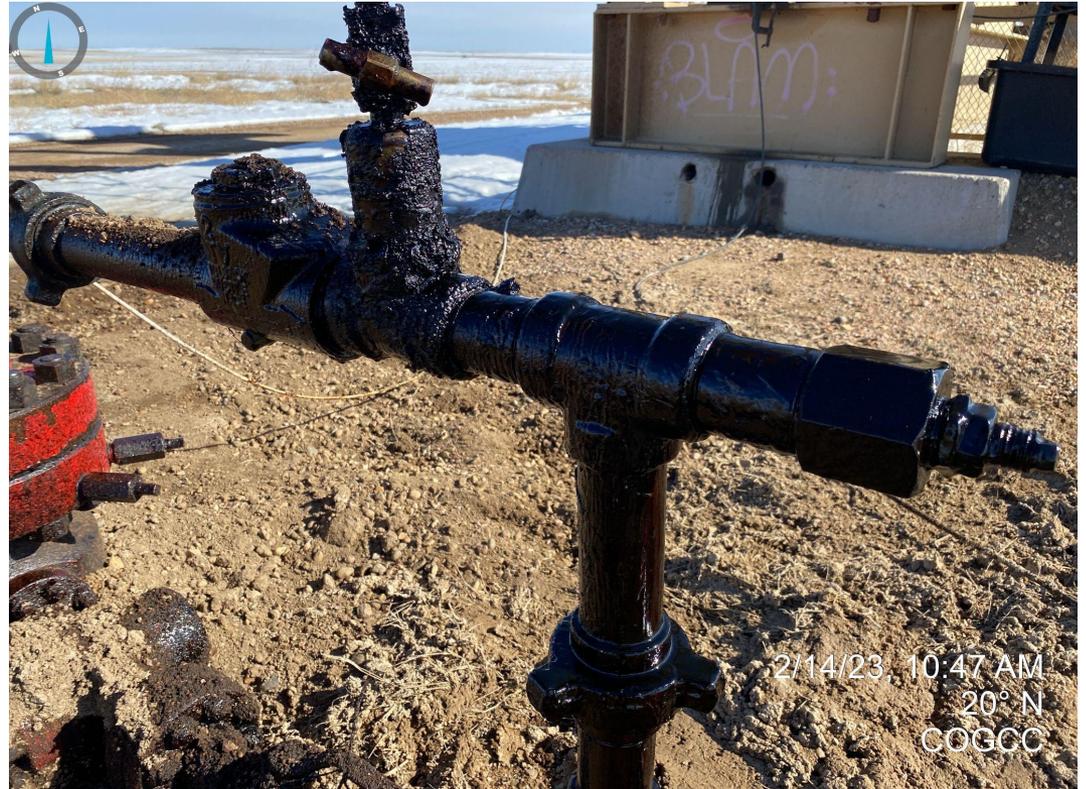
Photos 15 & 16. Facing northeast and north at well head. See comments in Photos 13 & 14.

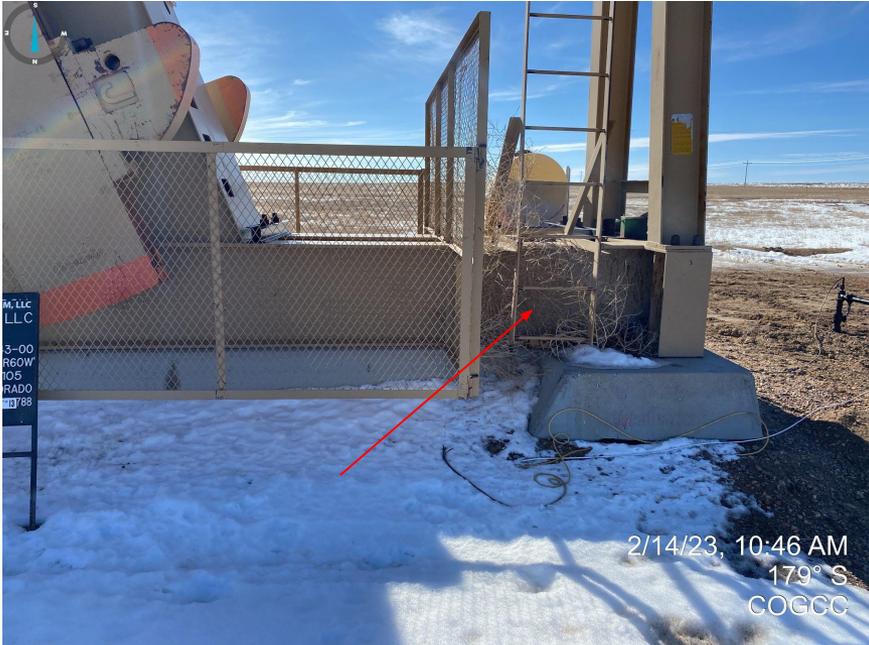
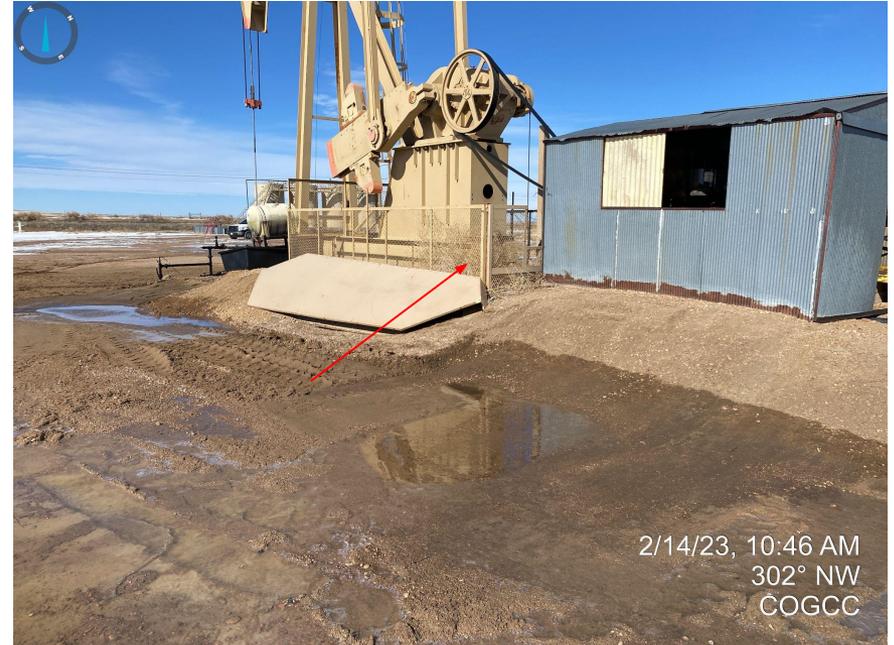
Photos 17 & 18. Facing south and northwest at the pump jack. Photos illustrate the accumulation of tumbleweeds within equipment; this presents a fire hazard and needs to be removed/disposed of.

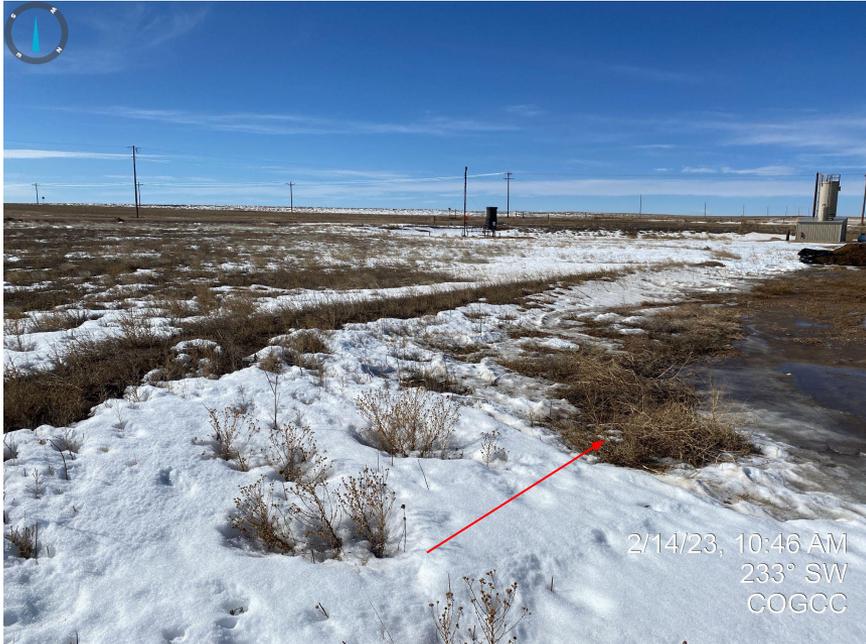
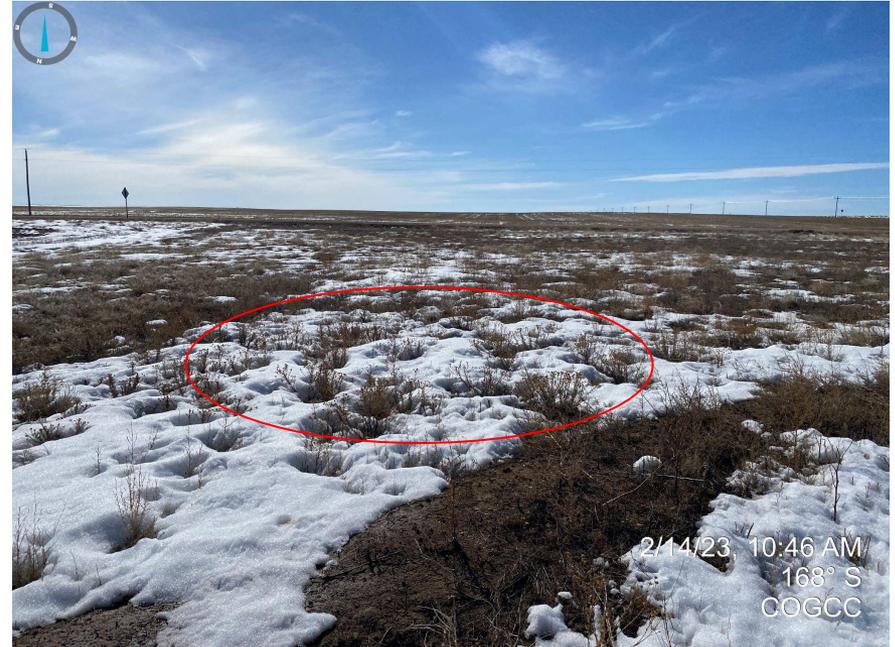
Photos 19 & 20. Facing southwest and south from the center portion of the location. Due to snow cover, this location will be re-inspected at a future date to document compliance with Rule 1003 standards. Additionally, Staff observed undesirable vegetation (e.g. russian thistle and kochia) throughout the interim areas; the operator will need to manage this location for weeds during this next growing season.

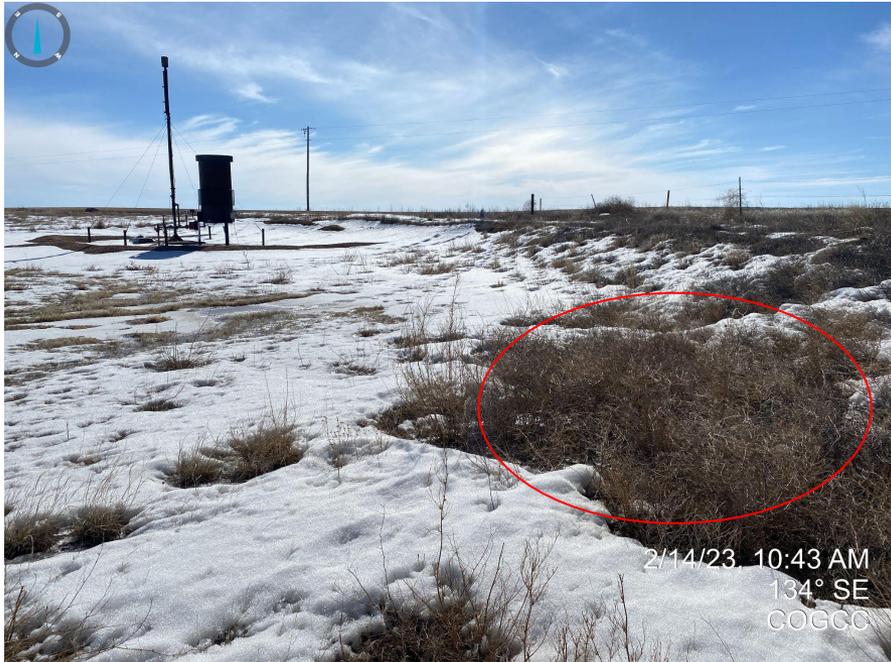
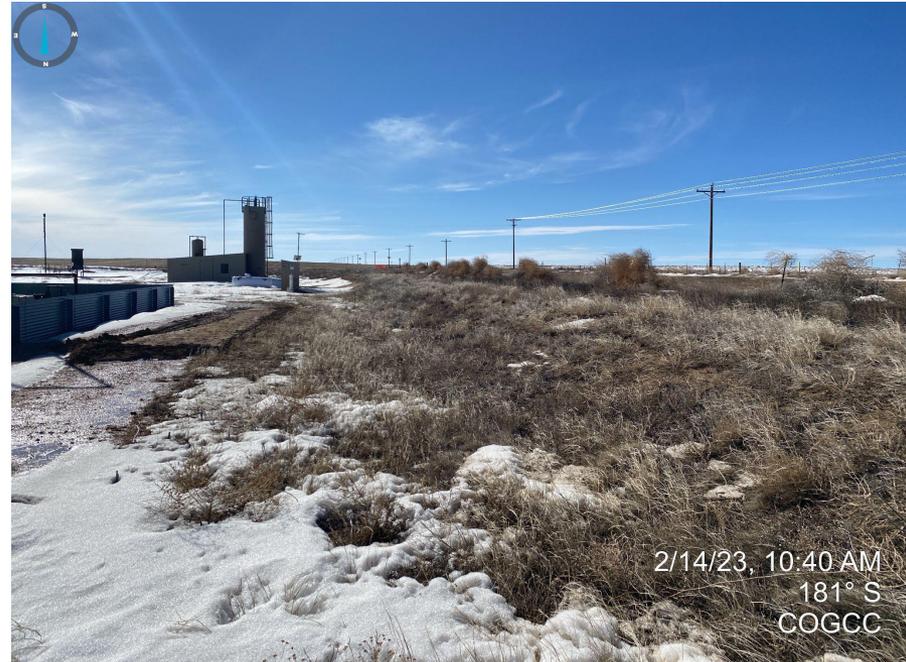
Photo 21 & 22. Facing southeast and south from the western portion of the location; see comments in Photos 19 & 20.
