Inspection Photos
Location Name: Redwin 22-4
API #069-06227

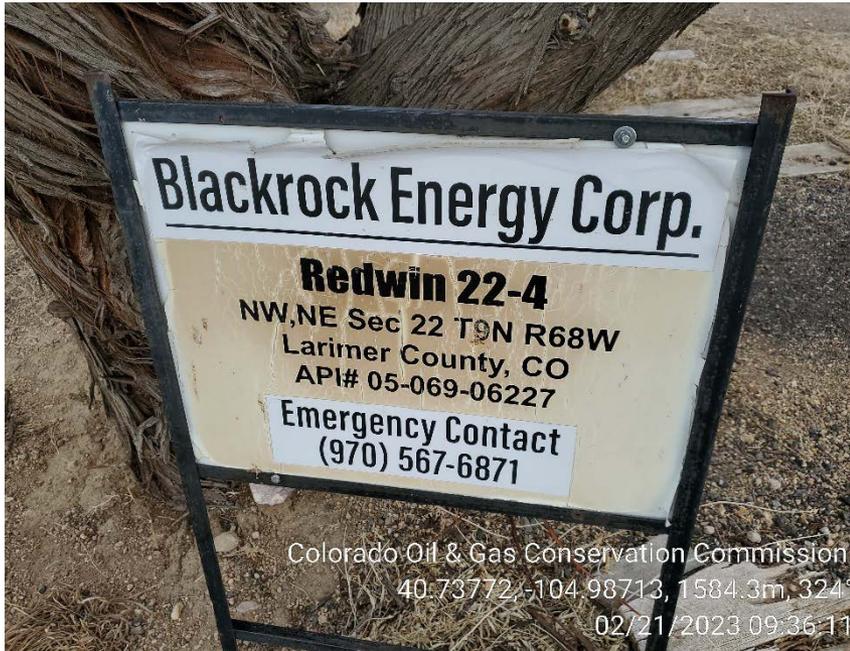
Wellhead sign

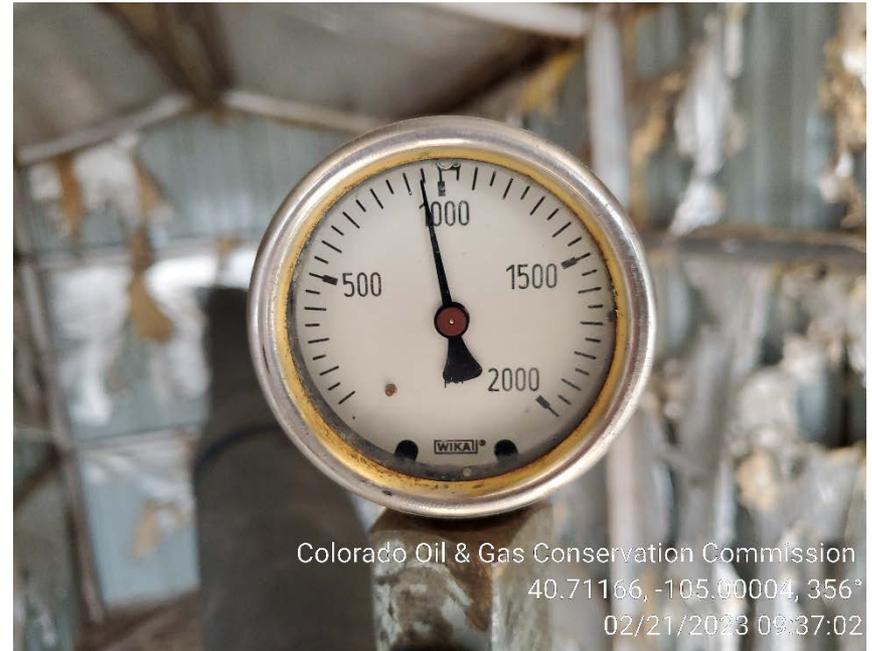
Tubing pressure

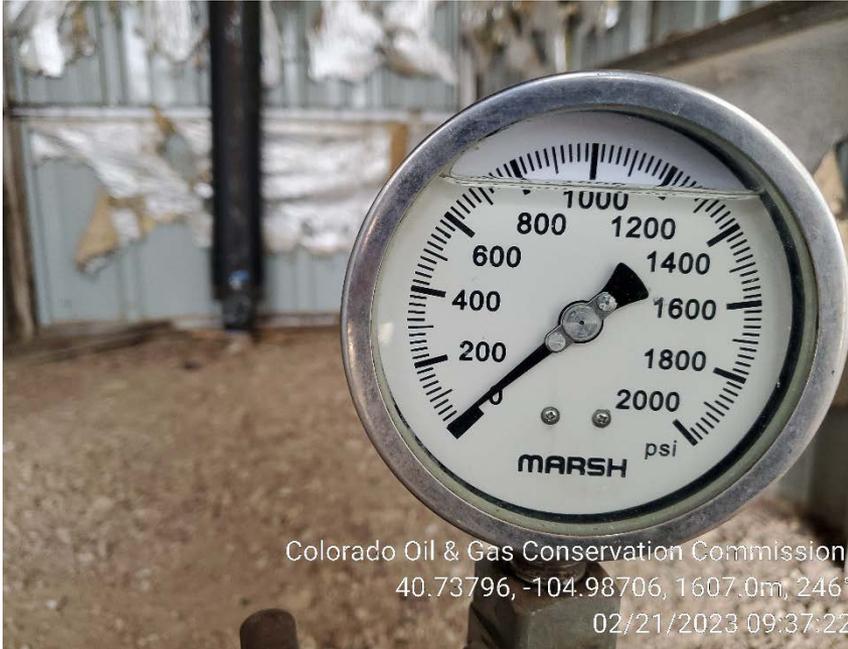
Casing pressure

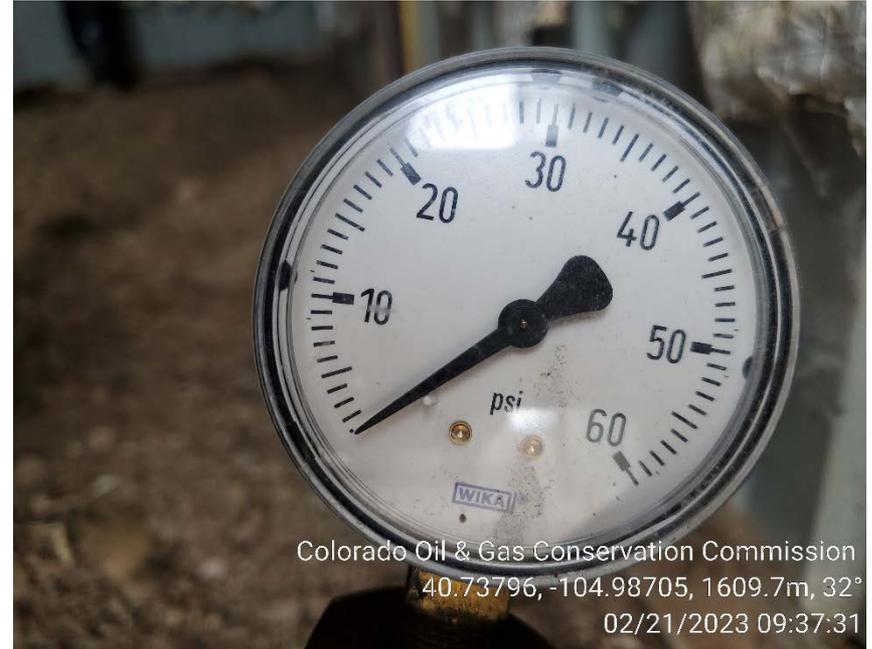
Bradenhead pressure
