# Inspection Photos

API: 071-07640

Operator: EVERGREEN NATURAL RESOURCES

Inspection Date: 2/21/2023

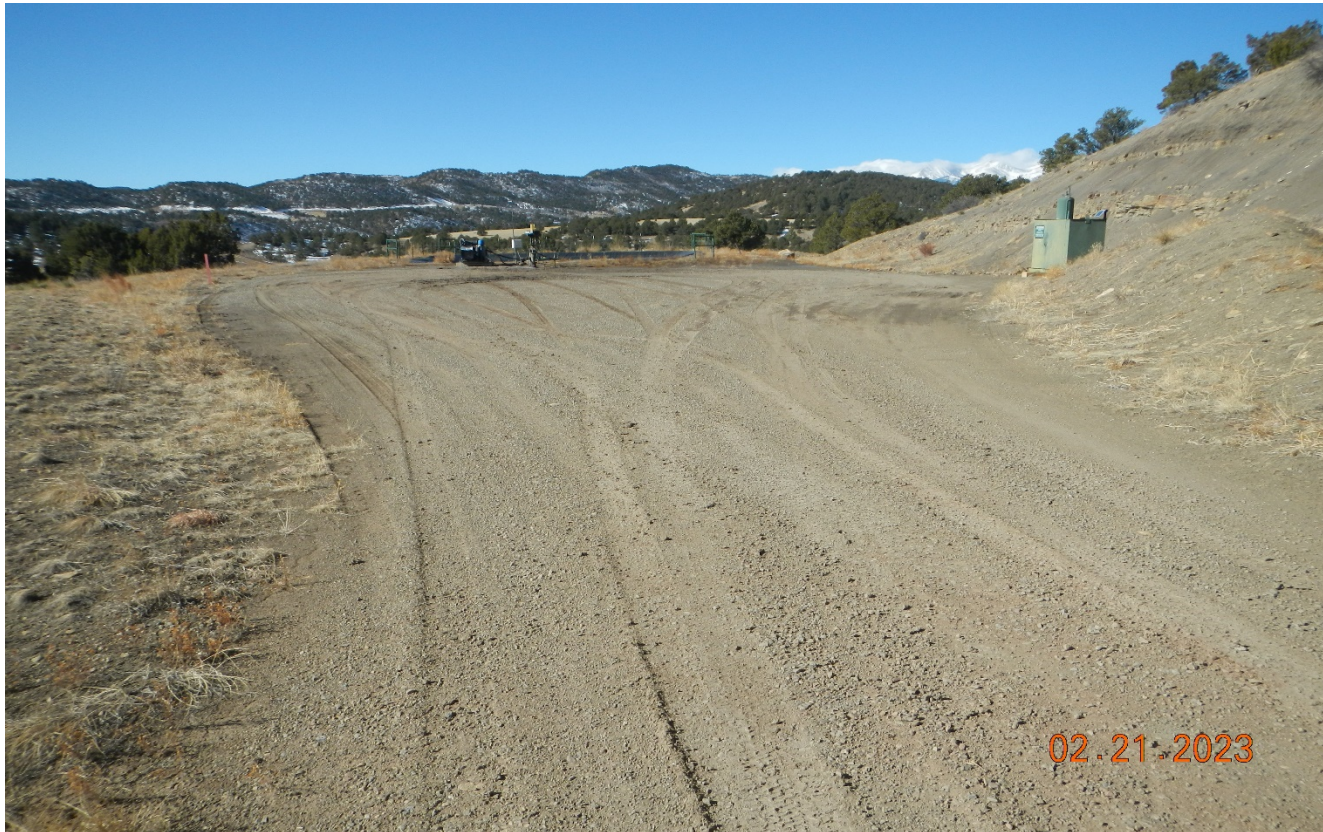
**Photo 1.** Facing southwest toward the location.

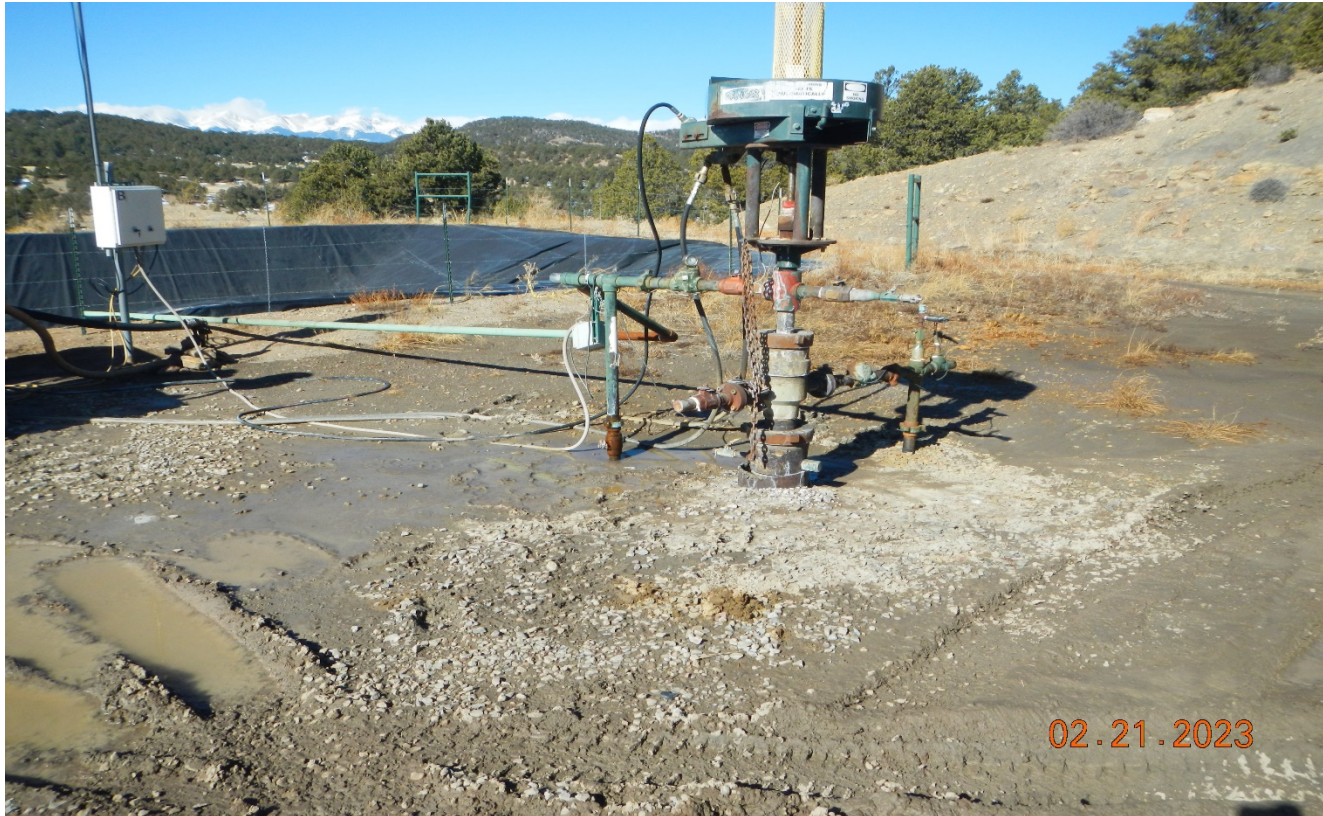
**Photo 2.** Facing toward the wellhead. There was a water leak that had occurred which is the reason for the wet soils in this area.

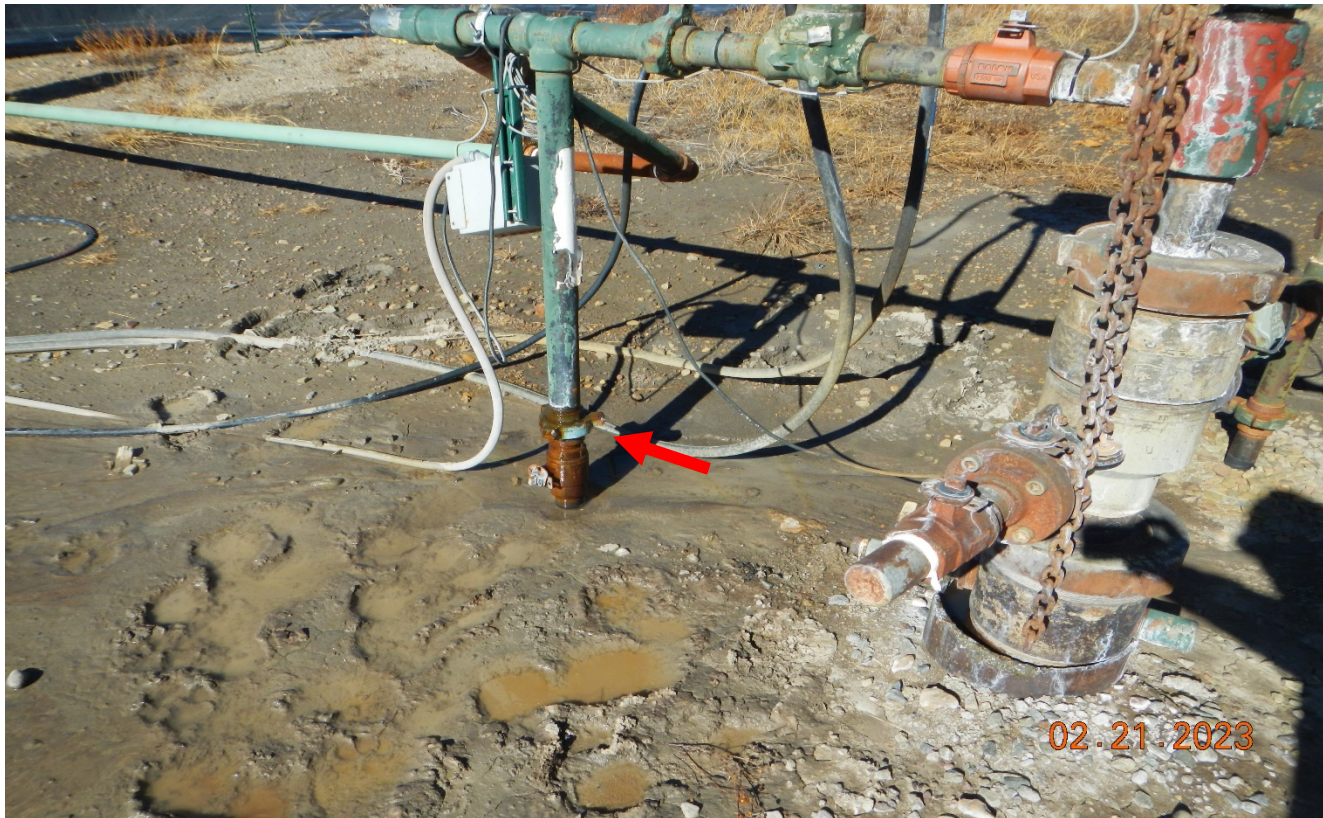
**Photo 3.** There is still a dripping water leak coming from this pipe joint.

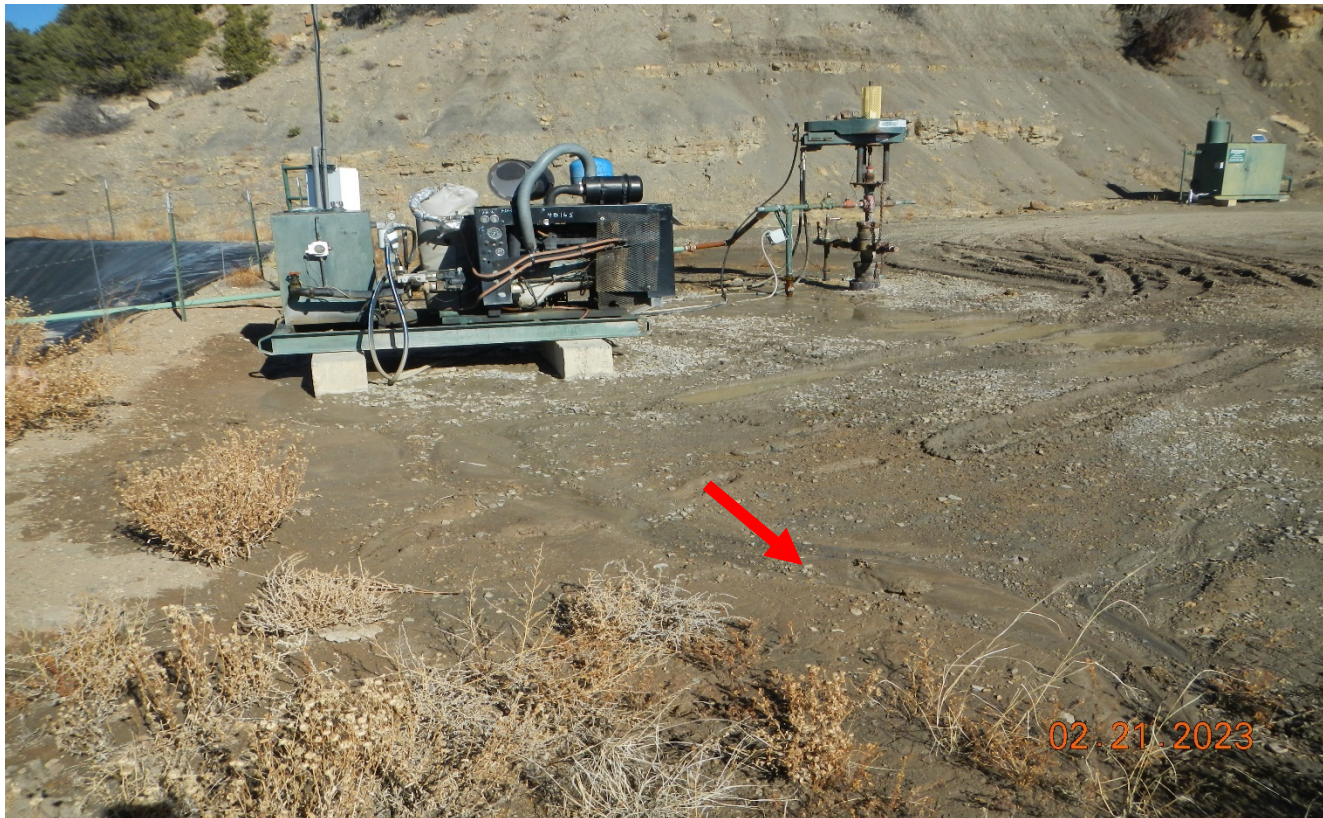
**Photo 4.** There are signs that produced water flowed off the southwest side of the location down toward CR 31.9.

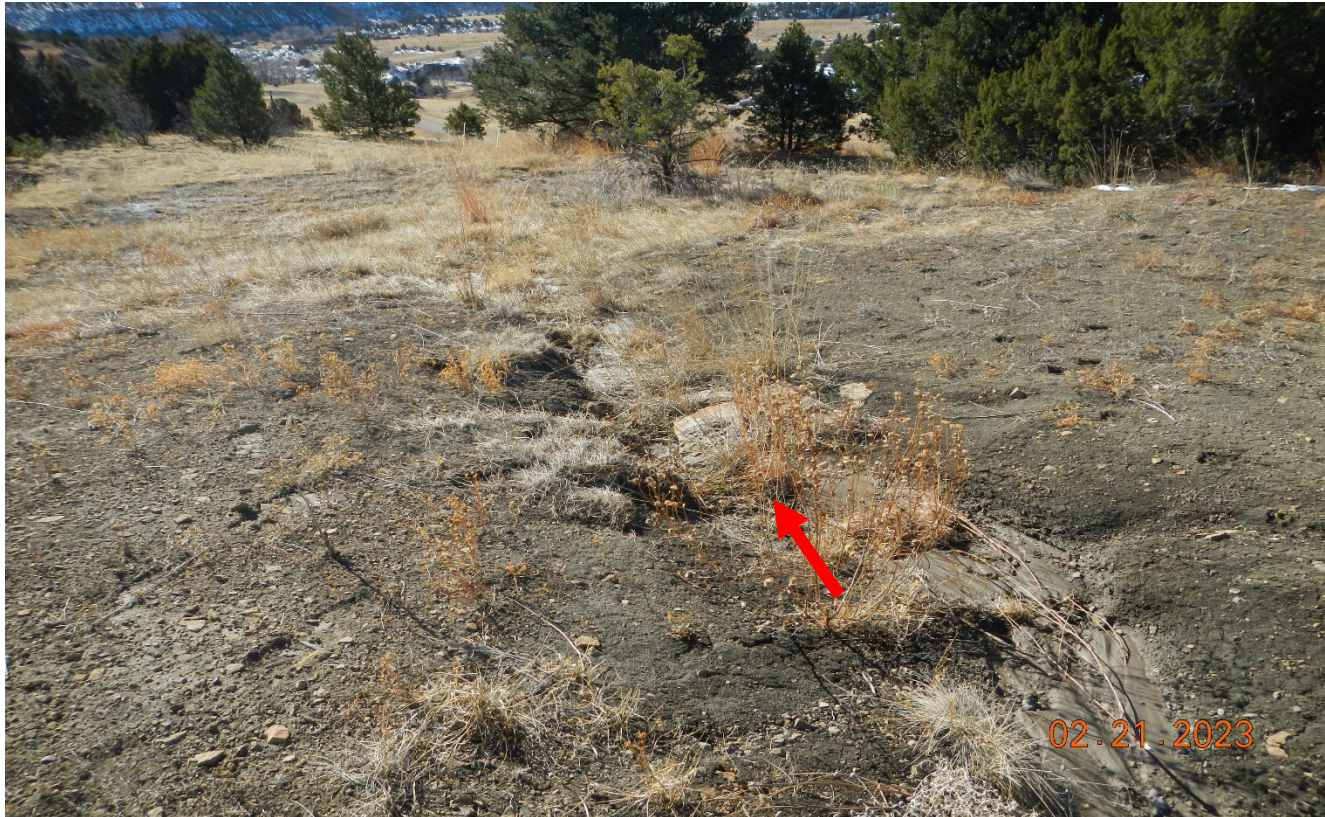
**Photo 5.** There are signs that produced water flowed off the southwest side of the location down toward CR 31.9.

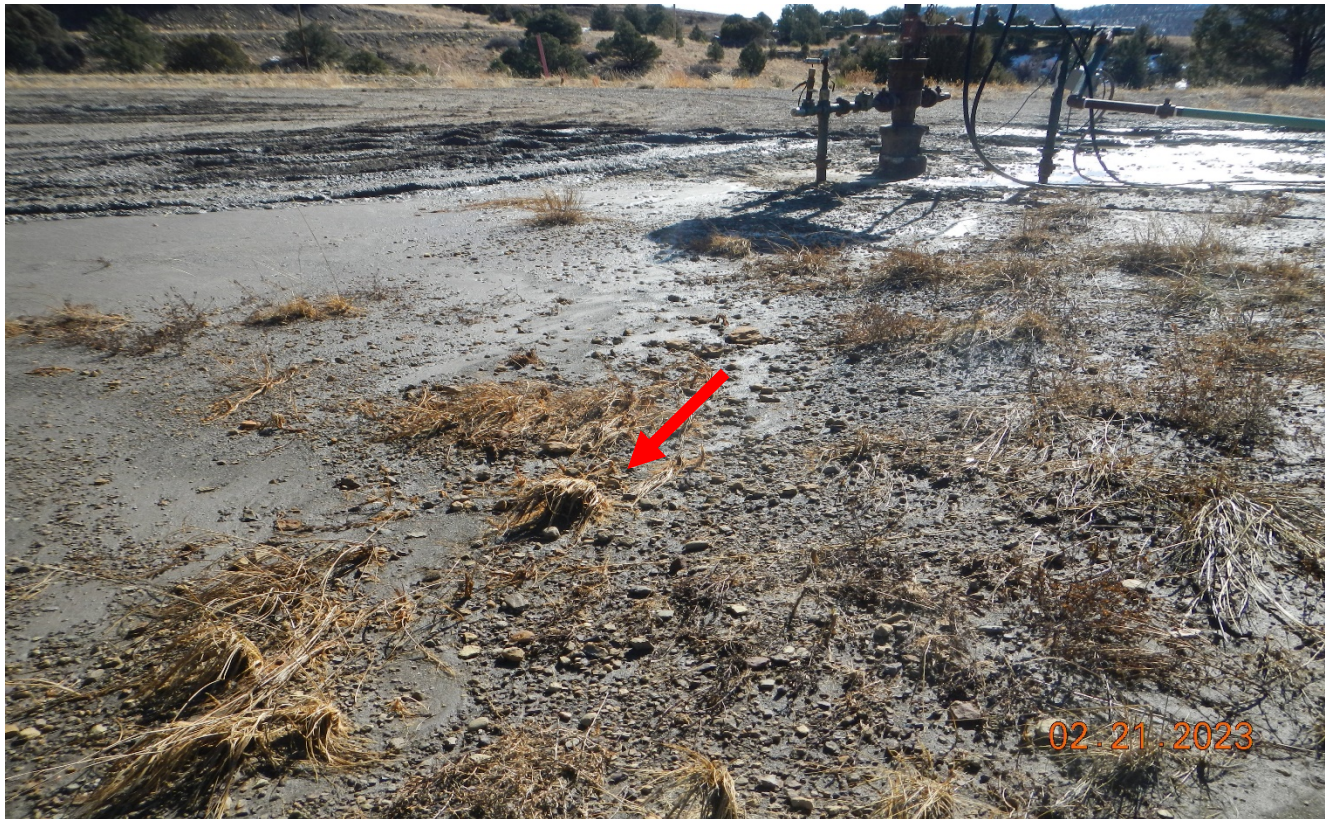
**Photo 6.** Facing southeast toward the wellsite. . There are signs that produced water flowed off northwest side of the location. The flow pattern laid the vegetation over in the direction of the water flow..

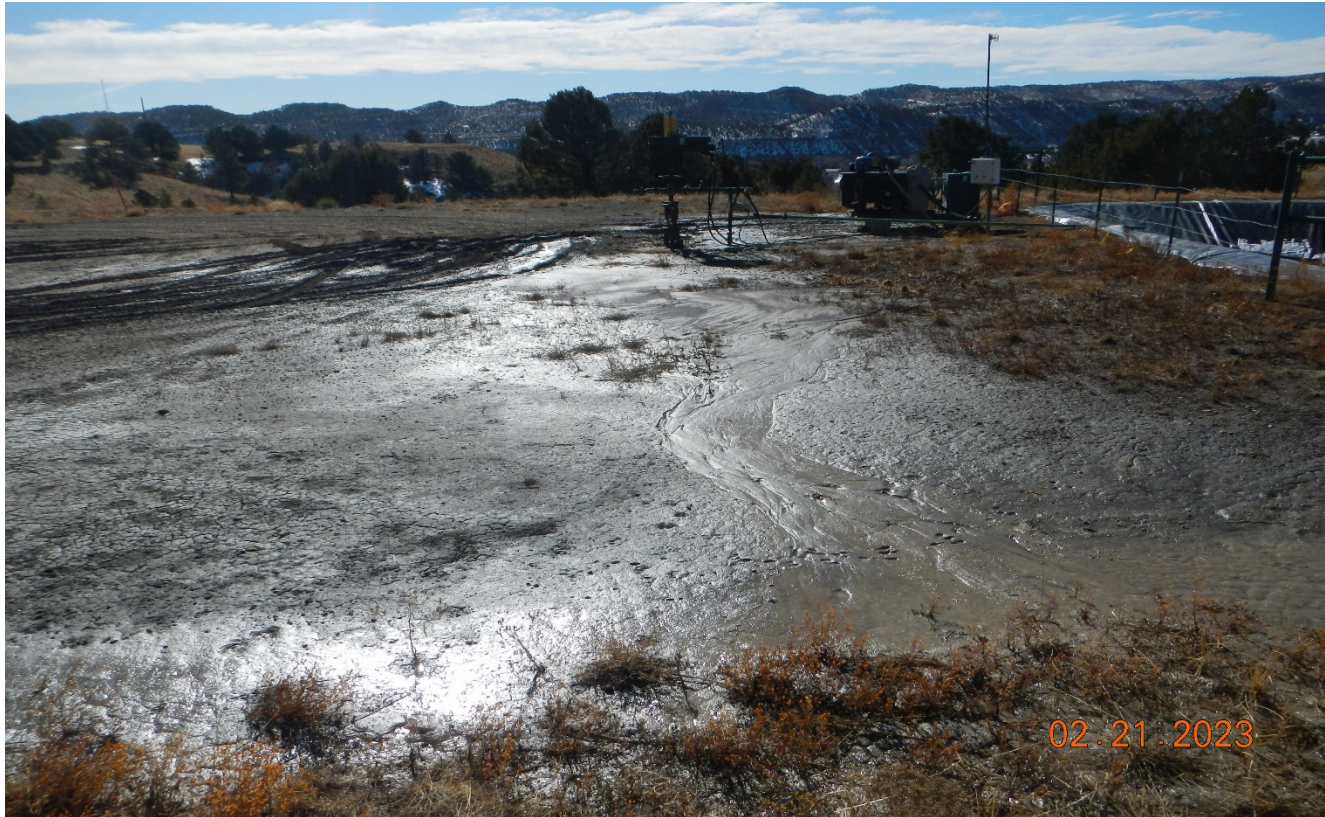
**Photo 7.** Facing southeast toward the wellsite. There are signs that produced water flowed off northwest side of the location.

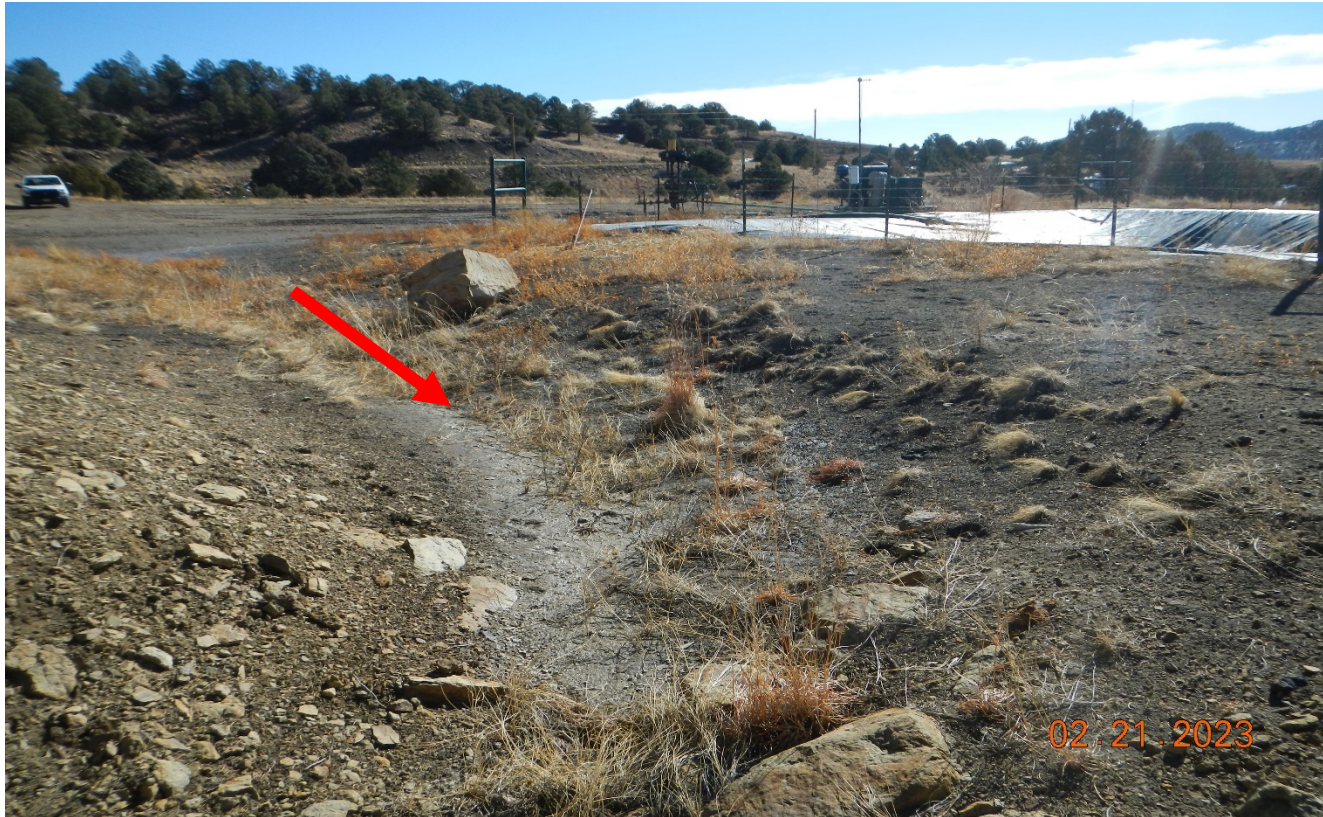
**Photo 8.** There are signs that produced water flowed off northwest side of the location.

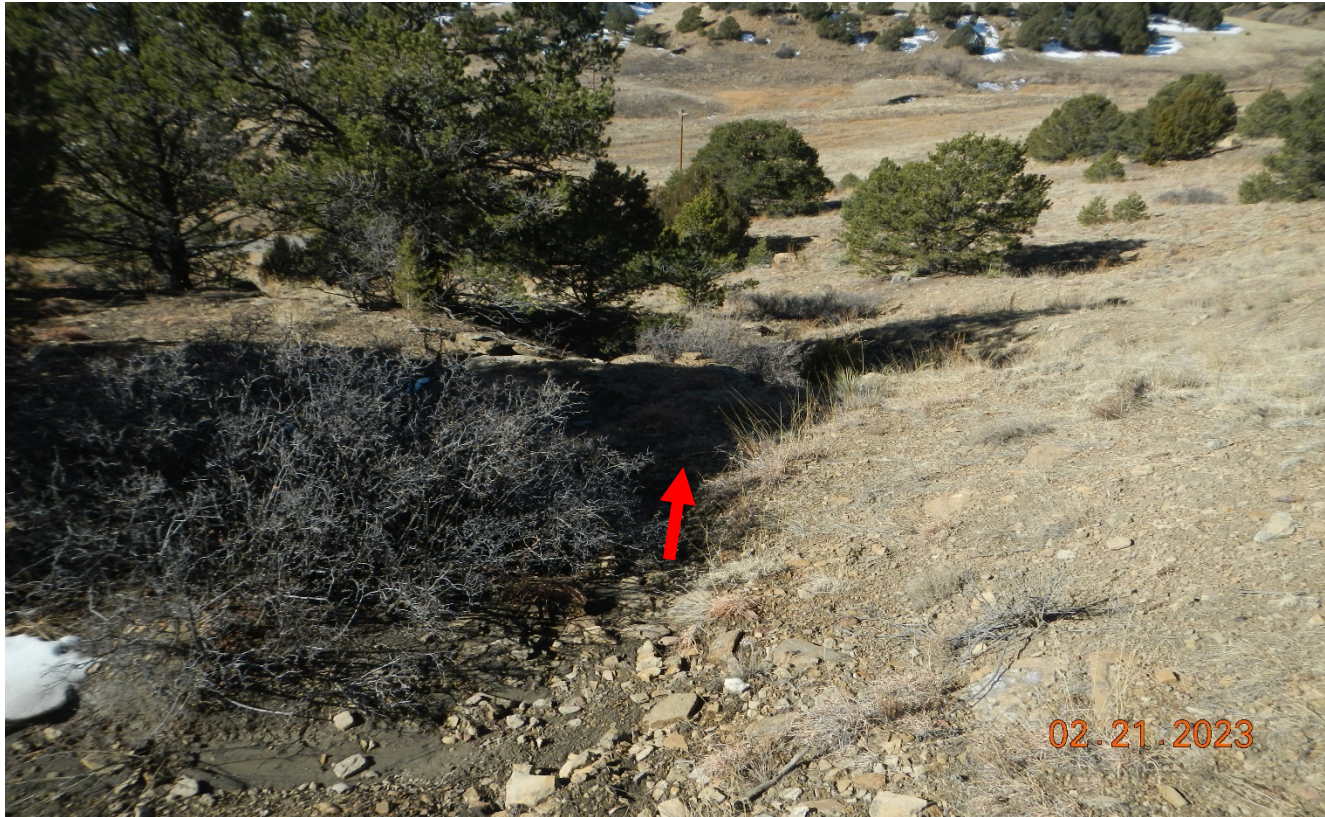
**Photo 9.** There are signs that produced water flowed off the northwest side of the location down toward CR 31.9.

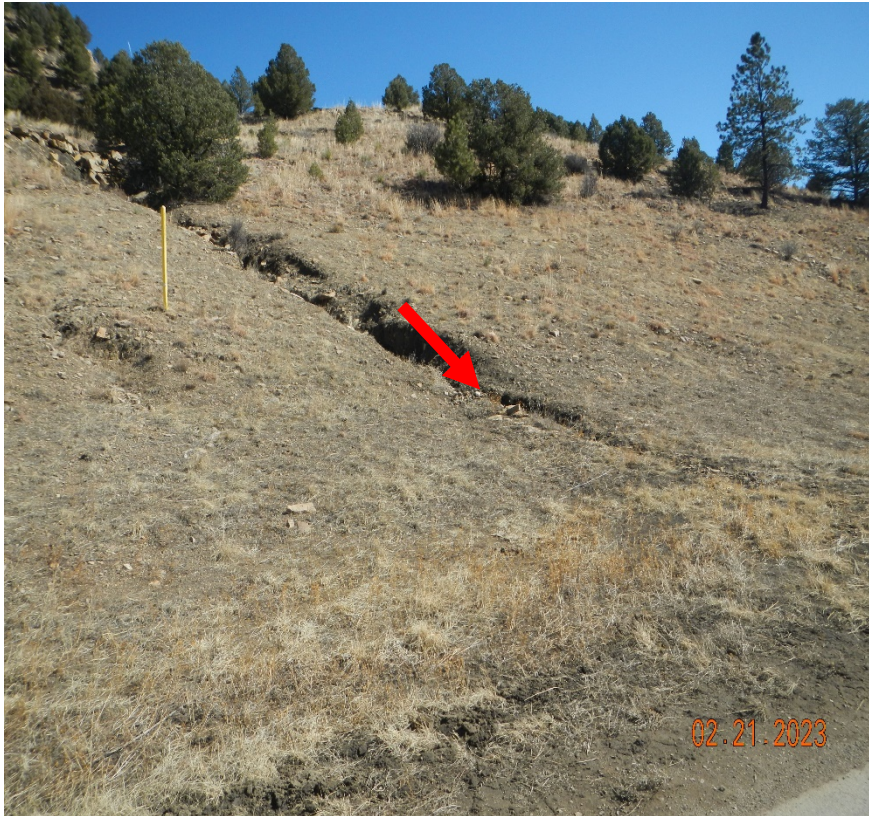
**Photo 10.** This is the point along the county road where produced water flowed from the northwest corner of the wellsite.

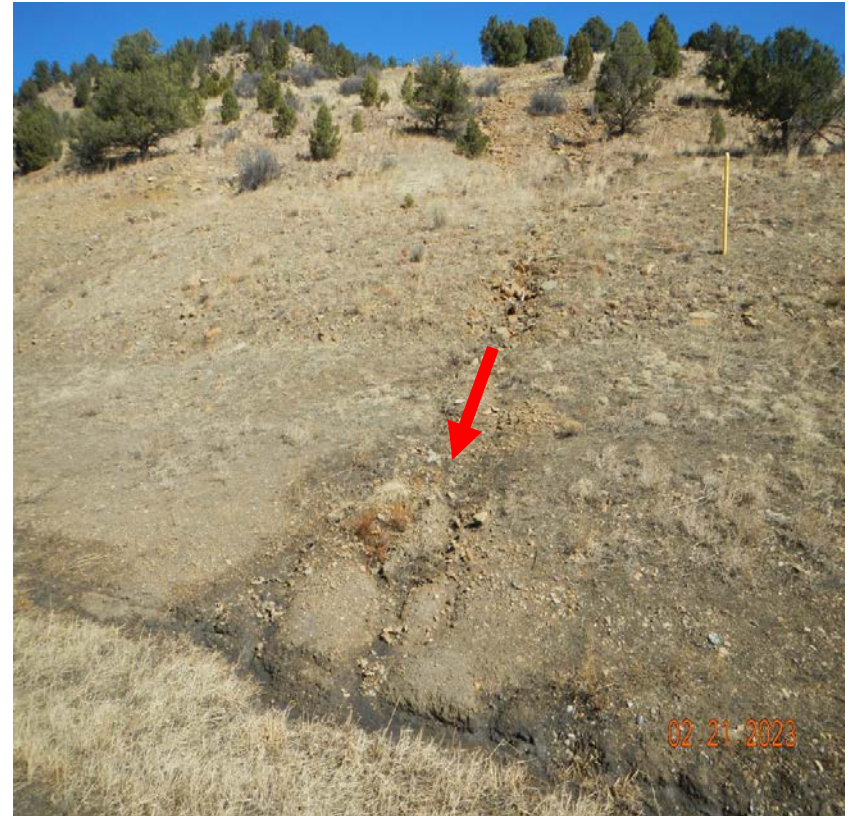
**Photo 11.** This is the point along the county road where produced water flowed from the southwest corner of the wellsite.

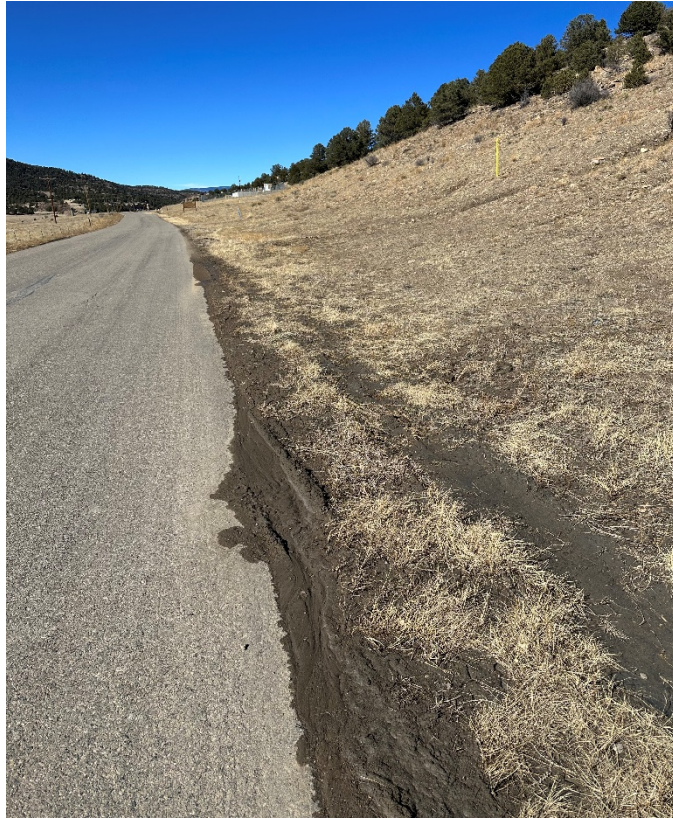
**Photo 12.** Facing northeast along CR 31.9 showing wet soils along the road.

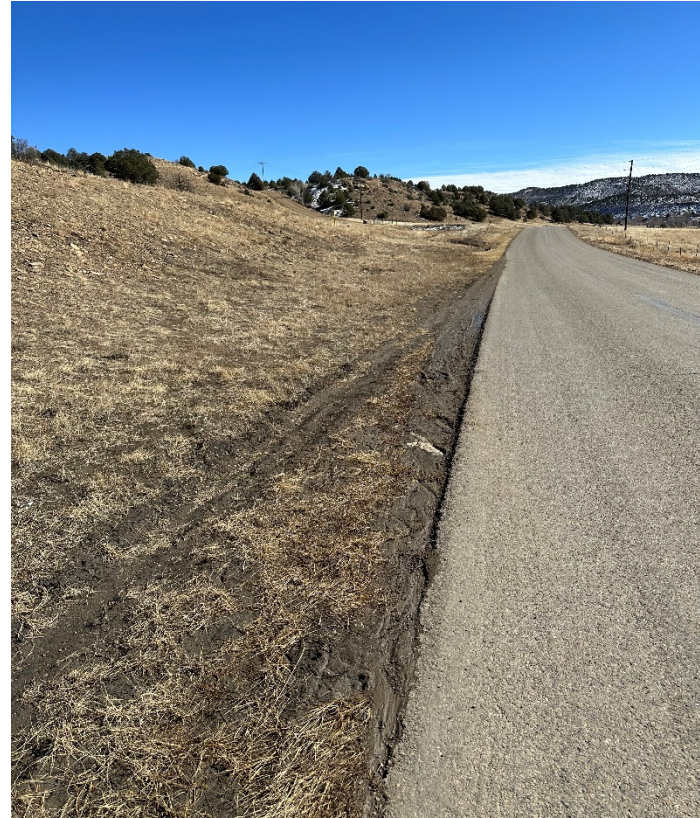
**Photo 13.** Facing northeast along CR 31.9 showing wet soils along the road.
