# Inspection Photos

API: 071-09381

Operator: XTO ENERGY INC

Inspection Date: 2/21/2023

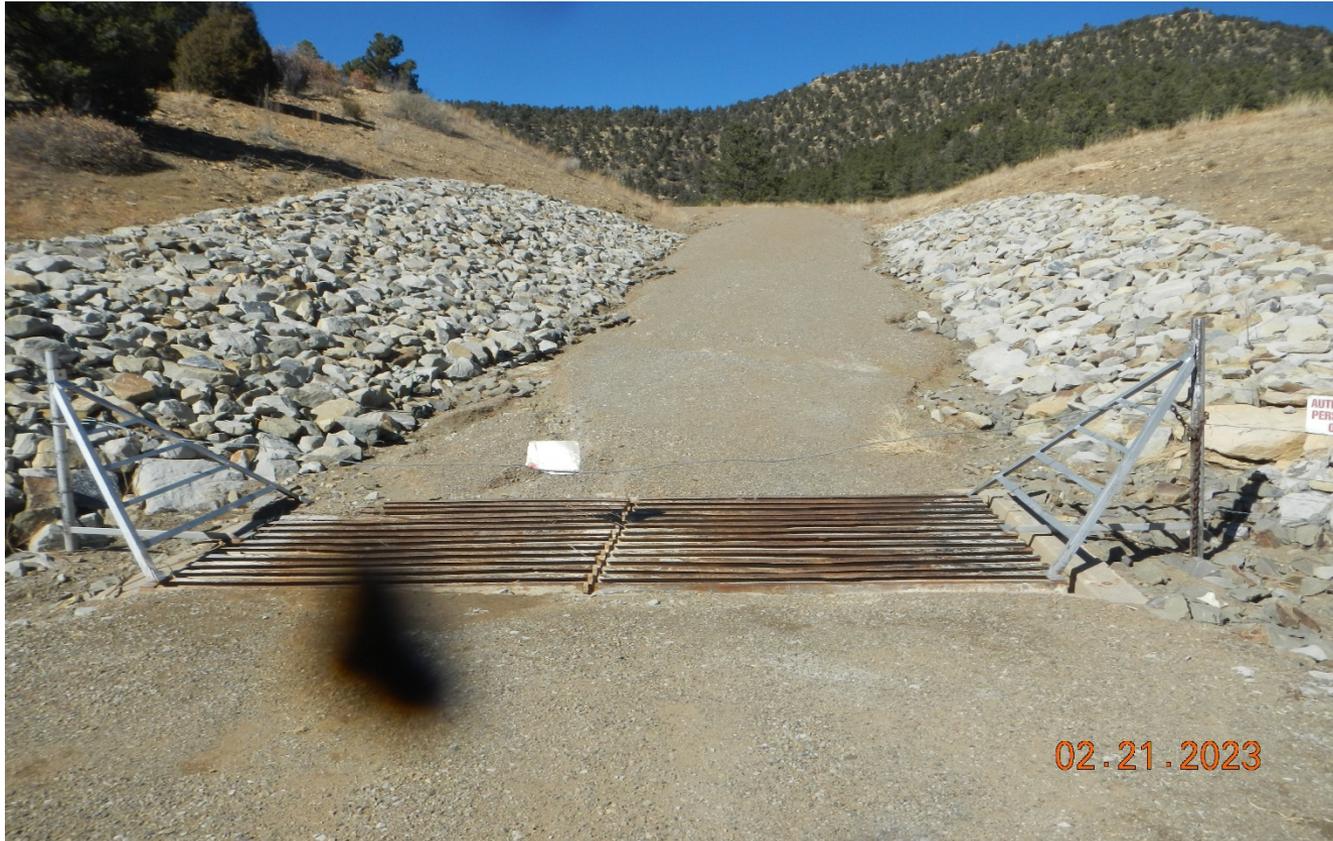
**Photo 1.** Facing north at the beginning of the access road.

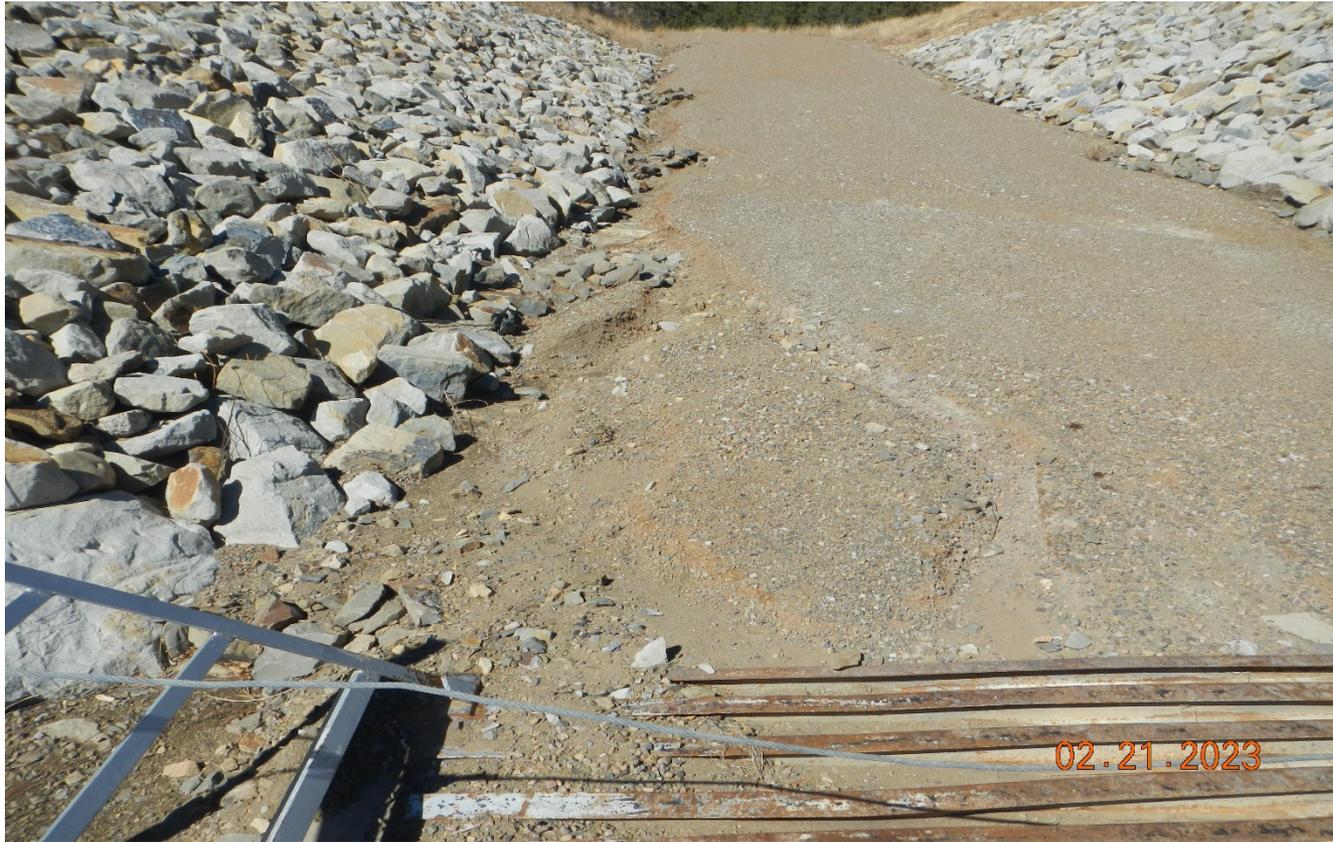
**Photo 2.** Facing north at the cattle guard. There has been erosion along the road sides and sediment is being deposited into the cattle guard.

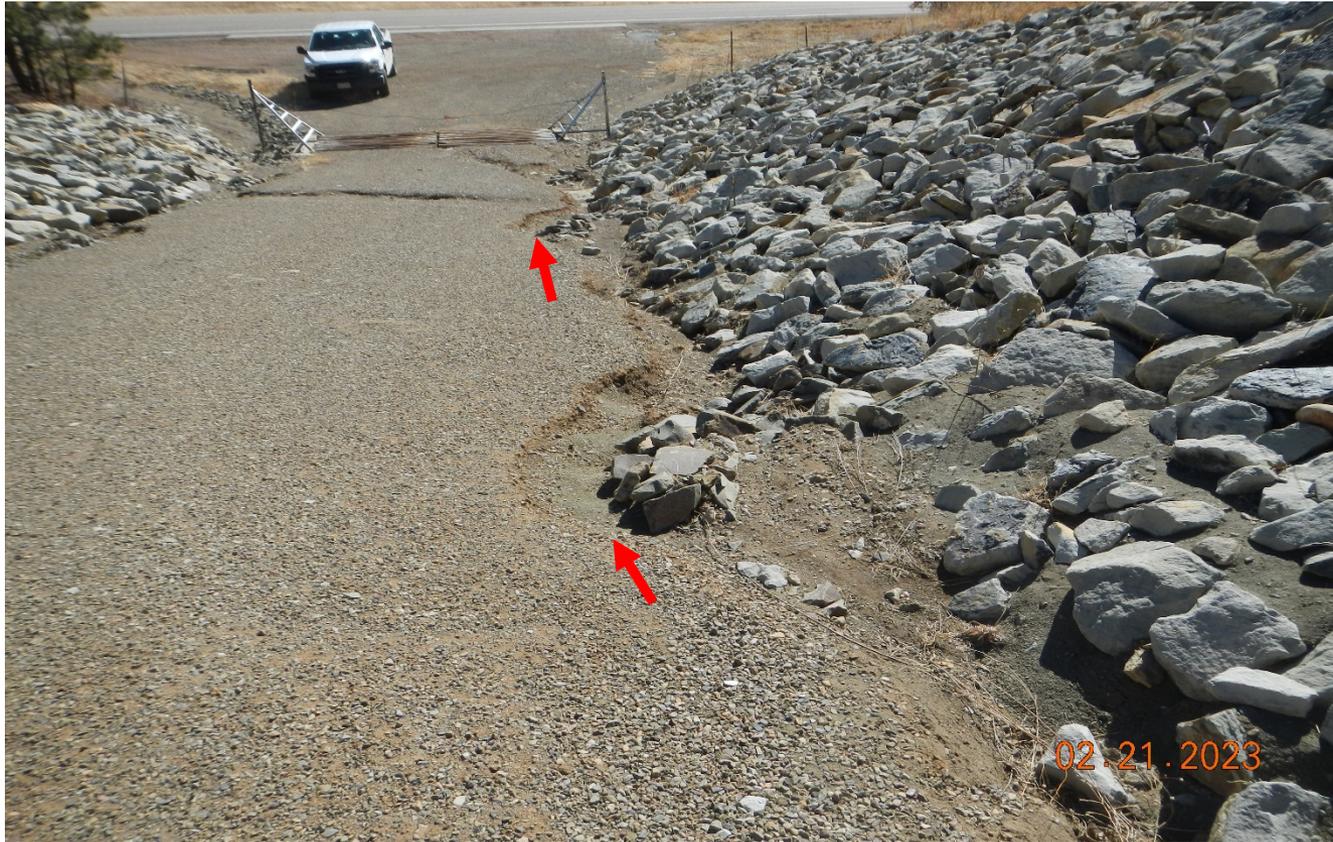
**Photo 3.** Facing back south on the access road. Sediment has filled in the check dams and stormwater has eroded around the outside shown at red arrows.

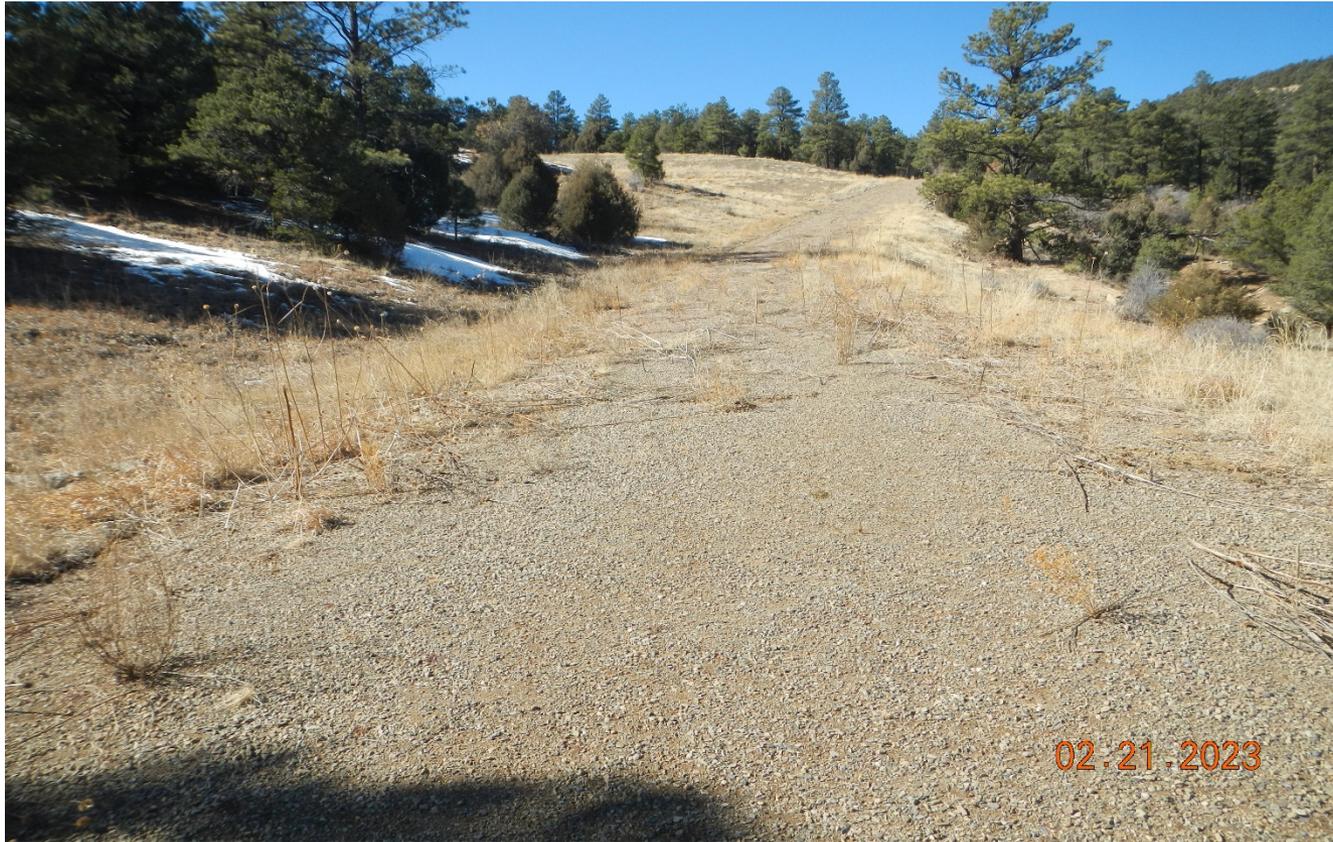
**Photo 4.** Facing northwest along the access road toward the location.

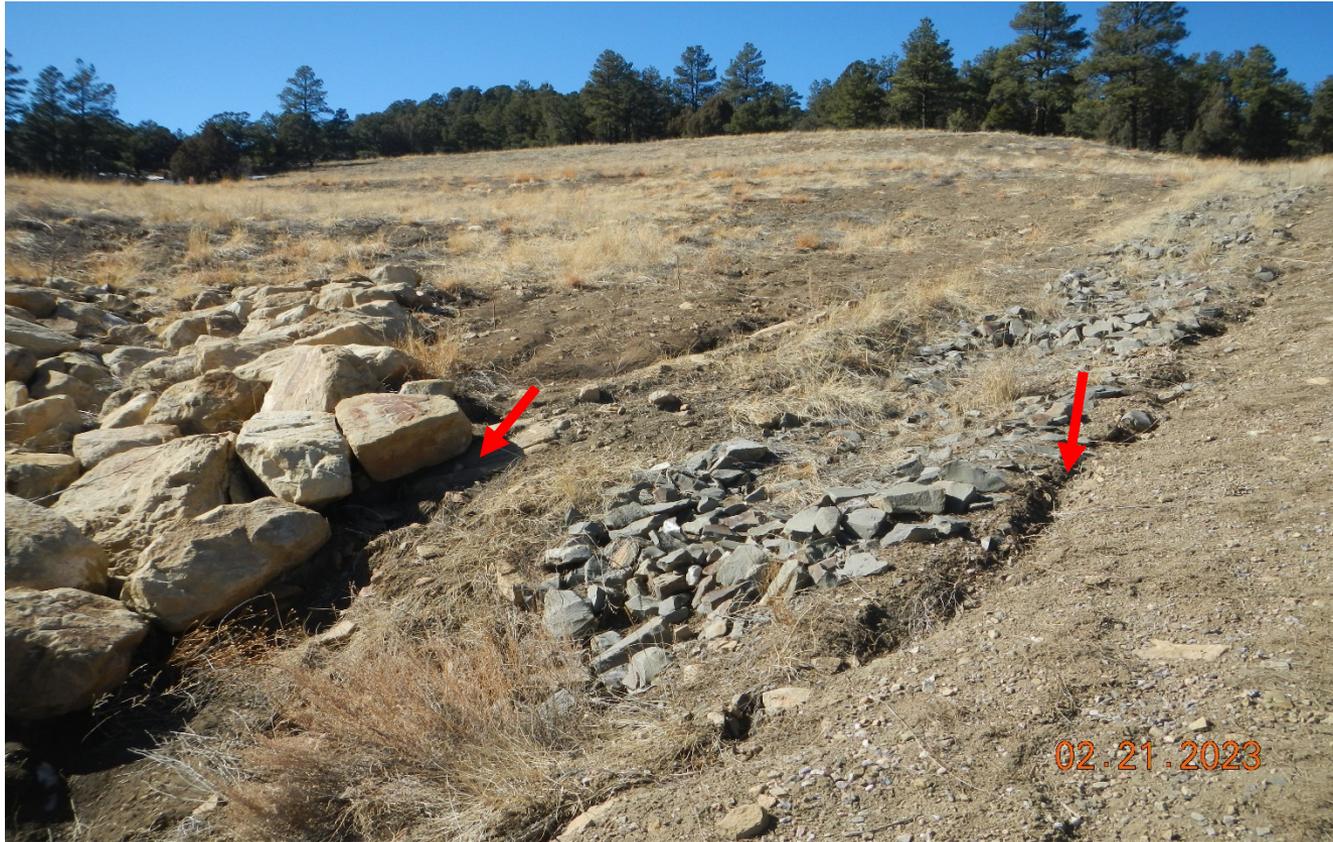
**Photo 5.** Facing northwest at the recontoured location. It appears stormwater erosion is occurring along the side of the rip/rap which will need maintenance.

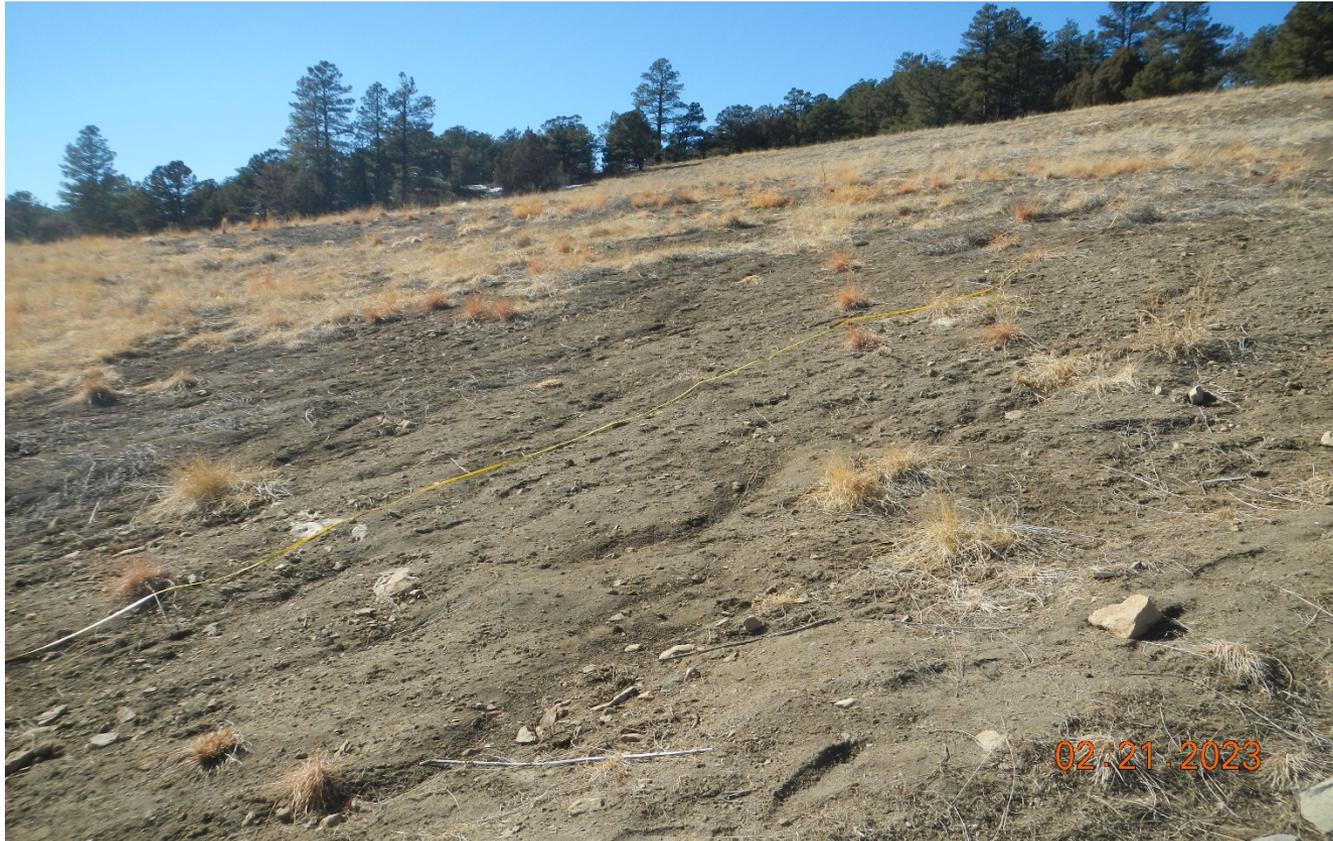
**Photo 6.** Facing west at the location. There are areas where there is no vegetation that will need to be reseeded. There is a 100ft. tape measure spread across this area for scale.

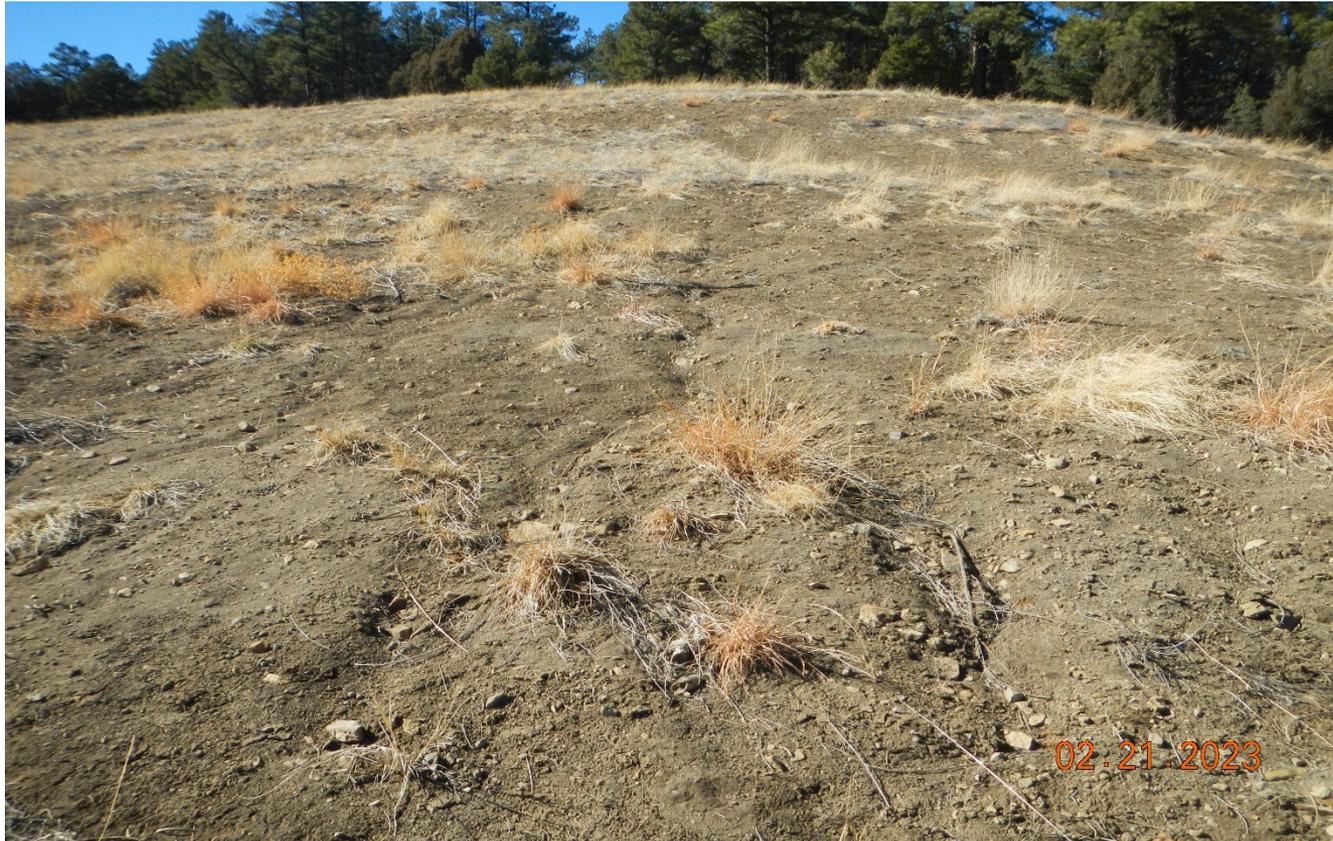
**Photo 7.** Facing northwest at the location. There are areas where there is no vegetation that will need to be reseeded.

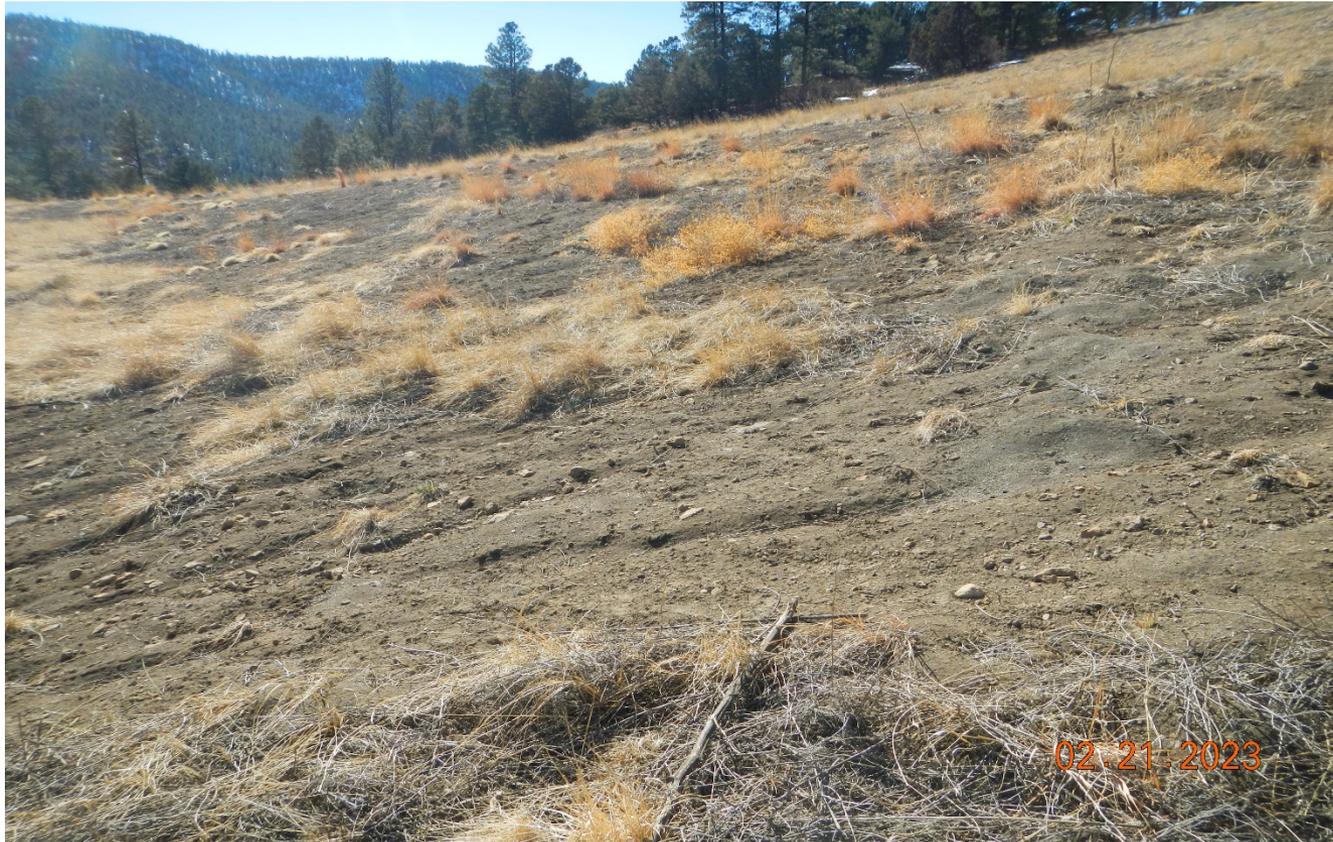
**Photo 8.** Facing southwest at the location. There are areas where there is no vegetation that will need to be reseeded.

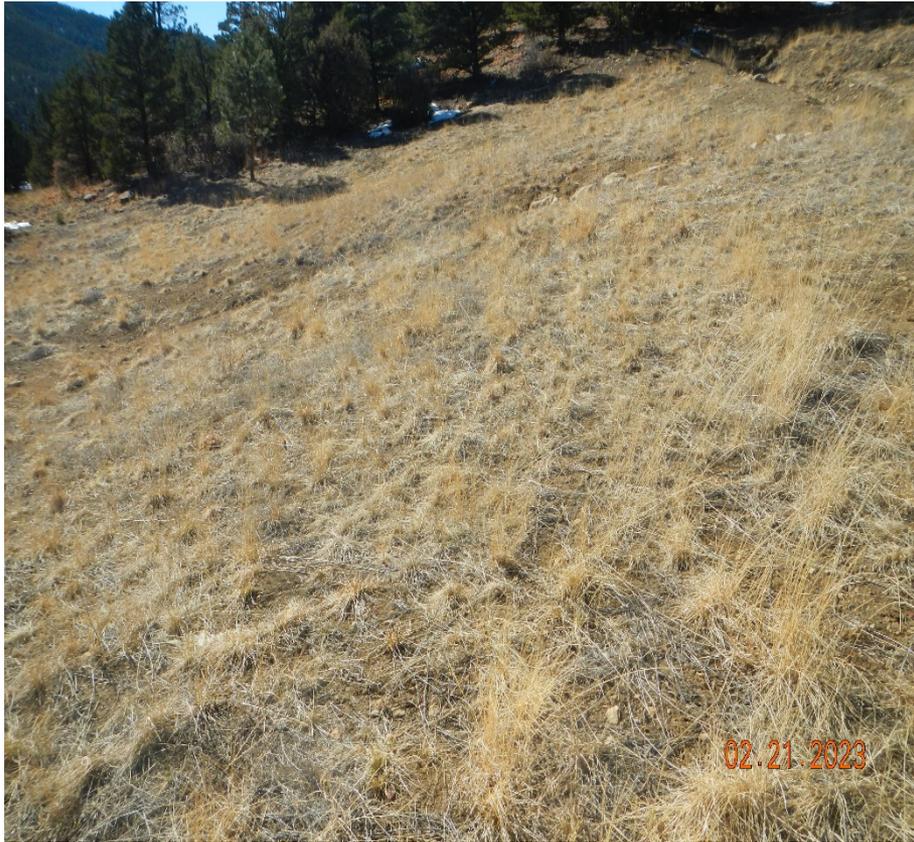
**Photo 9.** Facing toward the west side of the location. There are areas of perennial vegetation establishment.

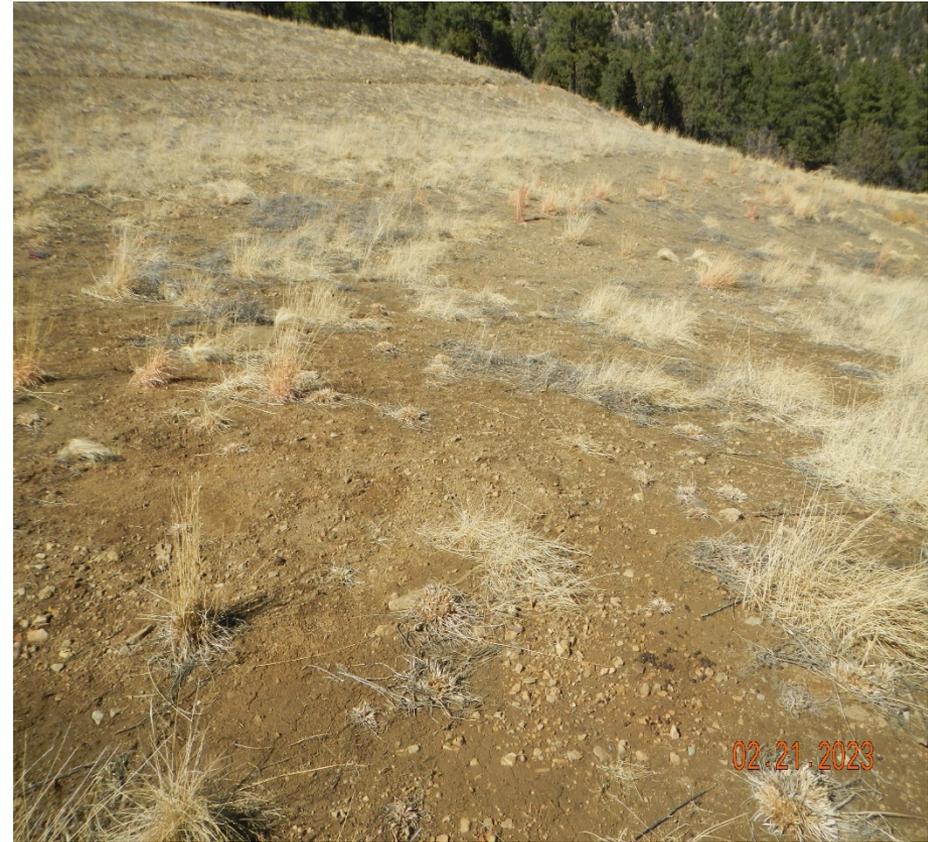
**Photo 10.** Facing toward the east side of the location. Some areas of the location have sparse establishment.

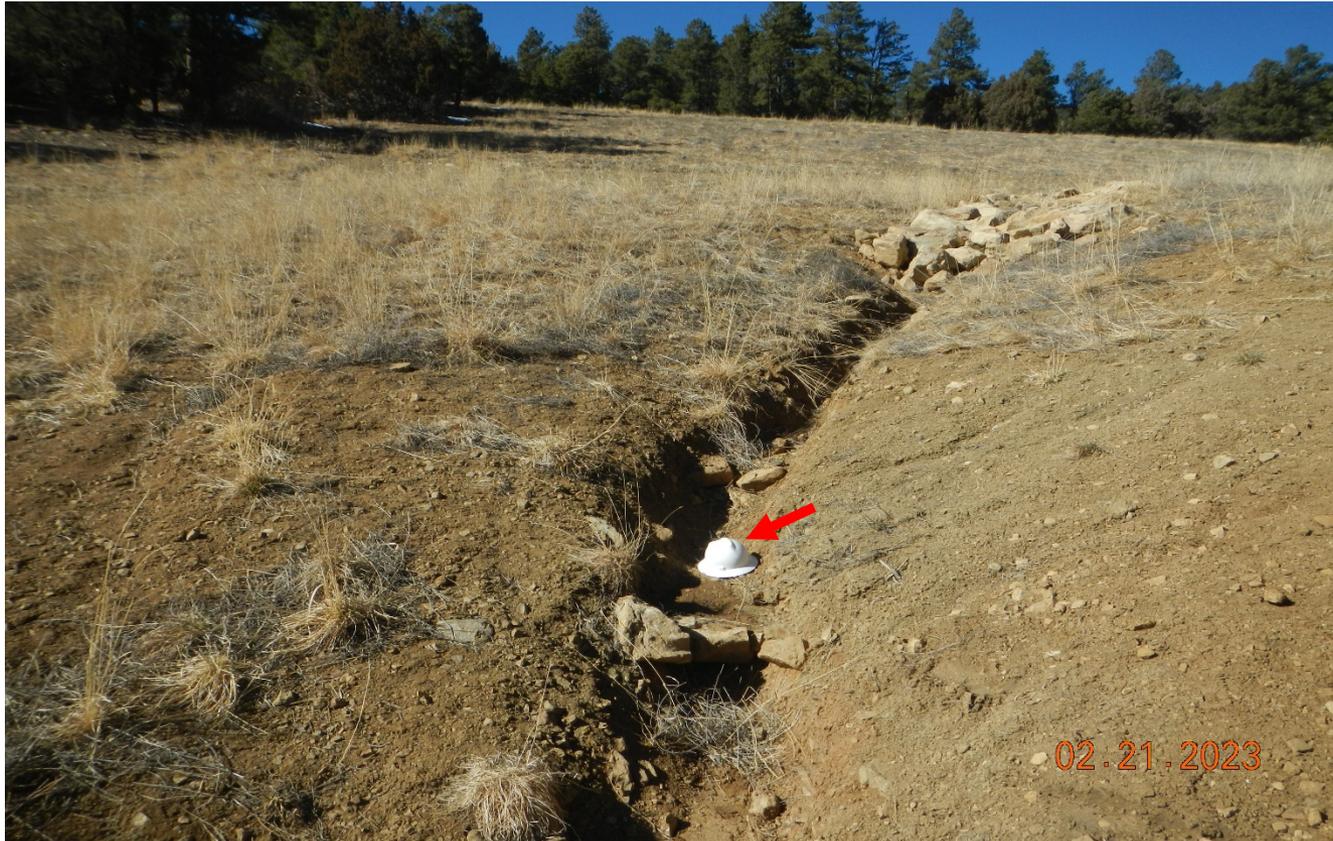
**Photo 11.** Facing north at the west side of the location. This stormwater diversion is eroding in this area and will need further stabilization. Red arrow points to hard hat for scale.

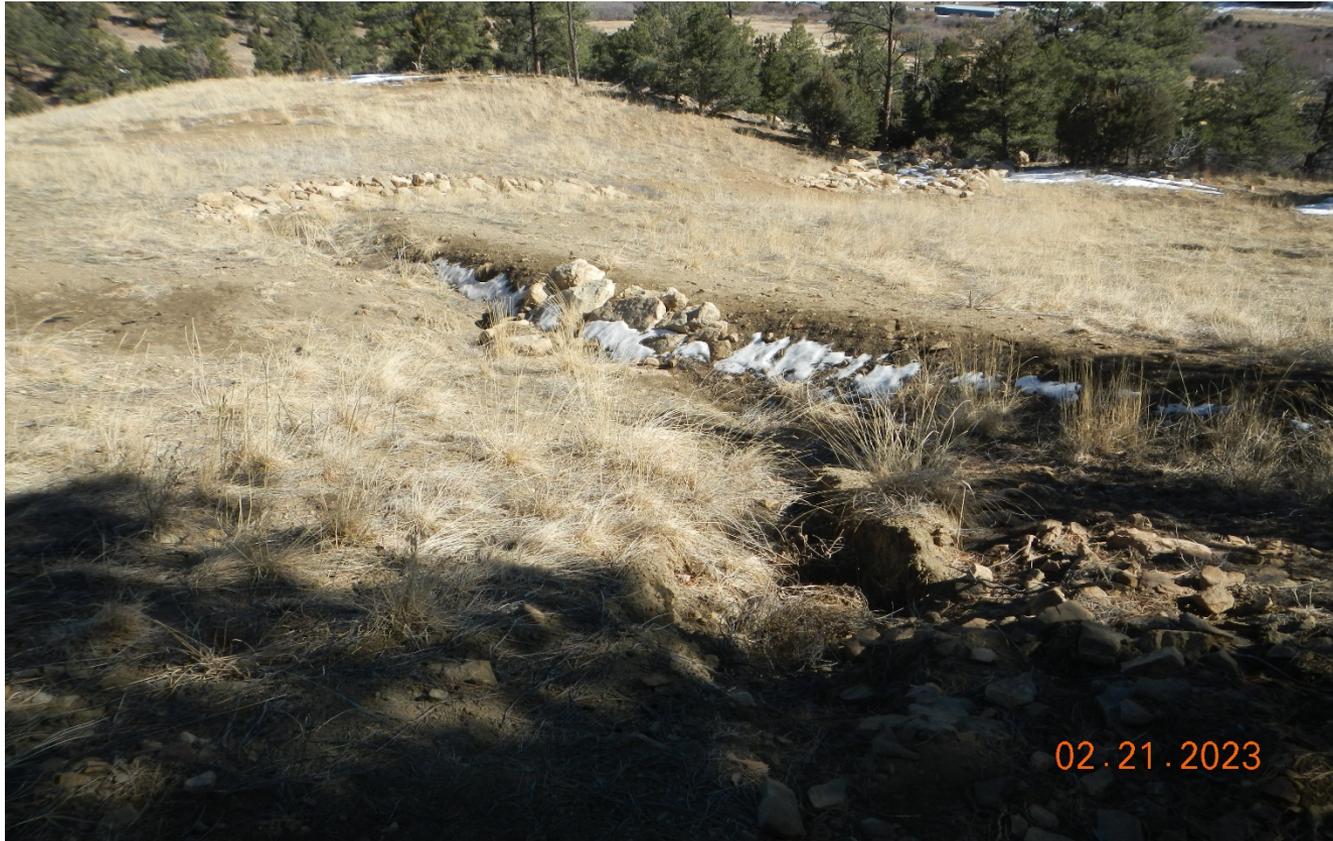
**Photo 12.** Standing at the upper NW portion of the location facing southeast.

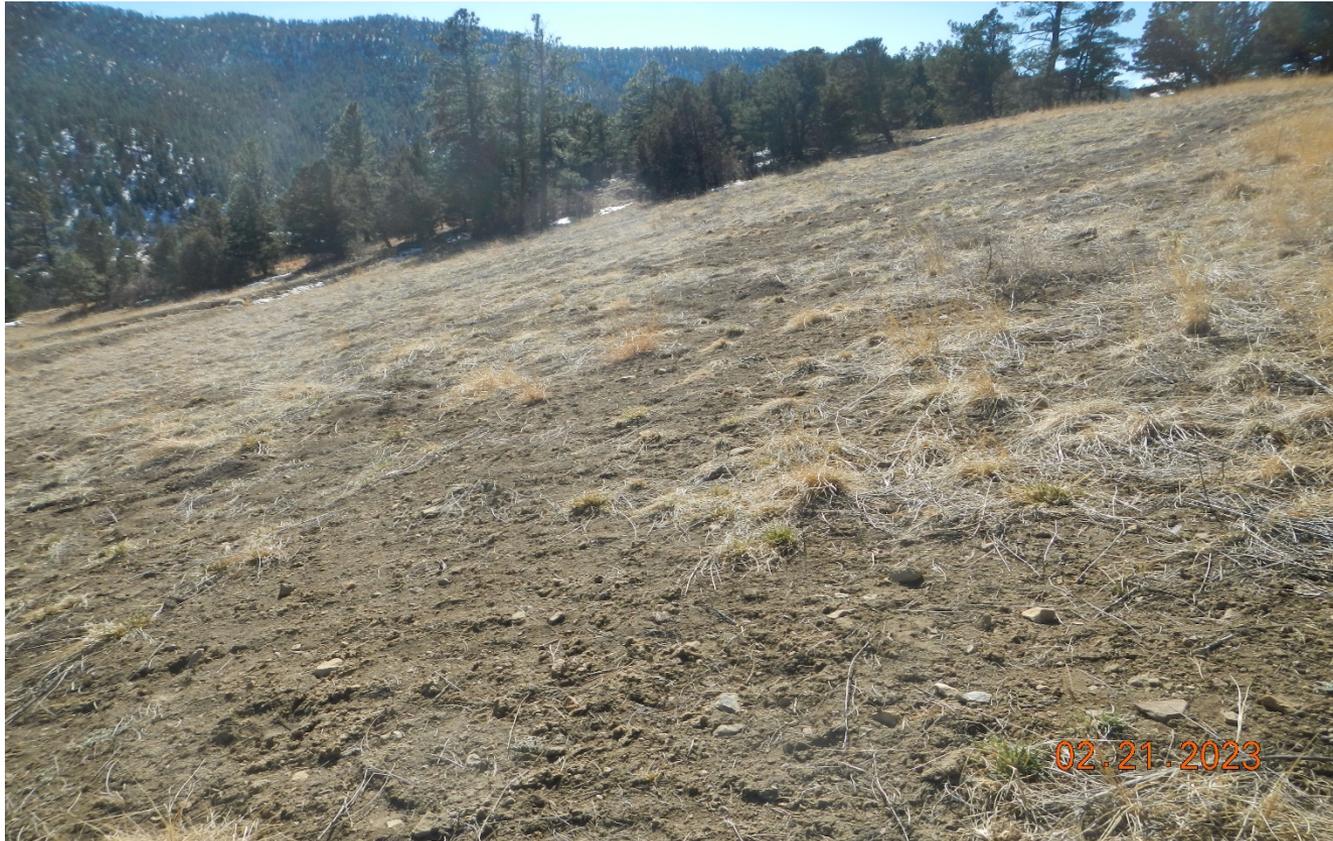
**Photo 13.** Standing at the upper portion of the location facing southwest. Some areas have sparse vegetation which needs additional seeding.

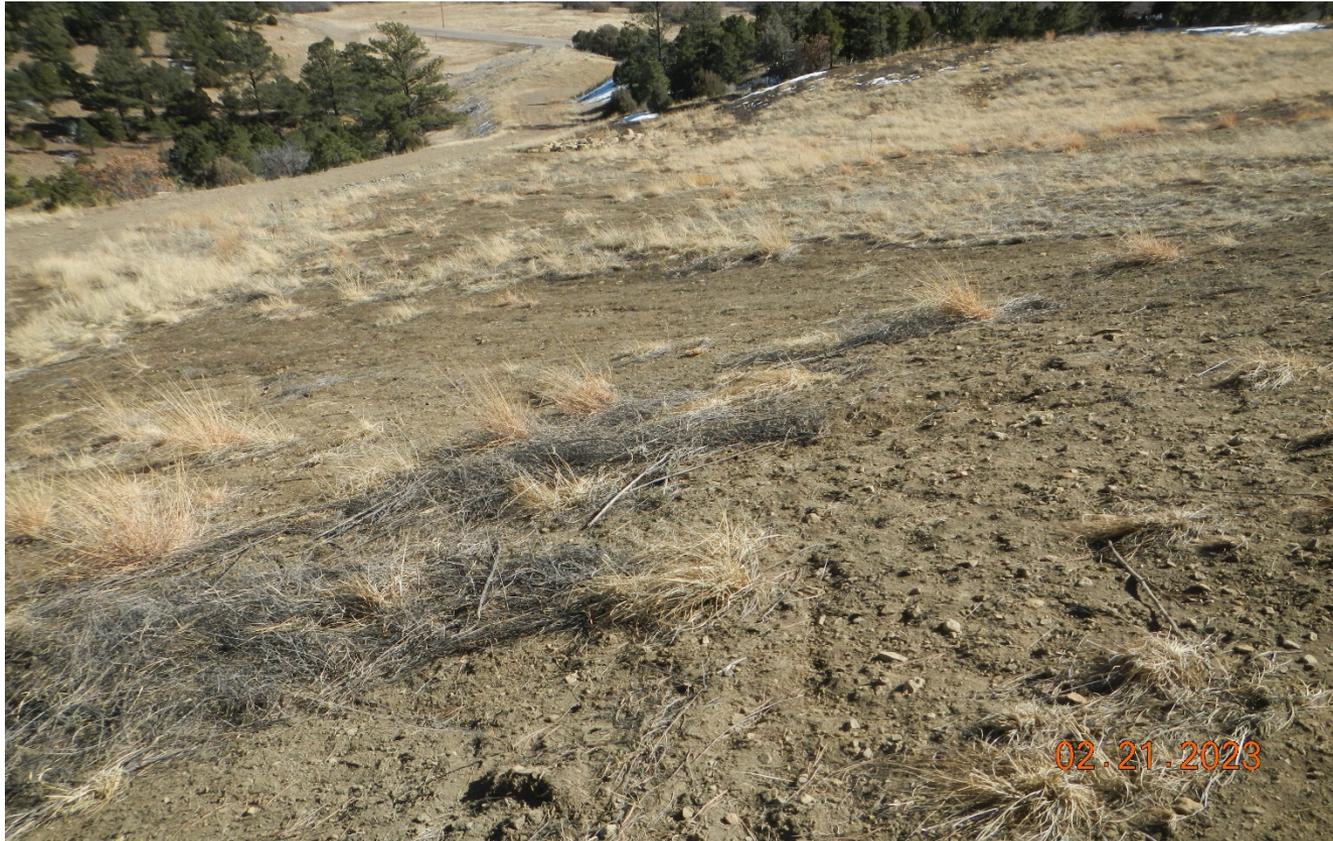
**Photo 14.** Standing at the upper NE portion of the location facing southeast. Some areas have sparse vegetation which needs additional seeding.
