# Inspection Photos

API: 071-08776

Operator: XTO ENERGY INC

Inspection Date: 2/21/2023

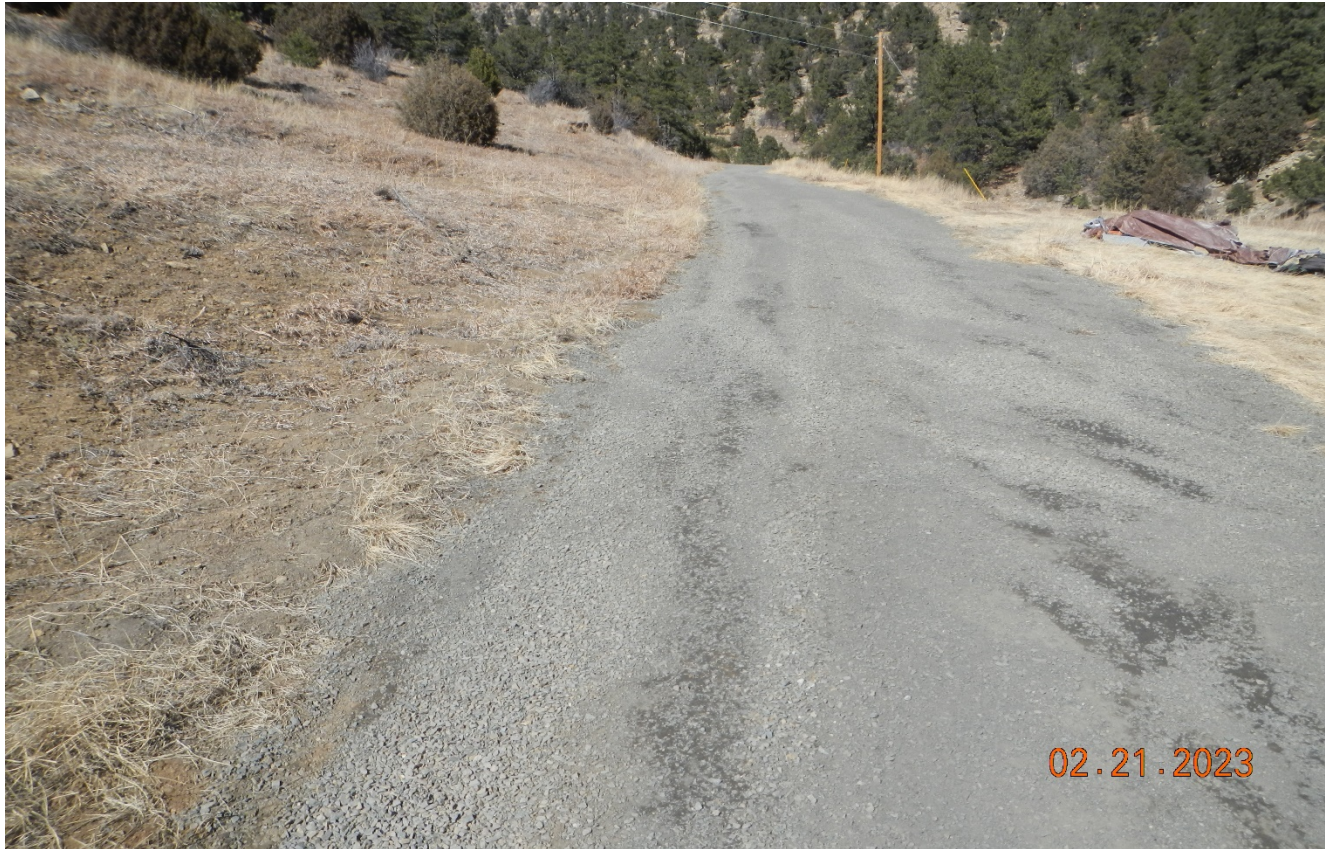
**Photo 1.** Facing north toward the access road.

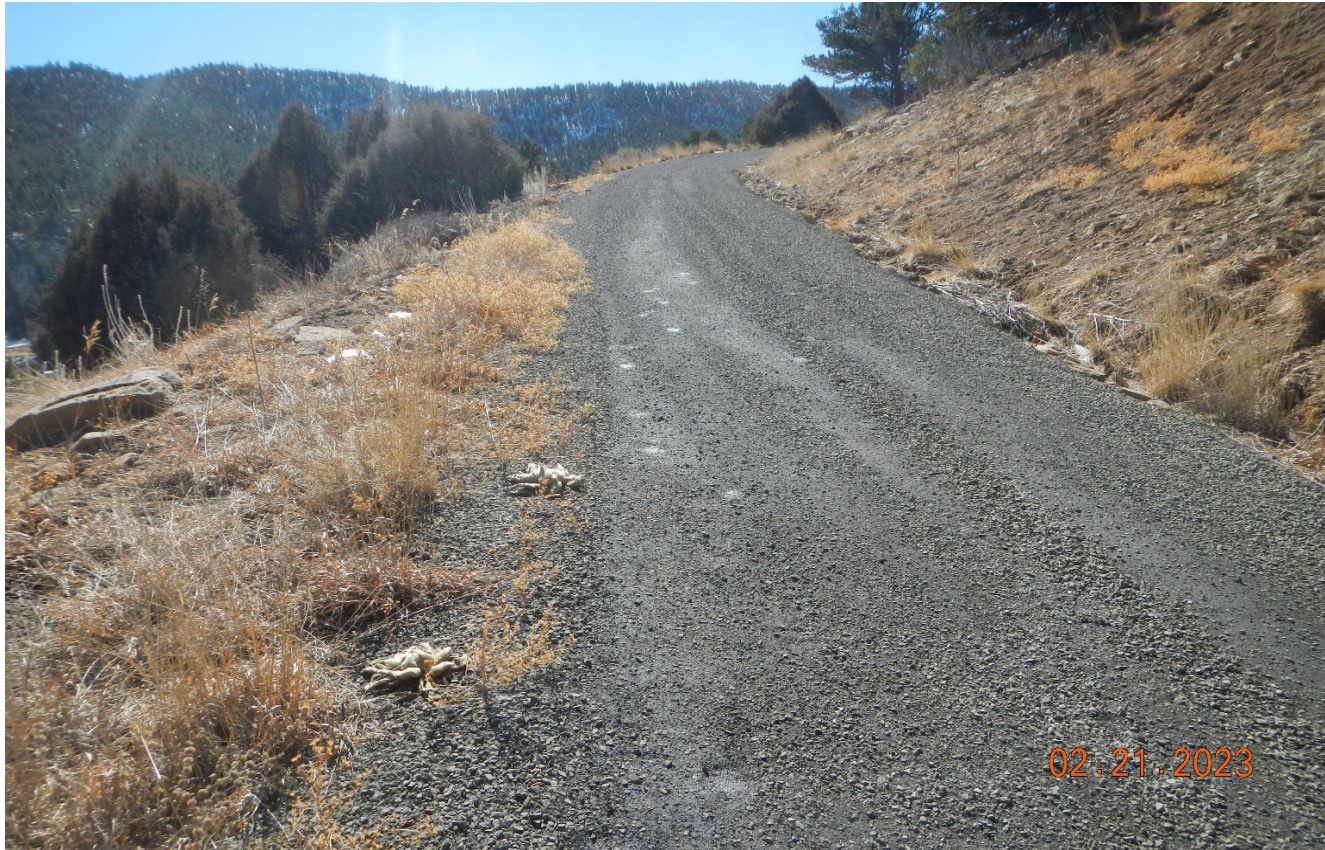
**Photo 2.** Facing back at the southwest at the first switch back of the road.

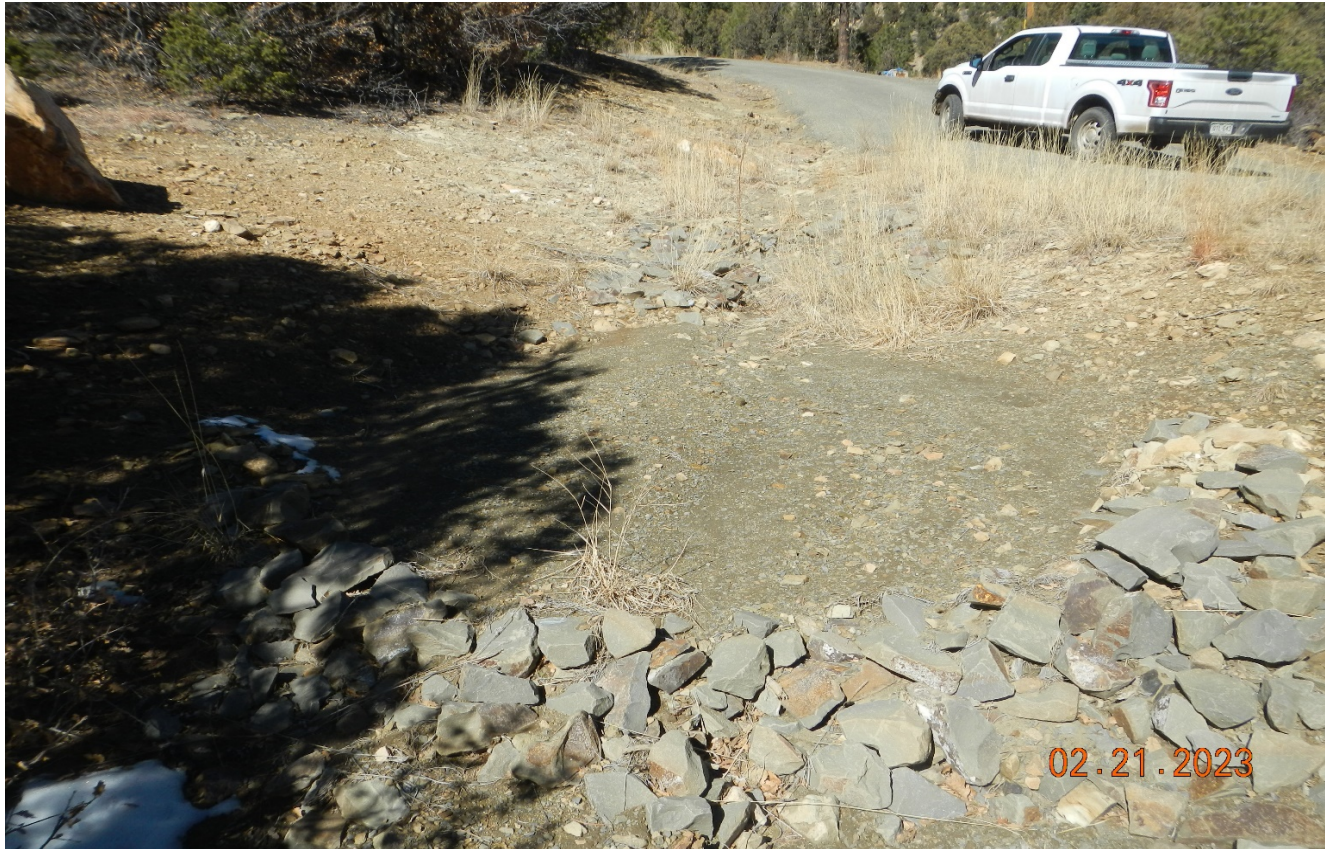
**Photo 3.** There is sediment accumulation along this rip/rap outlet which needs maintenance (shoveled/cleaned out).

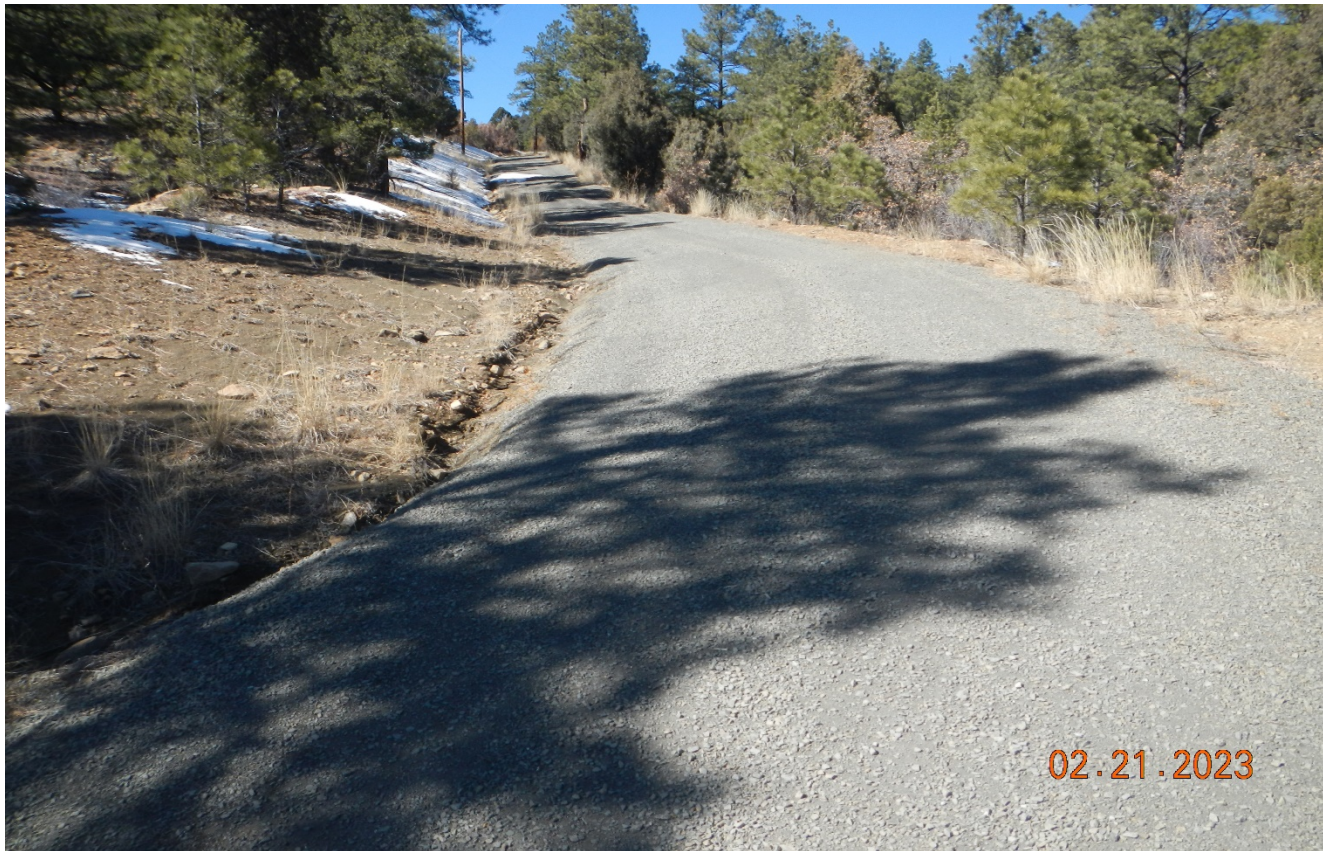
**Photo 4.** Facing northwest along the access road.

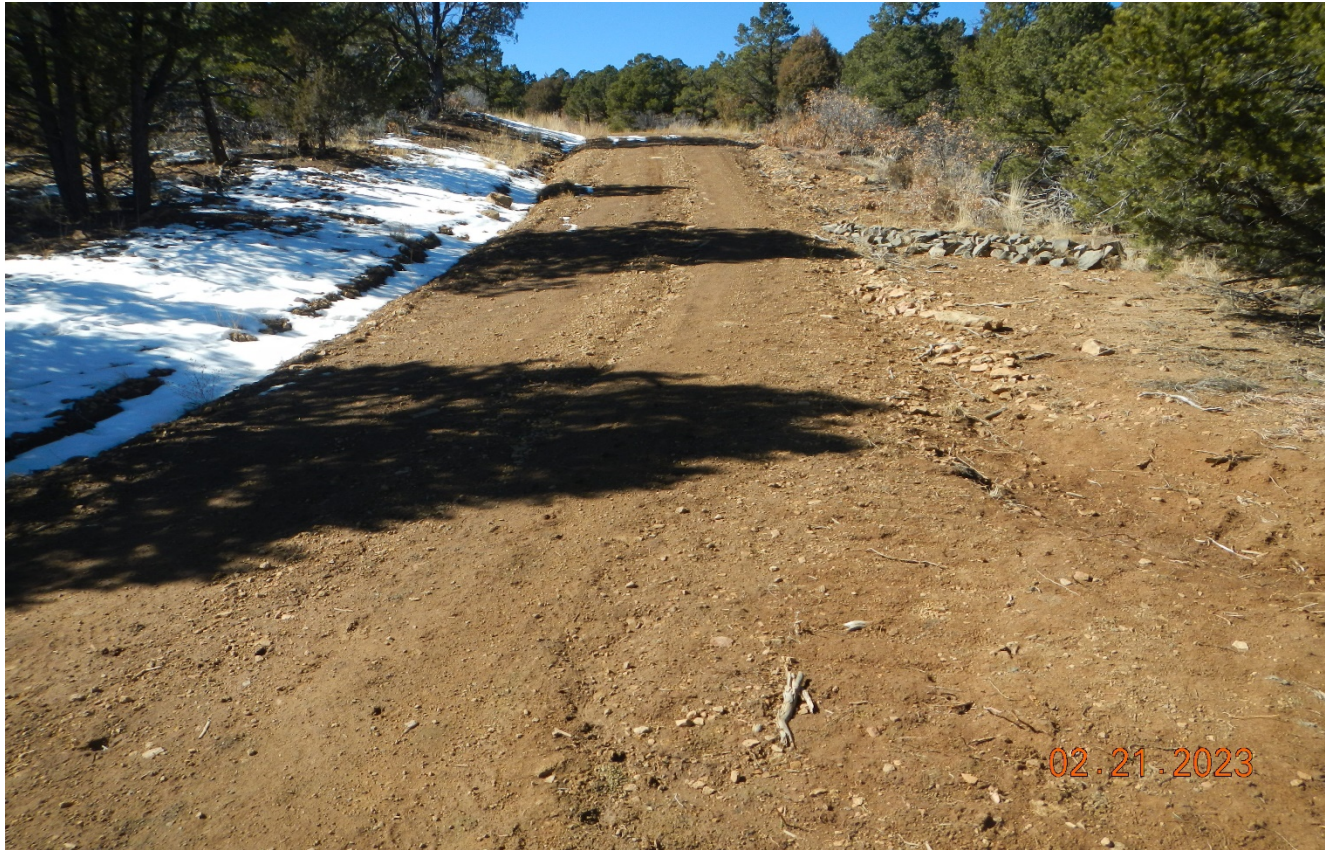
**Photo 5.** Facing northwest. The gravel ends at this point and a dirt road remains to the location.

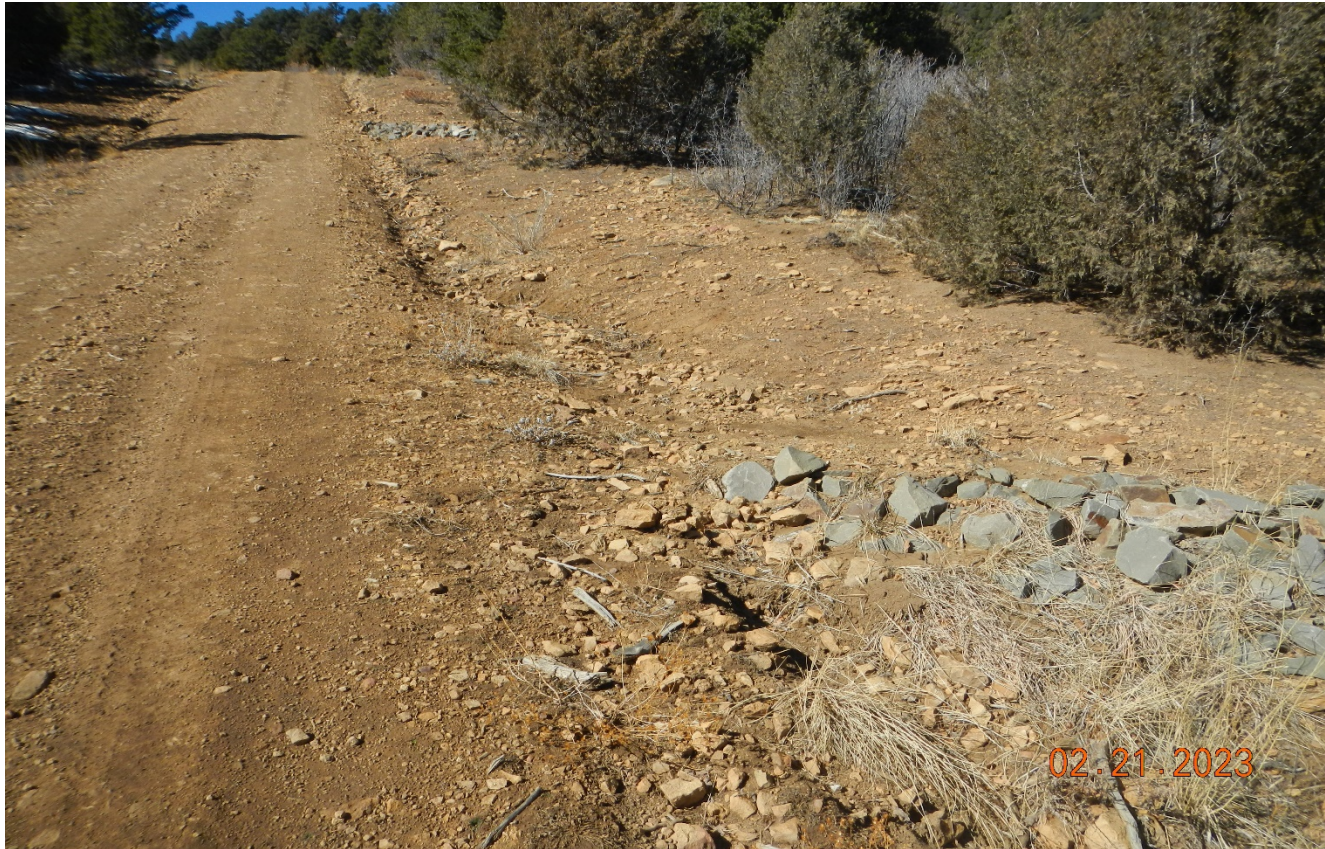
**Photo 6.** Some of the check dams could use some hand maintenance to allow proper flow away from the roadside.

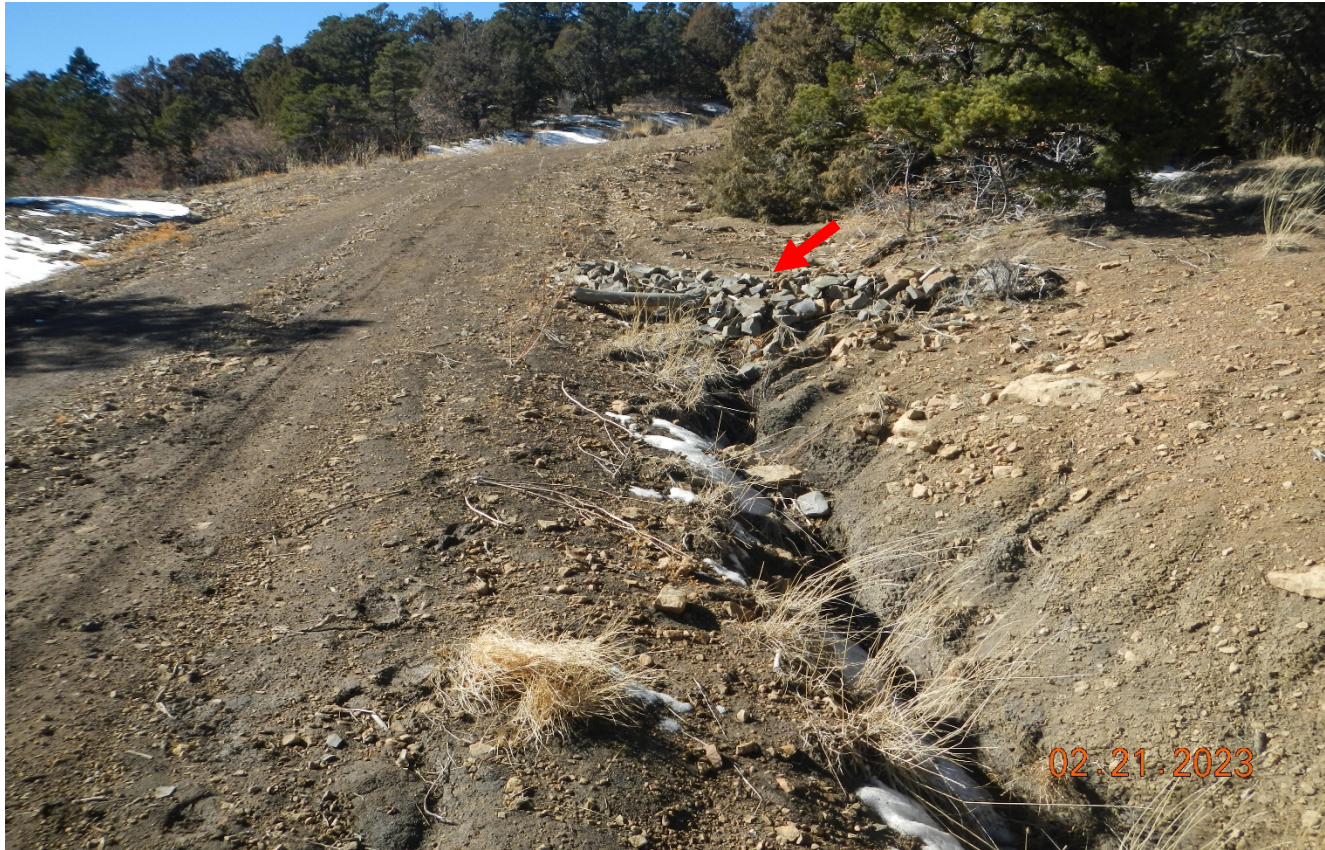
**Photo 7.** The rock check dam at red arrow is filled in with sediment and there is some erosion below the check dam. Lat/Long:37.15901,-104.99182

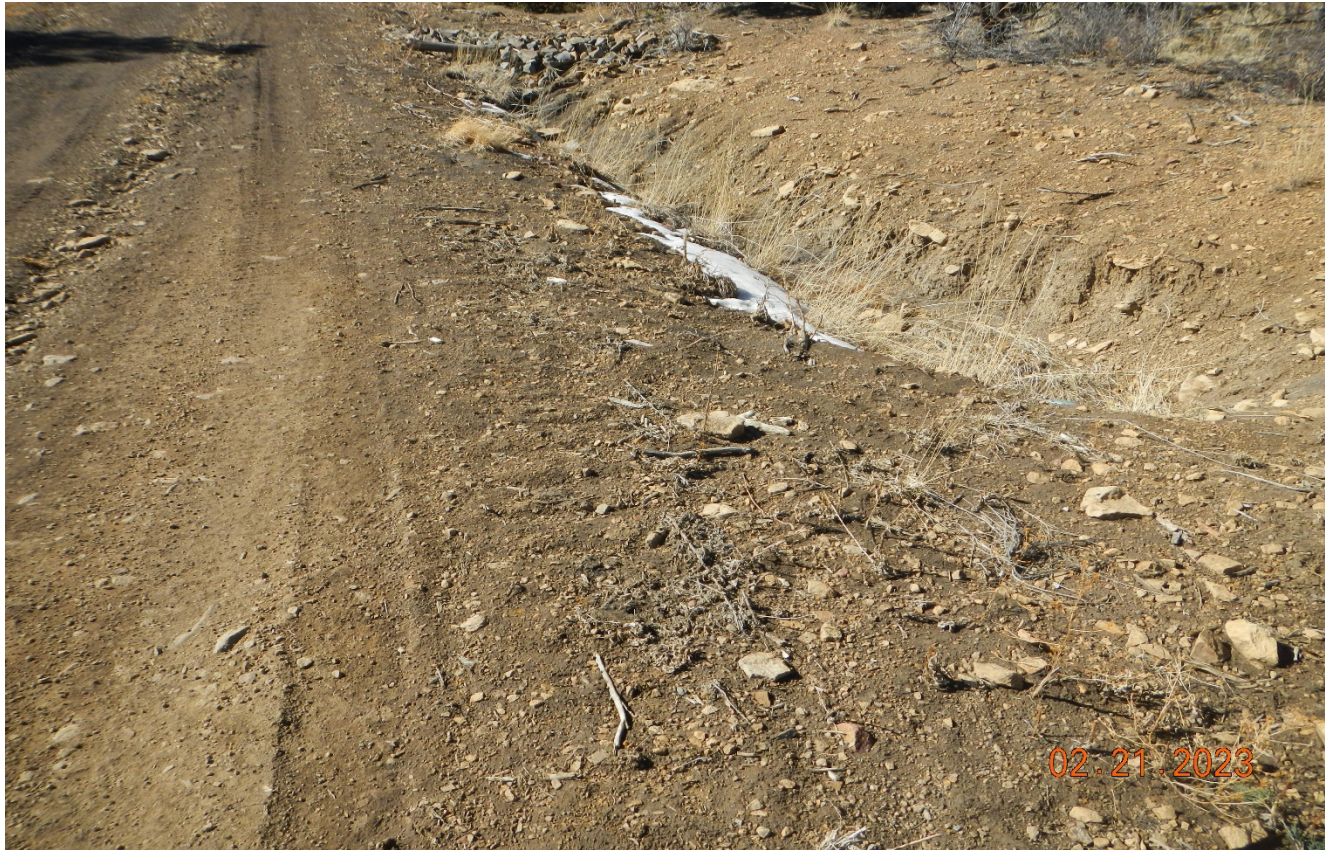
**Photo 8.** There is some noxious weed debris (Canada thistle) found along this area of the road. This should be monitored and controlled later in the spring time.

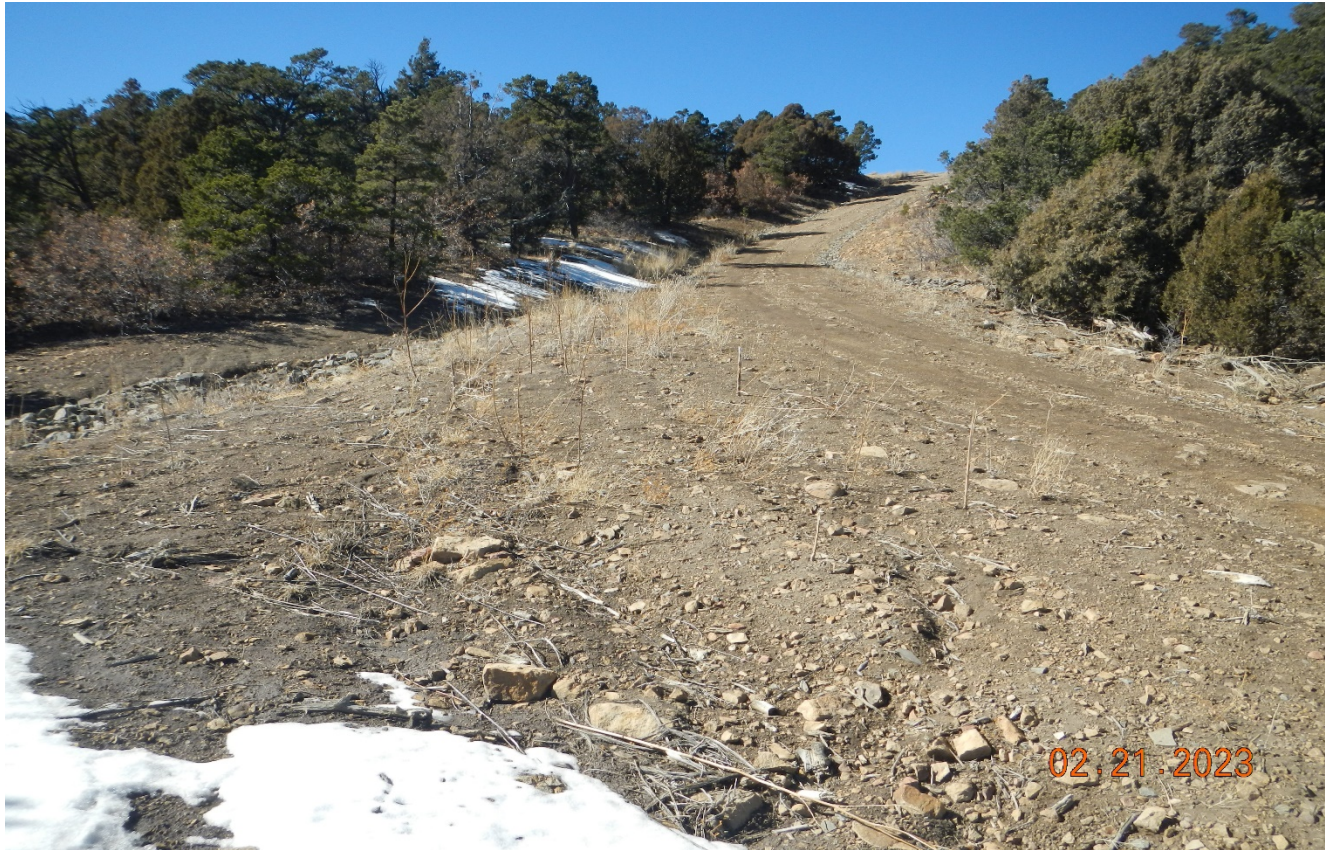
**Photo 9.** Facing northwest along the road near the location which is at the top of the hill. This wide area along the side of the road should be seeded to provide stabilization.

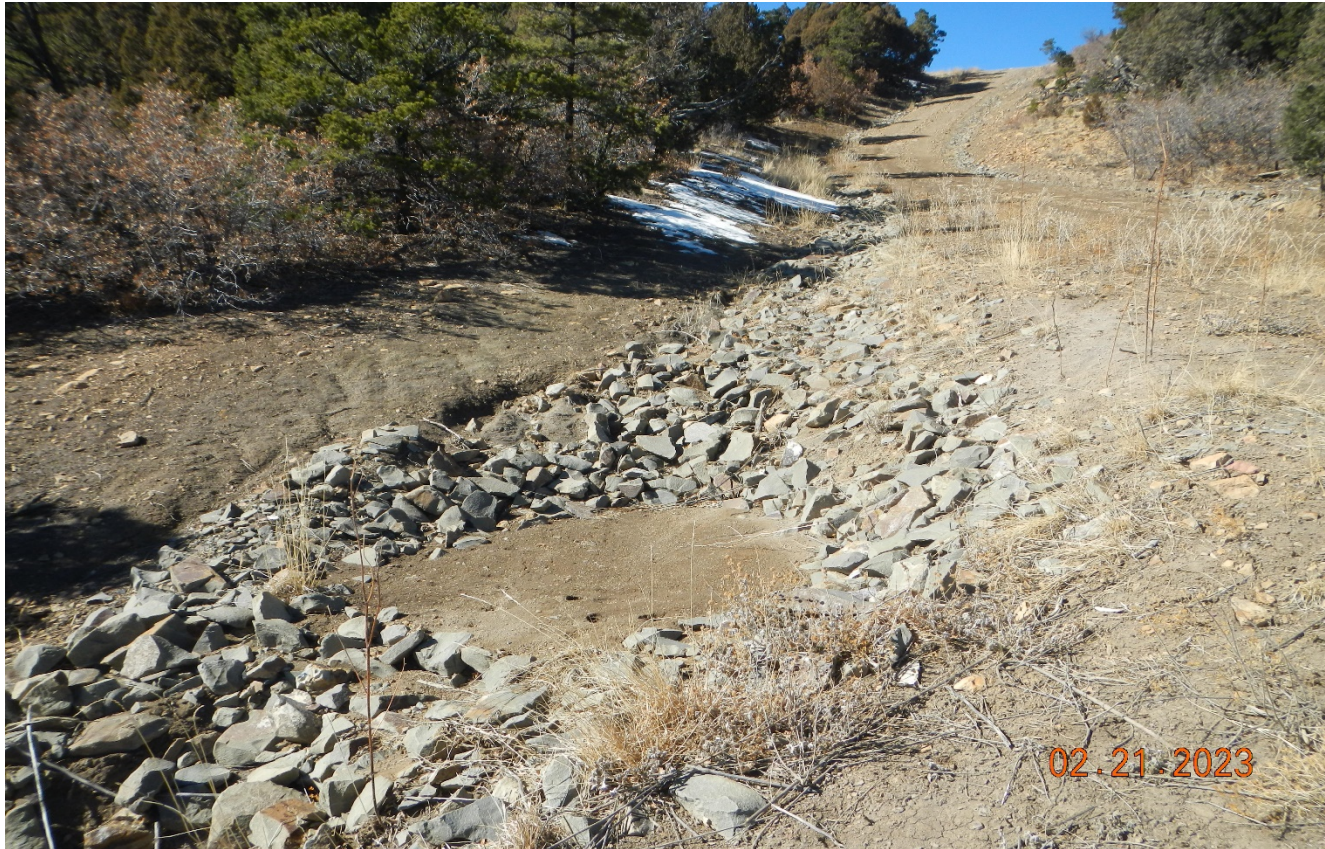
**Photo 10.** There is sediment accumulation along this rip/rap outlet which needs maintenance (shoveled/cleaned out).

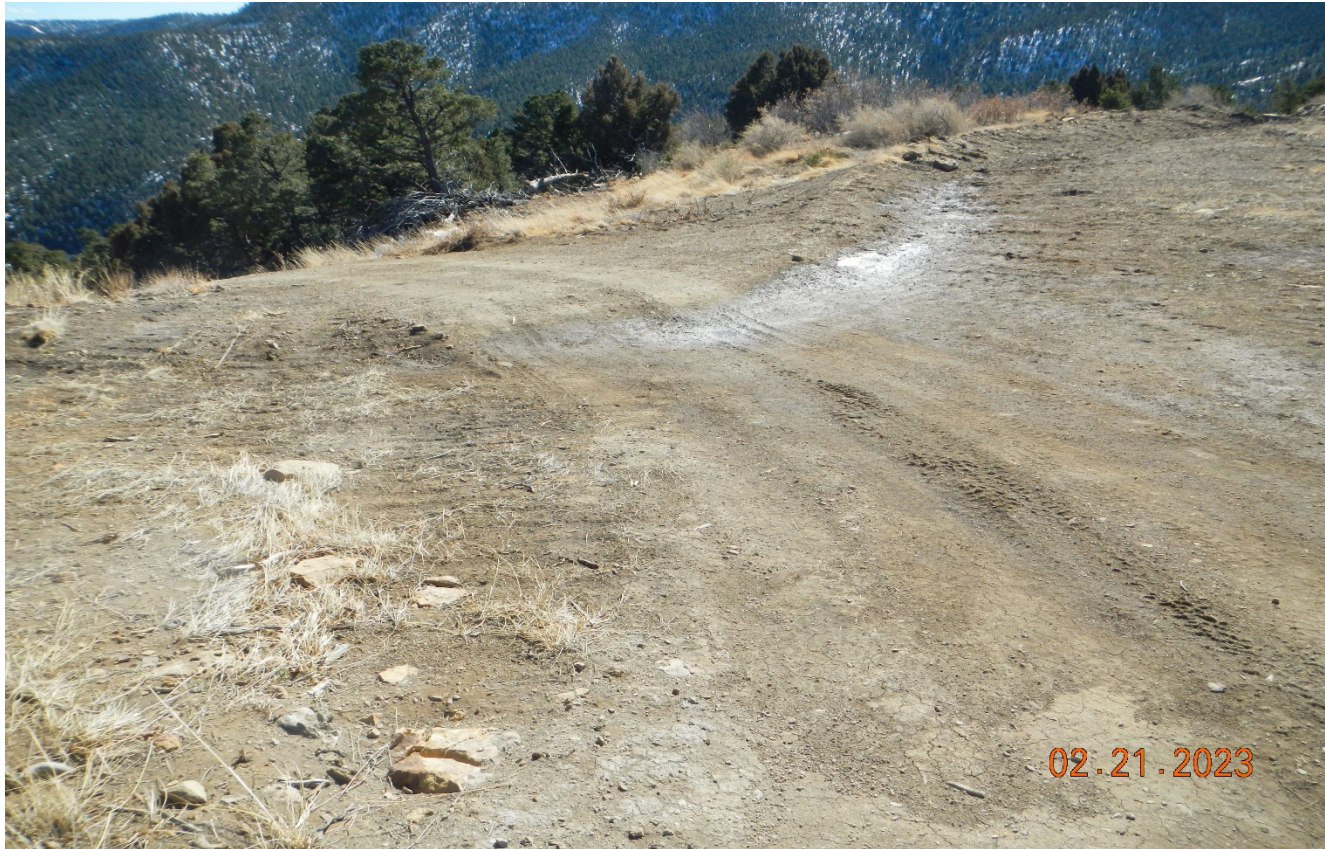
**Photo 11.** Standing at the location facing southeast. Maintenance was performed on the berm to allow drainage of stormwater away from the road.

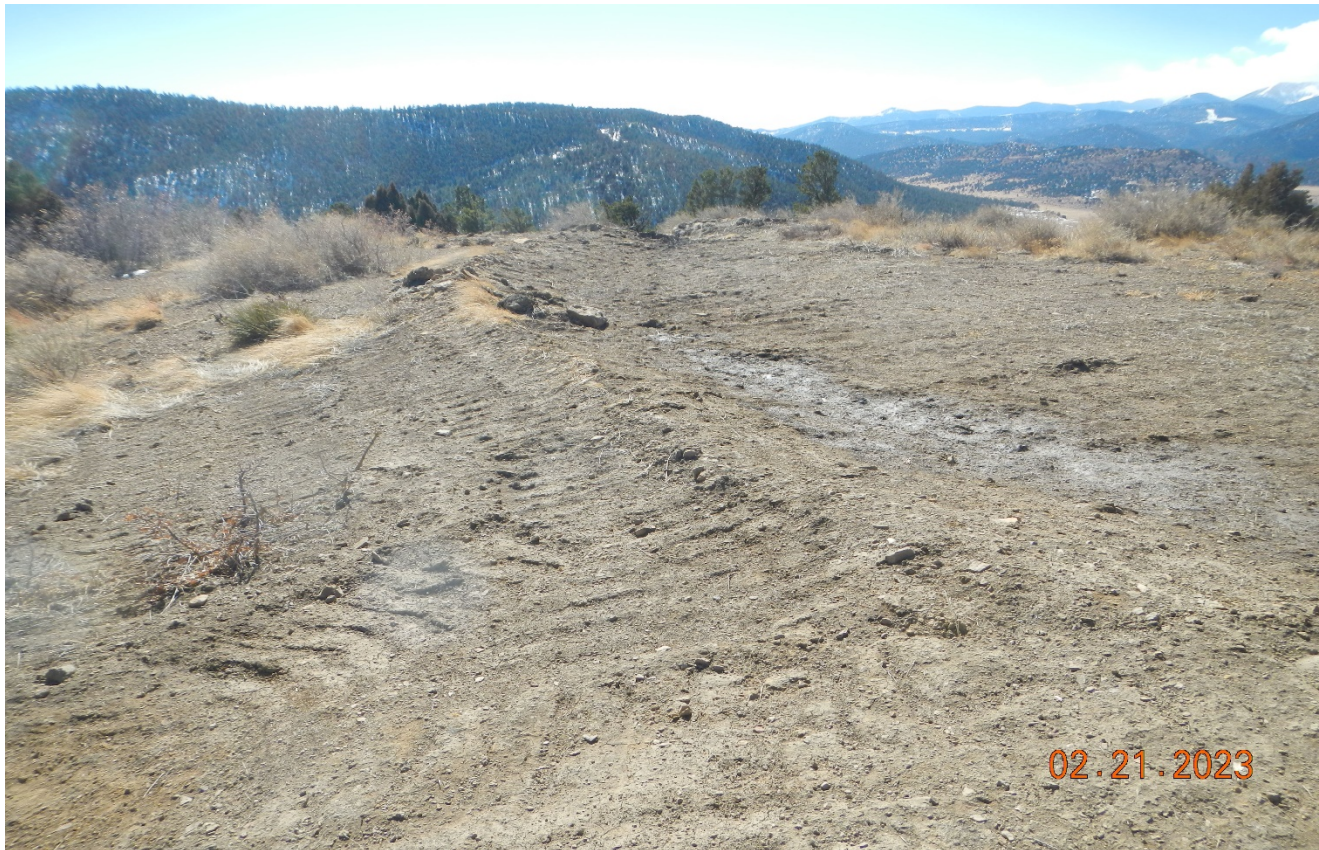
**Photo 12.** Facing south along the fill slope.

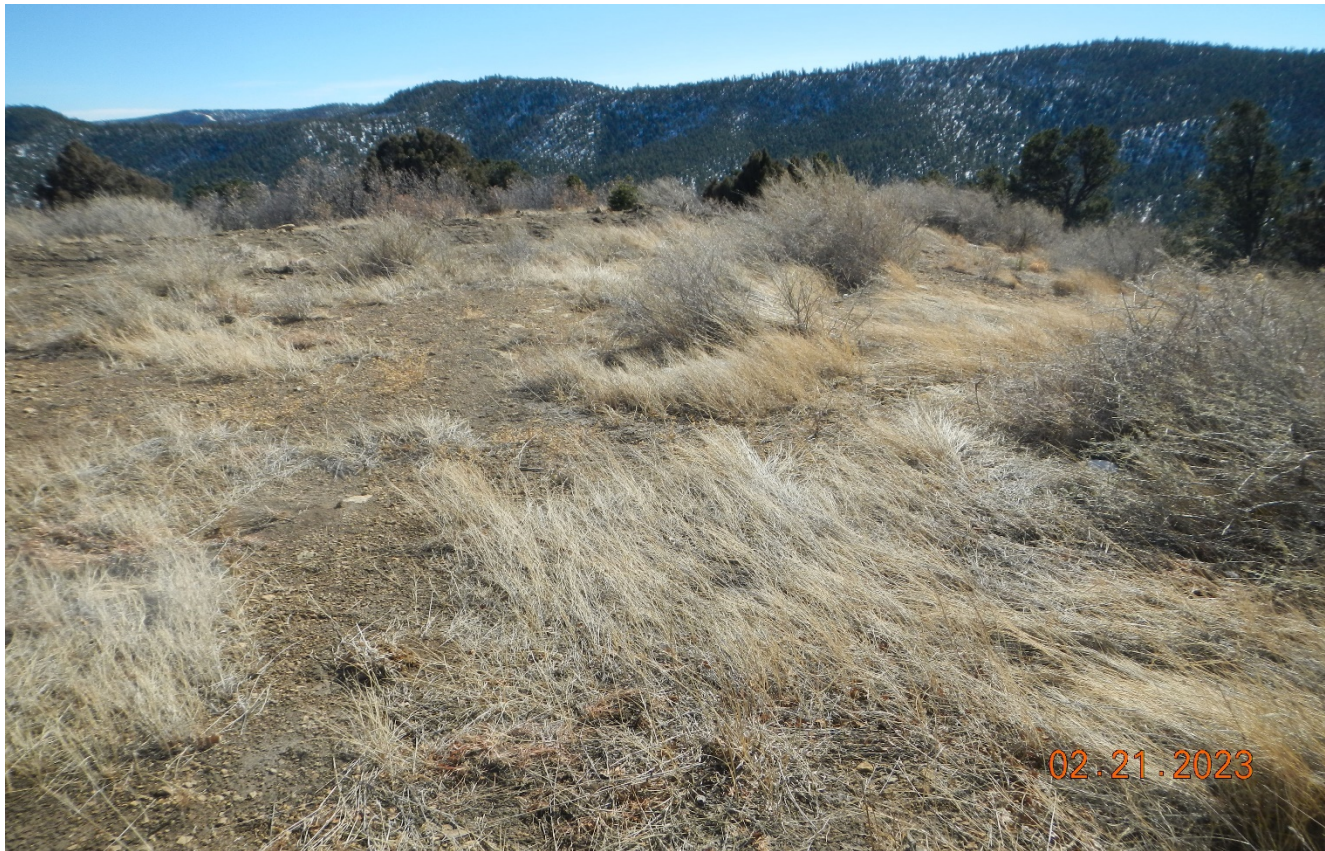
**Photo 13.** Facing southeast at the west side of location.

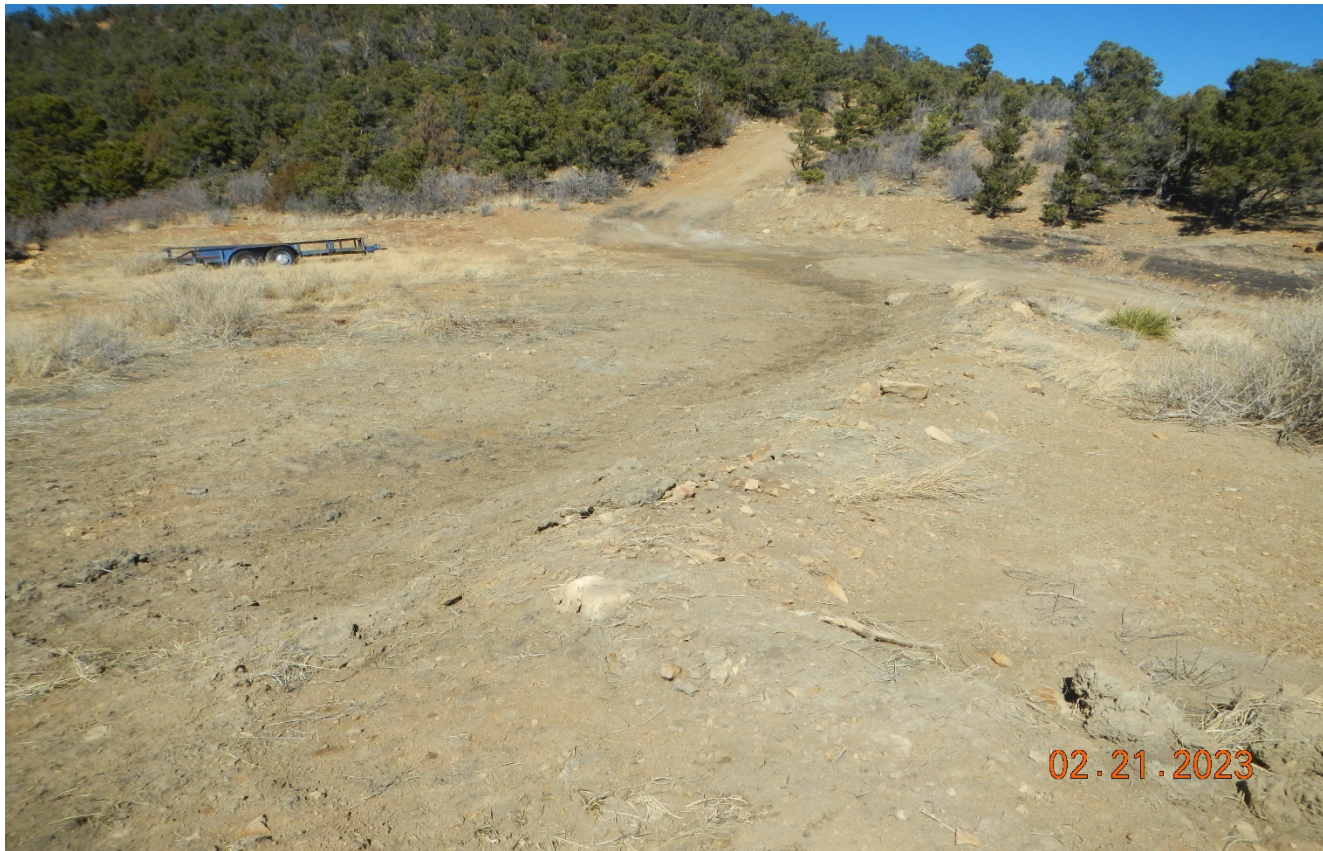
**Photo 14.** Facing northeast at the location.
