CHEVRON USA INC
MCLAUGHLIN UNIT A-62N103W 13NWNW
Location # 314488

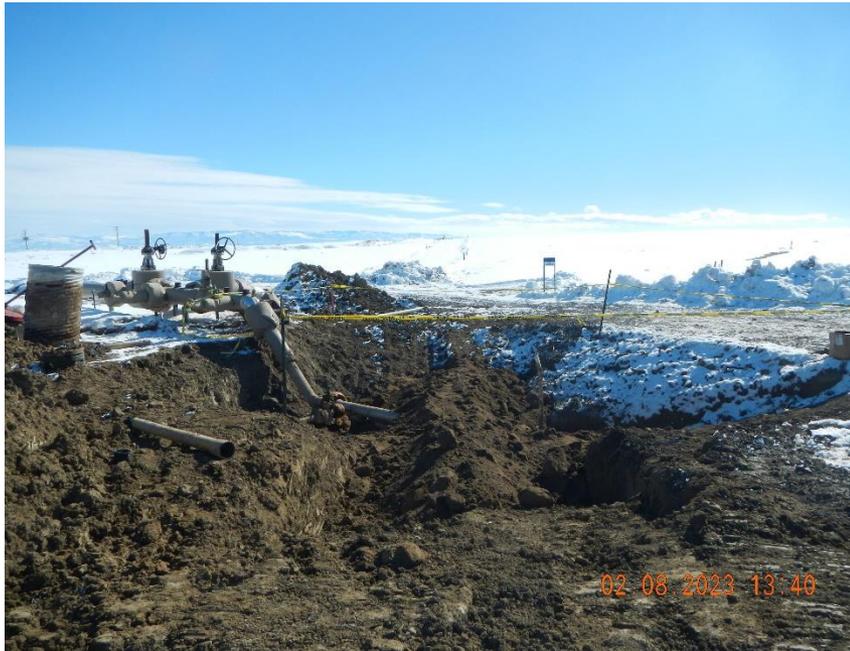
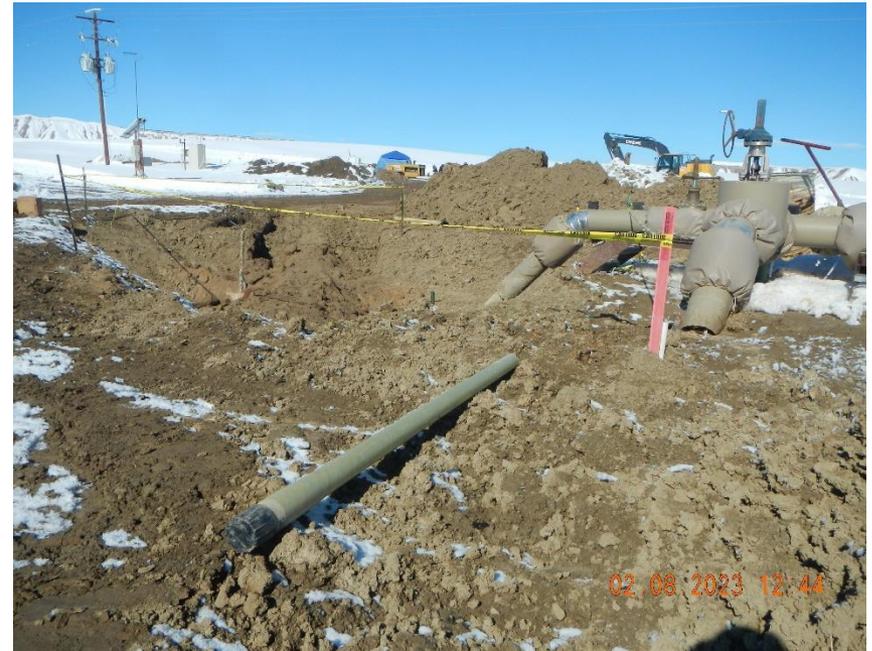
Repaired line partially covered to control temperature of line.

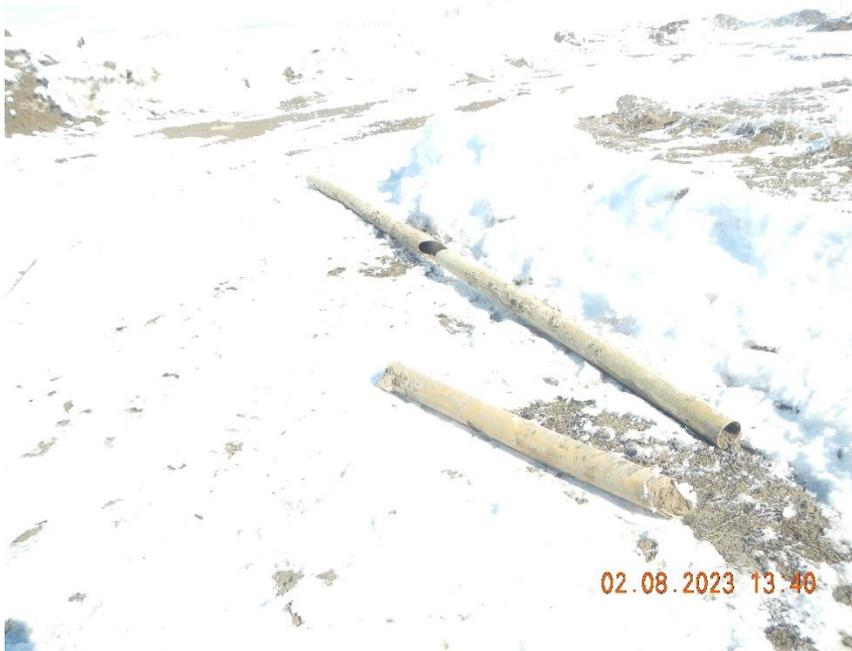
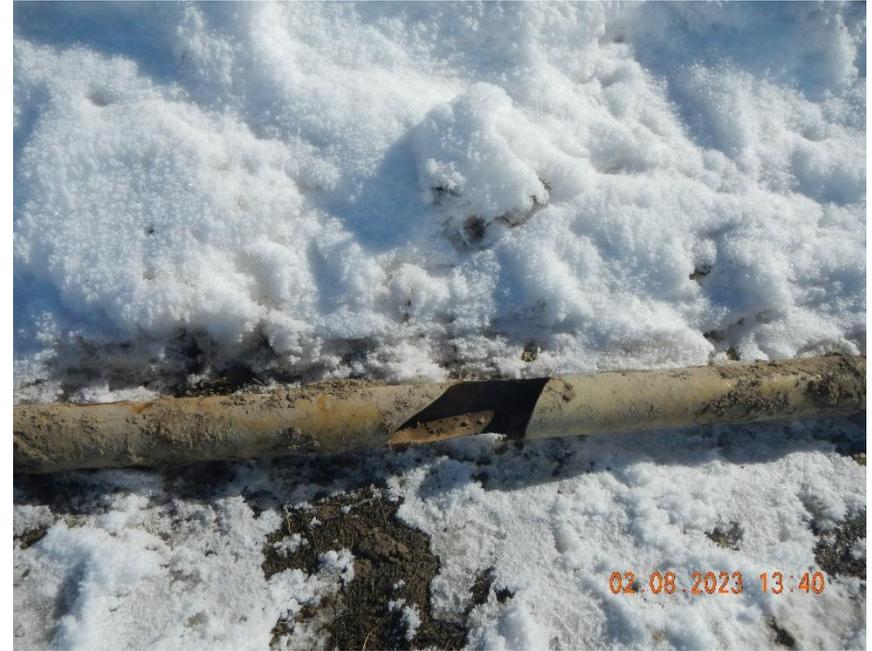
Removed section of damaged flowline
