Inspection Photos

API: 071-09921

Operator: VECTA OIL & GAS LTD

Inspection Date: 2/24/2023

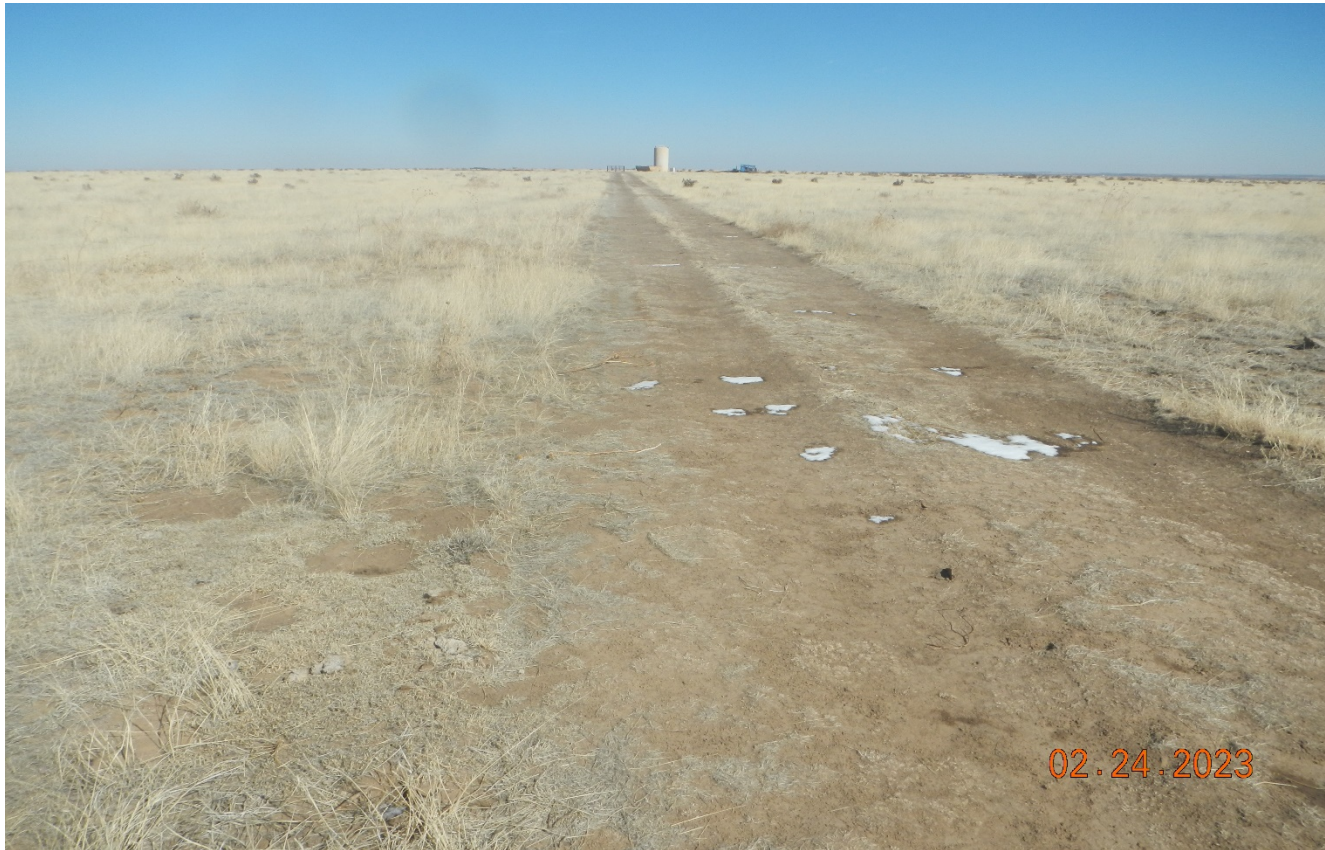
Photo 1. Facing east along the access road.

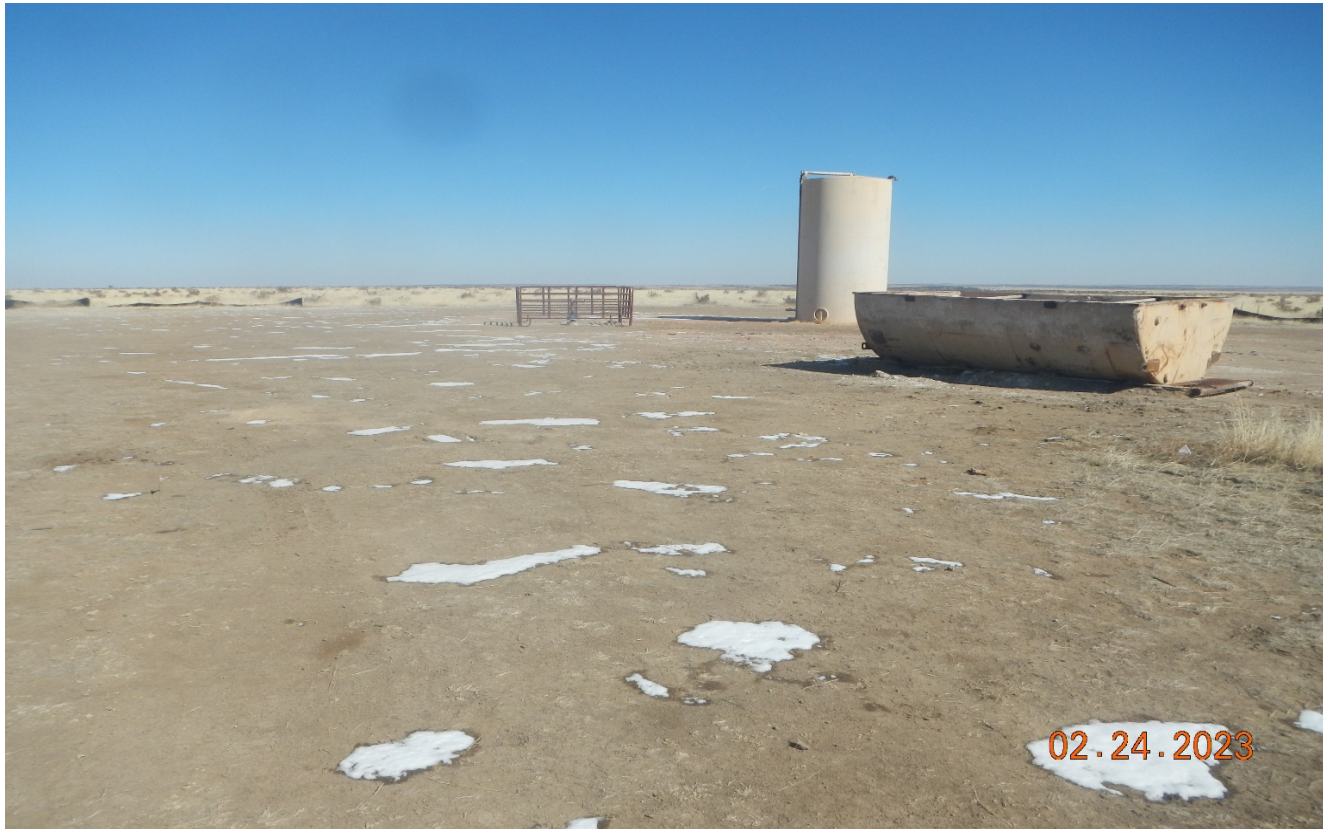
Photo 2. Facing north toward the location. The open top tank is empty and should be removed if unused.

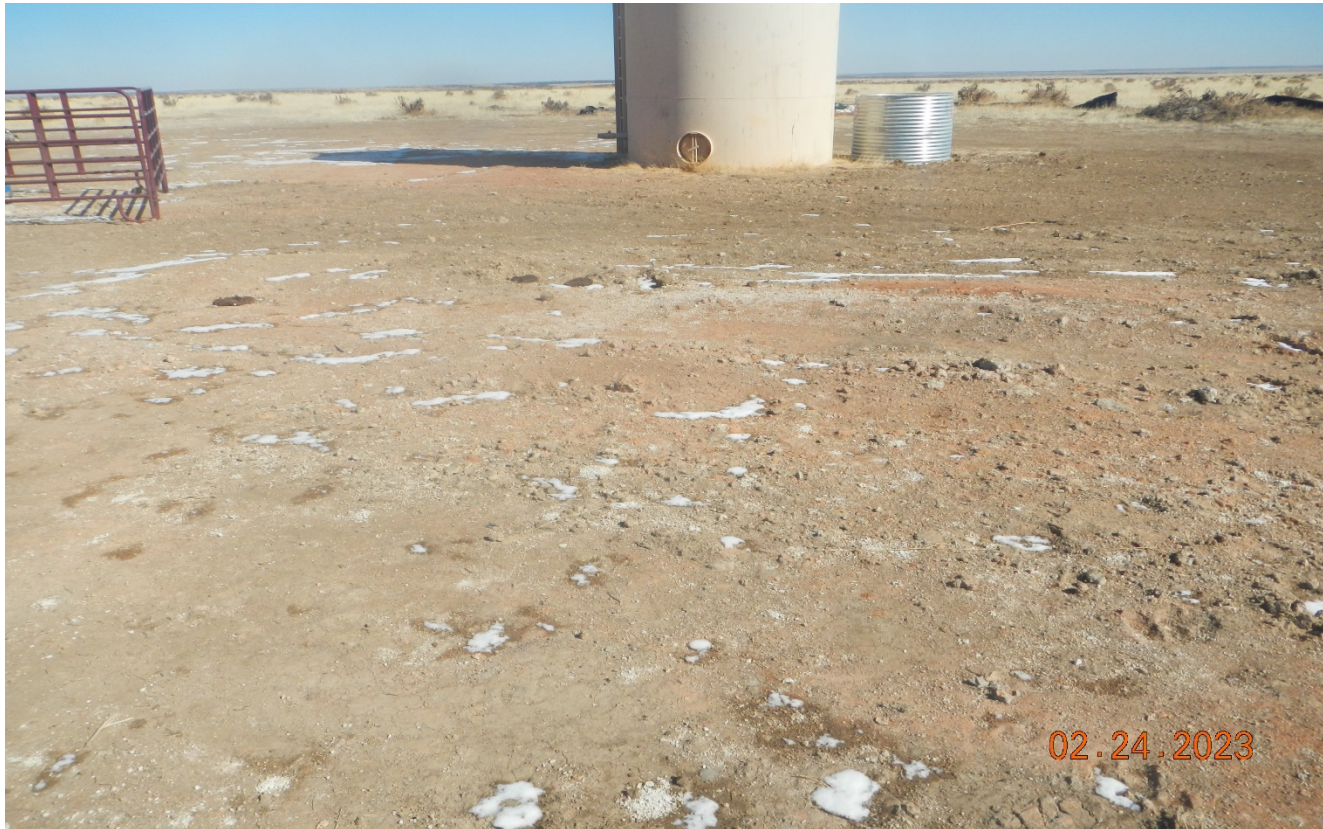
Photo 3. There is red colored material on the soil surface possibly from cutting that needs to be cleaned up and removed. Topsoil should be separated and salvaged where there is disturbance and production equipment.

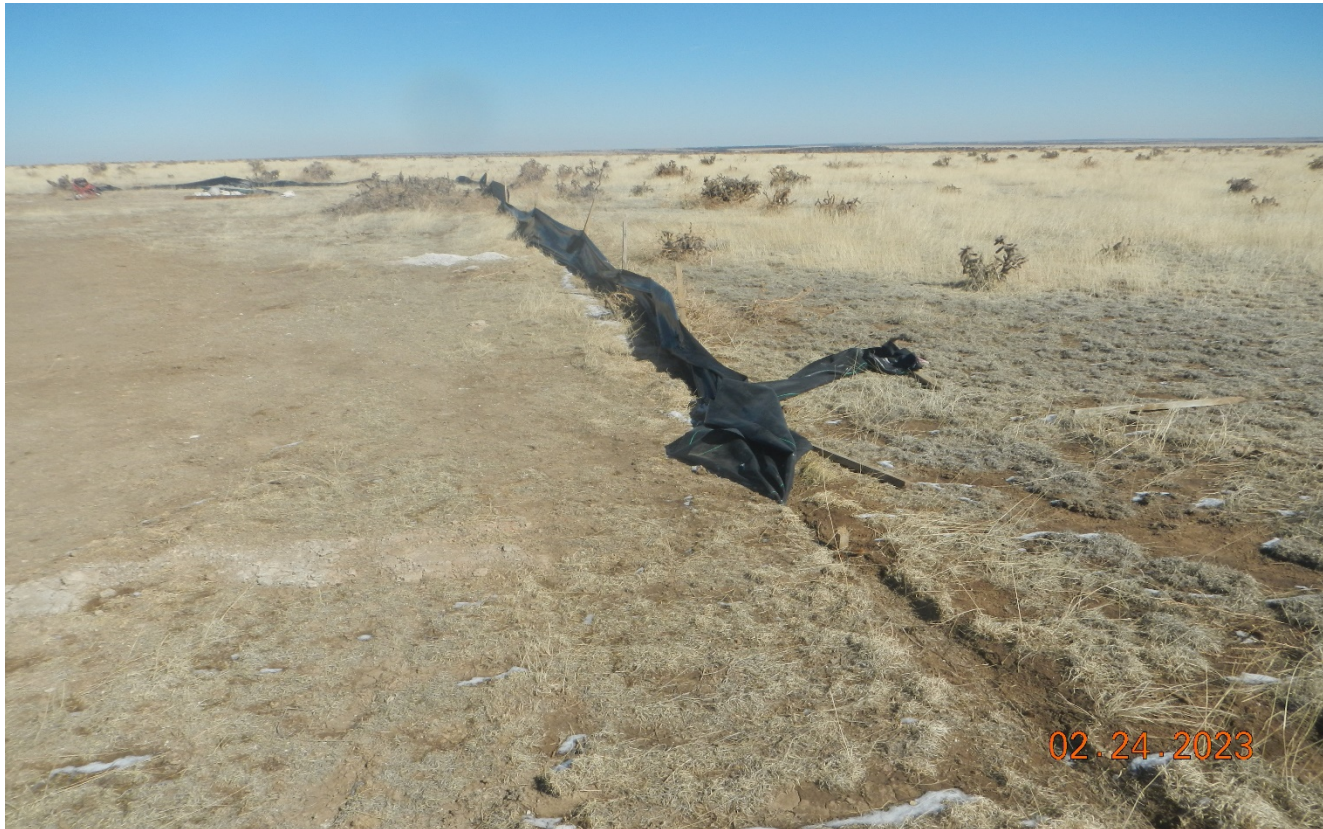
Photo 4. The silt fence is in disrepair. An alternative perimeter BMP may be more appropriate for the location.

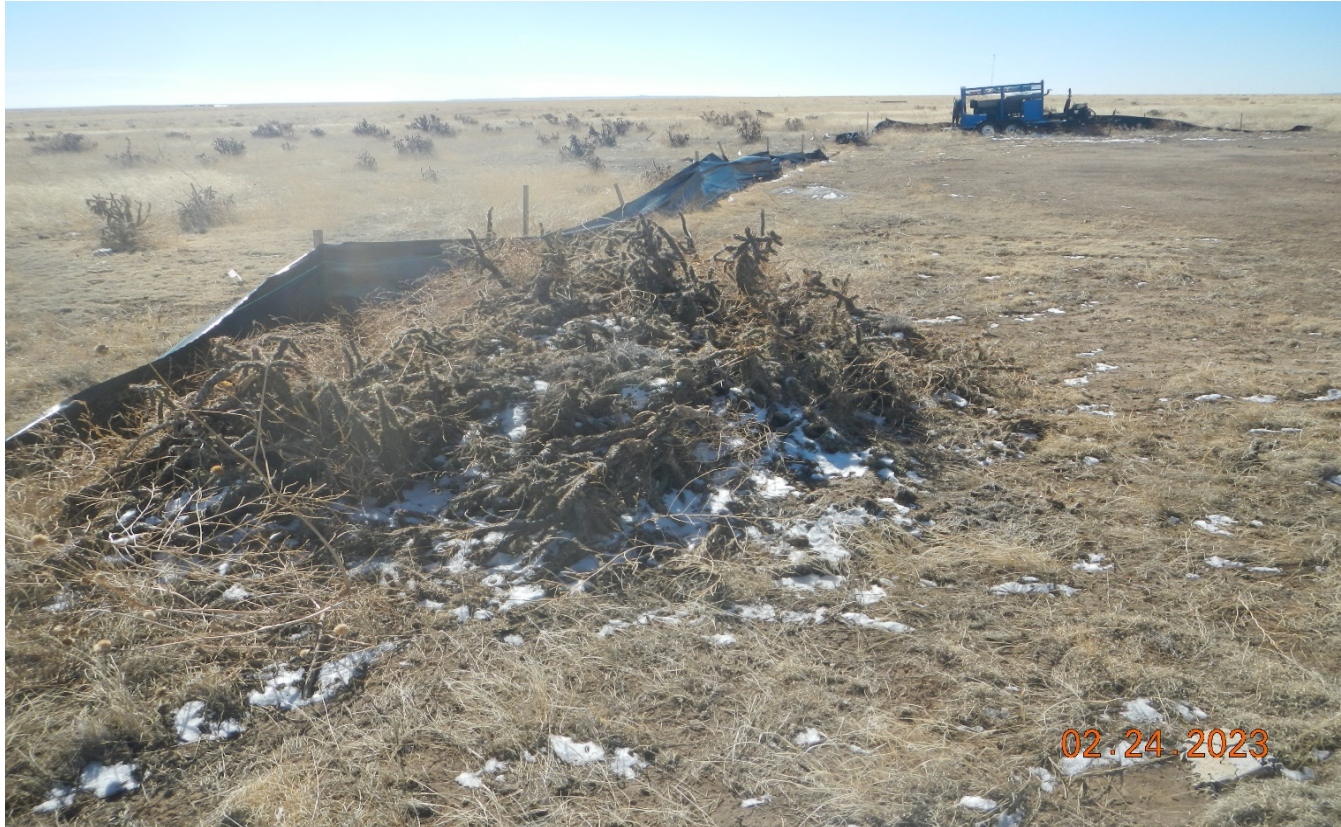
Photo 5. There is a pile of cactus debris at east side of the location that will need to be removed.

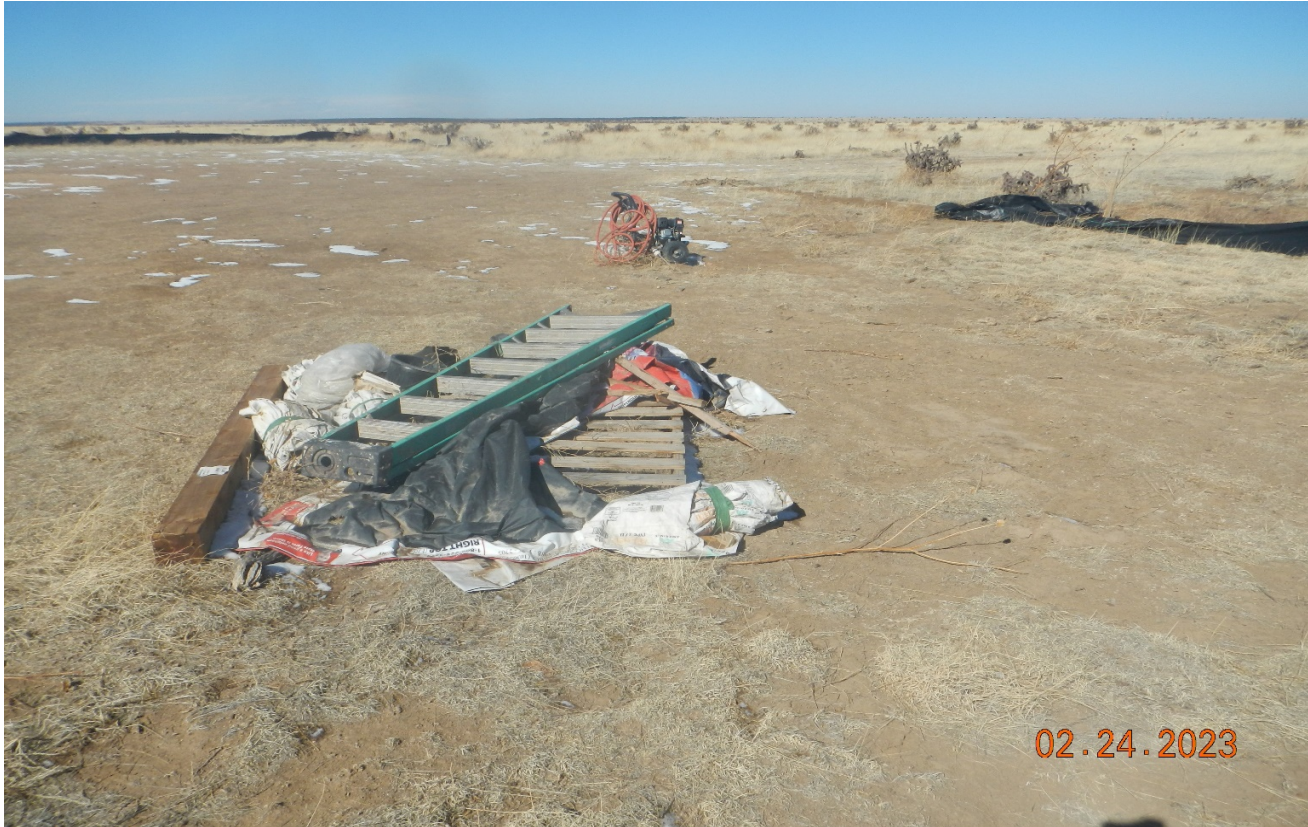
Photo 6. There is supplies that remain at the northeast side of the location that need to be removed.

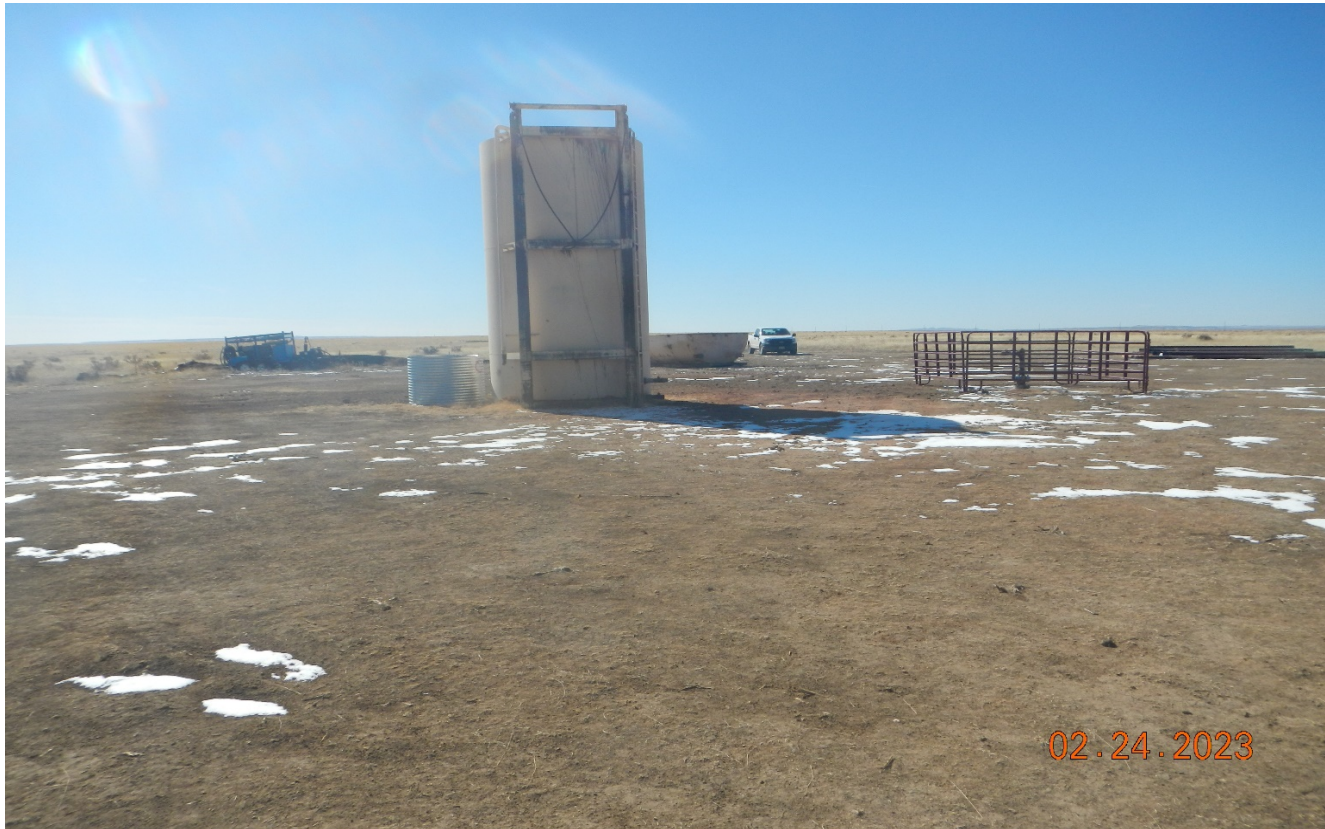
Photo 7. North side of the location facing south.

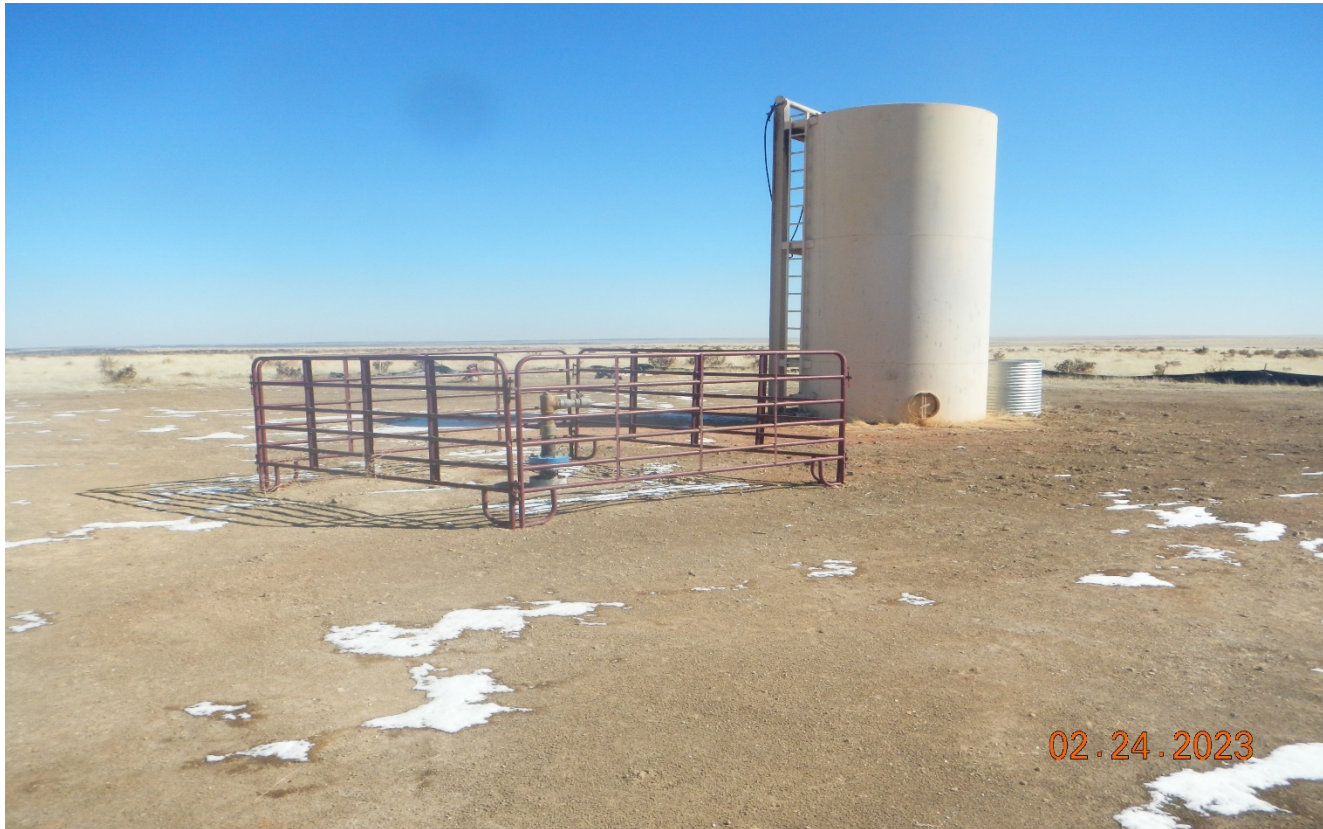
Photo 8. Facing toward the wellsite. No well sign is posted.

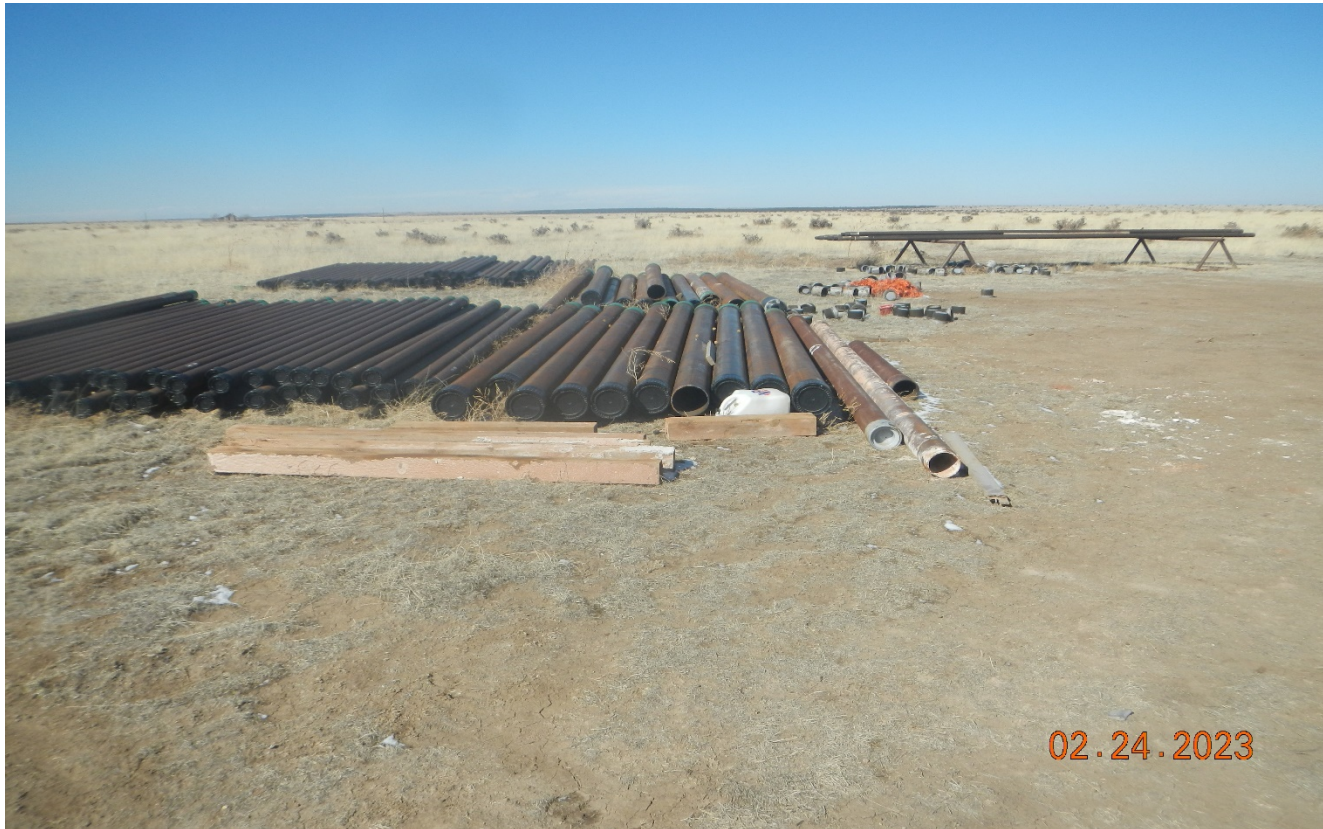
Photo 9. There is drilling pipe and supplies that remain at the southwest side of the location that must be removed.
