# Inspection Photos

Loc: 333719

Operator: [OGRIS OPERATING LLC](#)

Inspection Date: 2/23/2023

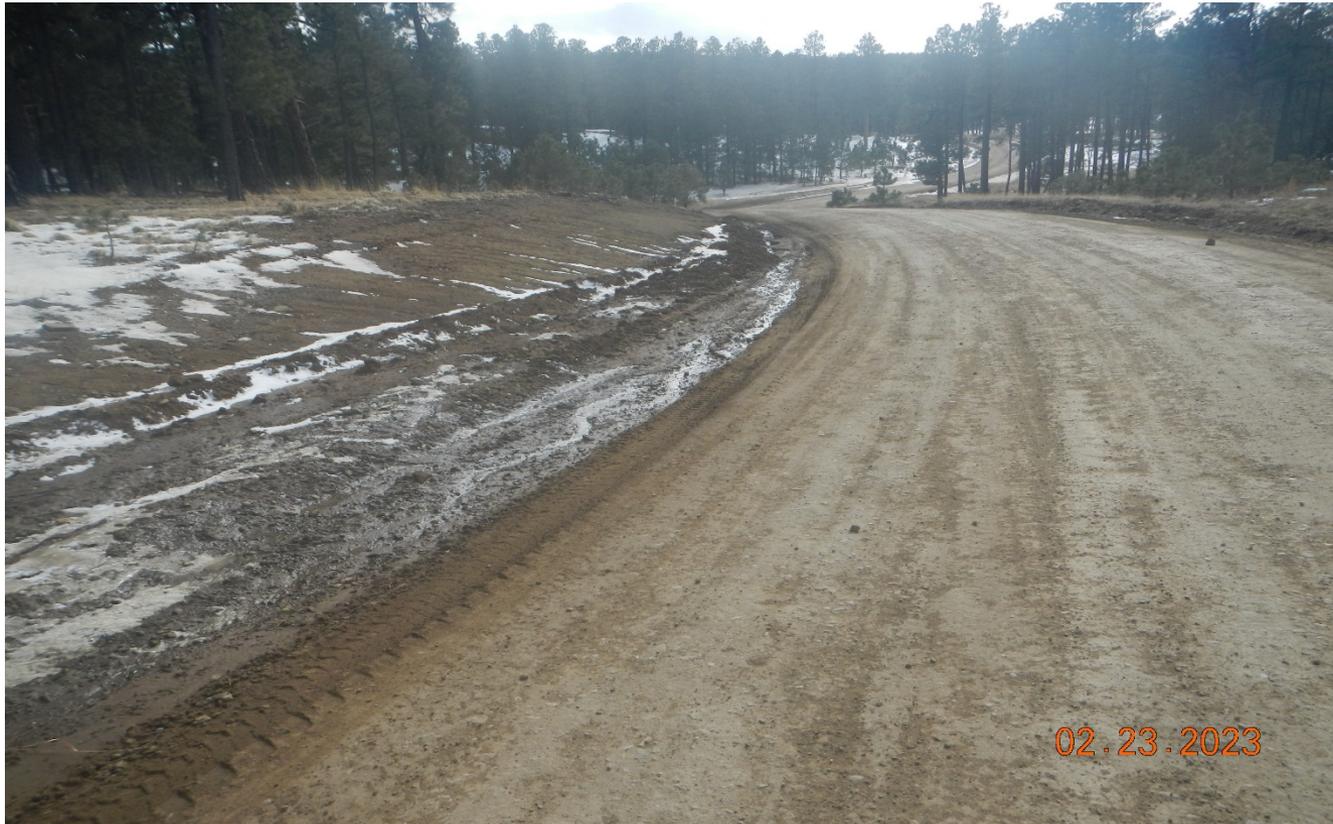
**Photo 1.** Facing southwest along the main road. The area on the left cut slope of the road should be seeded for stabilization. Lat/Long:37.01249,-104.89533

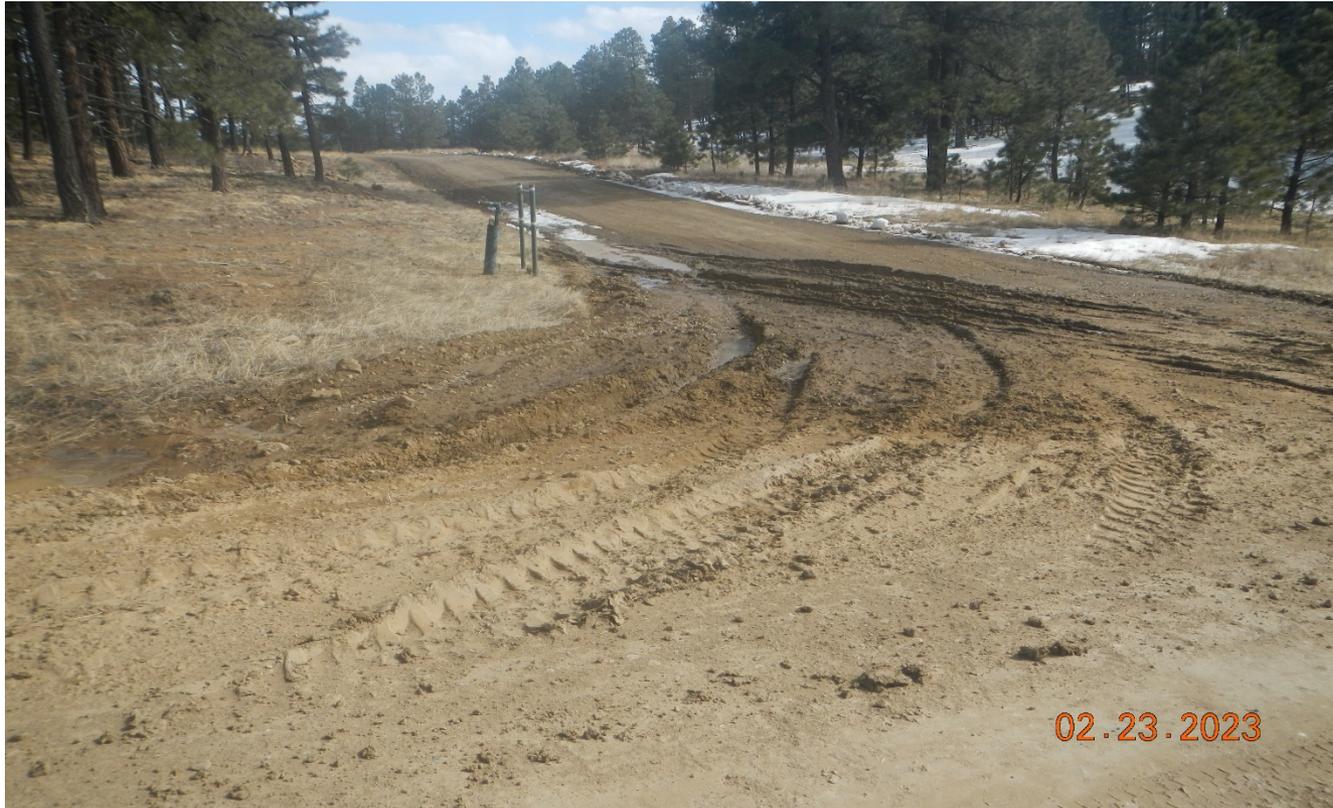
**Photo 2.** Facing southeast. Drainage from the road shown in the previous photo concentrates at this access road which does not have a culvert. Lat/Long:37.01055,-104.89653

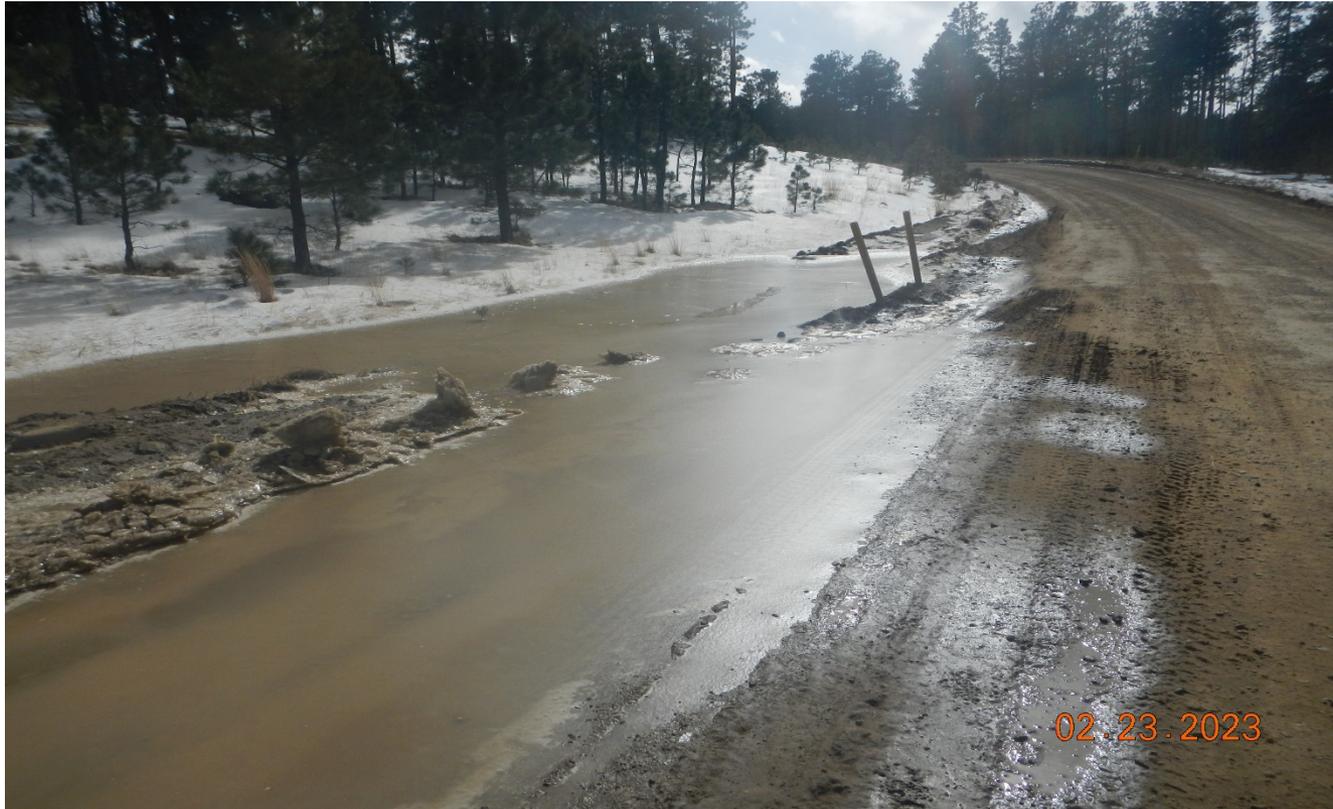
**Photo 3.** This culvert along the main road may be filled in or iced over and should be cleaned out when it dries out. Lat/Long:37.01149,-104.89621
