Inspection Photos

API: 071-09920

Operator: DESERT EAGLE OPERATING LLC

Inspection Date: 2/24/2023

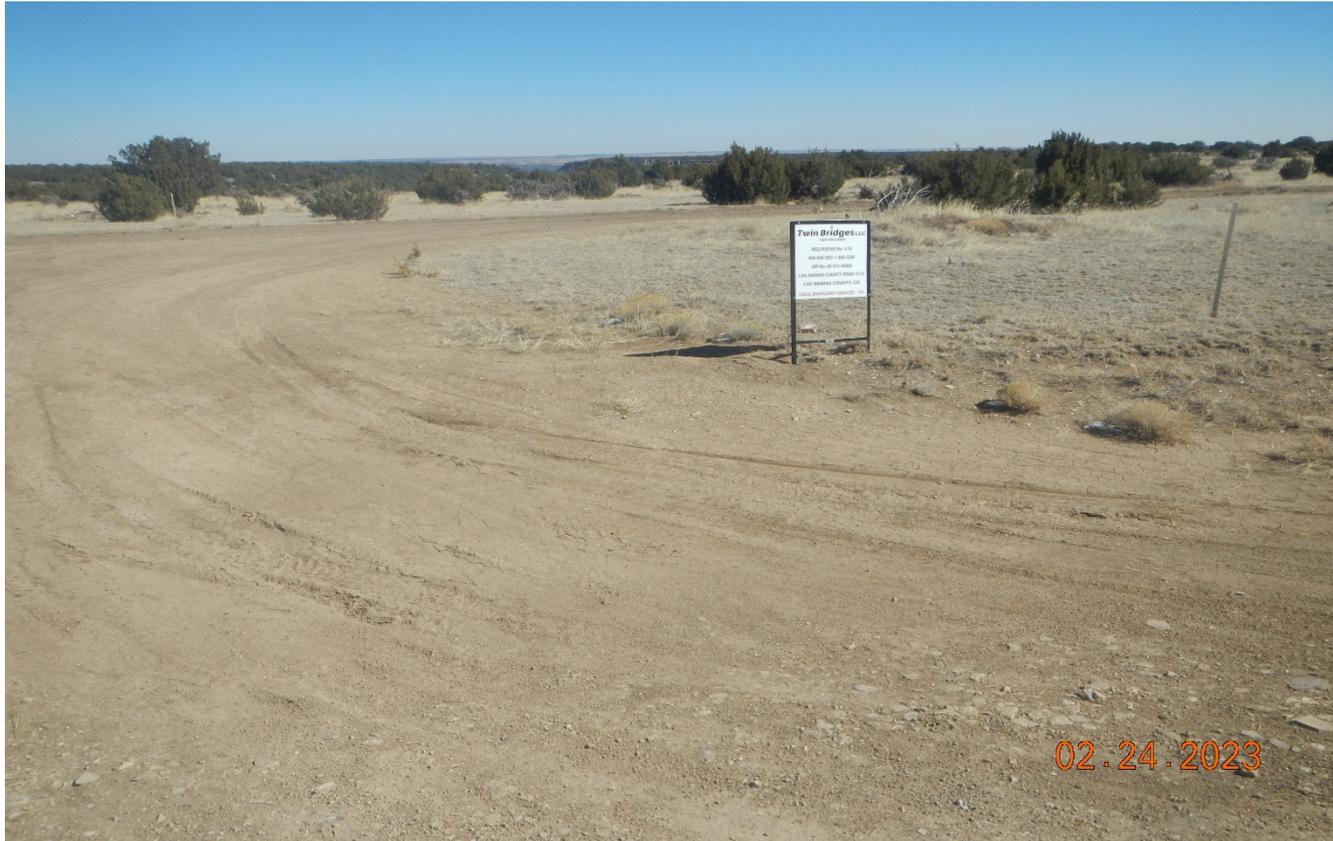
Photo 1. Facing southeast toward the access road. Sign posted at road does not reflect current operator.

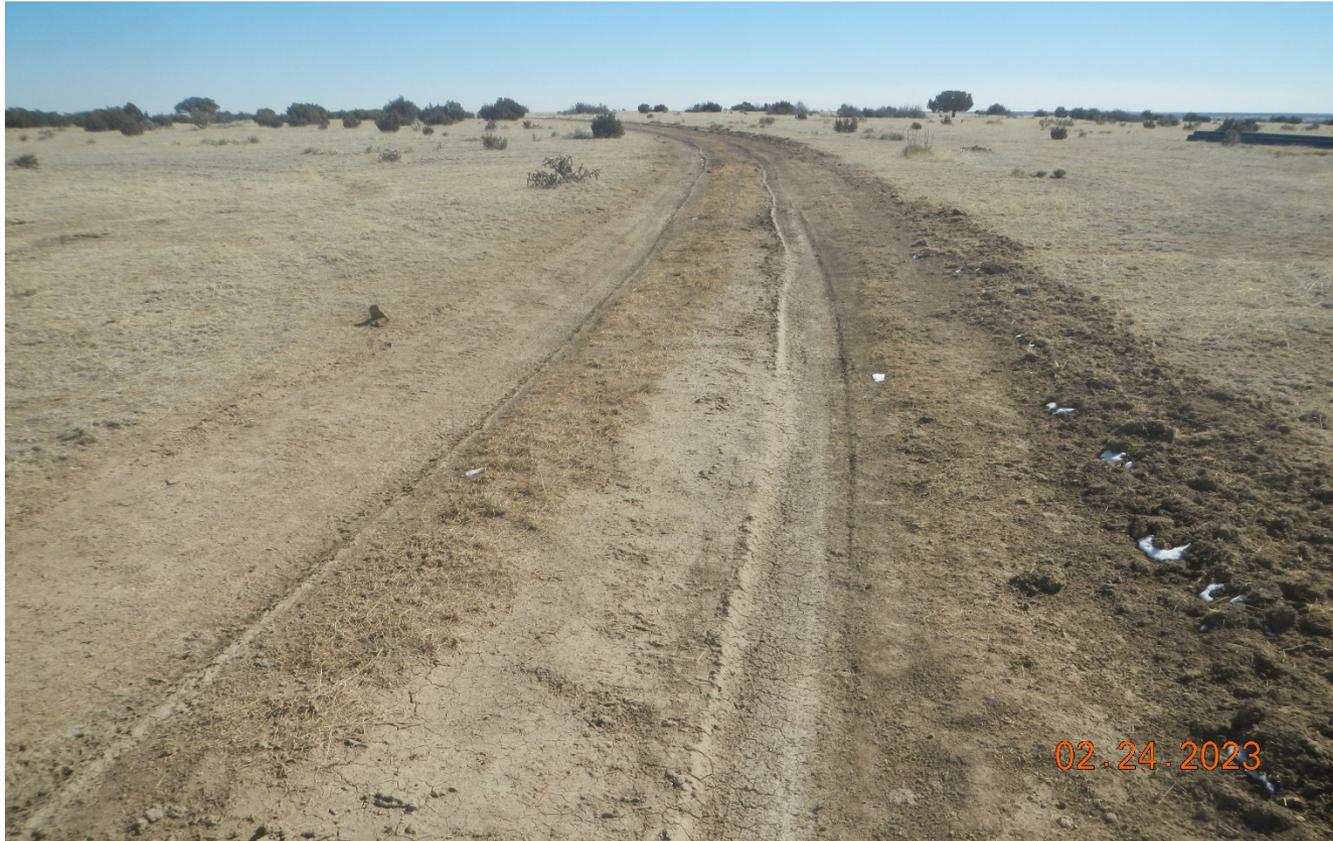
Photo 2. Facing southeast along the access road. The access road is not stabilized and soil is being pushed off the road. Soils should be segregated off the road before stabilizing the road with road base.

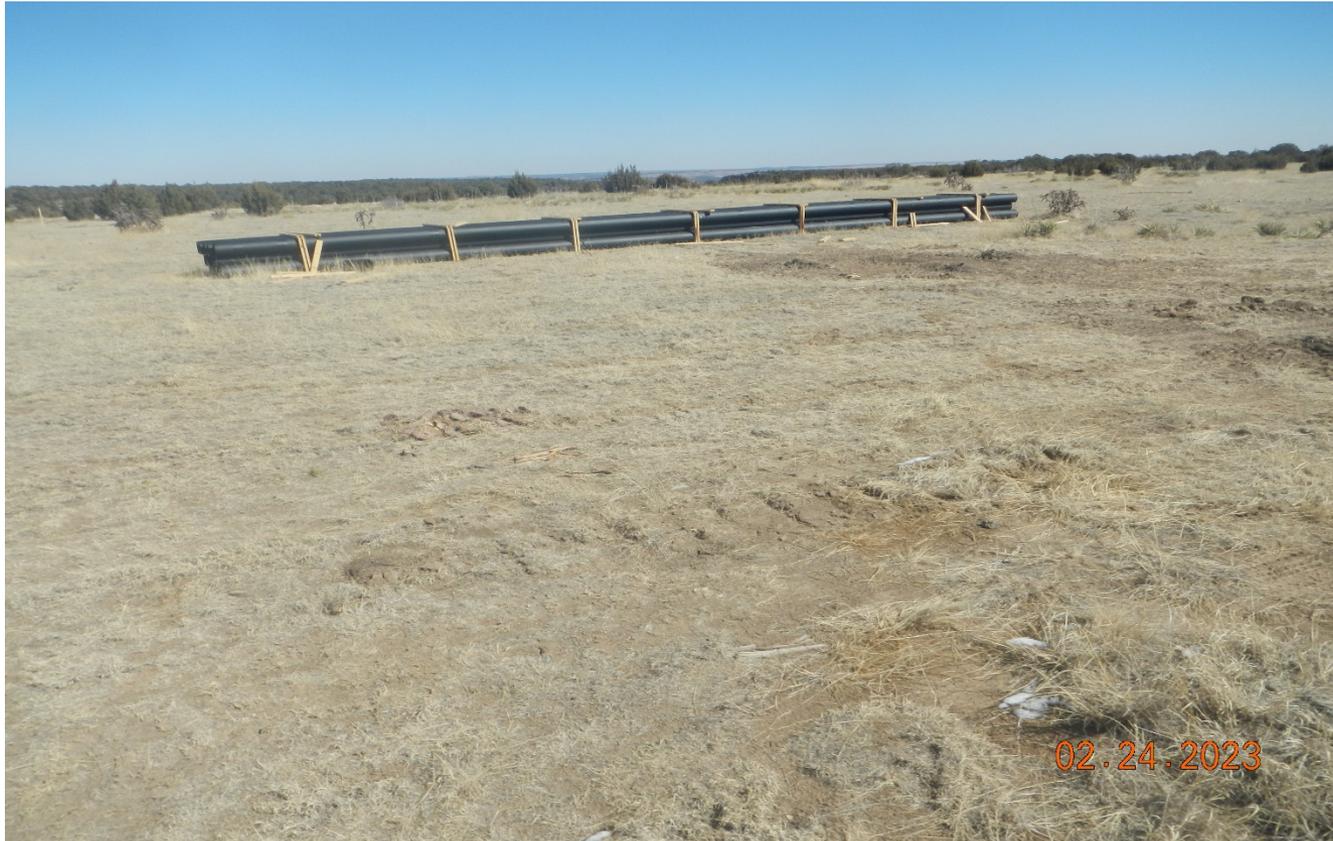
Photo 3. There is plastic pipe stored along the flowline and road that will need to be removed ASAP.

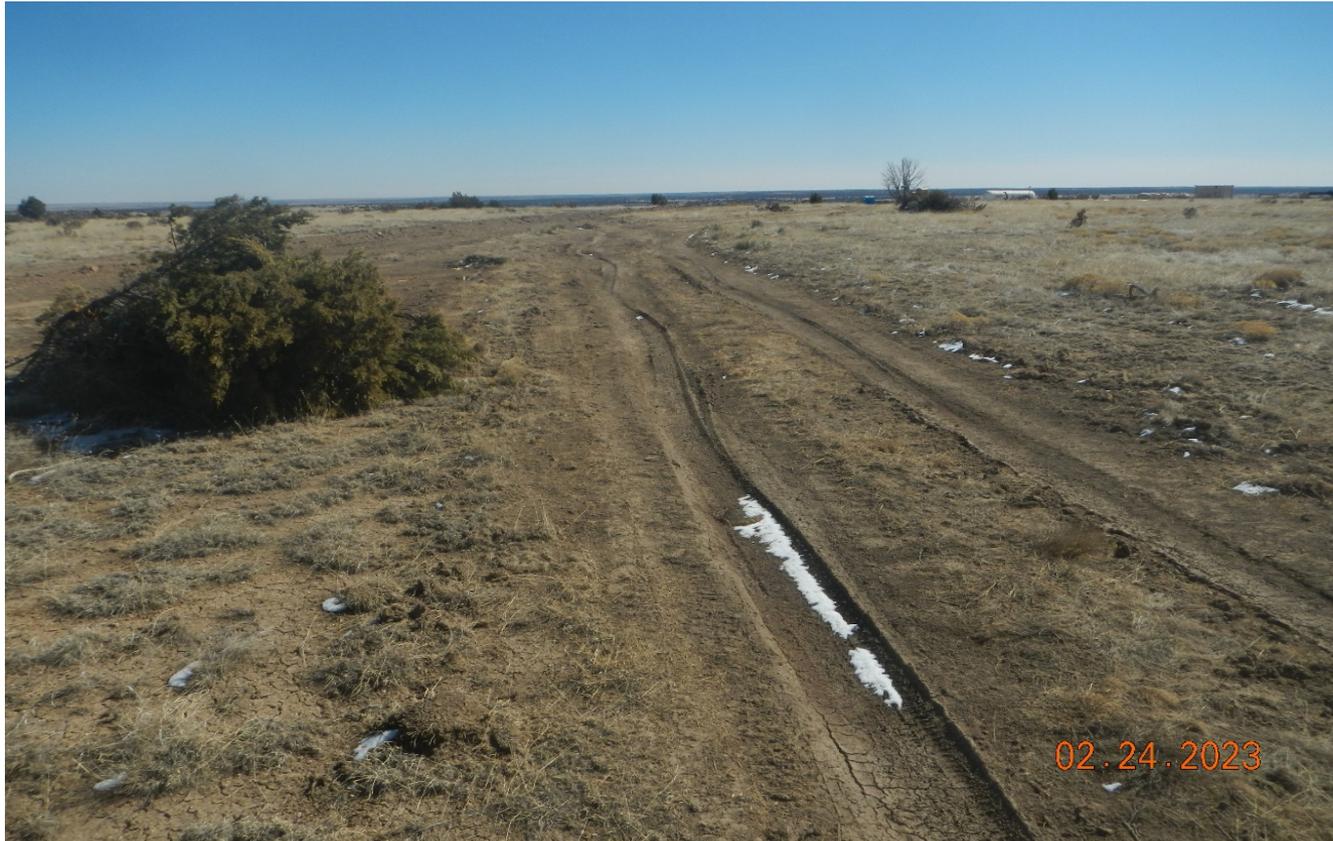
Photo 4. Facing southeast along the access road where flowline intersects the road to the processing plant and wellsite.

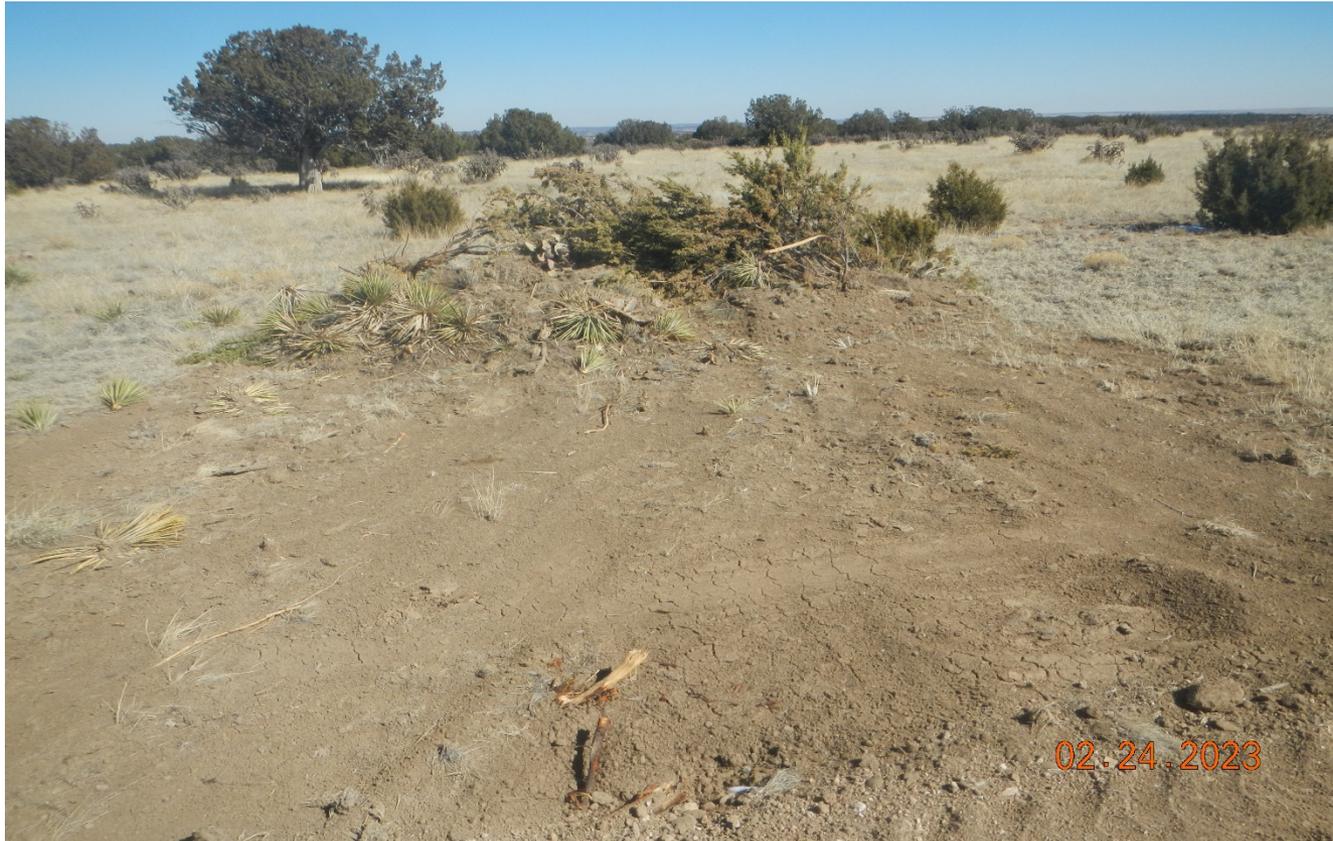
Photo 5. There are trees and soil pushed out along the area of trenching. All tree debris will need to be removed. Soil pushed out will need to be replaced.

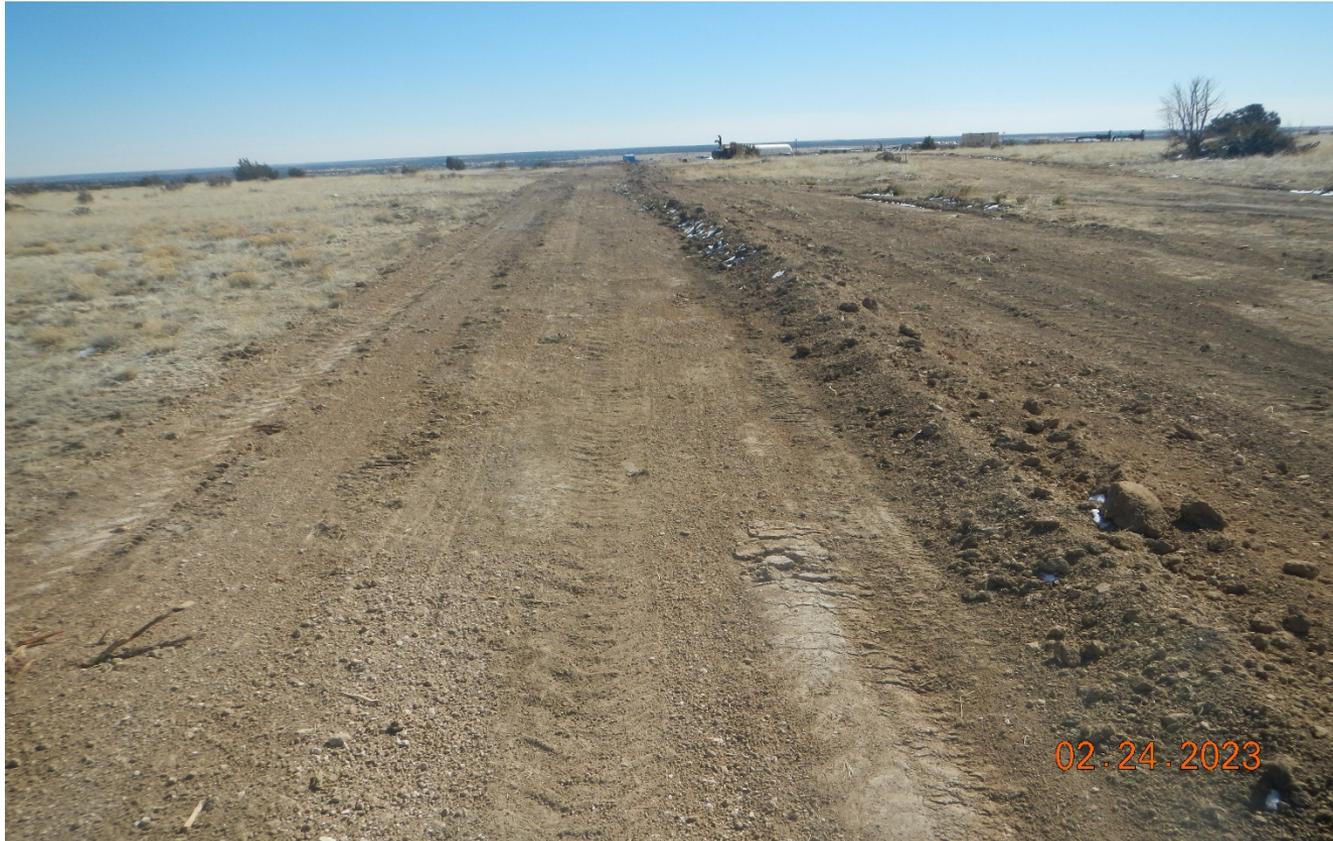
Photo 6. Facing southeast along the flowline disturbance.

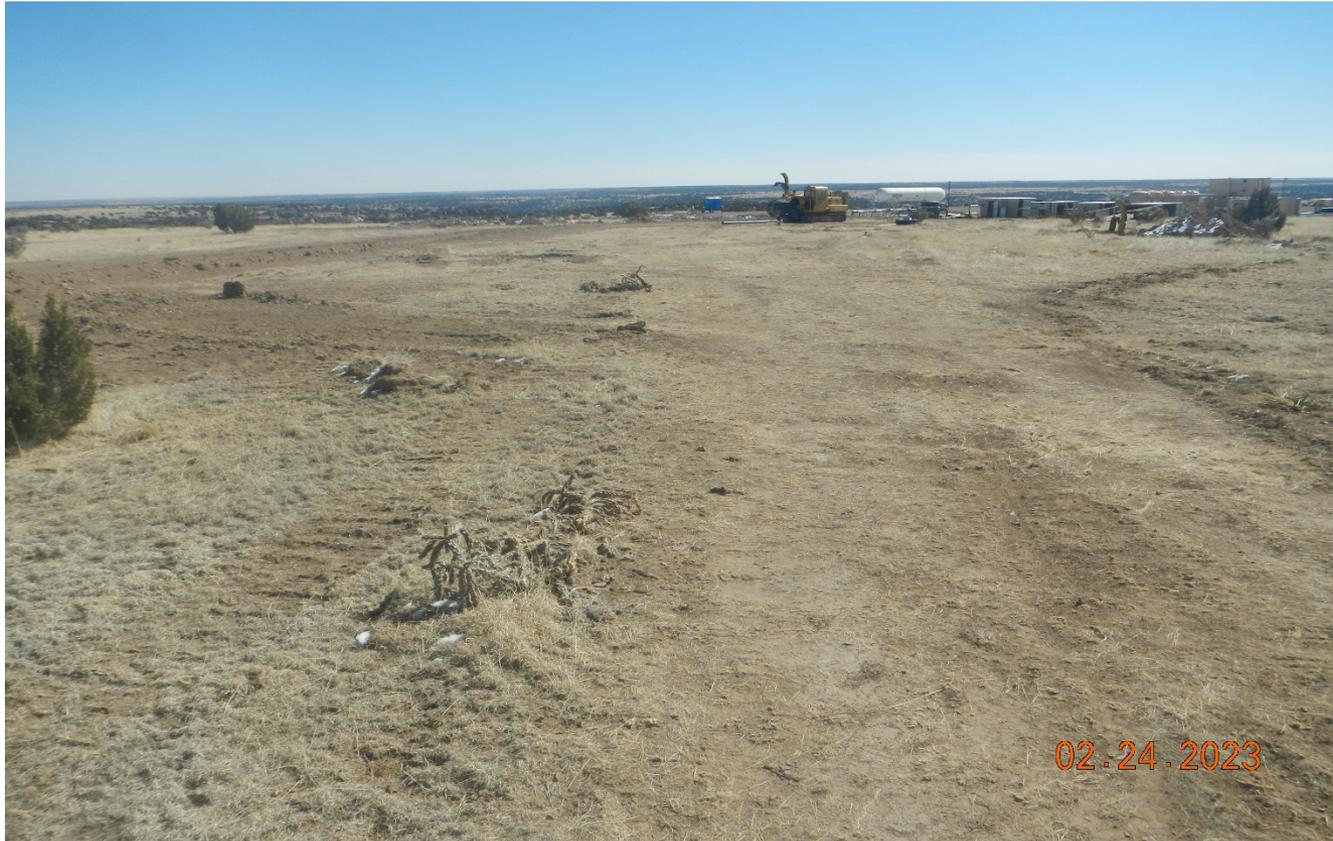
Photo 7. Facing southeast along the access road toward the location.

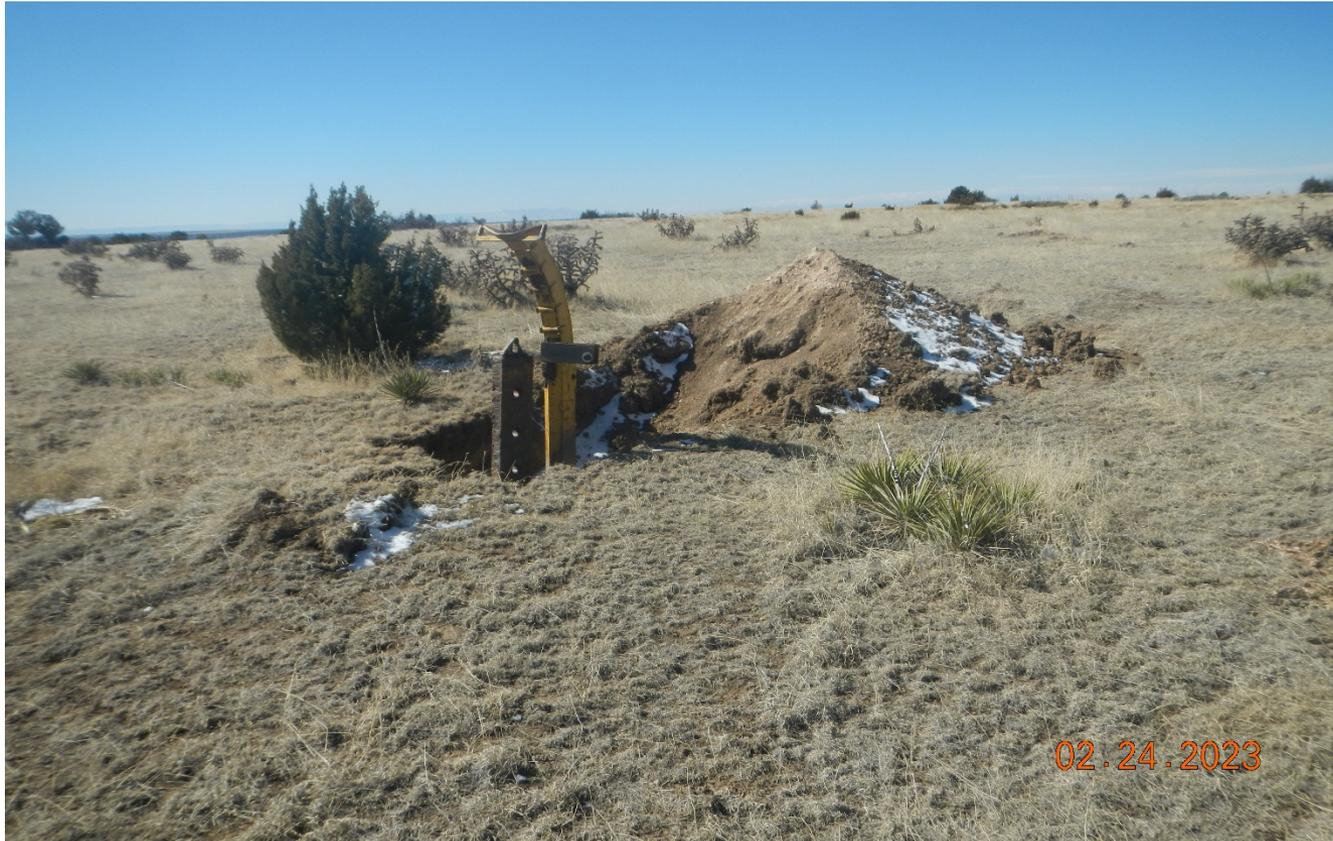
Photo 8. There was a hole dug out by the location to place the ripper. This has created unnecessary disturbance that will need to be reclaimed.

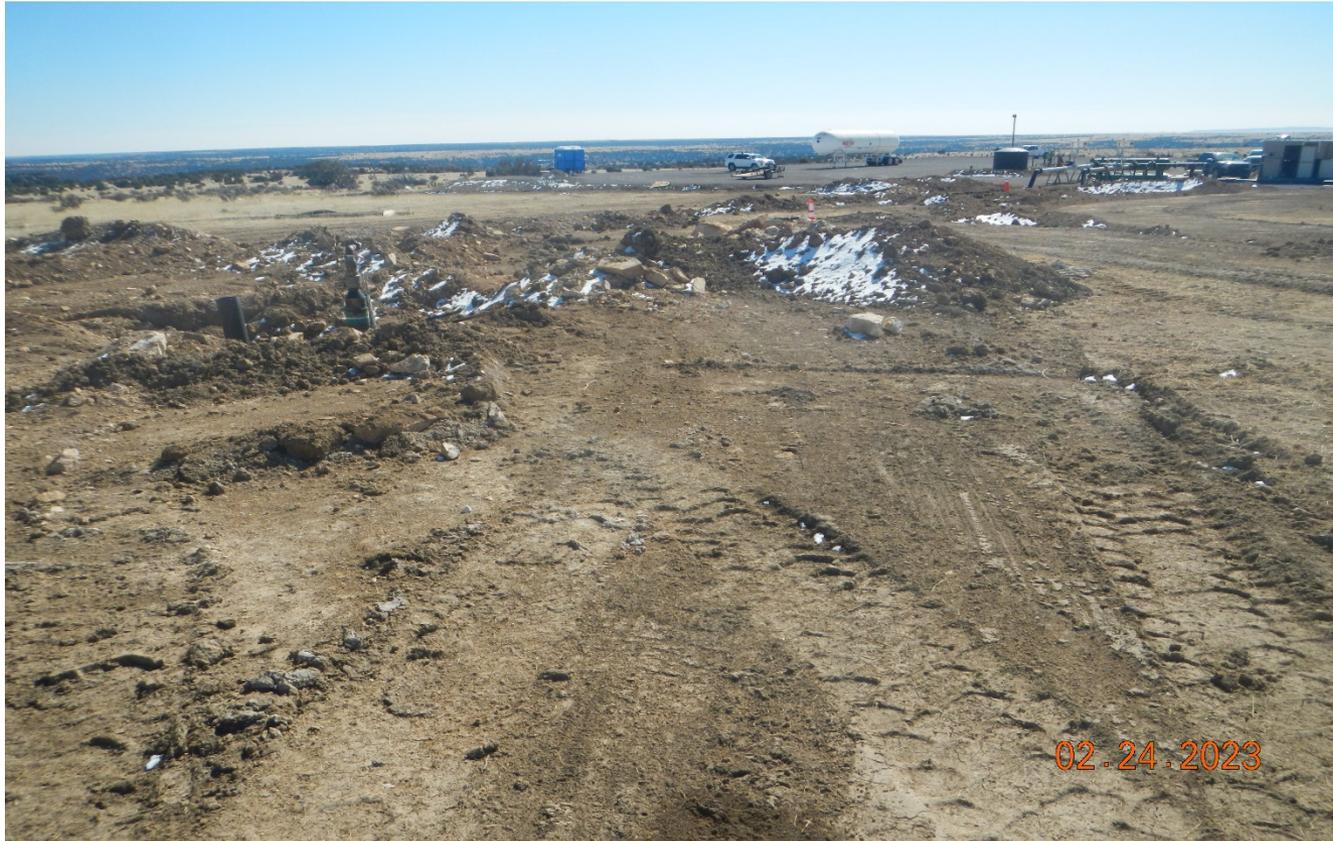
Photo 9. Facing southeast toward the wellsite. There is soil mixing throughout this area and soils are not salvage and protected from degradation and compaction.

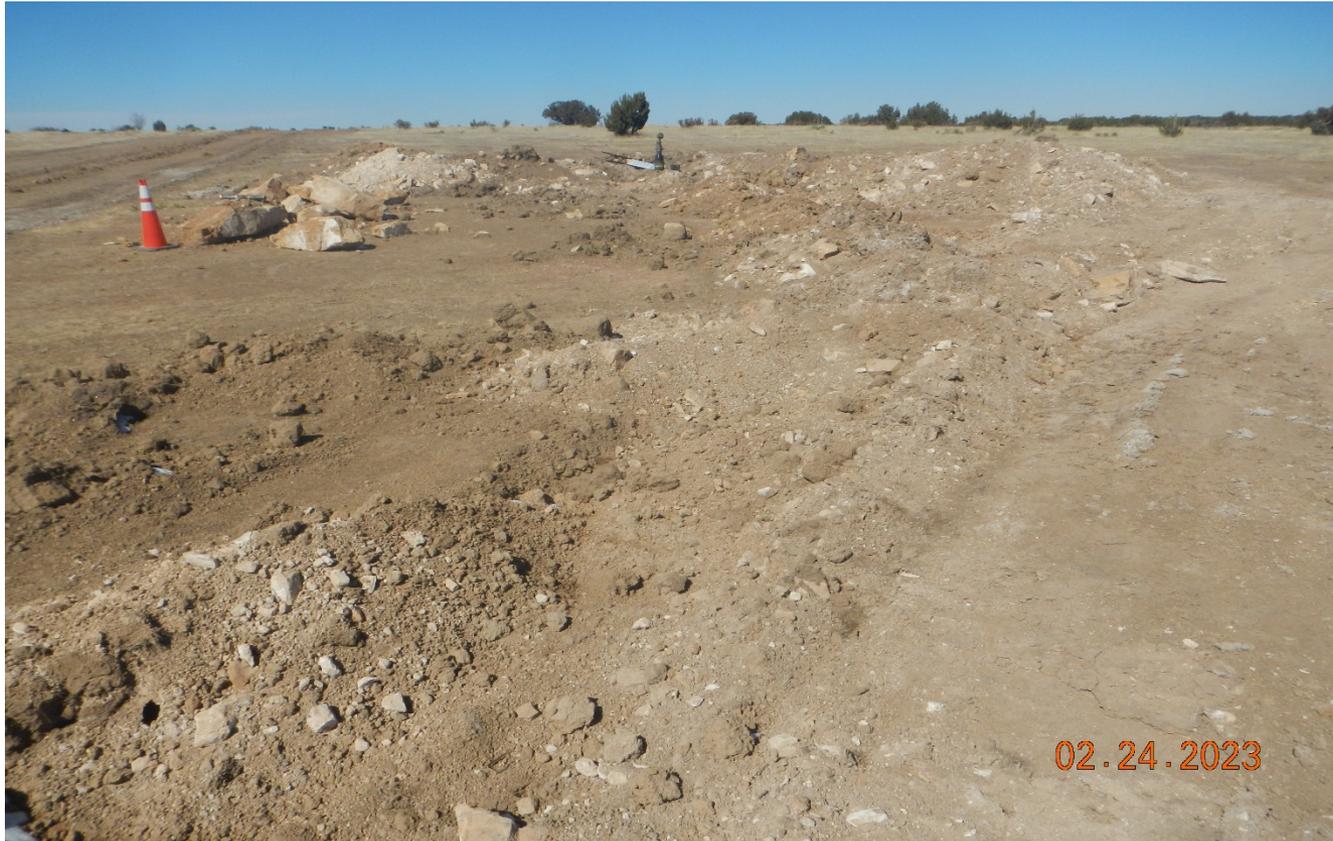
Photo 10. Facing northwest toward the wellsite. There is soil mixing throughout this area and soils are not salvage and protected from degradation and compaction.

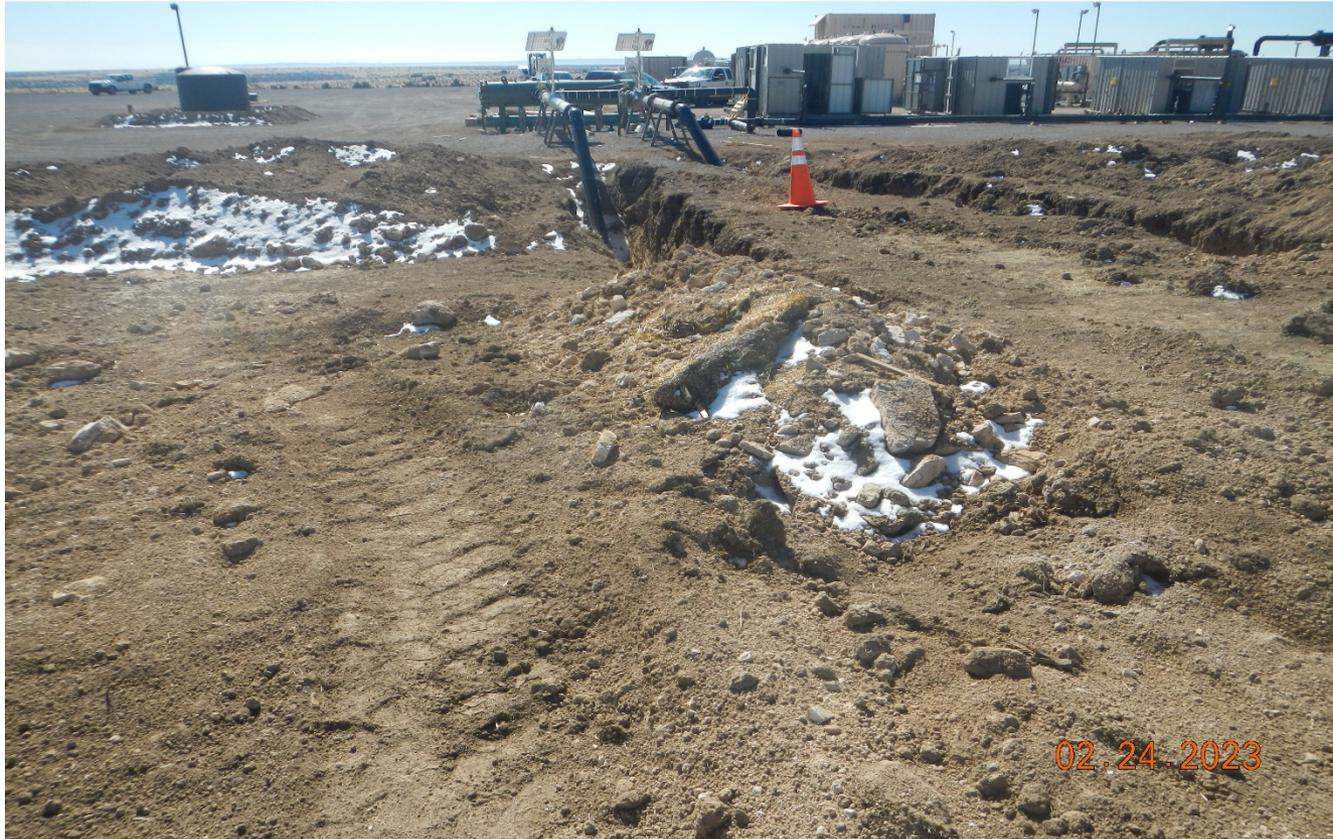
Photo 11. Facing south toward the processing plant adjacent to the wellsite. The two well site flowlines tie into the processing plant.

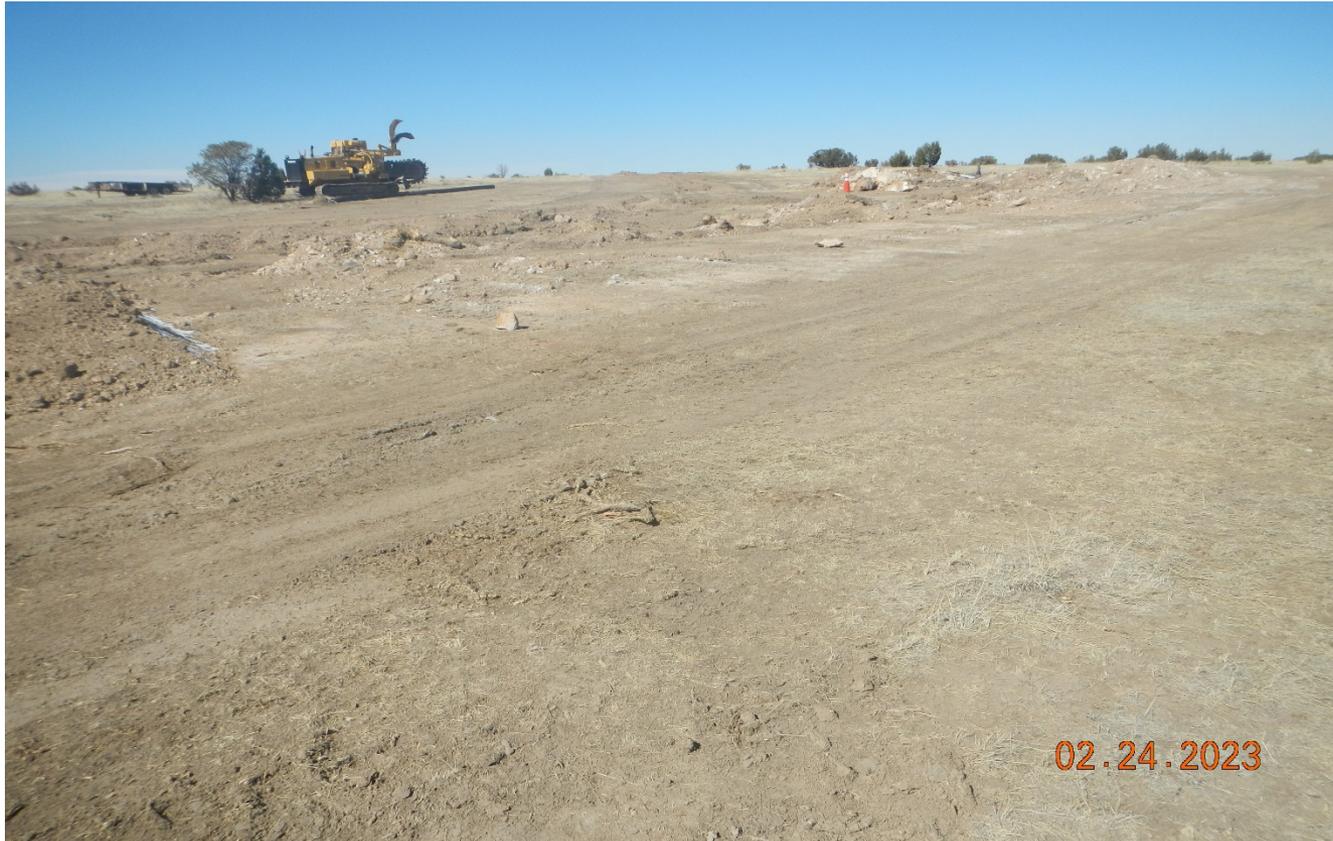
Photo 12. Facing northwest toward the wellsite. There is soil mixing throughout this area and soils are not salvage and protected from degradation and compaction.
