Inspection Photos

Location Name: CAERUS PICEANCE LLC BENZEL-66S93W /26NESE

Location ID: 335310

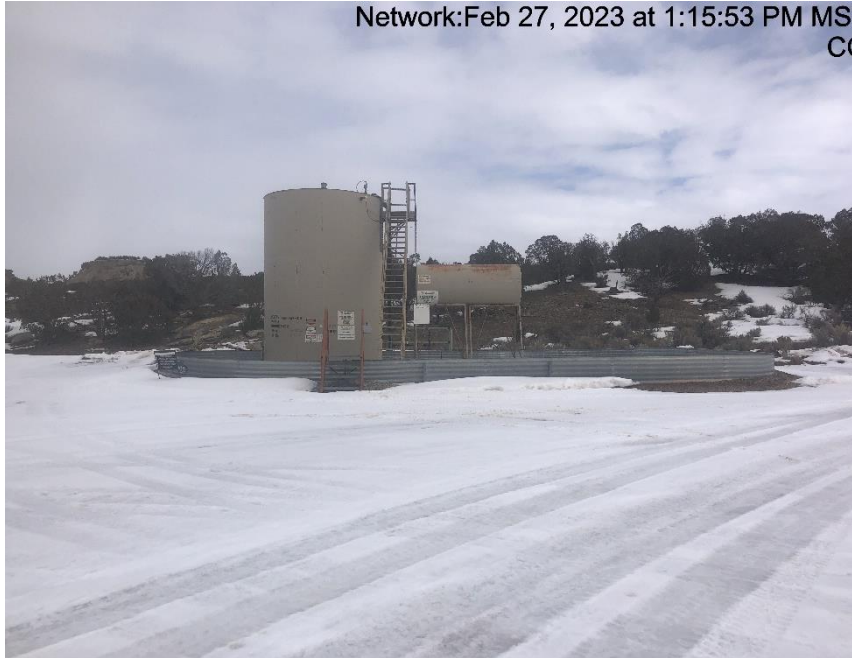
Photo #9095 From entrance to location.

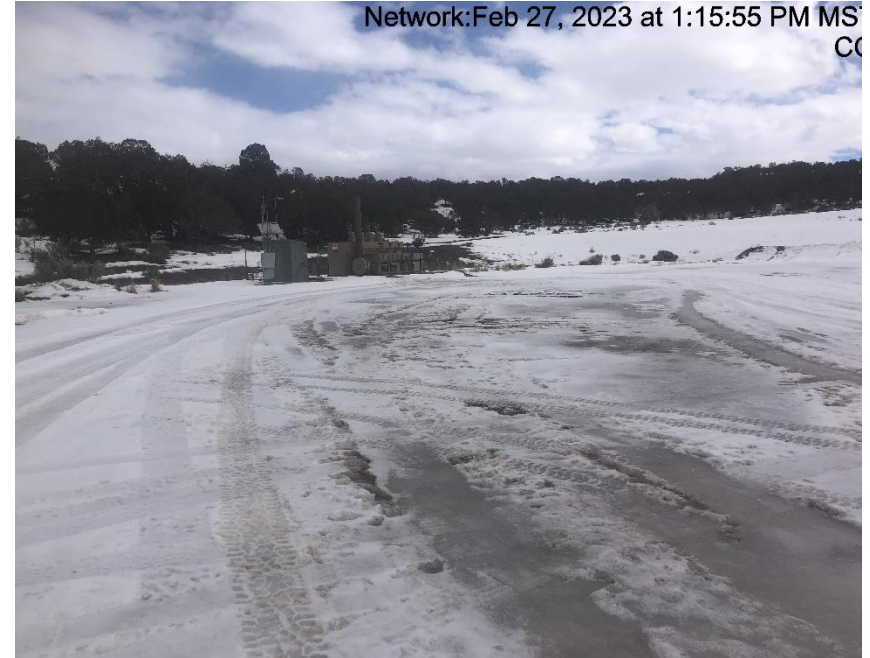
Photo #9096 From entrance to location

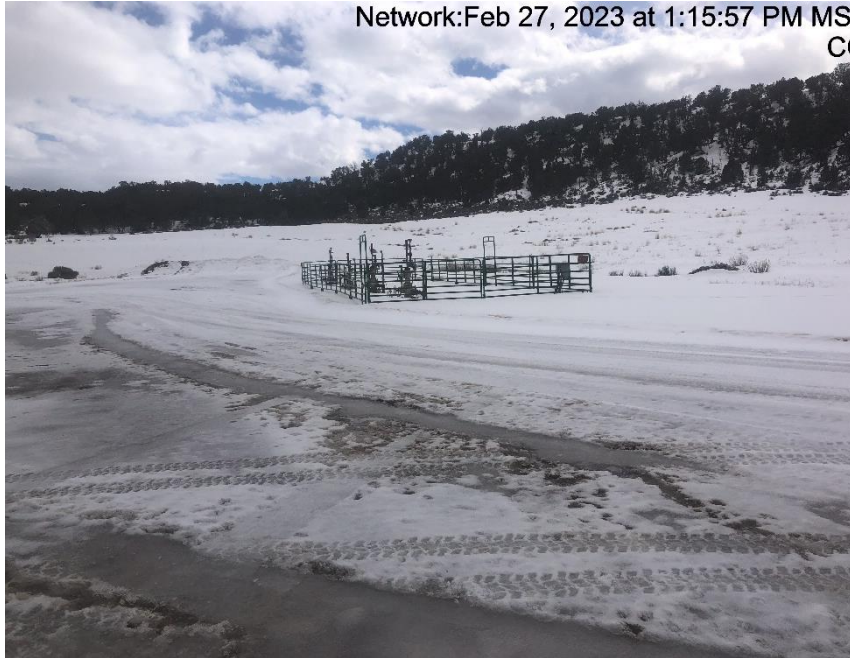
Photo #9097 From entrance to location.

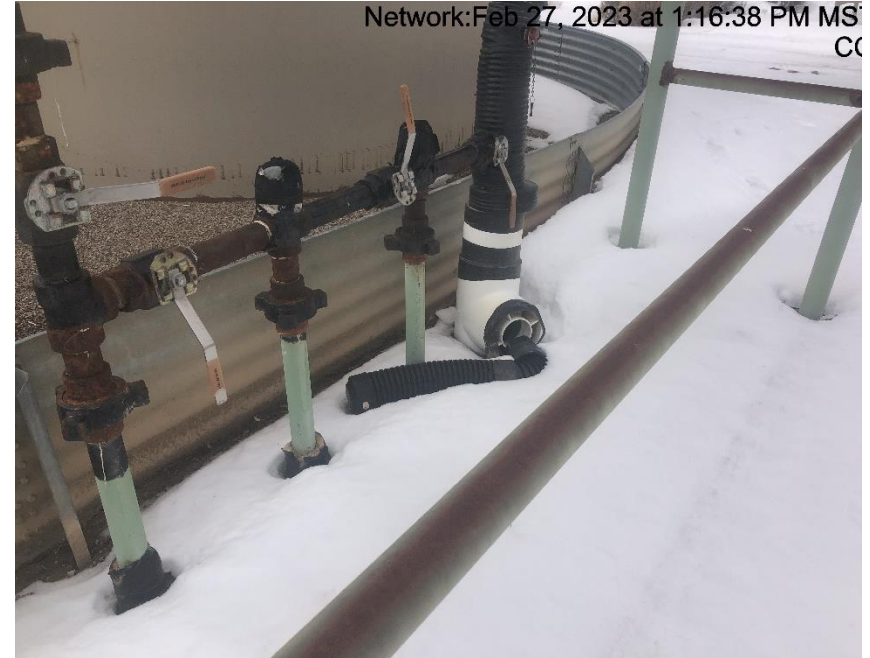
Photo #9098 Flow line heating insulation open ended.

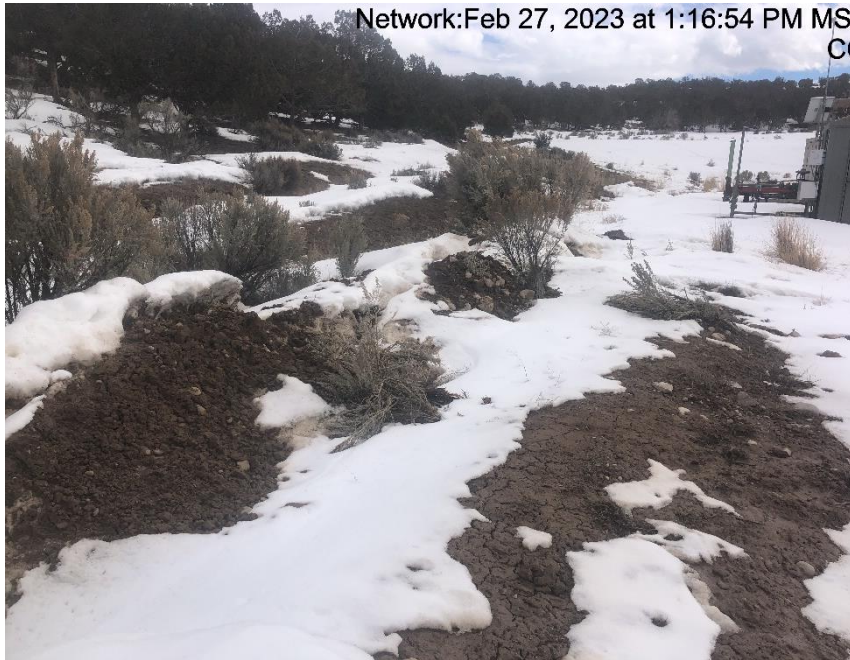
Photo #9099 Sediment has been transported off location and is now choking of vegetation.

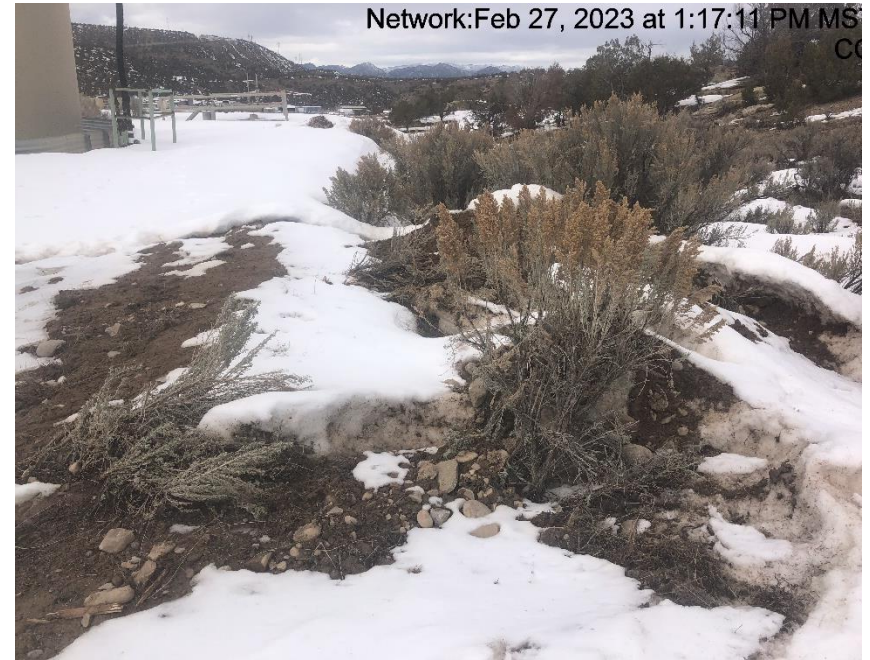
Photo #9100 Berm needs maintained.

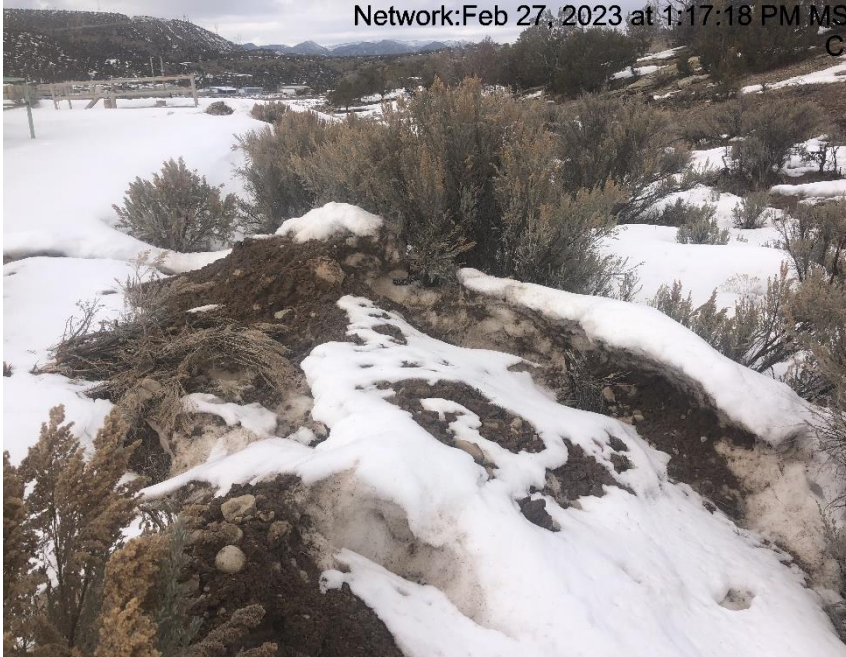
Photo #9101 Sediment has been transported off location and is now choking of vegetation.

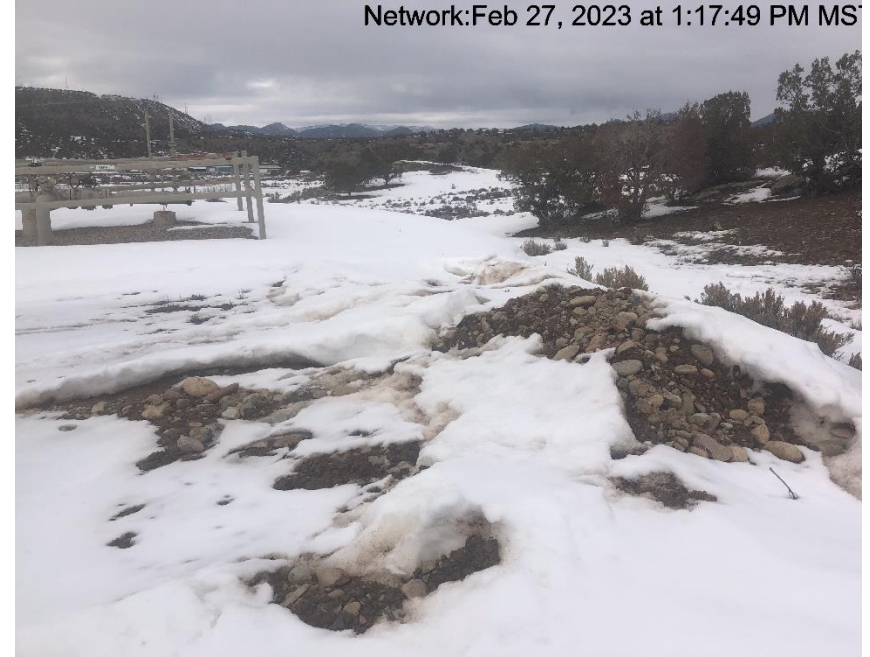
Photo #9102 Sediment has been transported off location and is now choking of vegetation.

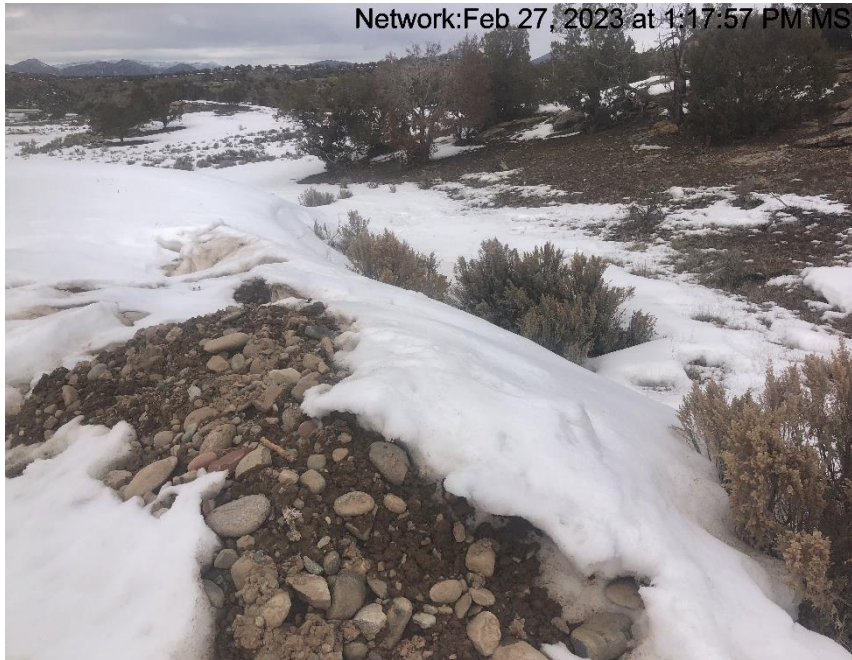
Photo #9104 Sediment has been transported off location and is now choking of vegetation.
