Inspection Photos

API: 05-061-06076

Operator: CHEMCO INC

Inspection Date: 3/1/2023

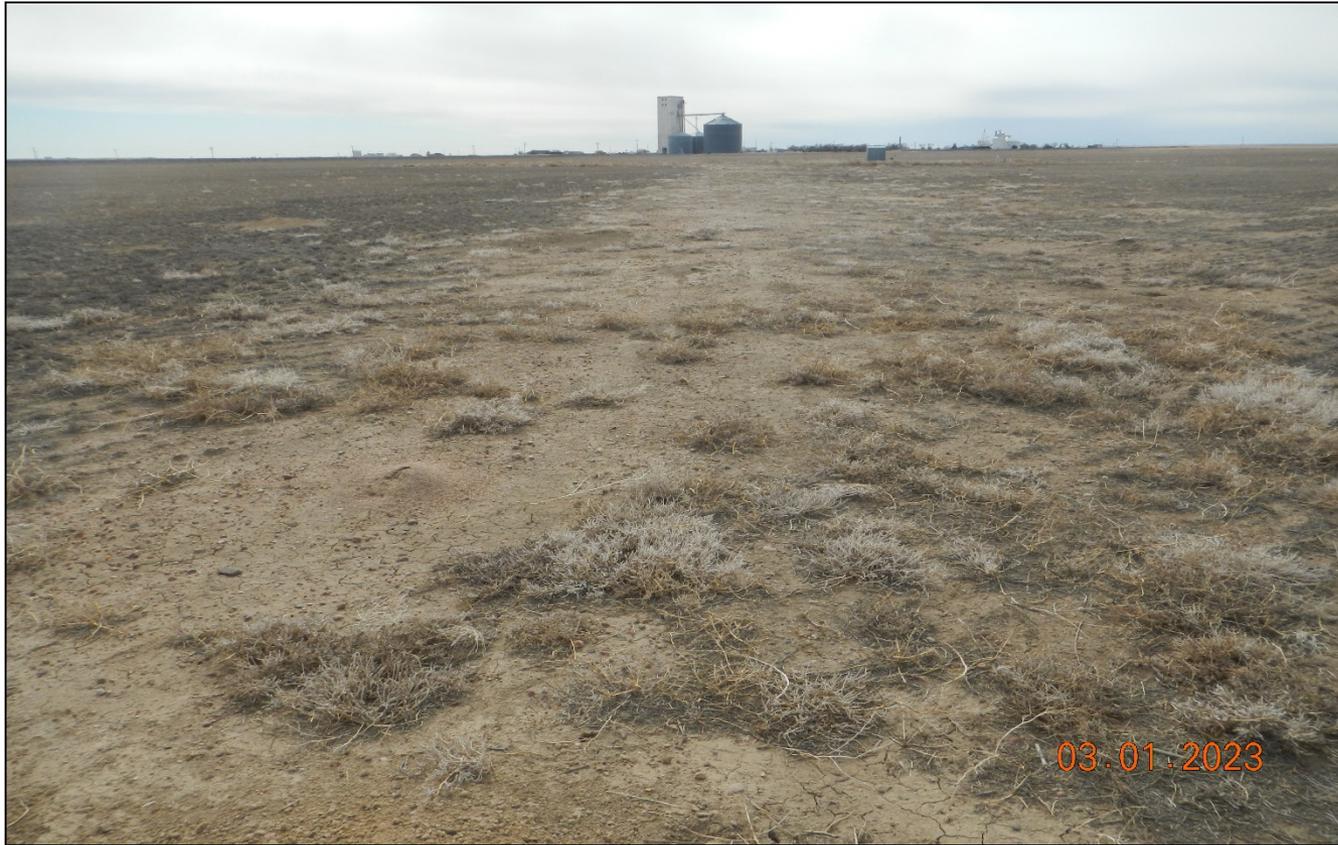
Photo 1. Facing southwest along the access road which has not been reclaimed. The crop has not re-established and there are undesirable weeds.

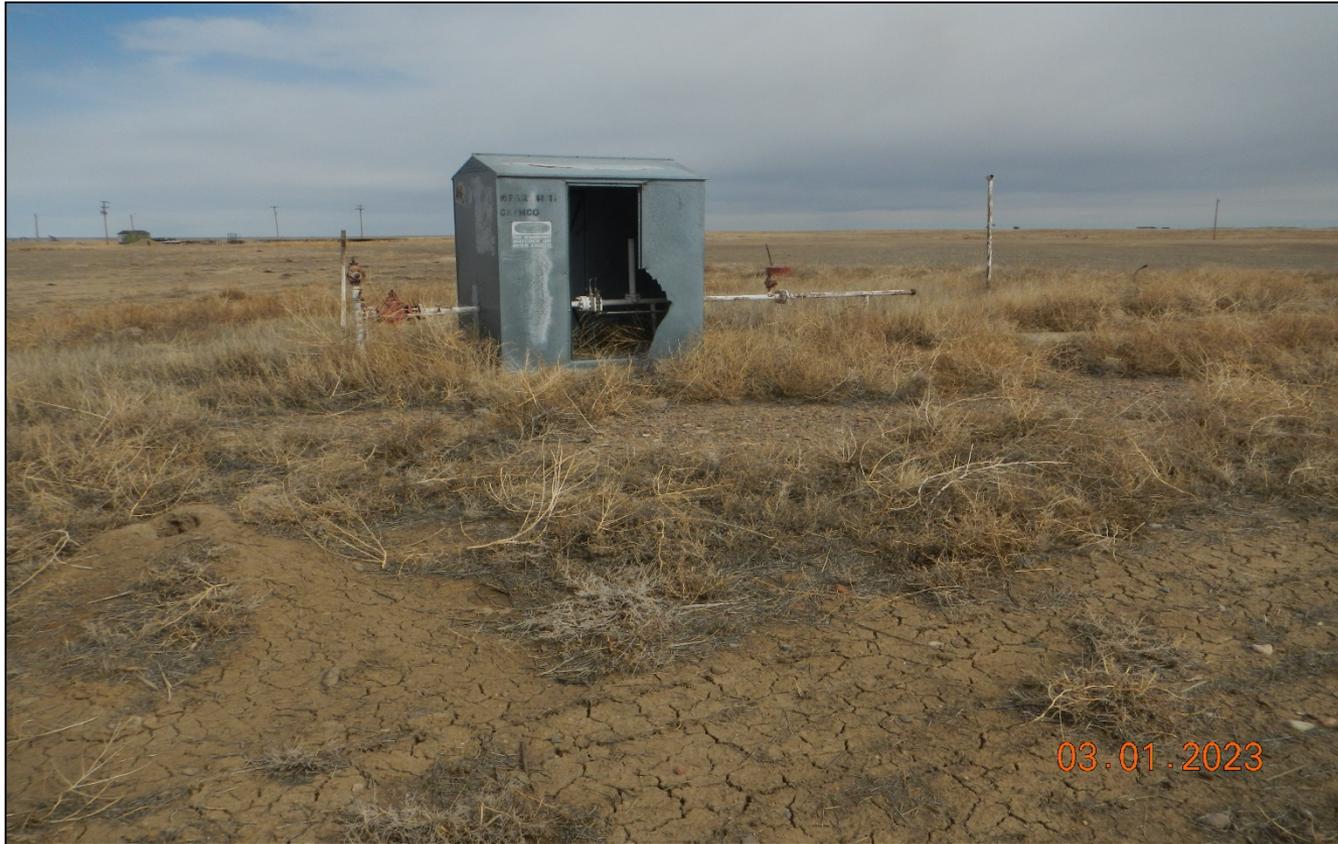
Photo 2. Facing northeast at the location. There is equipment that still remains at the location.

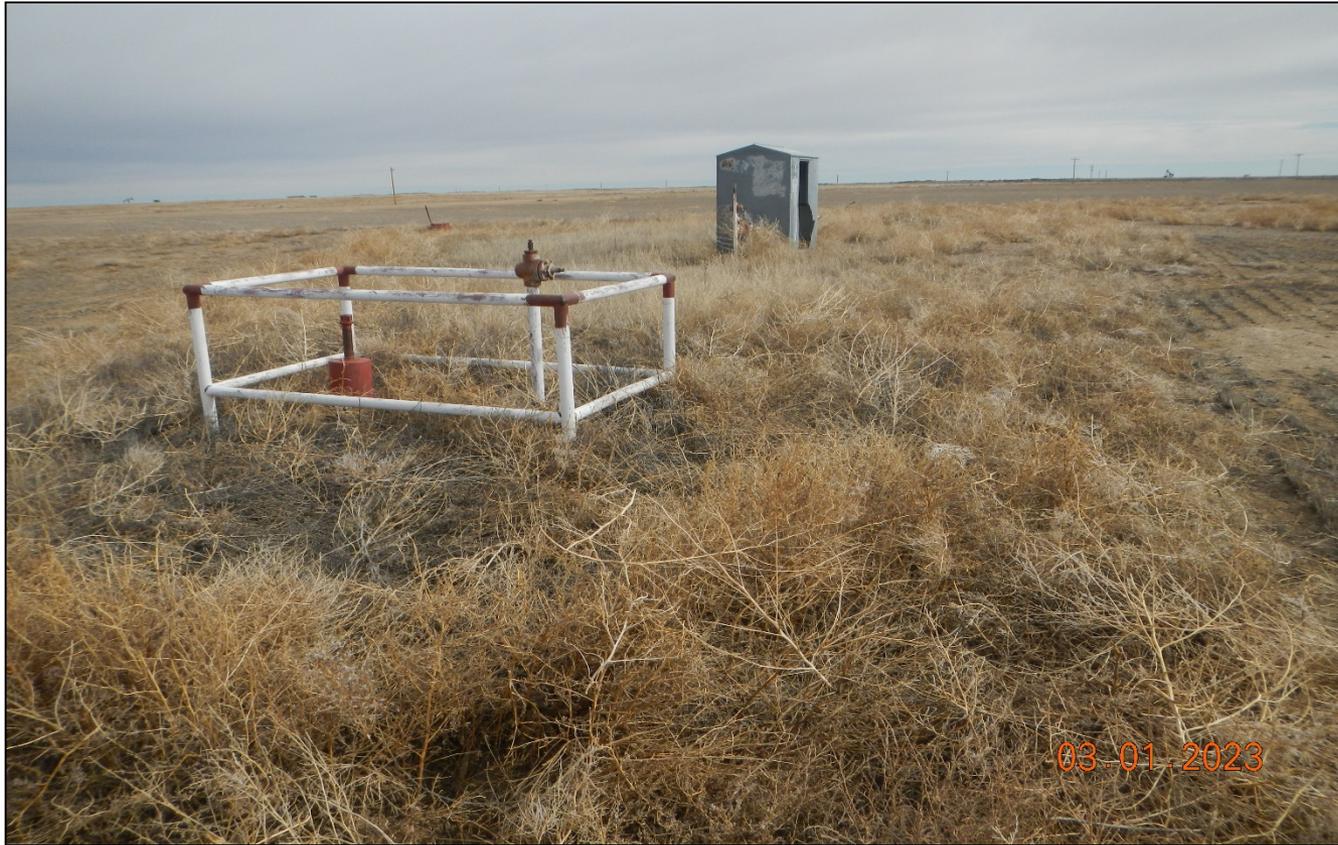
Photo 3. Facing east at the location. There is equipment that still remains at the location.

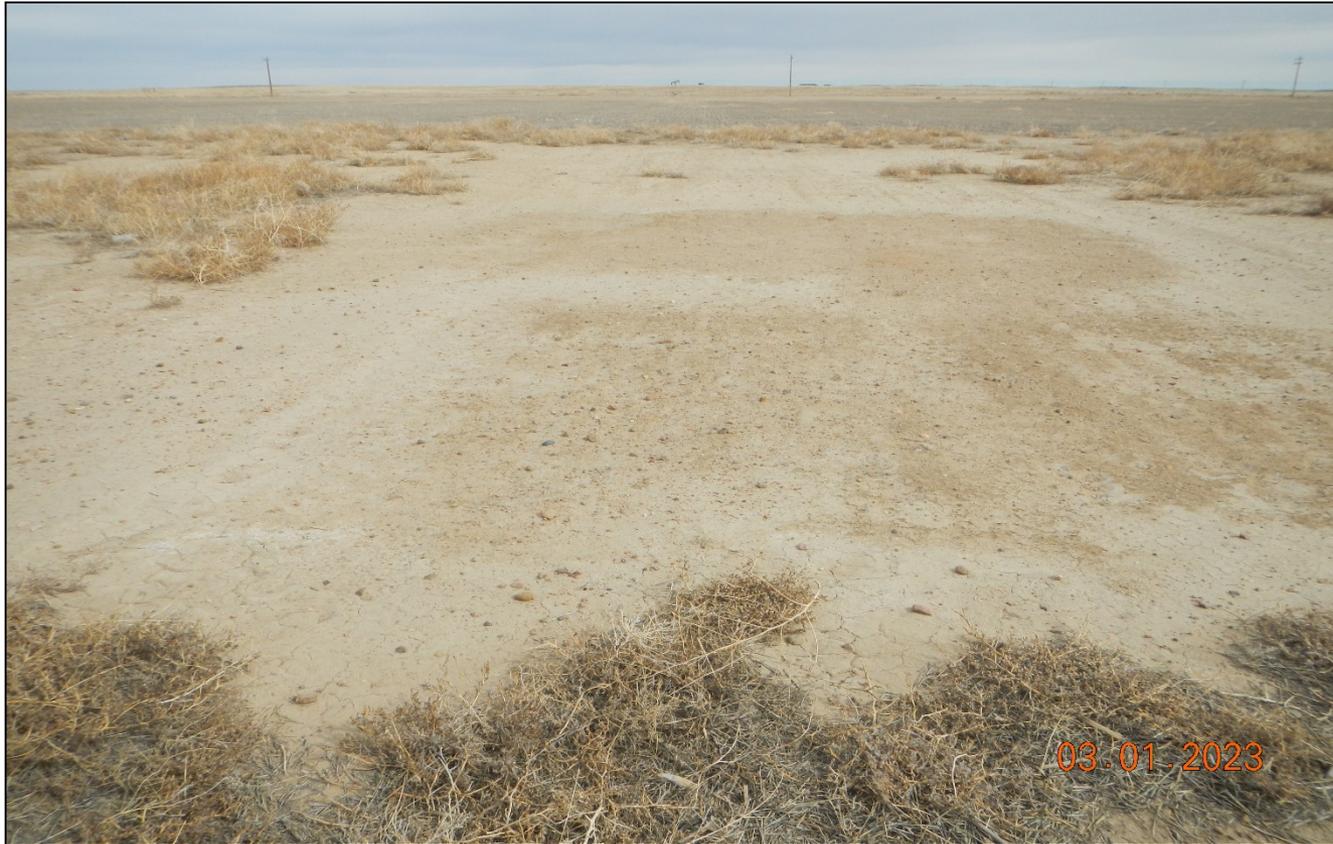
Photo 4. Facing east at the location. This area approx. 75'x75' is bare of vegetation with no crop growth. There is reason to believe a historic spill has caused impacted soils.

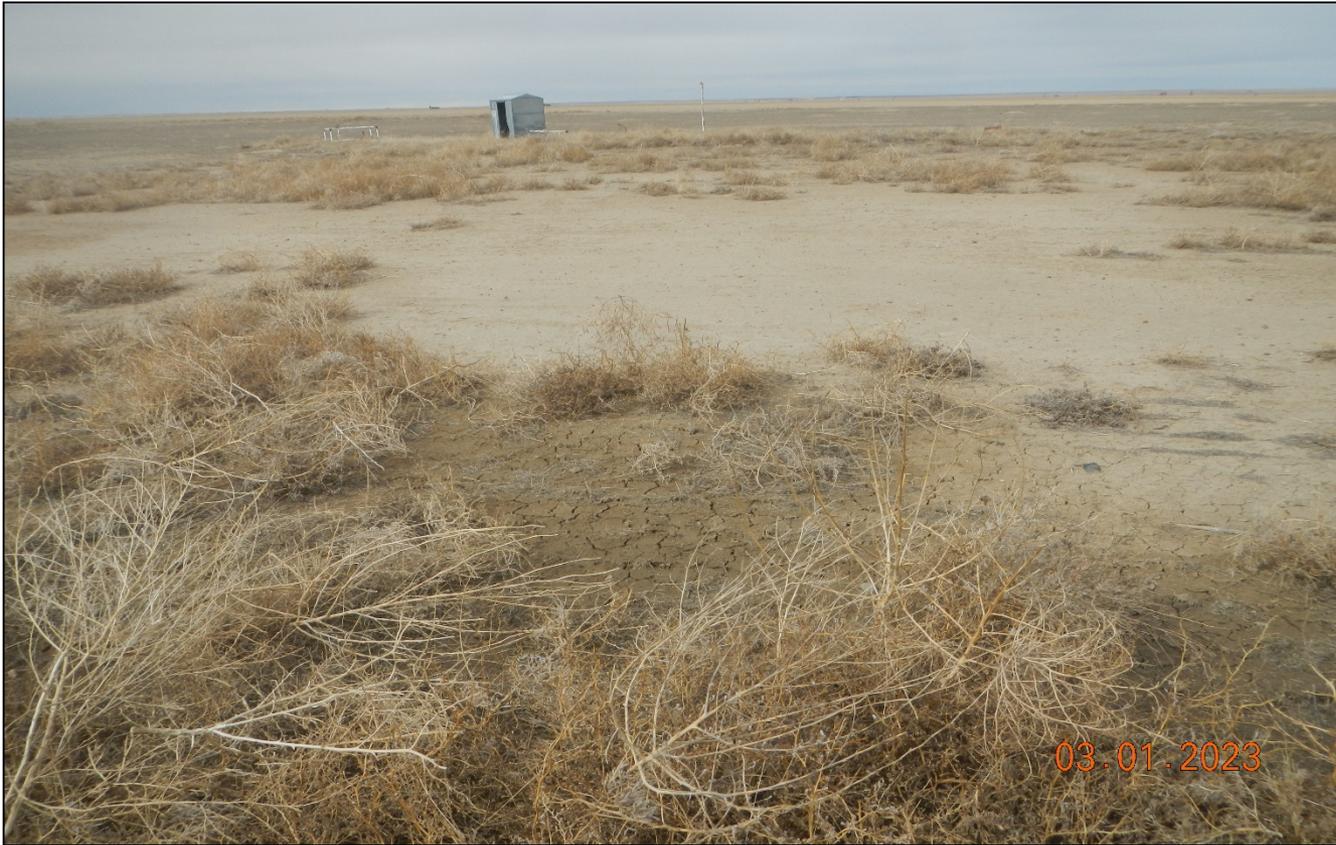
Photo 5. South side of the location facing north. This area approx. 75'x75' is bare of vegetation with no crop growth. There is reason to believe a historic spill has caused impacted soils.

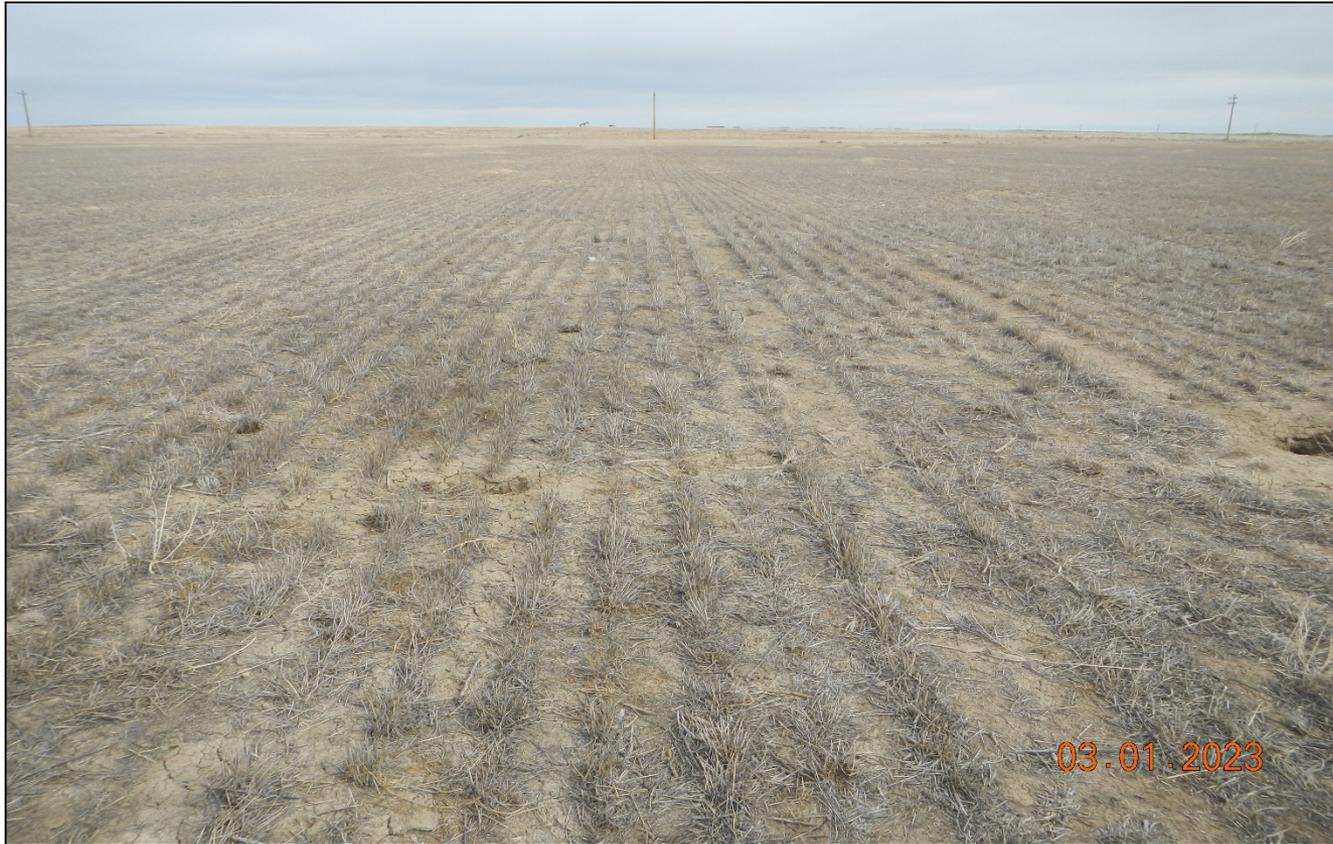
Photo 6. Facing east toward the surrounding undisturbed crop field. Wheat stubble is shown to be uniformly established.
