Inspection Photos

API: 061-05142

Operator: WESTERN OPERATING COMPANY

Inspection Date: 3/1/2023

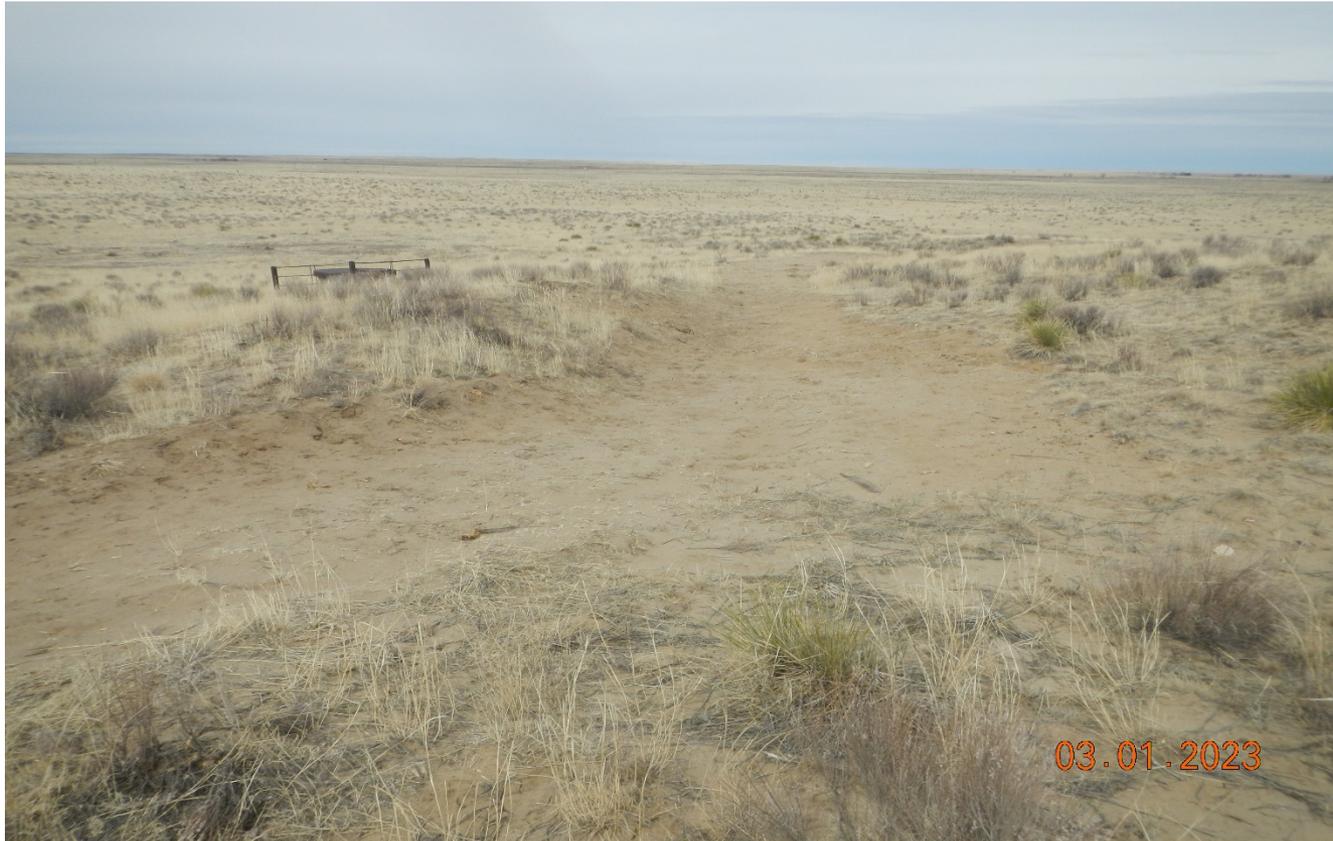
Photo 1. Facing northwest toward access road and location. This area of the access road has eroded and is not stabilized and reclaimed.

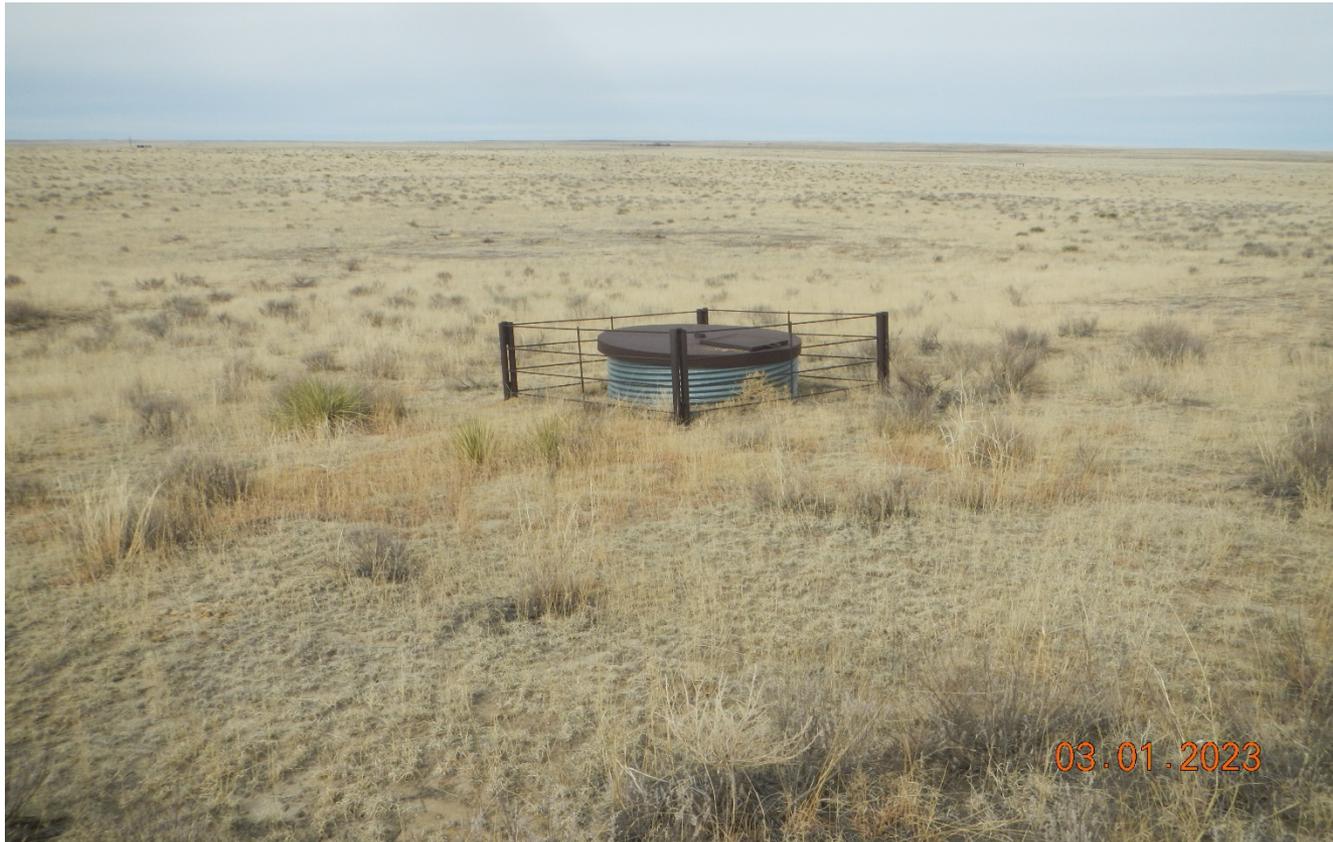
Photo 2. There is a metal cellar that remains at the location which needs to be removed.

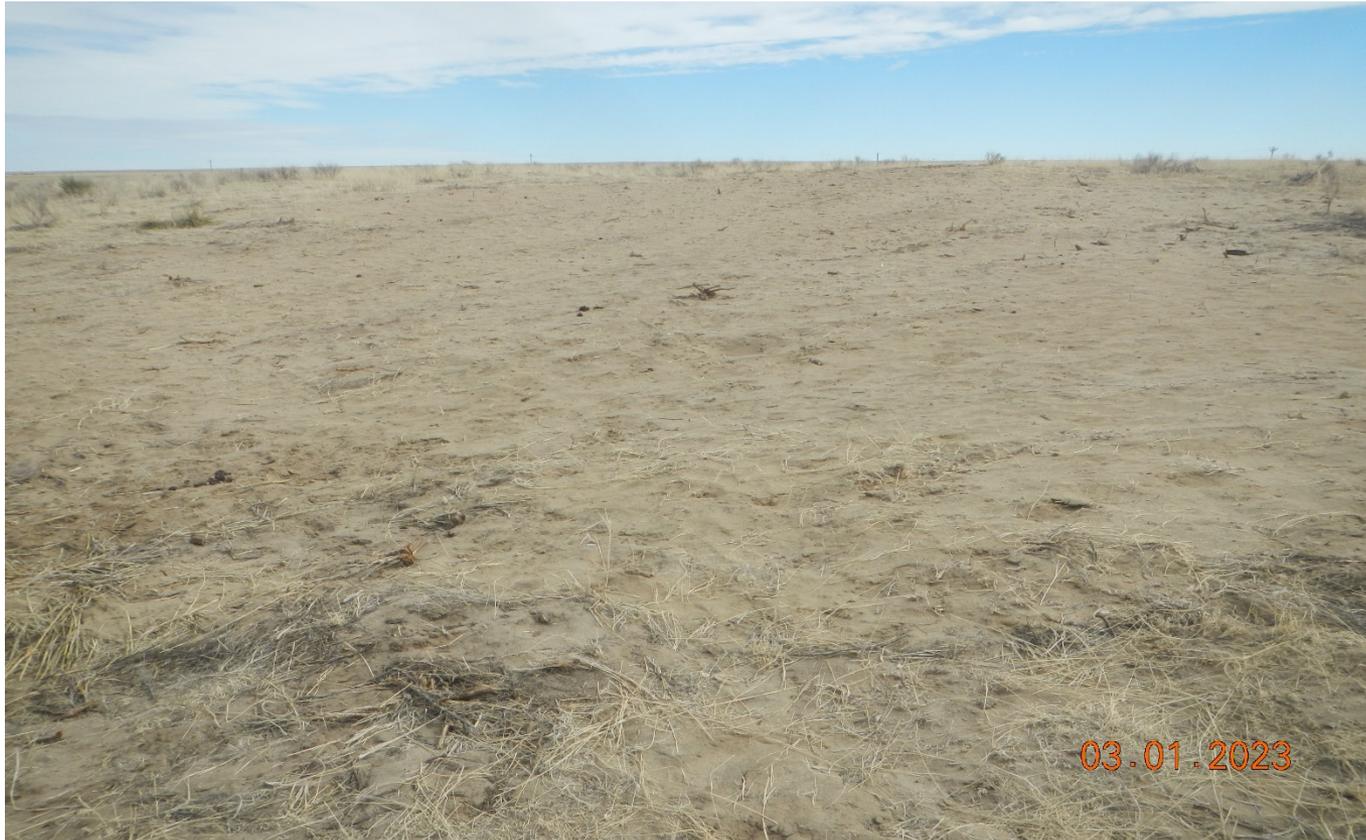
Photo 3. Facing east at the location. This area has not been reclaimed and sandy soils are susceptible to erosion.

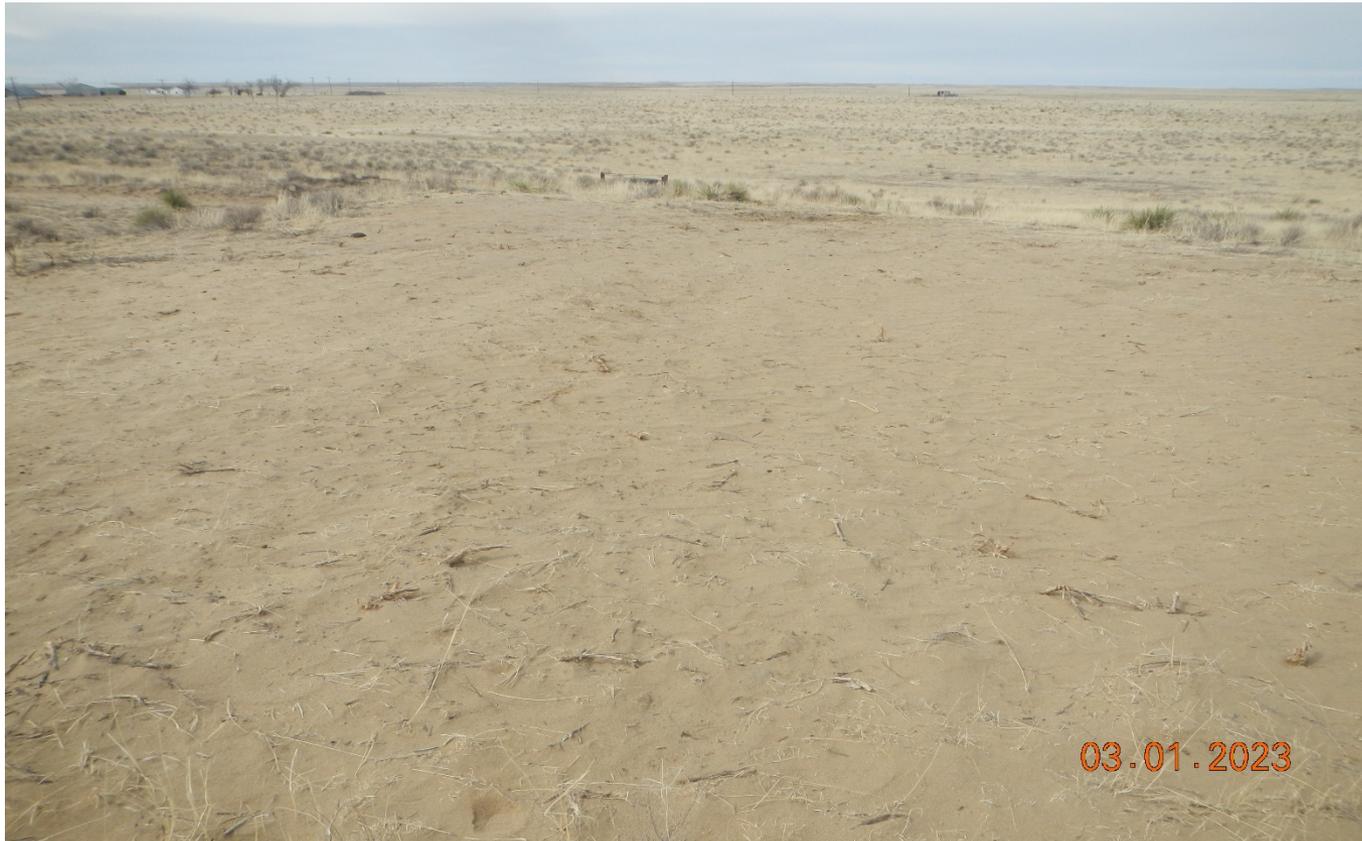
Photo 4. Facing west at the location. This area has not been reclaimed and sandy soils are susceptible to erosion.

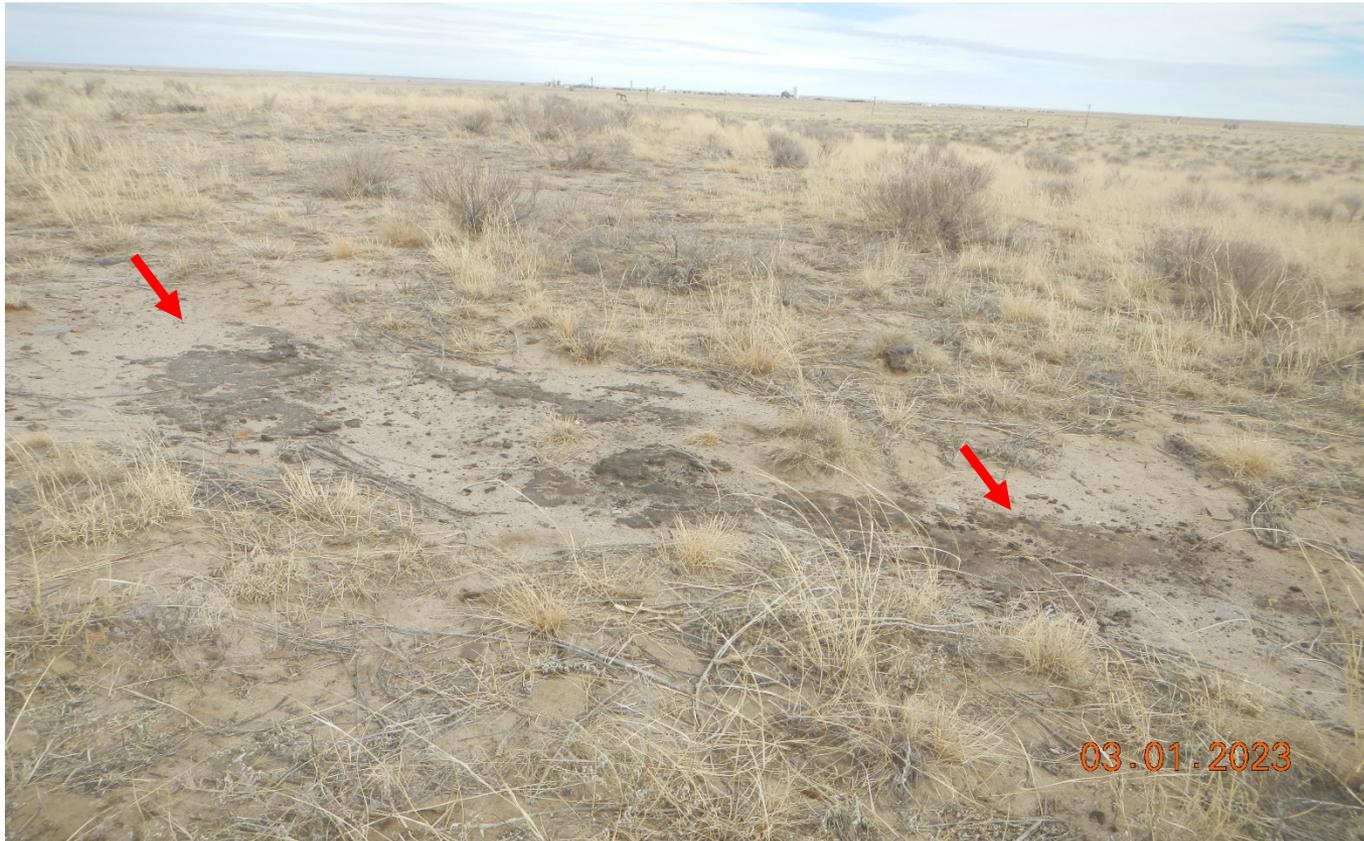
Photo 5. At the south side of the location there are several areas of hardened petroleum substance that needs to be cleaned up and removed.

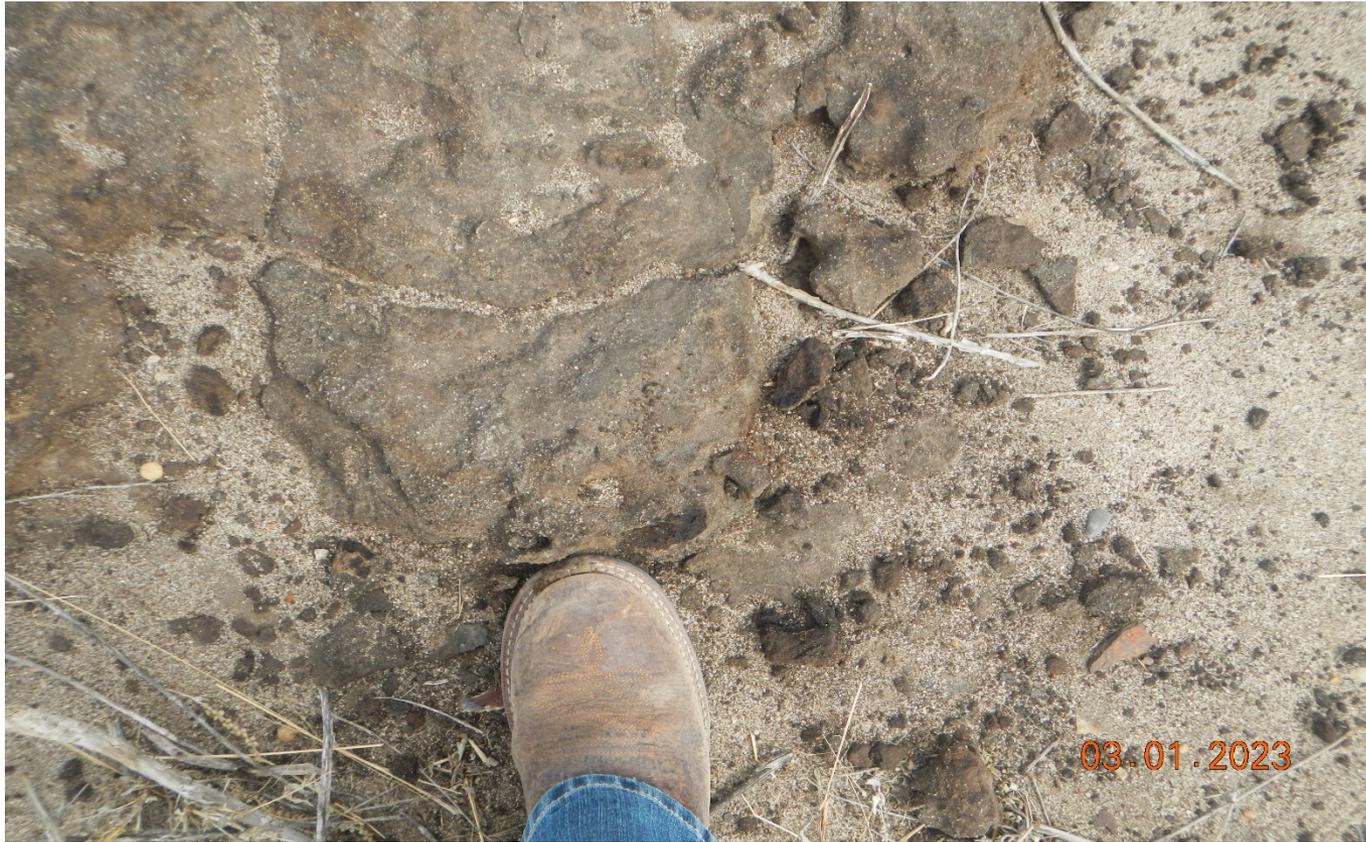
Photo 6. Closer view of the hardened petroleum substance that needs to be cleaned up and removed.
