# Inspection Photos

API# 061-06023

Operator: WESTERN OPERATING COMPANY

Inspection Date: 3/1/2023

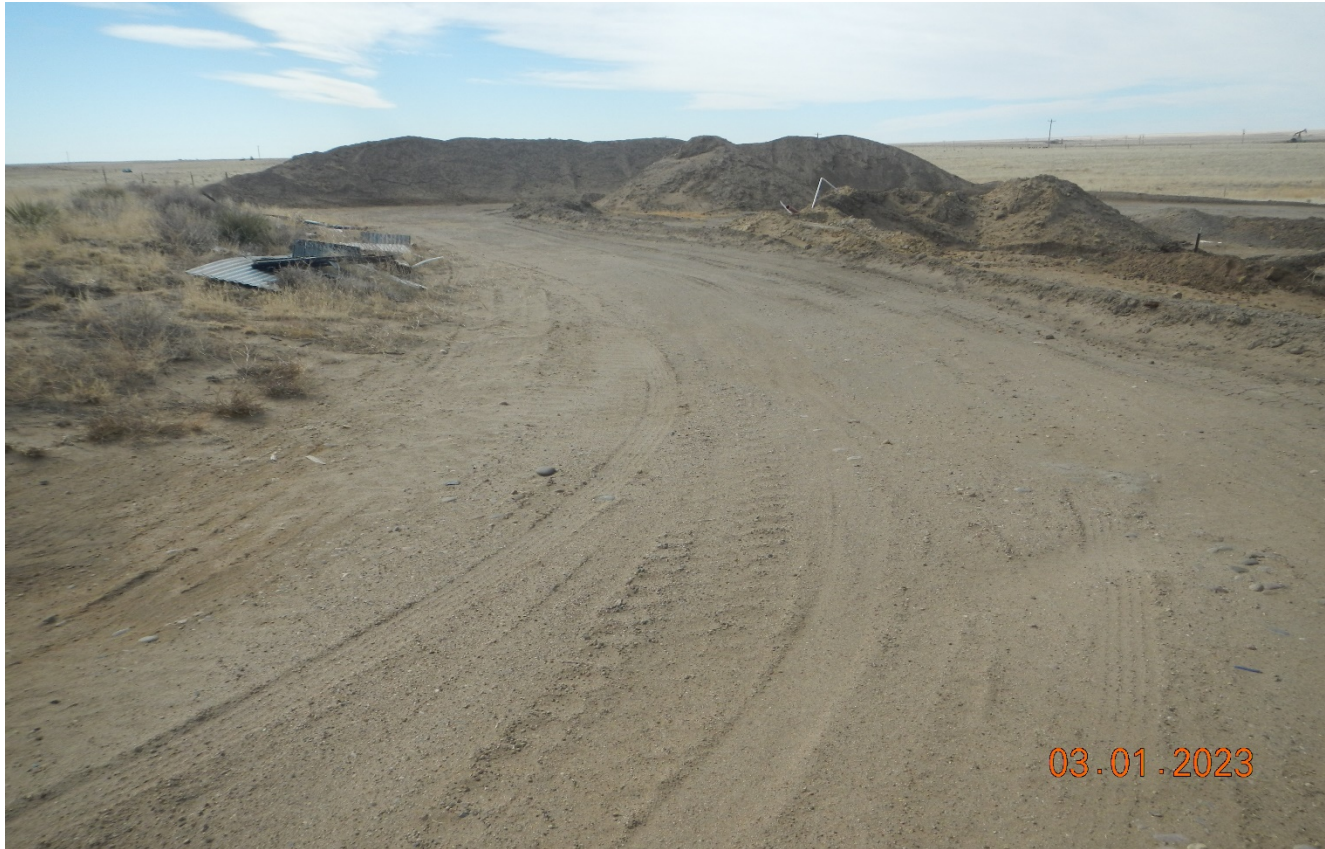
**Photo 1.** Facing southwest at the DAWSON A 1 tank battery facility. The tank was removed and soils have been excavated in this area. Remediation project: 20712

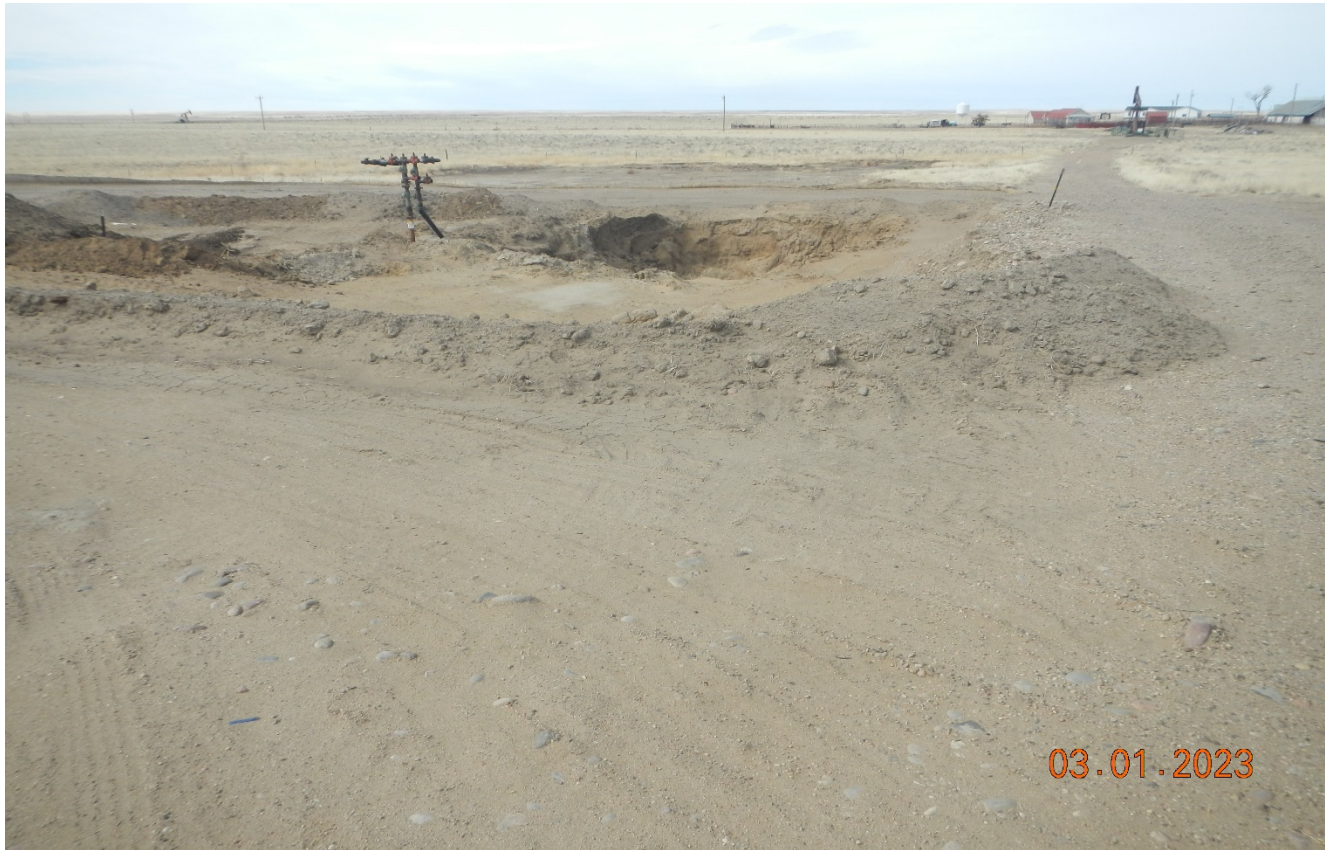
**Photo 2.** Facing southwest toward the tank battery facility. The tank was removed and soils have been excavated in this area. Remediation project: 20712

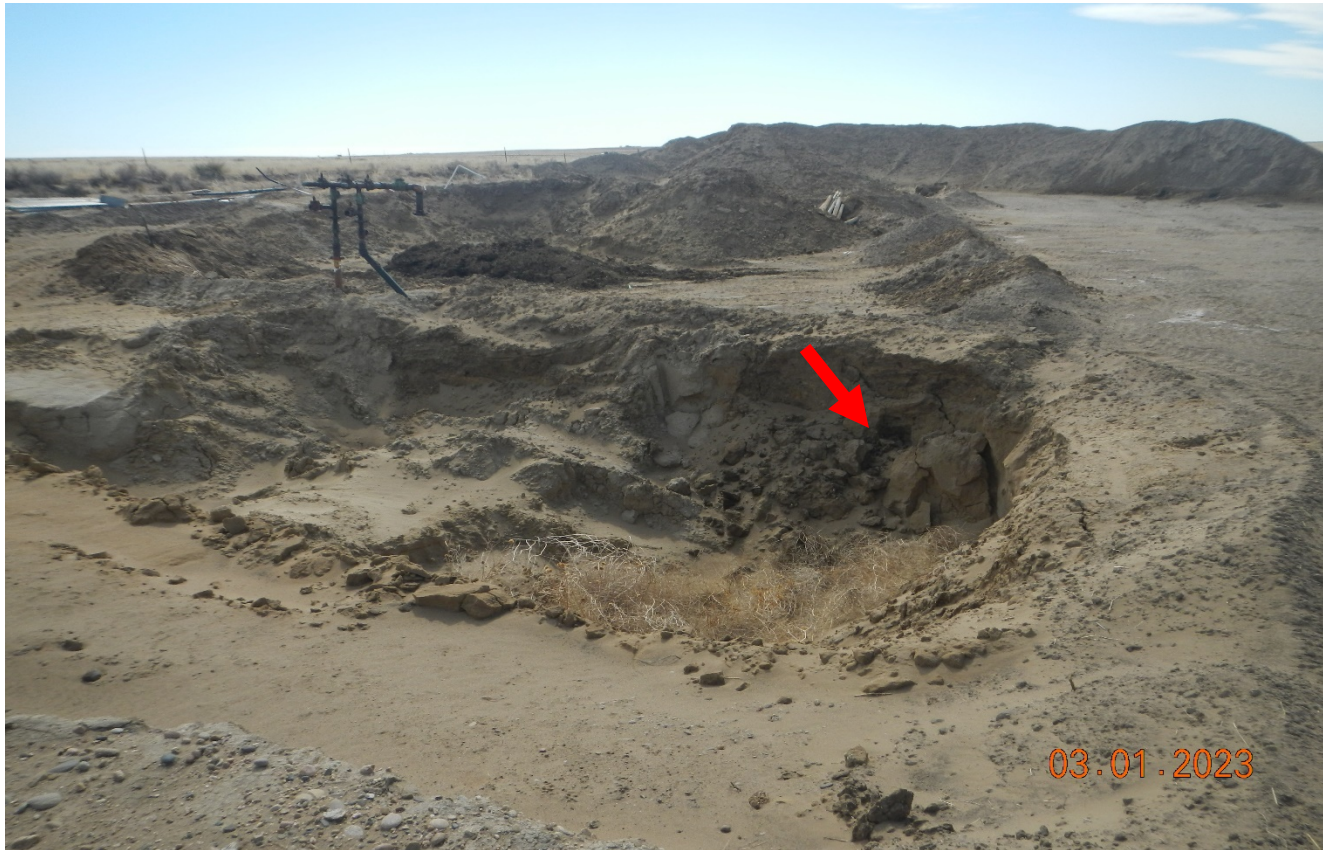
**Photo 3.** Facing south toward the tank battery facility. The tank was removed and soils have been excavated in this area. There are still oil impacted soil in the excavated area shown at red arrow.

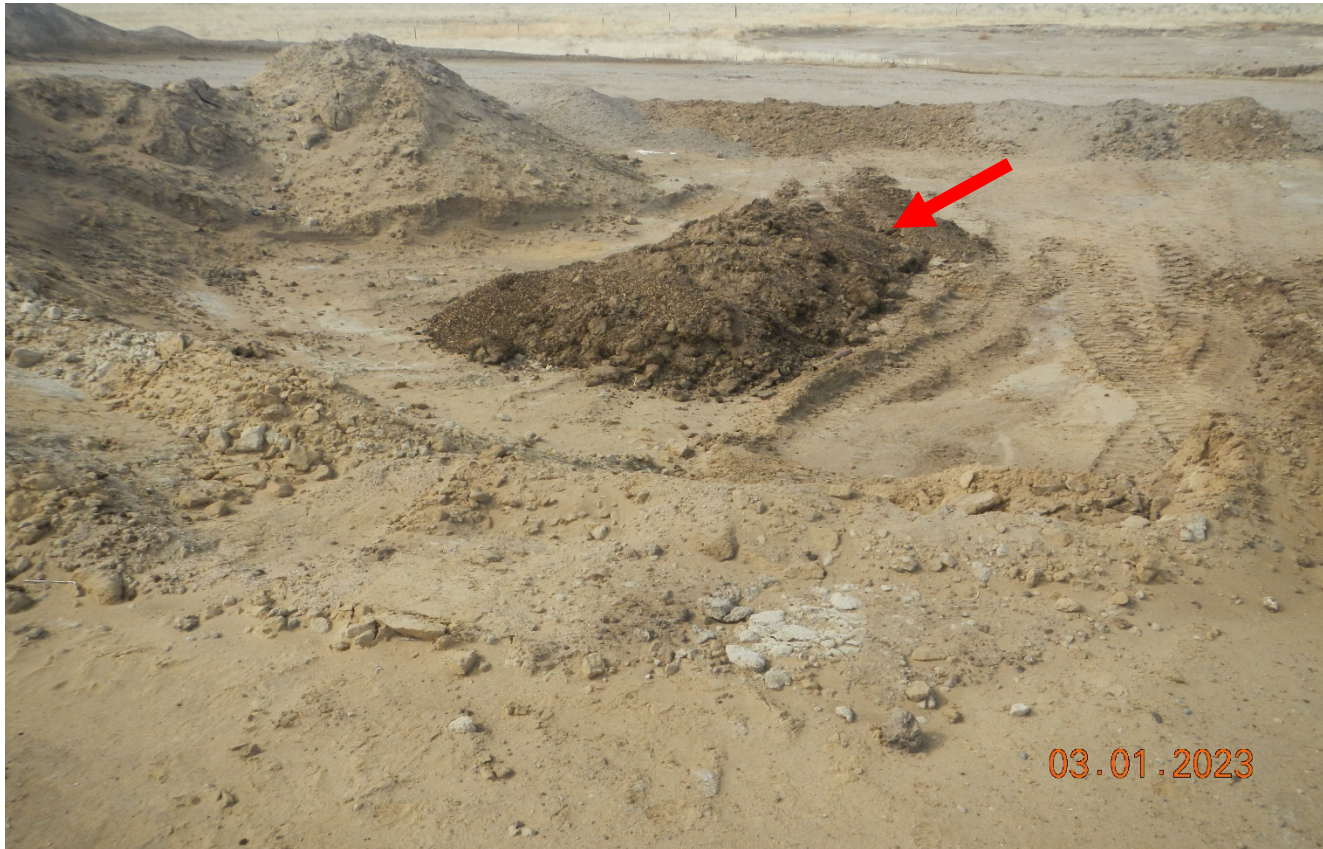
**Photo 4.** There is no liner observed under the contaminated soils which are not being properly stored. The berms around the material are not compacted. Contaminated soils should be removed and properly disposed immediately.

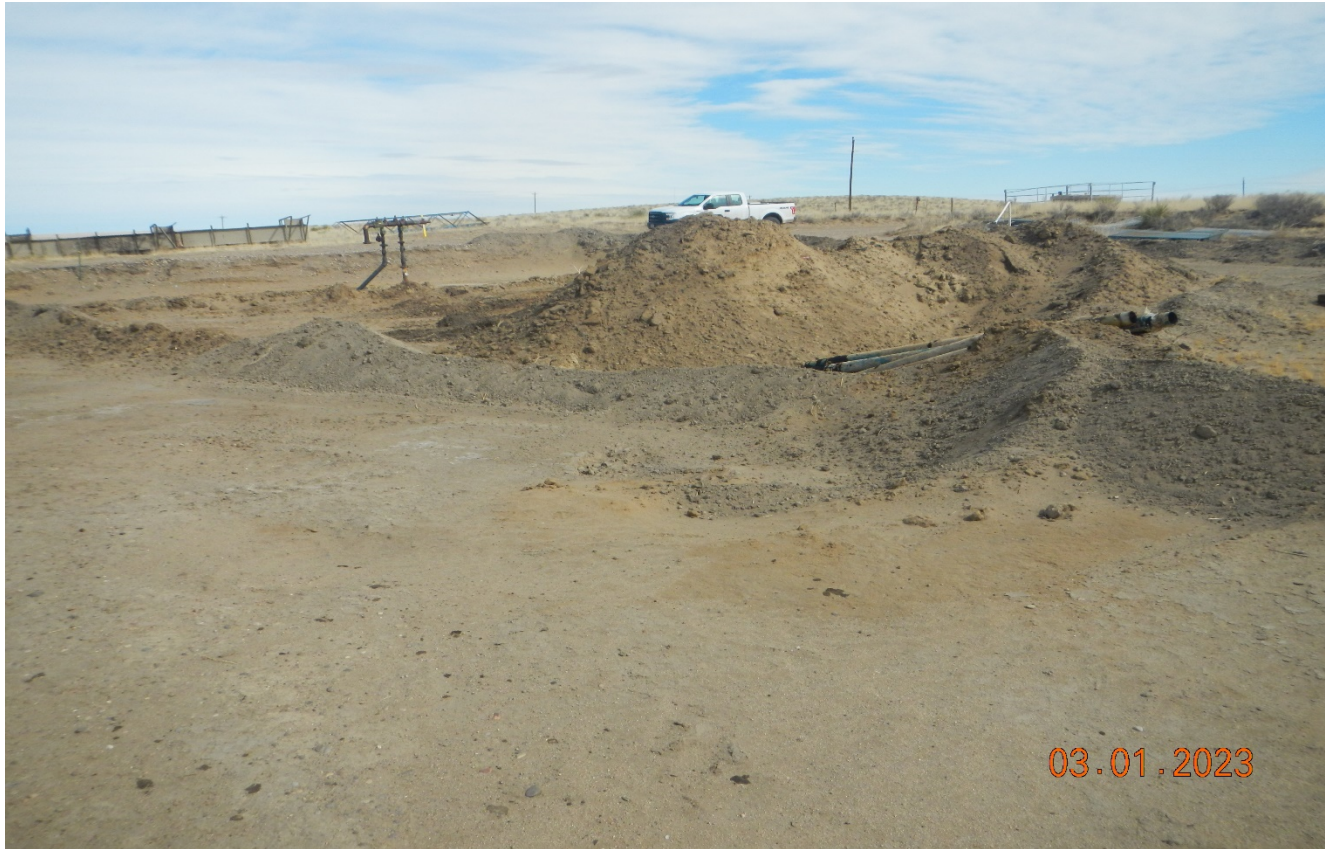
**Photo 5.** Facing northwest toward tank battery facility. There is loose material being stored that is not stabilized and susceptible to erosion. The berms around the material are not adequately sized or compacted.

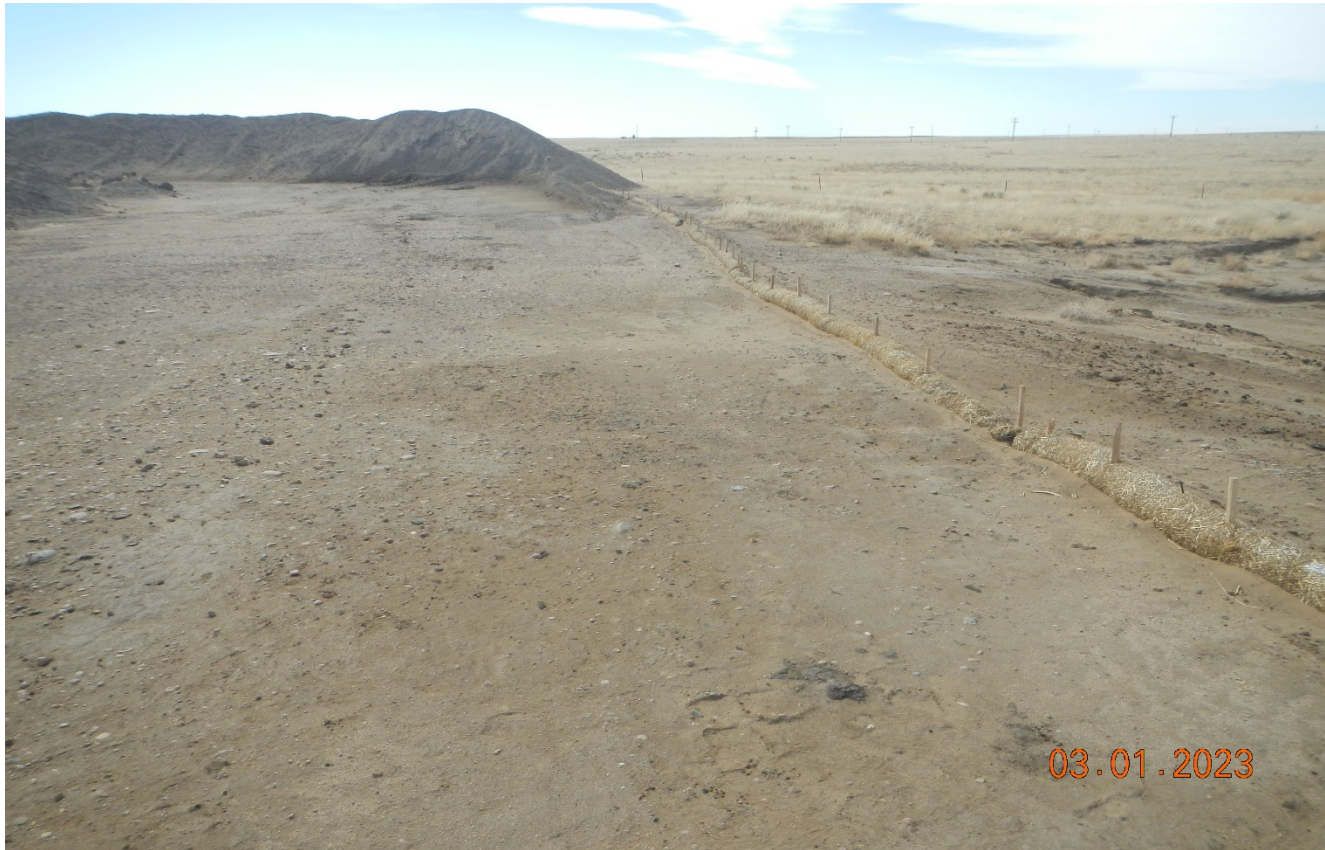
**Photo 6.** Facing south at the tank battery facility.

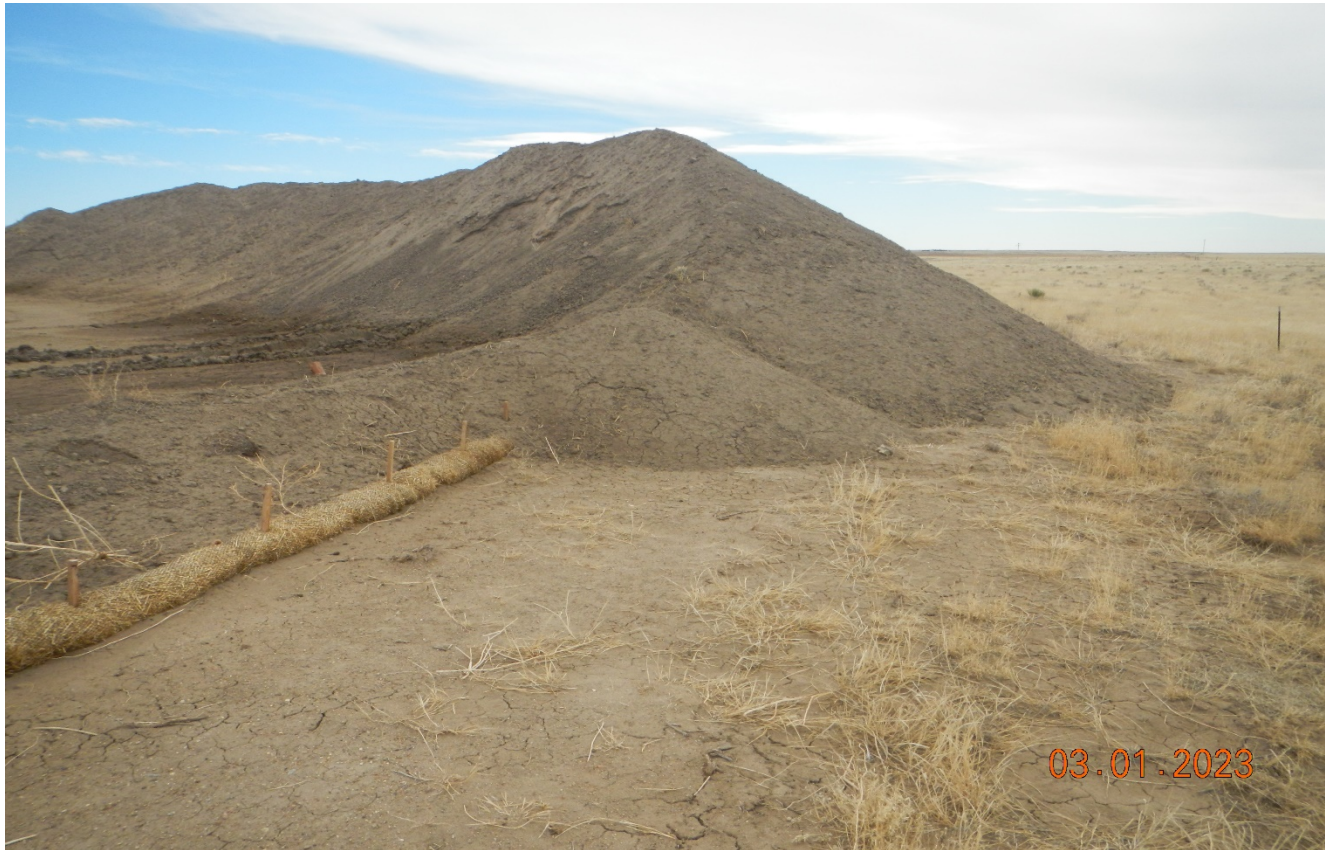
**Photo 7.** There have been soils brought in and stockpiled at the south side of the location. There is inadequate stormwater BMP's to prevent erosion of the stock piled soil. The wattles have been covered over with soil and are insufficient.

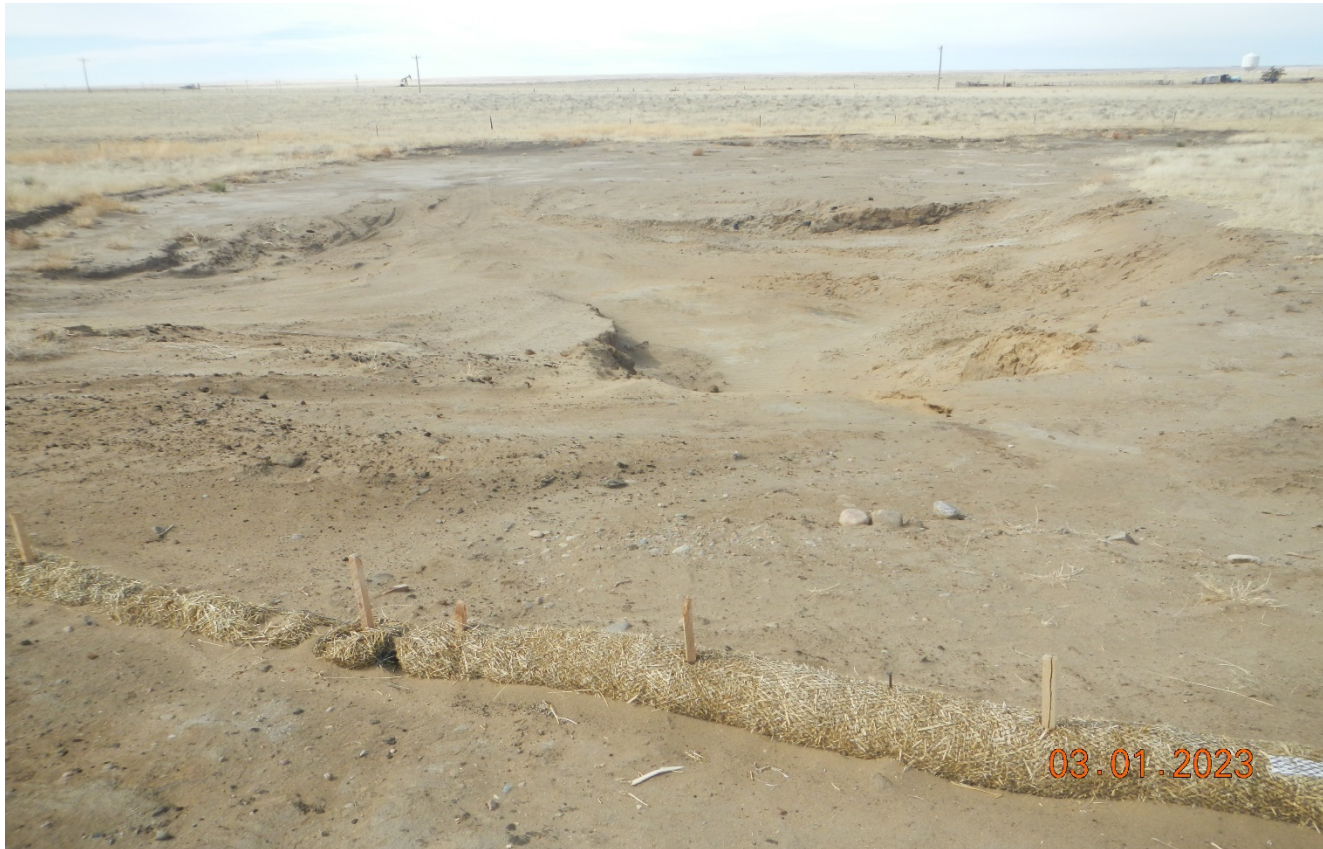
**Photo 8.** Facing southwest toward the area where the spill occurred February of 2022, Remediation project: 20712.

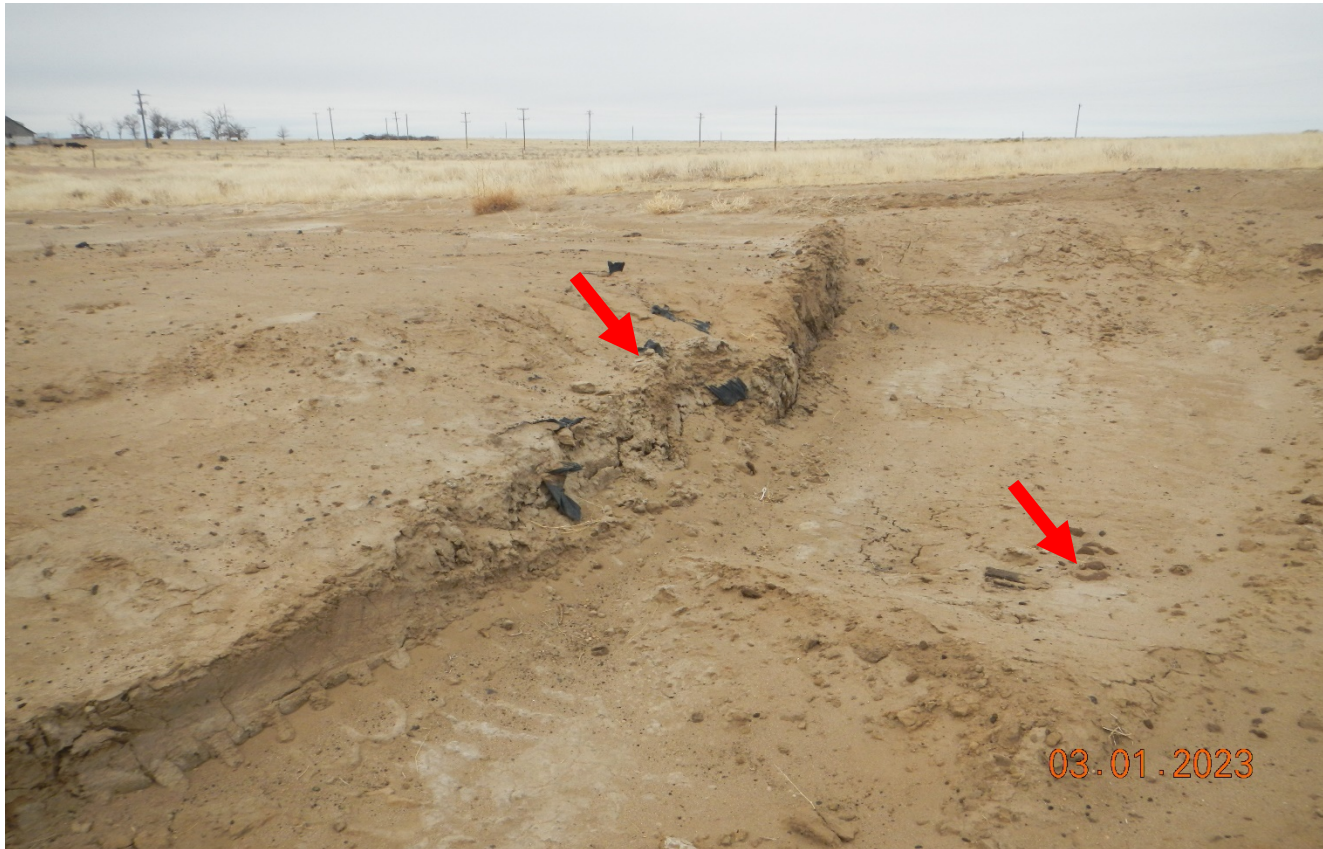
**Photo 9.** Facing southwest toward the area where the spill occurred. Remediation project: 20712. Some areas have been excavated more than other areas. There are still areas of impacted soils observed. Red arrow points to liner material and stained soil.

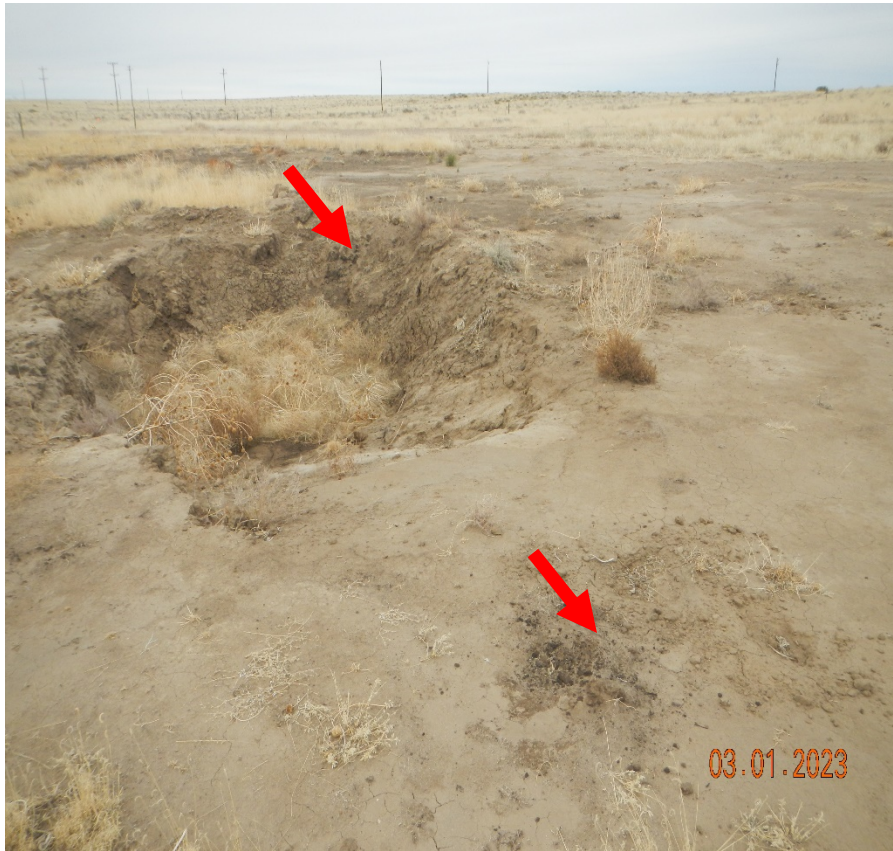
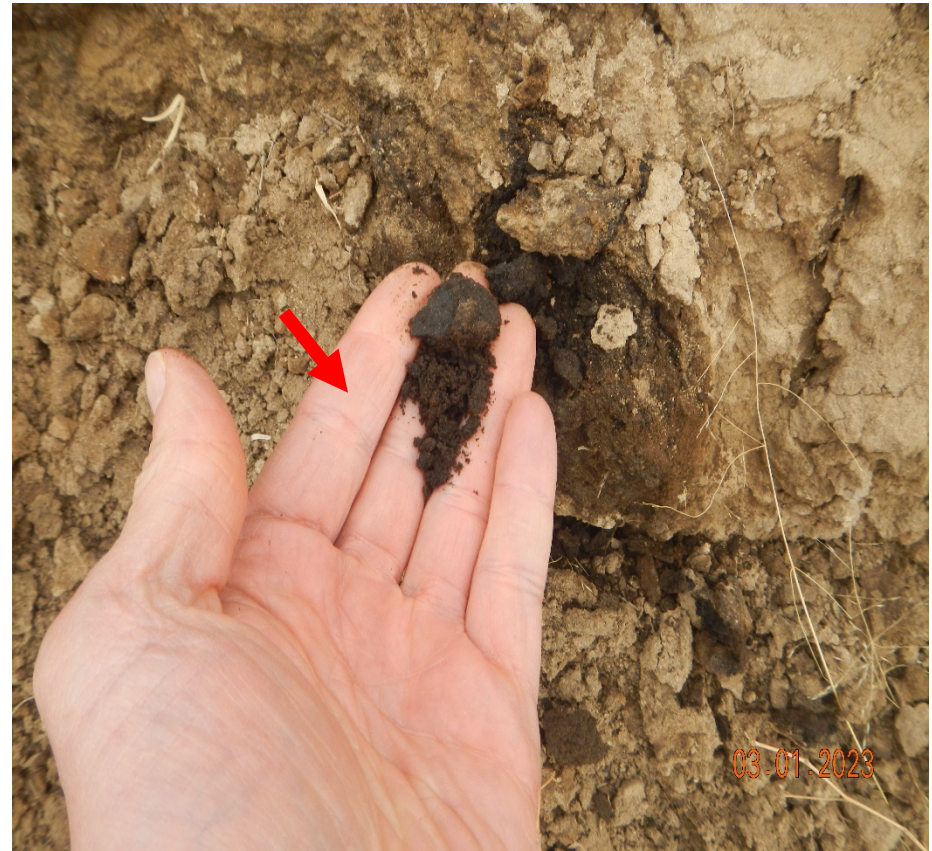
**Photo 10.** Located at the western side of the spill area. There is an excavated hole at this area approximately 12'x12'6'. There are still areas of oil stained soils at the surface (Bottom left) and 2ft. Down into the excavation area (right photo). Further excavation is needed.

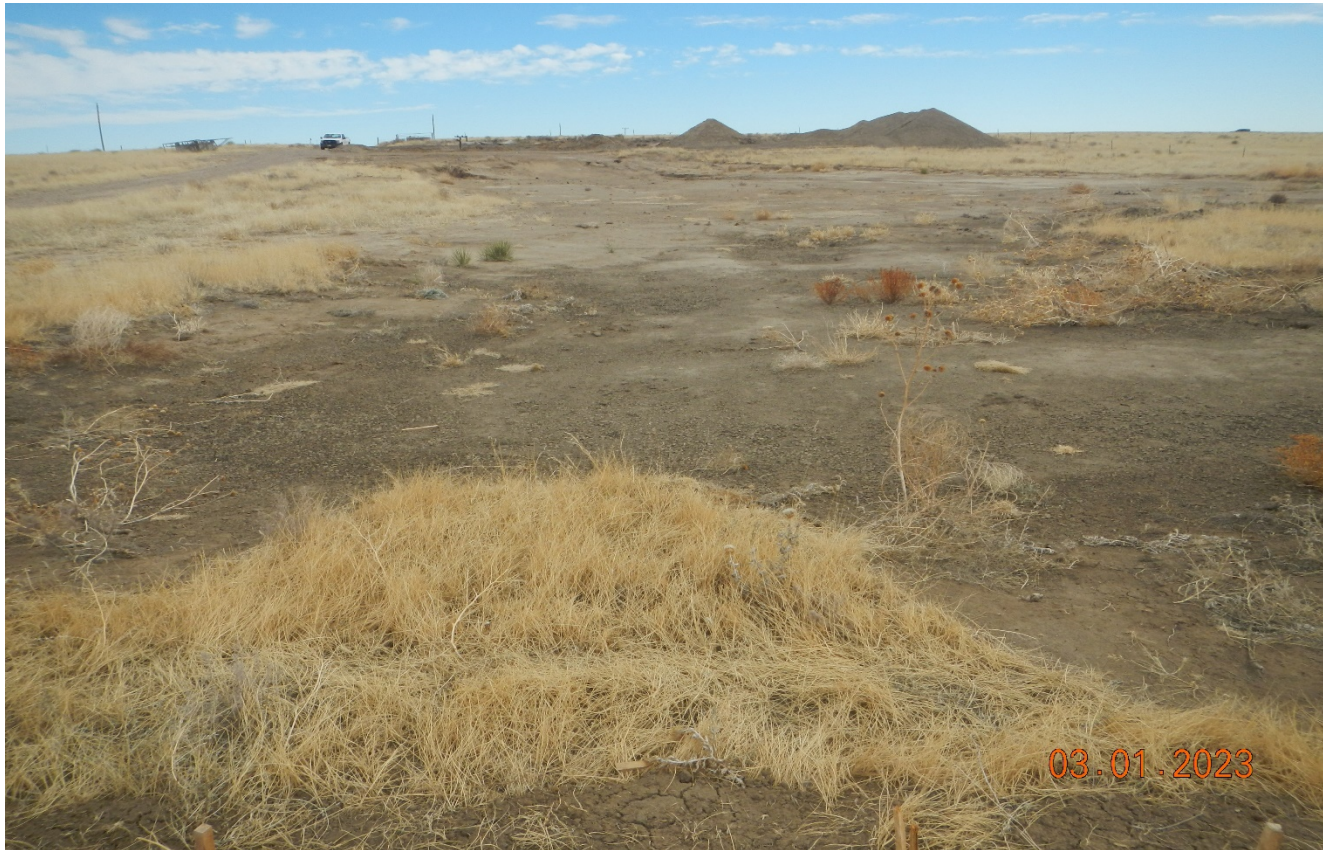
**Photo 11.** Facing east toward the area where the spill occurred.  
Remediation project: 20712.

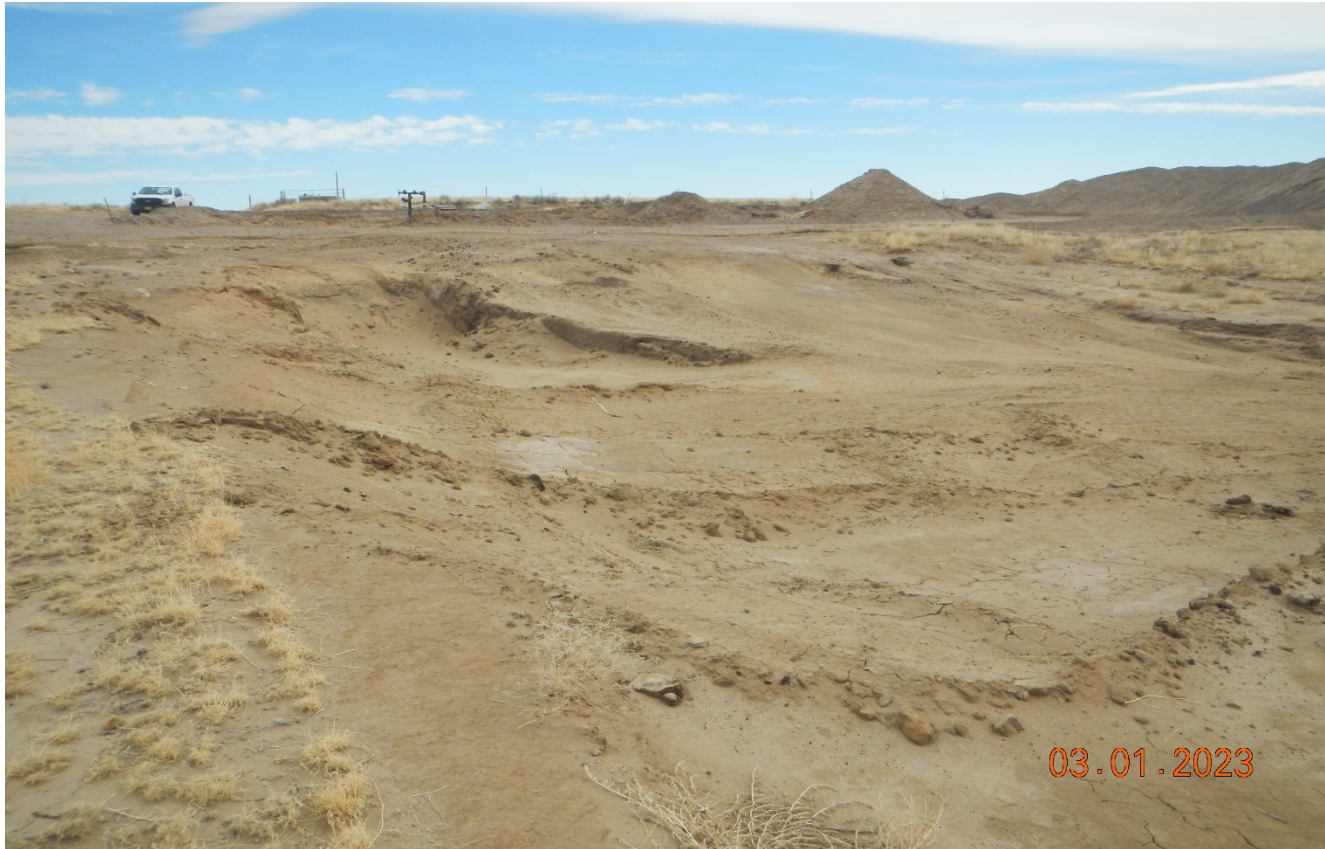
**Photo 12.** Facing east toward the area where the spill occurred. Remediation project: 20712. Some areas have been excavated more than other areas.

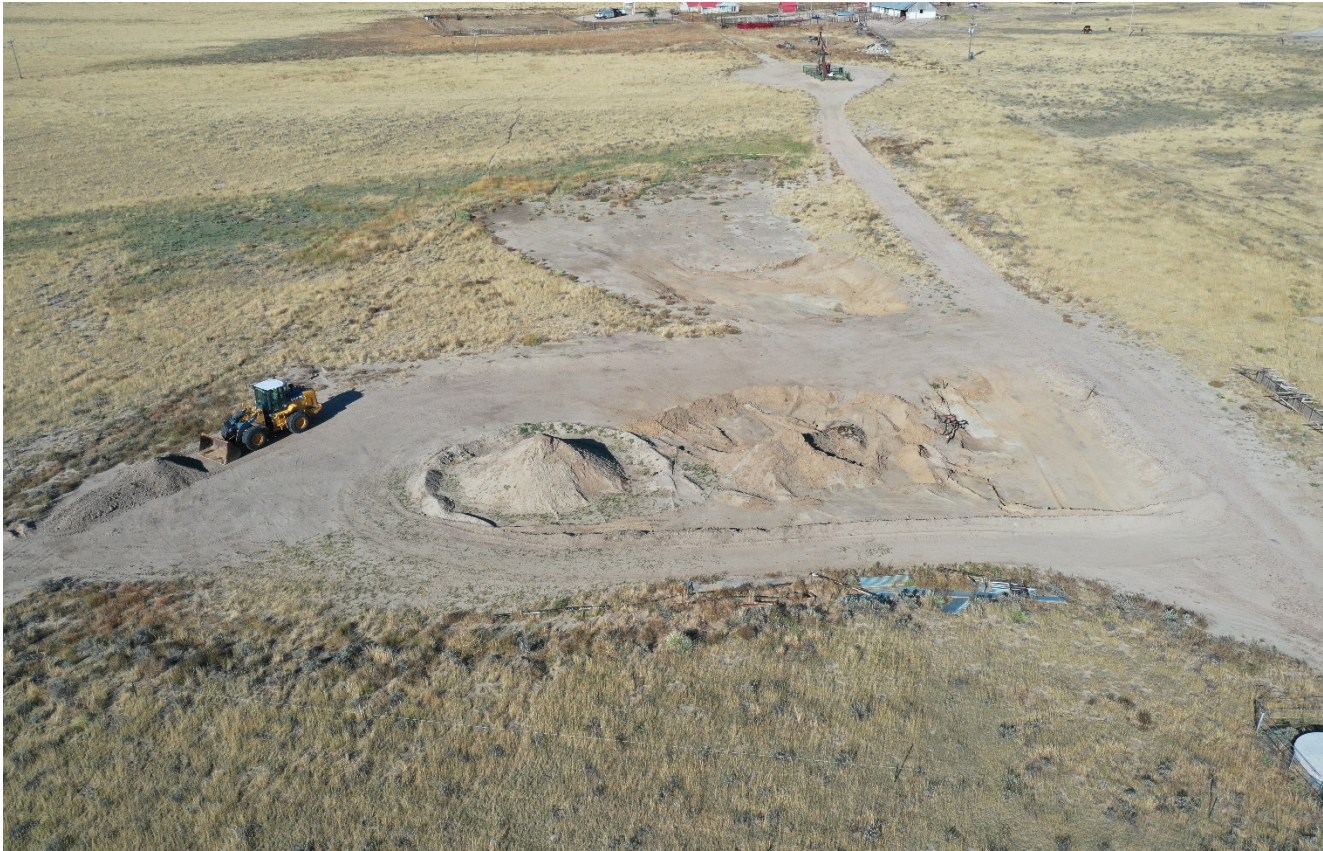
**Photo 13.** Drone aerial photo facing west toward the battery and wellsite. There is a remediation project in process. Photo taken on 10/12/2022.

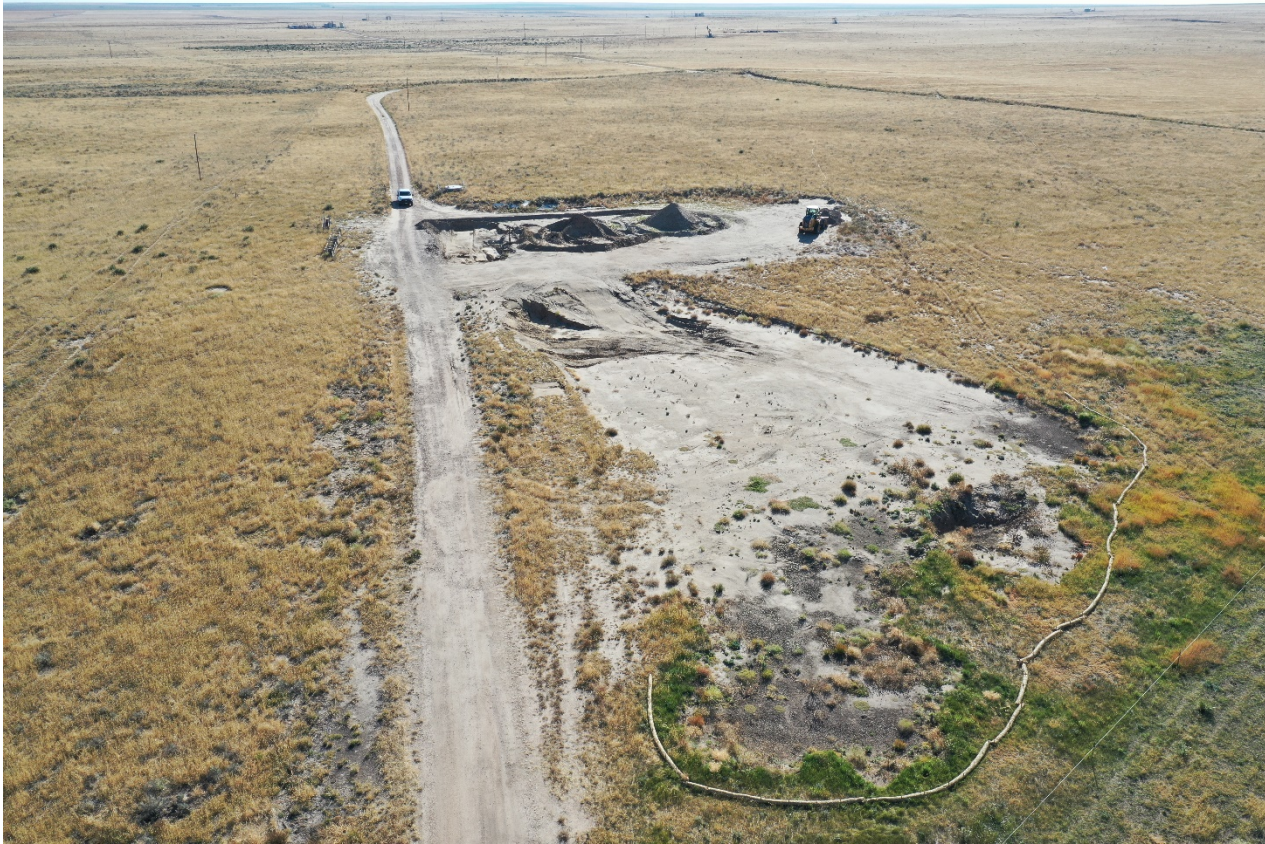
**Photo 14.** Drone aerial photo facing east toward the battery and remediation project. Photo taken on 10/12/2022.
