Inspection Photos

Location Name: TEP ROCKY MOUNTAIN LLC GM 322-12

Location ID: 334908

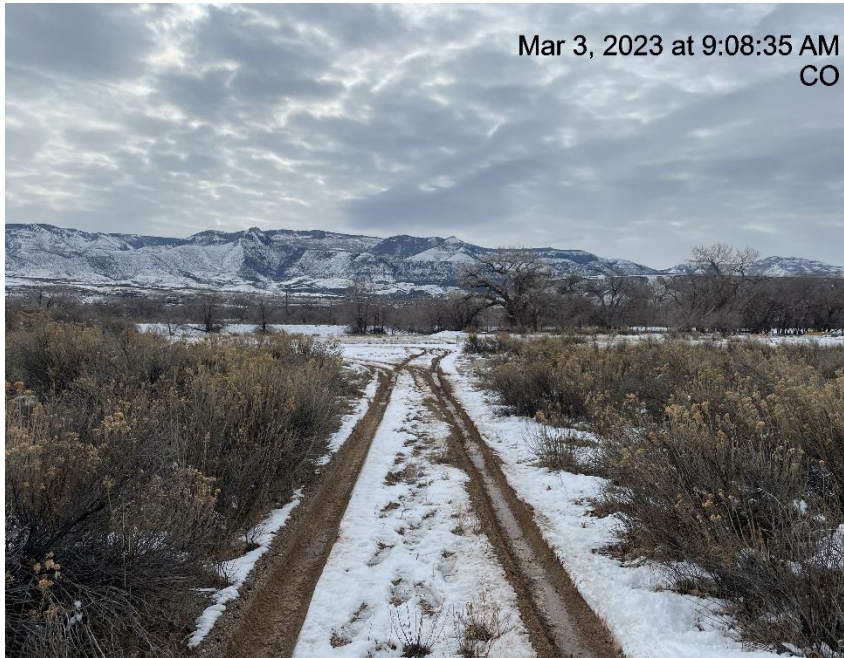
Photo # 1554 From entrance to location.

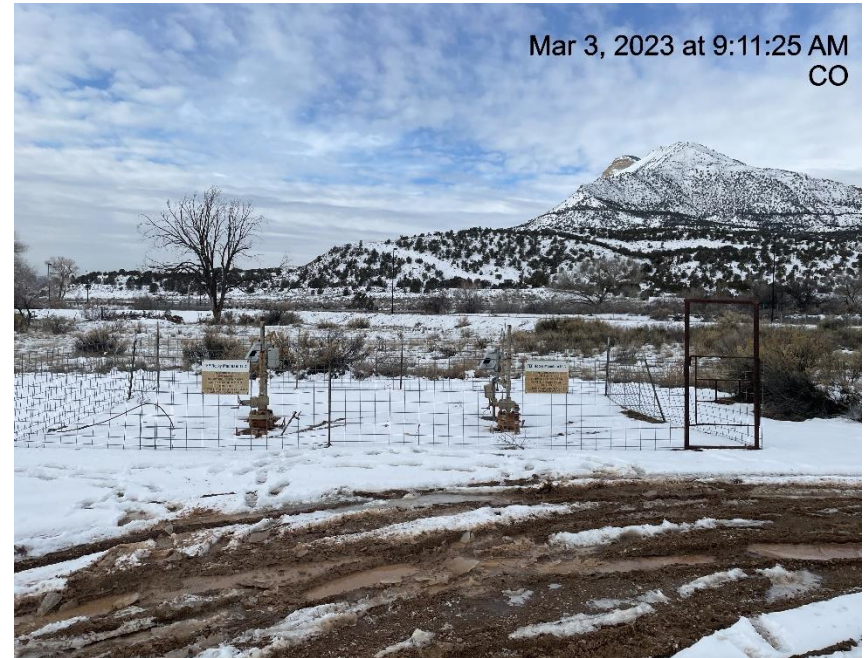
Photo # 1555 Location.

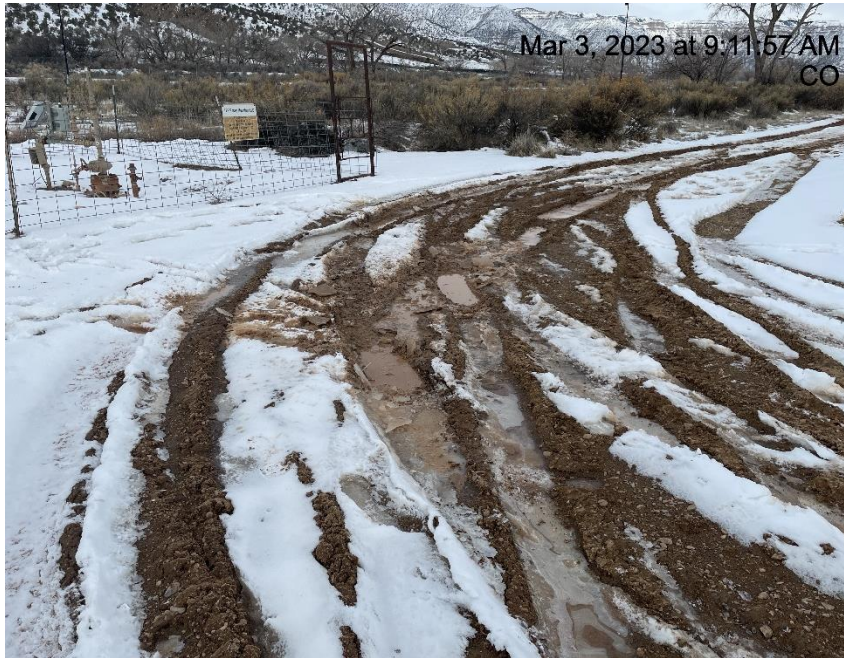
Photo # 1556 Lack of stabilization

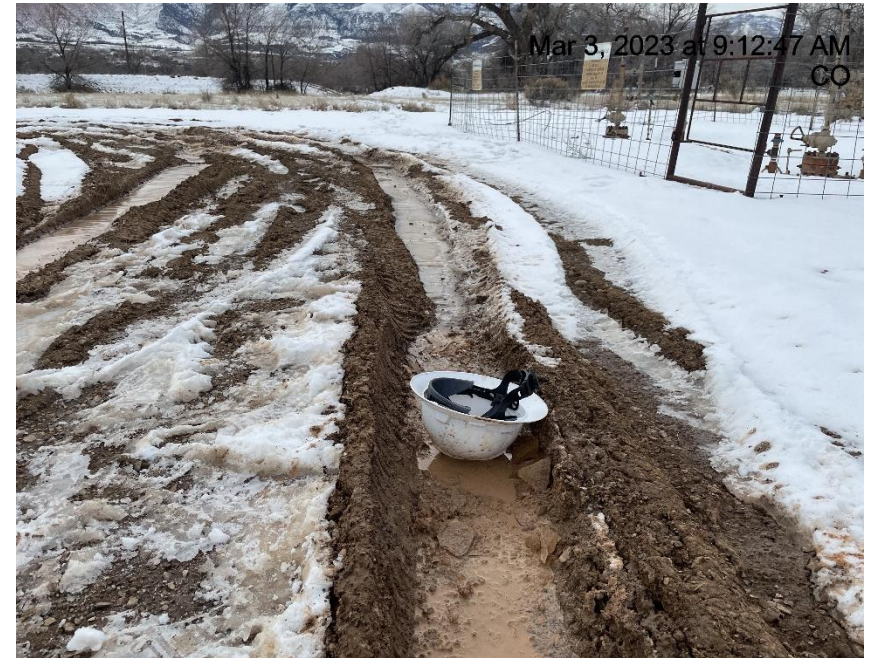
Photo # 1558 Lack of stabilization

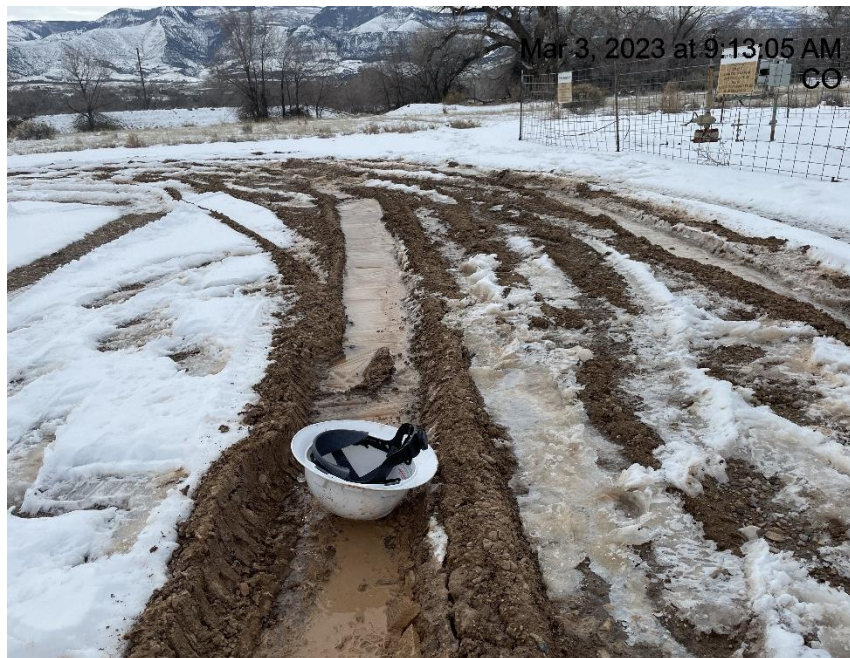
Photo # 1559 Lack of stabilization

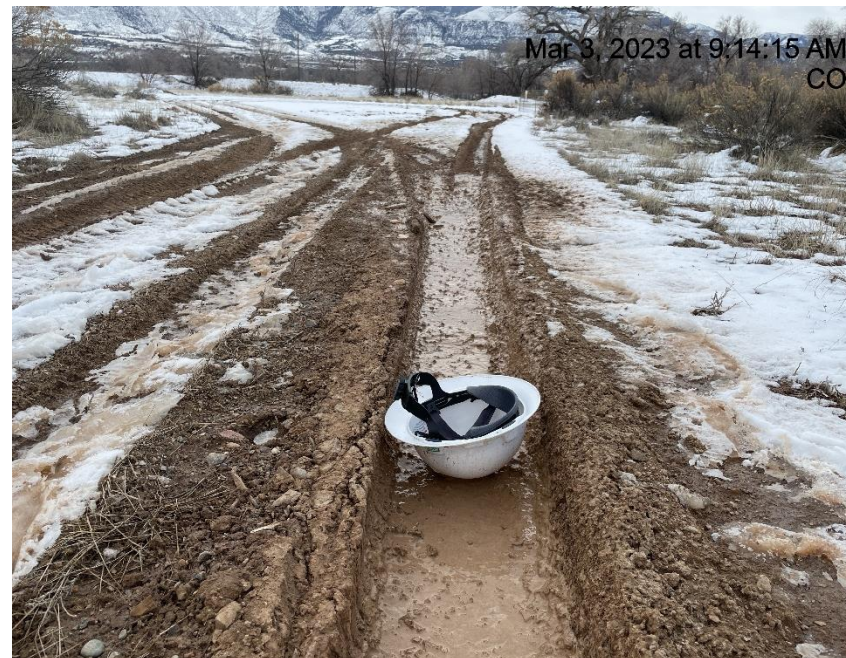
Photo # 1560 Lack of stabilization

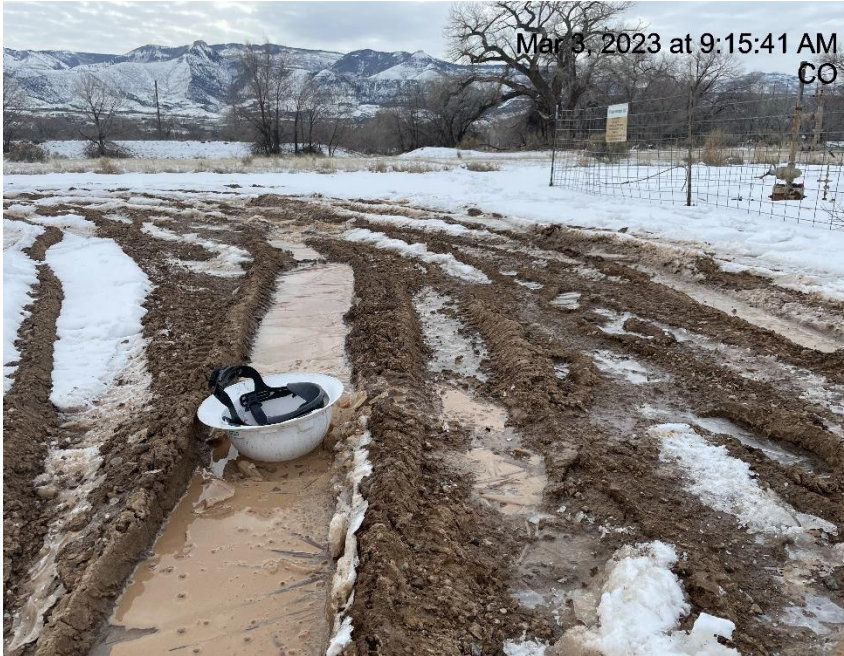
Photo # 1564 Lack of stabilization

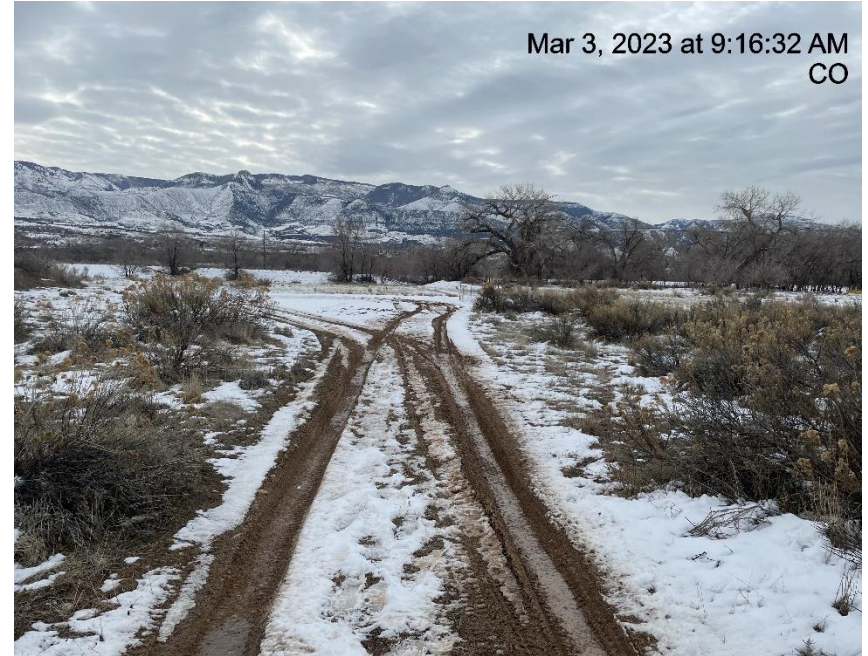
Photo # 1565 Lack of stabilization

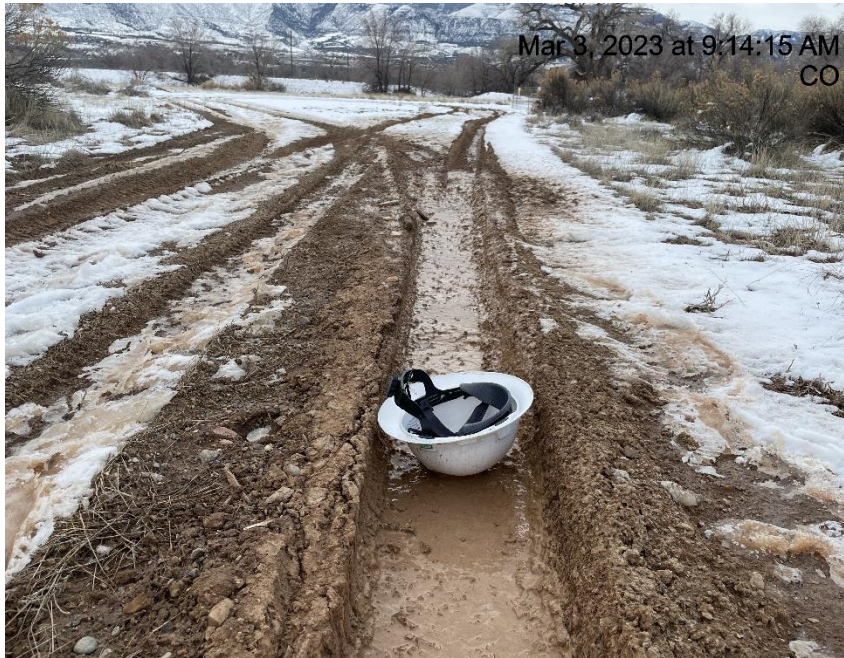
Photo # 1560 Lack of stabilization

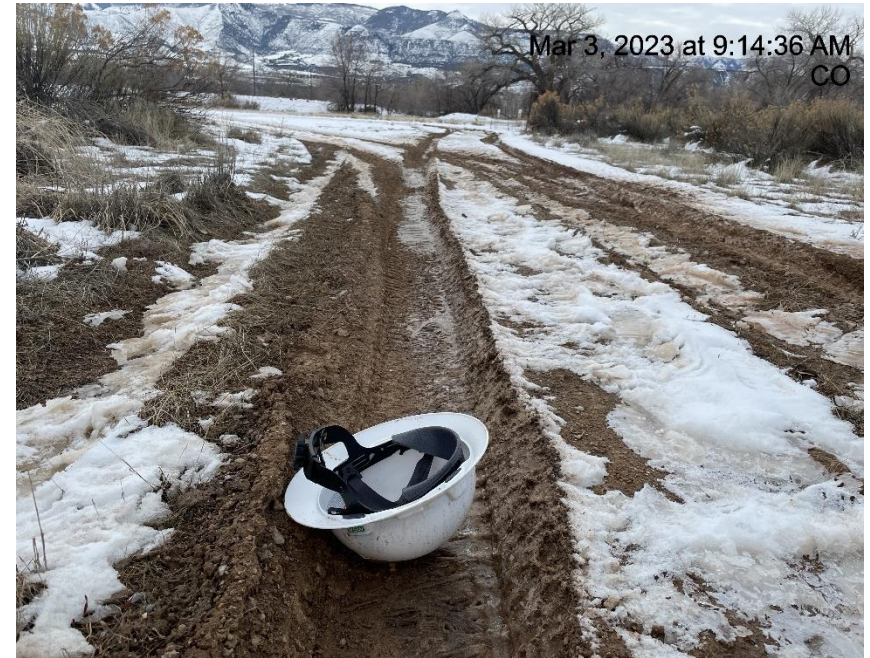
Photo # 1561 Lack of stabilization

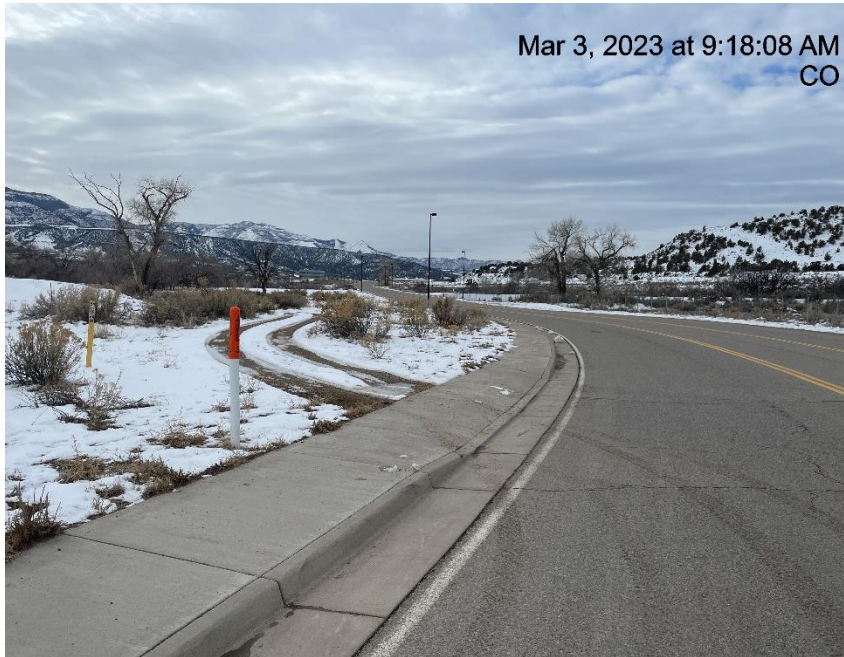
Photo #1566 Insufficient Tracking BMP

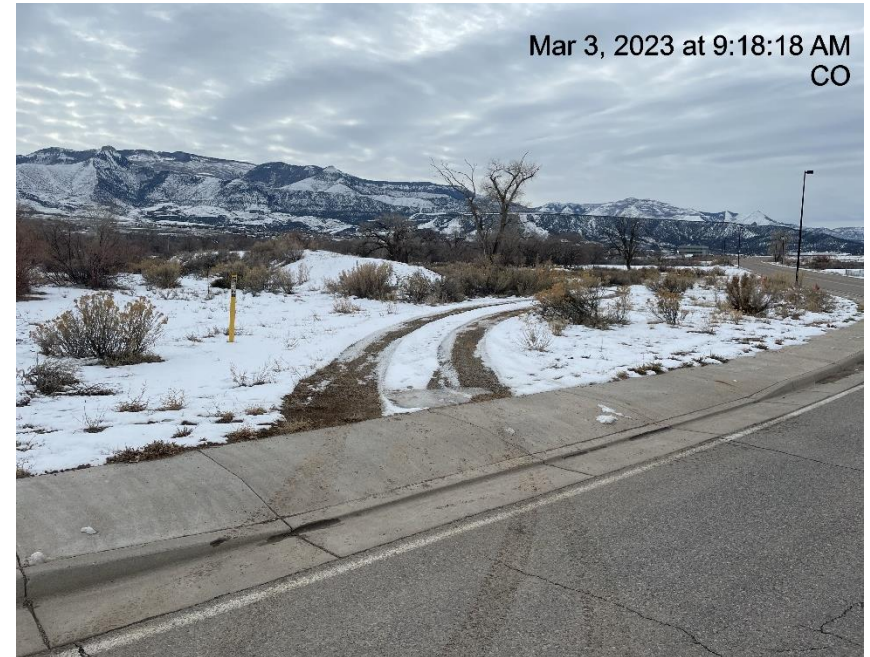
Photo # 1567 Insufficient Tracking BMP
