# Interim Reclamation and Stormwater Inspection

February 28, 2023

Operator: UPLAND EXPLORATION LLC- #10701

Location ID: 456651

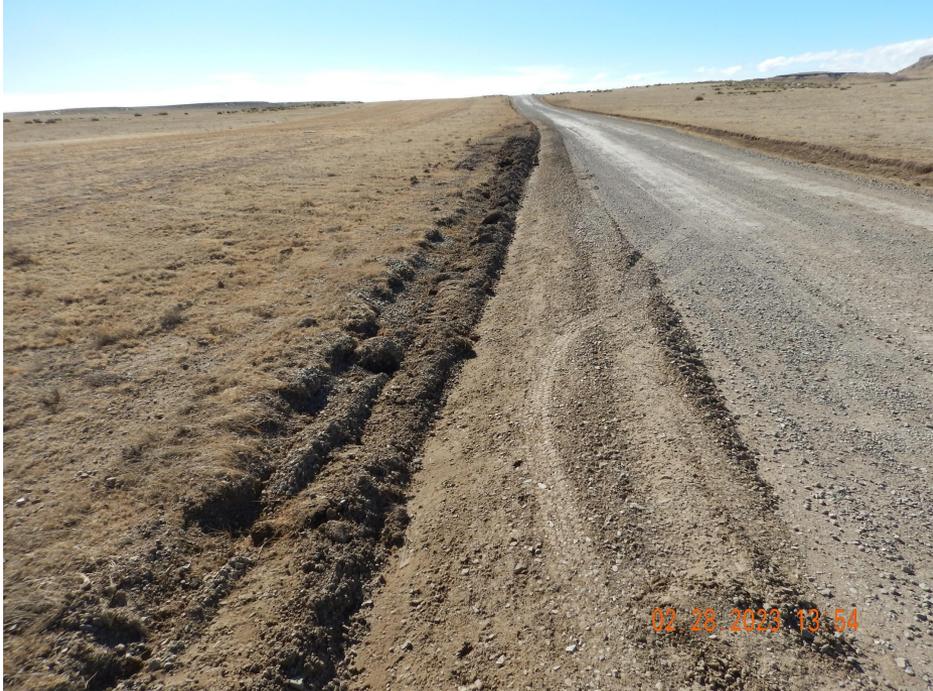
**Photo 1.** Photo taken from a section of the access road, facing West. Photo illustrates the Operator has initiated repairs along the access road but it still remains in-process.

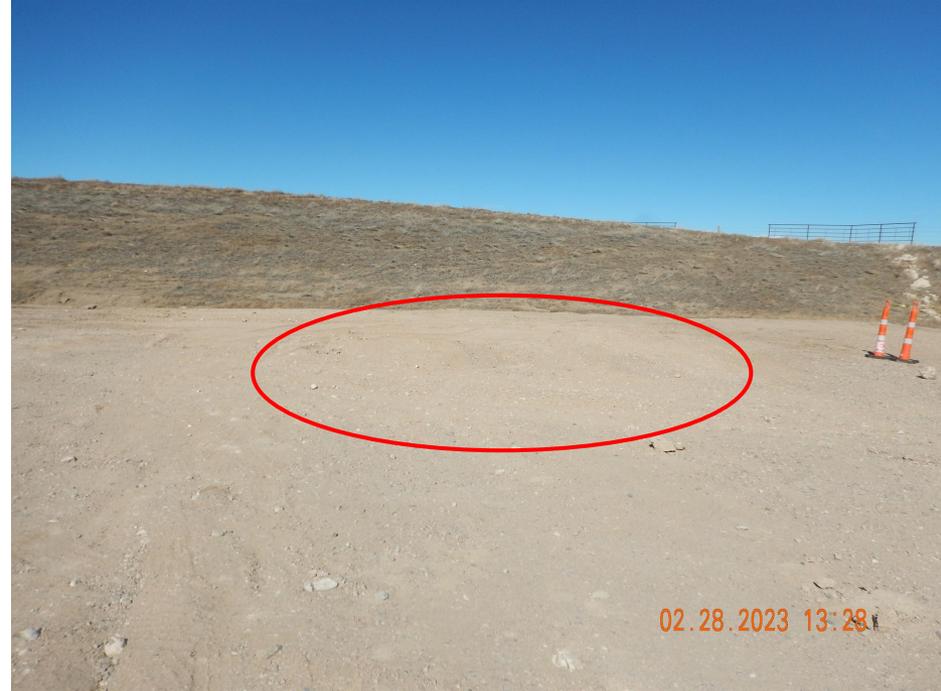
**Photo 2.** Photo taken from the northeastern location, East. Photo illustrates the pit has been backfilled prior to receiving approval by COGCC.

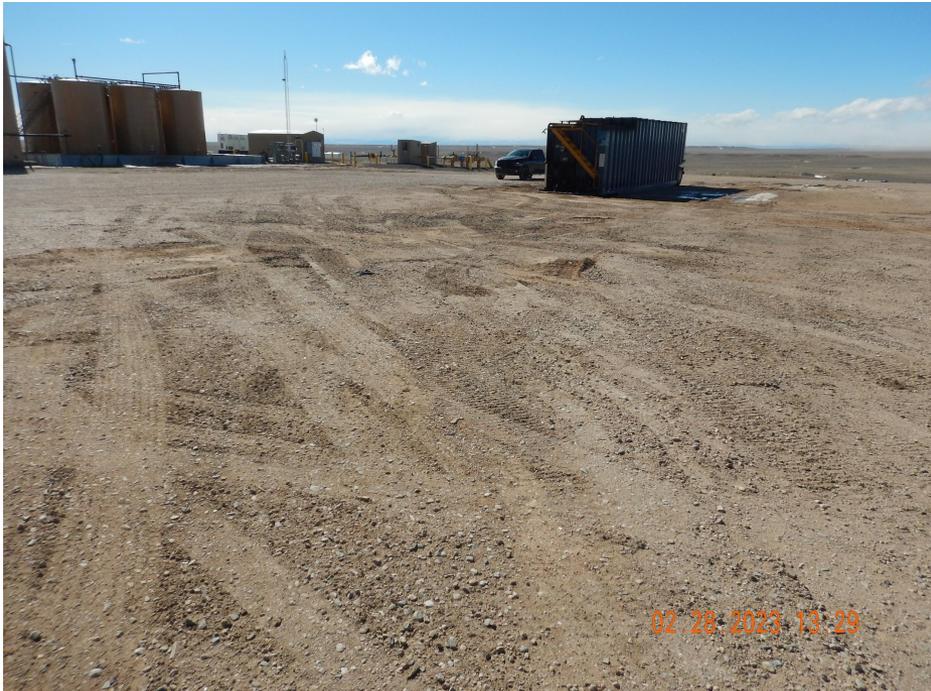
**Photo 3.** Photo taken from the frac tank on location, facing West. It appears that the Operator has cleaned up oily waste but has not submitted the required paperwork. Refer to Photo 4 illustrating the previous observations.

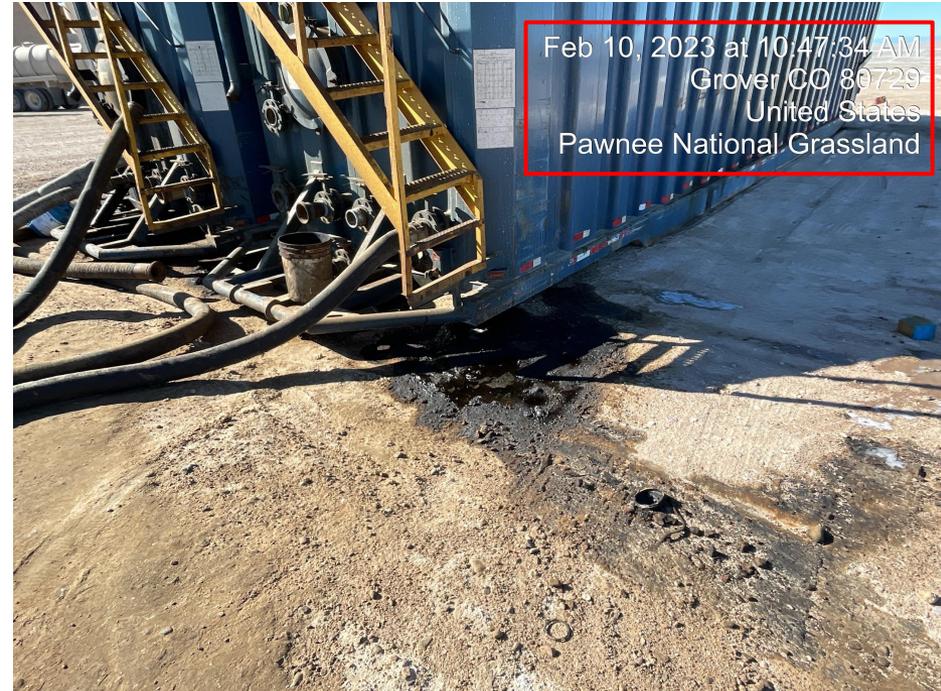
**Photo 4.** Photo taken from a frac tank on location back on 2/10/23. Photo illustrates frac tank is leaking oily waste. Oily waste appears to be underneath the frac tank.

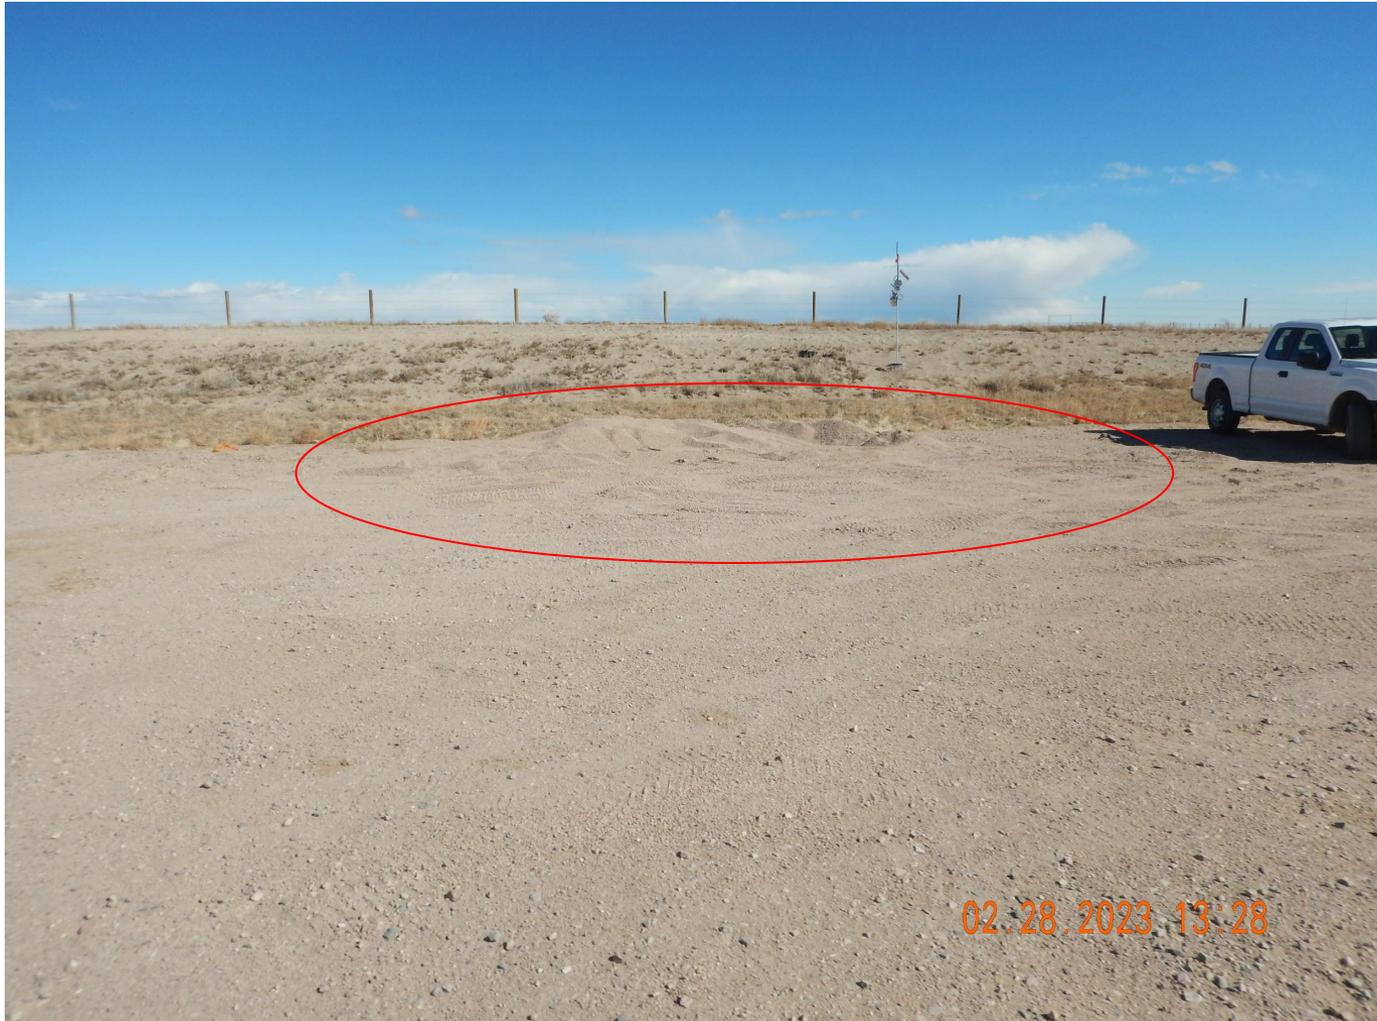
**Photo 5.** Photo taken from the eastern well pad, facing East. Photo illustrates a pile of rock being used. It is unclear what the use is but Staff will conduct another inspection to ensure this wasn't used to cover up stained soil.

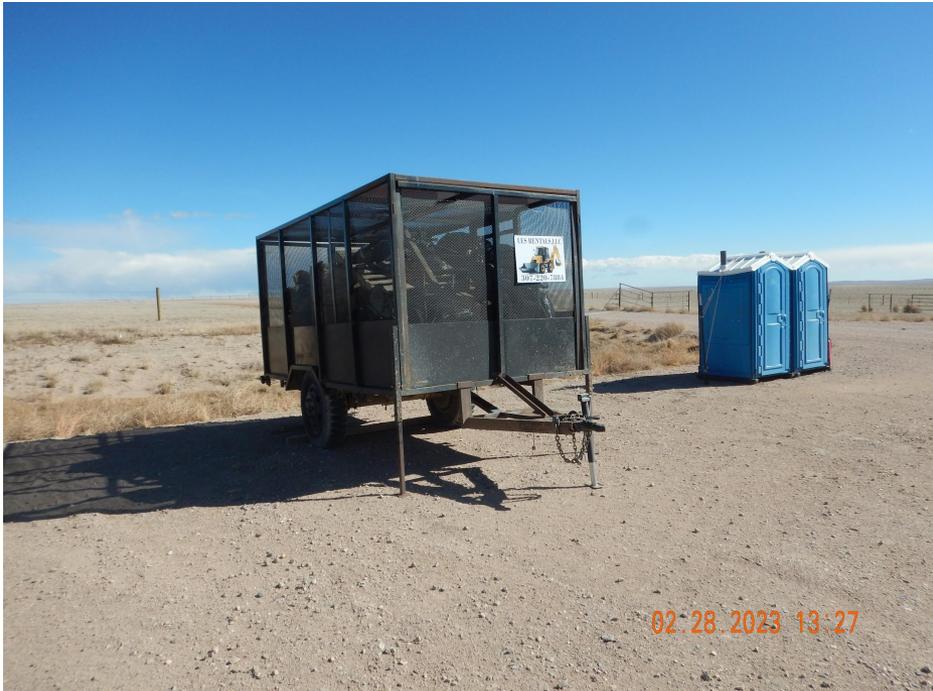
**Photo 6.** Photo taken from the southeastern location, facing East. Photo illustrates the porta-john has been picked up and a trash bin with a cover has been deployed. However, trash was still observed blowing off location.

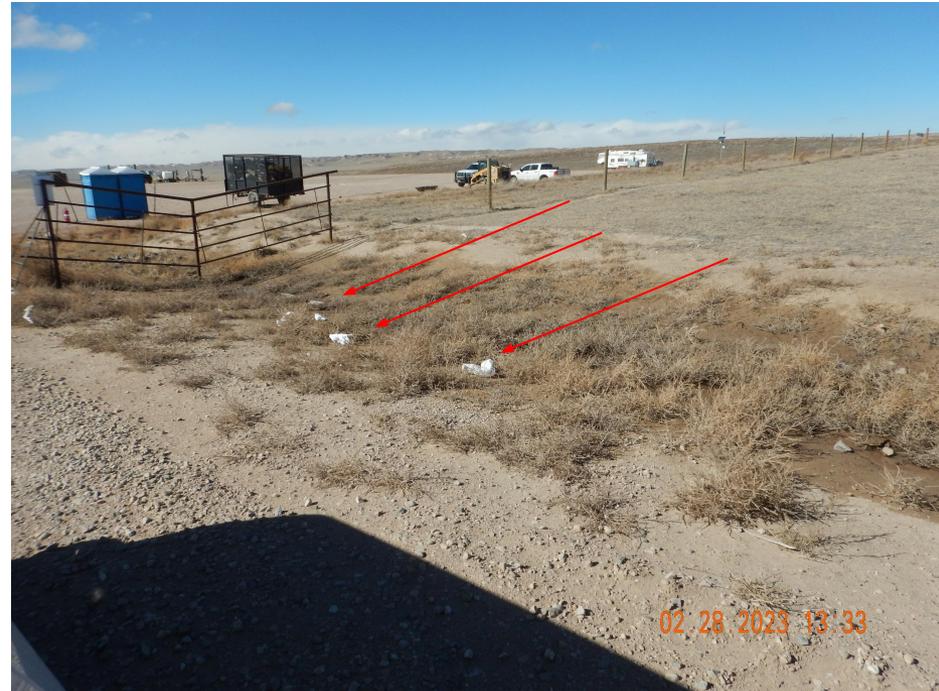
**Photo 7.** Photo taken from a portion of the access road, facing East. Photo illustrates Operator has conducted snow removal on the access road and is creating additional disturbances by plowing road base onto reference areas.

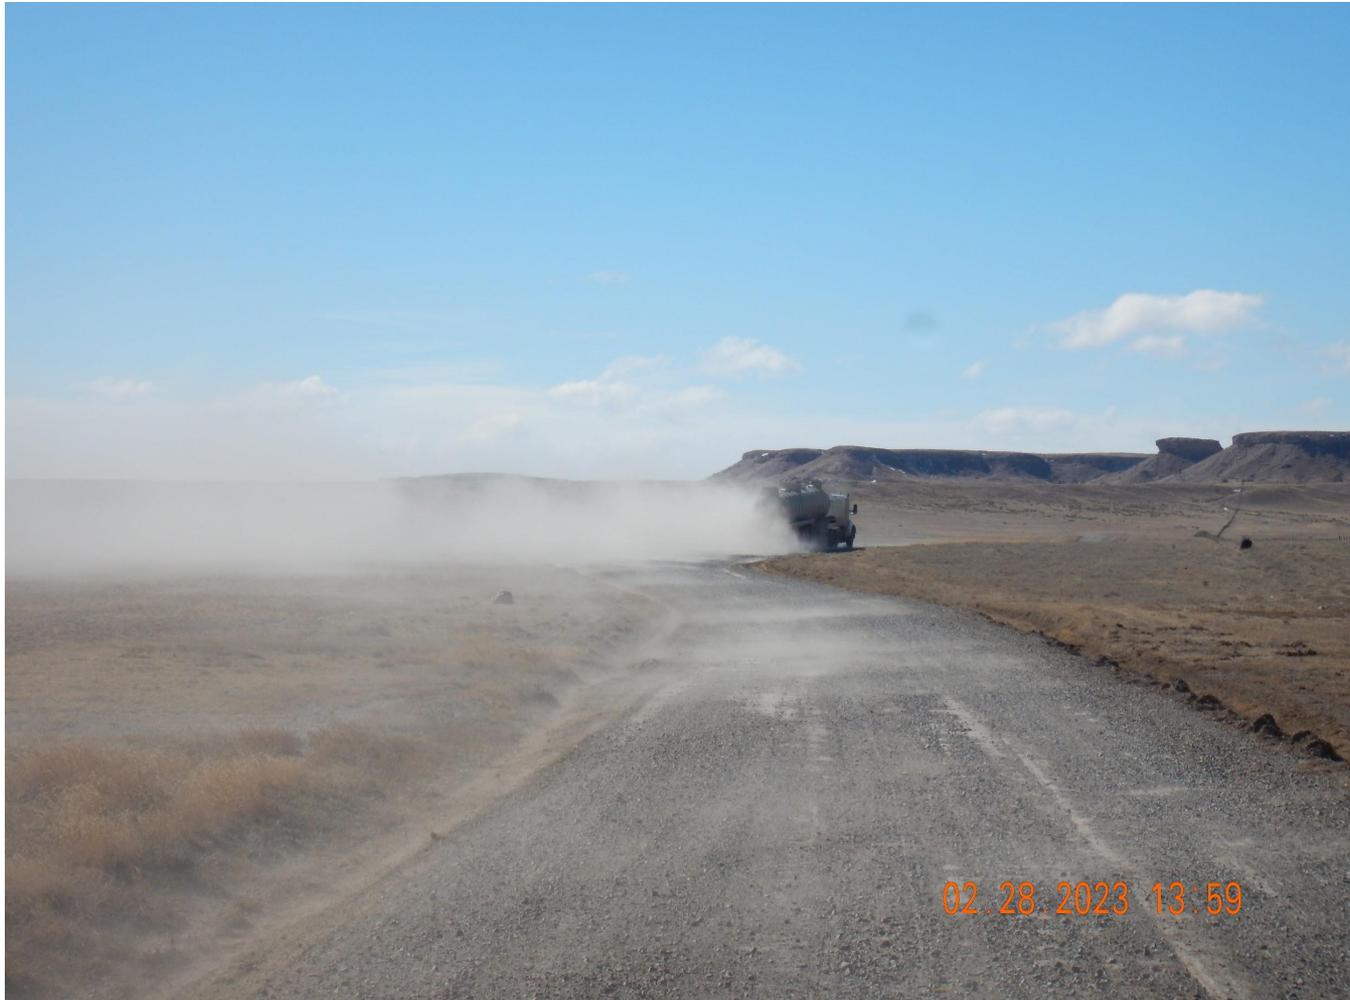
**Photo 8.** Photo taken from a section of the main access road, facing West. Photo illustrates fugitive dust originating from the access road due to Operator truck traffic (i.e., Produced Water truck). See next photo for a zoomed out perspective.

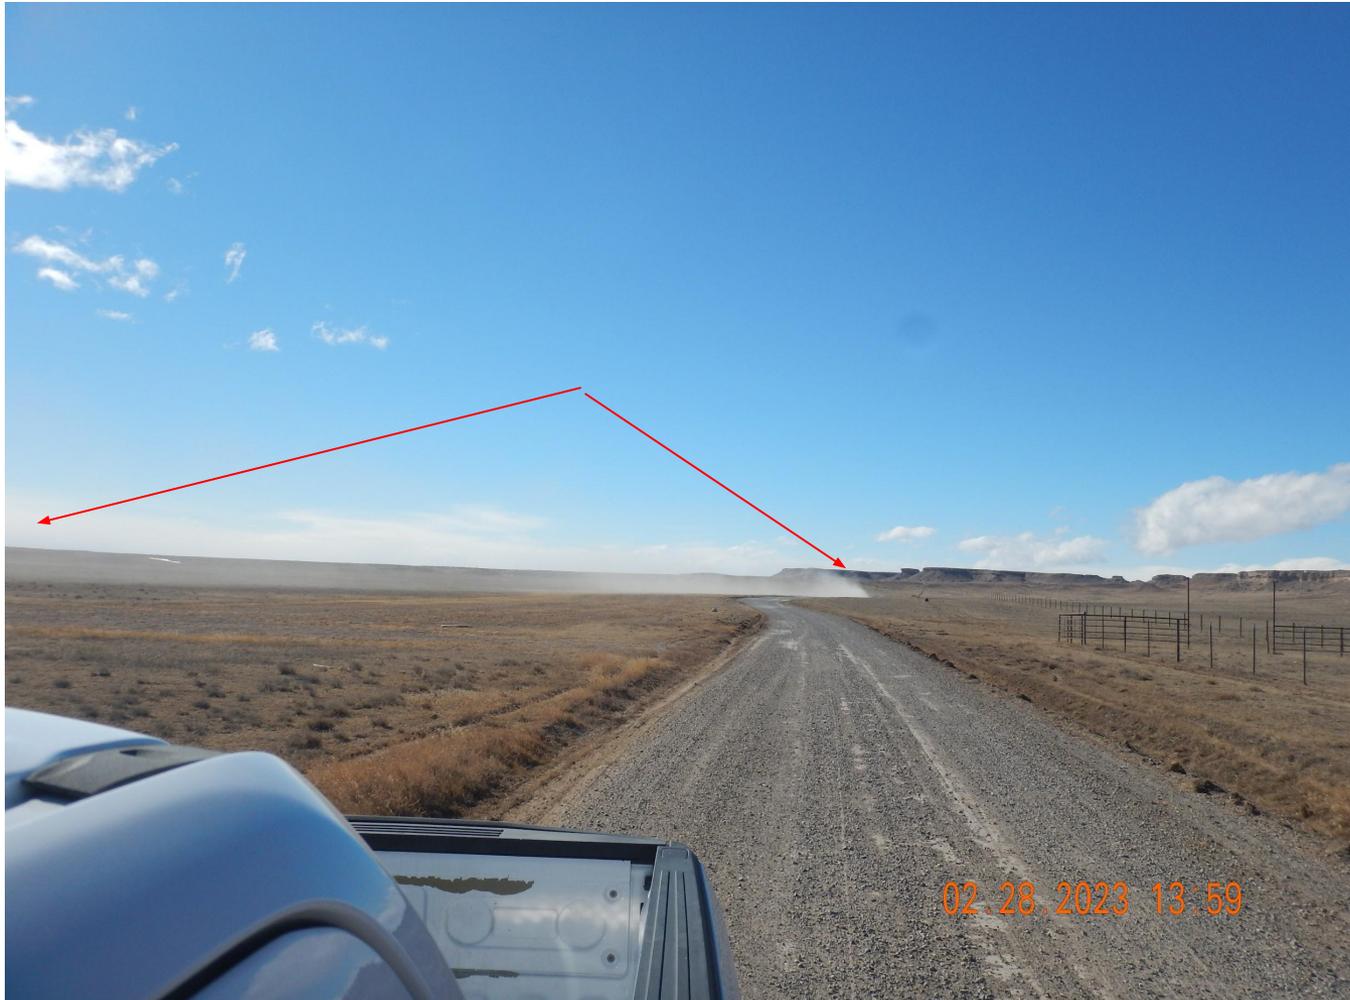
**Photo 9.** Photo taken from a section of the main access road, facing West. See comments under Photo 8.
