# Interim Reclamation and Stormwater Inspection

February 28, 2023

Operator: UPLAND EXPLORATION LLC- #10701

Inspection Photos  
Location Name: Little Lady 21/South Well Pad  
Location ID: 462919

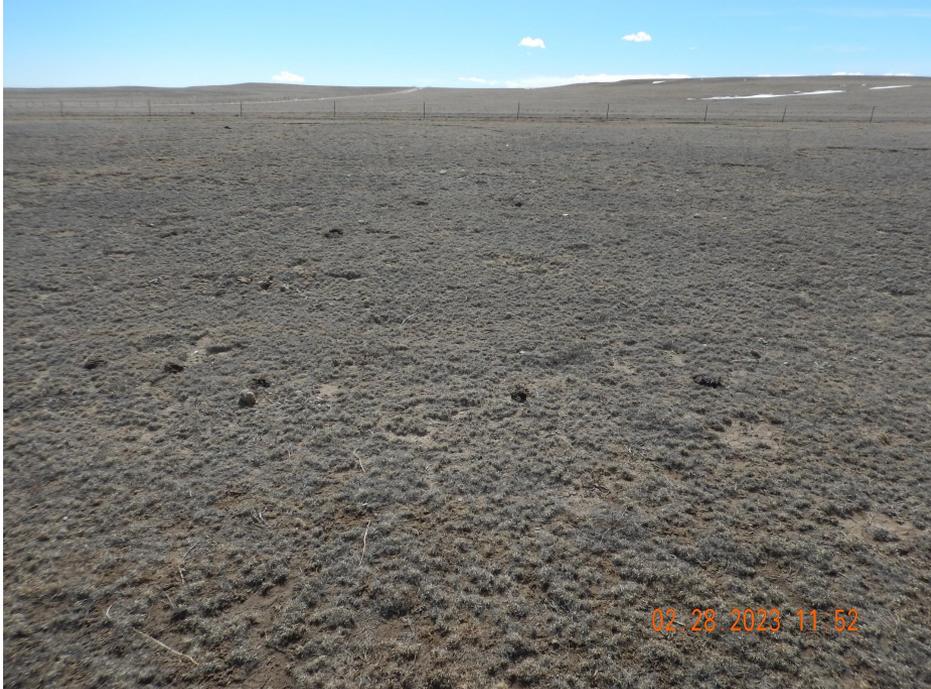
**Photo 1.** Photo taken from the southern location, facing South. Photo illustrates that it appears trash blown off location has been picked up.

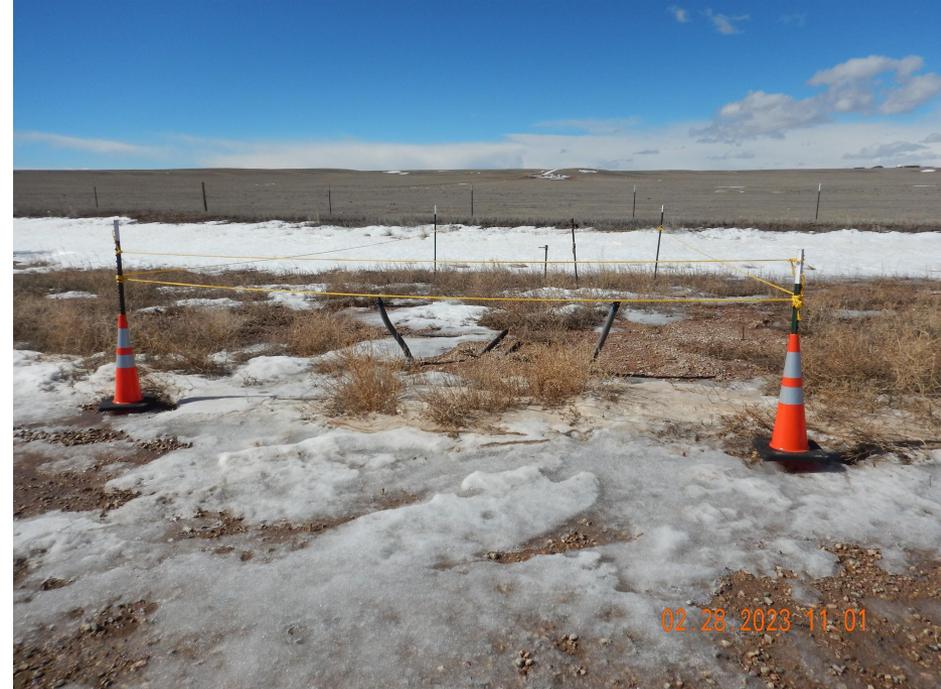
**Photo 2.** Photo taken from the western location, facing West. Photo illustrates previously identified unused equipment. Operator indicated a potential need; therefore, the Compliance Specialist is requiring a plug on the risers. Note- risers are disconnected from any potential gas source.

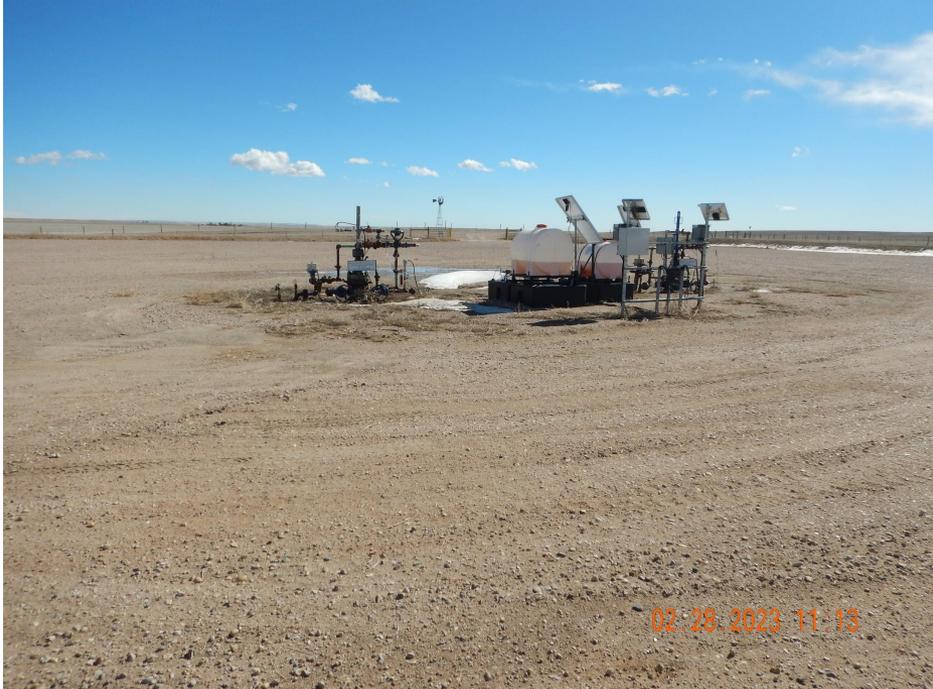
**Photo 3.** Photo taken from the wellheads, facing East. Photo illustrates unused has been removed.

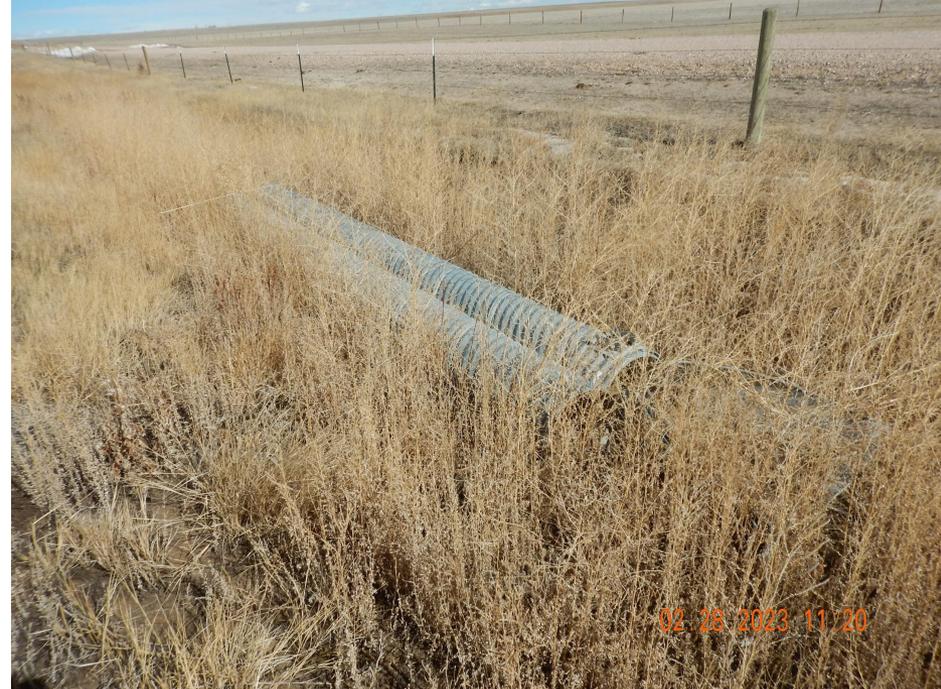
**Photo 4.** Photo taken from the eastern location, facing Northeast. Photo illustrates the weedy vegetation within the BMP area and unused equipment remains.

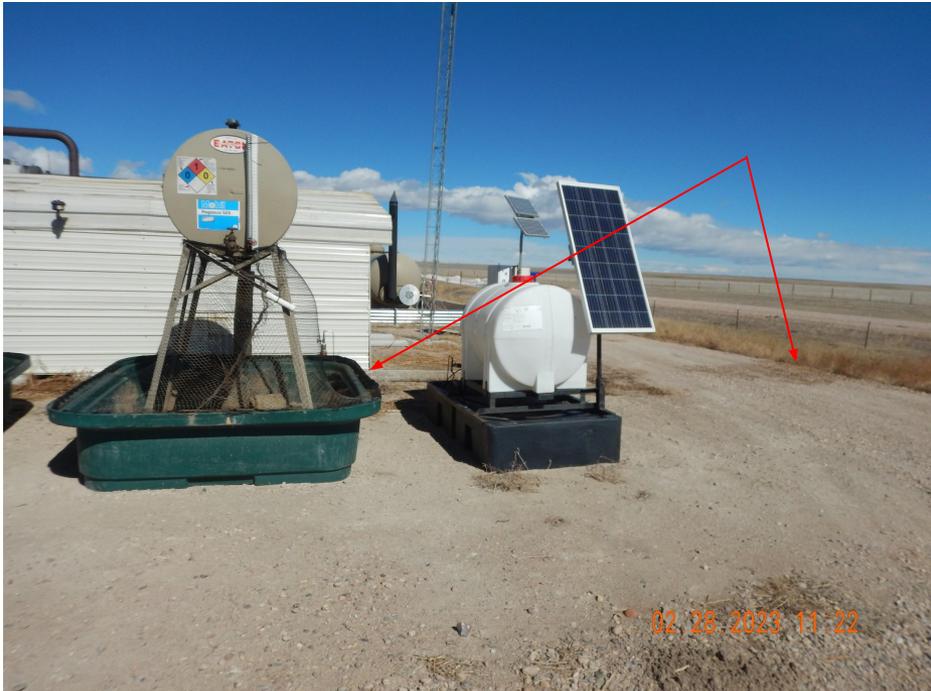
**Photo 5.** Photo taken from the eastern location, facing North. Photo illustrates a spill of what appears to be non-E&P exempt waste from a Mobil Pegasus SAE 40 container. This will need to be reported to CDPHE and this appears to be a violation of Rule 906.  
Note- it does not appear any action has been taken since the previous inspection.

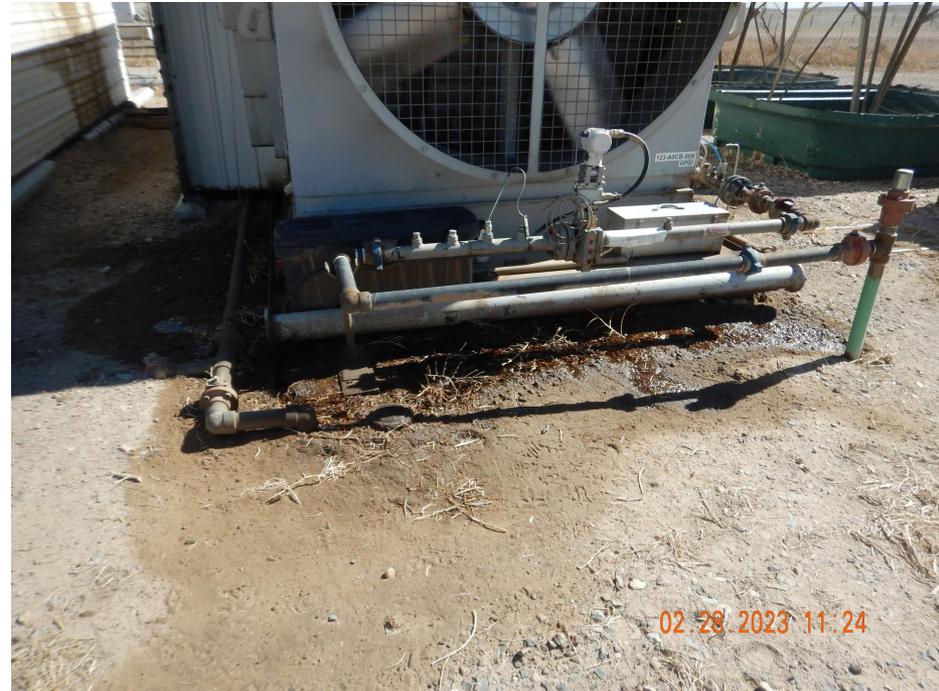
**Photo 6.** Photo taken from the eastern location, facing East. Photo illustrates stained soil/spill related to the compressor.  
Note- it does not appear any action has been taken since the previous inspection.

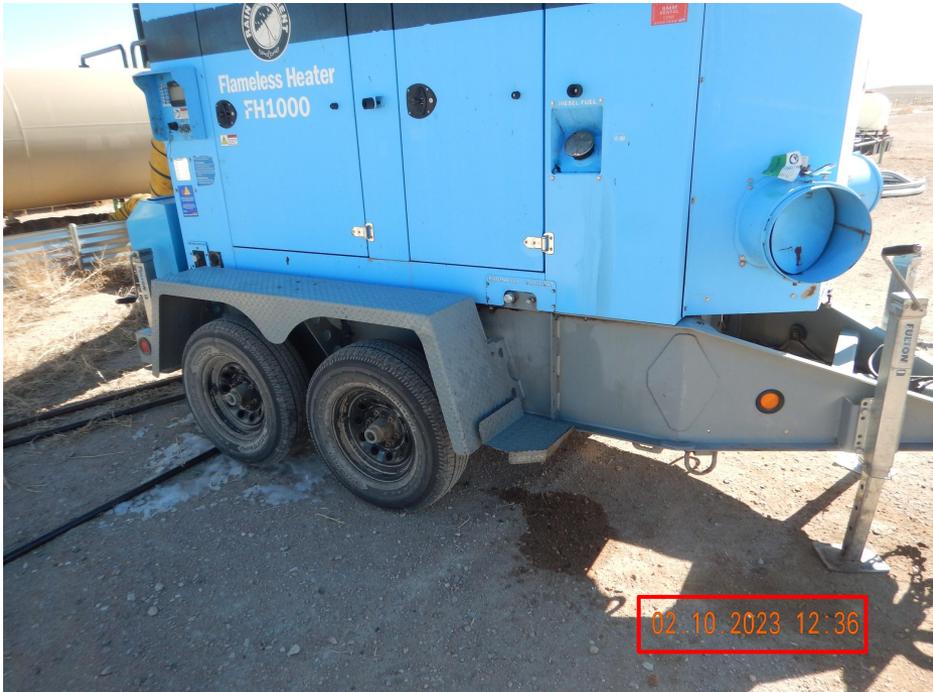
**Photo 7.** Photo taken from the eastern location on 2/10/2023. Photo illustrates poor housekeeping, as diesel fuel has spilled onto the ground. Note- Operator Operator has not installed secondary containment for materials handling and spill prevention practices for this piece of equipment.

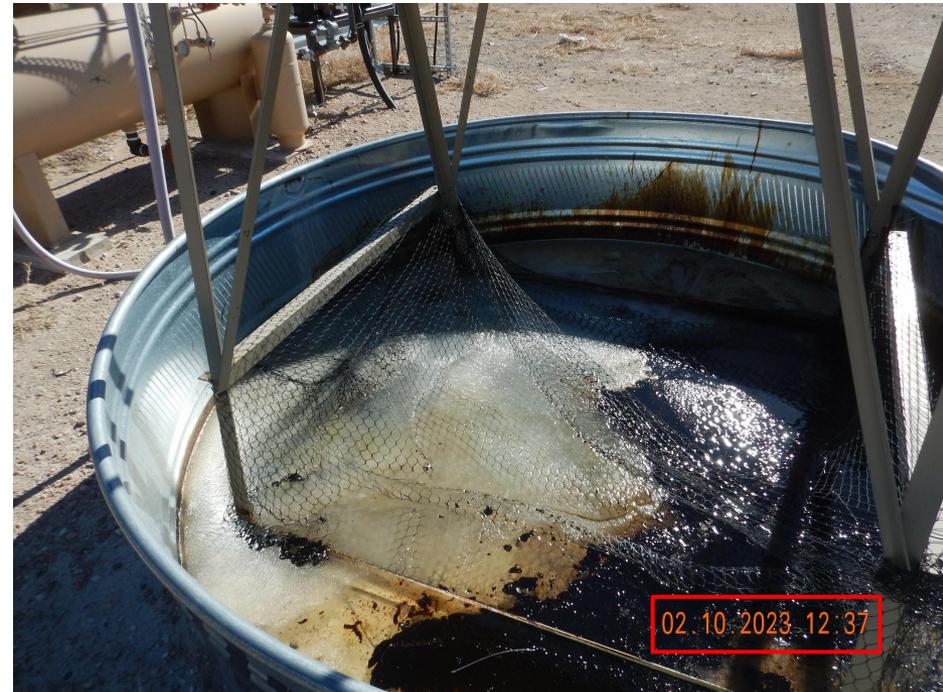
**Photo 8.** Photo taken from the eastern location on 2/10/2023. Photo illustrates netting is in disrepair. Remove and properly dispose fluids from within the secondary containment. Note- Operator has not addressed this corrective action.
