## Third Party Flowline Abandon in place Verification Letter

Parker 21-33

**Client:** Crestone Peak Resources Operating LLC

**Location:** NENW 33 3N67W 6

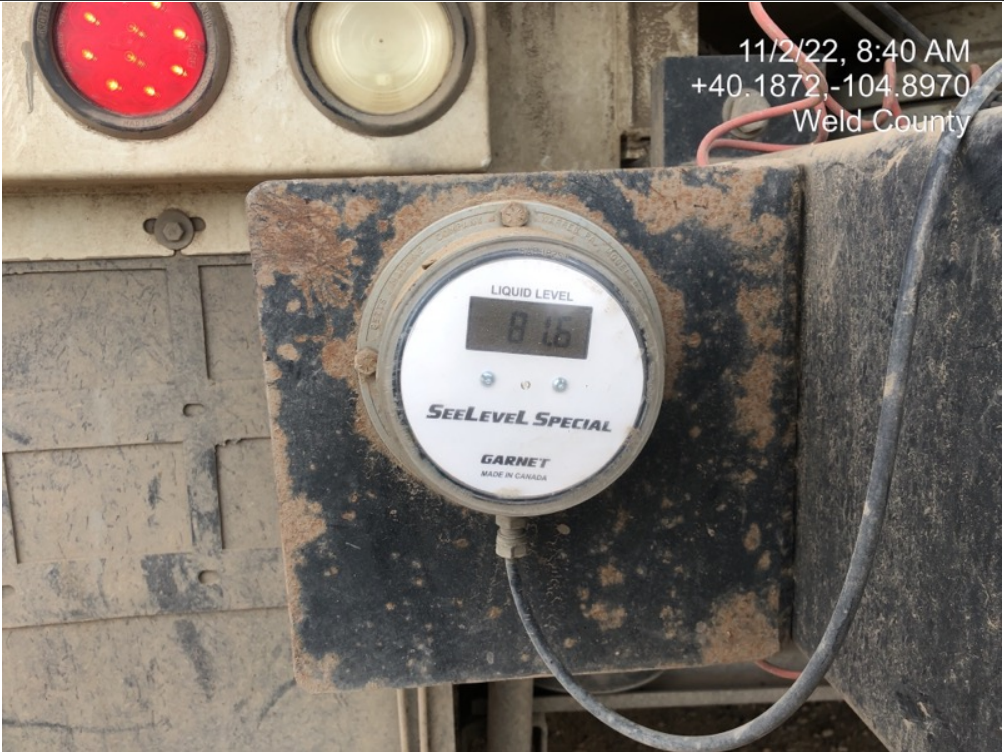
Information		Photo
Photo #: Location: Description:	3 Wellhead Hydrovac truck meter prior to flushing activity

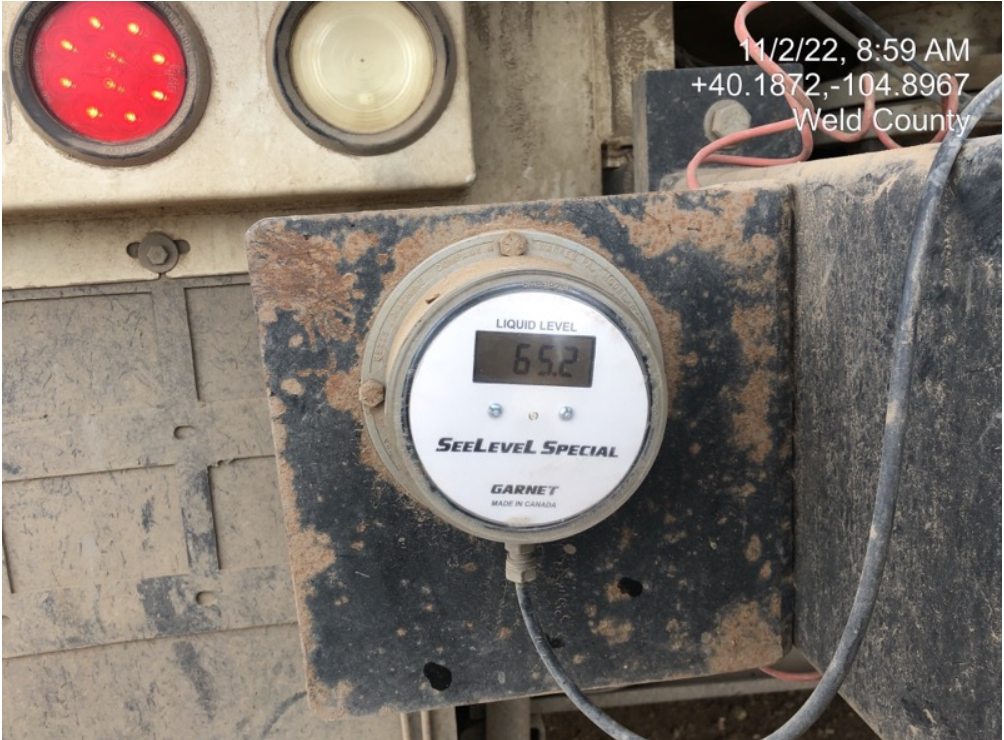
<p>11/2/22, 8:40 AM +40.1872,-104.8970 Weld County</p> <p>The image shows a close-up of a hydrovac truck meter. The meter is a circular gauge with a digital display in the center. The display shows the number '8.16'. Above the display, it says 'LIQUID LEVEL'. Below the display, it says 'SEELVEE SPECIAL' and 'GARNET MADE IN CANADA'. The meter is mounted on a dark, rusted metal panel. In the background, there are two circular lights, one red and one yellow.</p>
Photo #: Location: Description:	4 Wellhead Hydrovac truck meter post flushing activity
