Third Party Flowline Abandon in place Verification Letter

Parker 12-33

Client: Crestone Peak Resources Operating LLC

Location: Wellhead Line 33NWNW

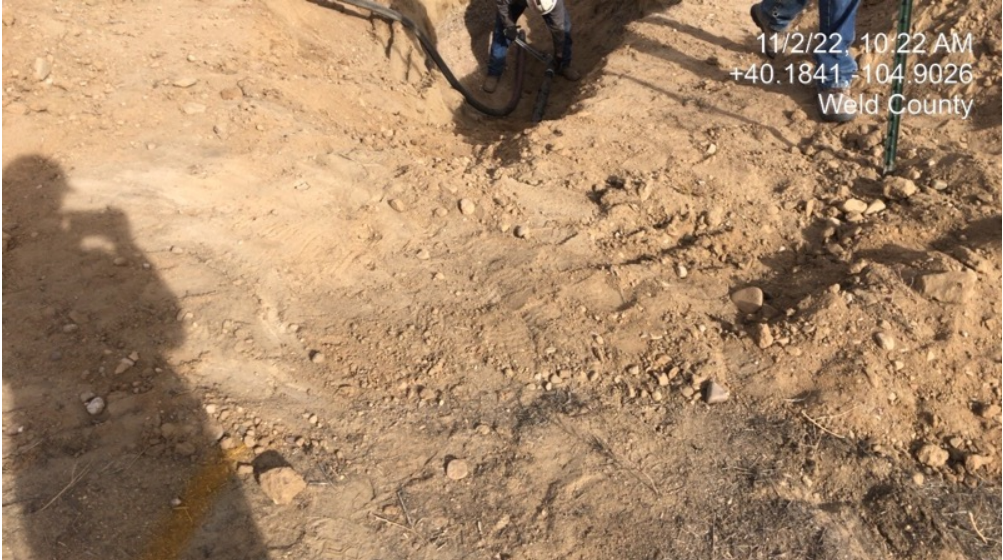
Information		Photo
Photo #: Location: Description:	1 Wellhead End A prior to flushing activity

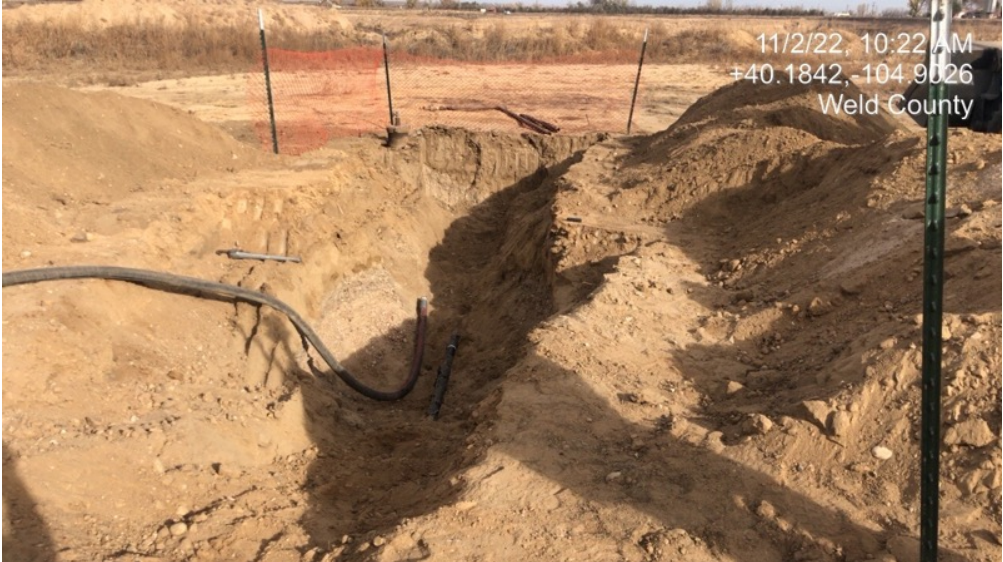
<p>11/2/22, 10:22 AM +40.1841, -104.9026 Weld County</p>
Photo #: Location: Description:	2 End B End B prior to flushing

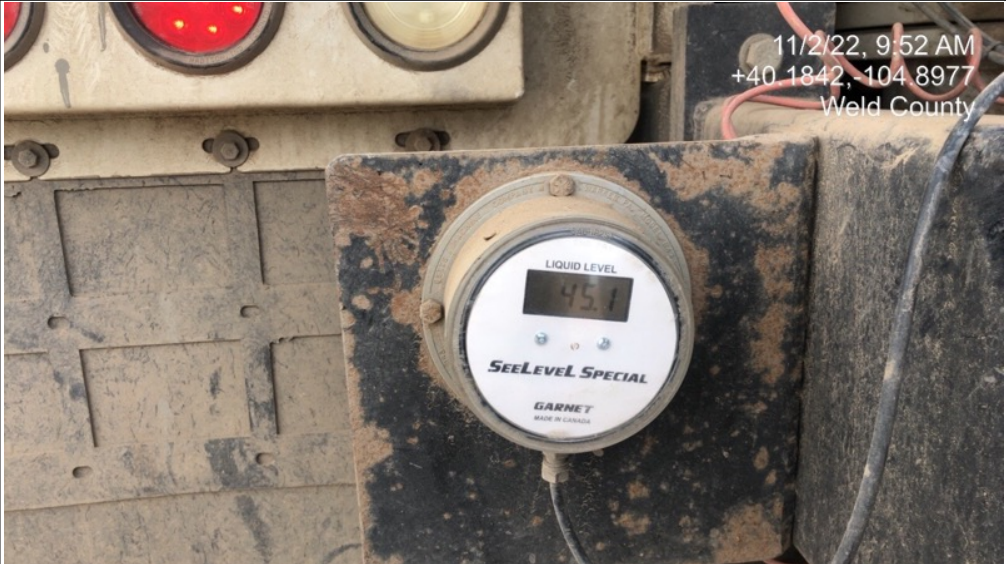
Information		Photo
Photo #: Location: Description:	3 Wellhead Hydrovac truck meter prior to flushing activity

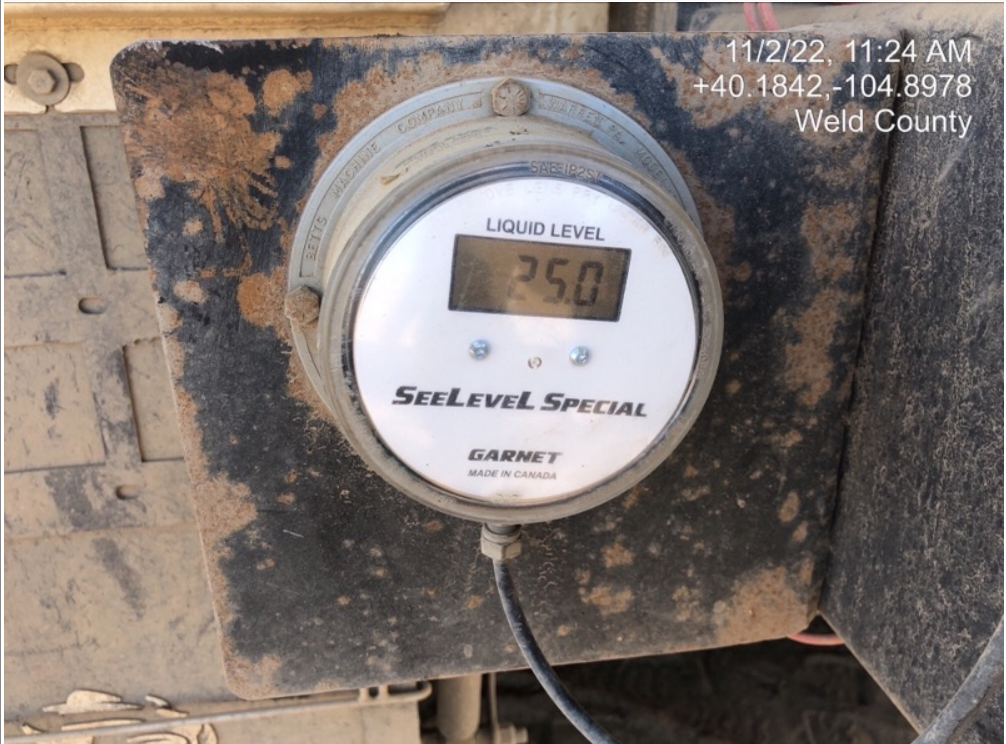
<p>11/2/22, 9:52 AM +40.1842, -104.8977 Weld County</p>
Photo #: Location: Description:	4 Wellhead Hydrovac truck meter post flushing activity
