Third Party Flowline Abandon in place Verification Letter

Parker 11-33

Client: Crestone Peak Resources Operating LLC

Location: Wellhead Line 33NWNW

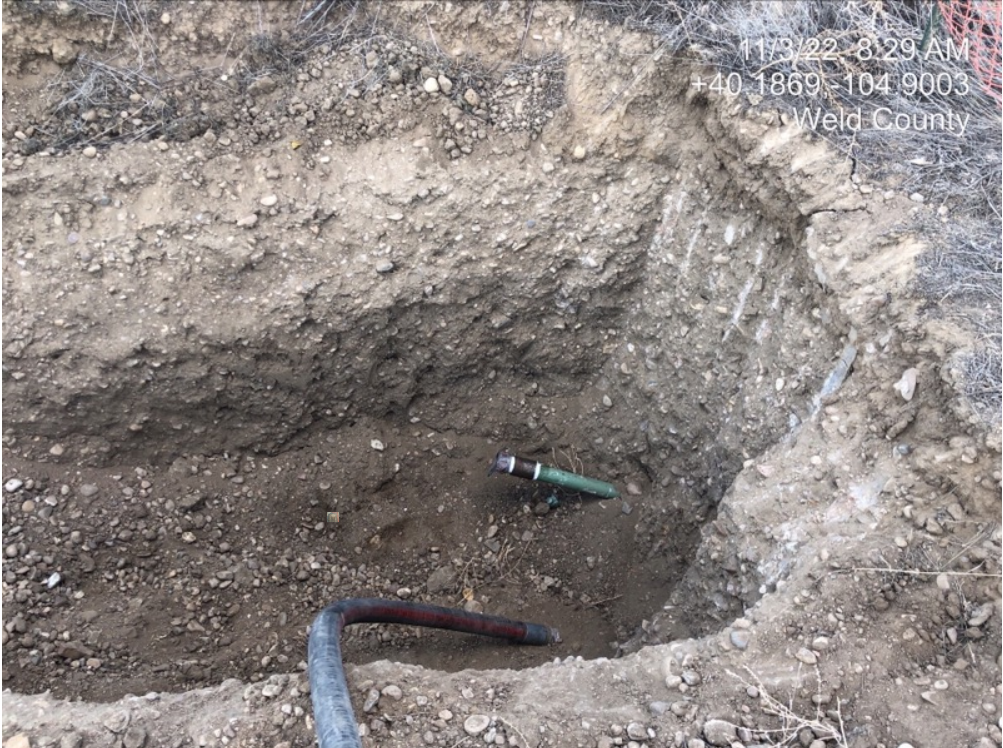
Information		Photo
Photo #: Location: Description:	1 Flowline End B End B prior to flushing activity

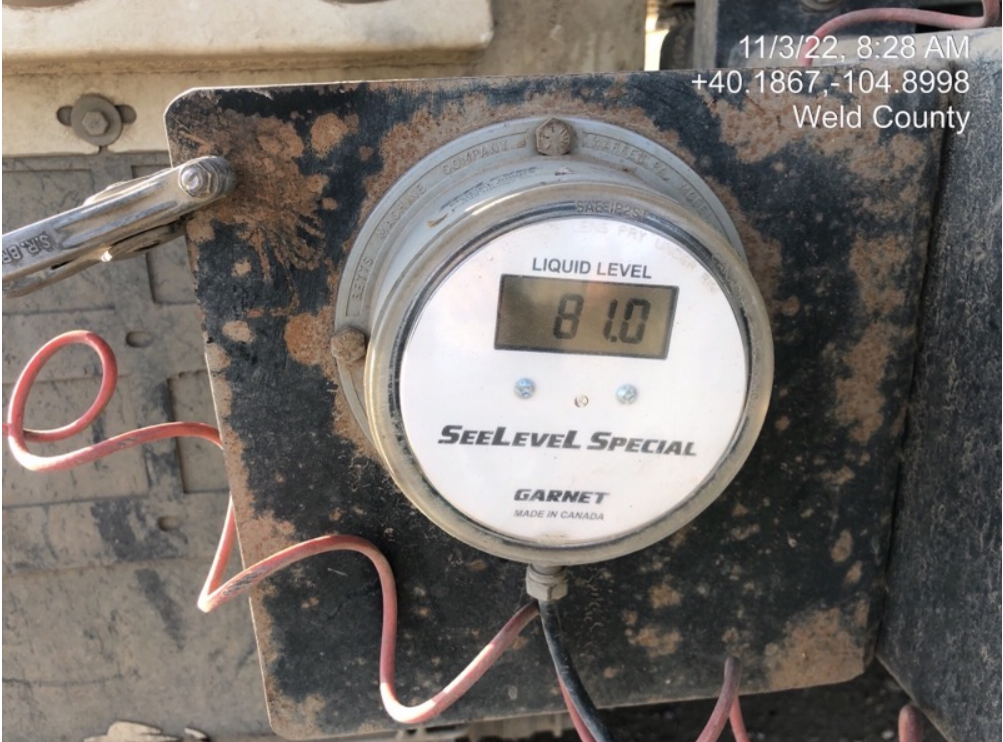
<p>11/3/22 8:29 AM +40.1869-104.9003 Weld County</p>
Photo #: Location: Description:	2 Wellhead Hydrovac truck Meter prior to flushing activity

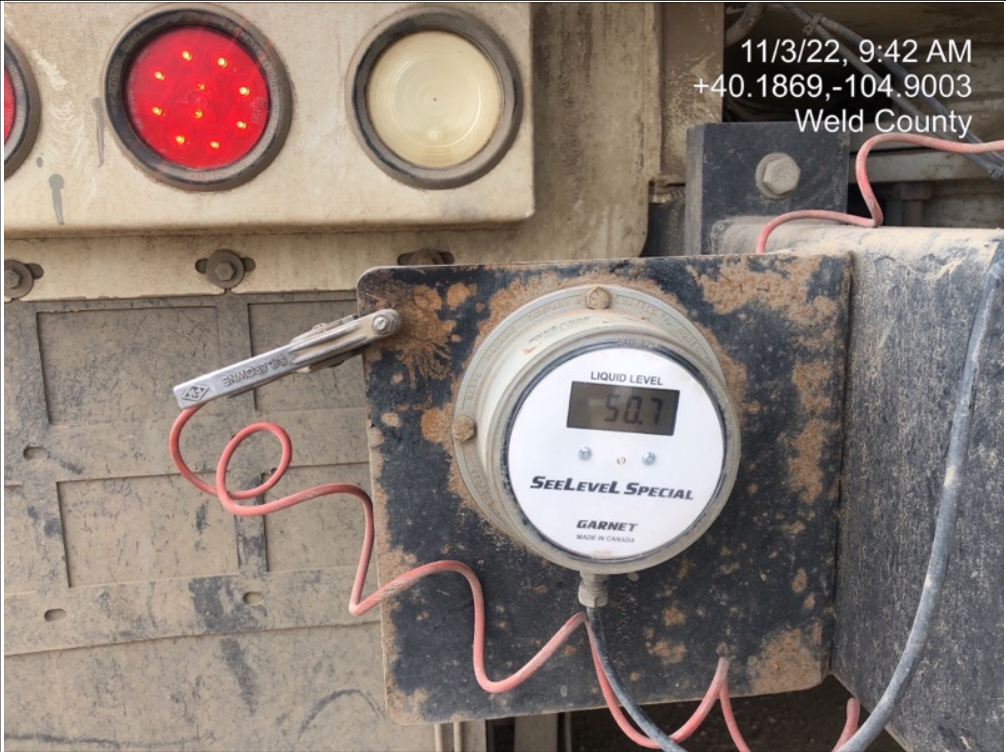
Information		Photo
Photo #: Location: Description:	3 Wellhead Hydrovac truck Meter post flushing activity

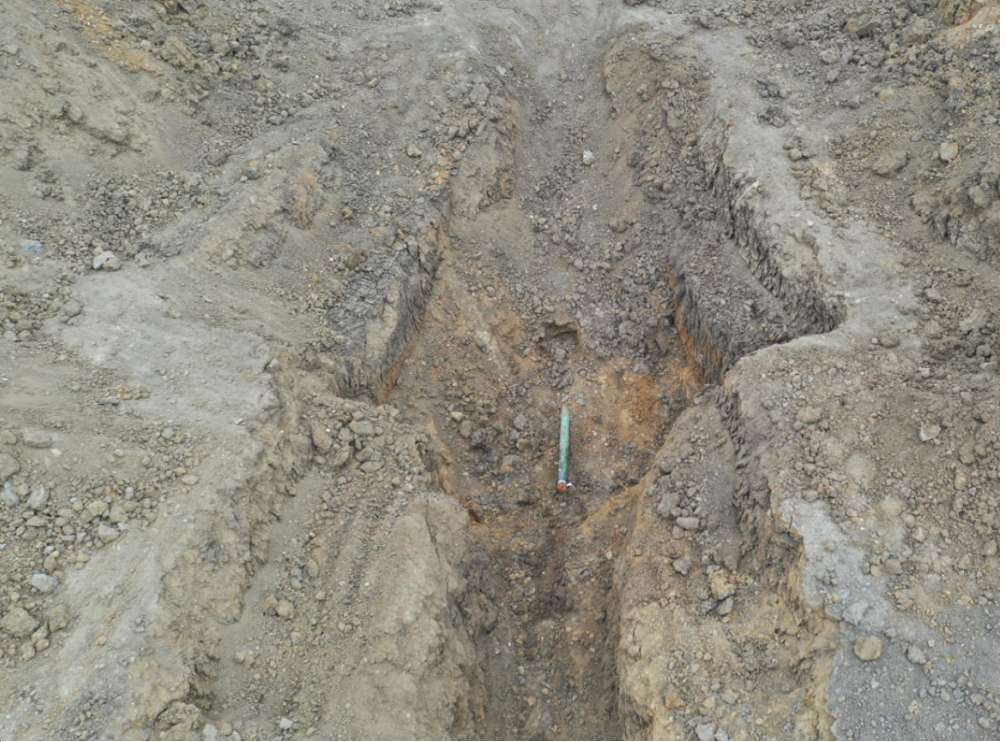
<p>11/3/22, 9:42 AM +40.1869,-104.9003 Weld County</p>
Photo #: Location: Description:	4 Wellhead End A post flushing operation

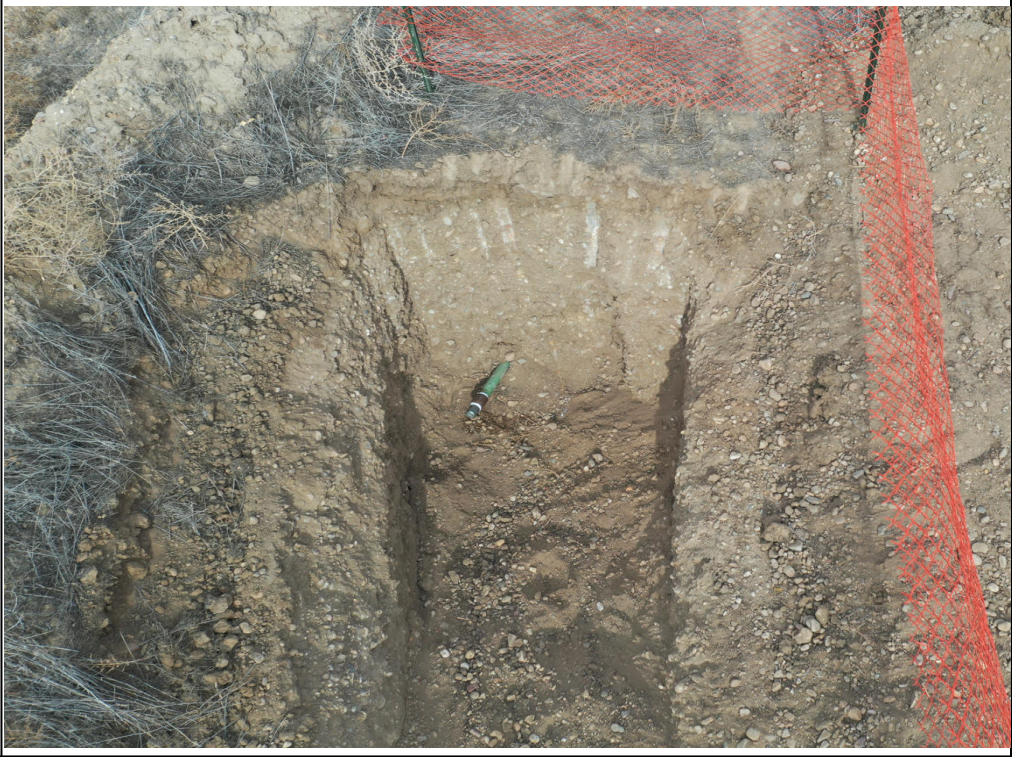
Information		Photo
Photo #: Location: Description:	5 Wellhead End A post flushing operation
