Final Reclamation and Stormwater Inspection

Date: 03/08/2023

Operator: SCHNEIDER ENERGY SERVICES INC - 76840

Location ID: 317498

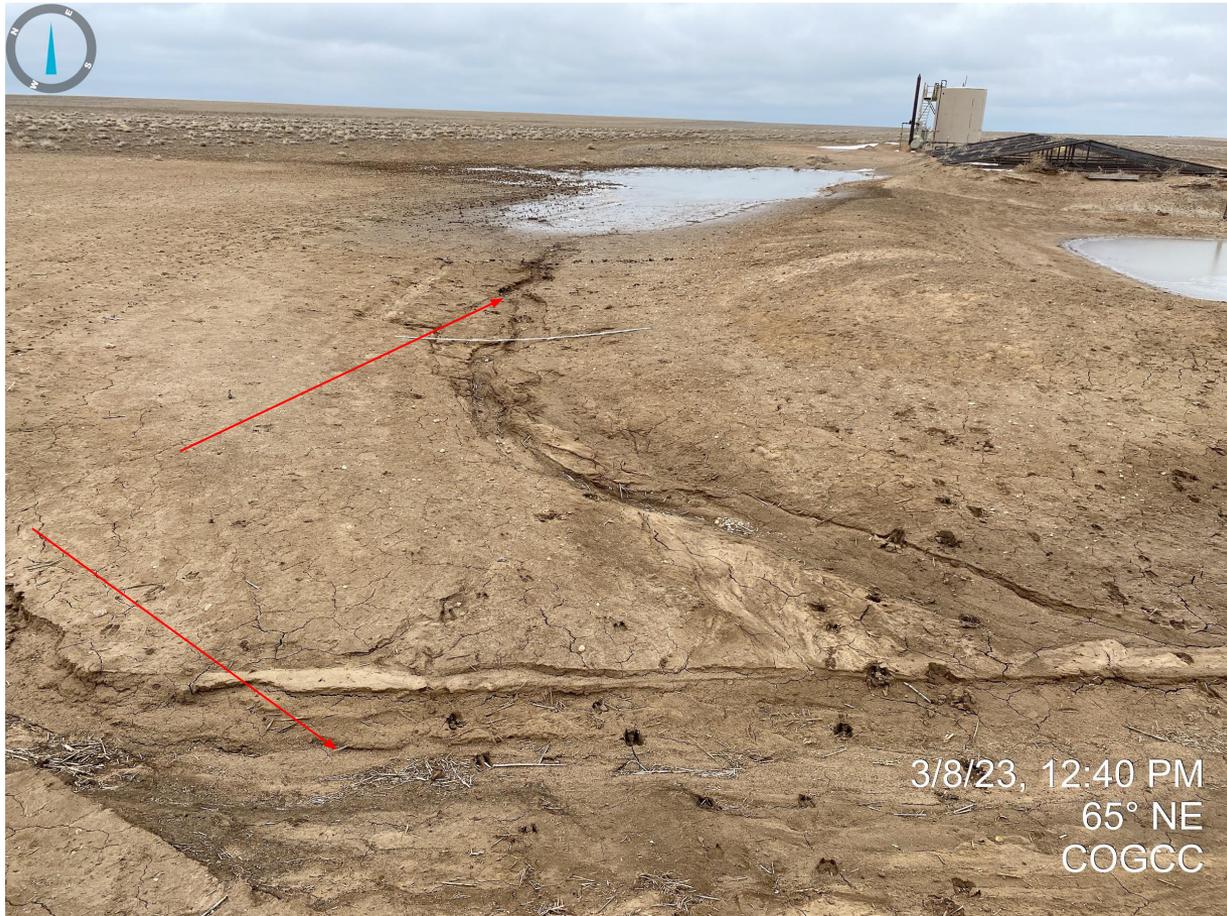
Photo 1. Facing northeast near pits. Photo illustrates rill and gully erosion occurring on location. No BMPs were observed on location to manage stormwater. Sediment laden stormwater was also observed to have migrated off location into adjacent lands (see Photos 5 & 6). Stormwater BMPs will need to be implemented immediately to prevent further off location degradation.

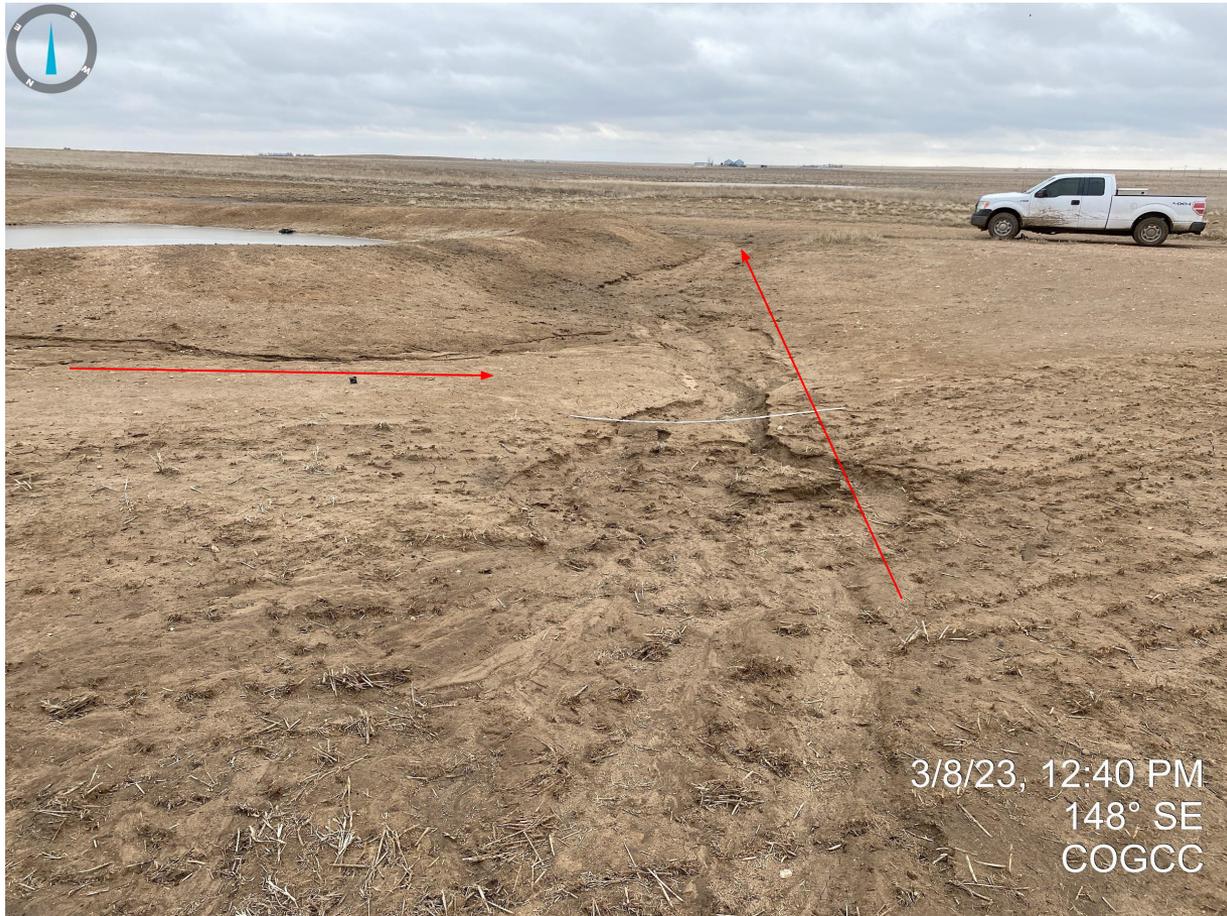
Photo 2. Facing southeast, see comments in Photo 1.

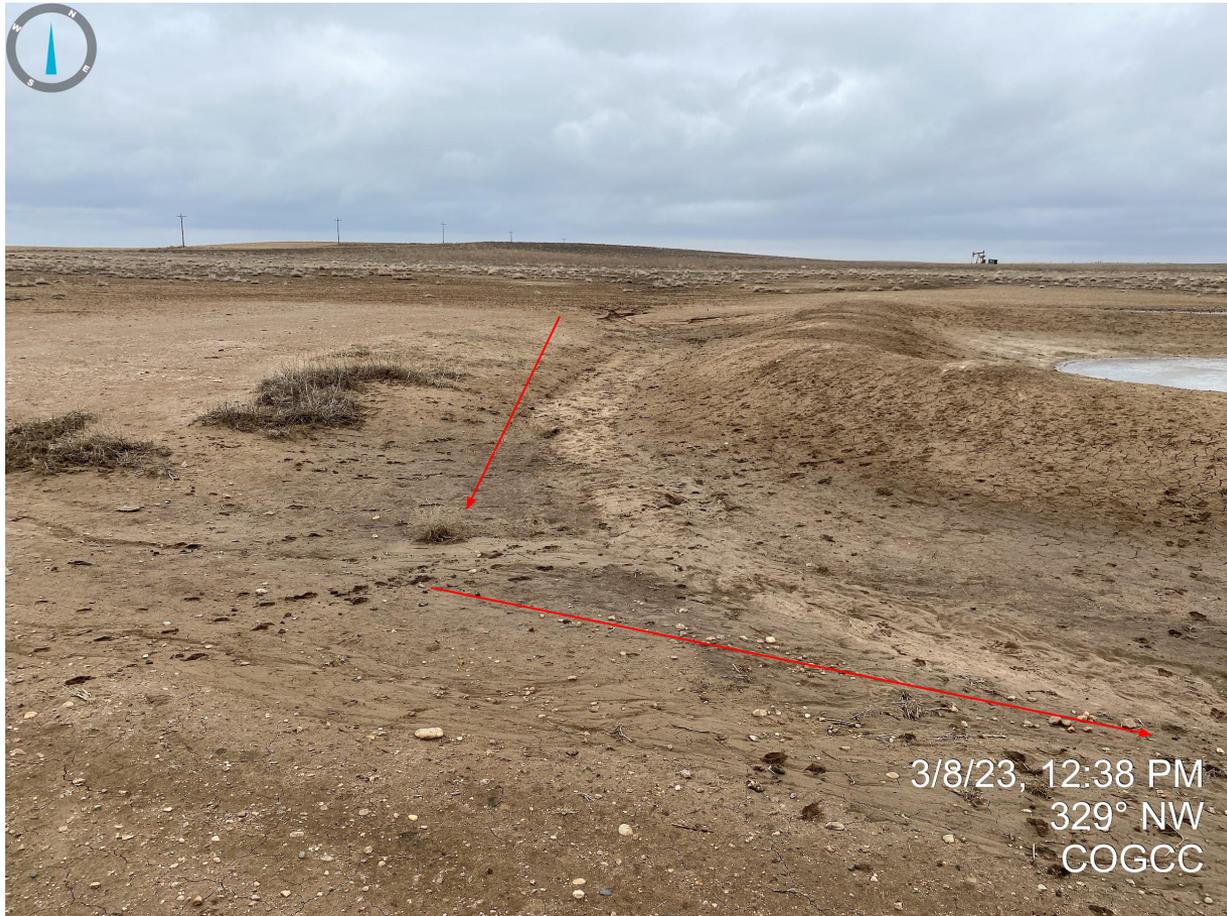
Photo 3. Facing northwest, see comments in Photo 1.

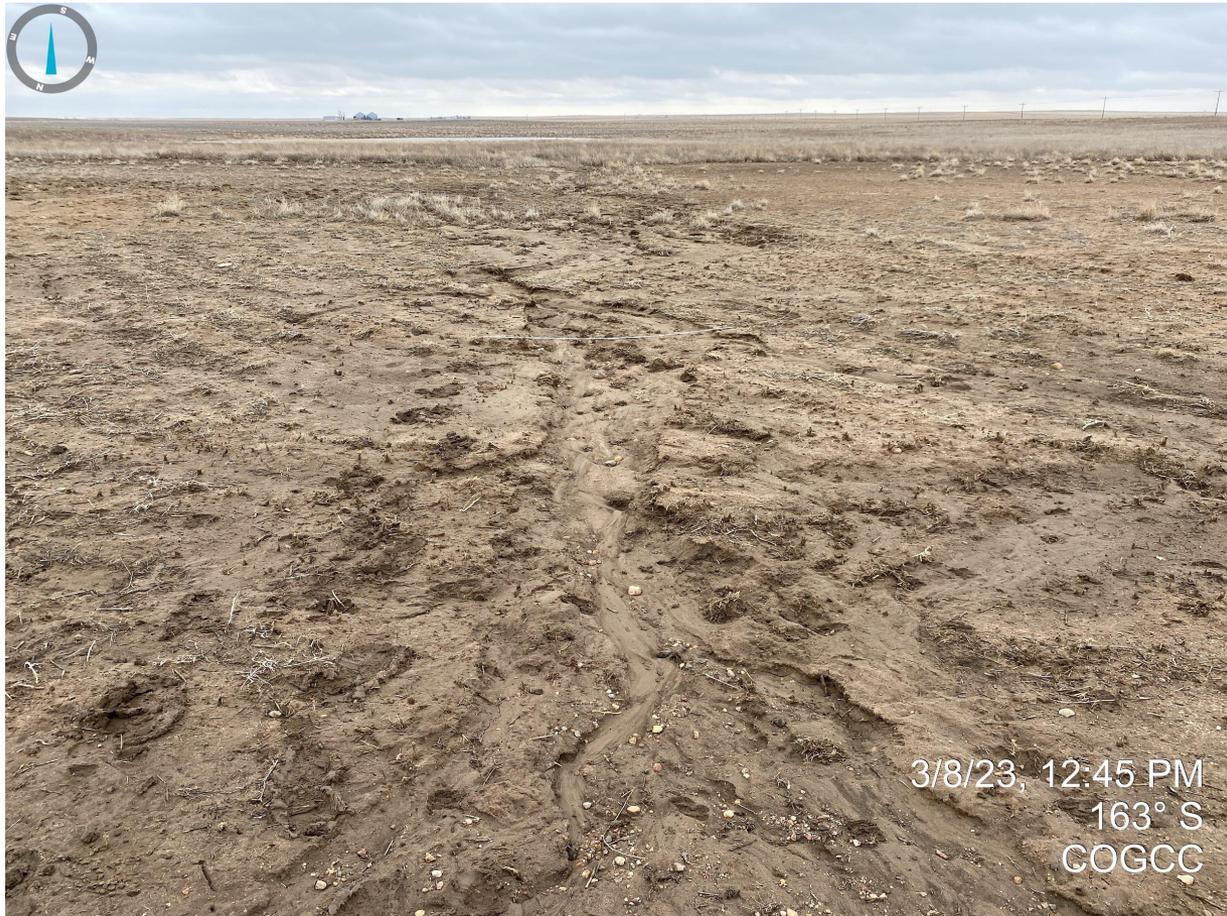
Photo 4. Facing south from reclaimed area, see comments in Photo 1.

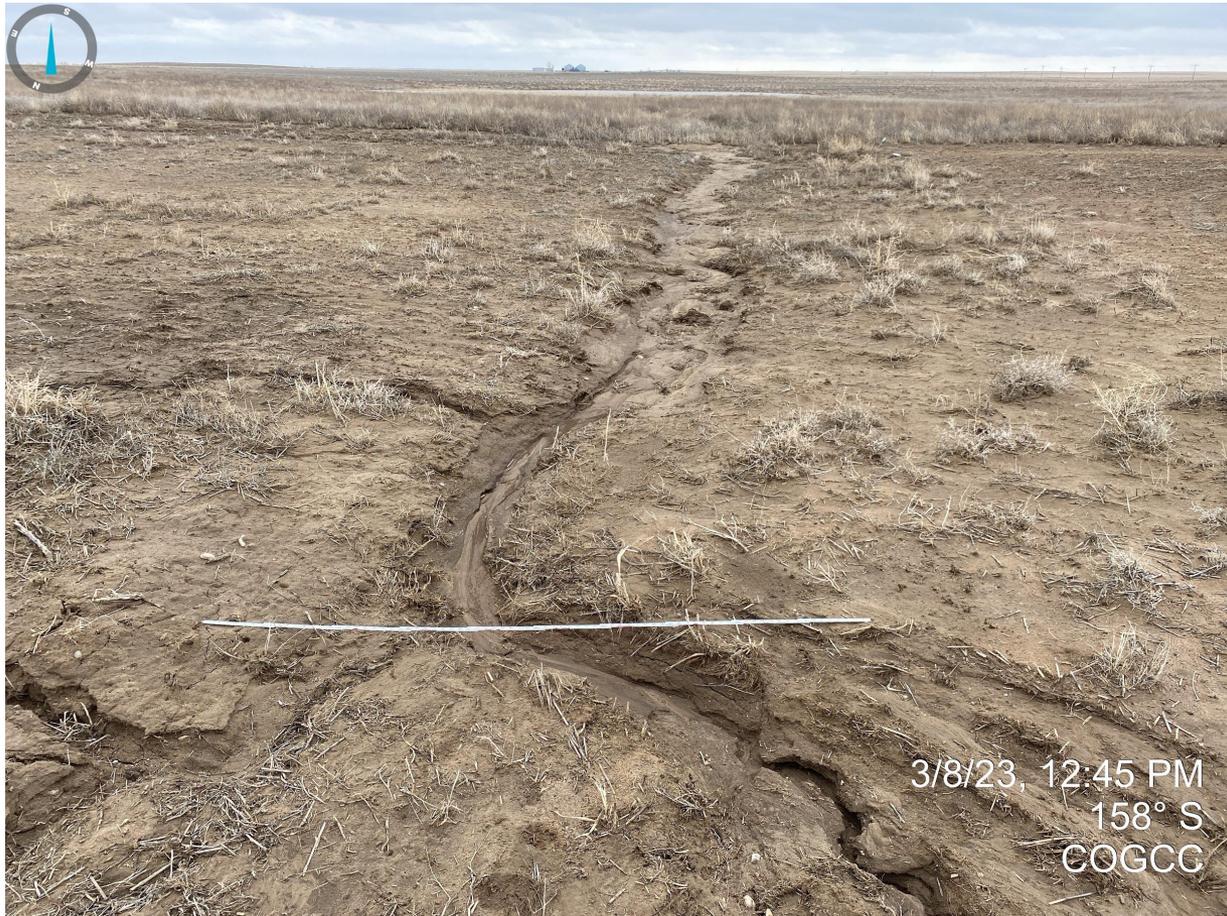
Photo 5. Facing south, see comments in Photo 1.

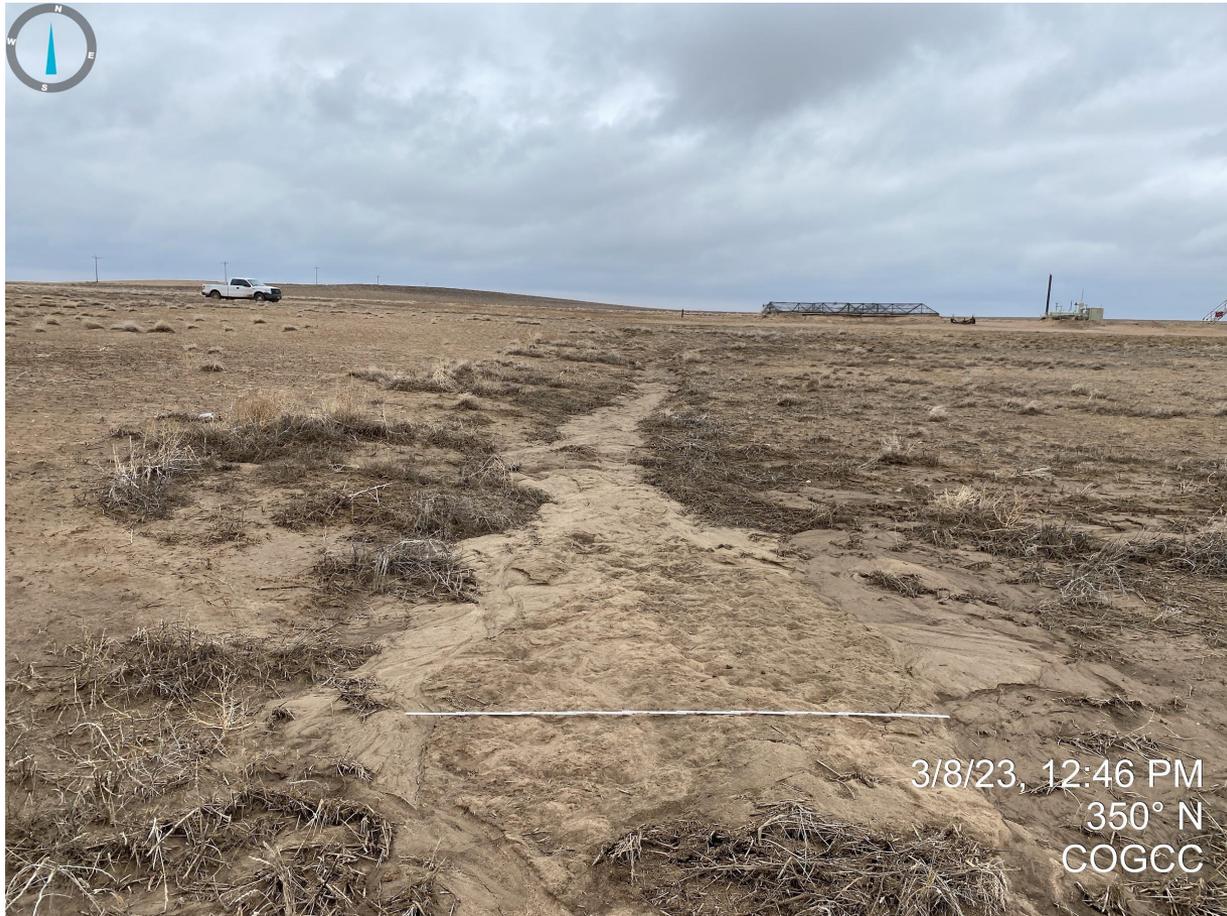
Photo 6. Facing north from adjacent land, off location. See comments in Photo 1.

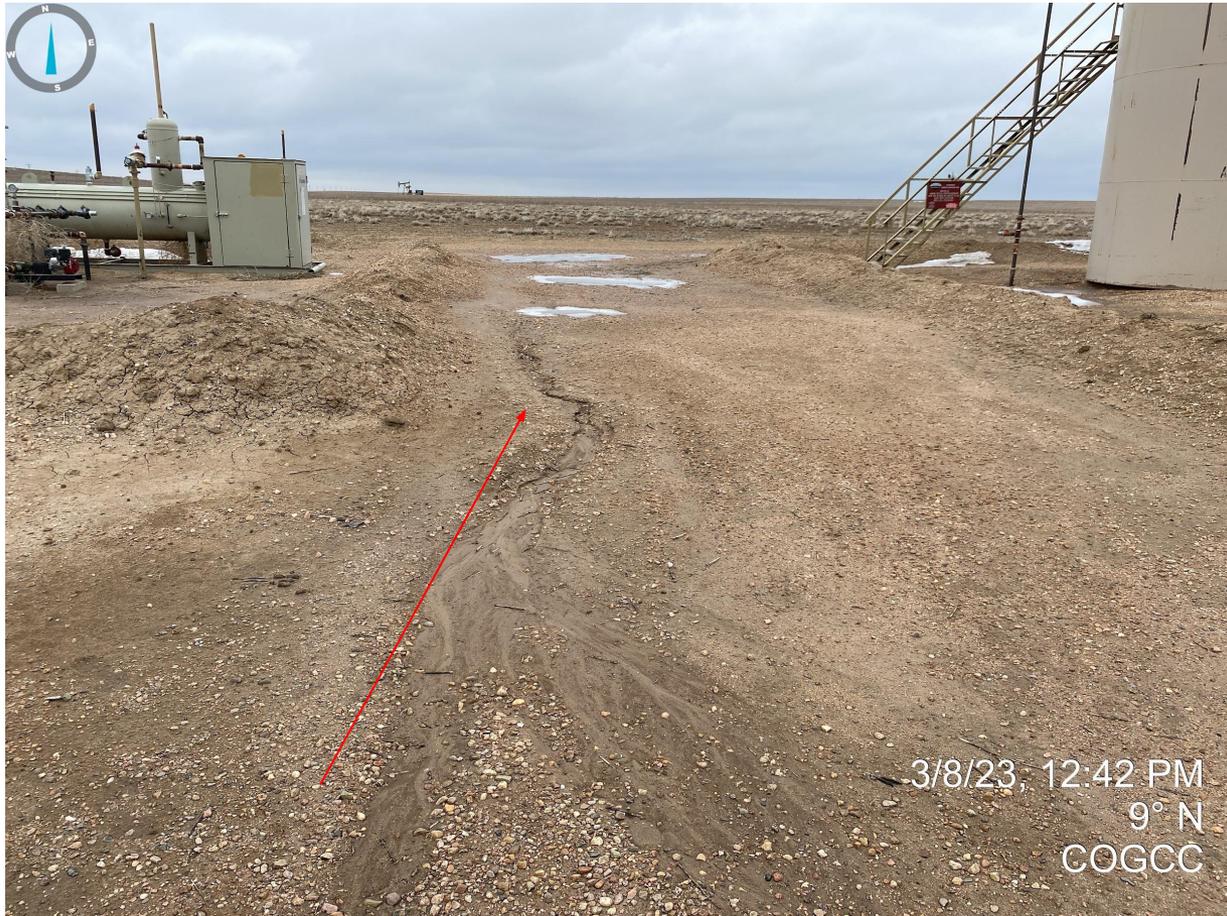
Photo 7. Facing north near separator and tank battery. See comments in Photo 1.

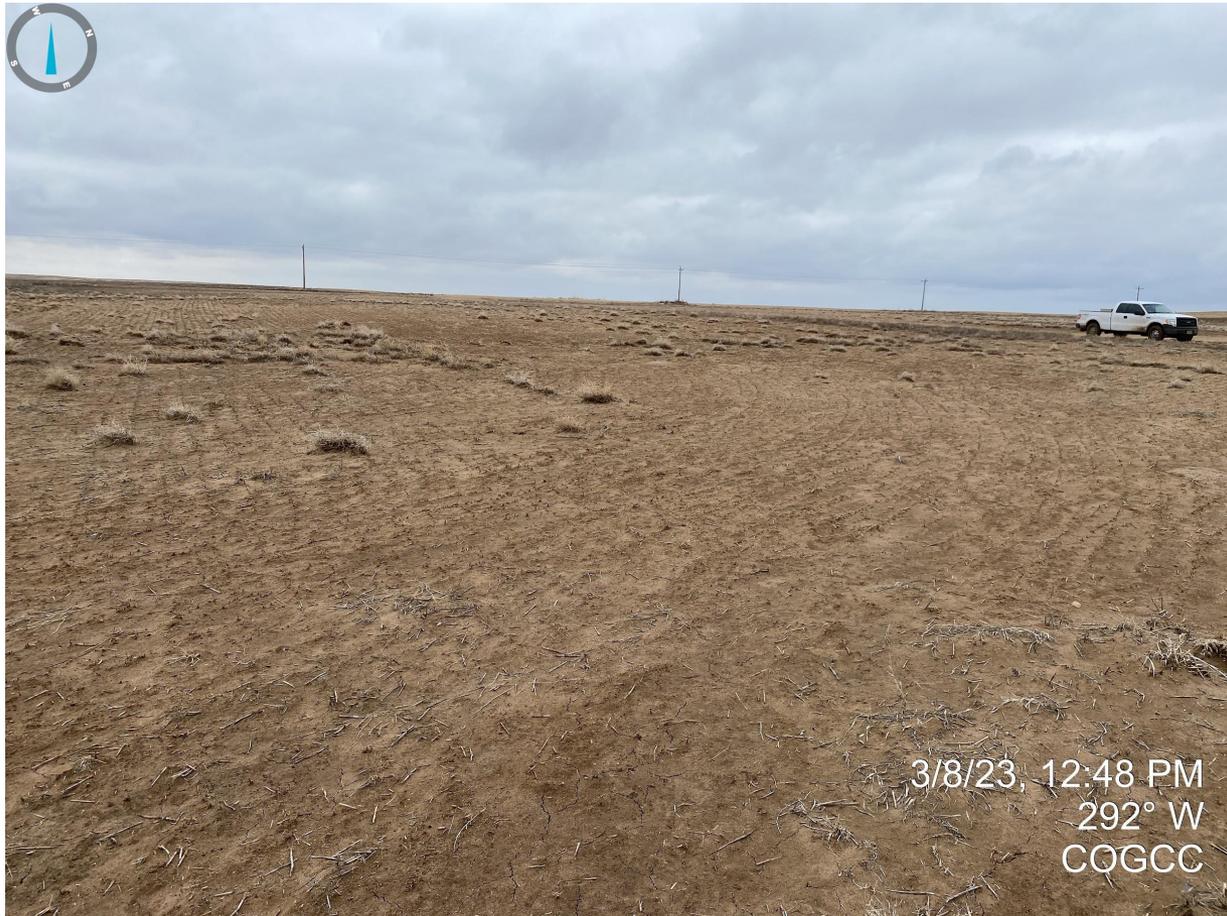
Photo 8. Facing west near reclaimed well location. It appears the operator has performed final reclamation activities with evidence of contouring and grading, and removal of debris and equipment.

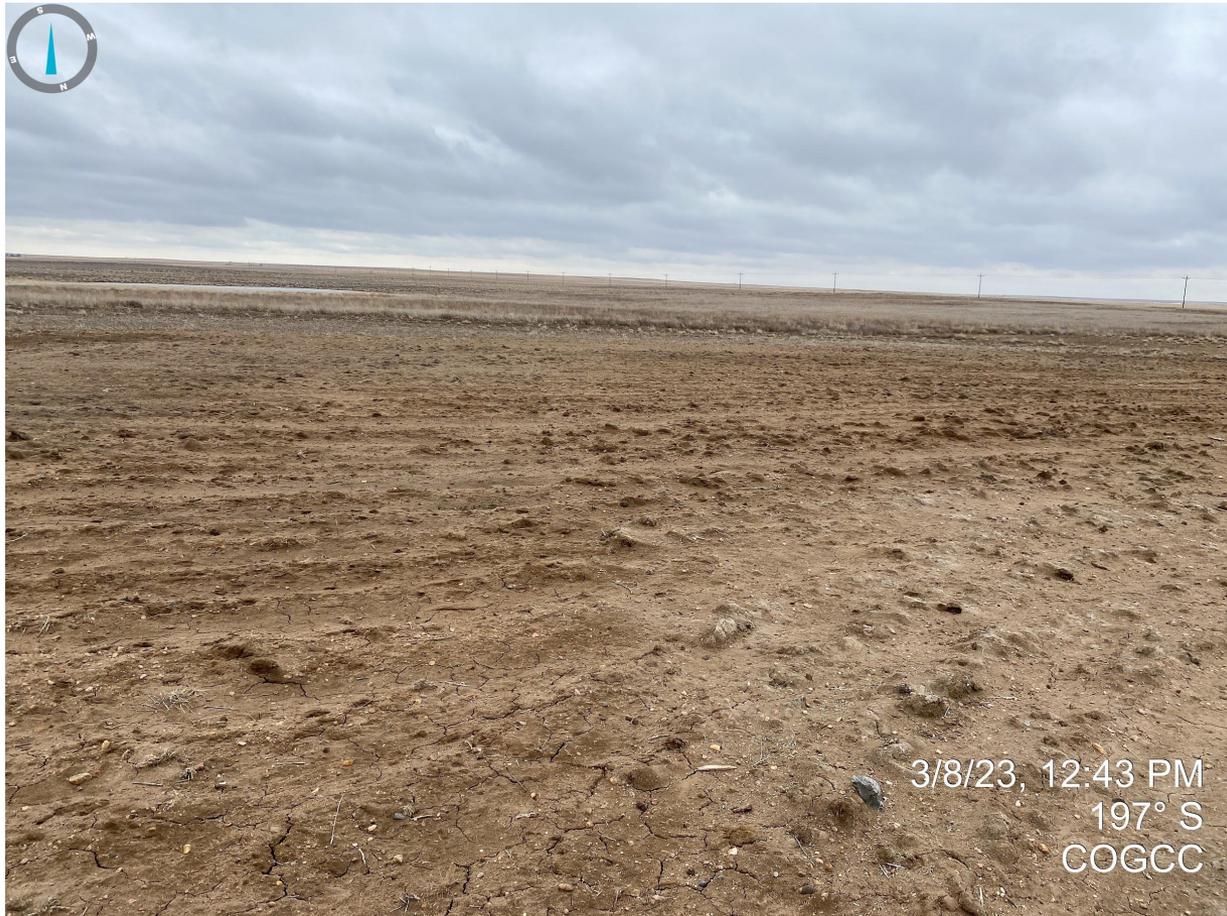
Photo 9. Facing south, see comments in Photo 8.

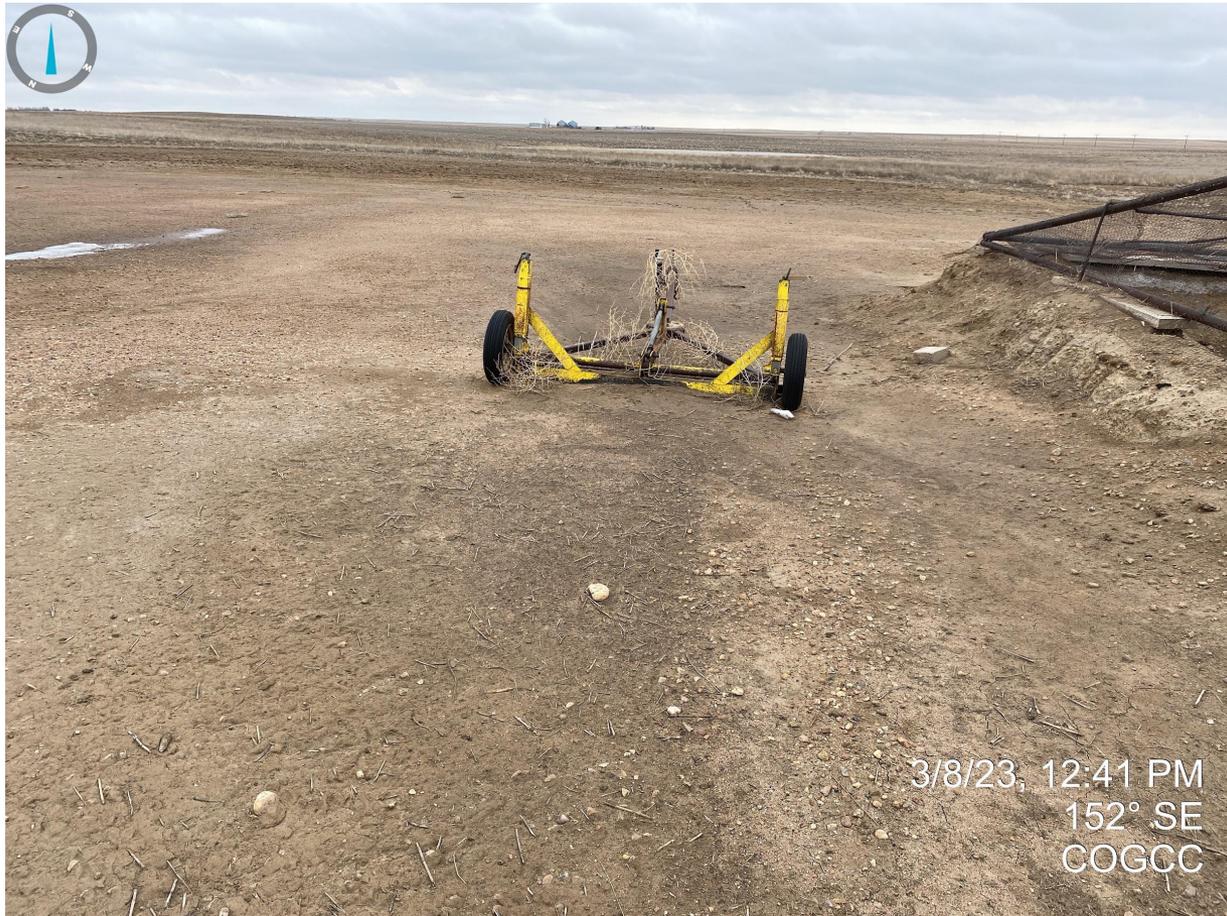
Photo 10. Facing southeast near pit; road drag observed on location. This is considered unused equipment and needs to be removed.

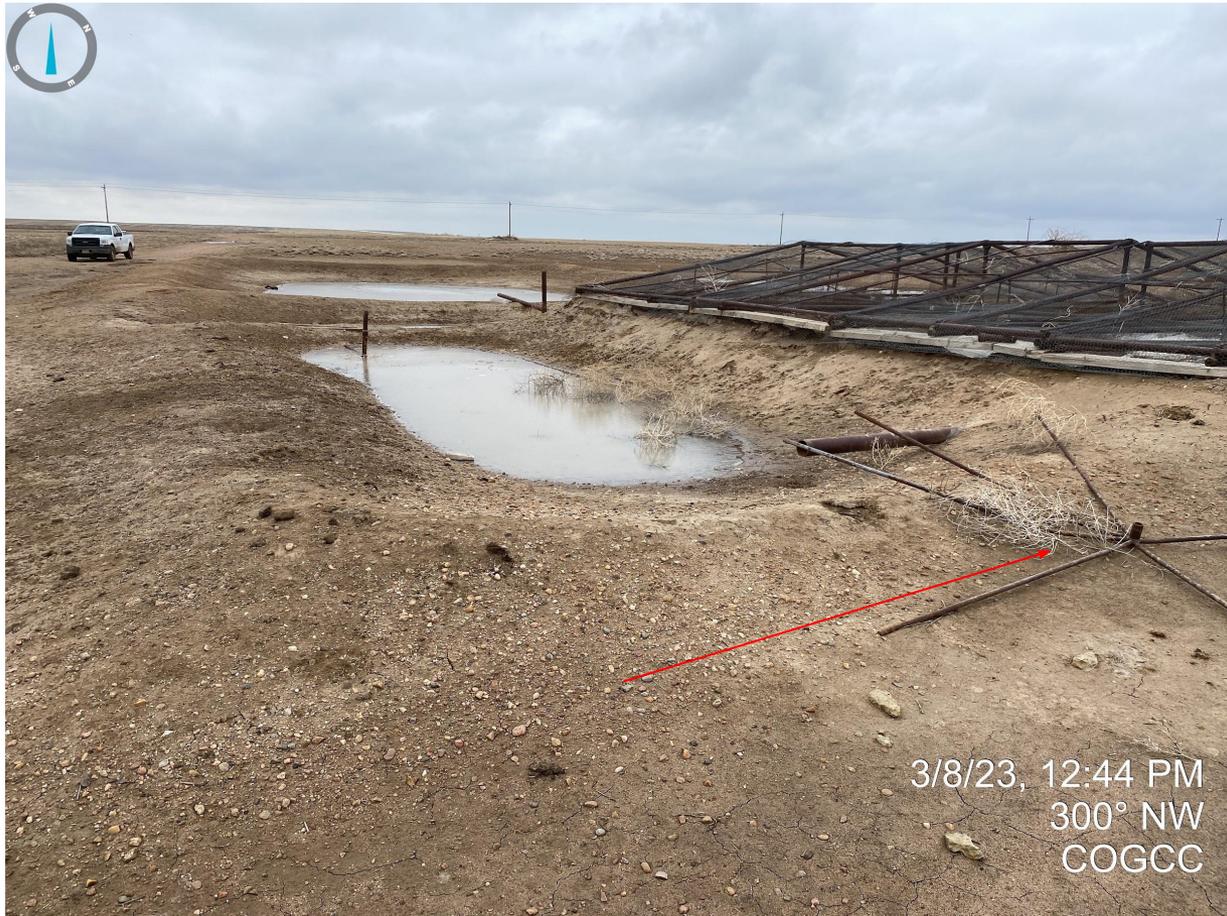
Photo 11. Facing northwest near pit; pipe observed on location. This is considered unused equipment and needs to be removed.

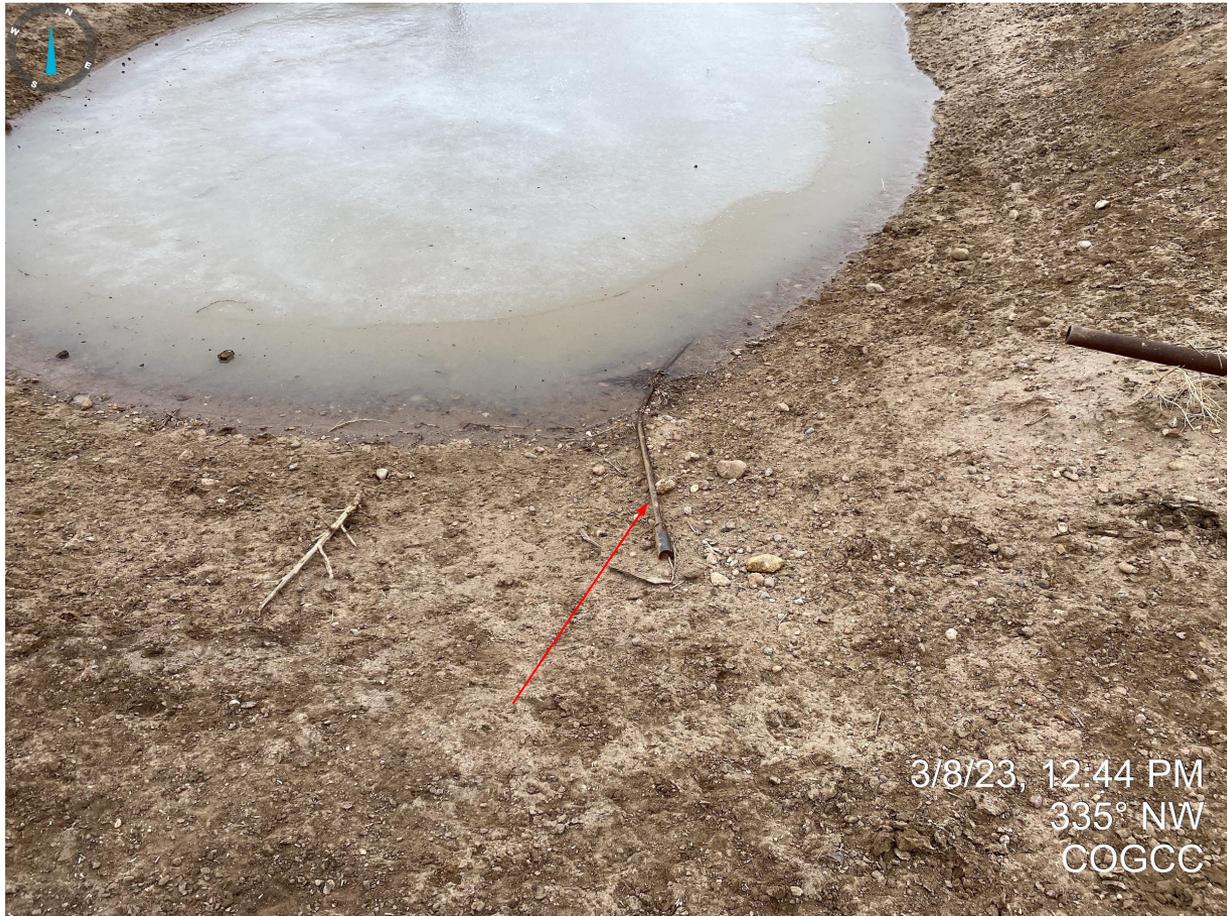
Photo 12. Facing northwest at pit. Sucker rod observed within pit is considered used equipment and needs to be removed.

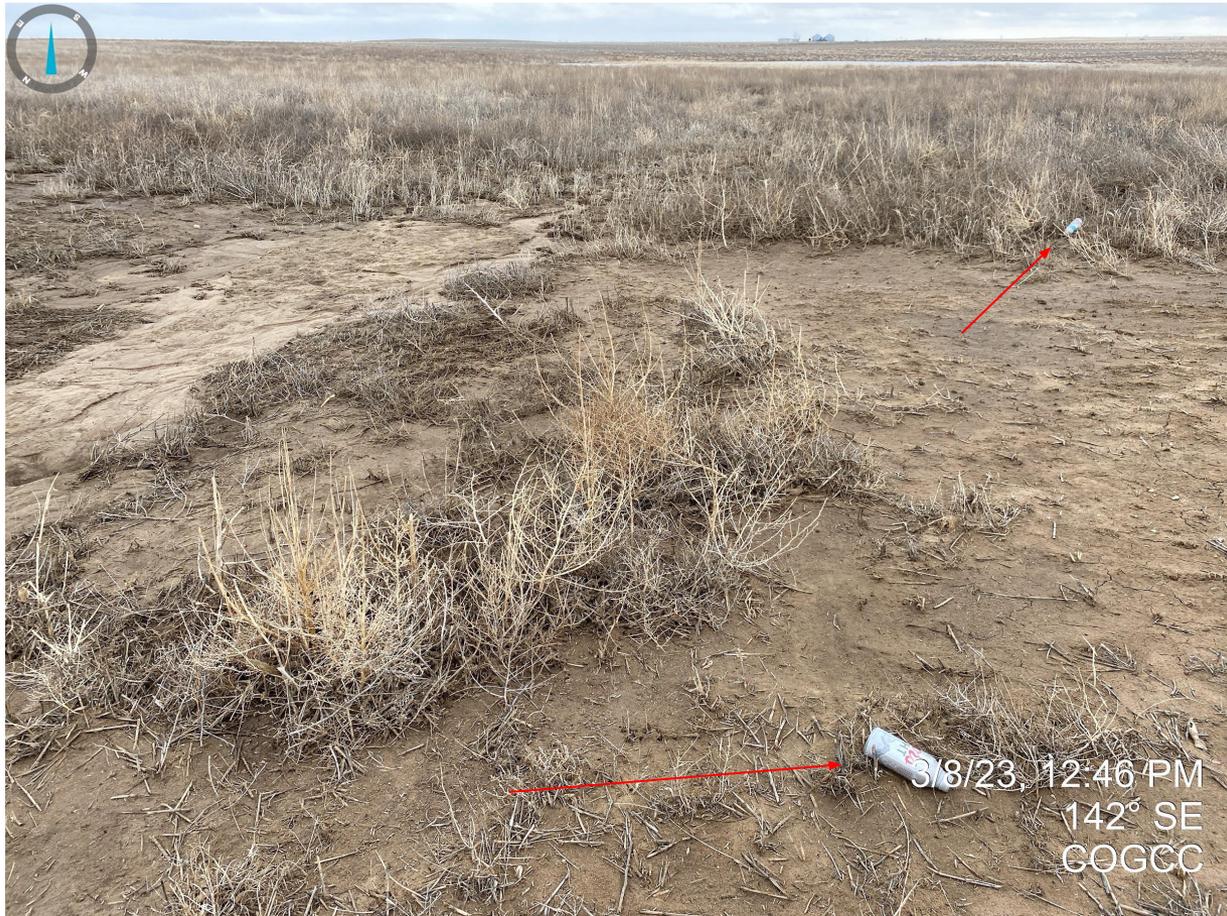
Photo 13. Facing southeast; trash observed on the southern portion of the reclaimed well location.
