Inspection Photos

Location Name: CAERUS PICEANCE LLC N. Parachute MF10B E09 696 pad

Location # 335856

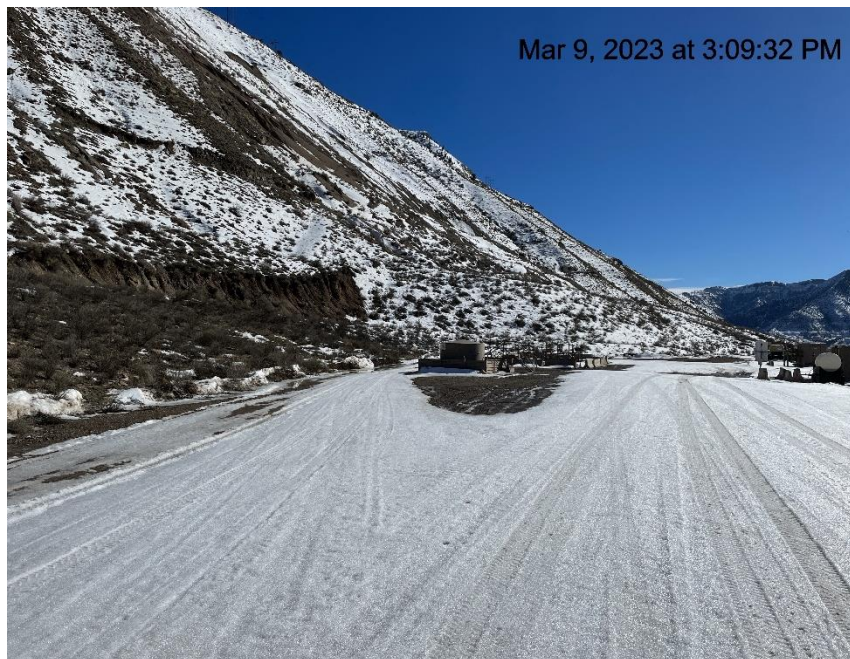
Photo # 2162 From entrance to location

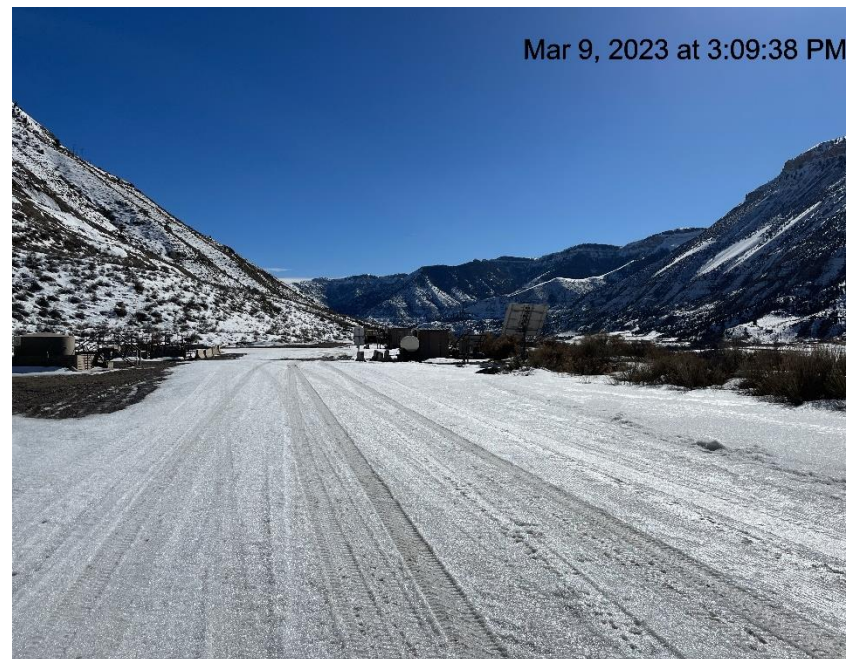
Photo # 2163 From entrance to location

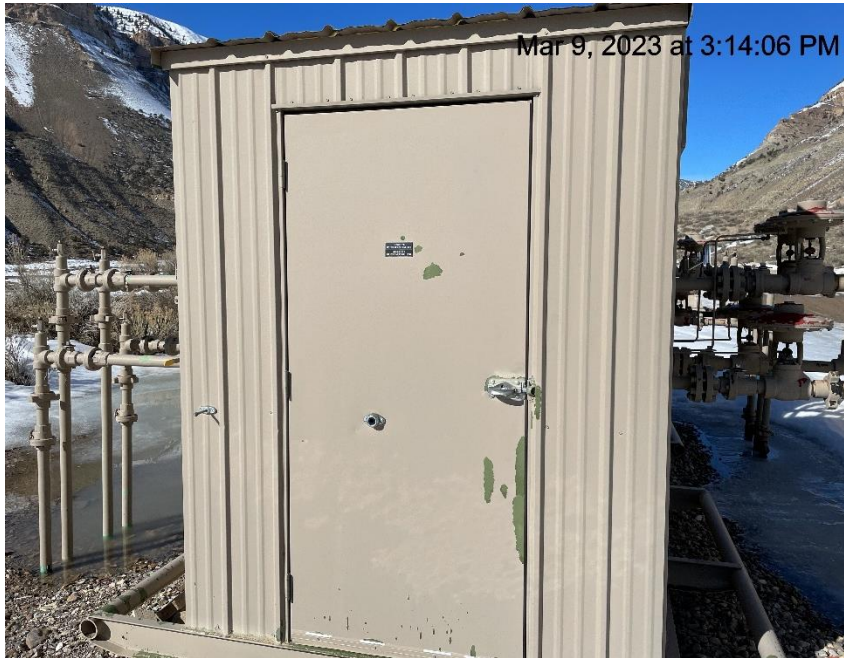
Photo # 2170 Calibration info not conspicuously posted

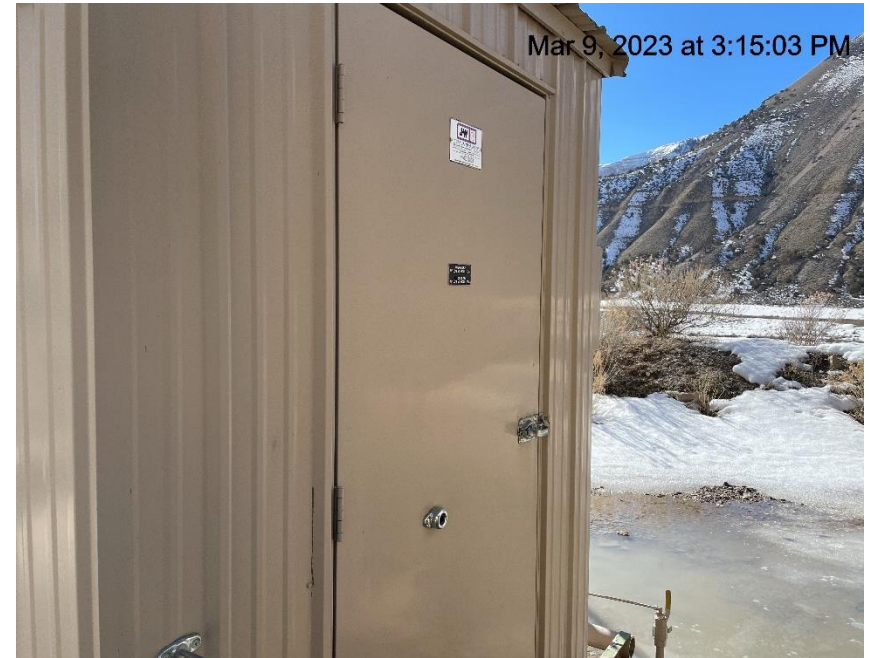
Photo # 2172 Calibration info not conspicuously posted

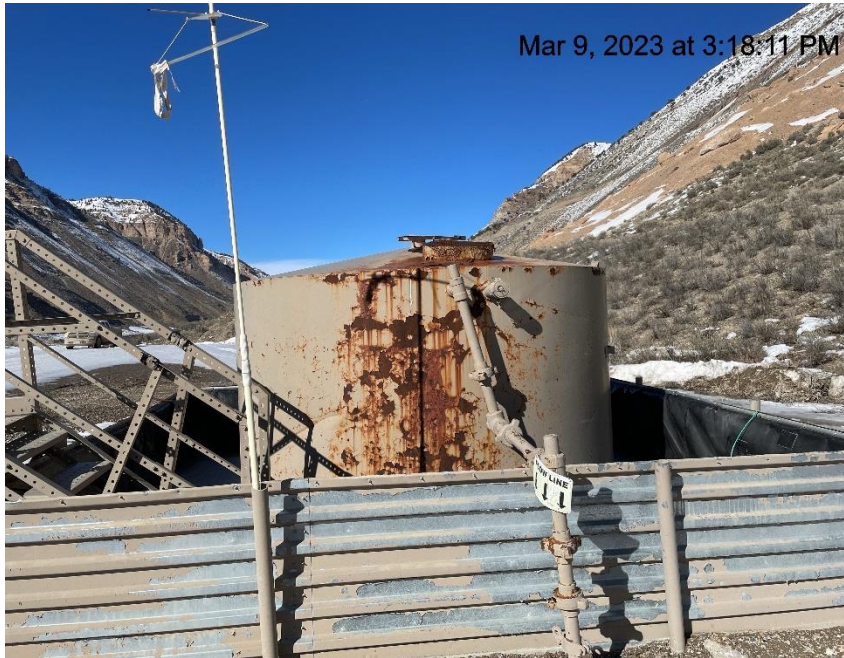
Photo # 2180 Tank needs maintenance

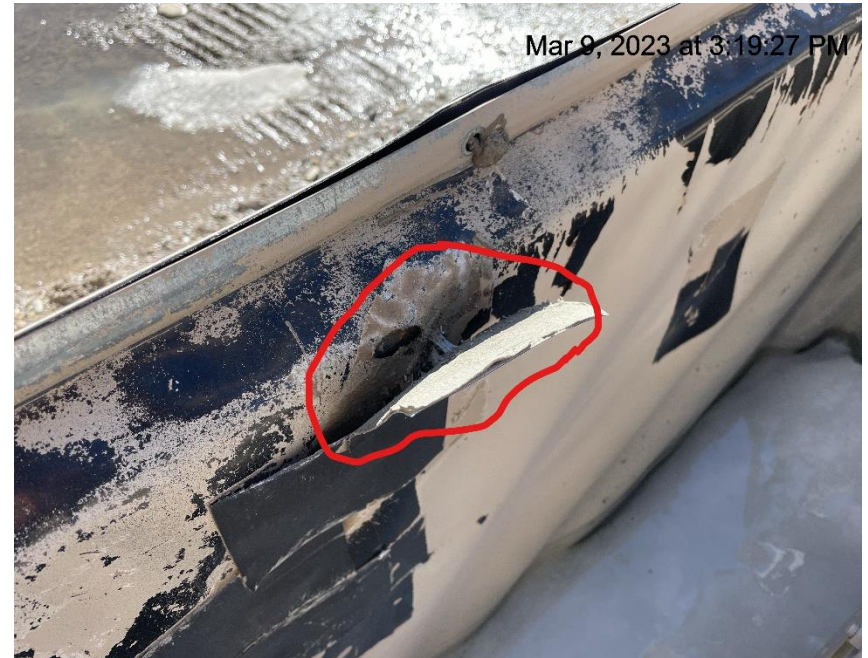
Photo # 2181 Containment needs maintenance

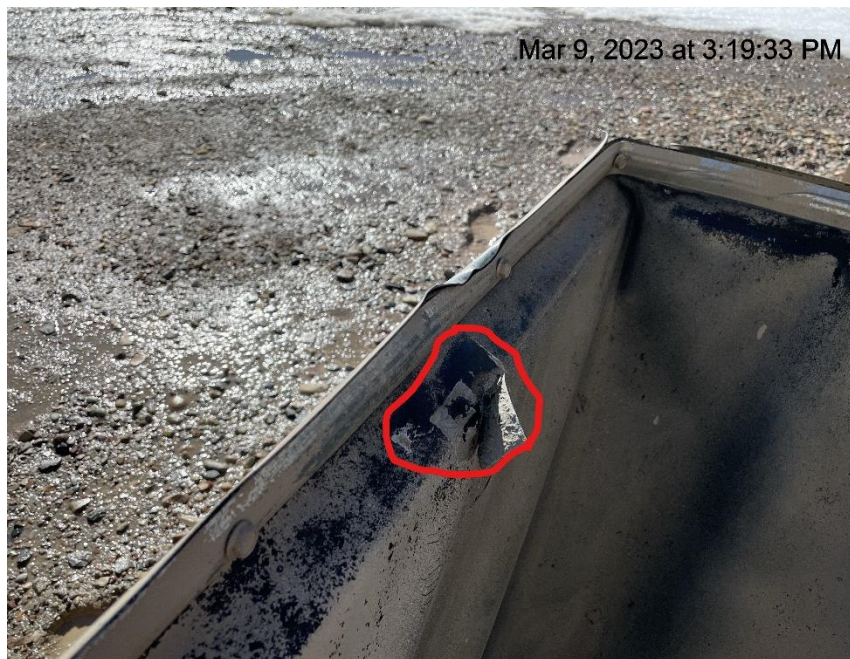
Photo # 2182 Containment needs maintenance

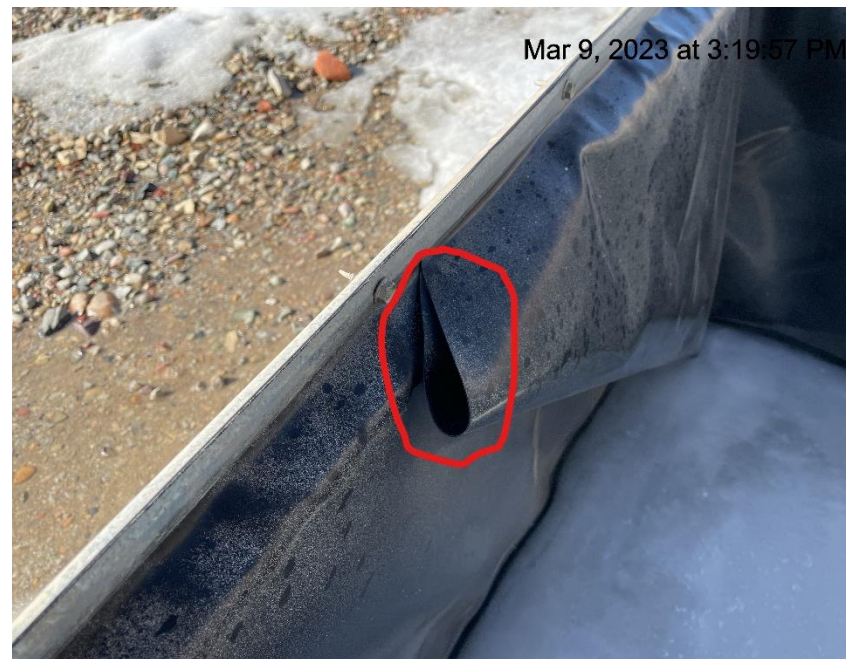
Photo # 2183 Containment needs maintenance

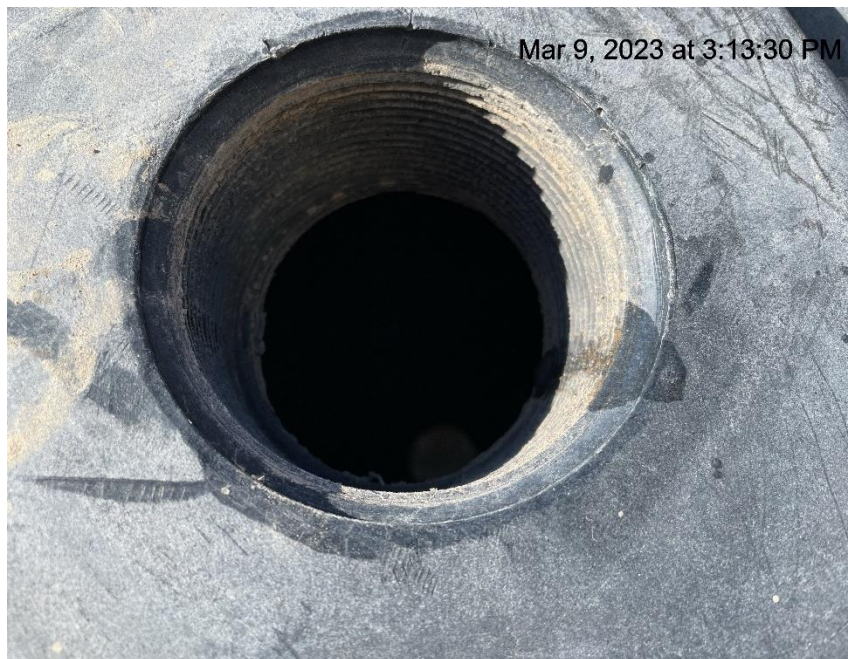
Photo # 2169 Chemical BMP not maintained

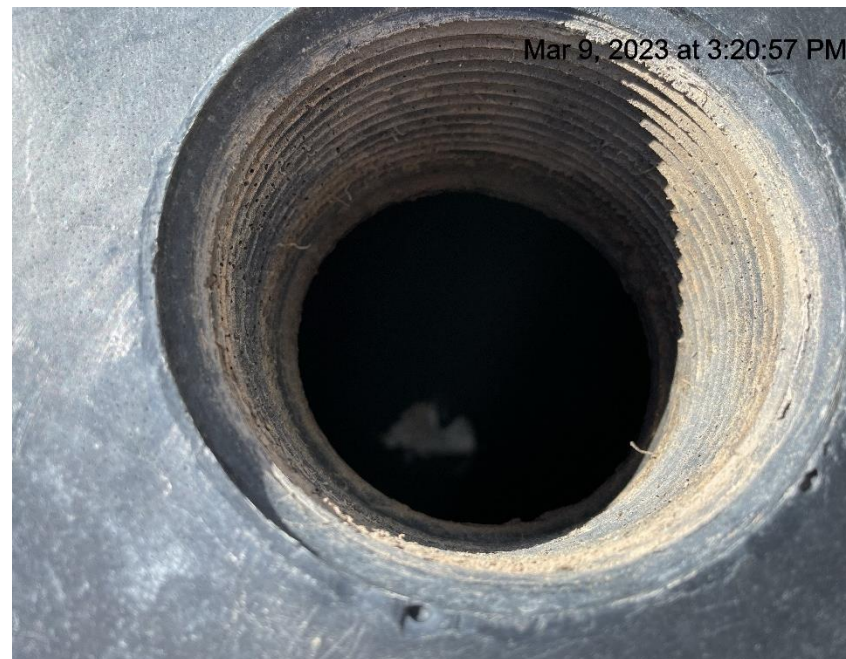
Photo # 2184 Chemical BMP not maintained

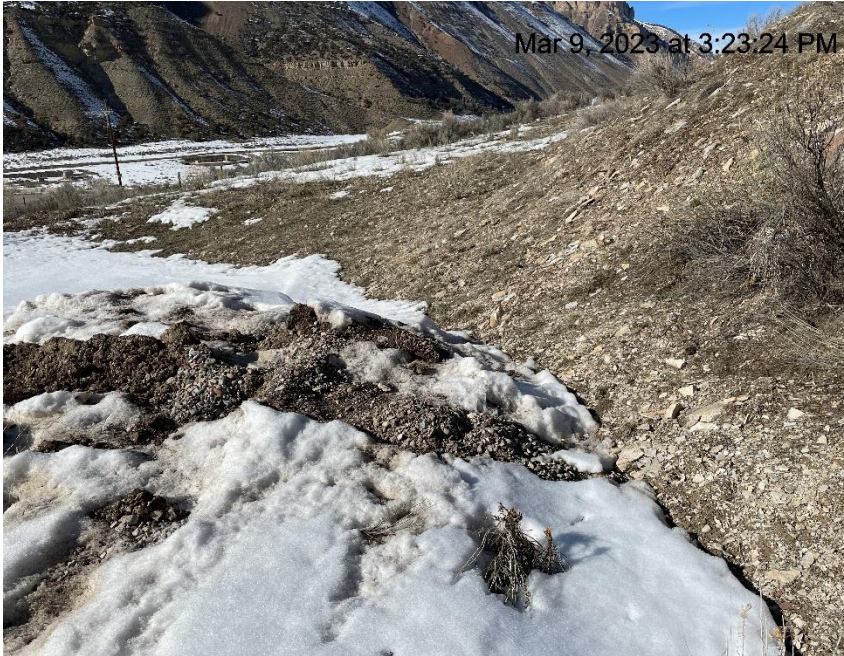
Photo # 2187 Sediment transported into ditch, ditch needs maintenance

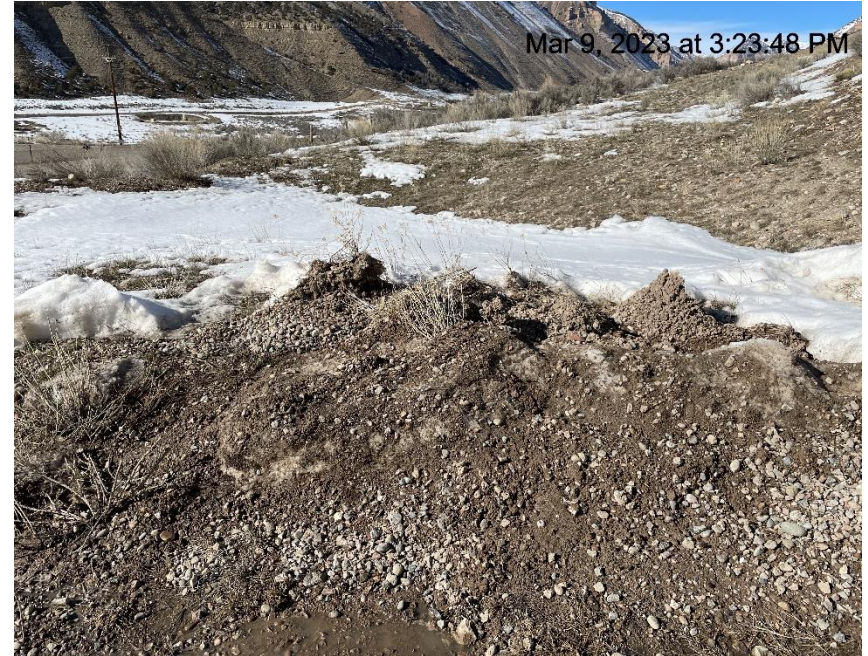
Photo # 2188 Sediment transported into vegetated area

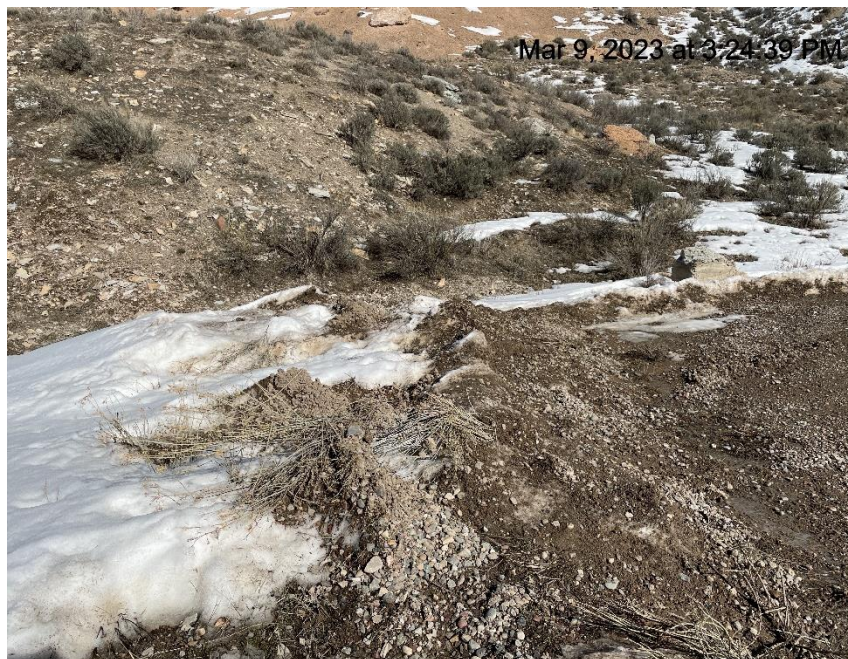
Photo # 2189 Sediment transported into vegetated area
