# Inspection Photos

3/13/2023

Operator: CHEVRON USA INC - 16700

Location #314696

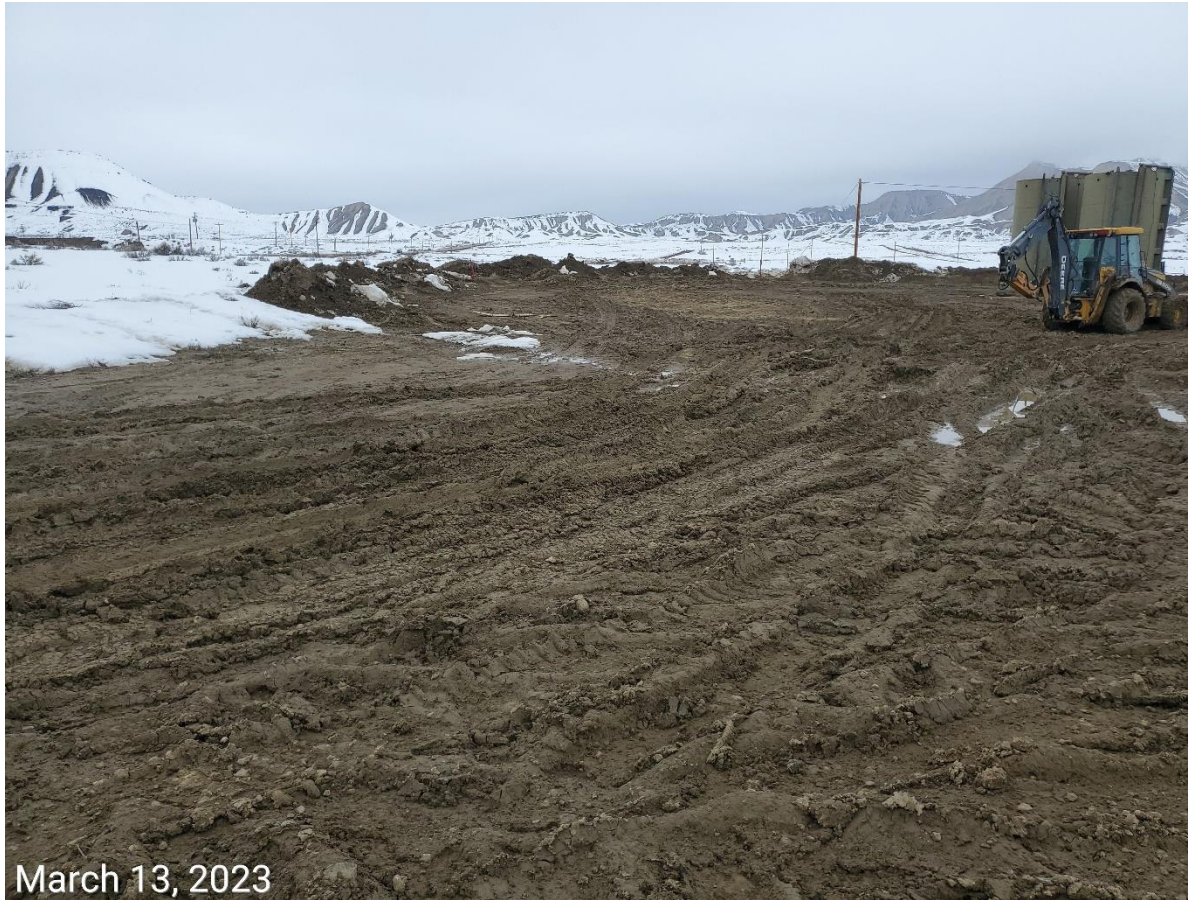
**Photo 1:** Photos 1- 8 taken from the Location and access road. Photos examples showing BMPs to stabilize the working pad and access road, as well as to minimize degradation, tracking and offsite sediment transport are missing or insufficient.

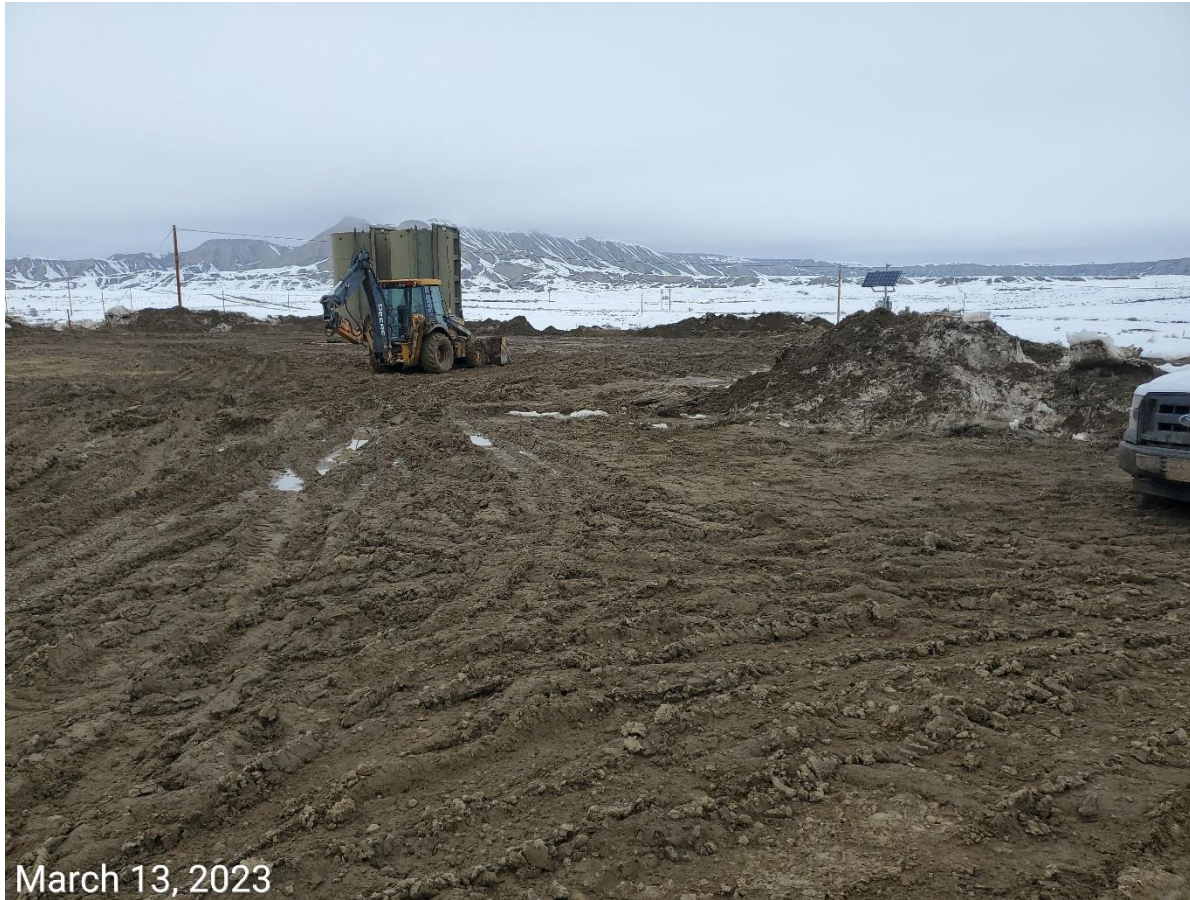
**Photo 2:** See comments under photo 1.

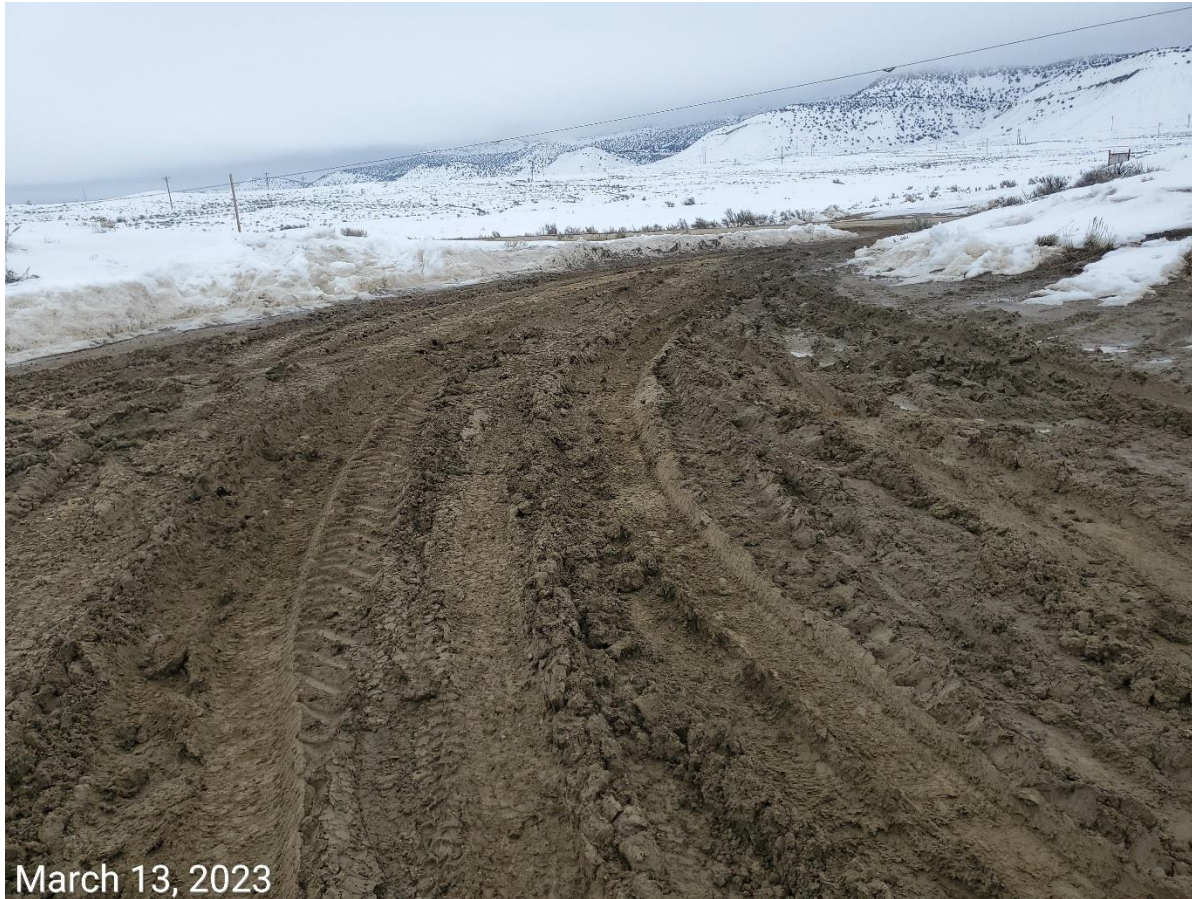
**Photo 3:** See comments under photo 1.

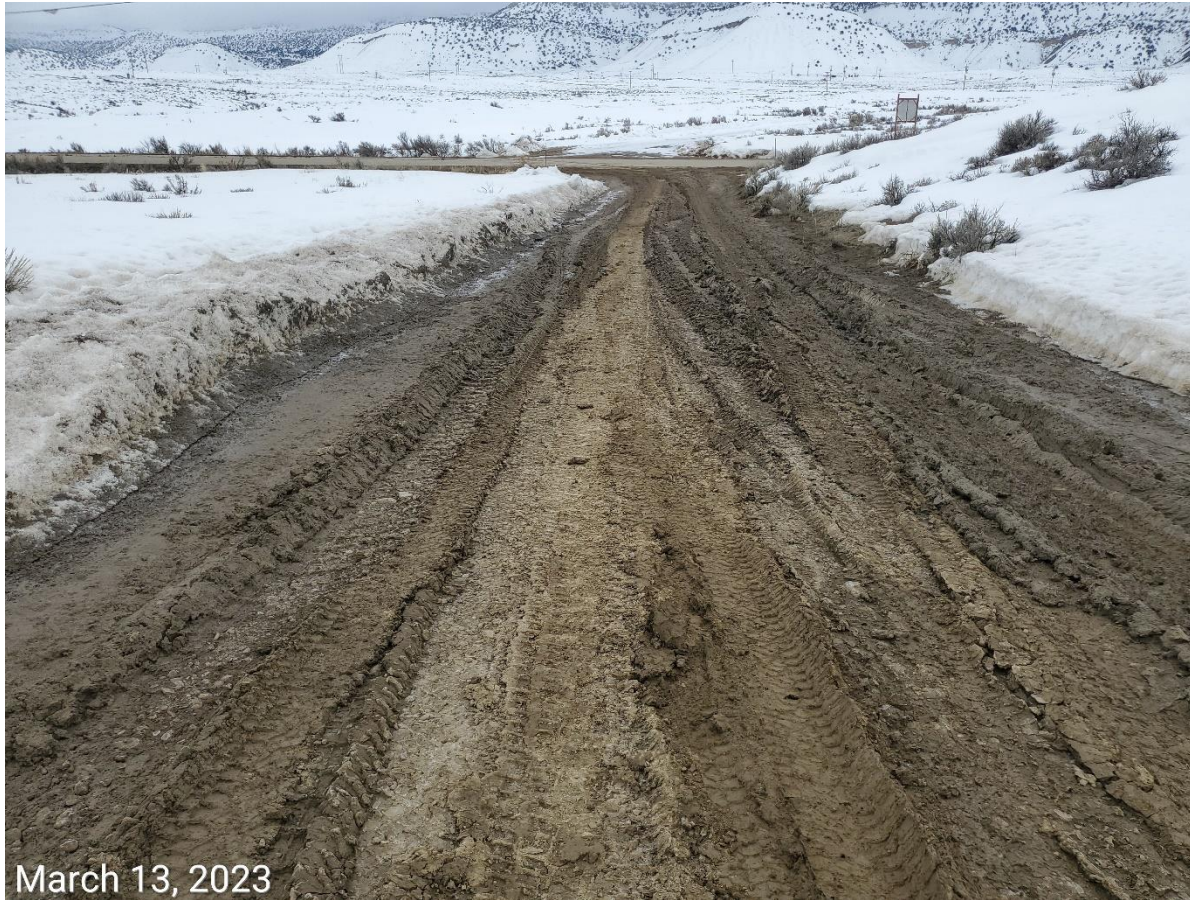
**Photo 4:** See comments under photo 1.

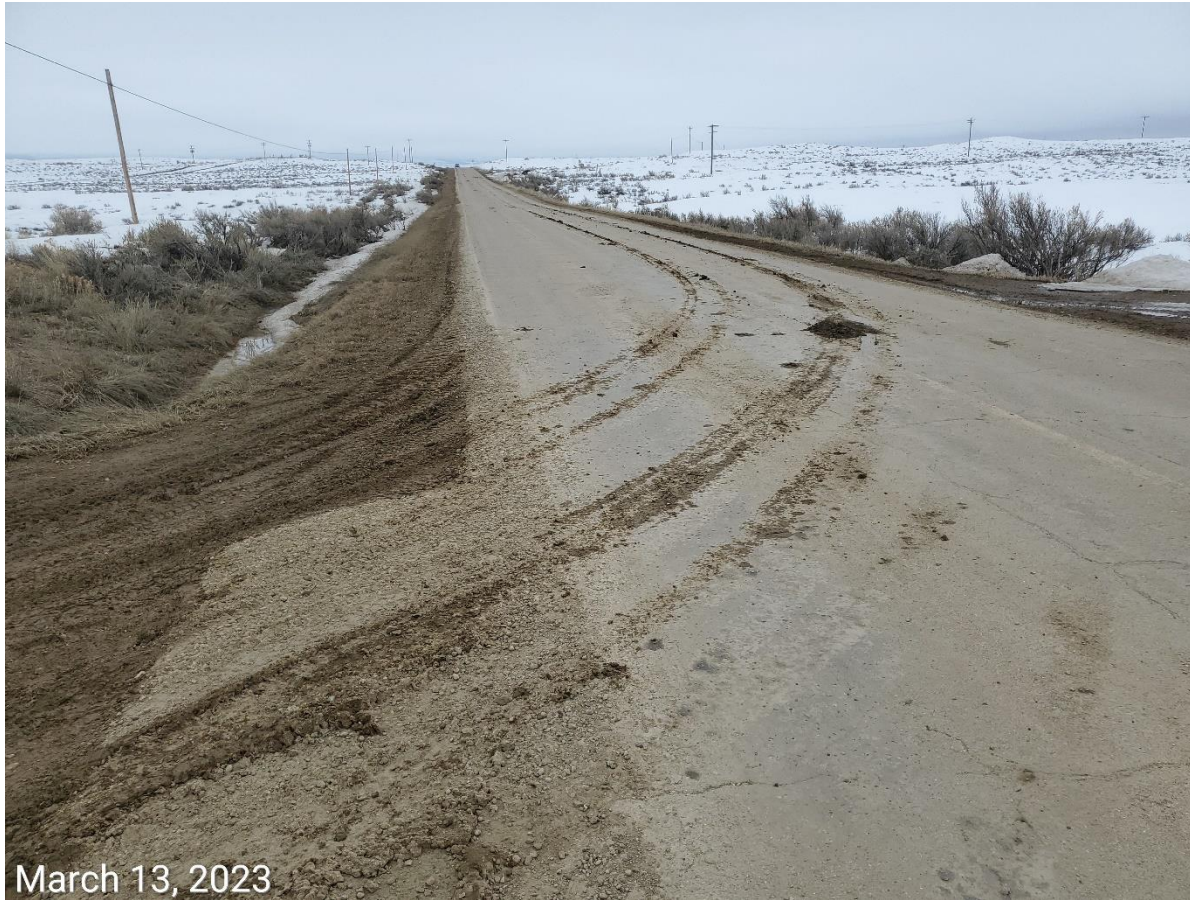
**Photo 5:** See comments under photo 1. Photo also shows tracking from access road onto Hwy 64.

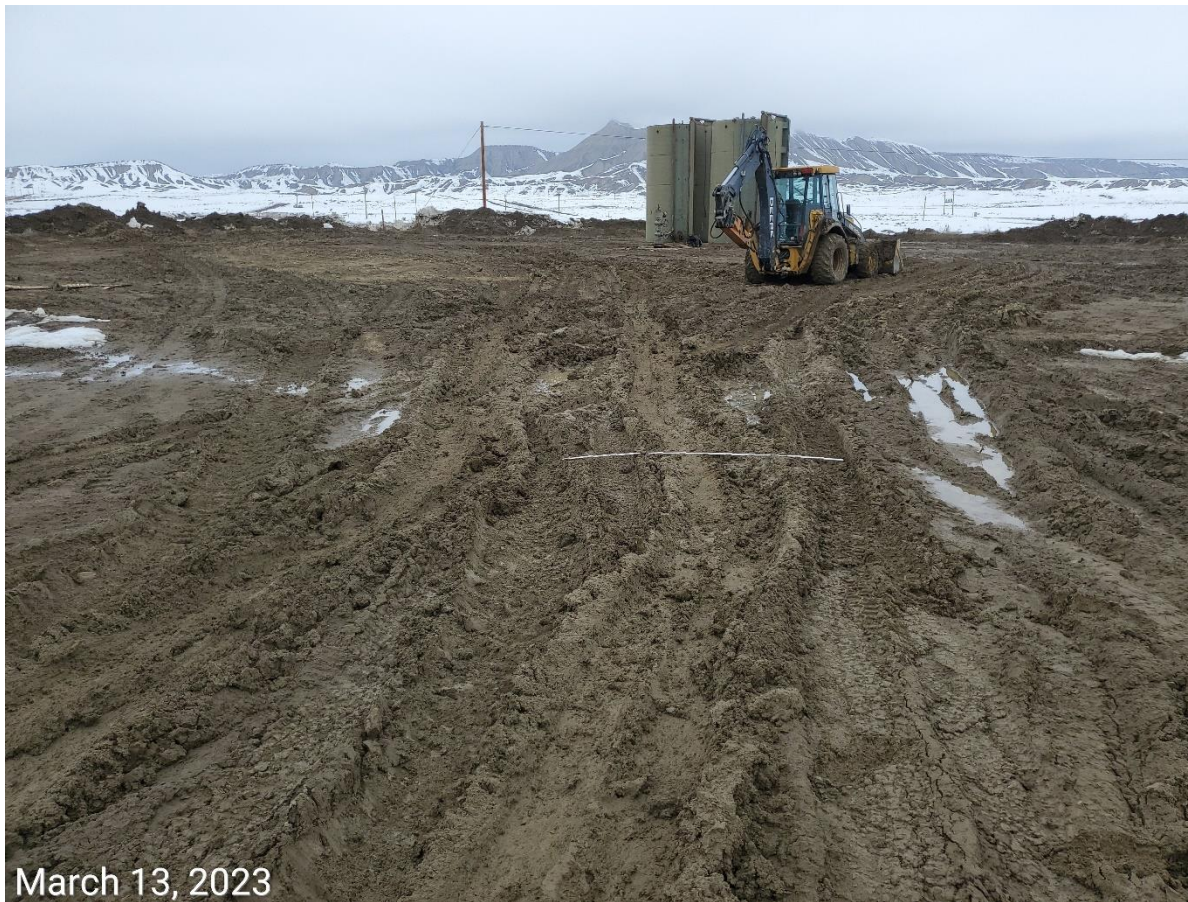
**Photo 6:** See comments under photo 1. 6 foot measuring stock for reference.

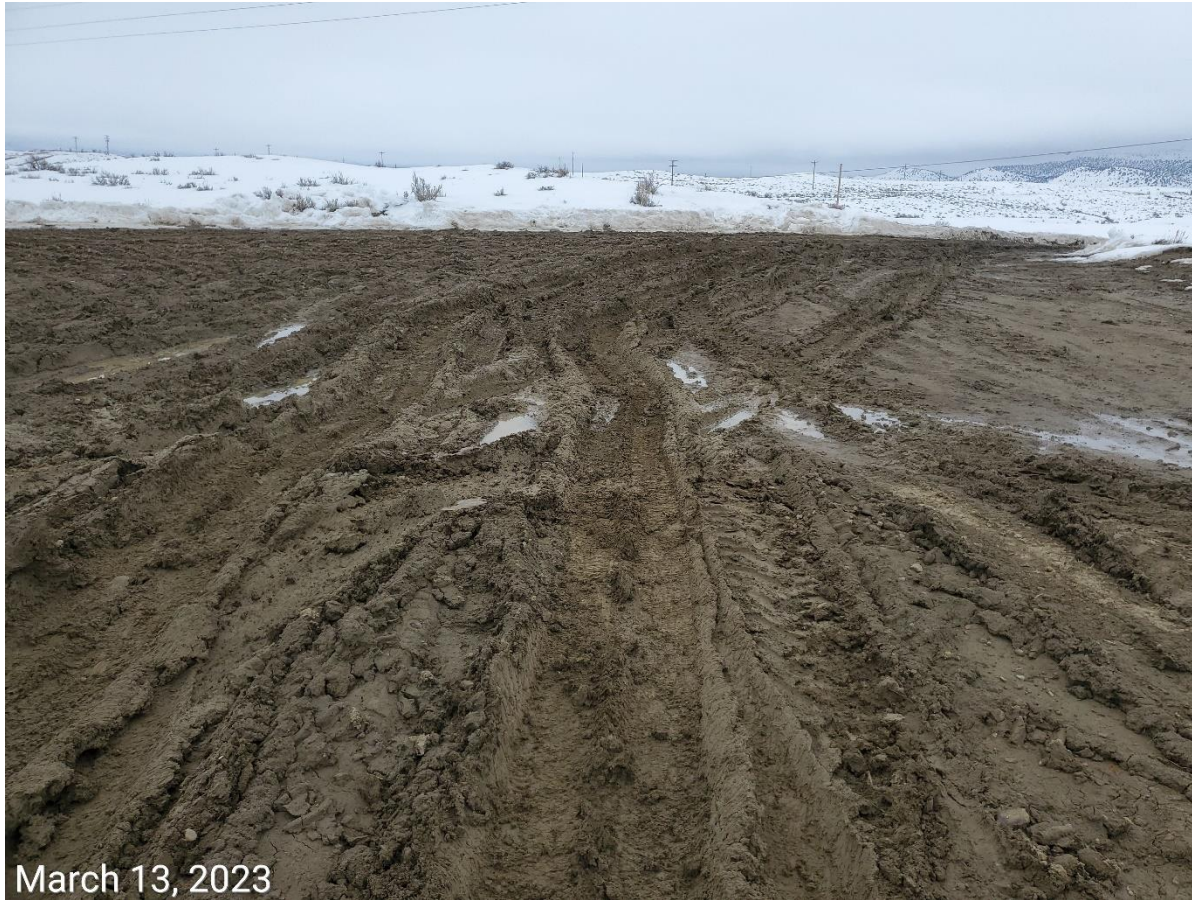
**Photo 7:** See comments under photo 1.

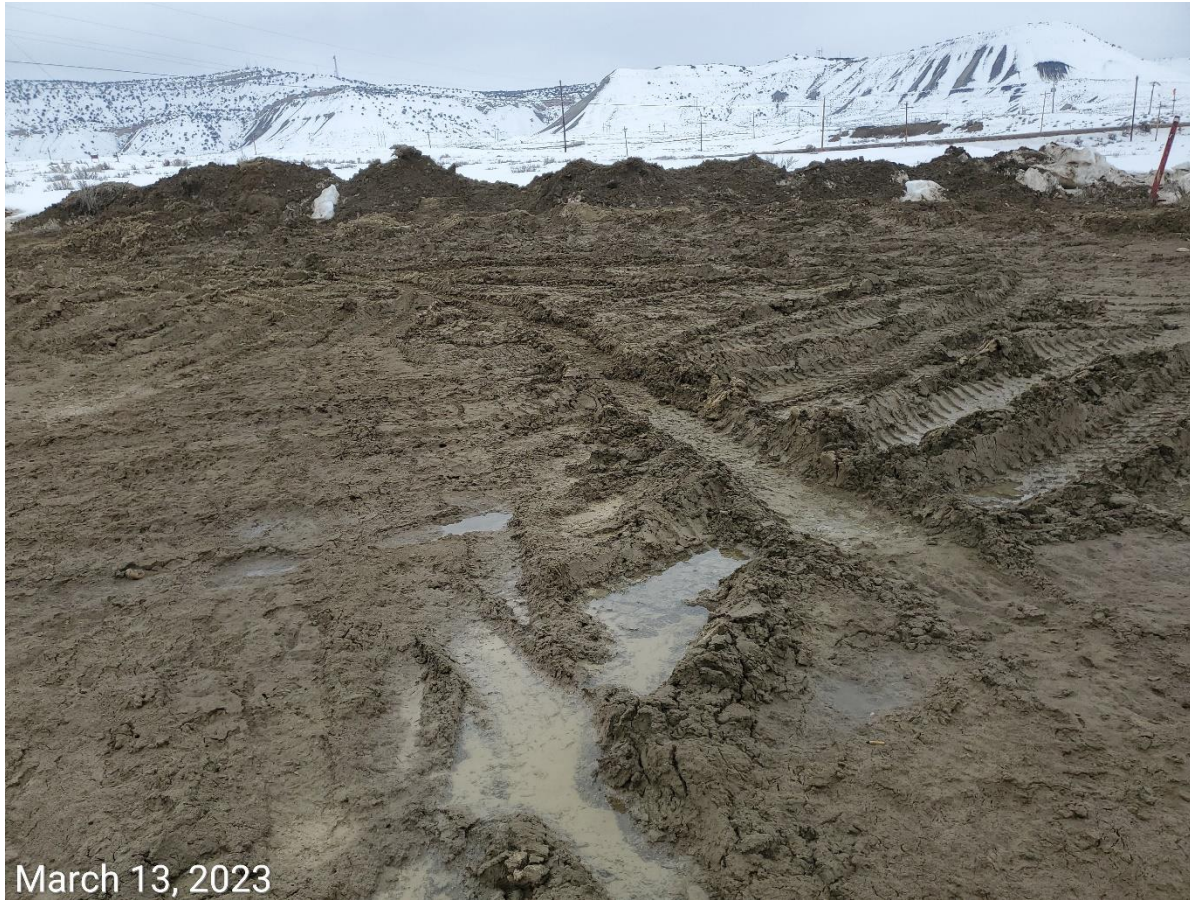
**Photo 8:** See comments under photo 1.

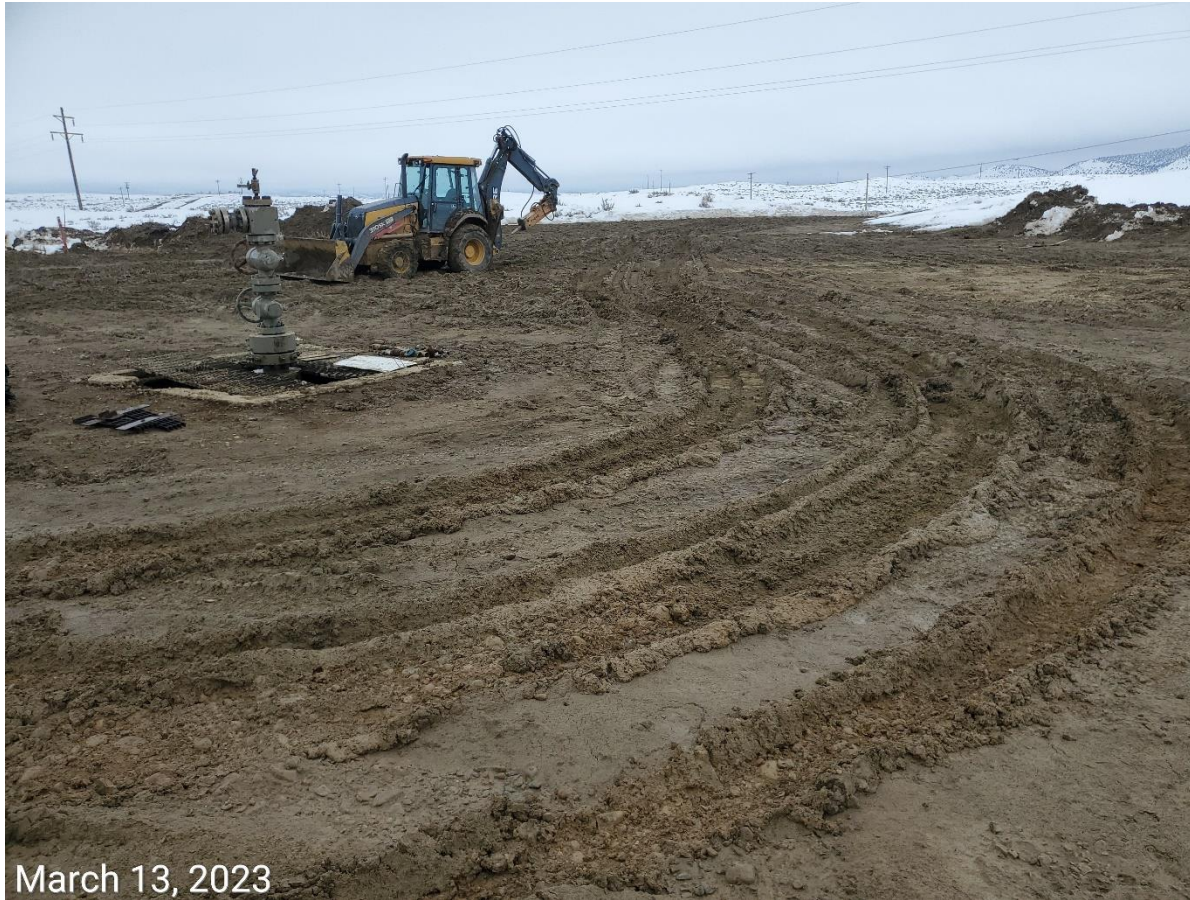
**Photo 9:** See comments under photo 1. Photo also shows wellhead. Well repair appears to be “in process”.

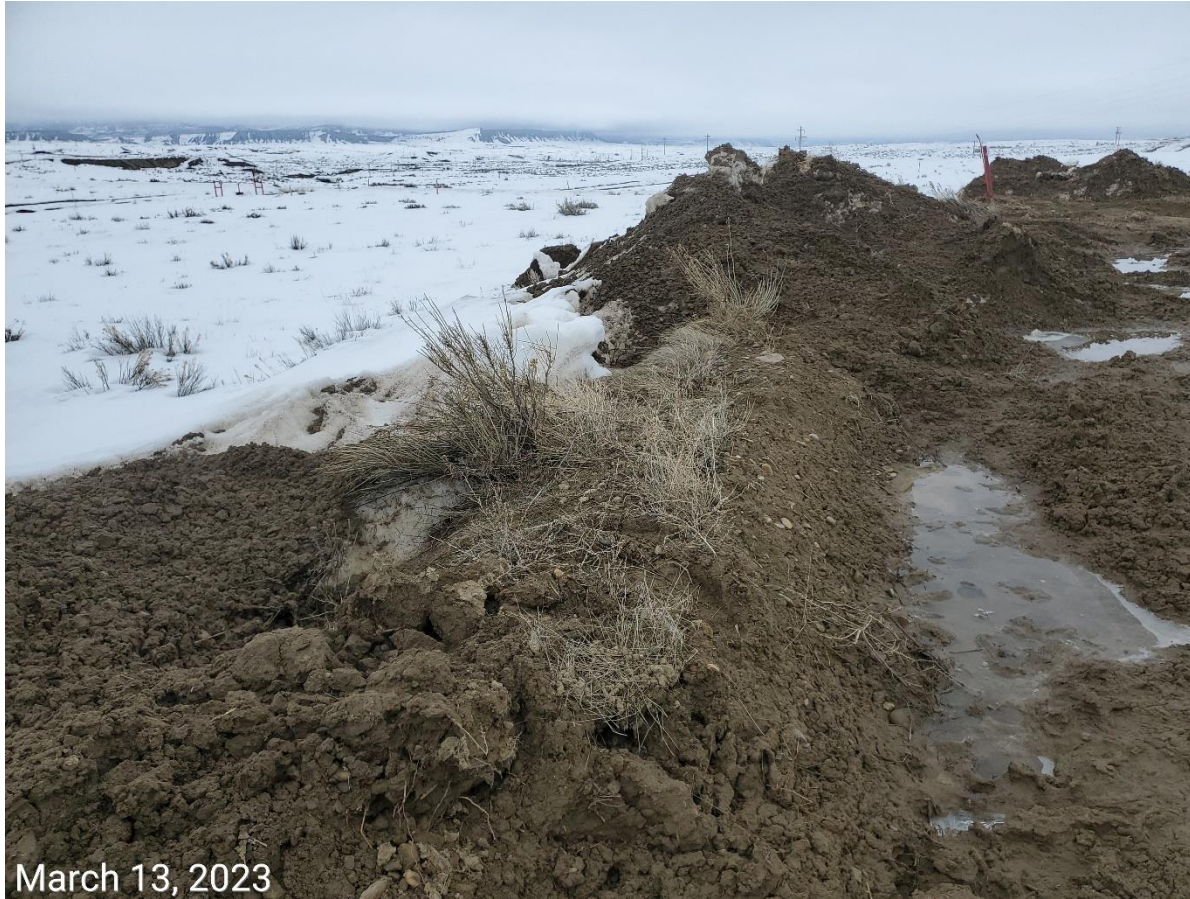
**Photo 10:** Photos 10-11 taken from the perimeter of the Location. Photos show Operator appears to have pushed soils beyond the perimeter of the working pad; soils observed covering vegetation; soils are unconsolidated and a pollutant source; BMPs to minimize off-site sediment transport from the soils missing or insufficient.

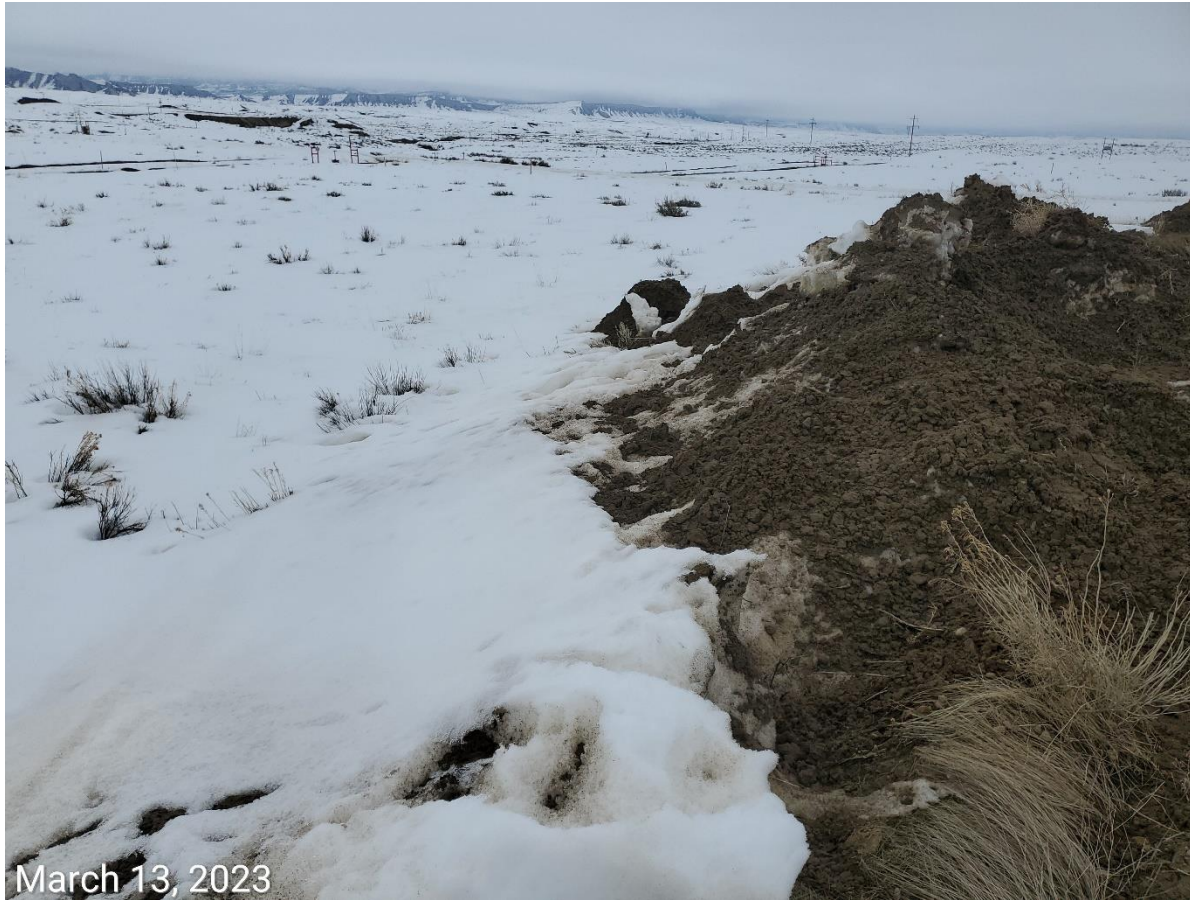
**Photo 11:** See comments under photo 10.

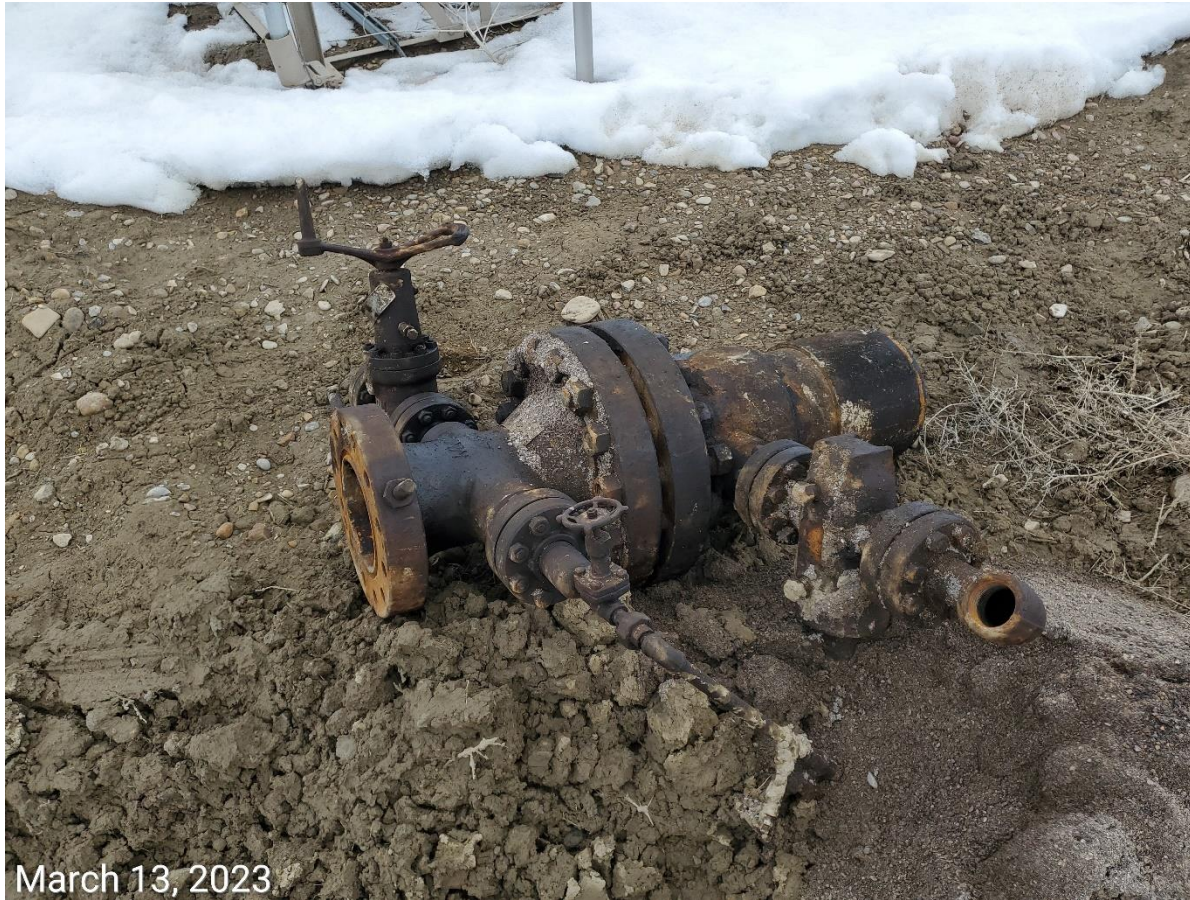
**Photo 12:** Photo taken from the east end of the Location. Photo shows disassembles well equipment improperly stored on the perimeter of the pad; equipment appears to be covered in production fluids; fluids evident within equipment and observed dripping onto the soil surface.

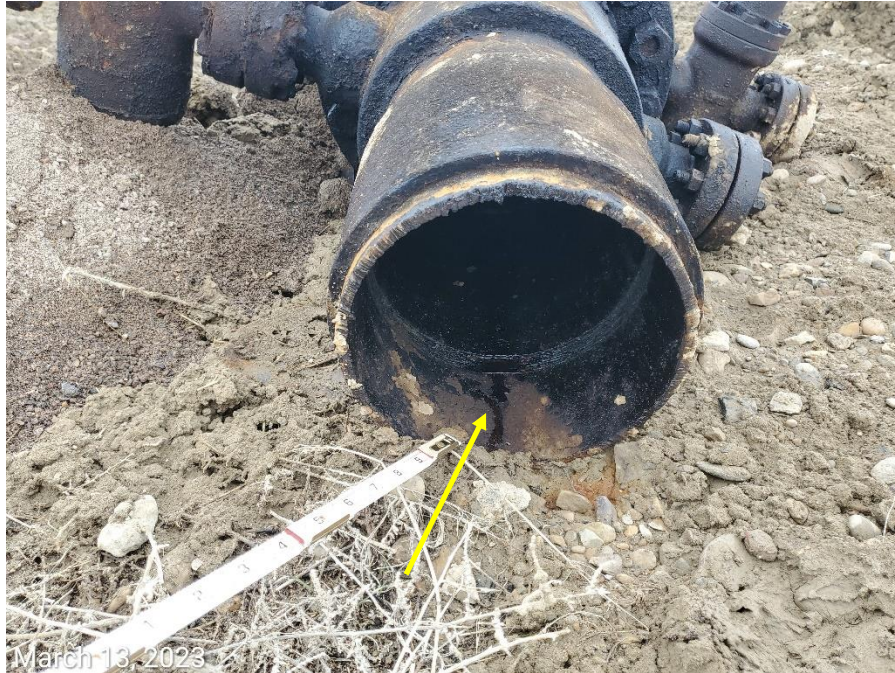
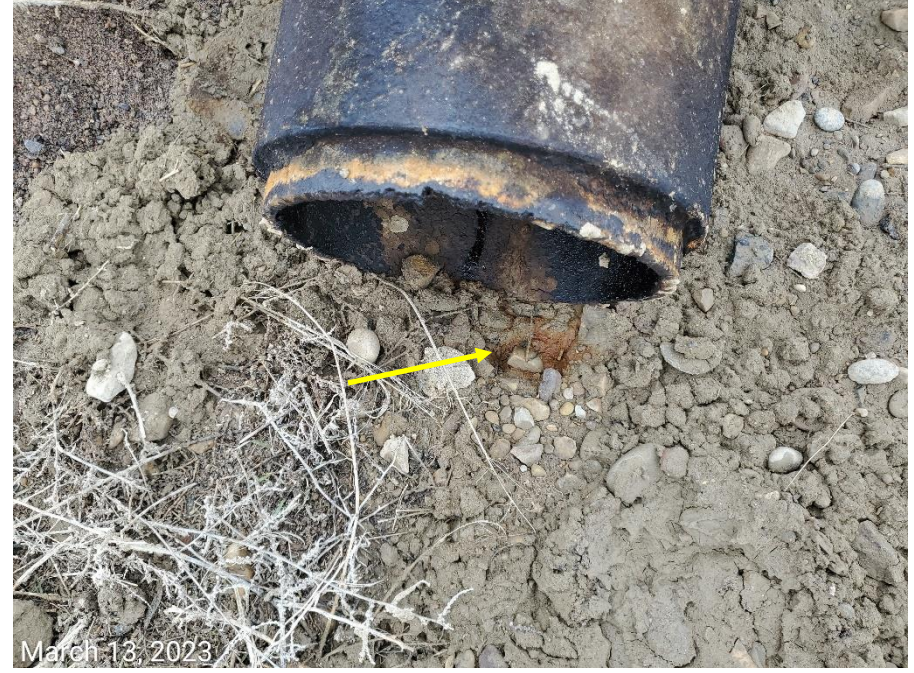
**Photo 13:** Continued from photo 12. Photo shows what appears to be produced fluids within the disassembled well equipment dripping onto the soil surface.

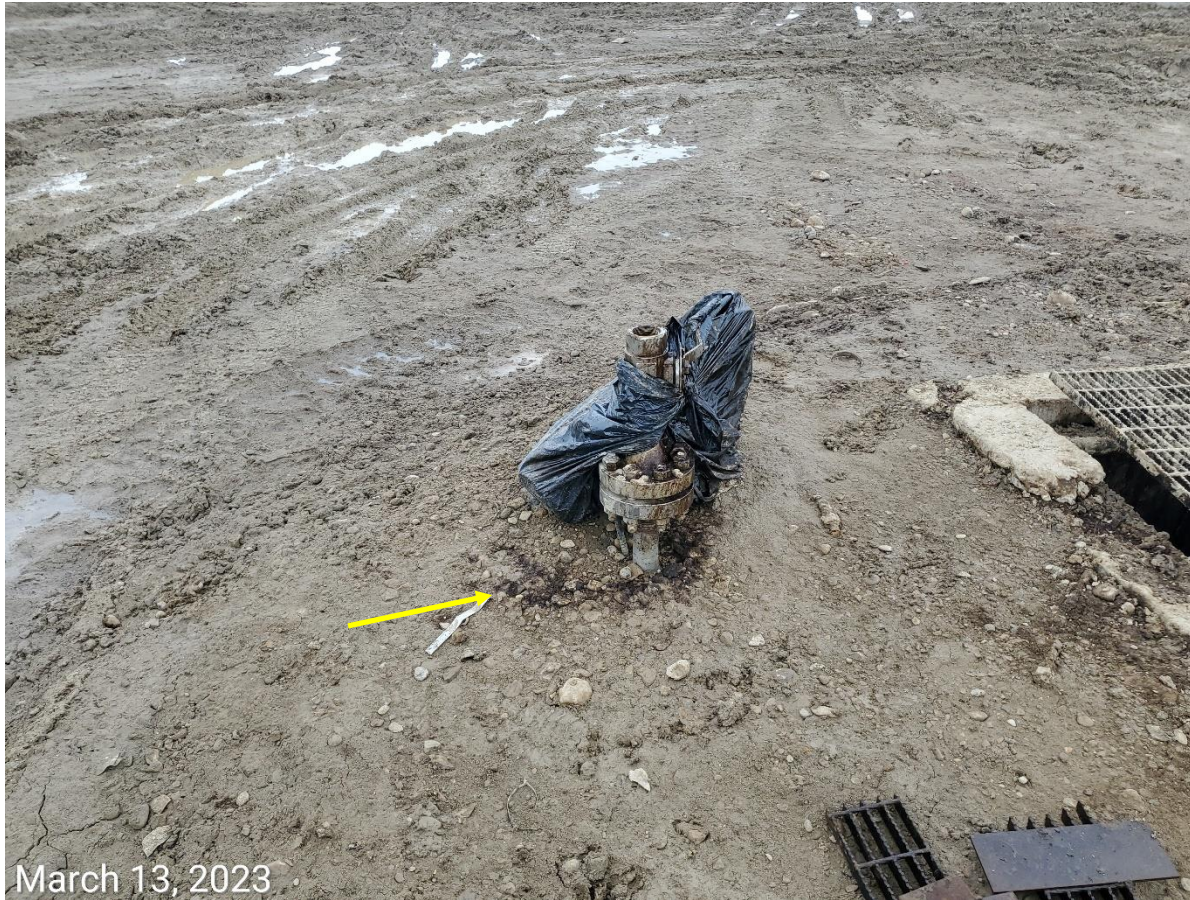
**Photo 14:** Photos 14-16 examples showing stained soils observed throughout the working pad area.

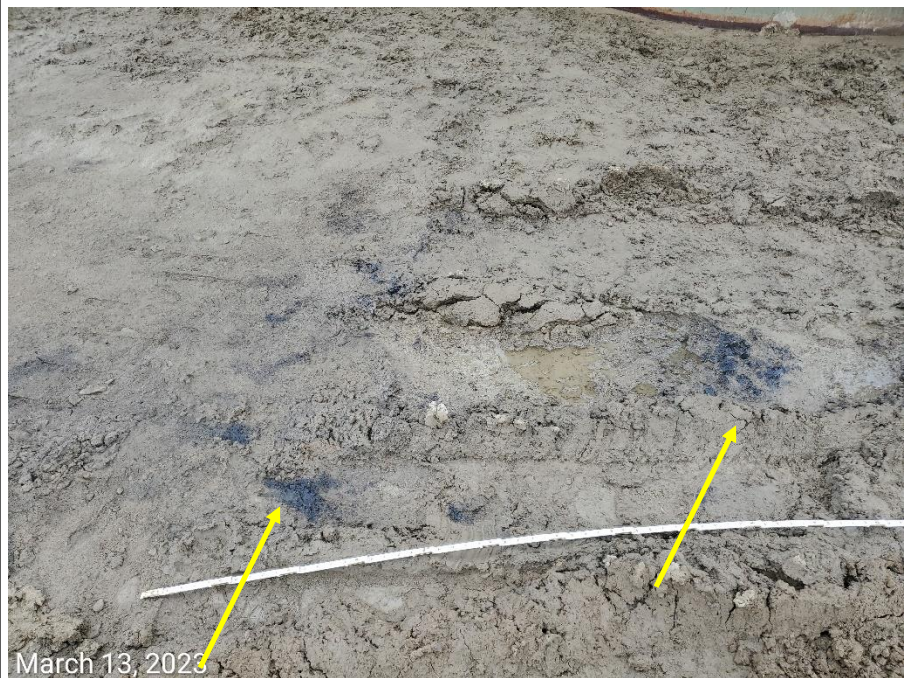
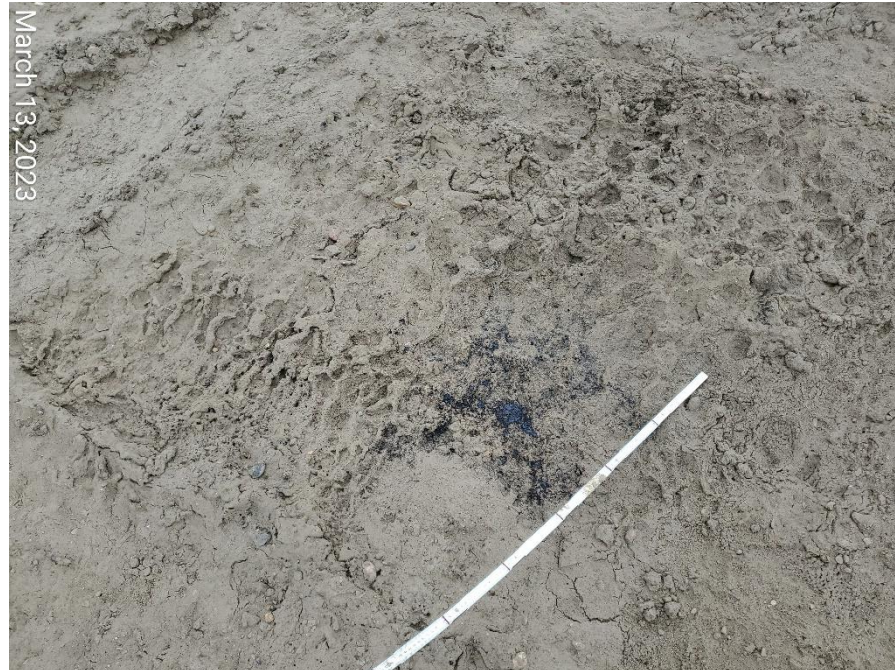
**Photo 15:** See comments under photo 14. 6 foot measuring stick for reference.

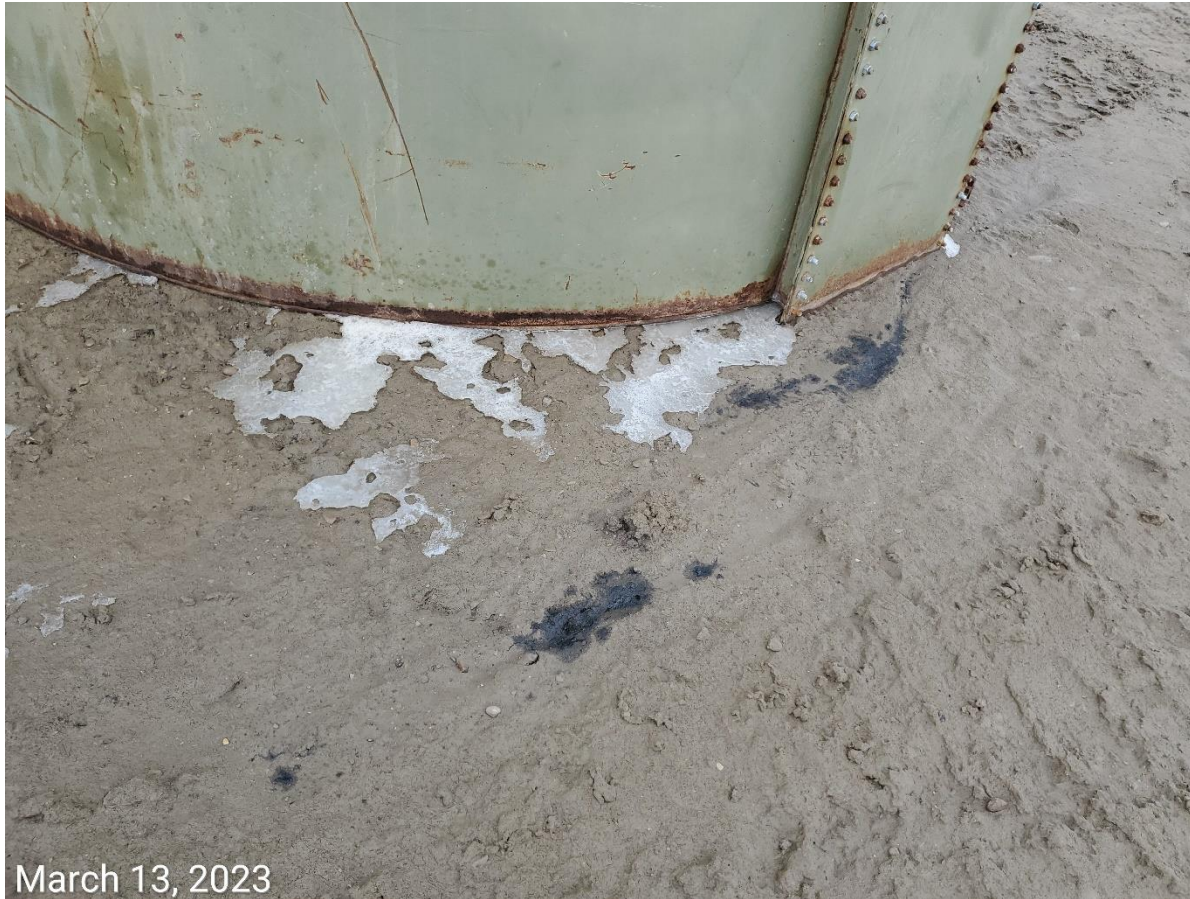
**Photo 16:** See comments under photo 14.

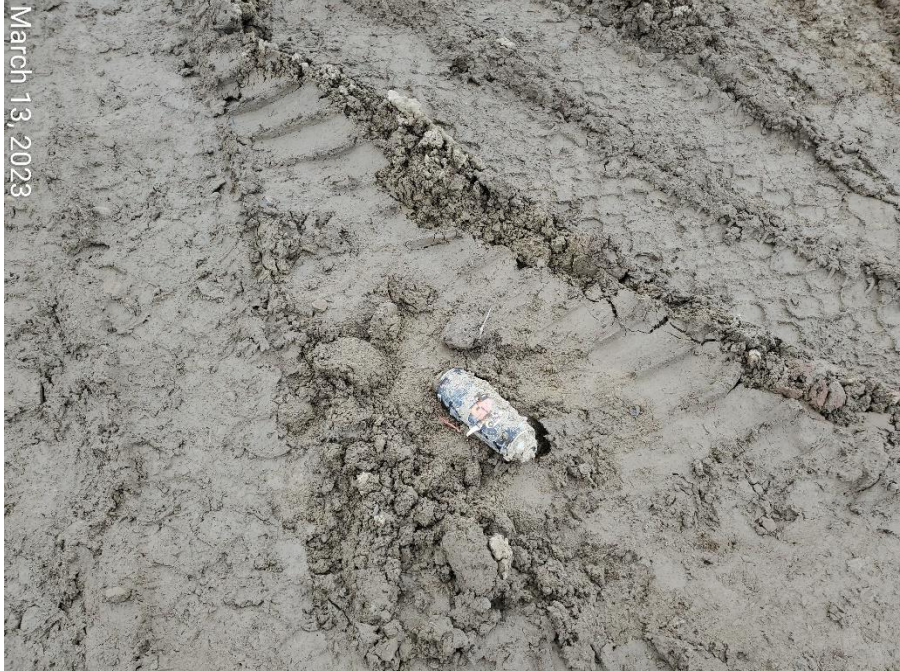
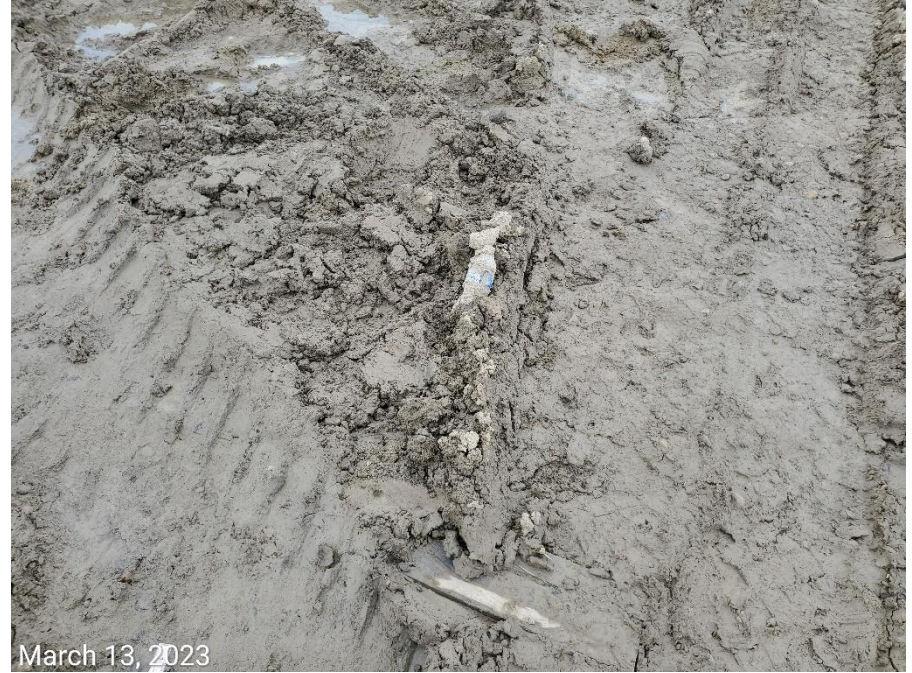
**Photo 17:** Photos 17-18 provide examples of trash/debris observed throughout the Location.

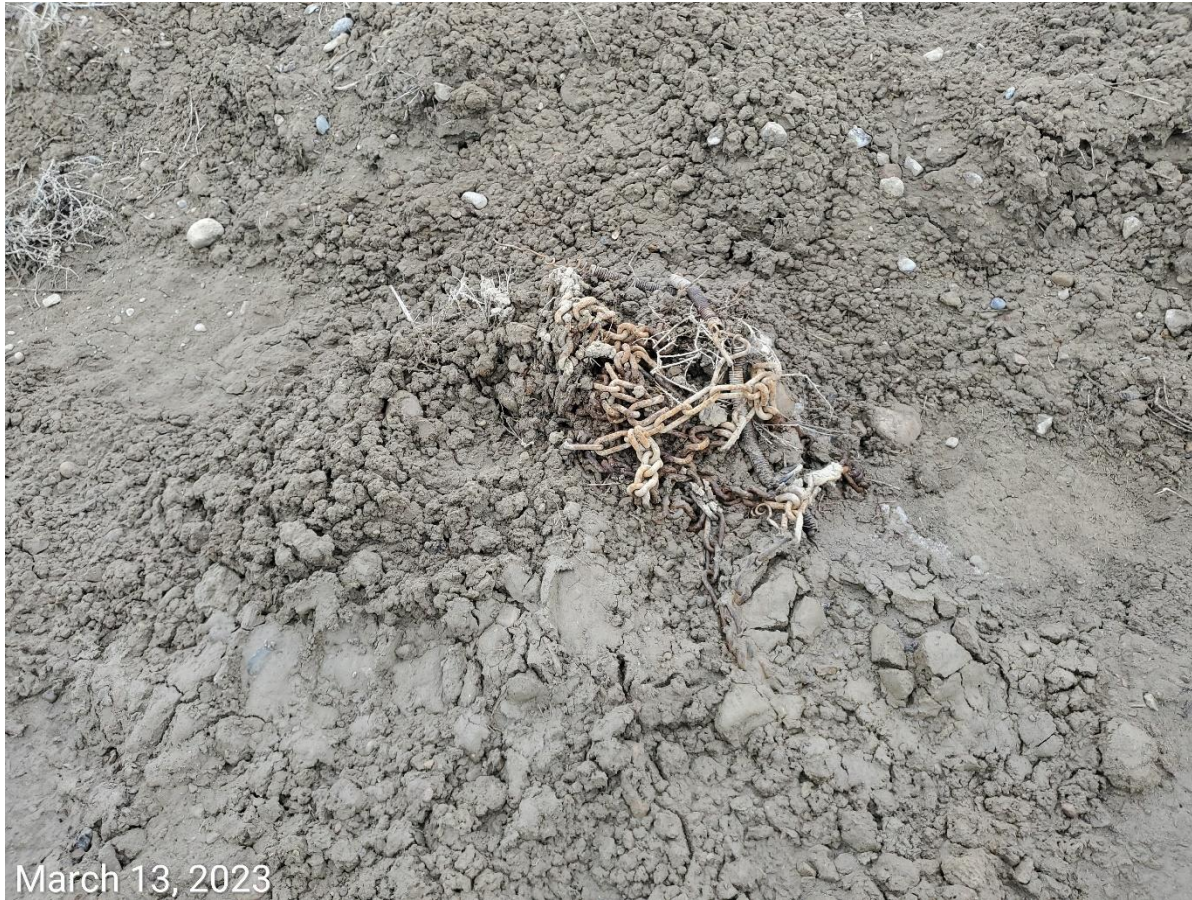
**Photo 18:** See comments under photo 16.

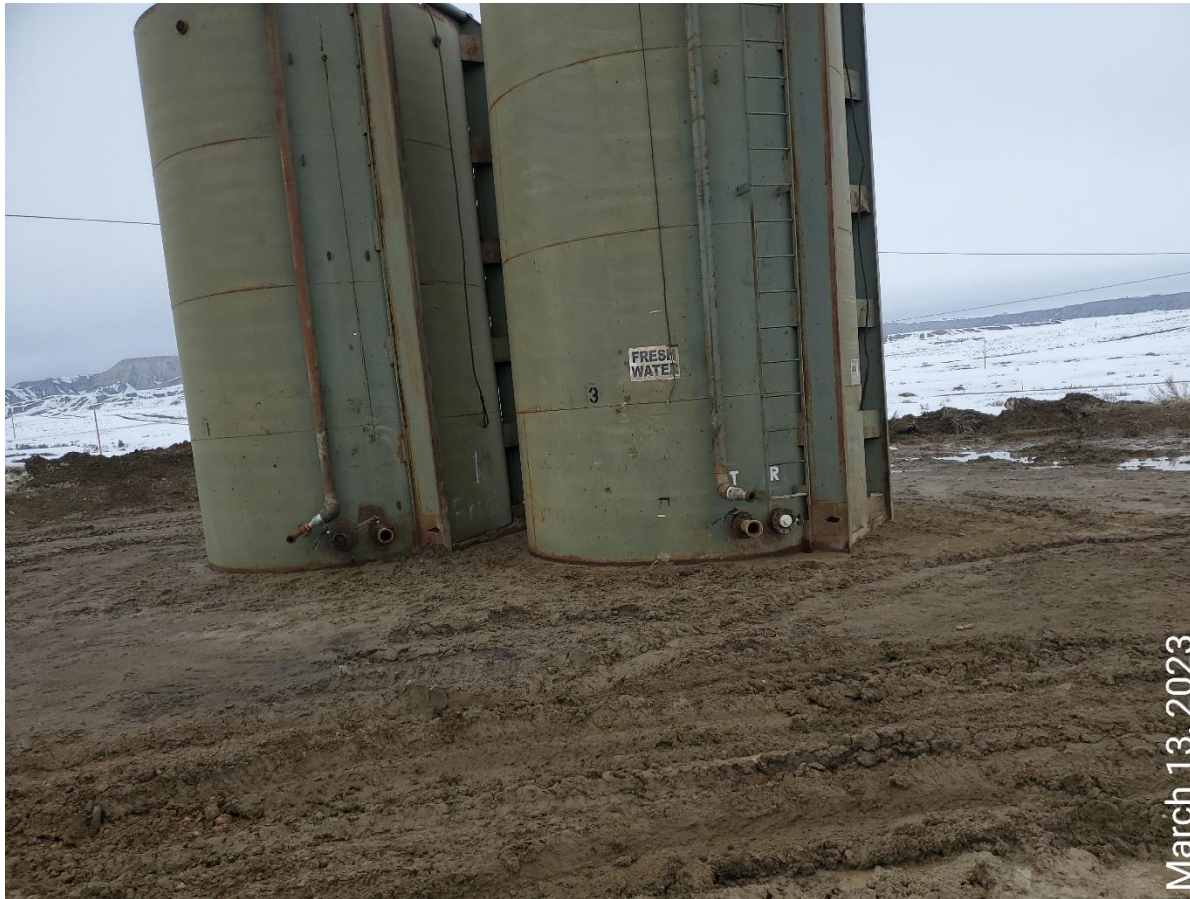
**Photo 19:** Photo shows tank on Location missing required labeling.

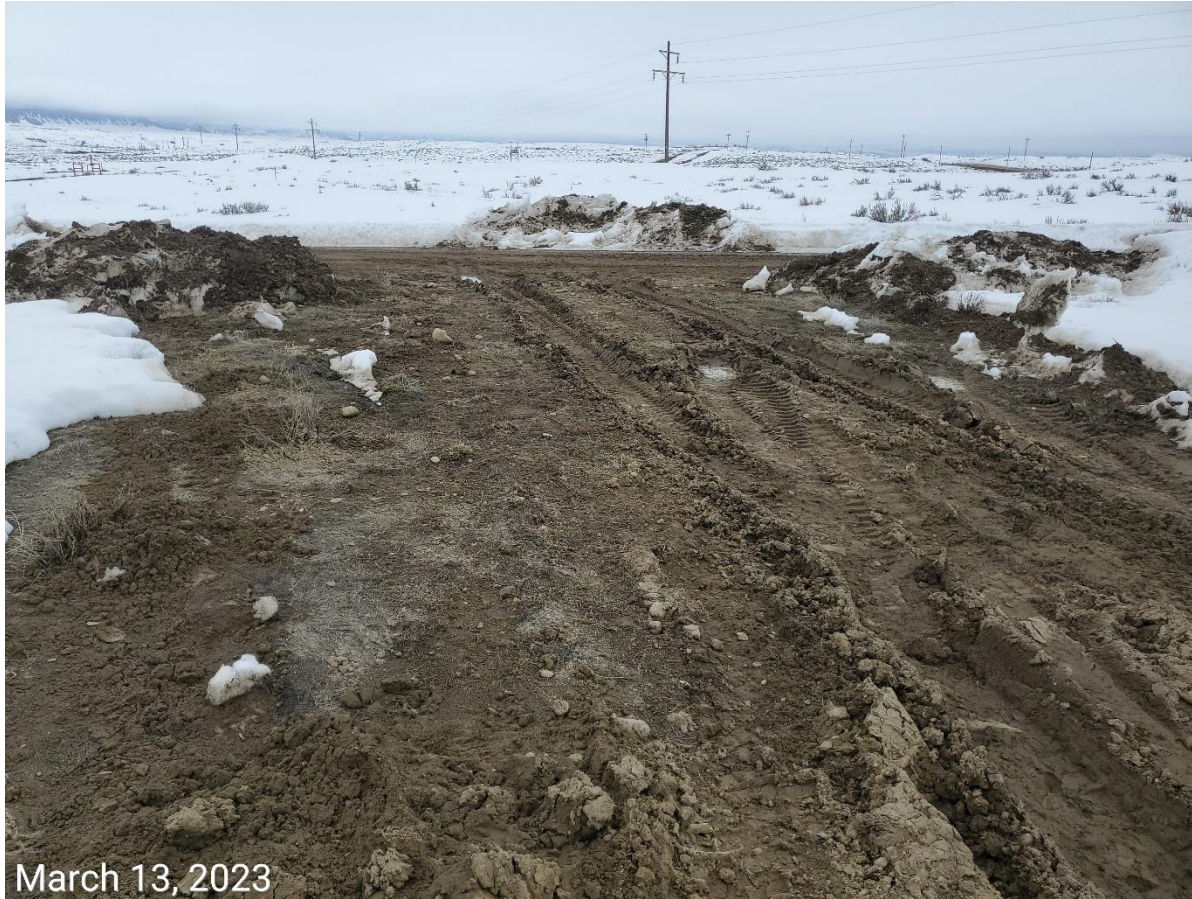
**Photo 20:** Photo taken from the east end of the Location, facing east. Photo shows off-location areas previously undisturbed, that have been disturbed due to off-location travel by the Operator.
