# Inspection Photos

3/13/2023

Operator: CHEVRON USA INC - 16700

Location #314696

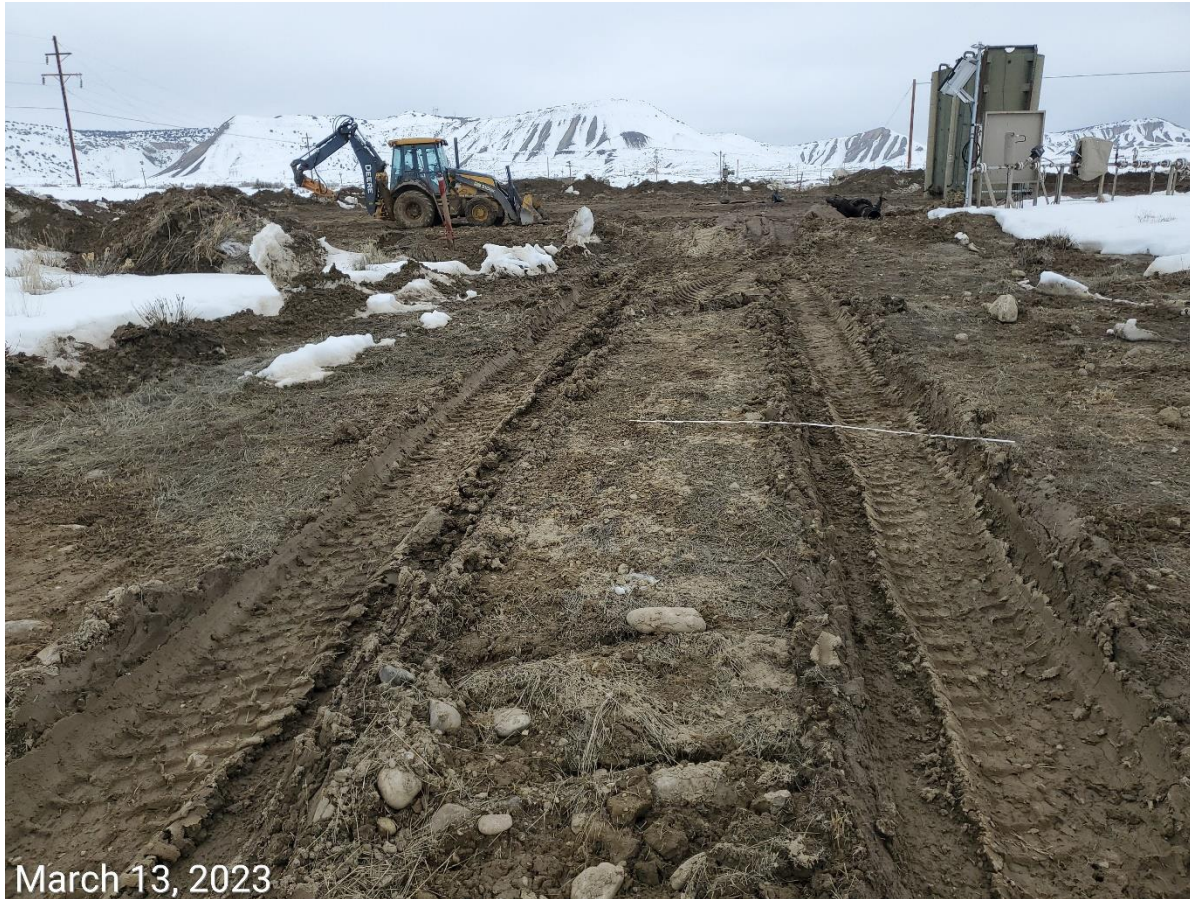
**Photo 20:** Photo taken from the east end of the Location, facing east. Photo shows off-location areas previously undisturbed, that have been disturbed due to off-location travel by the Operator.

**Photo 21:** See comments under photo 21. 6 foot measuring stick for reference.

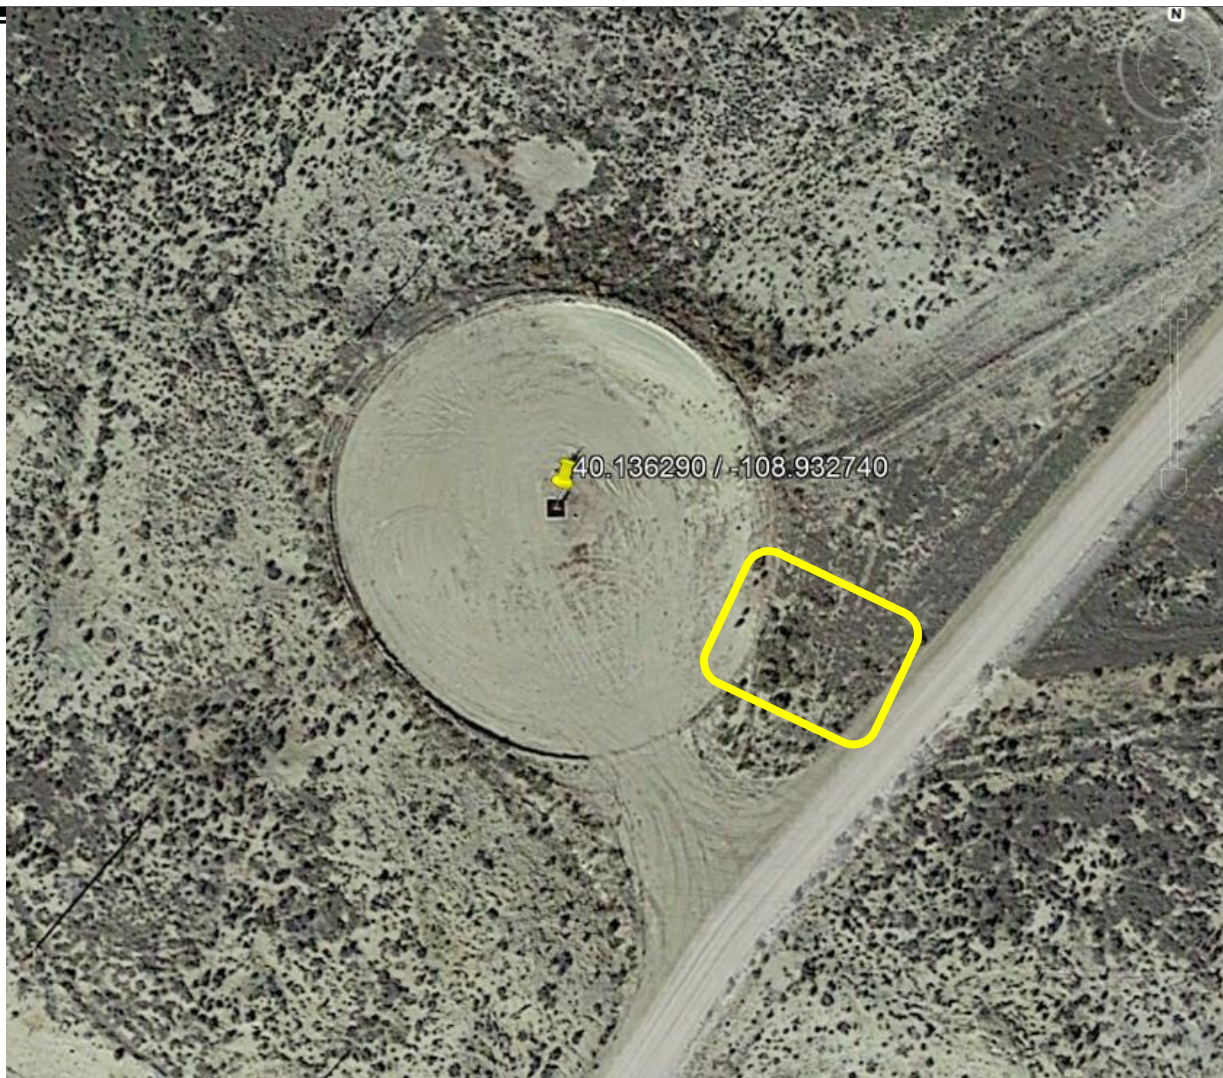
**Photo 22:** Photo shows a Google Earth Aerial image of the Location. Areas outlined by the yellow polygon represents areas of new disturbance (see photos 20-21). Areas appear to be previously undisturbed, and outside of the designated working pad and access road.

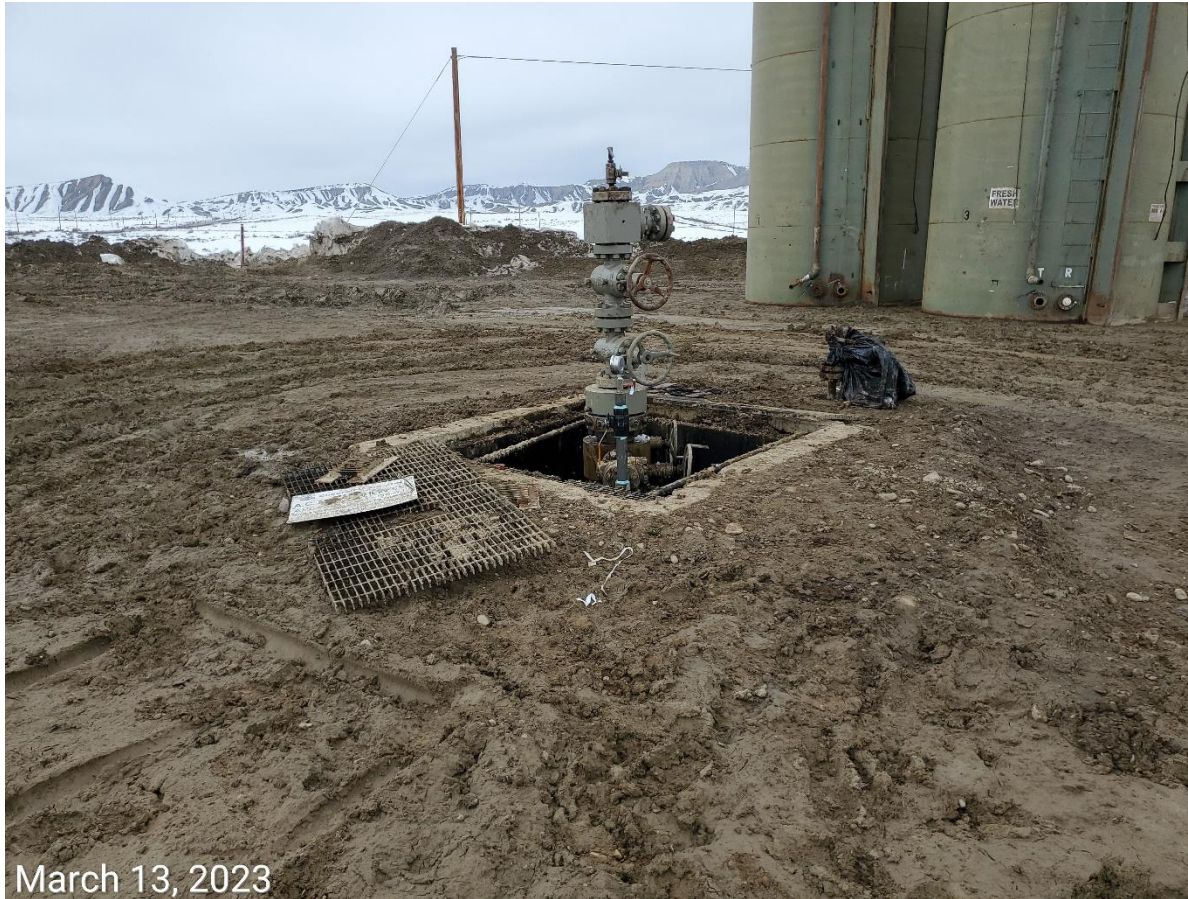
**Photo 23:** Cellar left uncovered.
