Interim Reclamation and Stormwater Inspection

Operator: MALLARD EXPLORATION LLC - 10670

Location ID: 455365

Inspection Photos
Location Name: Shoveler Pad
Location ID: 455365

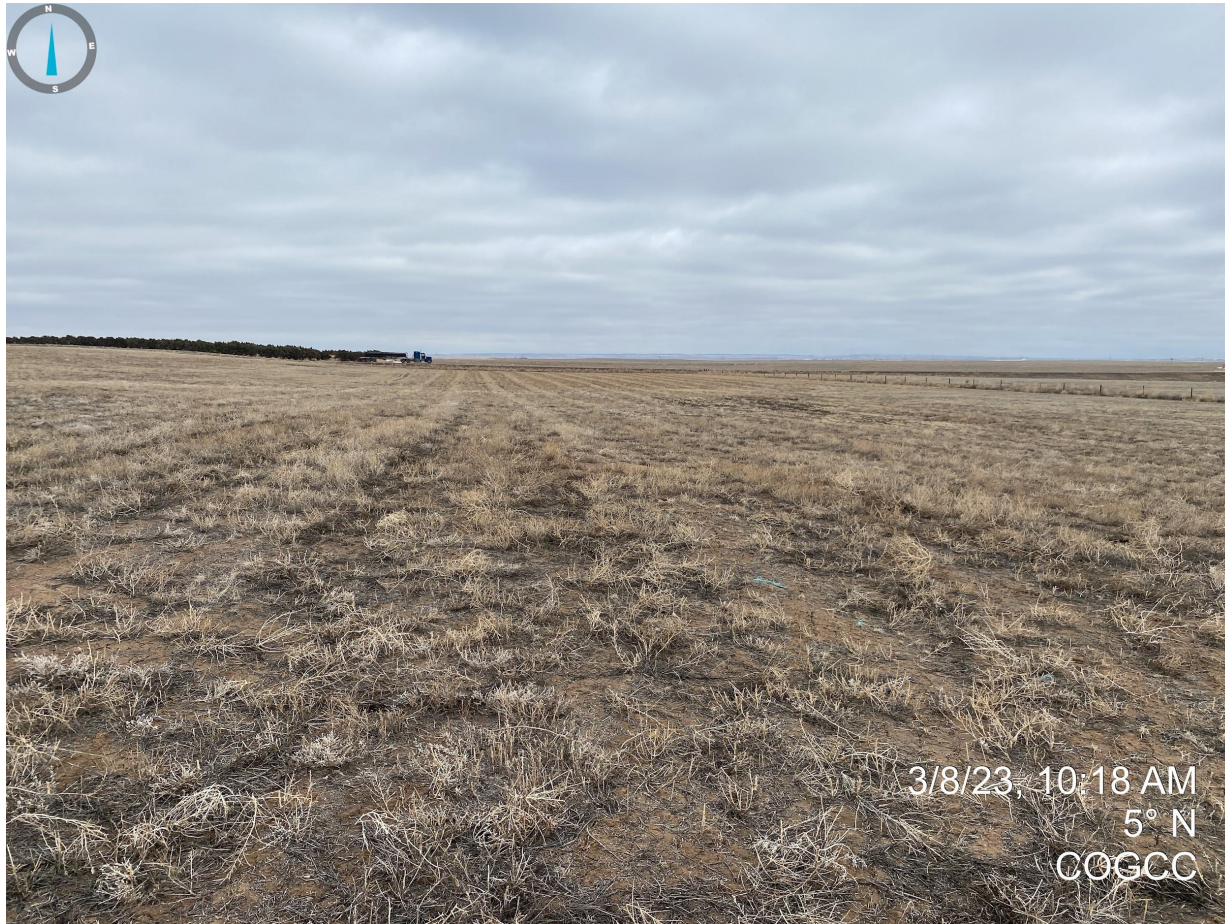
Photo 1. Facing north from the southeastern portion of the interim reclamation areas. Undesirable vegetation (e.g. kochia and russian thistle) and areas of bare soil were observed throughout the interim areas. It appears that the weeds have been managed previously with evidence of mowing.

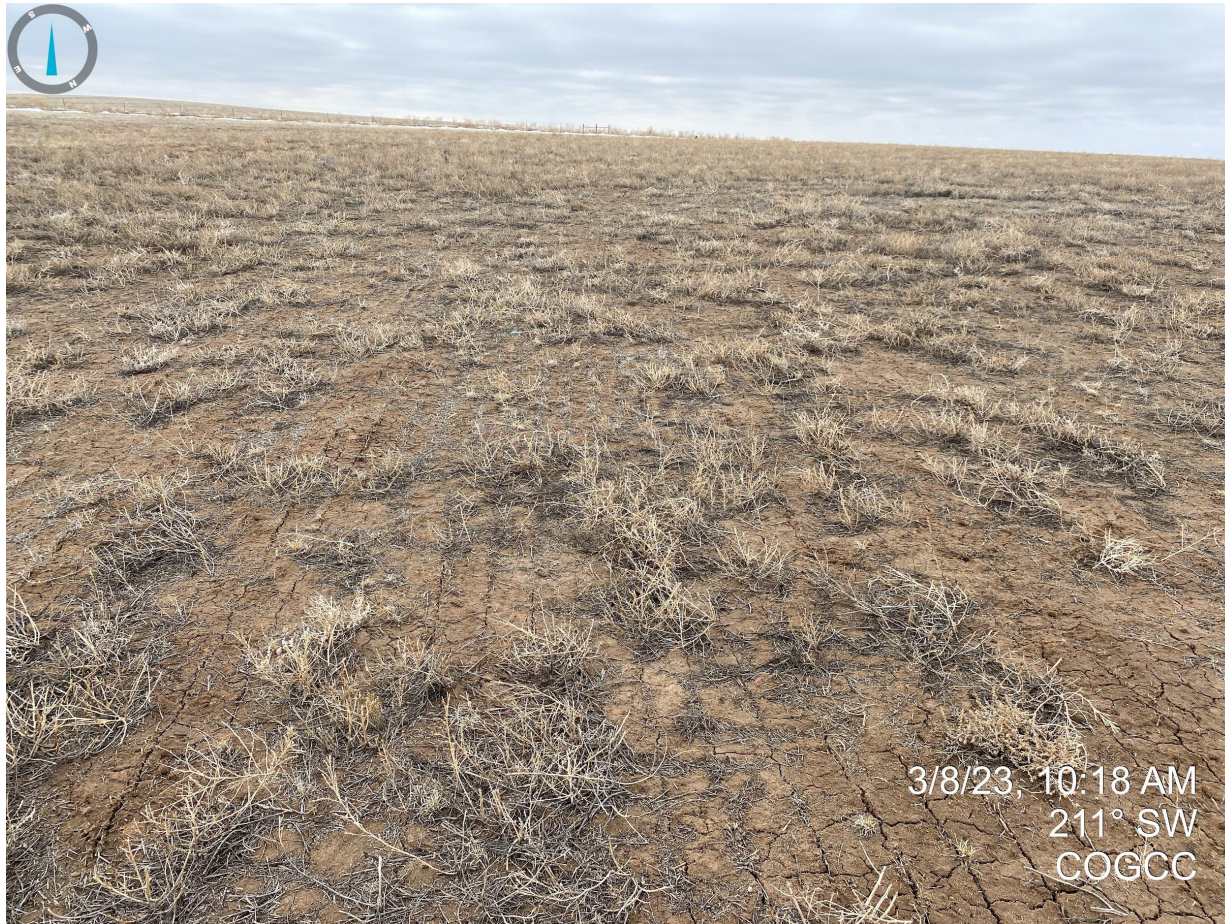
Photo 2. Facing southwest from the southeastern portion of the interim area. See comments in Photo 1.

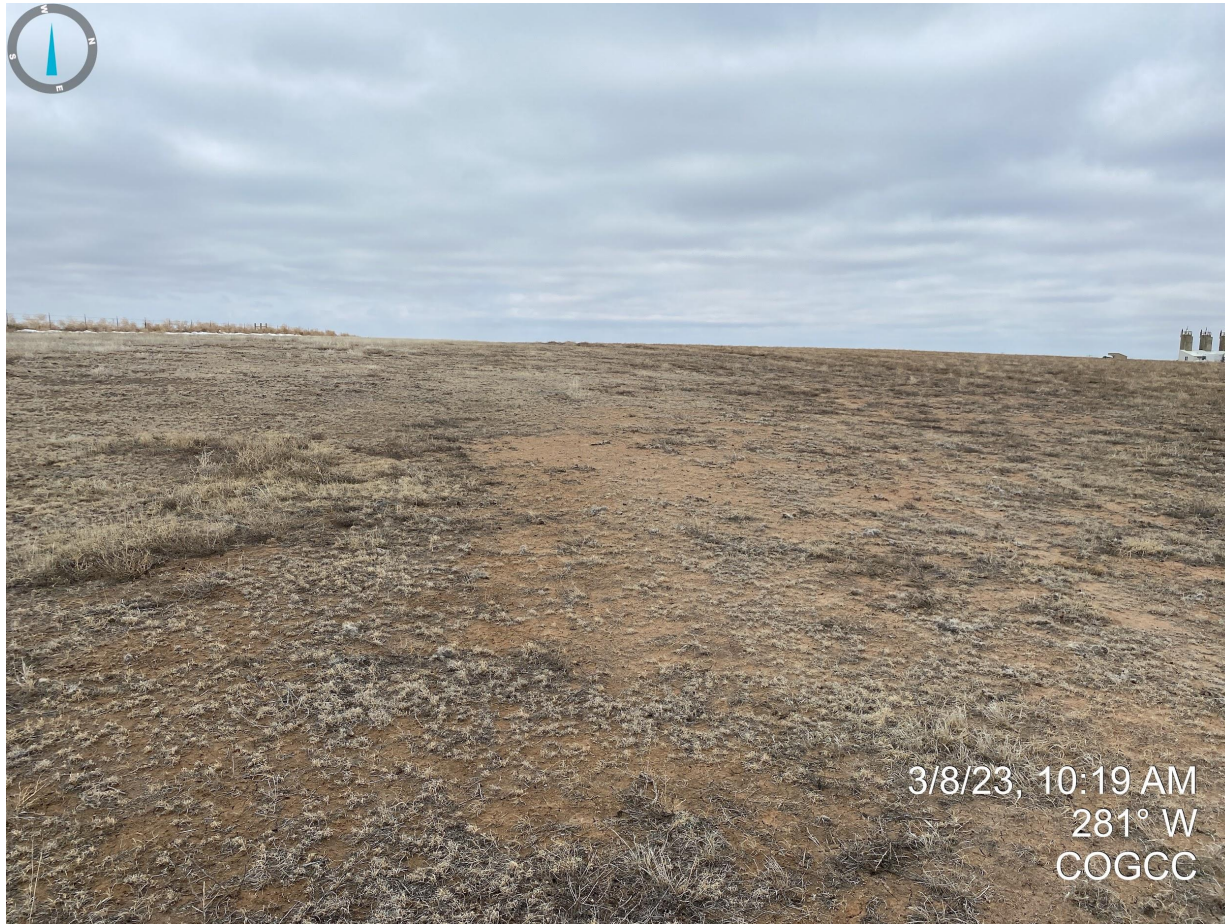
Photo 3. Facing west from the southeastern portion of the interim area. See comments in Photo 1.

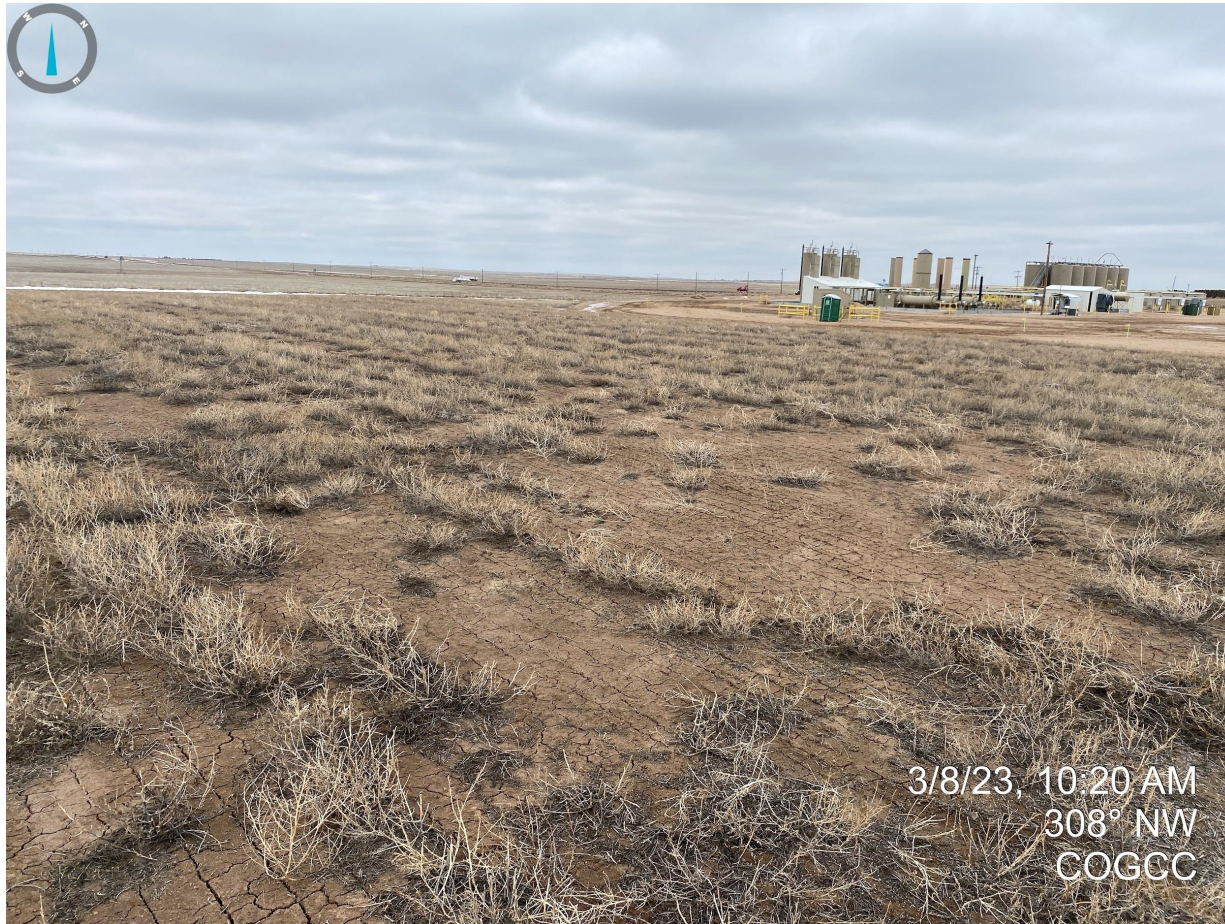
Photo 4. Facing northwest from the southern/central portion of the interim area. See comments in Photo 1.

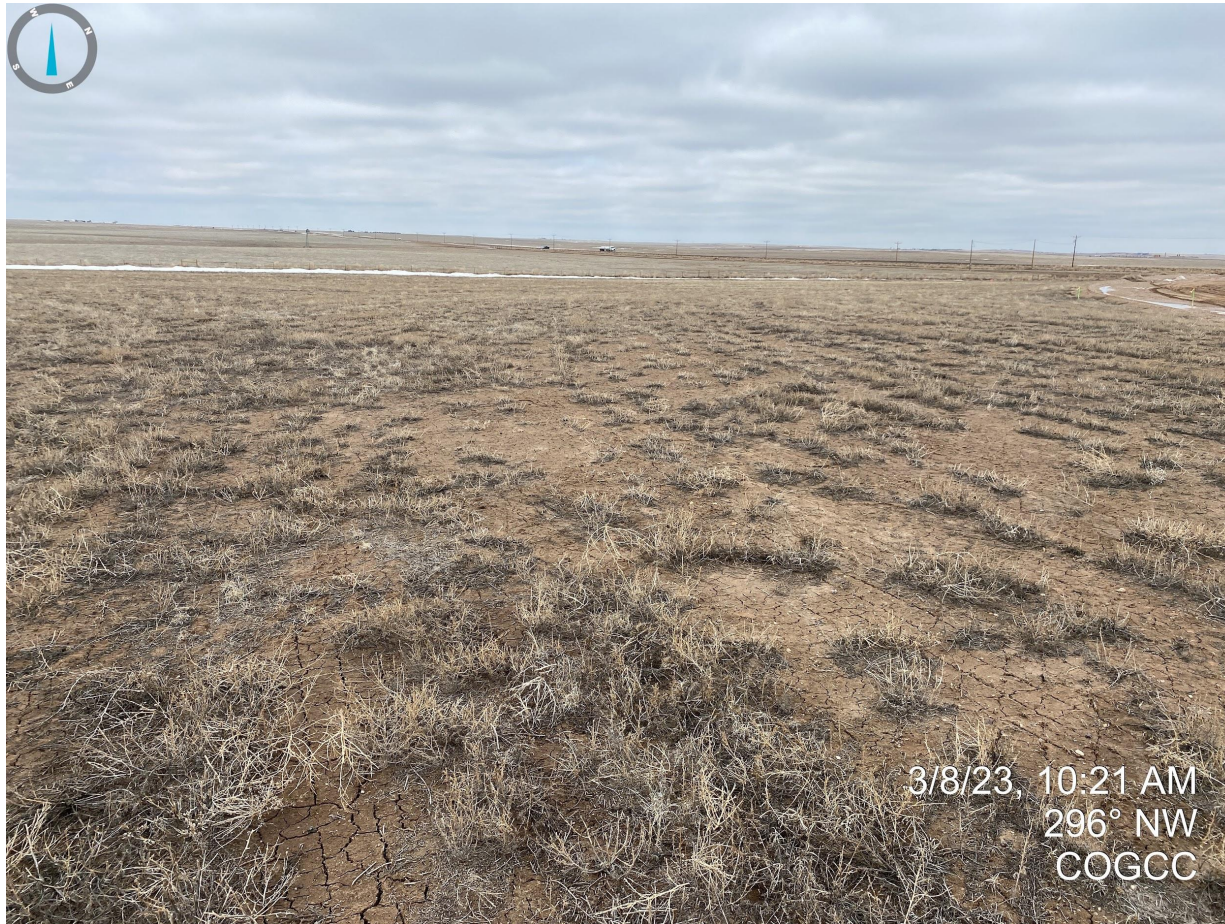
Photo 5. Facing northwest towards the western interim area. See comments in Photo 1.

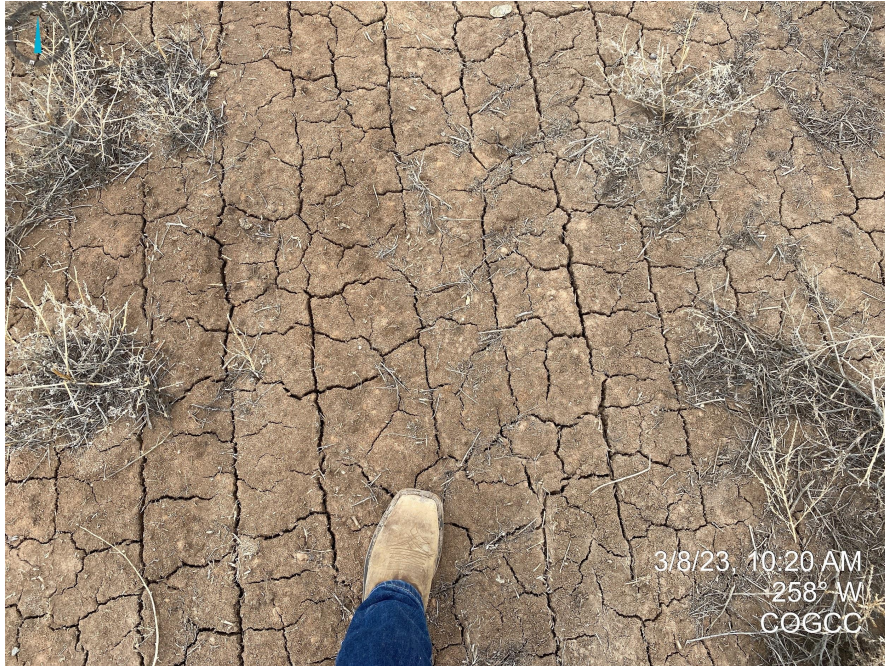
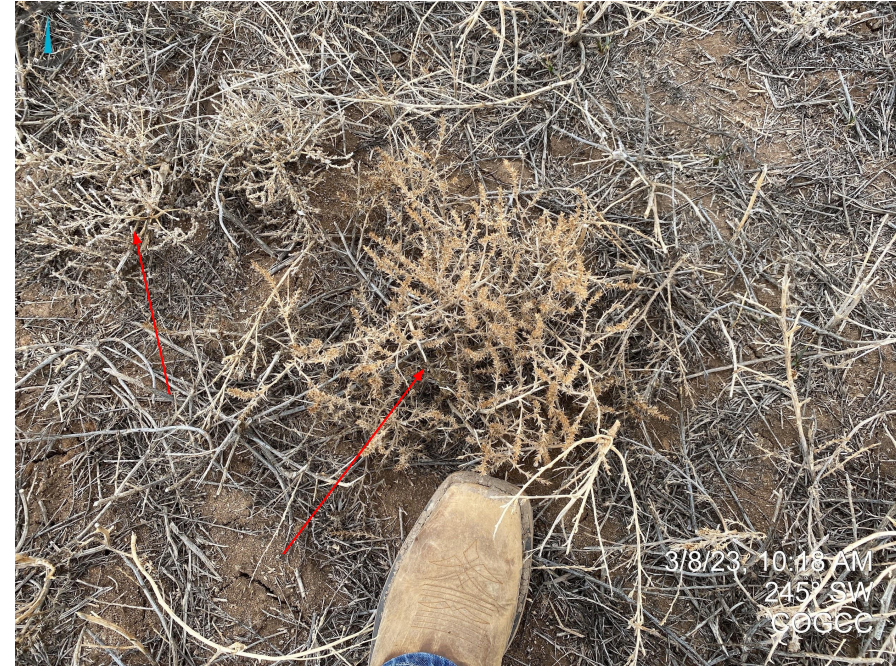
Photos 6 & 7. Close up photos illustrating bare soil and undesirable vegetation (e.g. russian thistle and kochia).

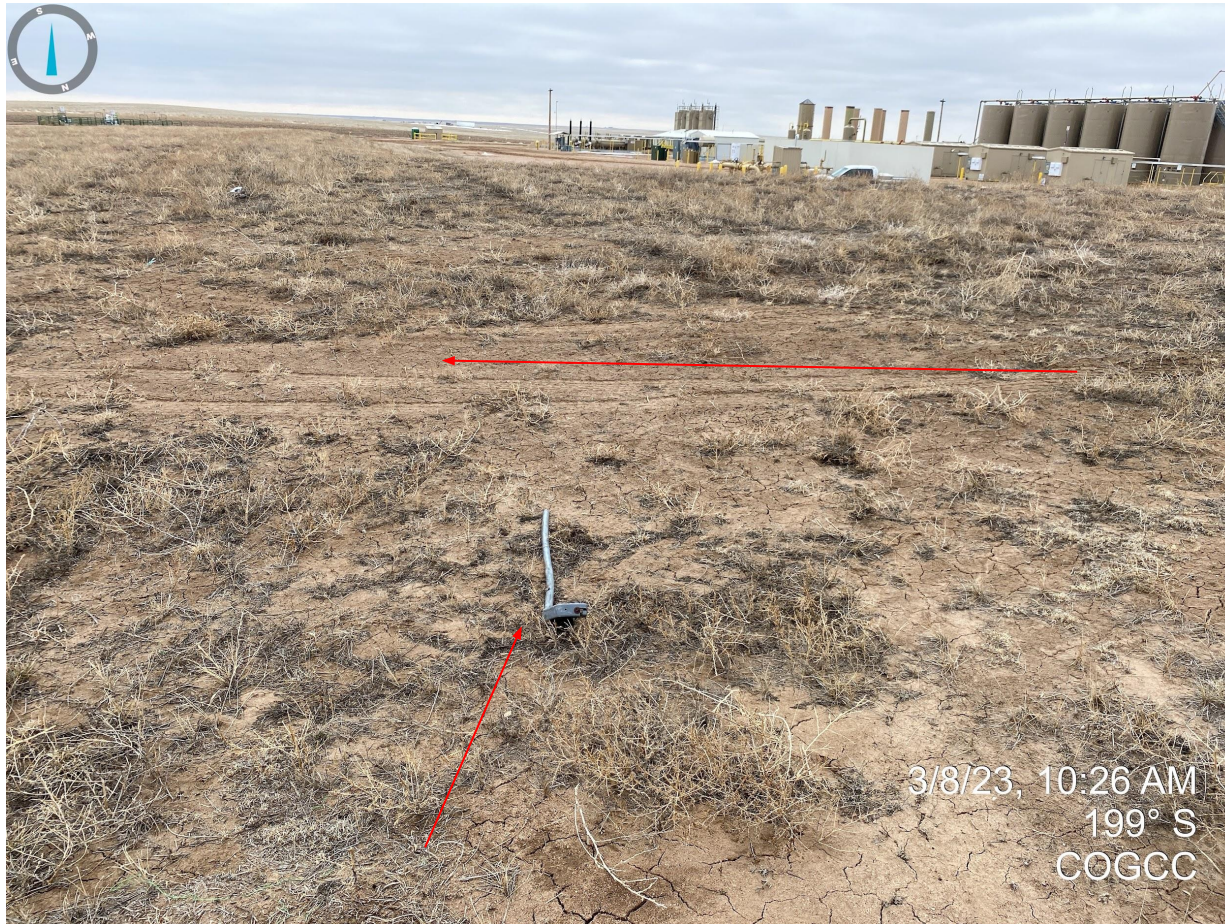
Photo 8. Facing south from the topsoil stockpile. Photo illustrates debris and evidence of vehicle traffic on the stockpile.

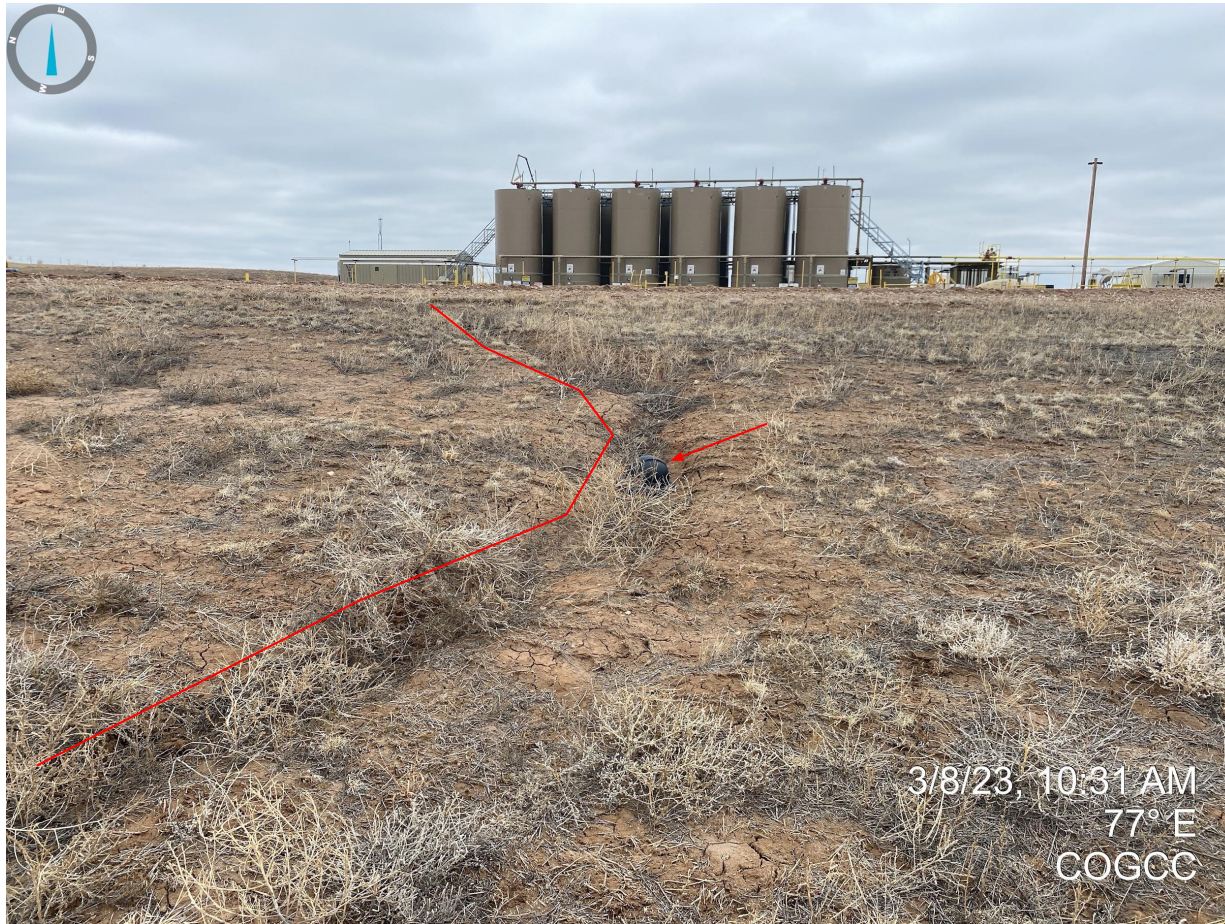
Photo 9. Facing east from the western edge of the pad. Photo illustrates rill erosion occurring within the interim areas that appears to have originated from a breached perimeter berm. (Hard hat for scale)

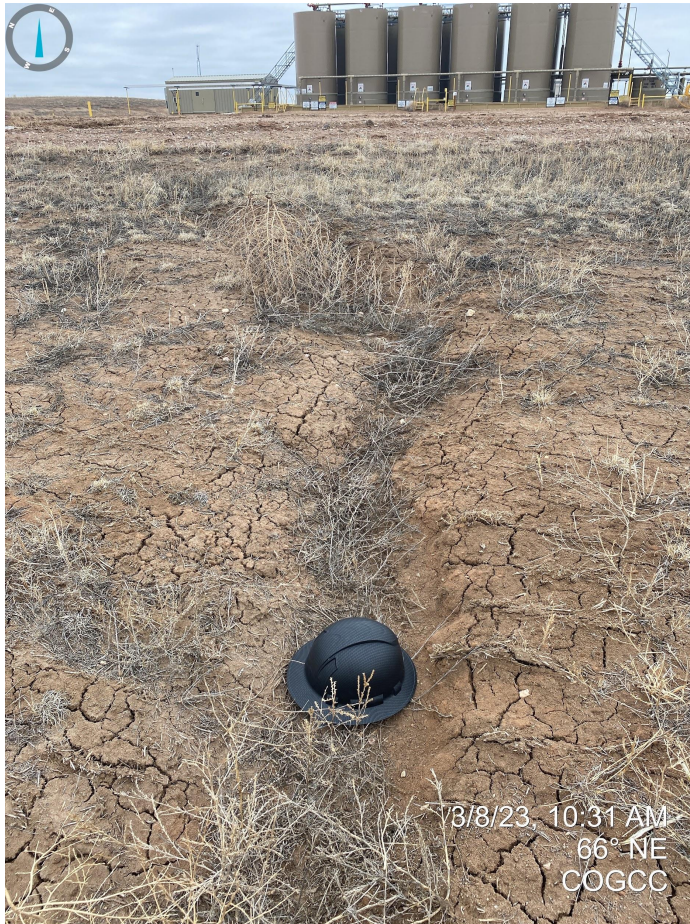
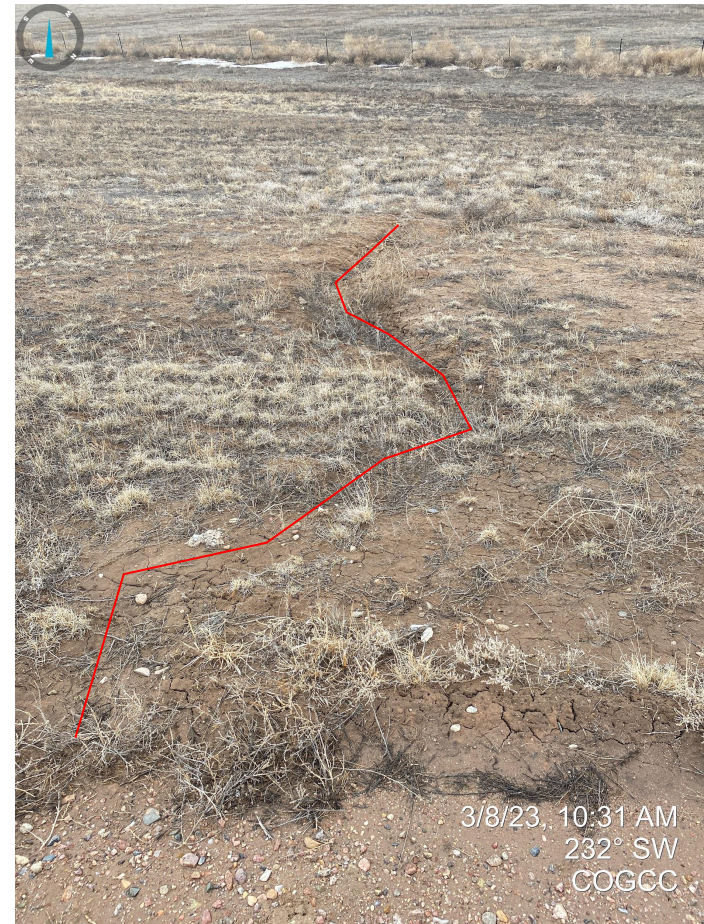
Photos 10 & 11. Close up photos; See comments in Photo 9.

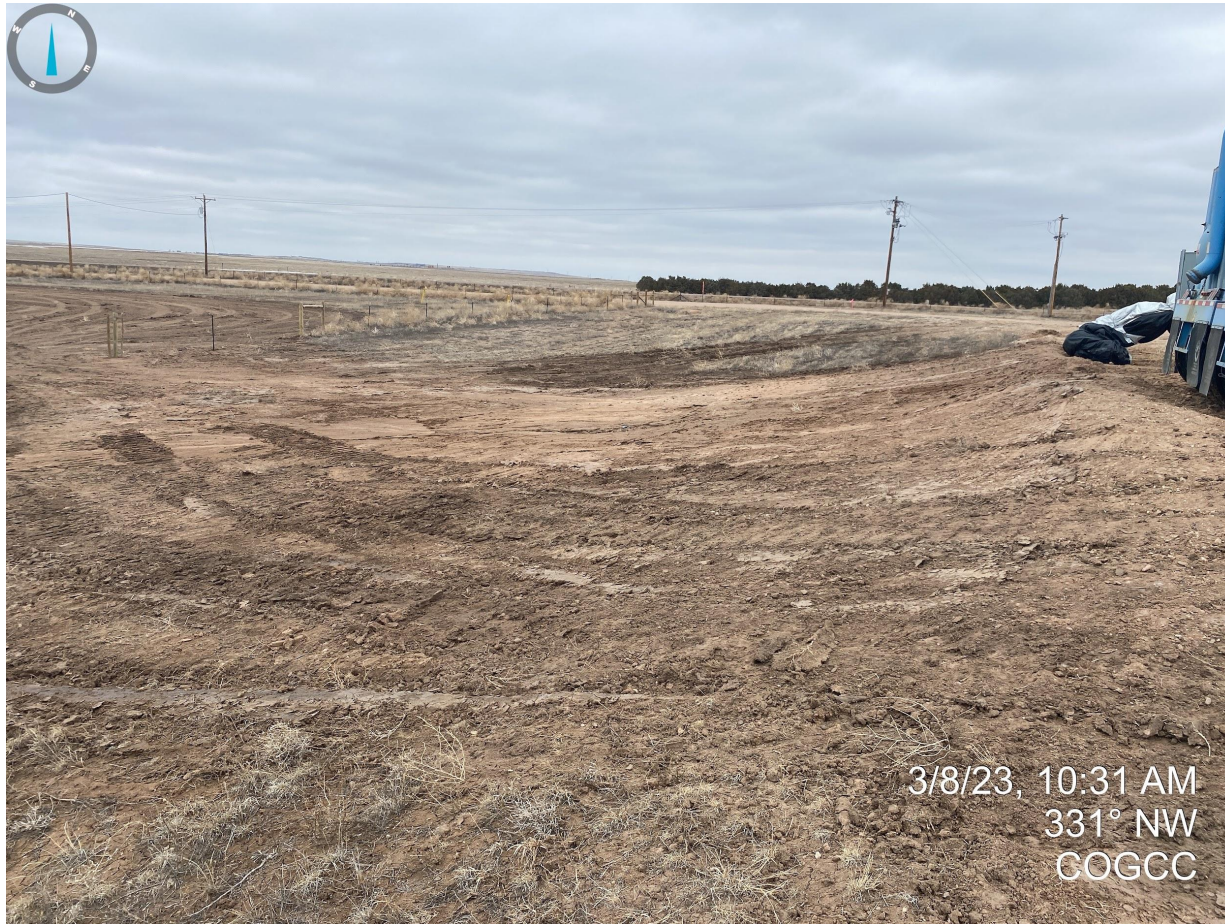
Photo 12. Facing northwest from the western portion of the pad; this portion of the interim area will need to be reclaimed once the pipeline work has been completed.

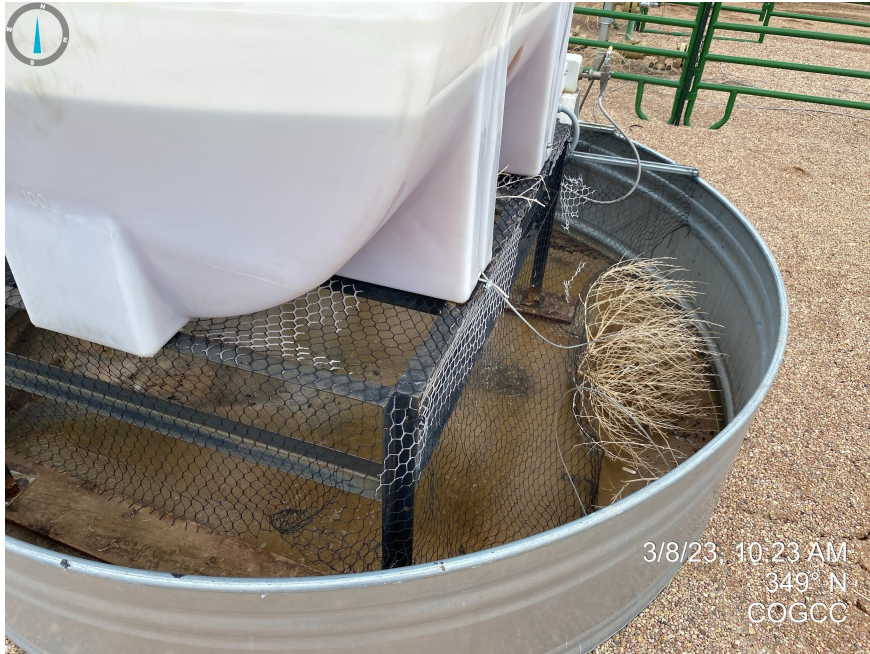
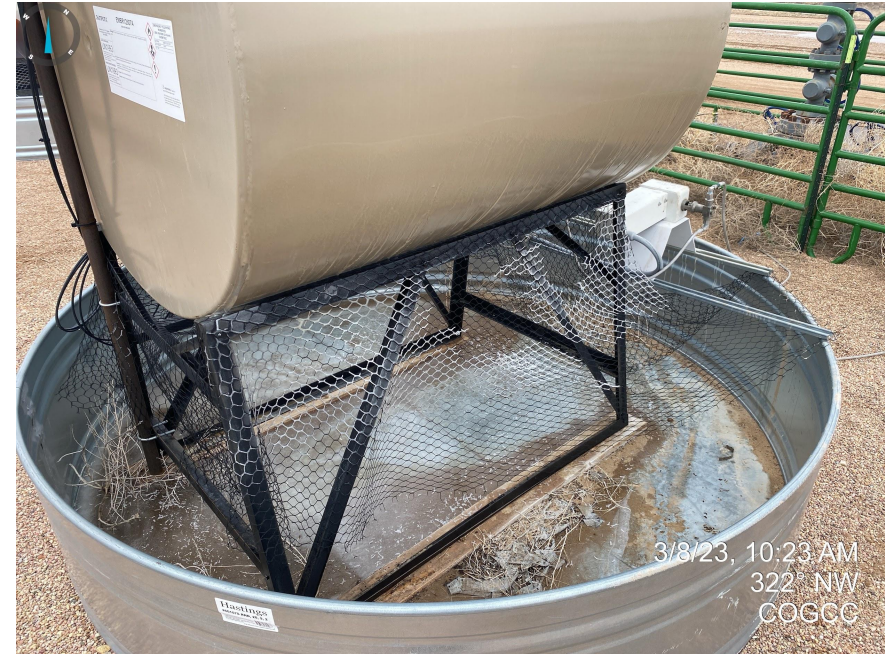
Photos 13 & 14. Close up photos of open top tanks near the location's wells; the wildlife netting is inadequate and will need to be repaired or replaced to exclude wildlife entry.

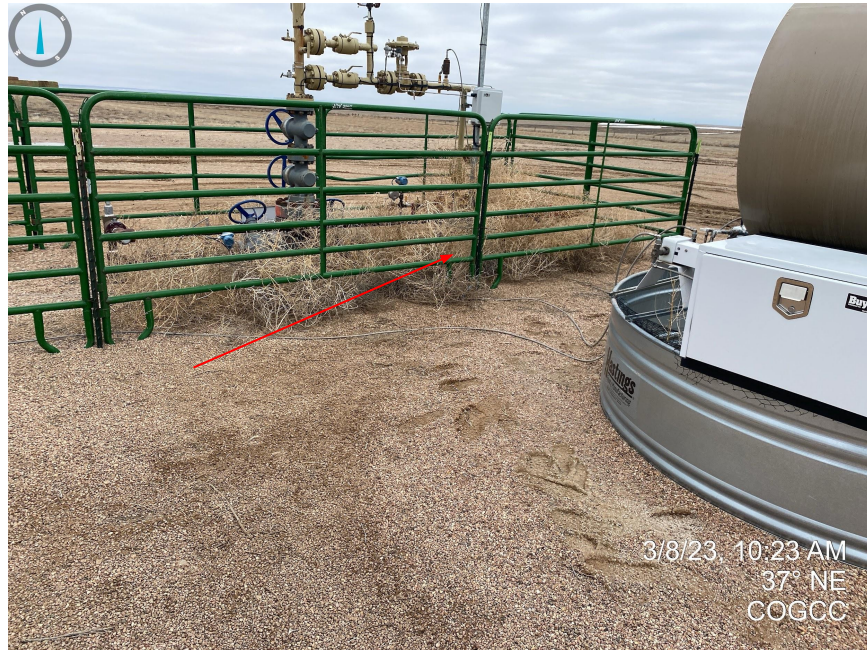
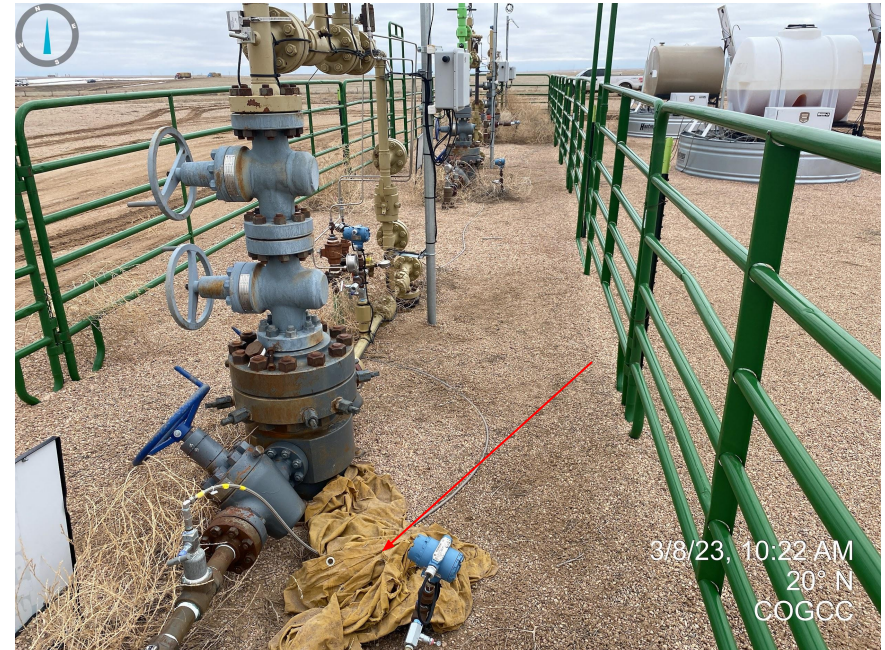
Photos 15 & 16. Close up photos of debris that needs to be removed.

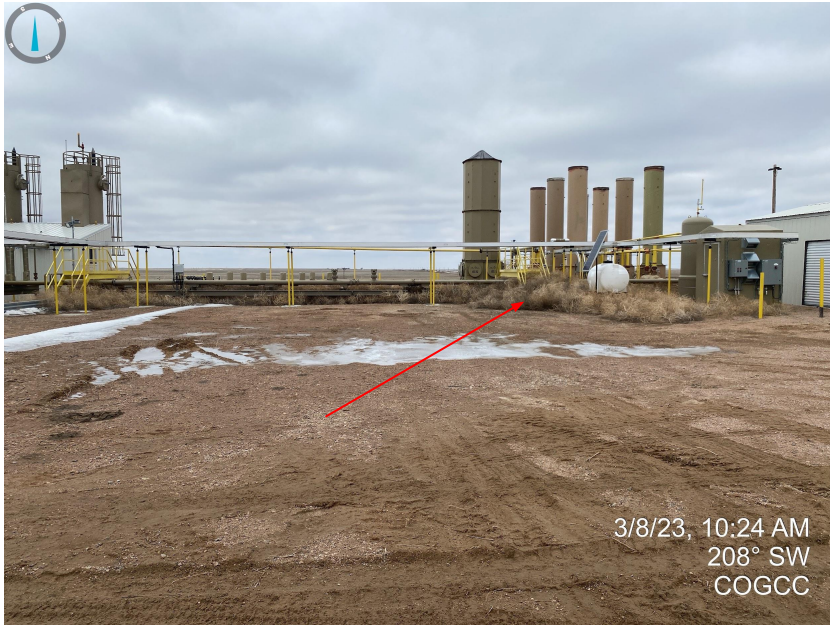
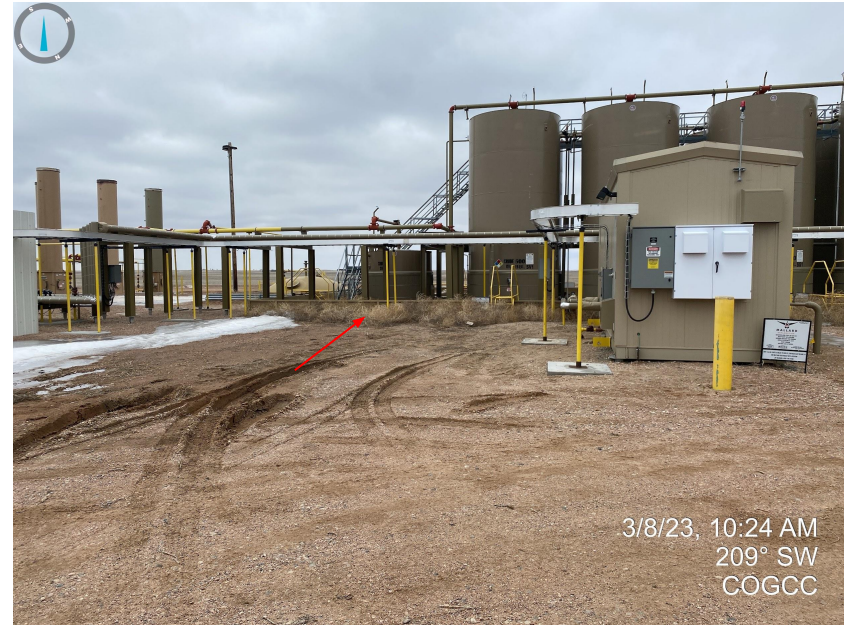
Photos 17 & 18. Facing southwest near production equipment. Photo illustrates tumbleweed accumulations within equipment; this is now considered debris and needs to be removed as it present a fire hazard.

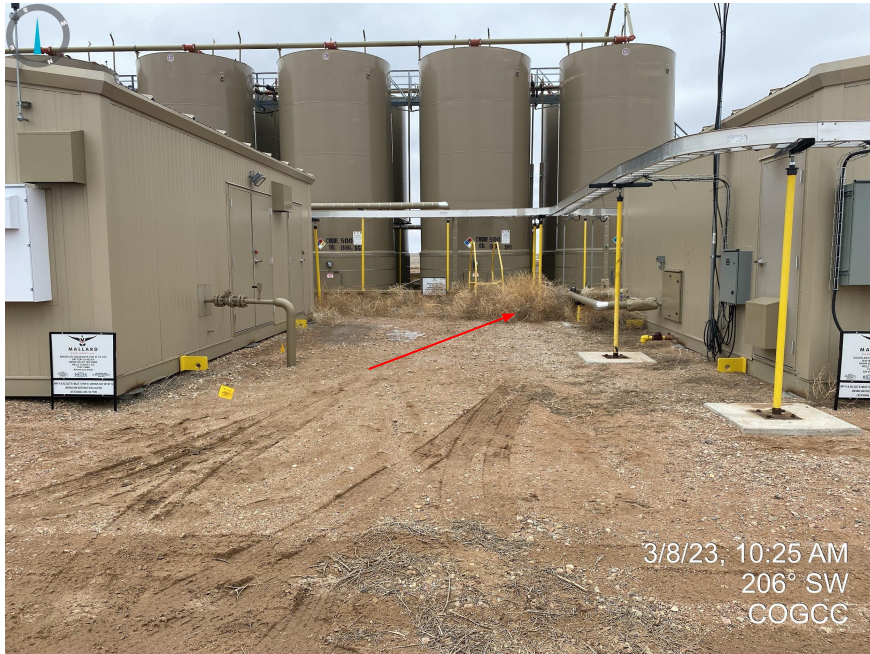
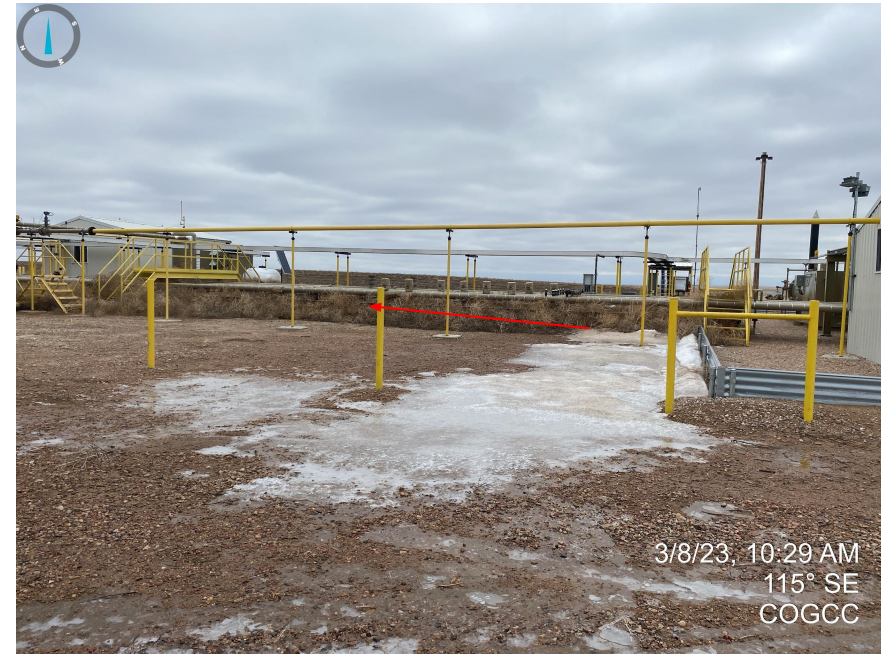
Photos 19 & 20. See comments in Photos 17 & 18.

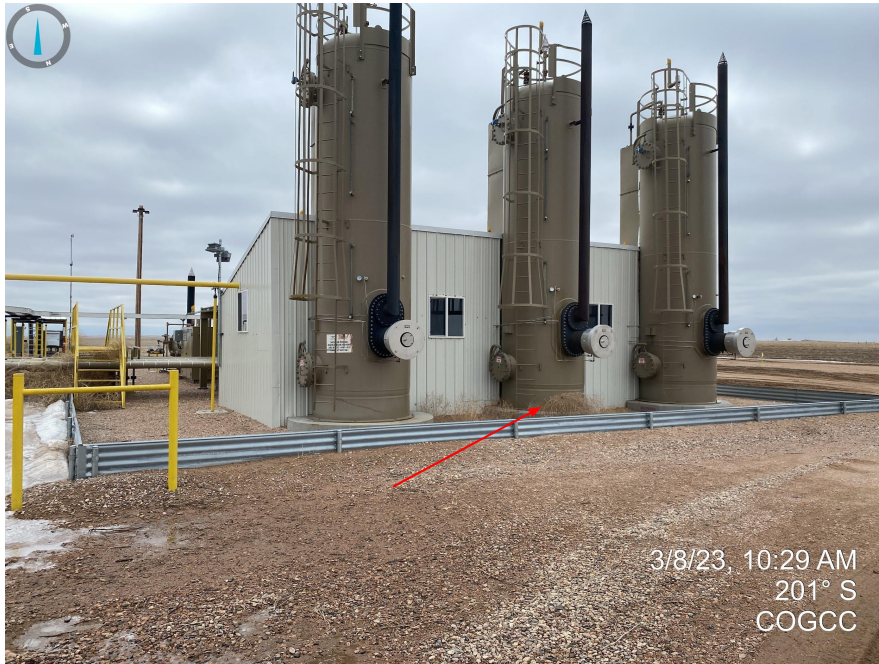
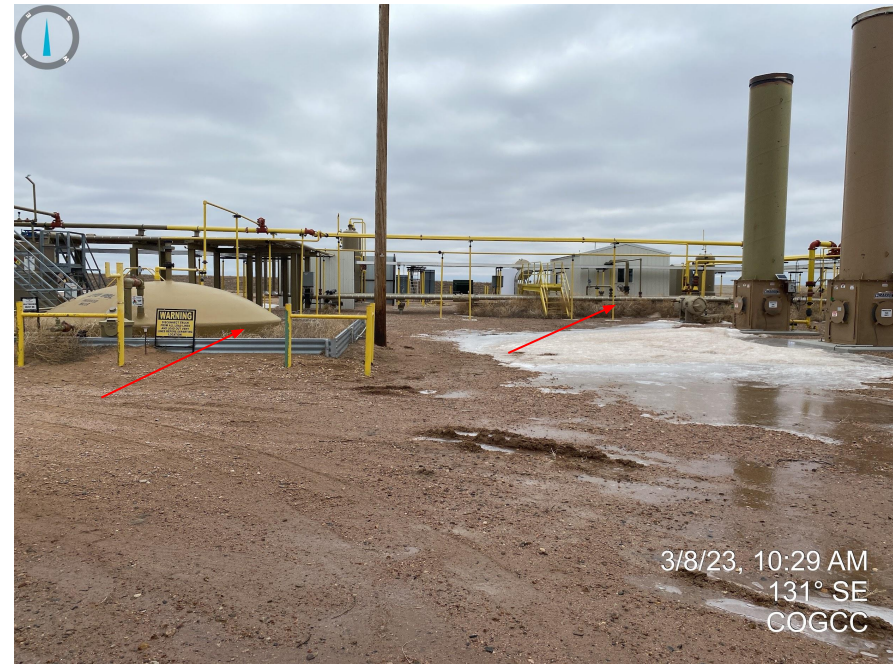
Photos 21 & 22. See comments in Photos 17 & 18.
