Inspection Photos

Location Name: TEP ROCKY MOUNTAIN LLC CLOUGH RWF 22-29 Pad

Location ID: 335076

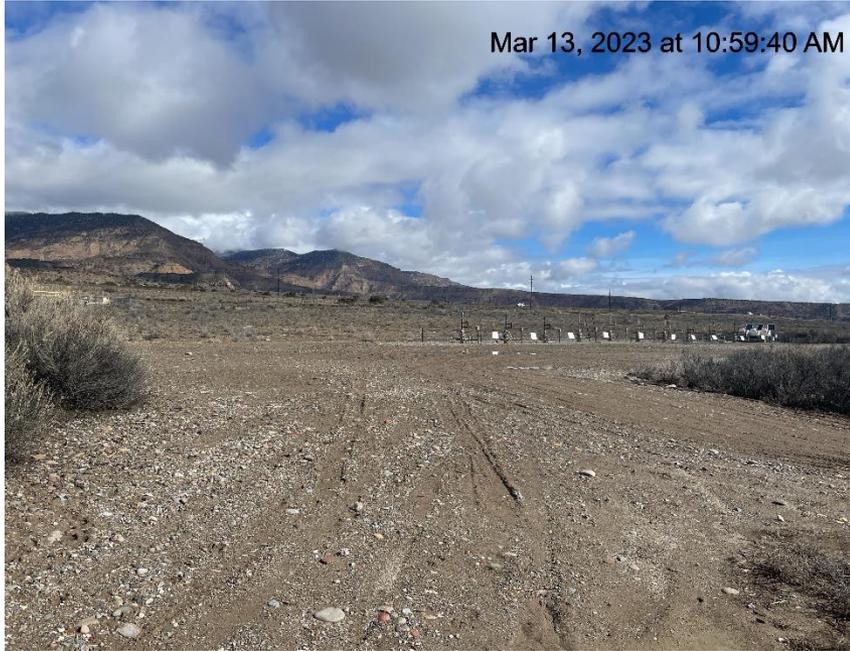
Photo # 2194 From entrance to location

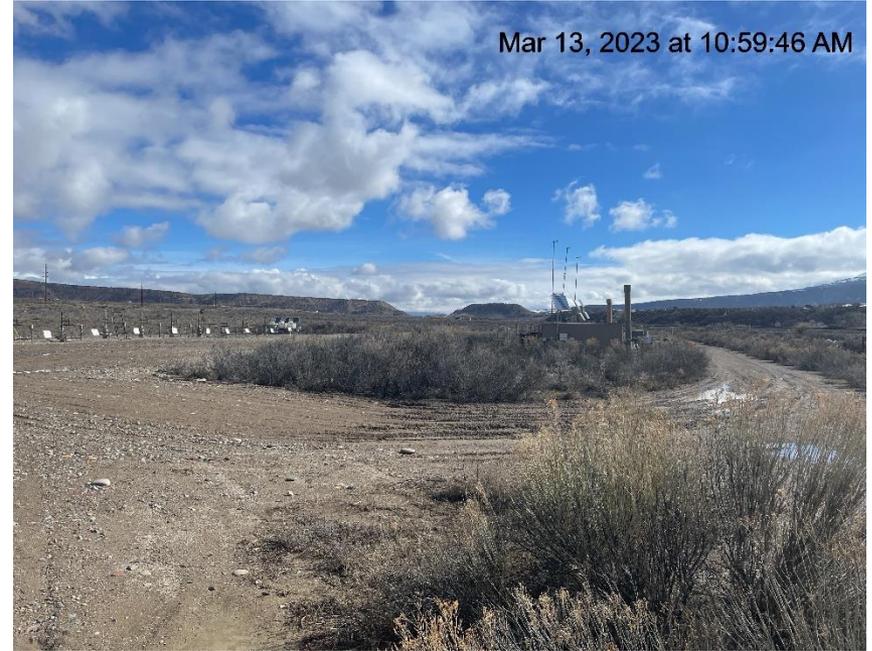
Photo # 2195 From entrance to location

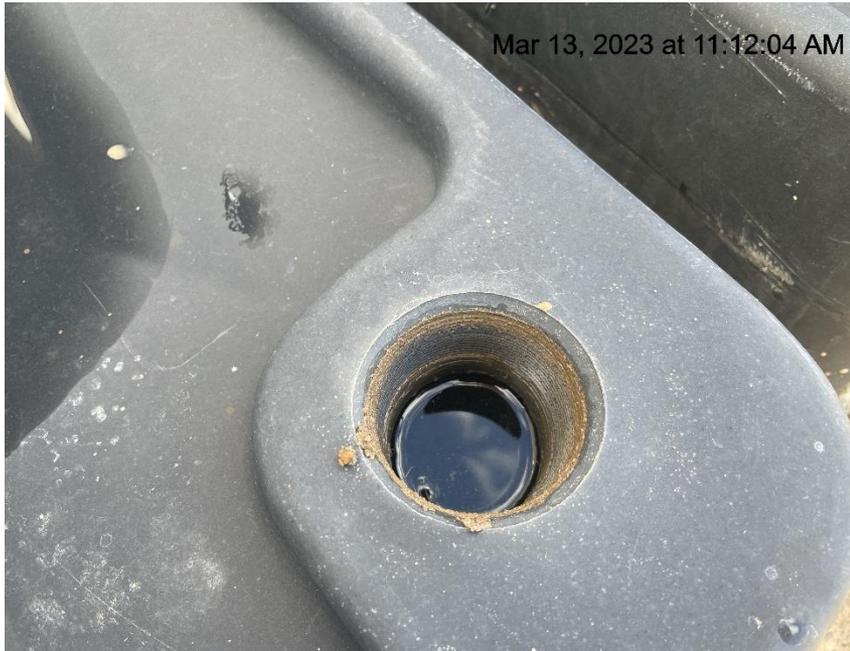
Photo # 2201 Chemical BMP not maintained

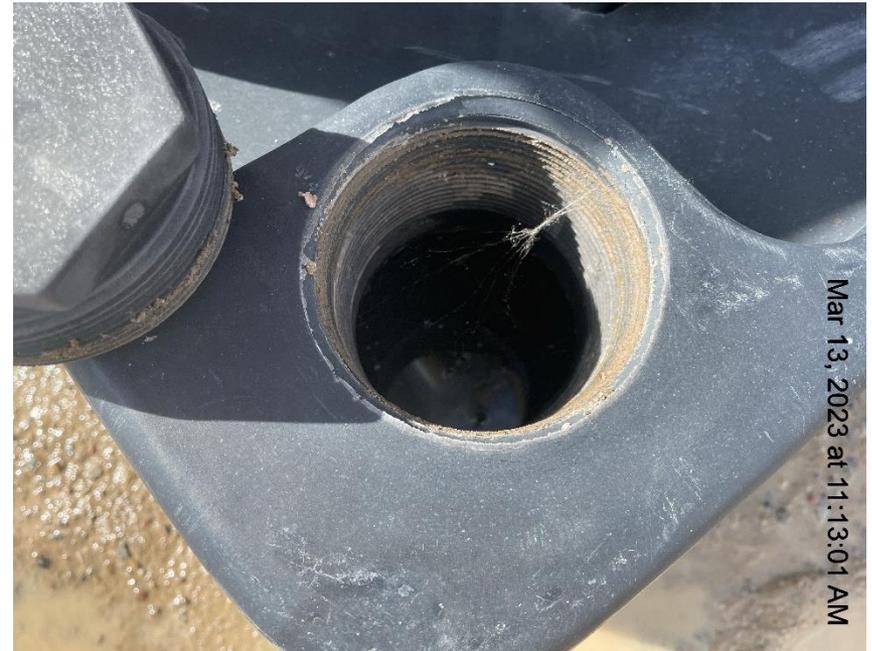
Photo # 2203 Chemical BMP not maintained

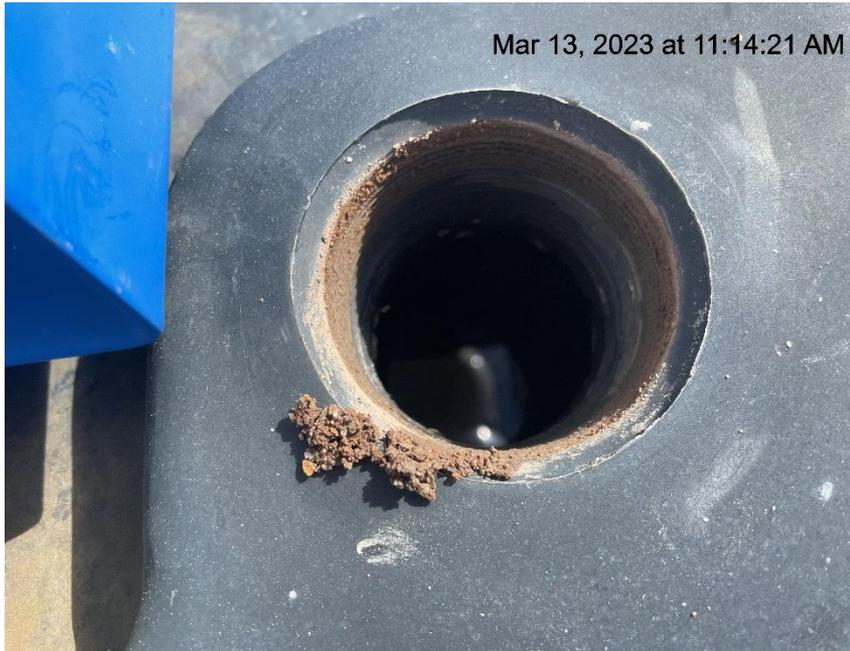
Photo # 2209 Chemical BMP not maintained

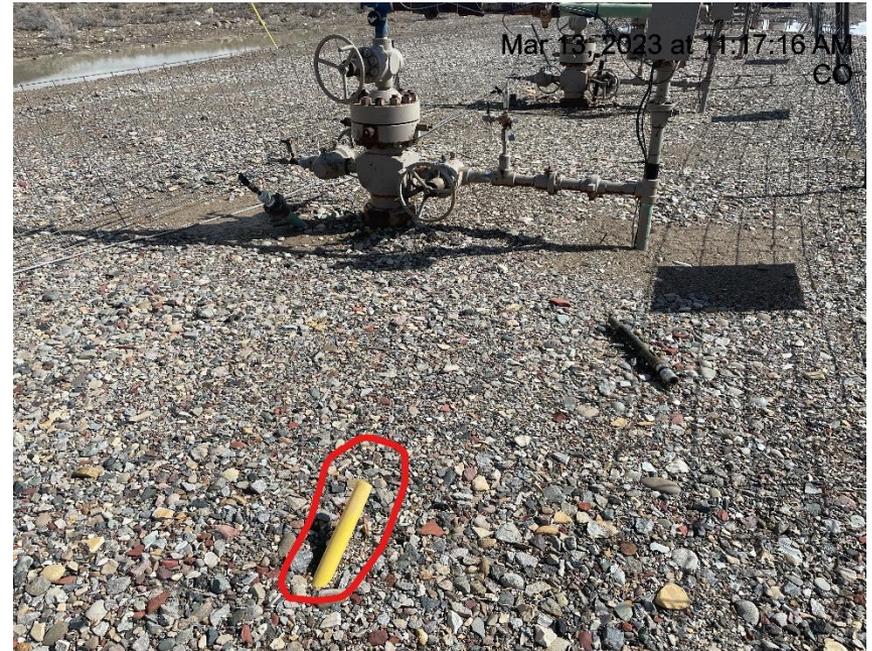
Photo # 2213 Improperly marked deadman

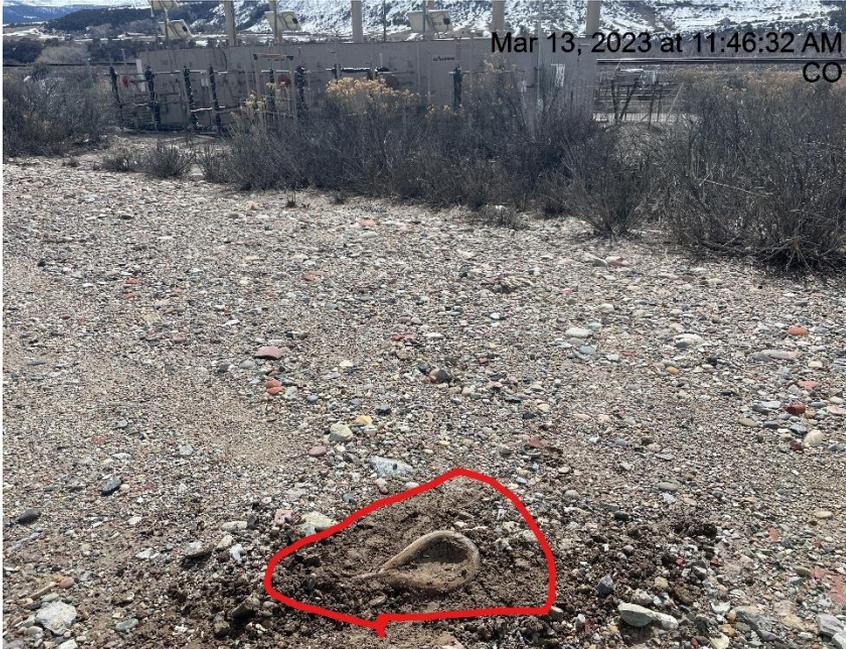
Photo # 2219 Unmarked deadman

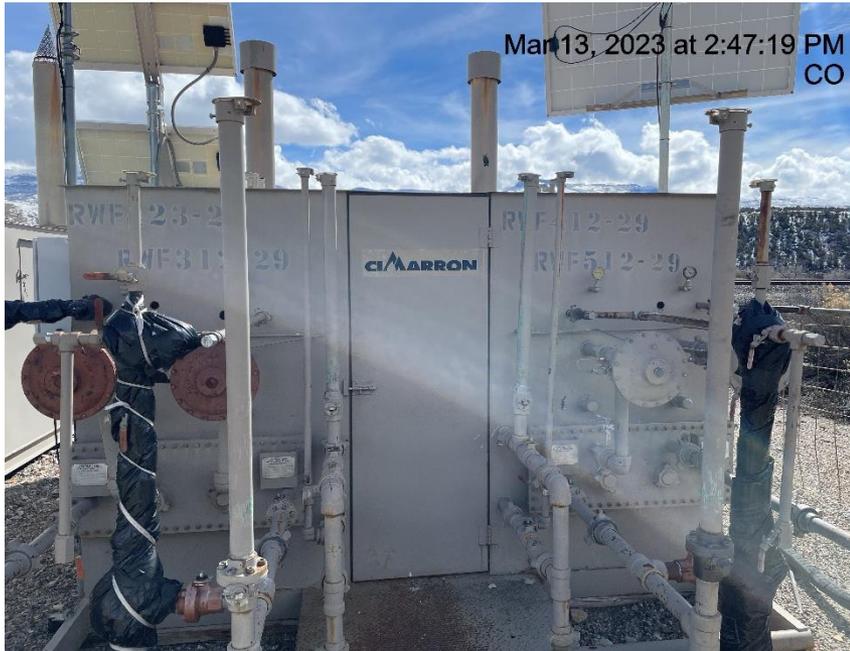
Photo # 2325 Meter calibration info not conspicuously posted

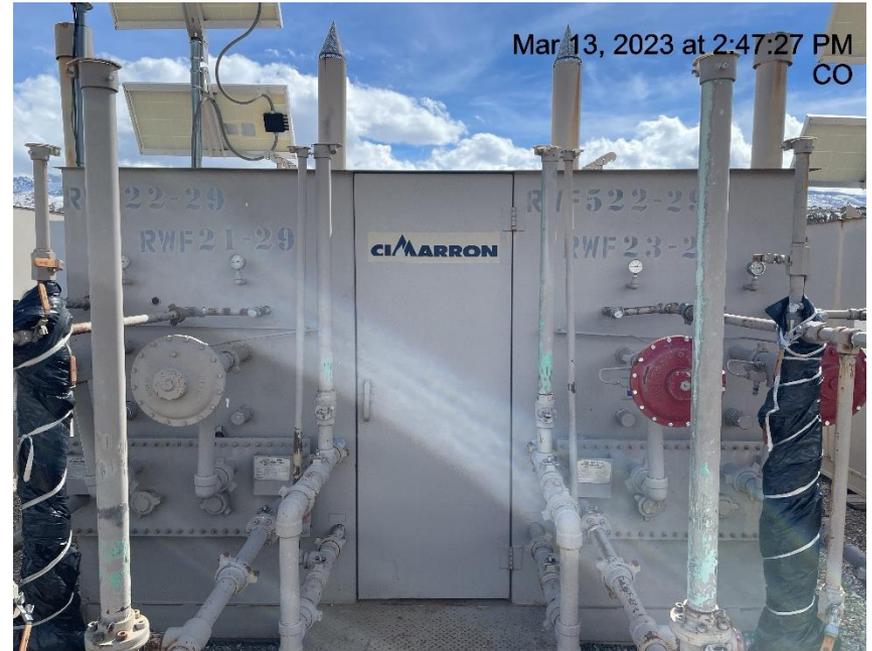
Photo # 2326 Meter calibration info not conspicuously posted

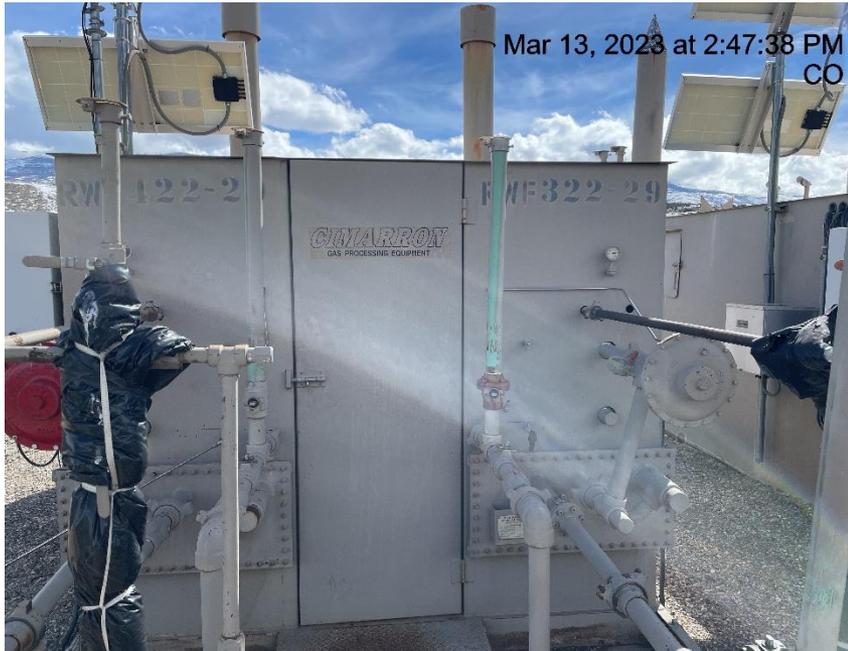
Photo # 2327 Meter calibration info not conspicuously posted

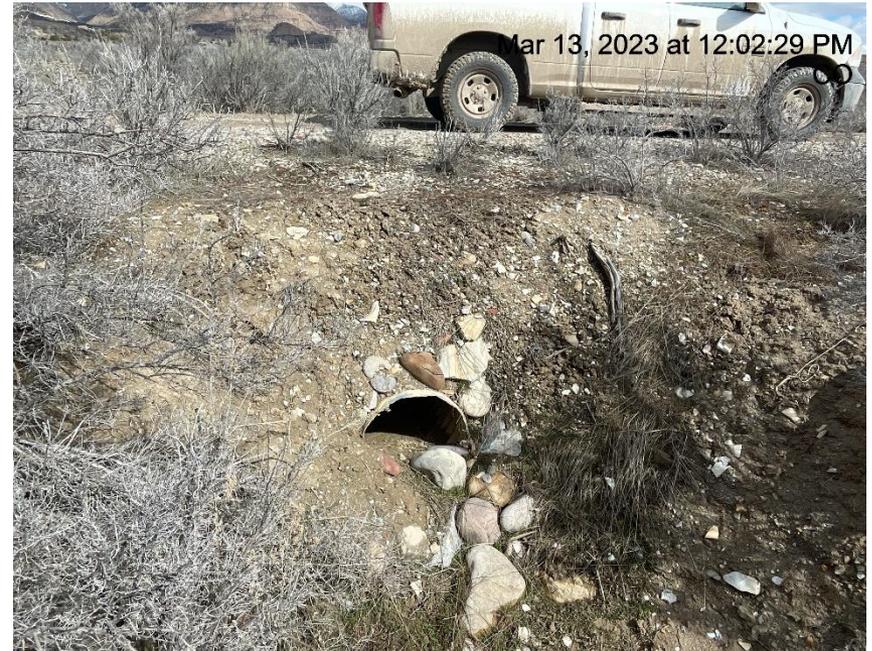
Photo # 2223 Culvert needs maintenance – 160 ft west of location on spur road
