**Caerus Piceance LLC
Love Ranch Fee 5
Location #316250**

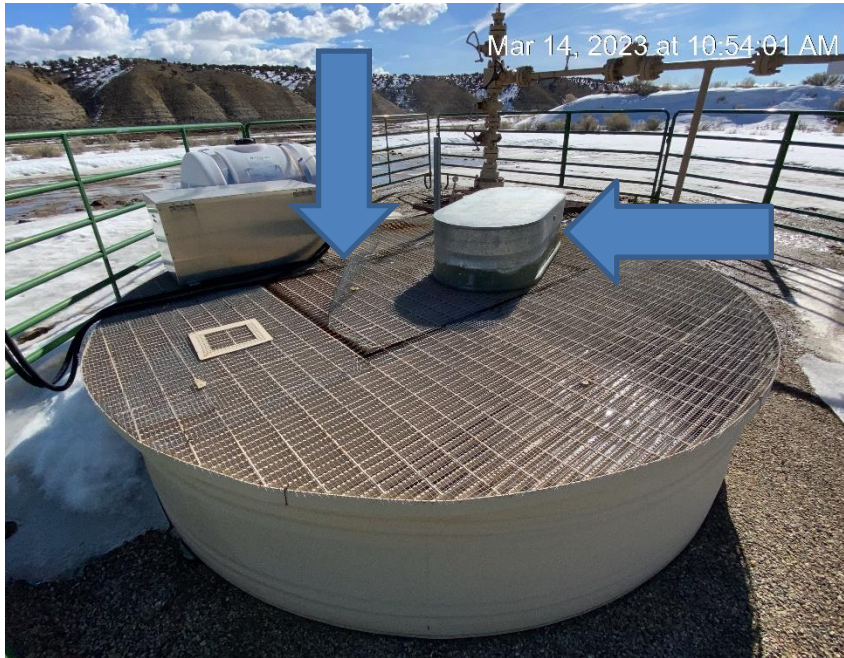
Debris, wire screen repair

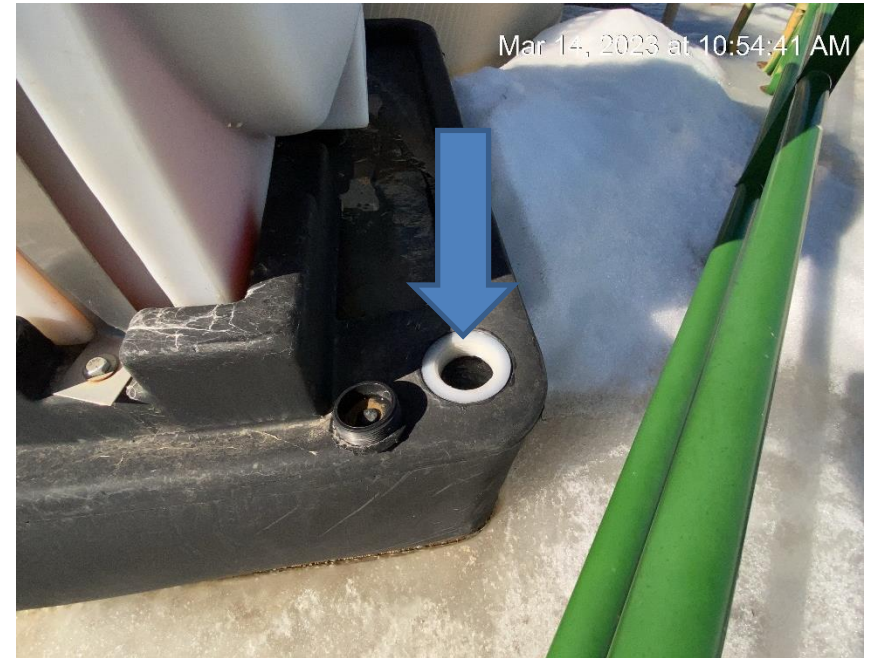
Chemical containment full of liquid

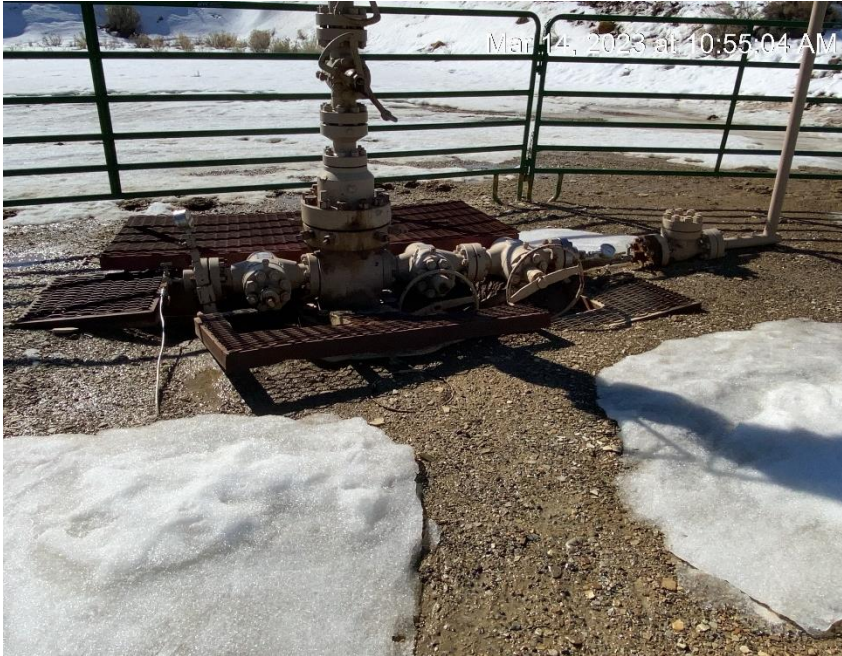
Cellar covers not maintained.

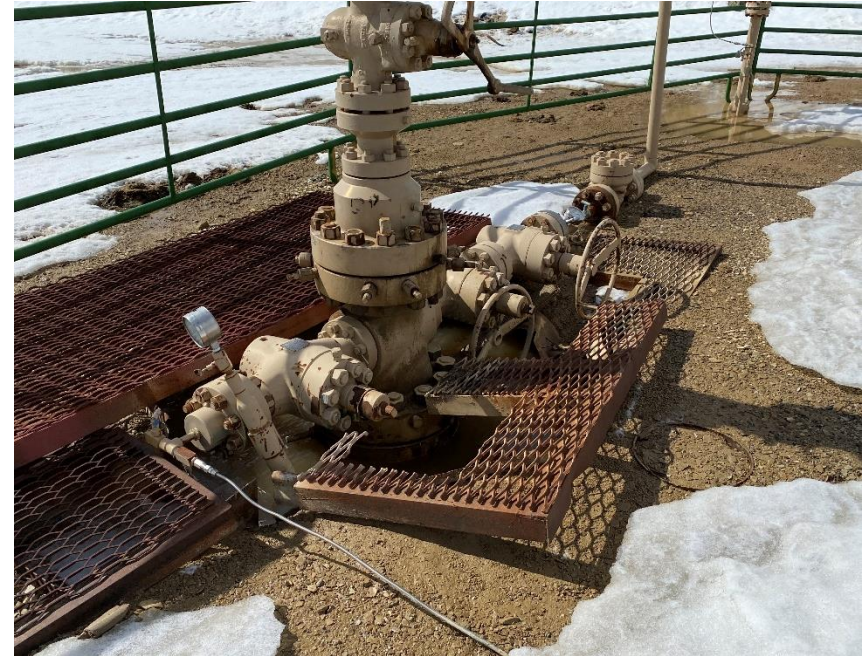
Cellar covers need to fit properly

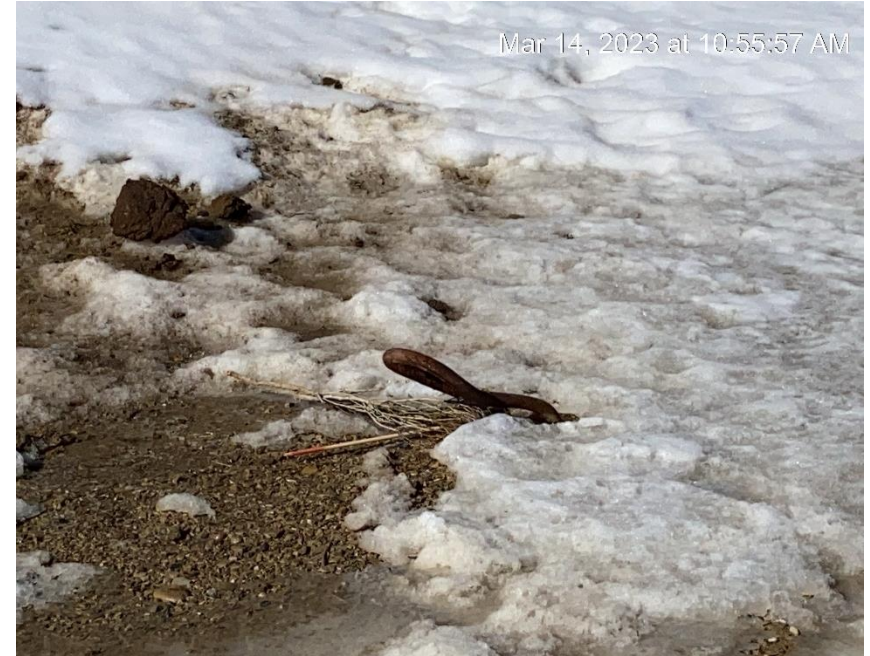
Unmarked guy line anchor.

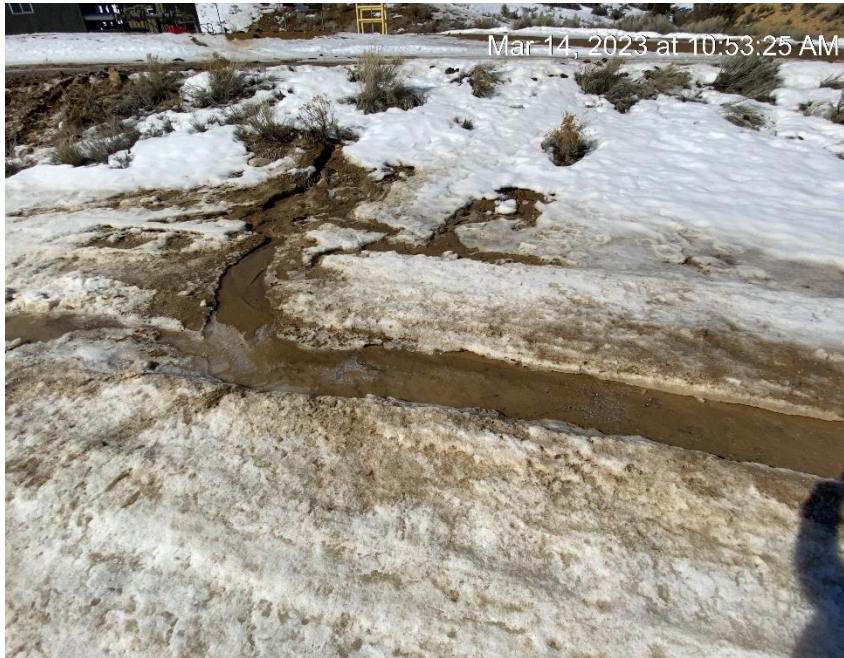
Erosion from upper lease road

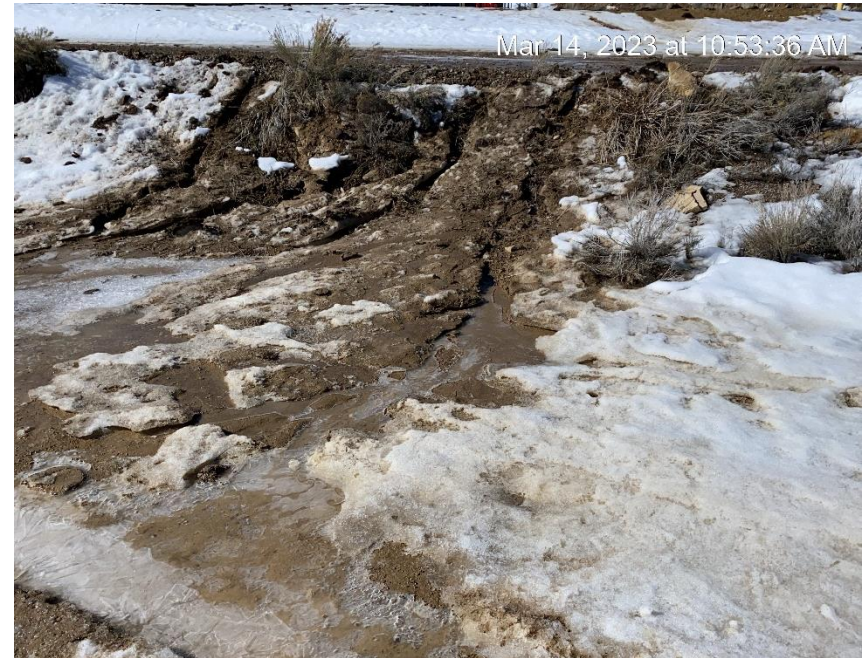
Erosion from upper lease road

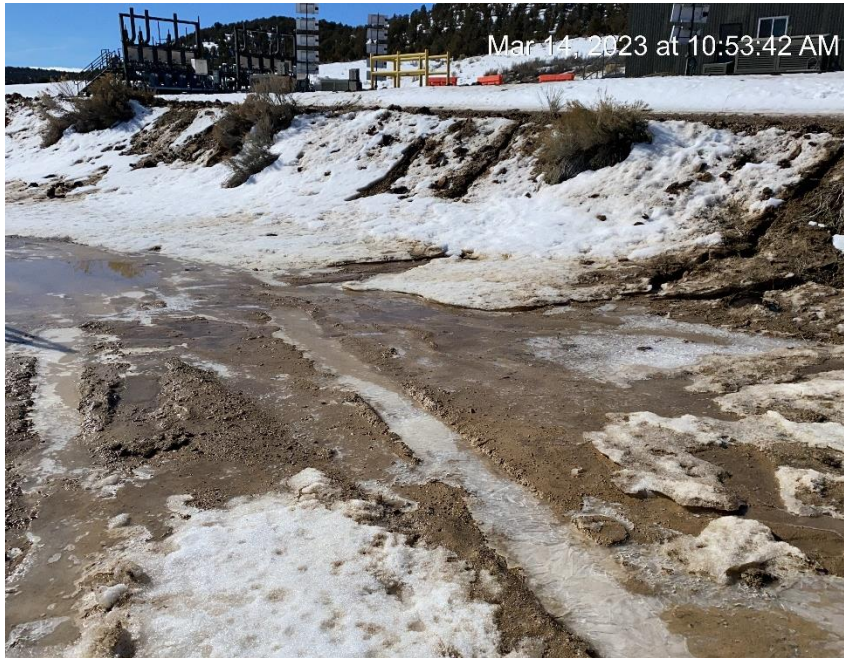
Sediment migration on to location

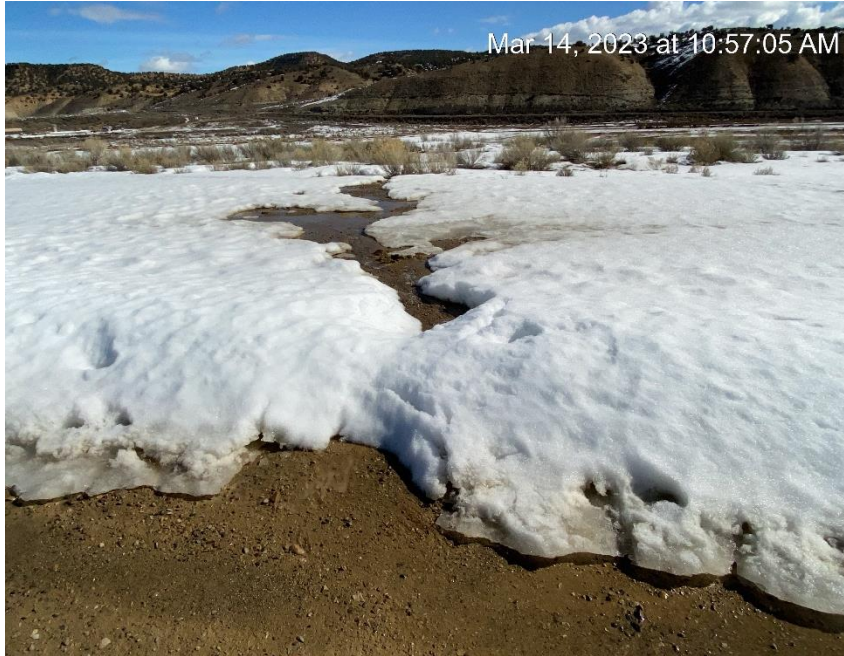
Stormwater BMPs not in place and maintained

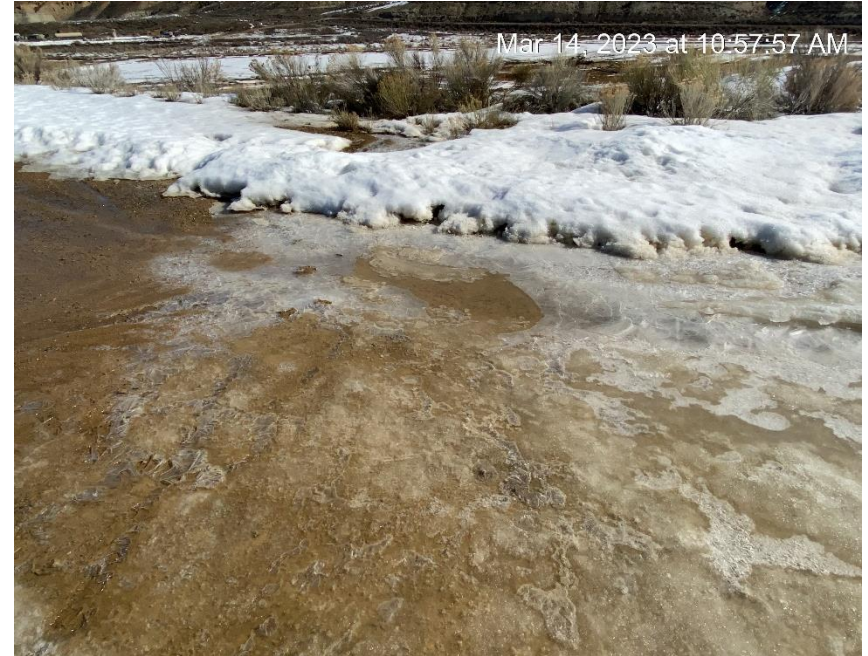
Stormwater BMPs not in place and maintained

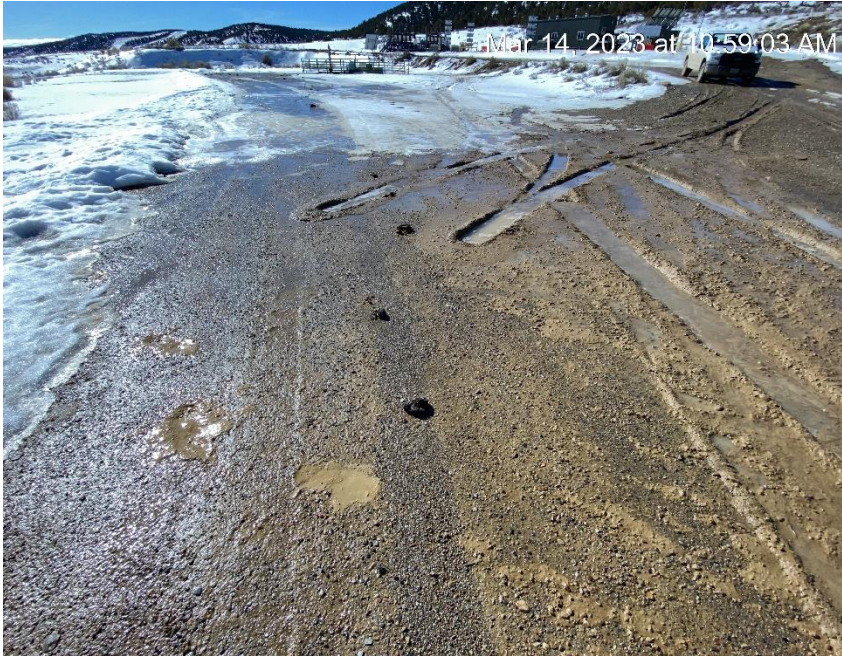
Location lacks stabilization.

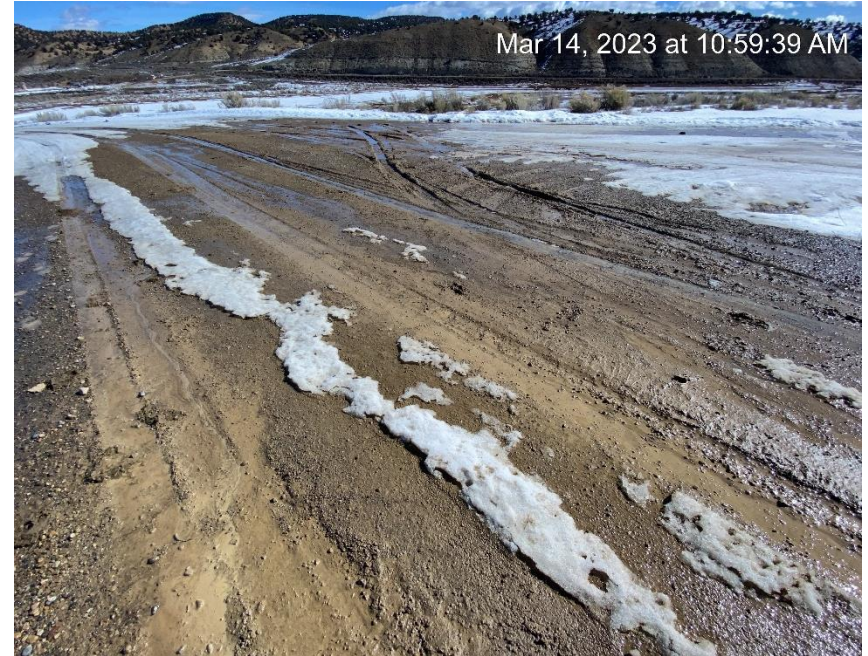
Insufficient tracking BMP at entrance to location.
