Inspection Photos

Location Name: TEP ROCKY MOUNTAIN LLC CLOUGH RWF 432-29 Pad

Location ID: 335494

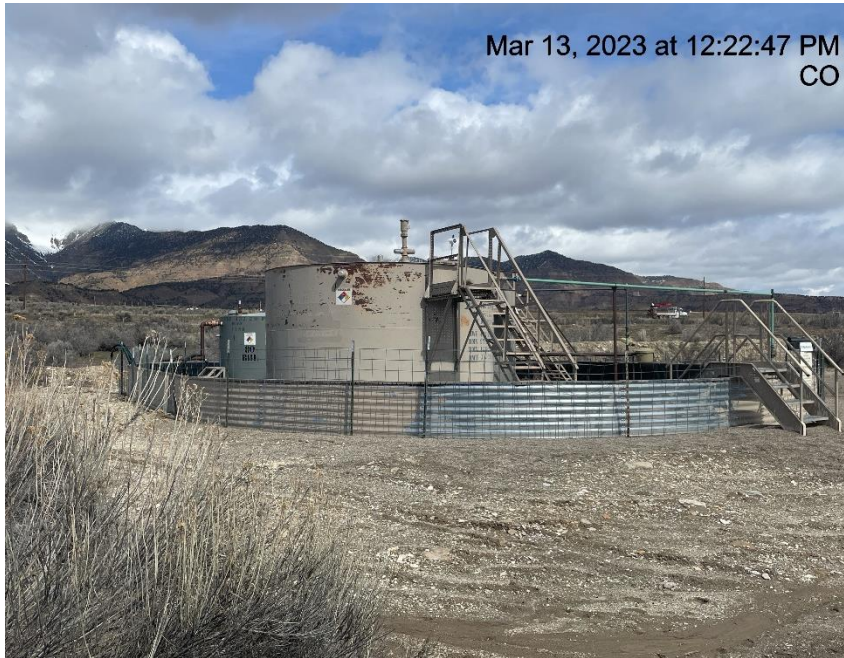
Photo # 2228 From entrance to location

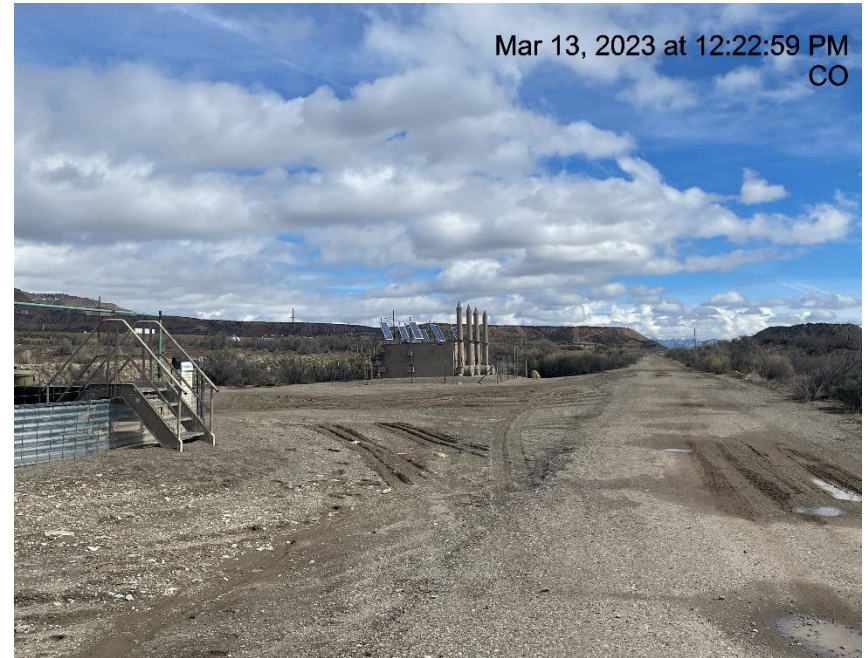
Photo # 2229 From entrance to location

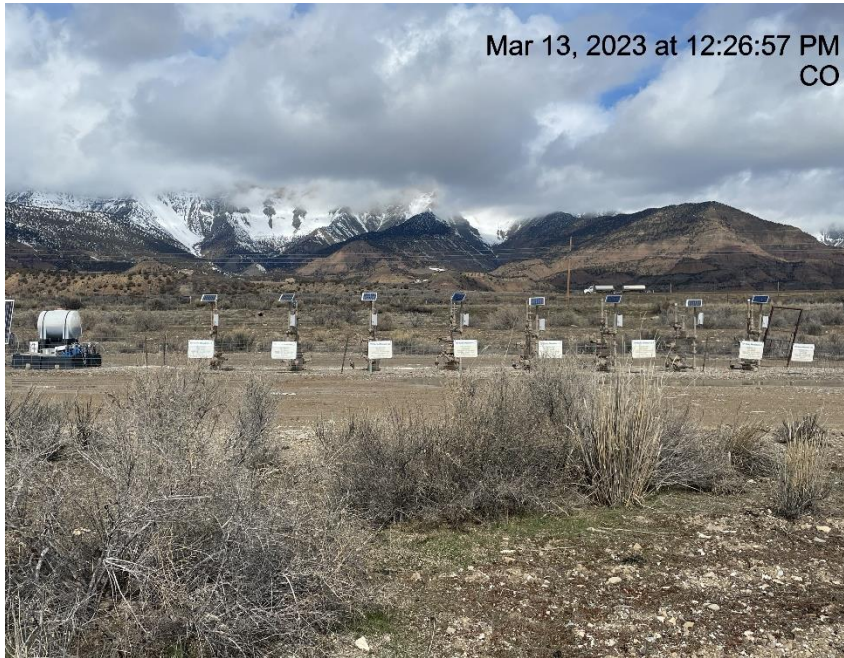
Photo # 2232 Location

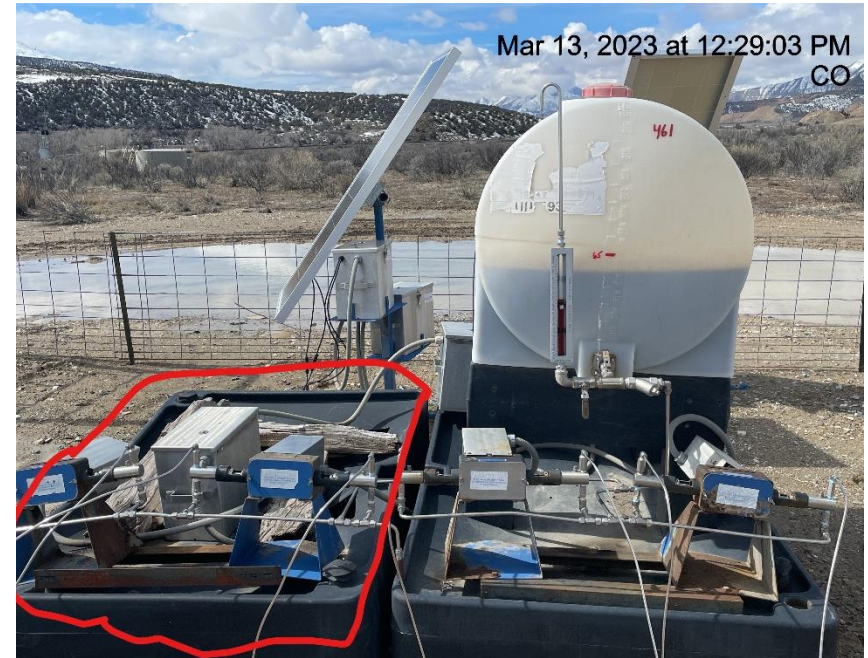
Photo # 2233 Unused equipment

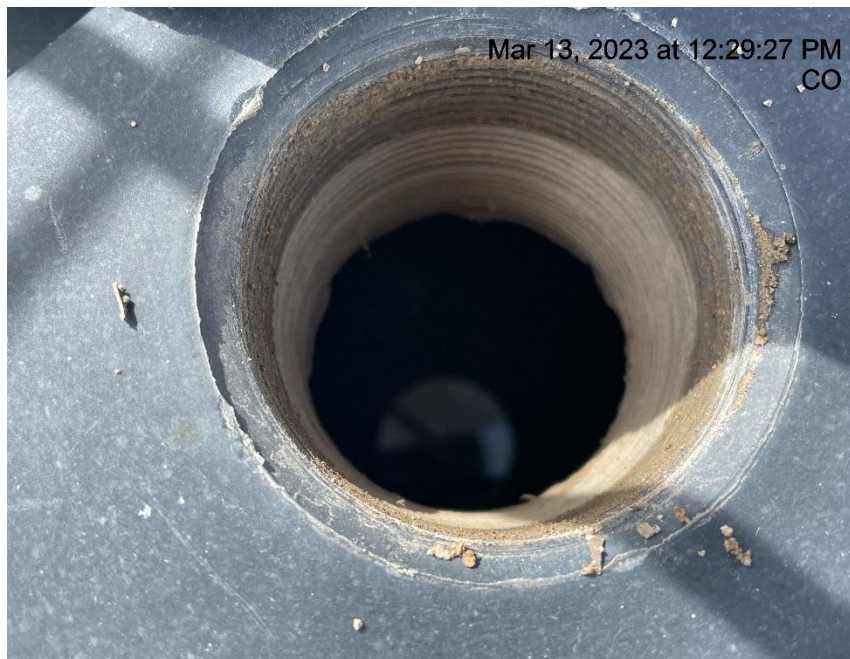
Photo # 2235 Chemical BMP not maintained

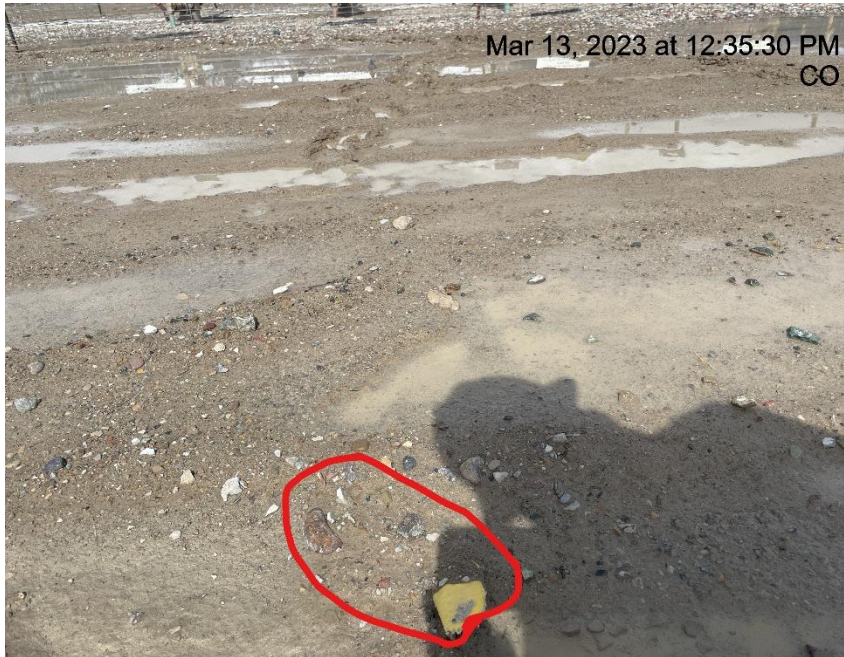
Photo # 2240 Unmarked deadman

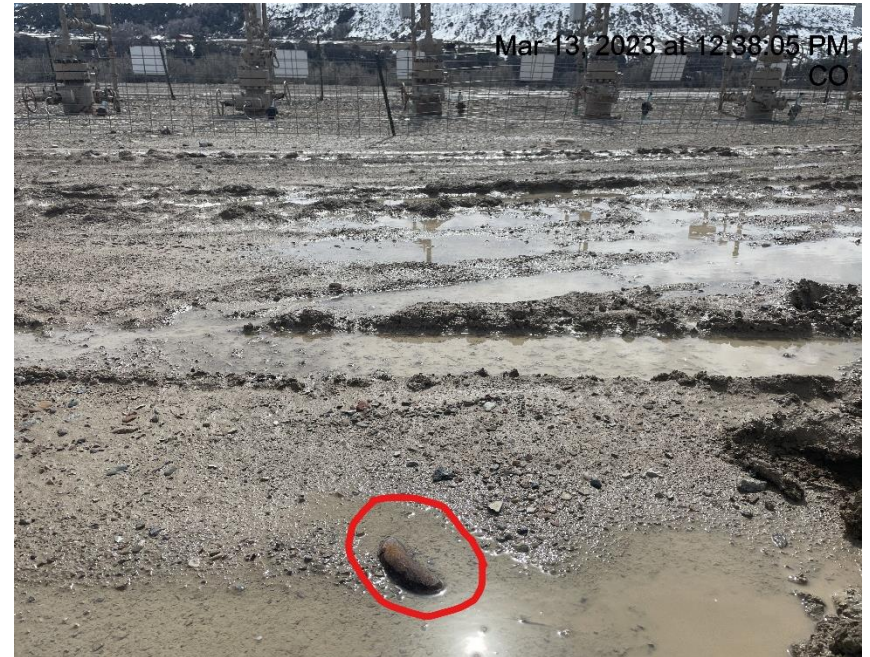
Photo # 2241 Unmarked deadman

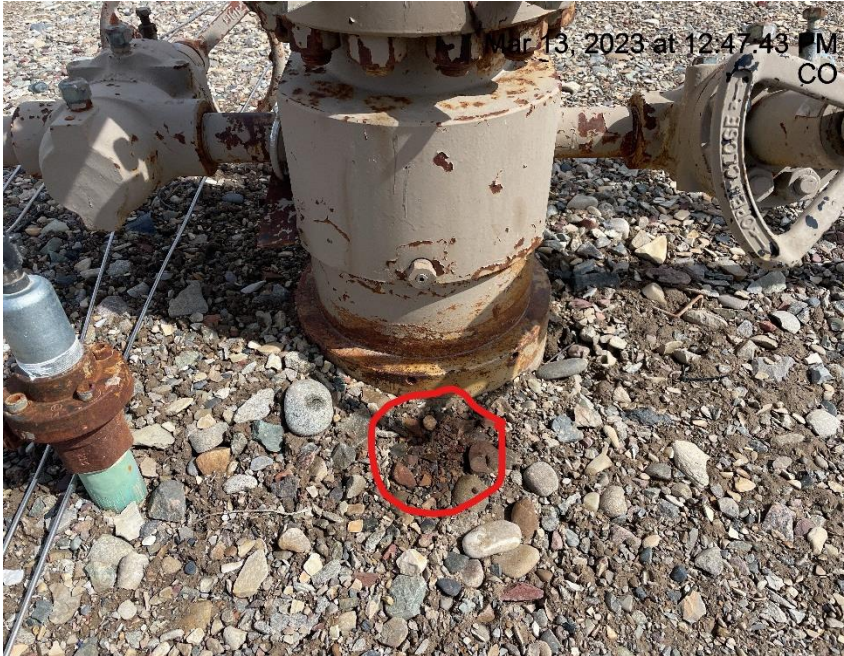
Photo # 2242 Stained soil & gravel

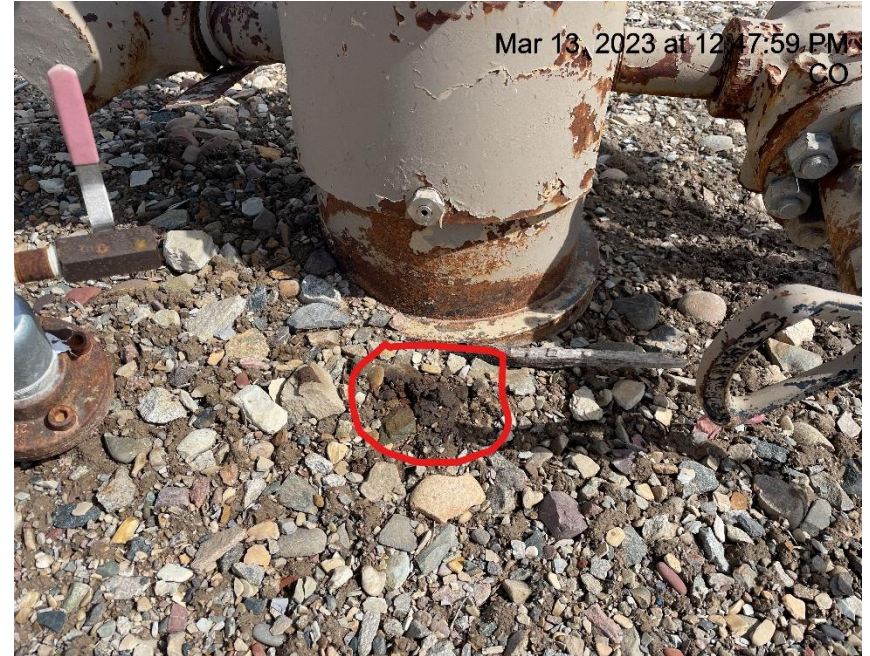
Photo # 2243 Stained soil & gravel

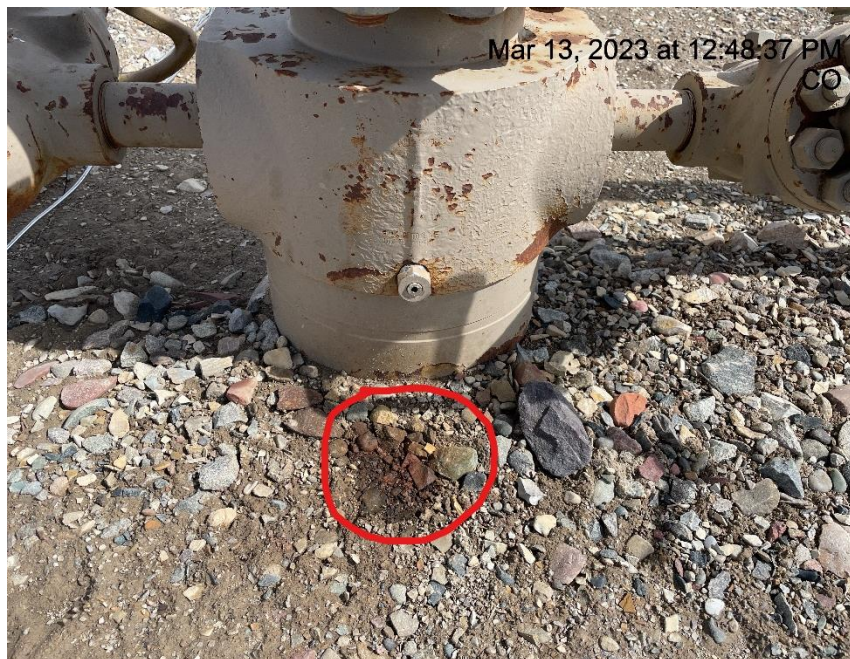
Photo # 2244 Stained soil & gravel

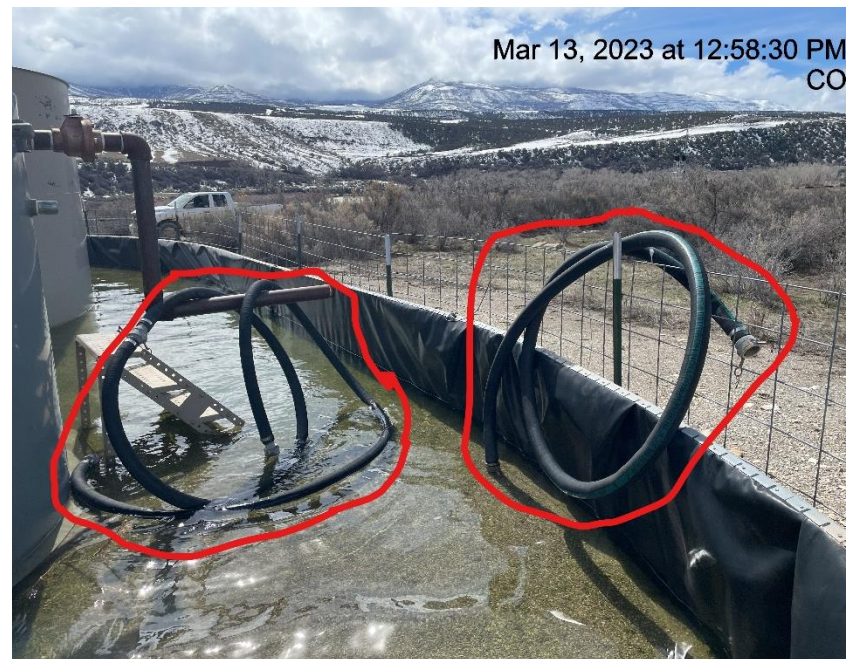
Photo # 2255 Unused equipment

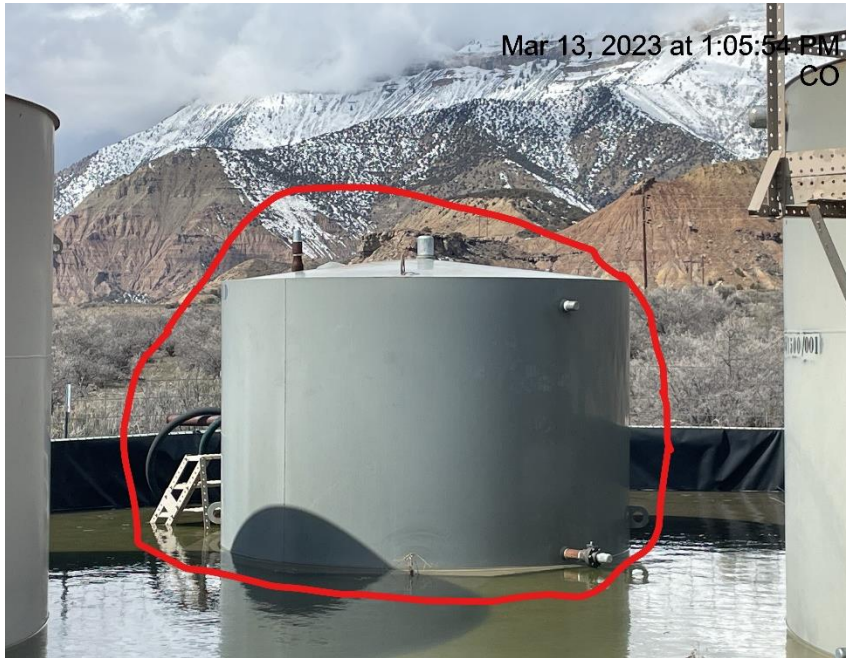
Photo # 2266 Unused equipment

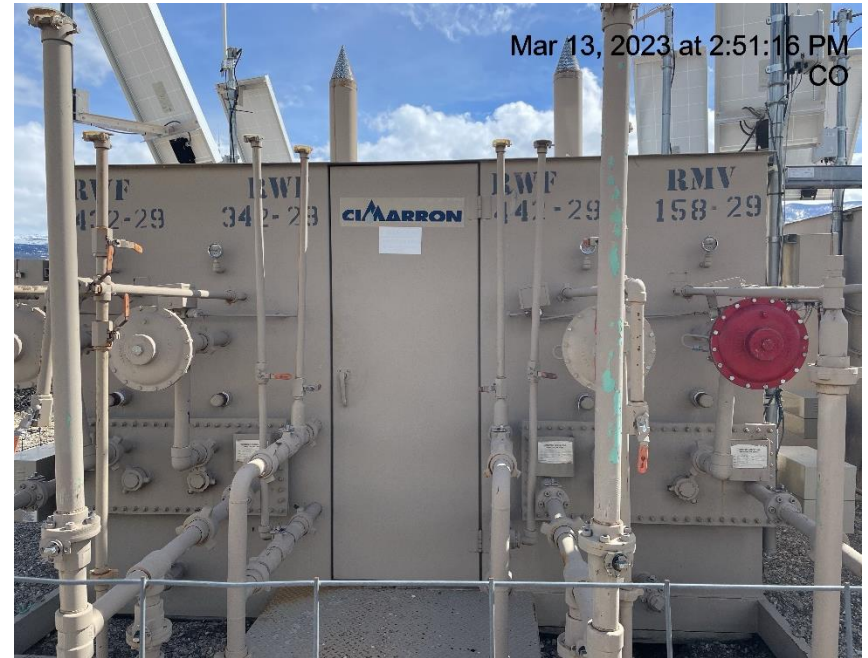
Photo # 2331 Calibration info not conspicuously posted

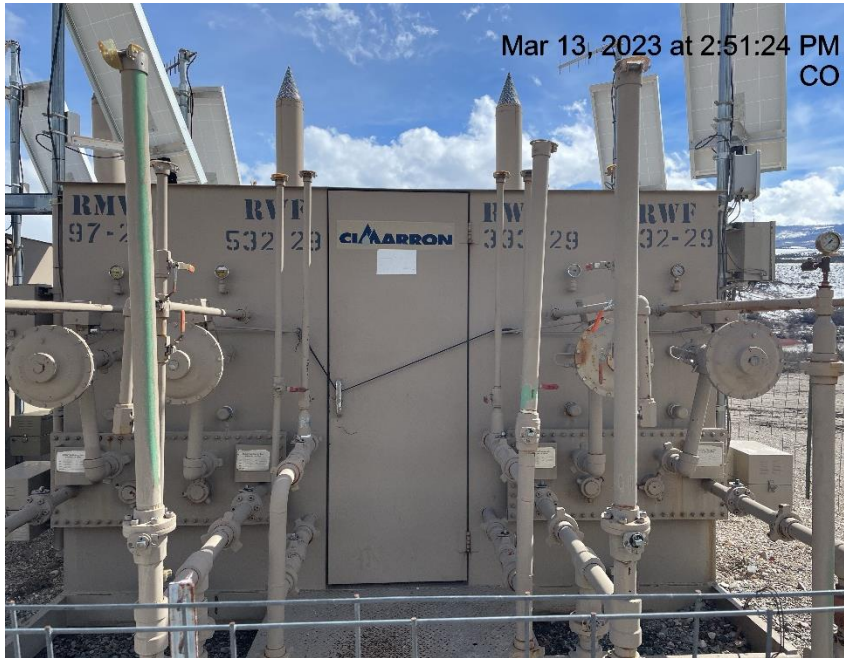
Photo # 2332 Calibration info not conspicuously posted

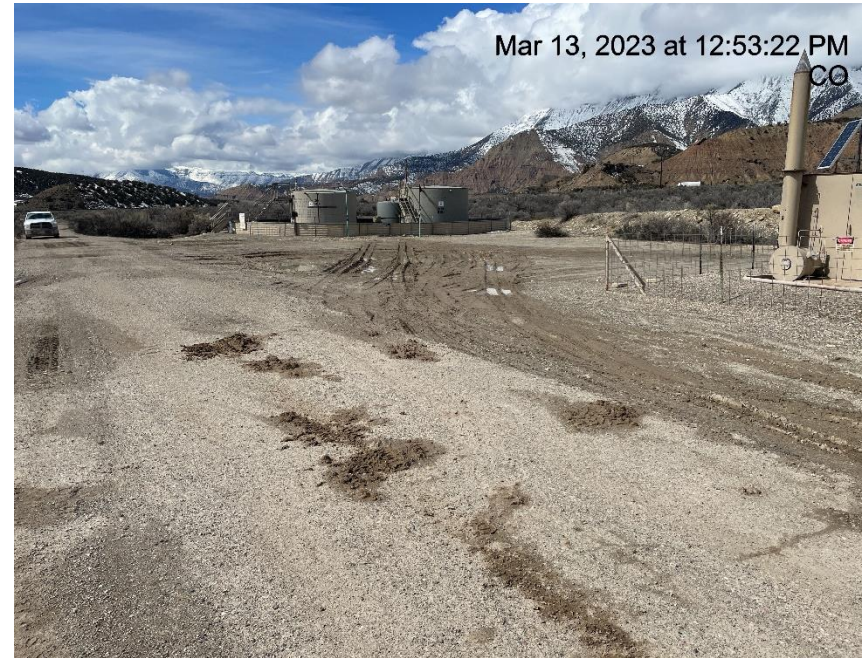
Photo # 2245 Vehicle tracking/No tracking BMP

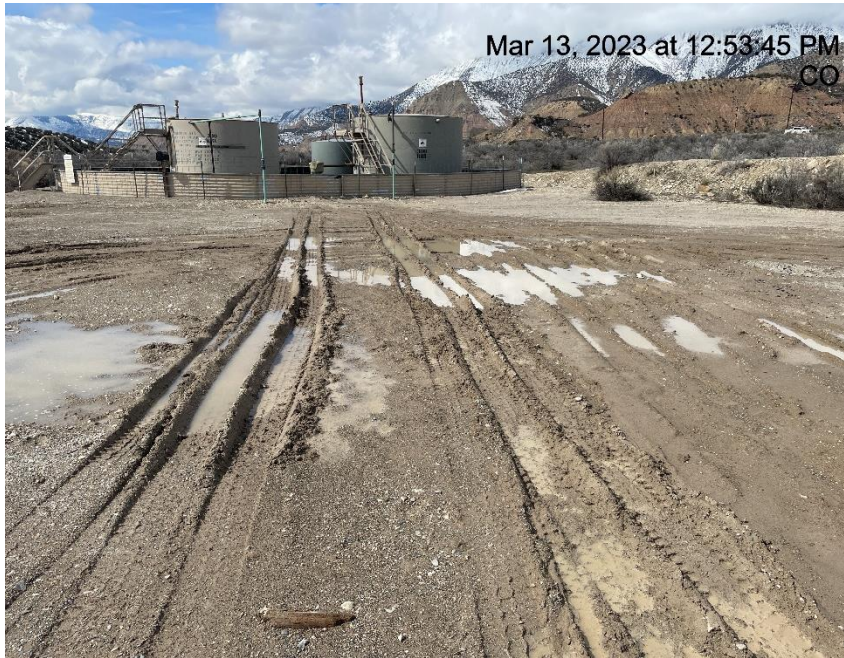
Photo # 2246 Lack of stabilization

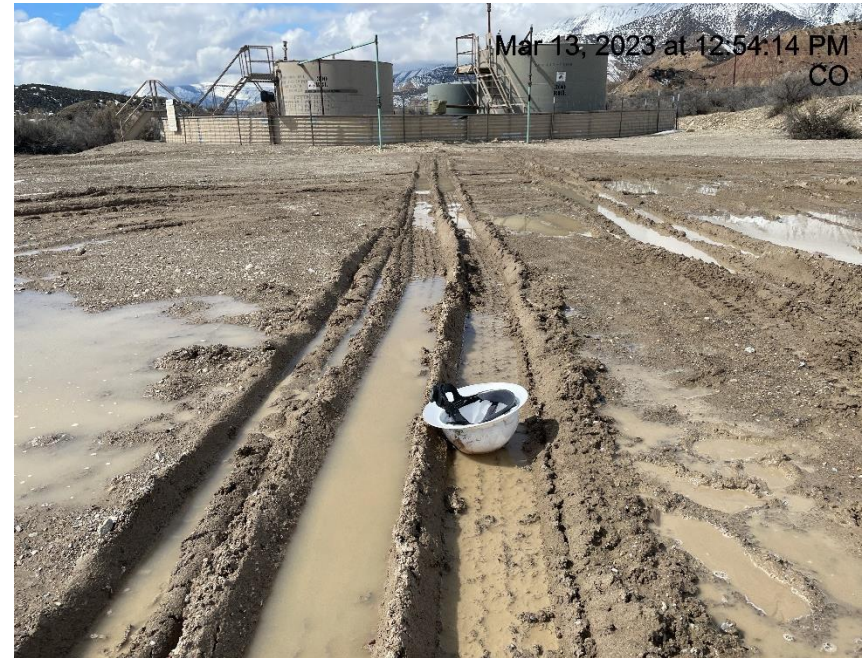
Photo # 2248 Lack of stabilization

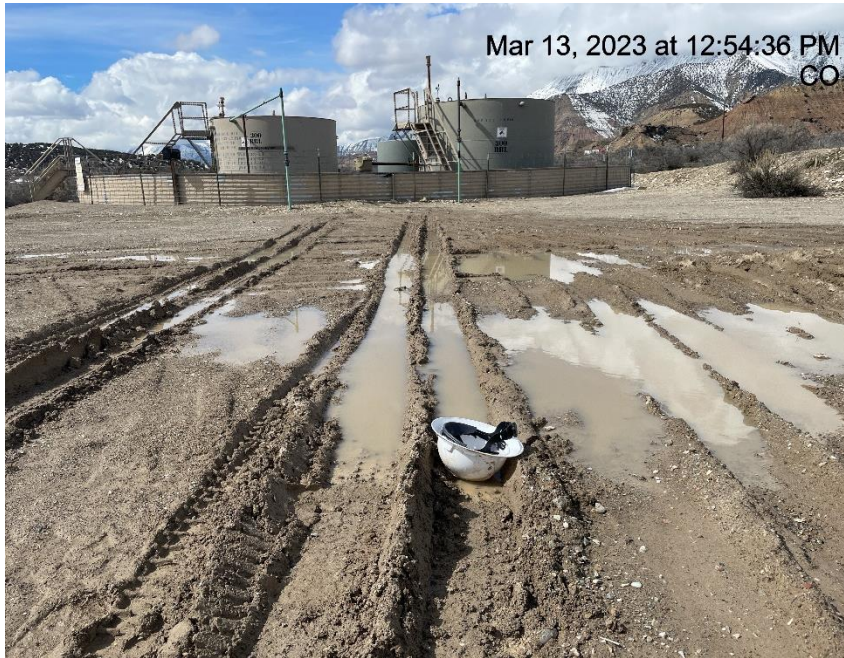
Photo # 2249 Lack of stabilization

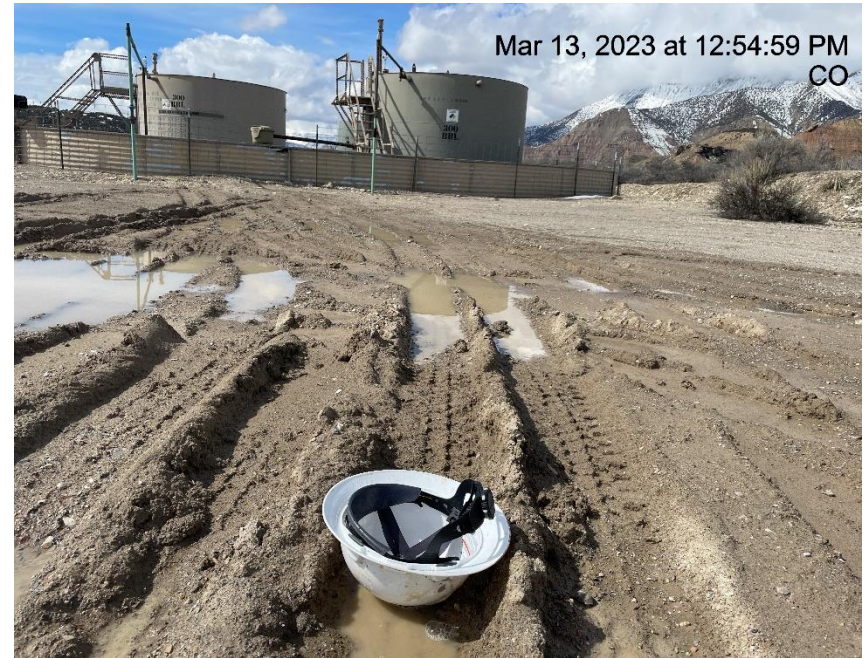
Photo # 2250 Lack of stabilization

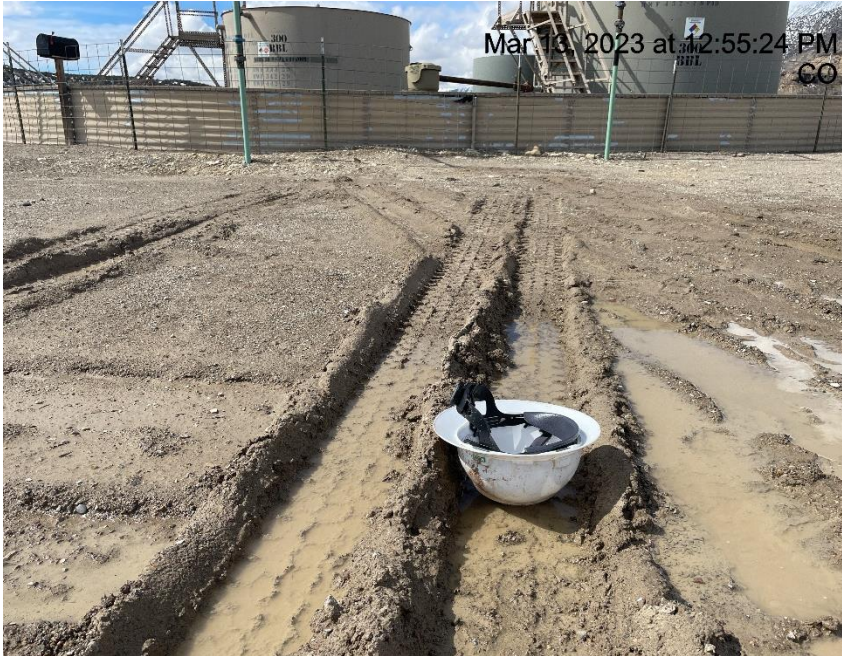
Photo # 2251 Lack of stabilization

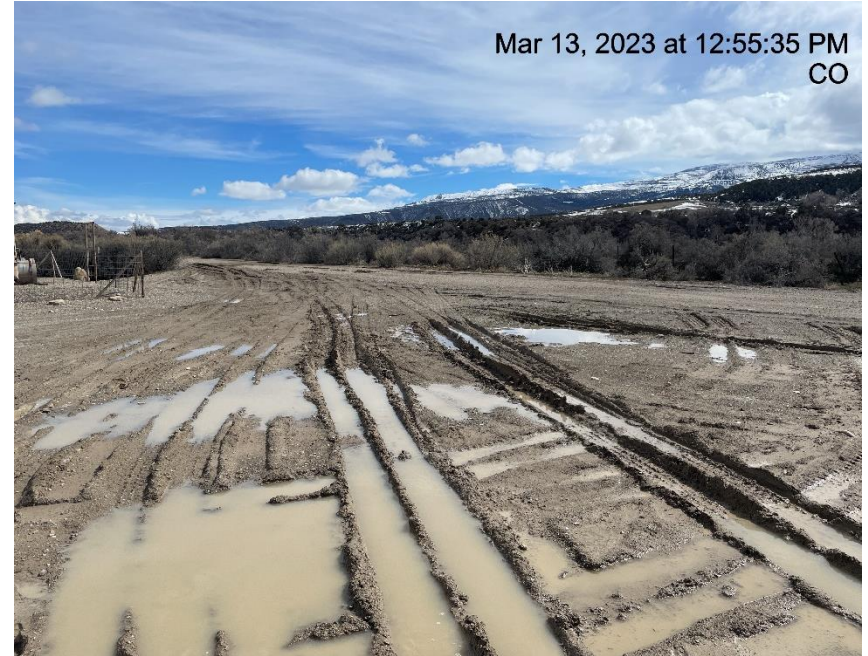
Photo # 2252 Lack of stabilization

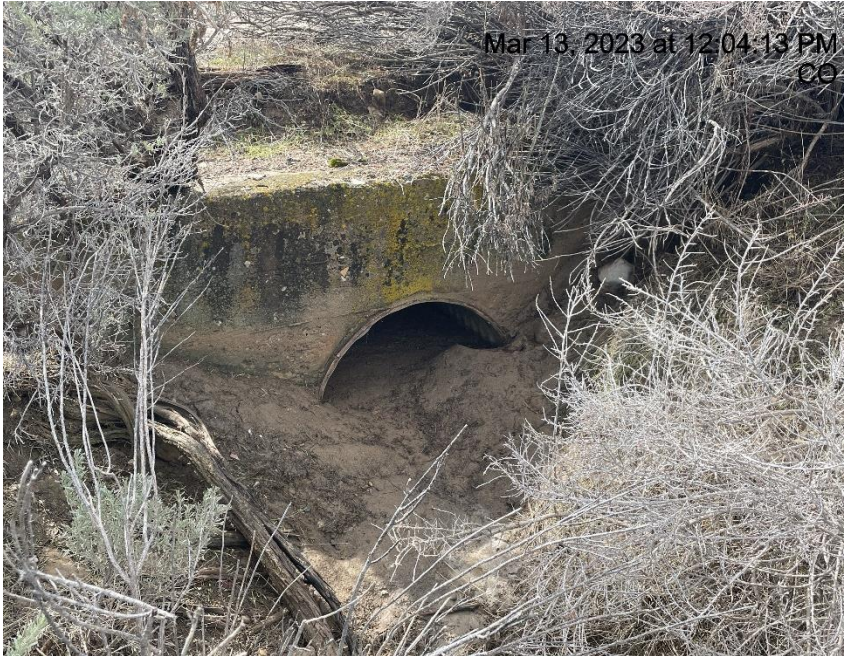
Photo # 2226 Culvert needs maintenance – Culvert on access road, 40 ft east of RWF 22-29 pad

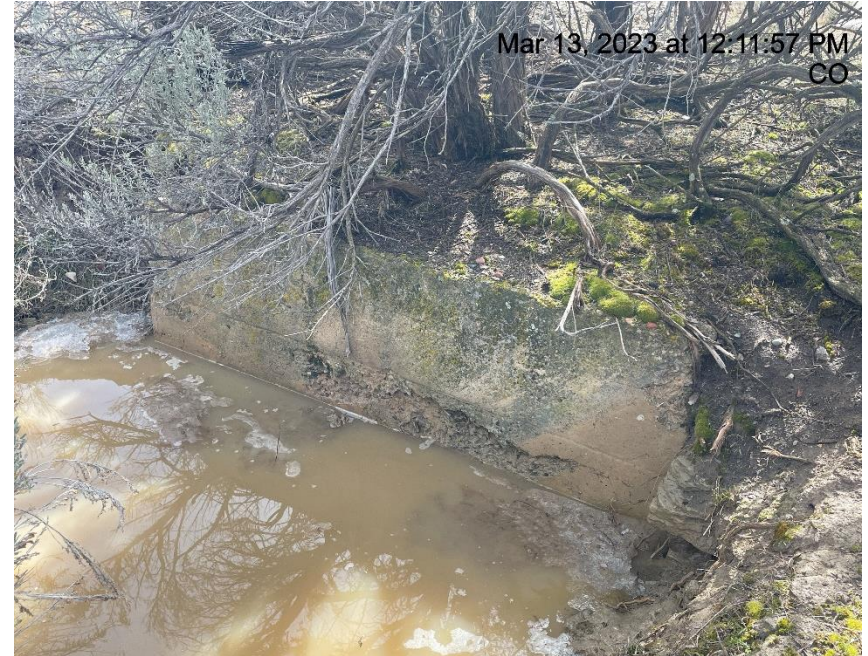
Photo # 2227 Culvert needs maintenance – Culvert on access road, 180 ft east of RWF 22-29 pad
