Interim Reclamation and Stormwater Inspection

March 9, 2023

Operator: CONFLUENCE DJ LLC #10518

Location ID: 442024

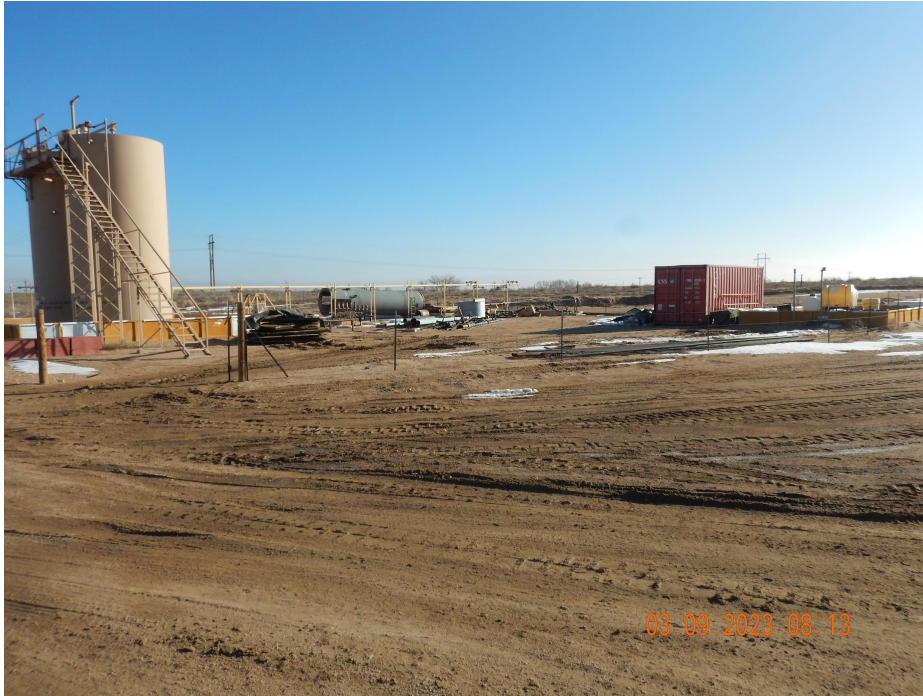
Photo 1. Photo taken from the northeastern location, facing East. Photo illustrates the Operator is storing unused equipment.

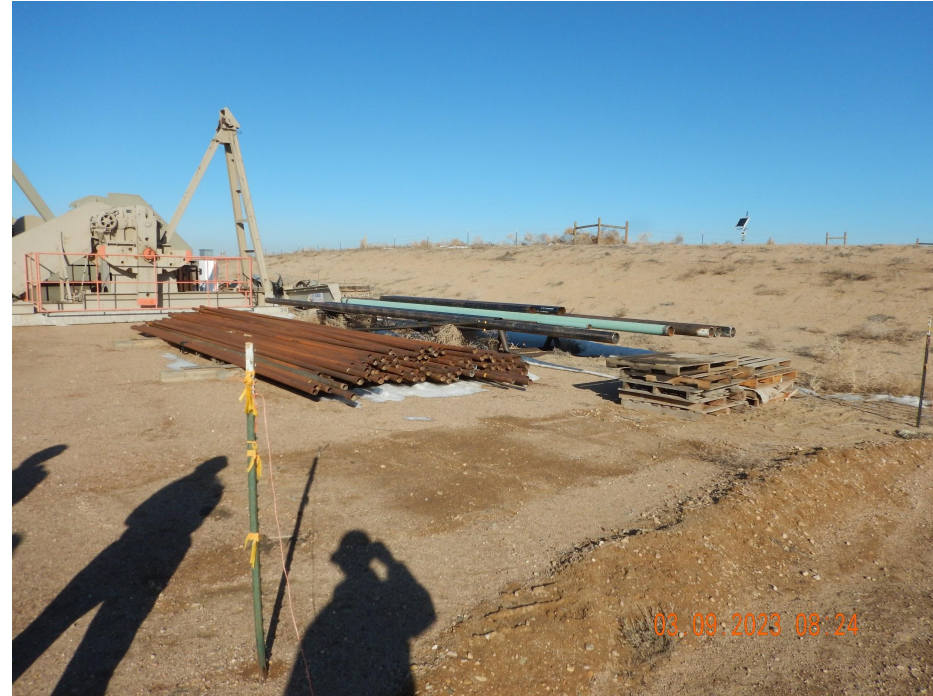
Photo 2. Photo taken from the northern location, west of the access road, facing Northwest. See comments under Photo 1.

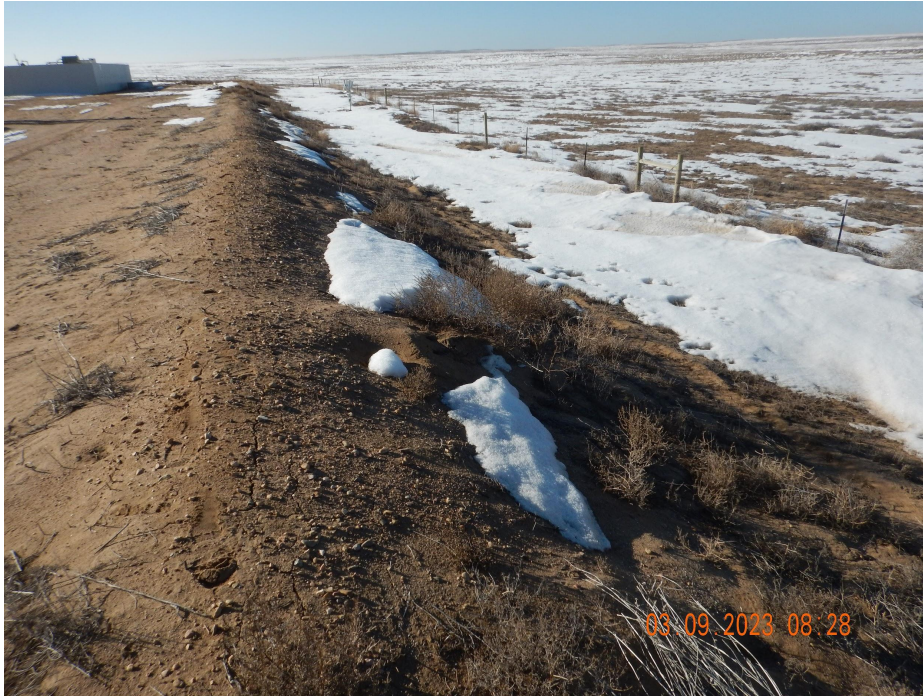
Photo 3. Photo taken from the western location, facing South. Photo illustrates weed establishment and weed maintenance needed along the western fill slope.

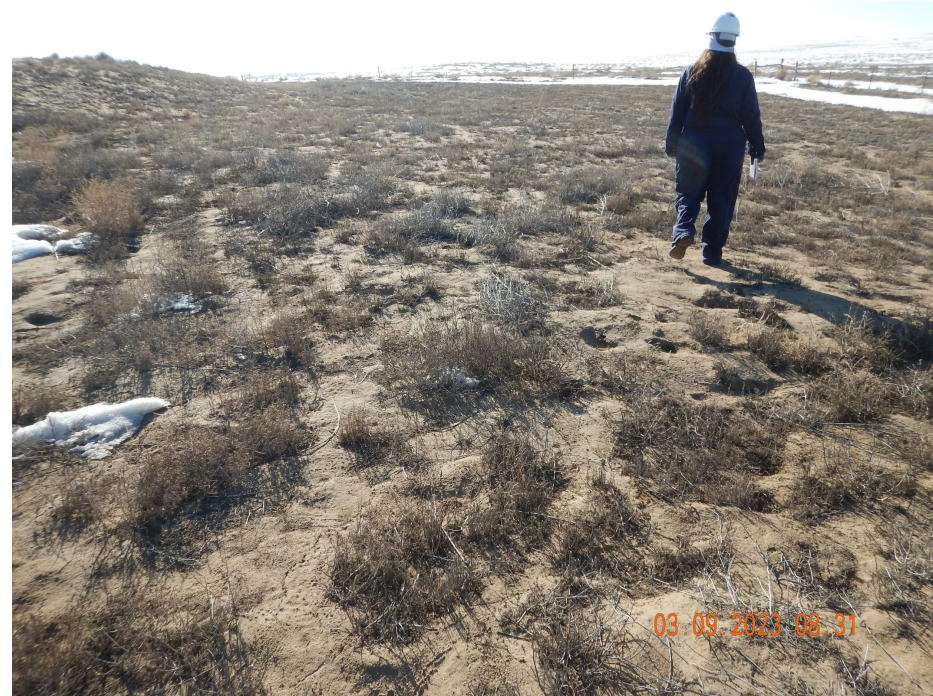
Photo 4. Photo taken from the southwestern location, facing South. Photo illustrates both the establishment of desirable vegetation and weeds- see Photo 5.

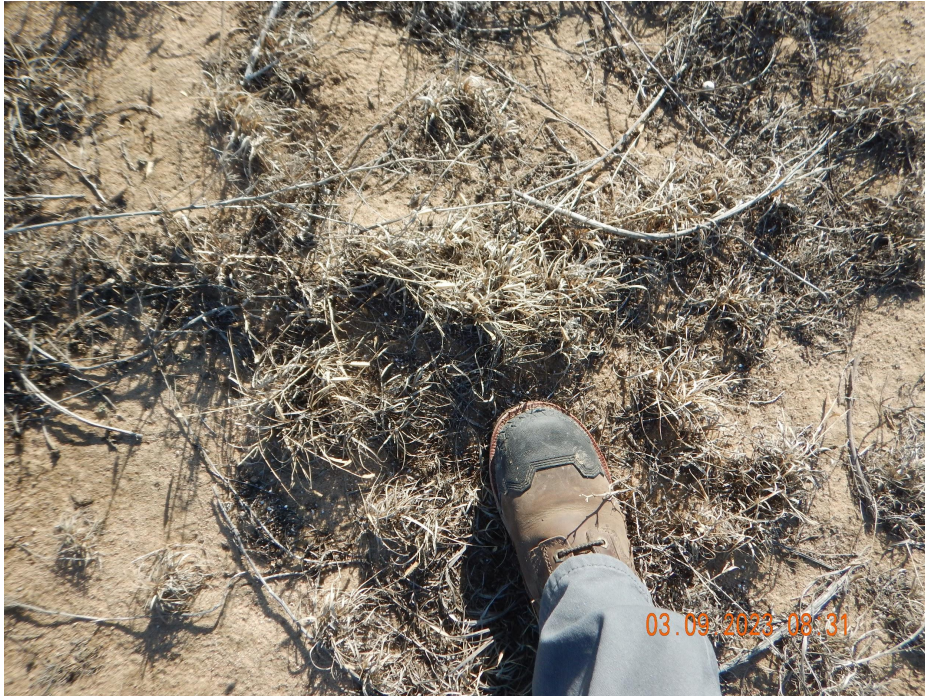
Photo 5. Close up photo illustrating desirable vegetation- Blue grama.

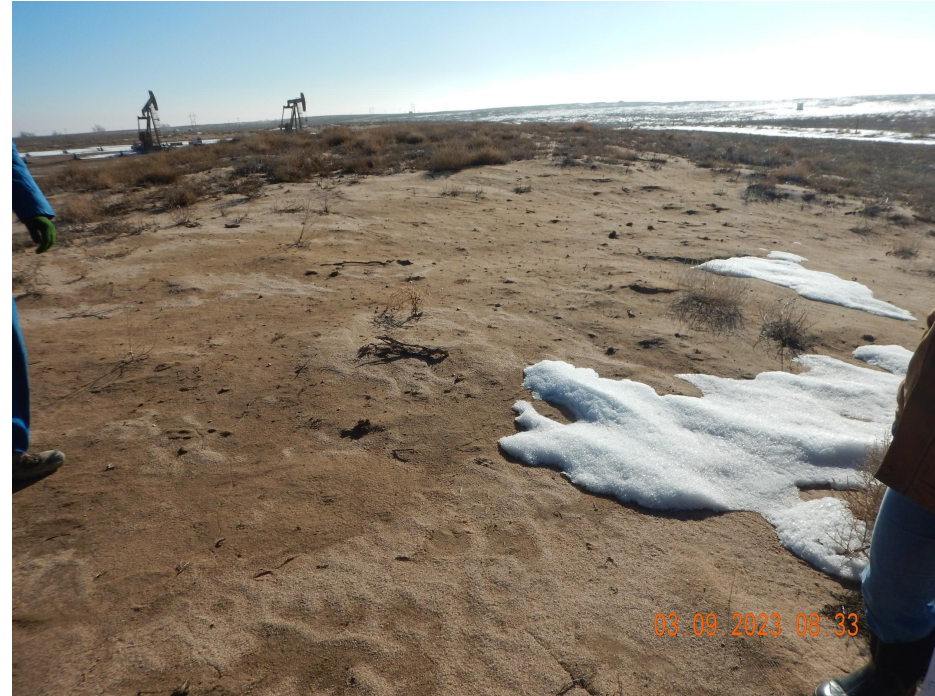
Photo 6. Photo taken from the topsoil stockpile, facing East. Photo illustrates bare ground and wind erosion with the establishment of weeds.

CDPHE is addressing this observation.

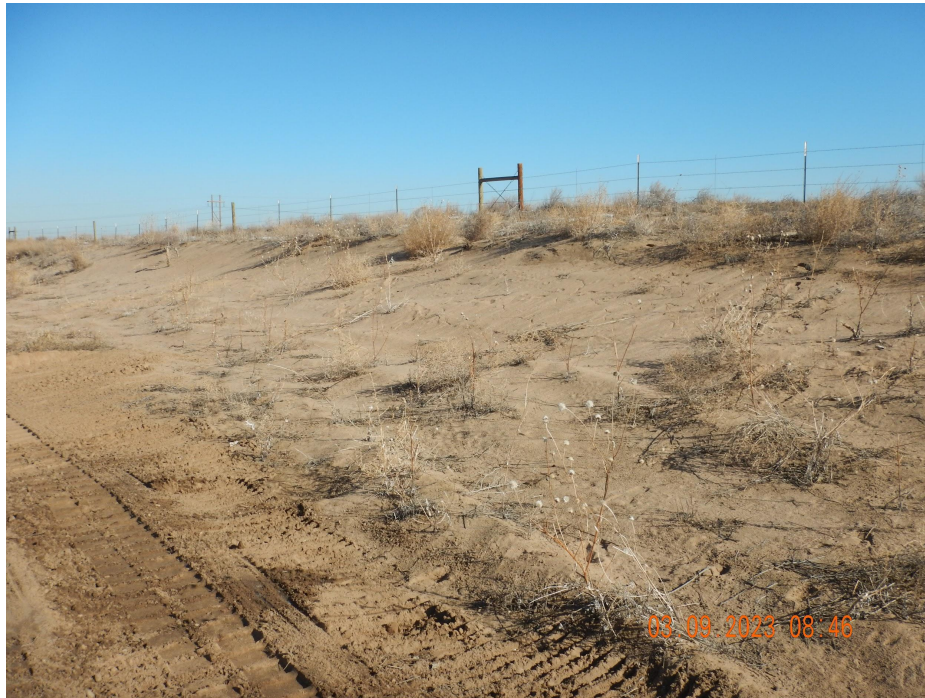
Photo 7. Photo taken from the southeastern location, facing North. Photo illustrates the cut slope has not been stabilized and wind erosion is evident- see Photo 8.

CDPHE is addressing this observation.

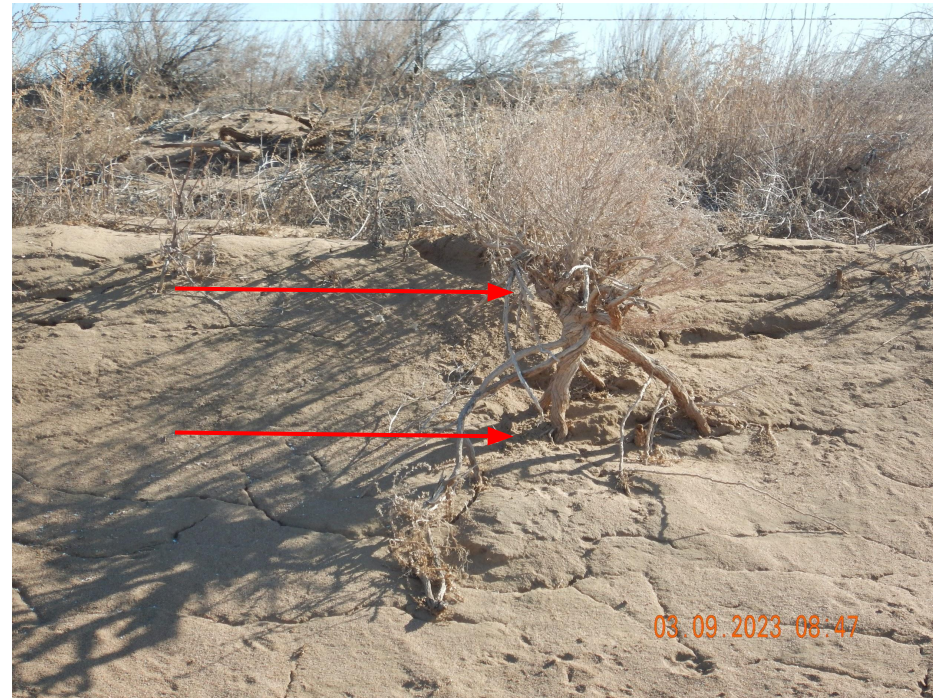
Photo 8. Photo taken from the eastern cut slope illustrates the soil loss due to wind erosion. Sand sagebrush roots are exposed and about 1-1.5' of soil loss.

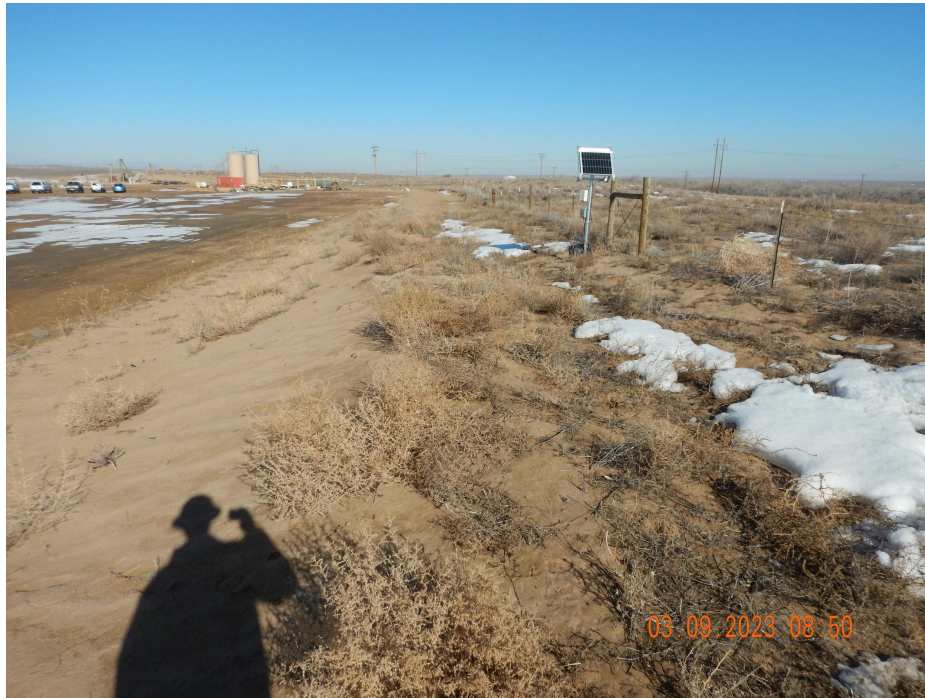
Photo 9. Photo taken from the eastern location, facing North. Photo illustrates weed establishment and weed maintenance needed along the eastern perimeter/cut slope.

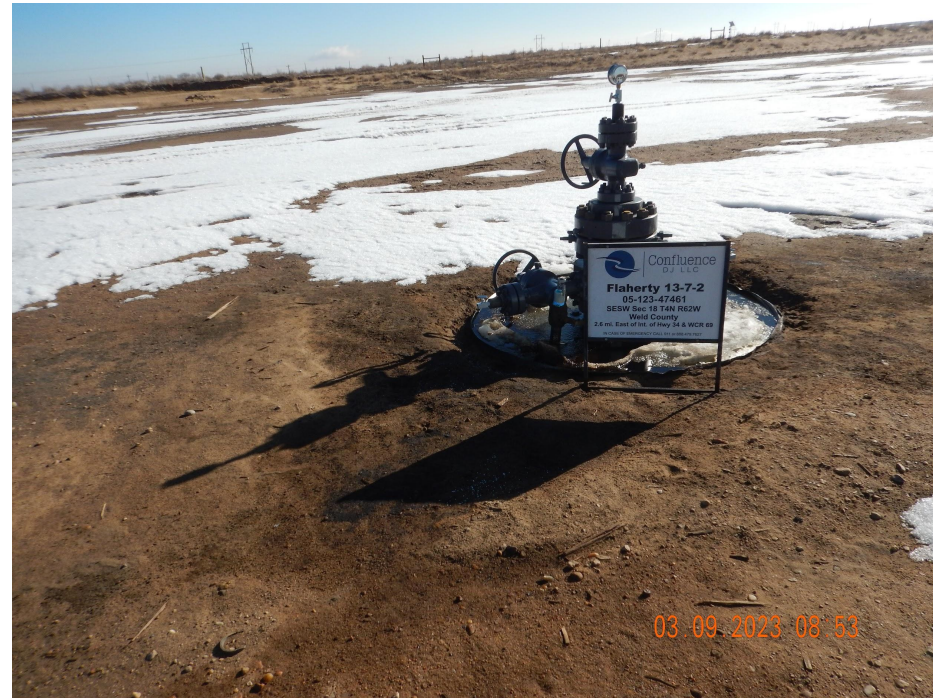
Photo 10. Photo taken from one of the wellheads, facing East. Photo illustrates oily stained soil.

CDPHE is addressing this observation.
