Interim Reclamation and Stormwater Inspection

March 9, 2023

Operator: CONFLUENCE DJ LLC #10518

Location ID: 458676

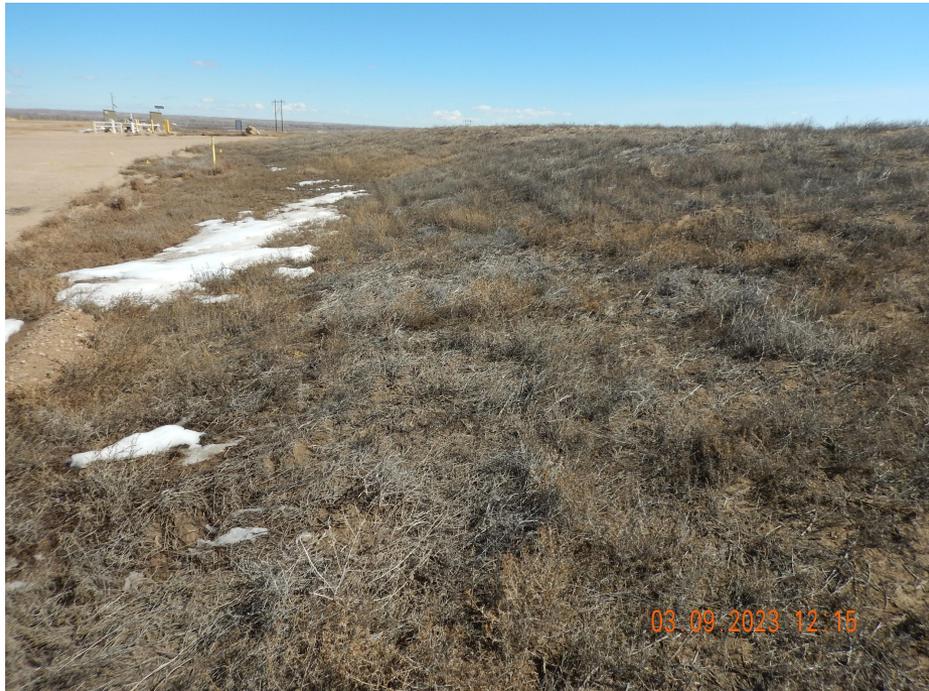
Photo 1. Photo taken from the southwestern location, facing East. Photo illustrates weed establishment and weed maintenance needed.

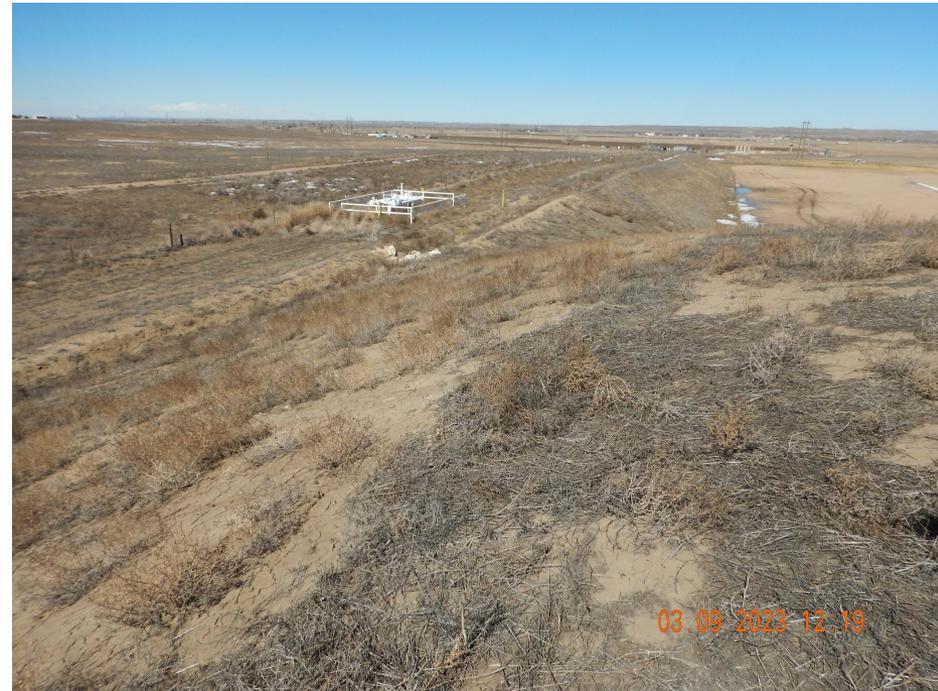
Photo 2. Photo taken from the topsoil stockpile, facing North. Photo illustrates bare ground with the establishment of weeds.

CDPHE is addressing this observation.

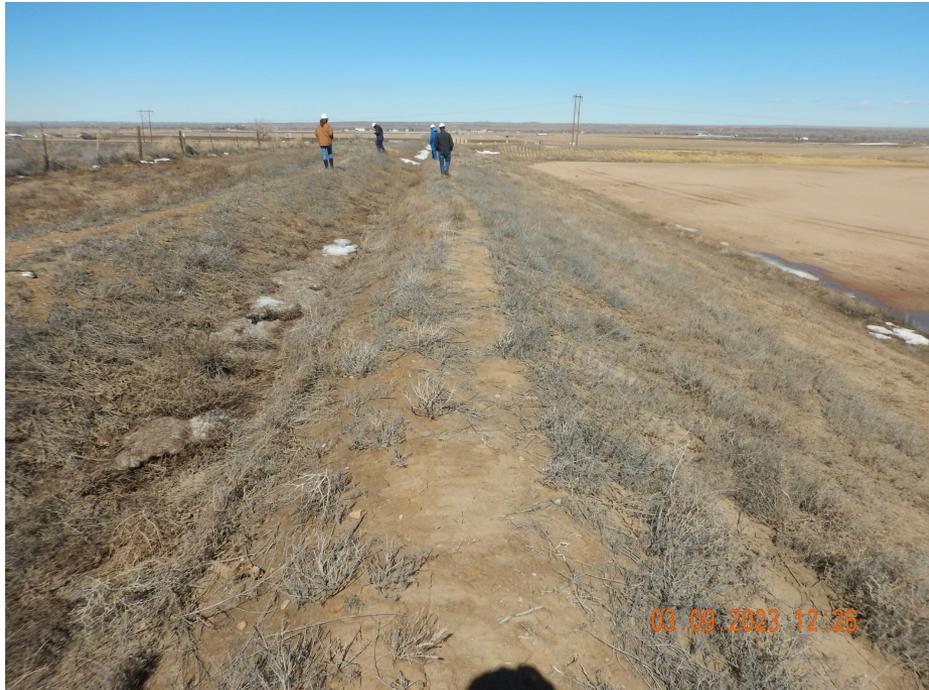
Photo 3. Photo taken from the western location, facing North. See comments under Photo 1 regarding weeds.

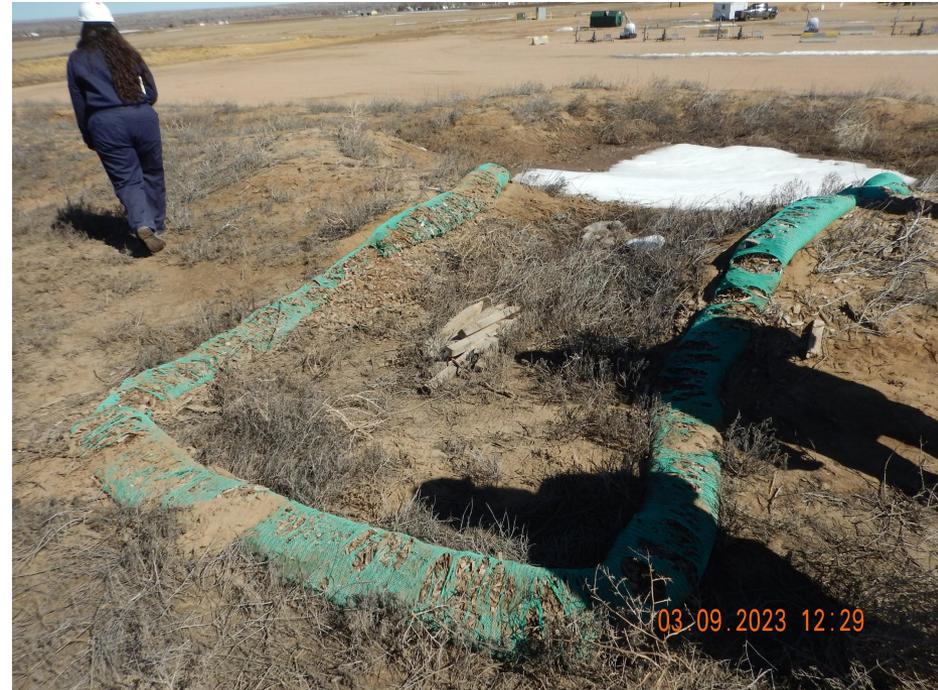
Photo 4. Photo taken from the western location, facing Northeast. Photo illustrates BMPs have not been maintained.

CDPHE is addressing this observation.

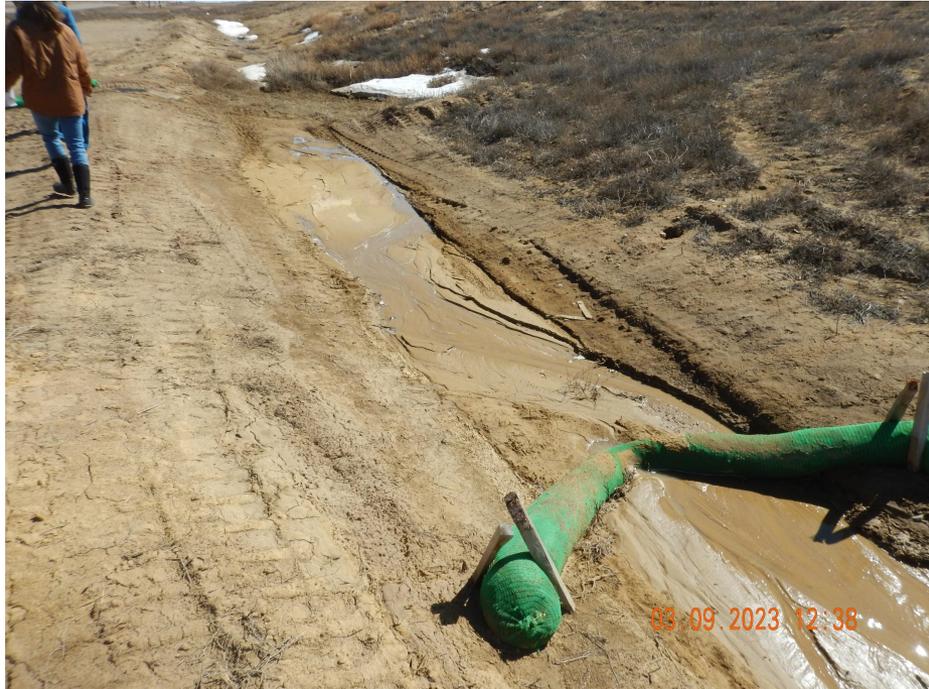
Photo 5. Photo taken from the northern location, facing East. Photo illustrates BMPs have not been maintained.

CDPHE is addressing this observation.

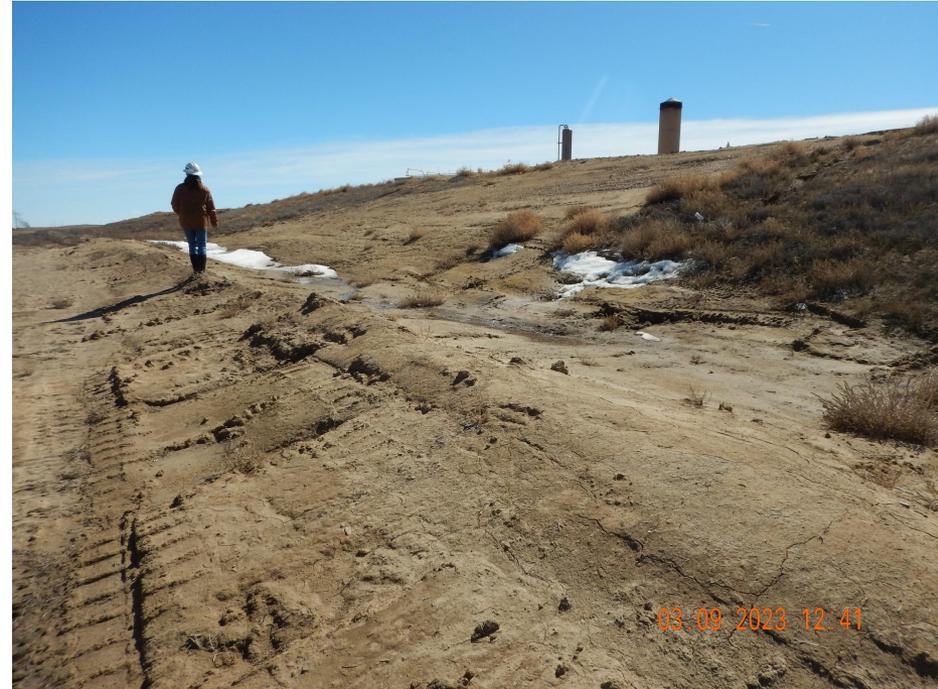
Photo 6. Photo taken from the northern location, facing East. Photo illustrates what appears to be a fill slope failure resulting in sediment discharge off location. See Photo 7.

CDPHE is addressing this observation.

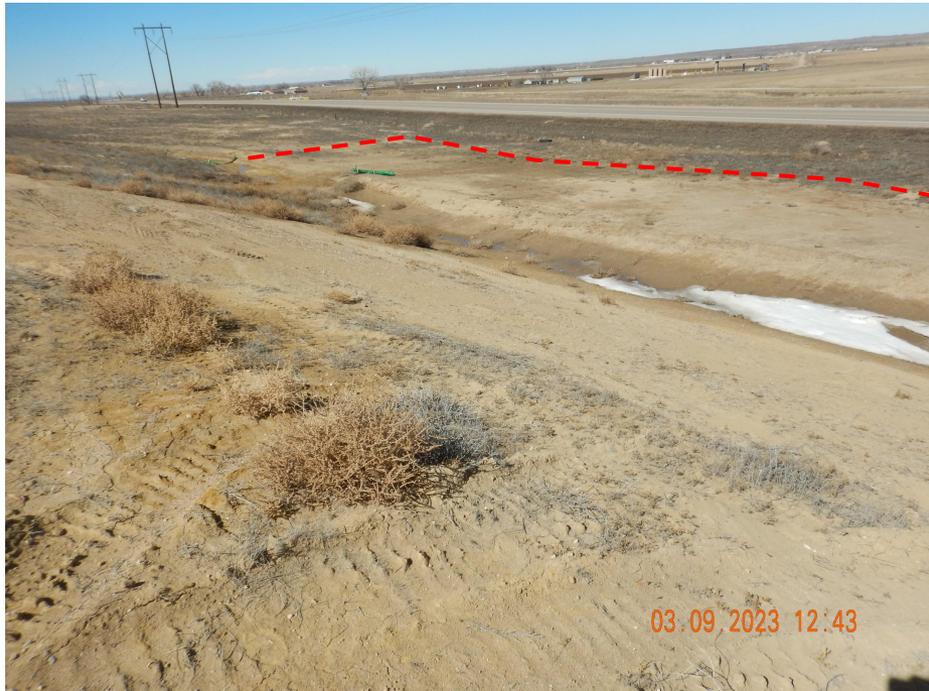
Photo 7. Photo taken from the northern location, on top of the fill slope, facing Northwest. Photo illustrates sediment discharge beyond the ditch BMP.

CDPHE is addressing this observation.

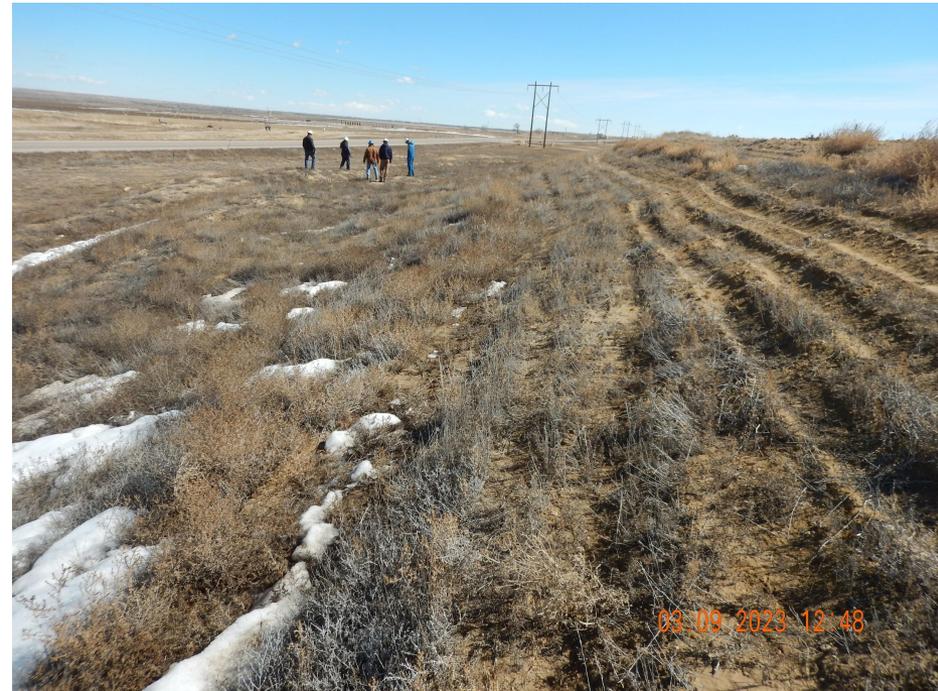
Photo 8. Photo taken from the northern location, facing East. See comments under Photo 1 regarding weeds.

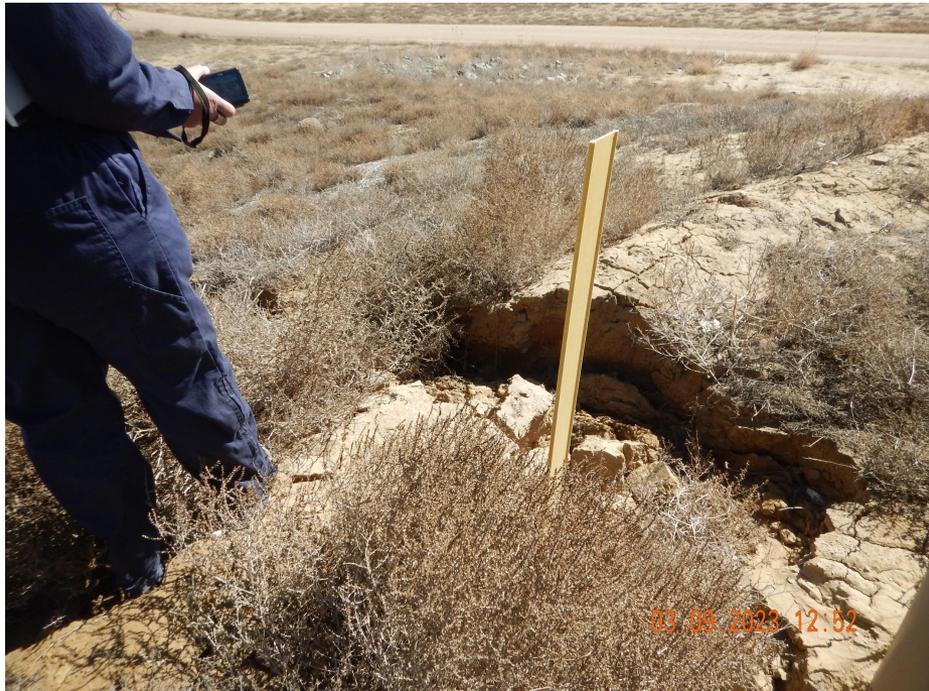
Photo 9. Photo taken from the northeastern location, facing East. Photo illustrates gully erosion along the ditch and berm BMP and weed establishment.

CDPHE is addressing this observation.

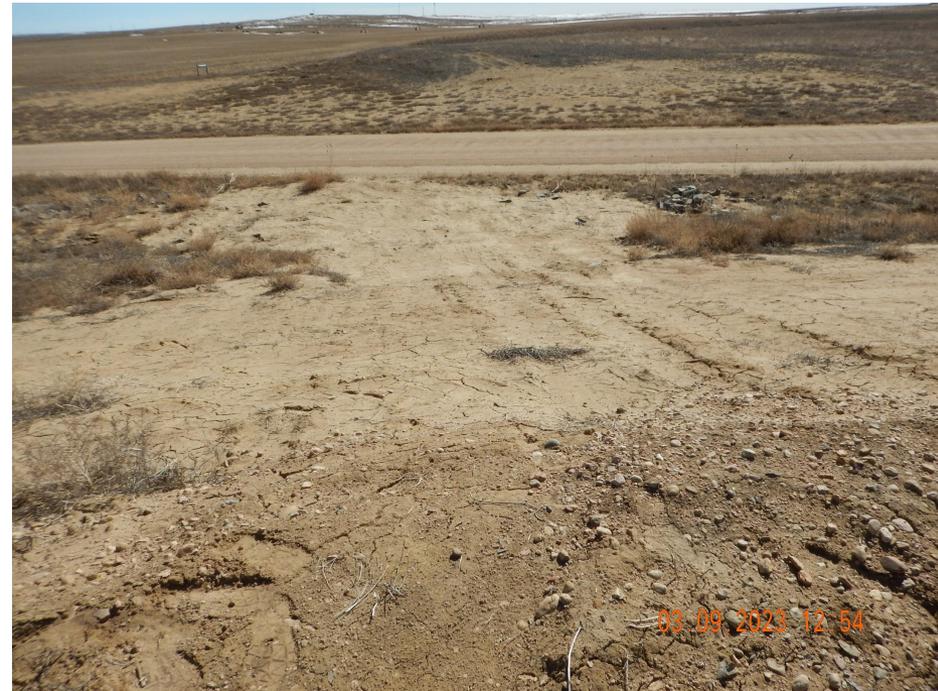
Photo 10. Photo taken from the northeastern location, facing South. Photo illustrates sediment has accumulated in the ditch/rip rap BMP.

CDPHE is addressing this observation.

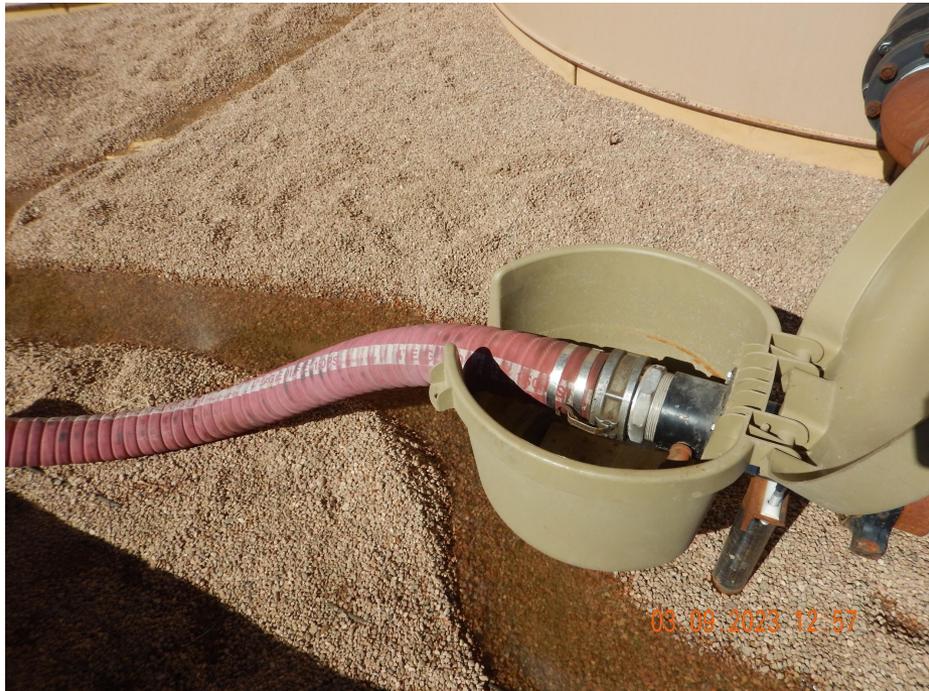
Photo 11. Photo taken from the produced water load out within secondary containment. Photo illustrates the hose has been left connected and is a potential safety concern with regards to a potential spill.

Note- Operator did disconnect hose during this inspection.

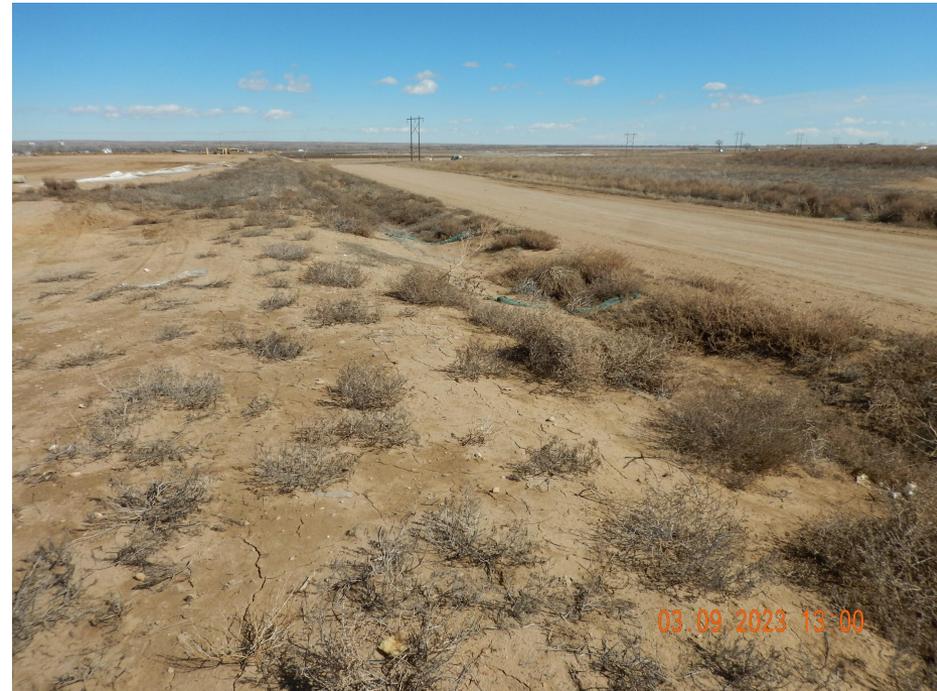
Photo 12. Photo taken from the southern location, facing East. See comments under Photo 1 regarding weeds.
