Inspection Photos

Location Name: TEP ROCKY MOUNTAIN LLC BUXTON RWF 13-30 pad

Location ID: 335503

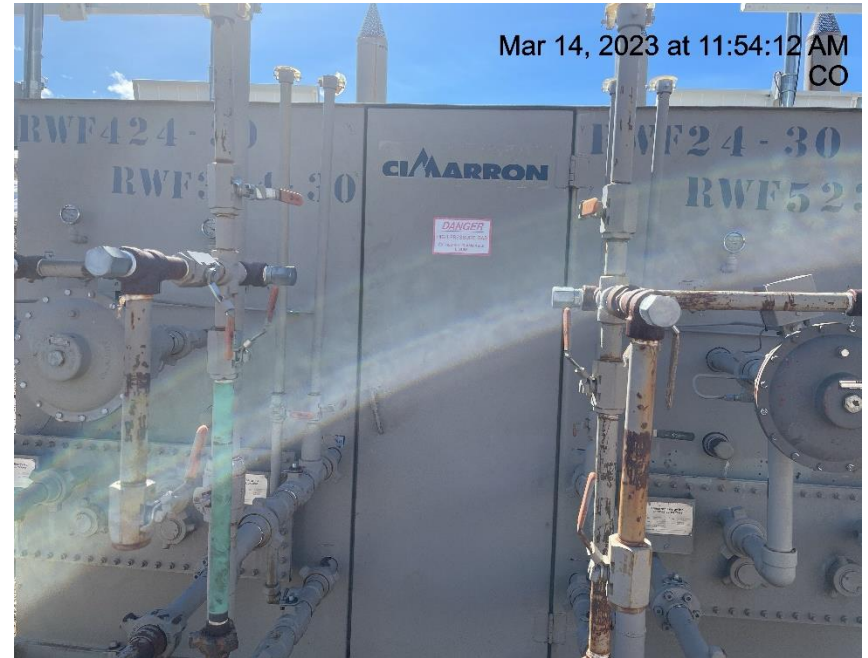
Photo # 2344 Calibration info not conspicuously posted

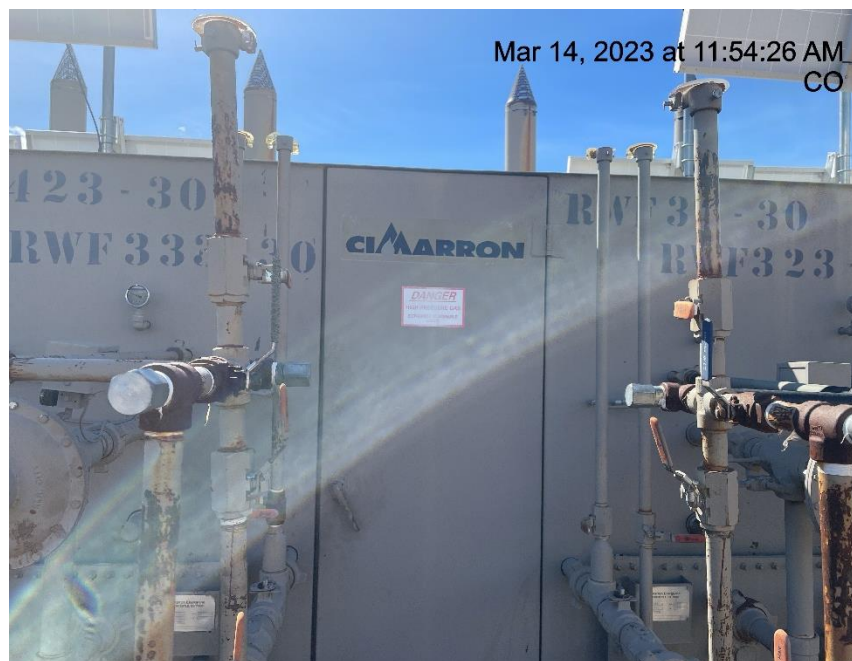
Photo # 2345 Calibration info not conspicuously posted

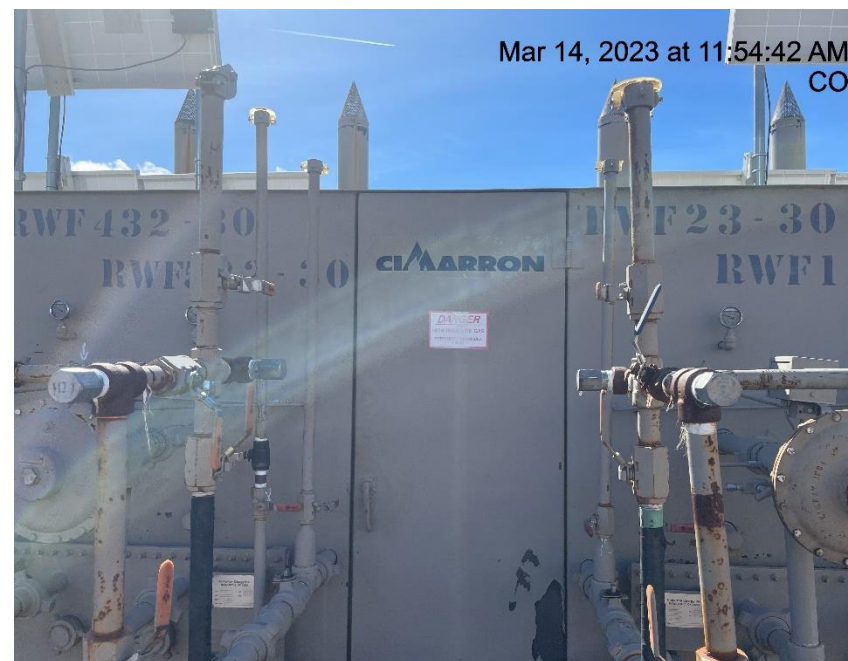
Photo # 2346 Calibration info not conspicuously posted

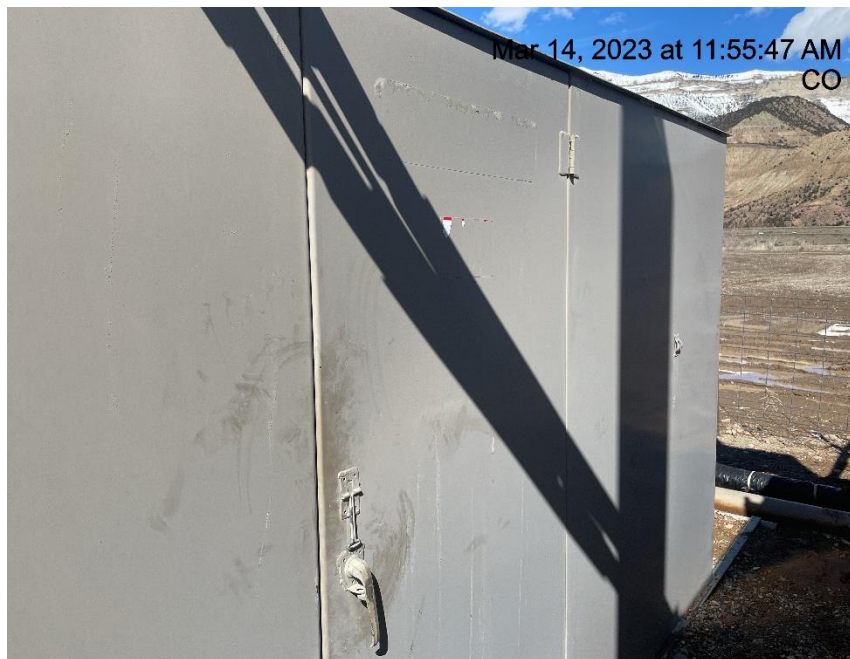
Photo # 2348 Calibration info not conspicuously posted

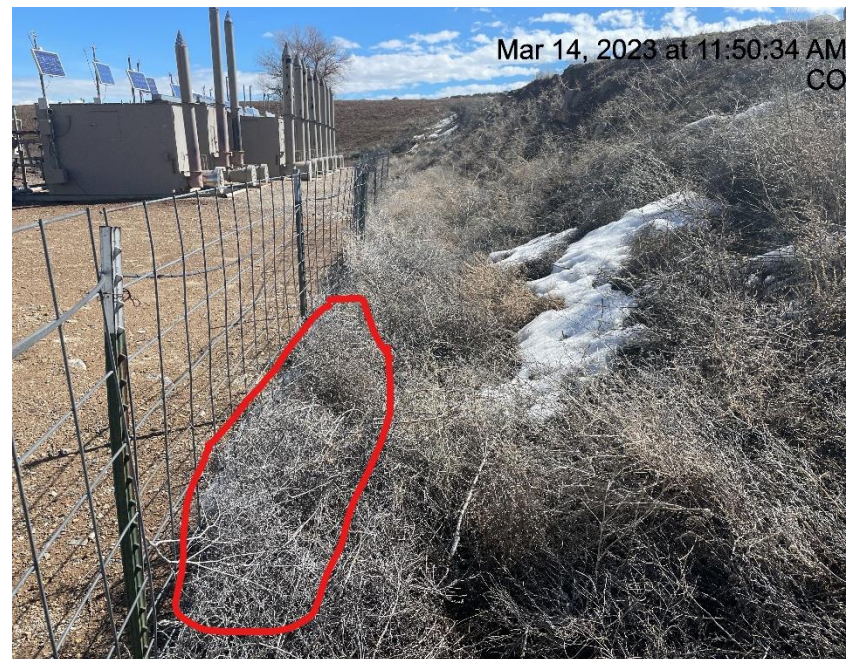
Photo # 2340 Weeds/Undesirable plant species

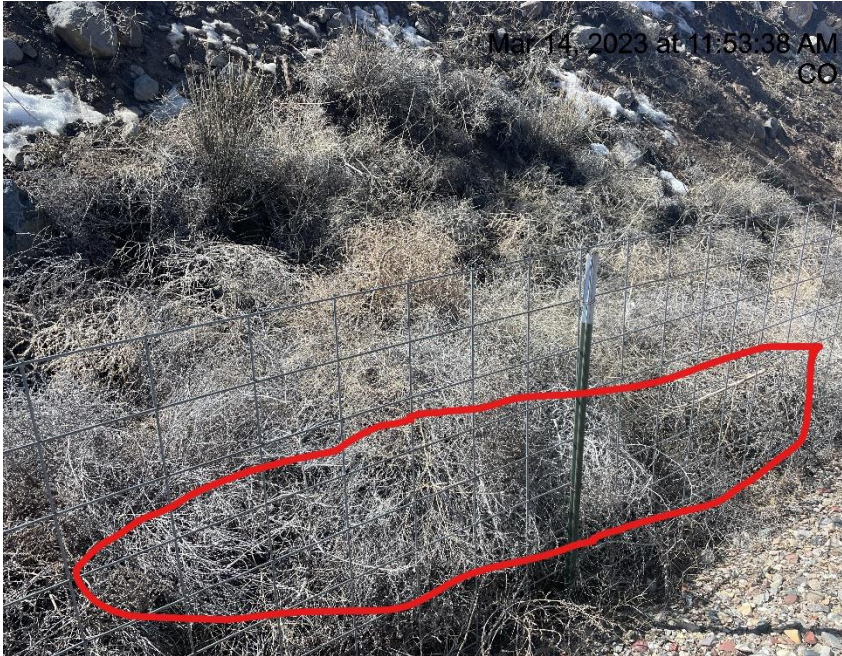
Photo # 2343 Weeds/Undesirable plant species

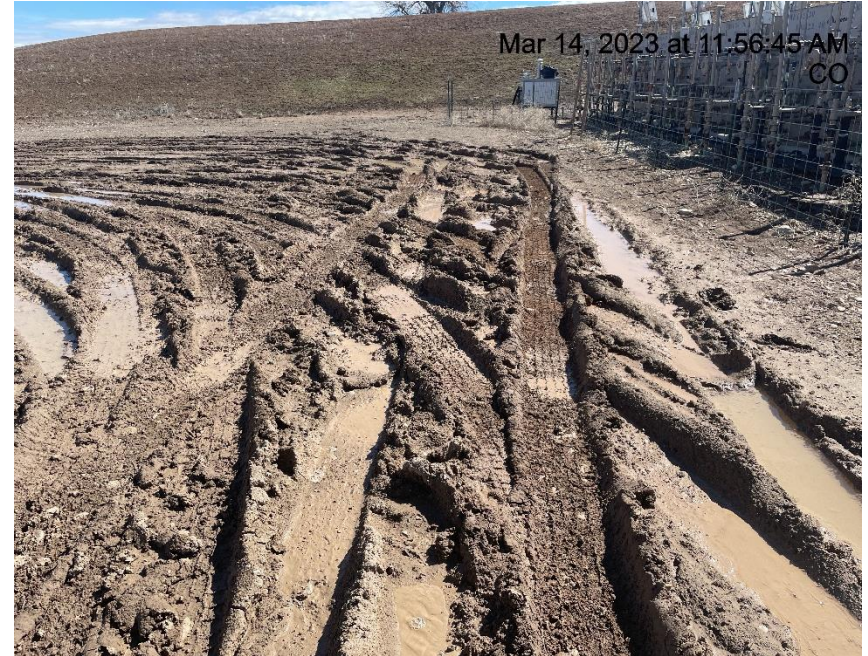
Photo # 2340 Lack of stabilization

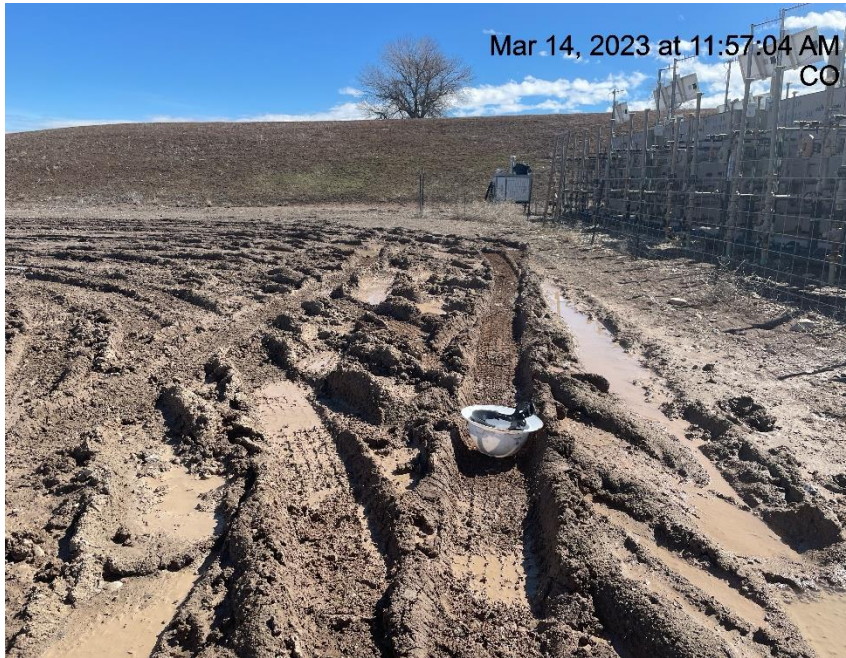
Photo # 2350 Lack of stabilization

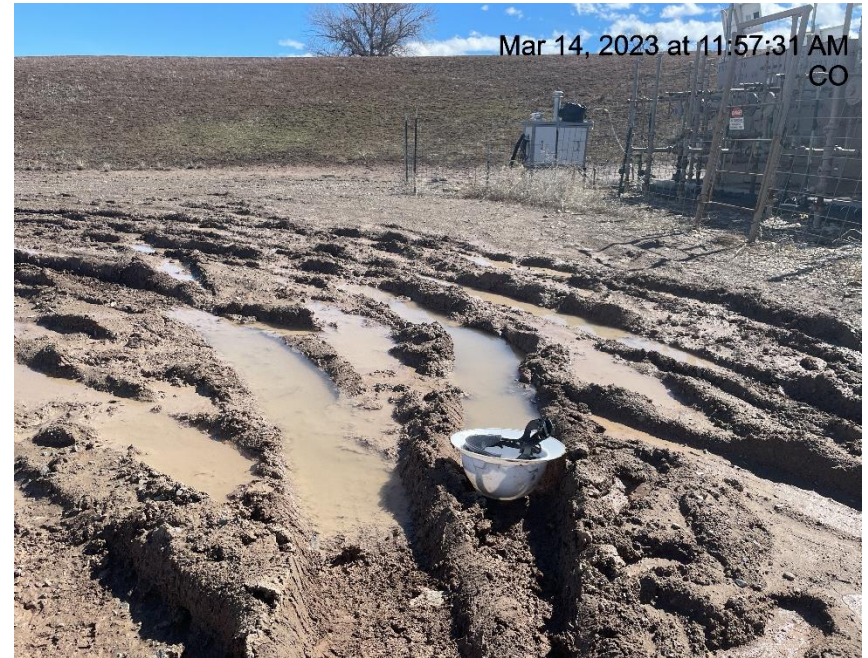
Photo # 2351 Lack of stabilization

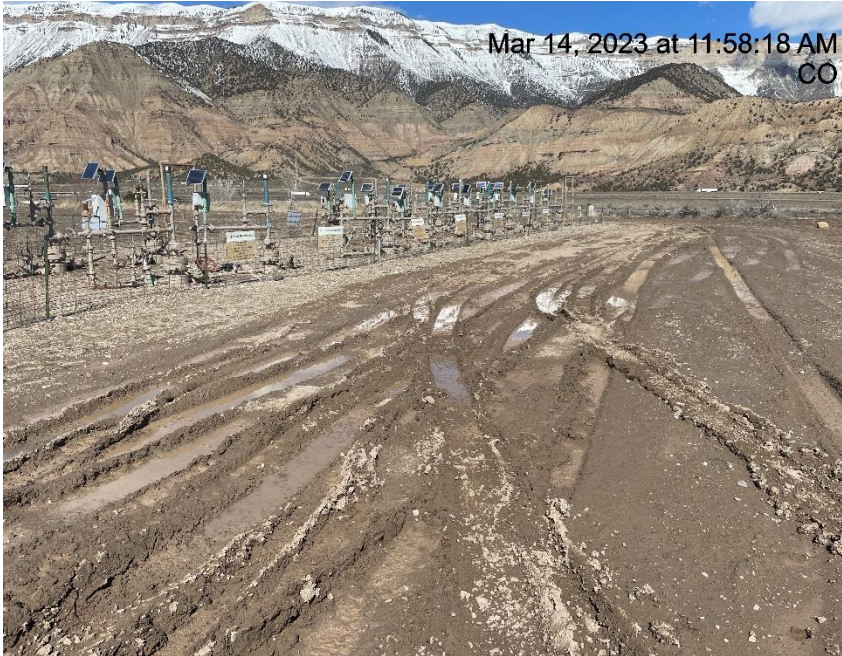
Photo # 2352 Lack of stabilization

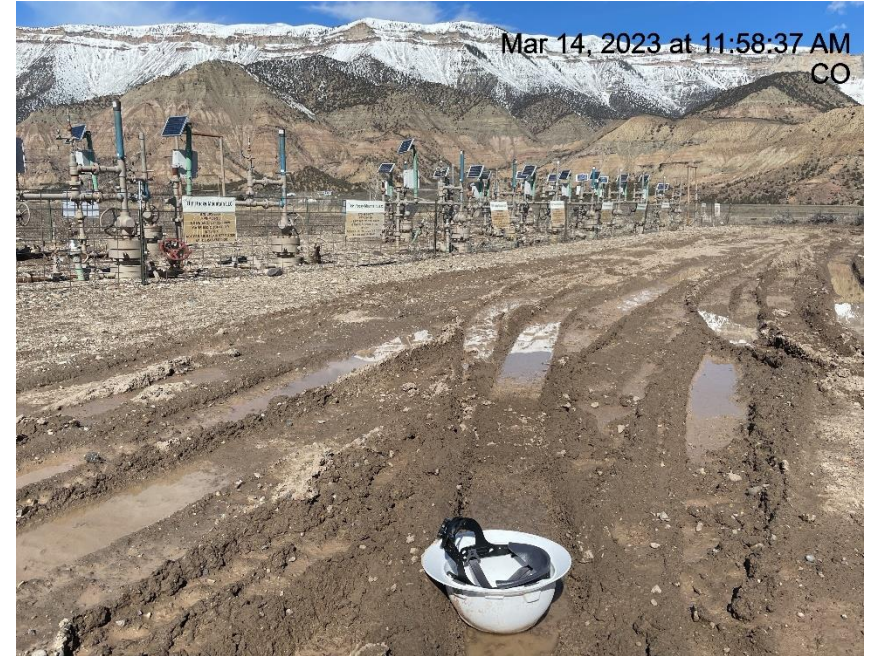
Photo # 2353 Lack of stabilization

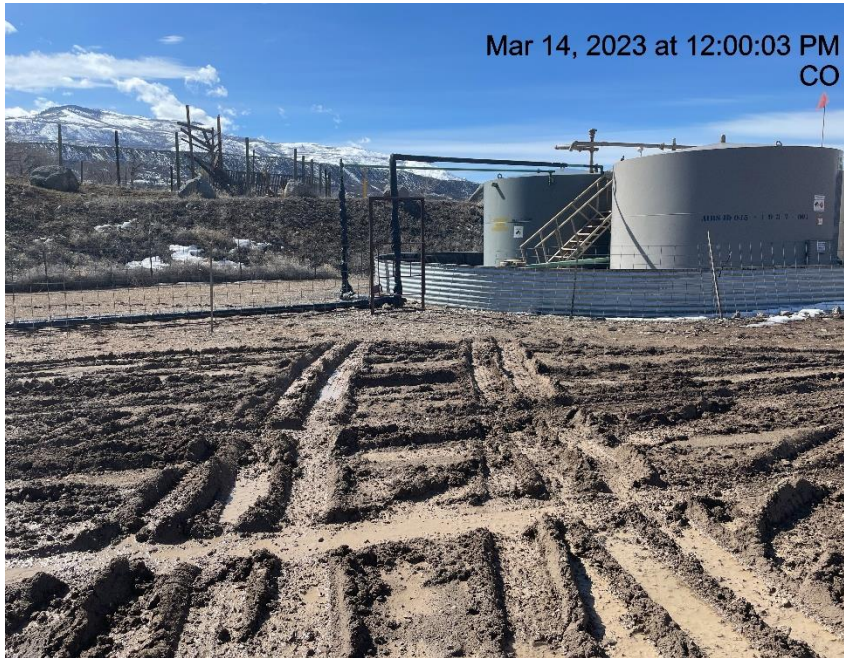
Photo # 2354 Lack of stabilization

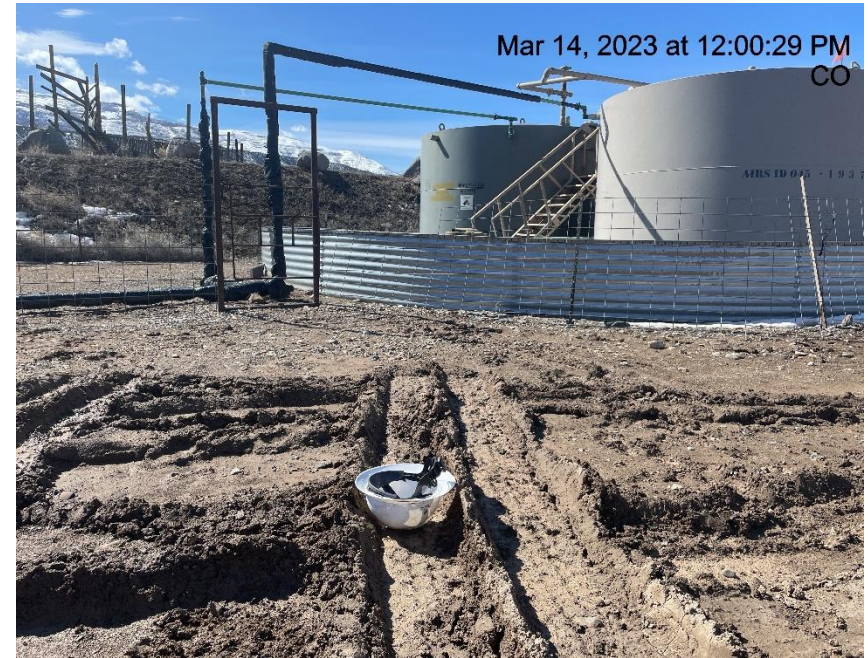
Photo # 2355 Lack of stabilization

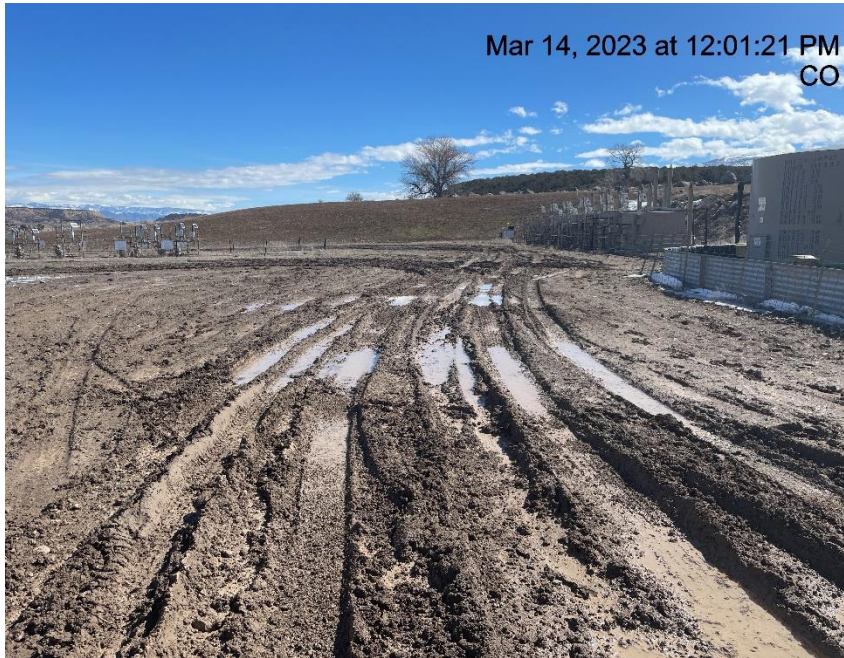
Photo # 2356 Lack of stabilization

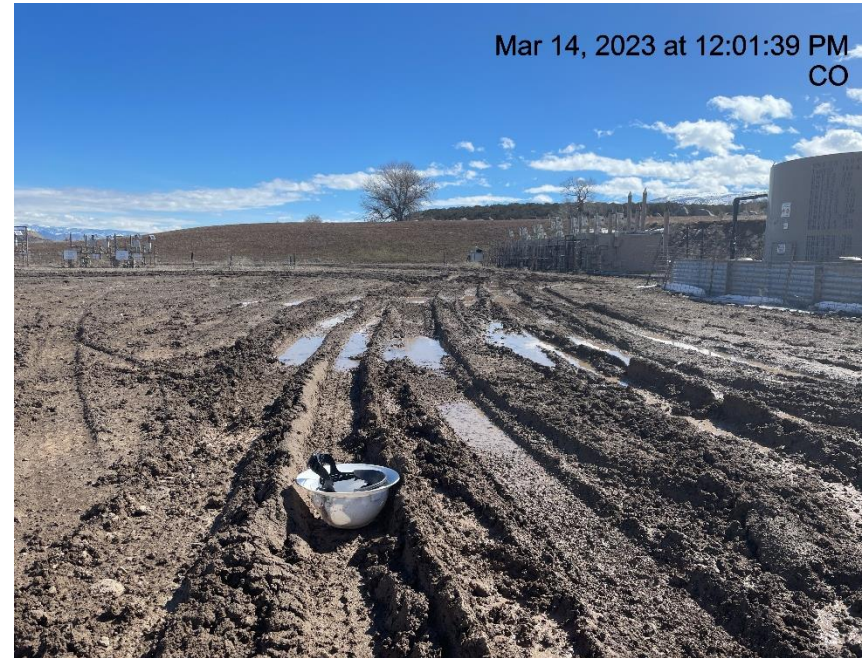
Photo # 2357 Lack of stabilization

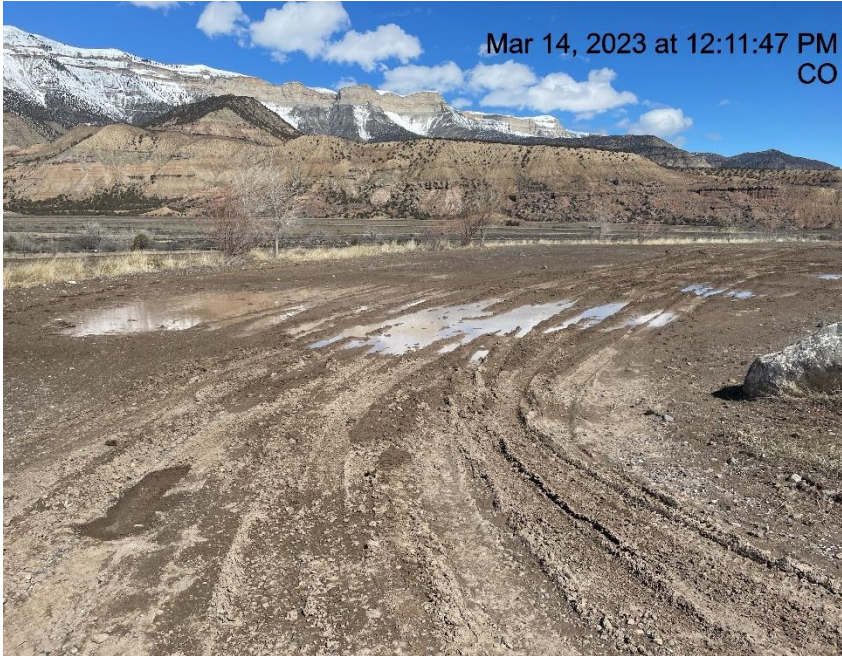
Photo # 2358 Lack of stabilization/Tracking onto lease road

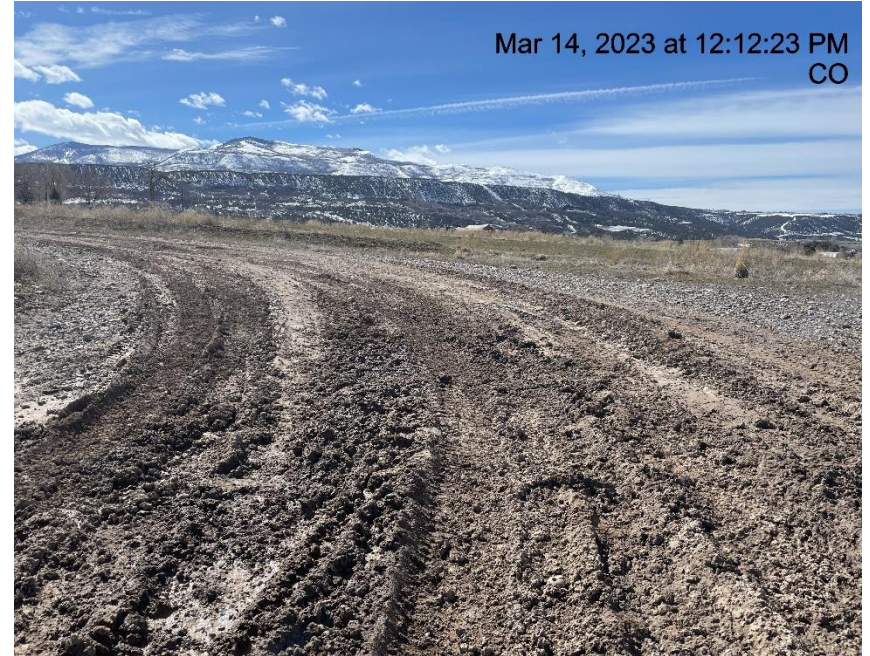
Photo # 2359 Tracking onto lease road

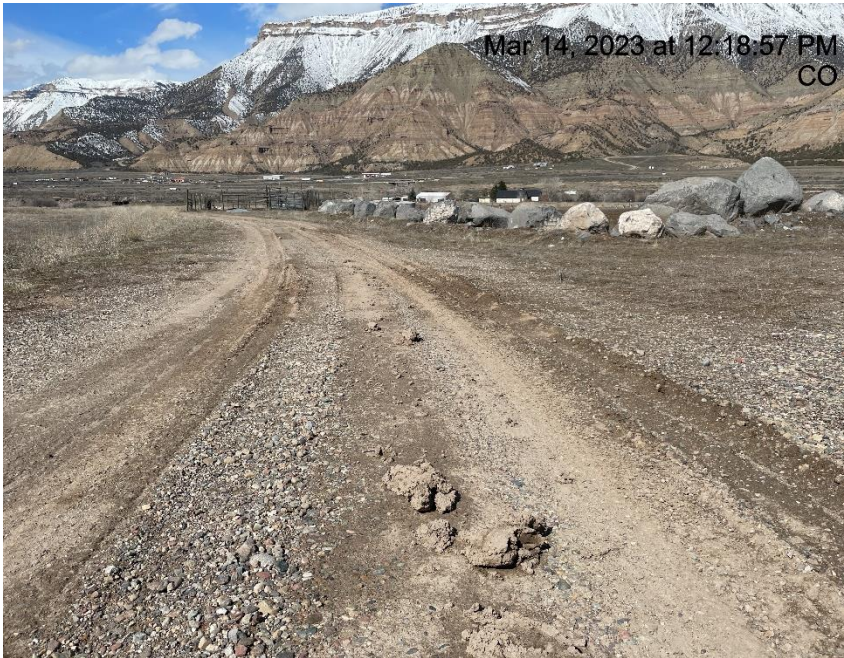
Photo # 2362 Tracking on lease road
