Inspection Photos  
Location Name: Anderson Trust 1  
Location ID: 318607

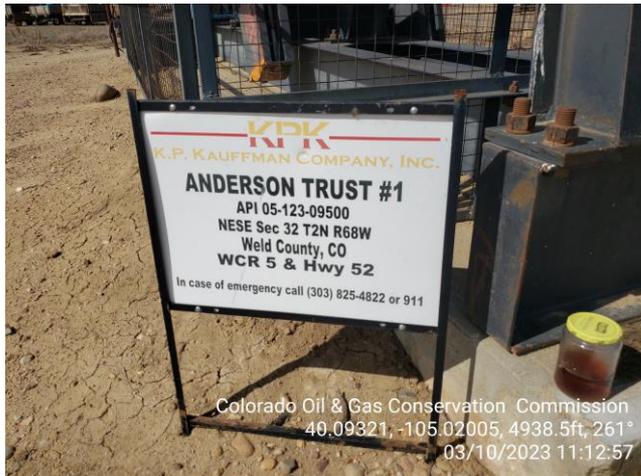
Photo 1 WH sign.

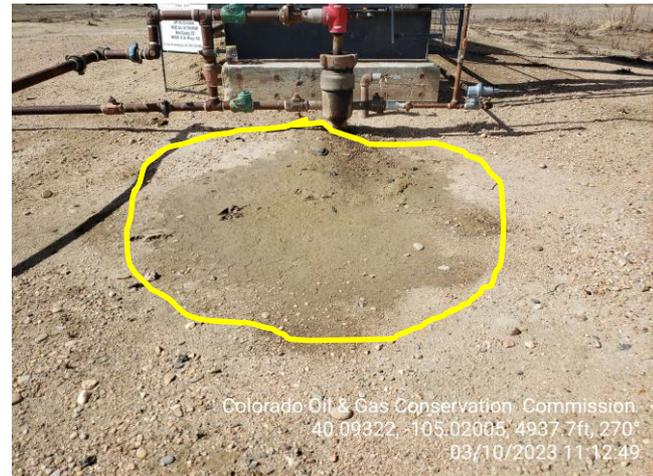
Photo 2 WH possible leak, ground is saturated in outline.

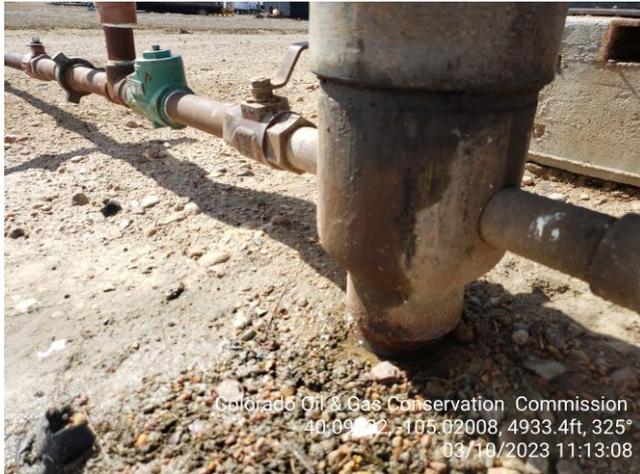
**Photo 3 possible leak from threads on WH.**

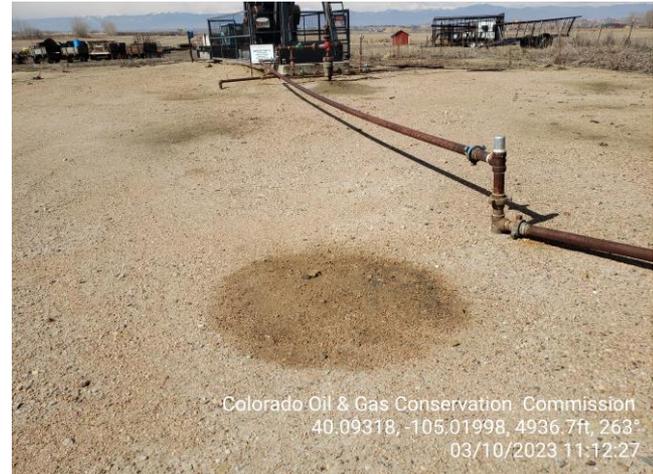
**Photo 4 stained ground**

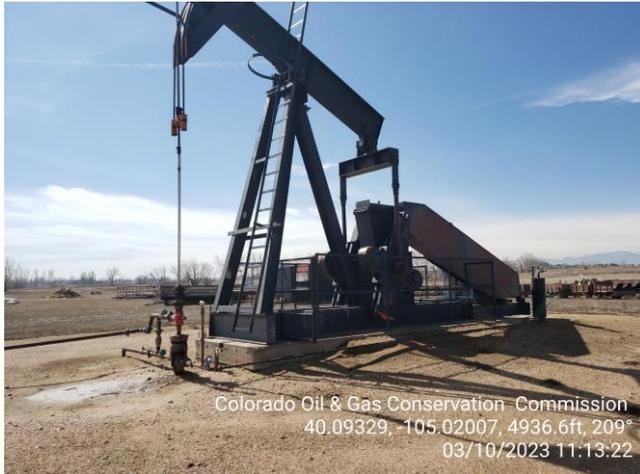
**Photo 5 Pump jack.**

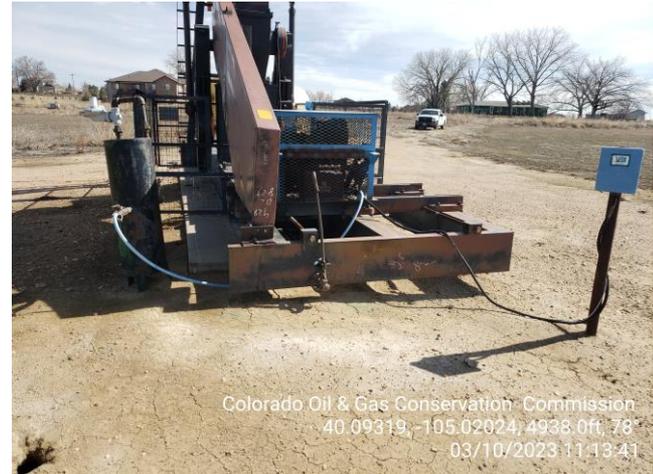
**Photo 6 Prime mover (gas engine)**

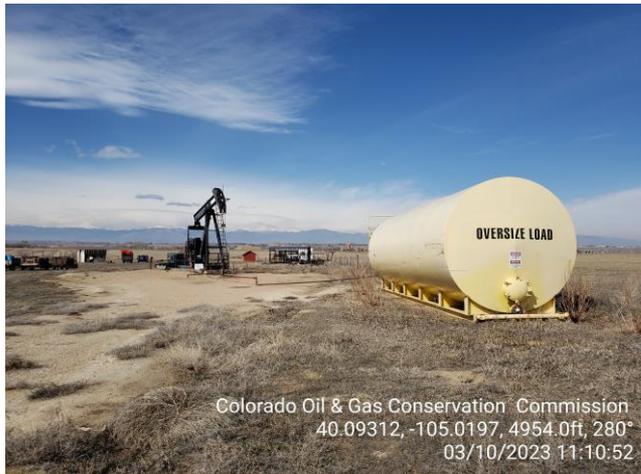
**Photo 7 wellsite.**

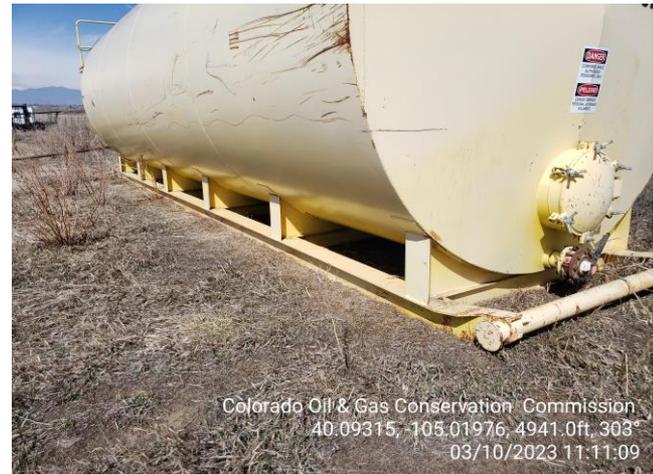
**Photo 8 Auxiliary tank no spill containment.**

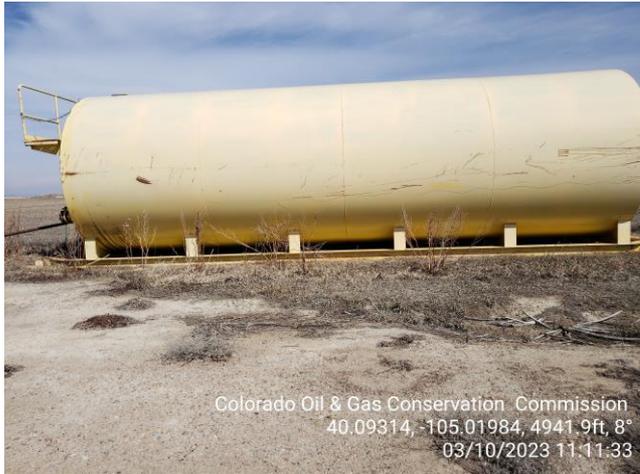
**Photo 9 Aux. tank has no labels or markers to indicate volume or contents, no spill containment.**

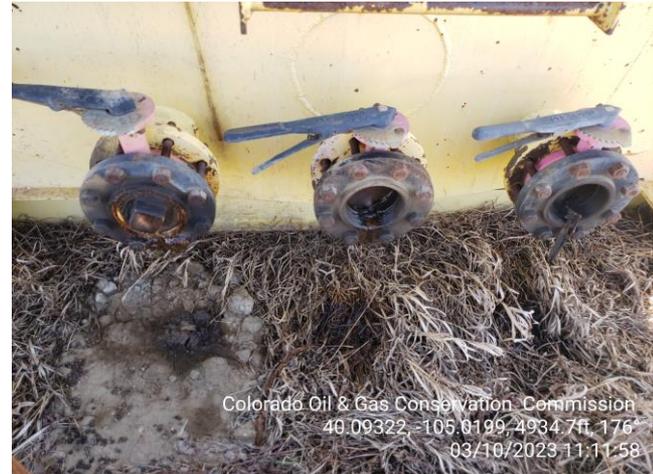
**Photo 10 Auxiliary tank valves leaking no spill containment.**

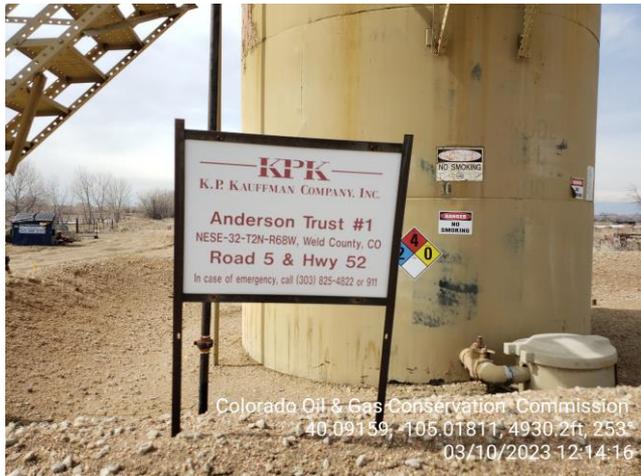
Photo 11 TB Sign.

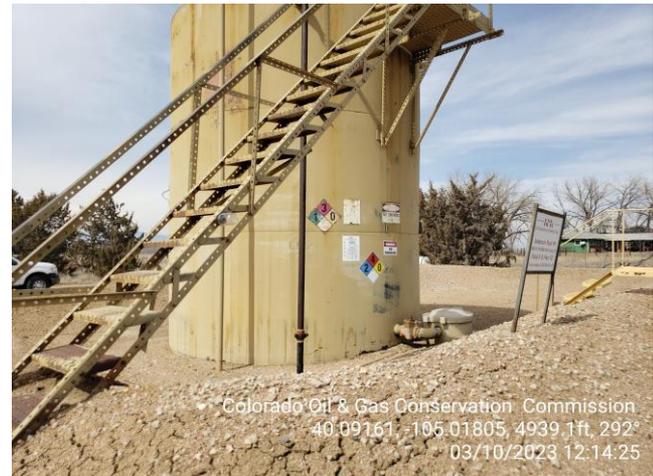
Photo 12 TB.

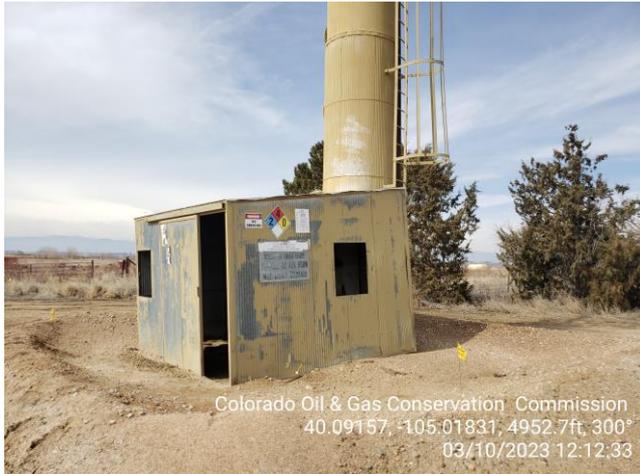
Photo 11 TB Sign.

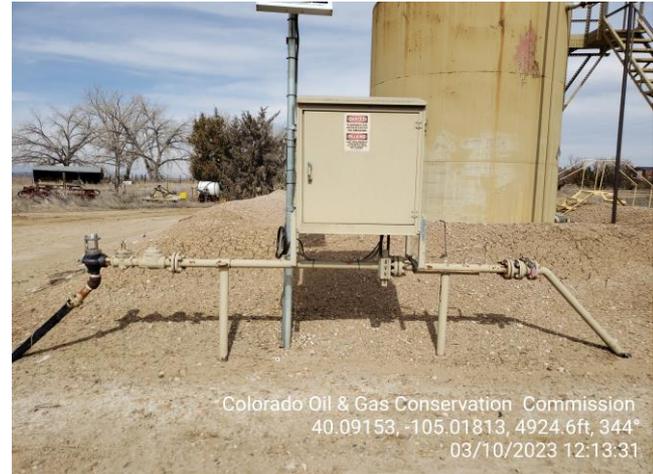
Photo 12 TB.
