# Inspection Photos

API: 025-06021

Operator: VAL ENERGY INC

Inspection Date: 3/14/2023

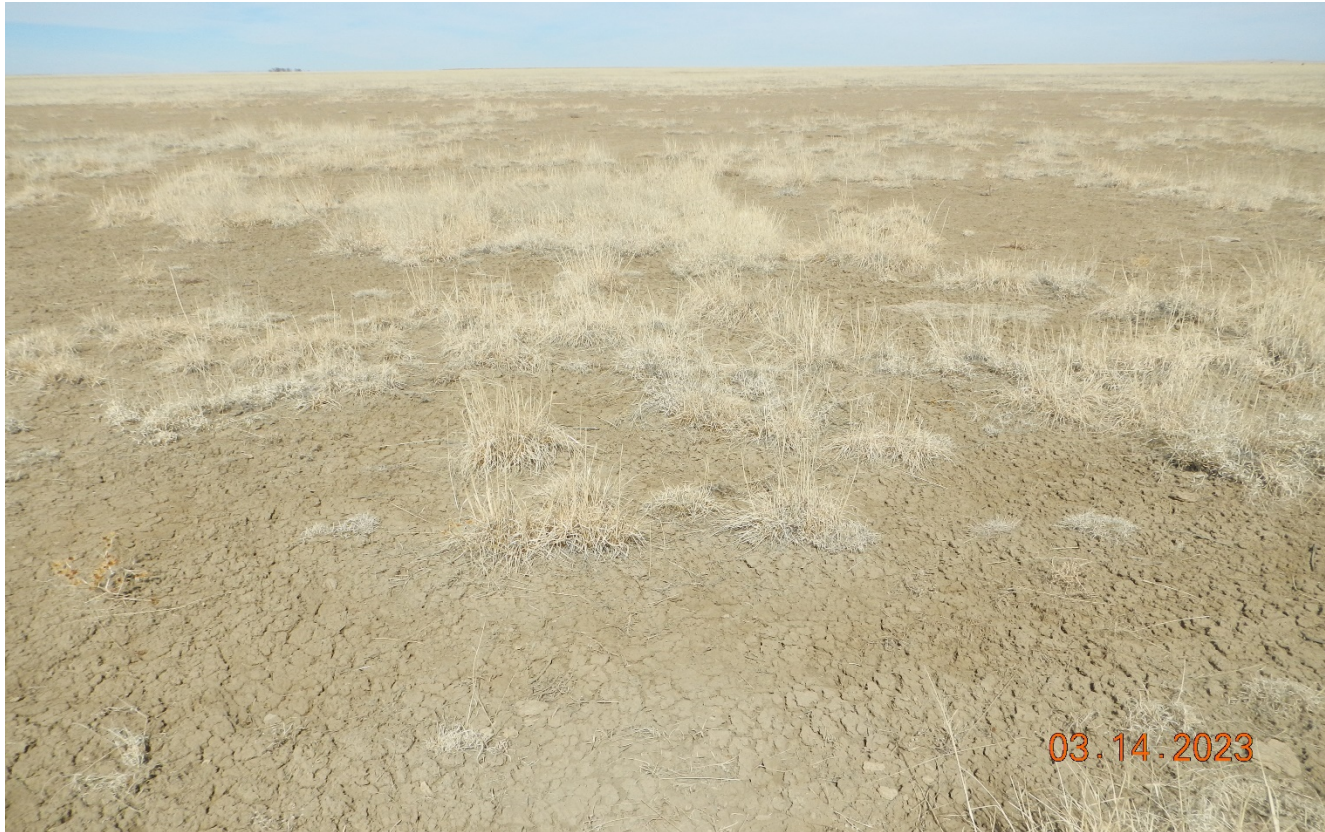
**Photo 1.** Center of the location facing north. The perennial vegetation has not yet established to 80% of reference area levels.

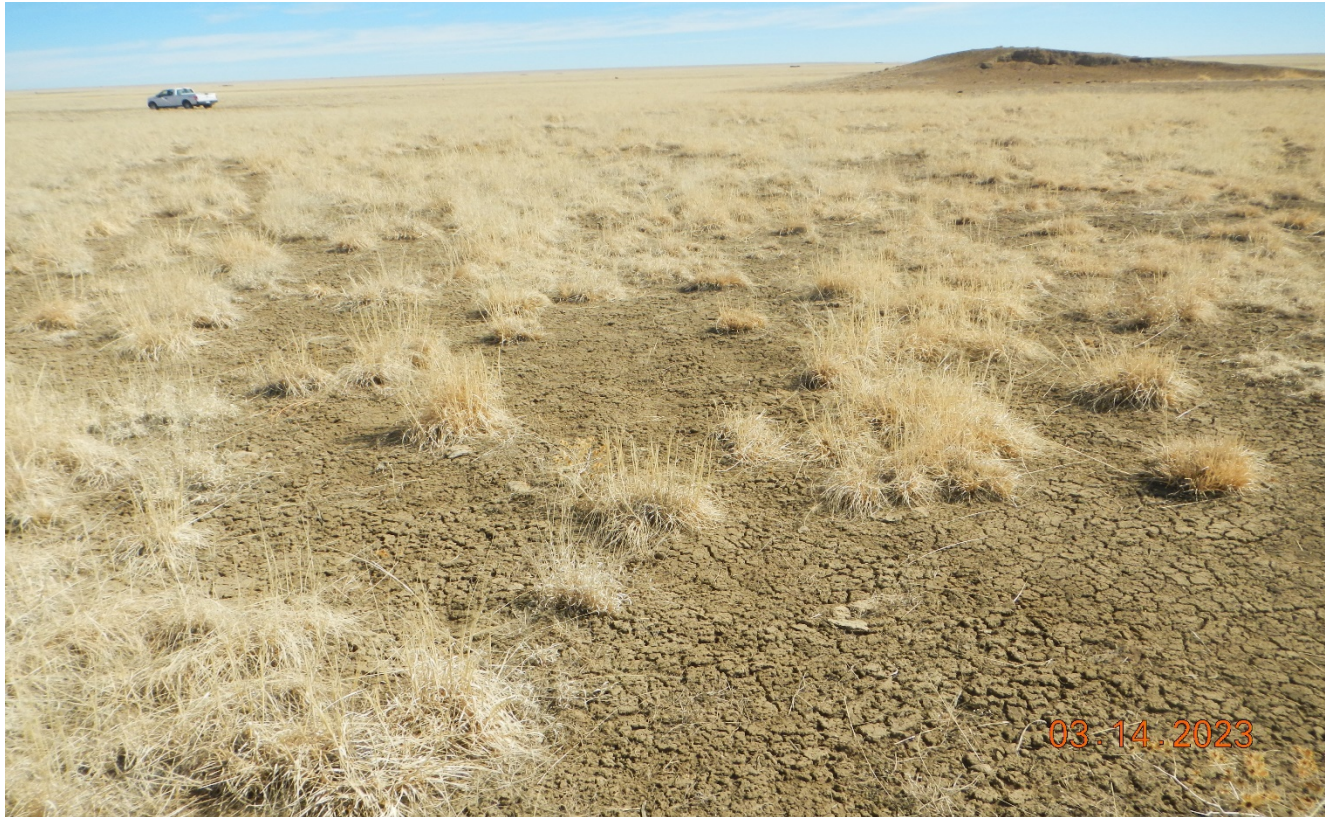
**Photo 2.** Center of the location facing east.

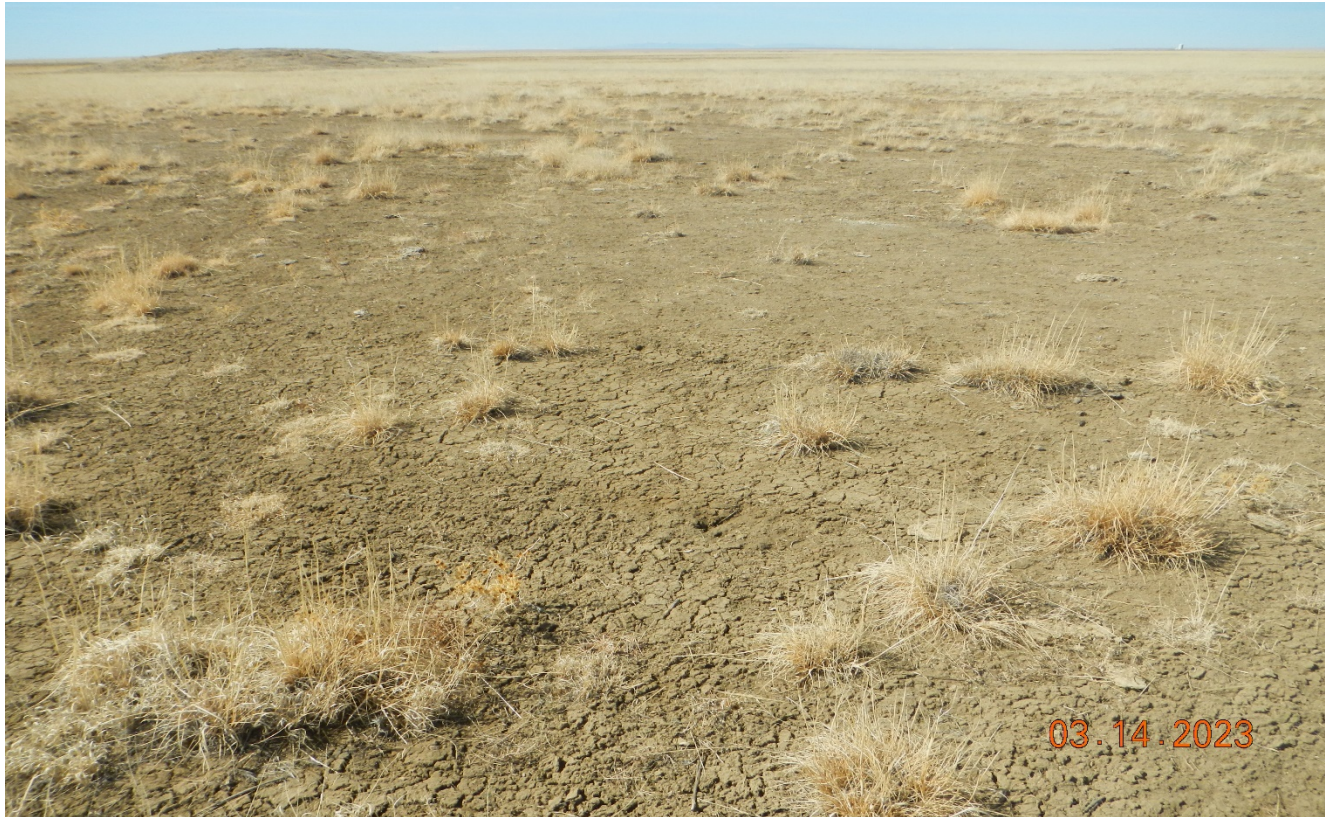
**Photo 3.** Center of the location facing south.

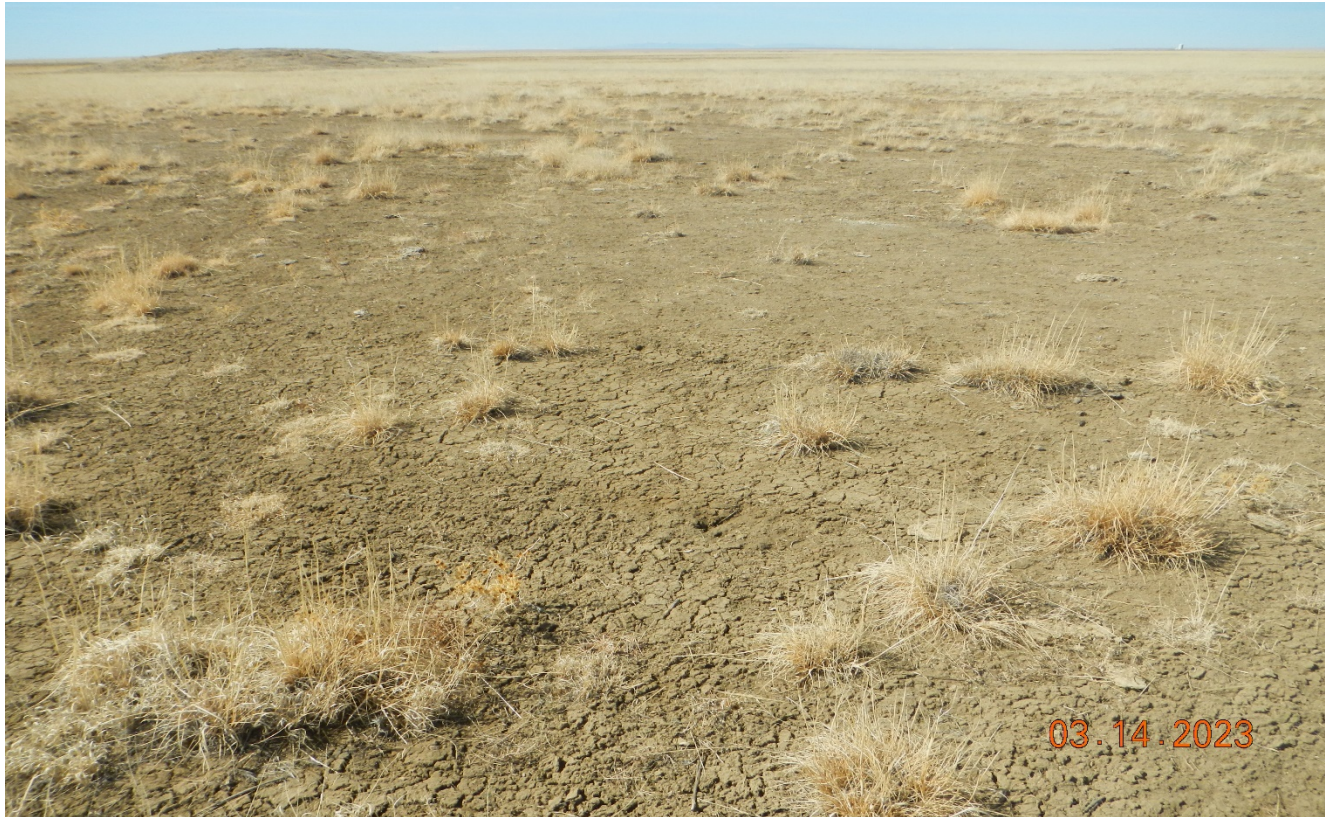
**Photo 4.** Center of the location facing west.

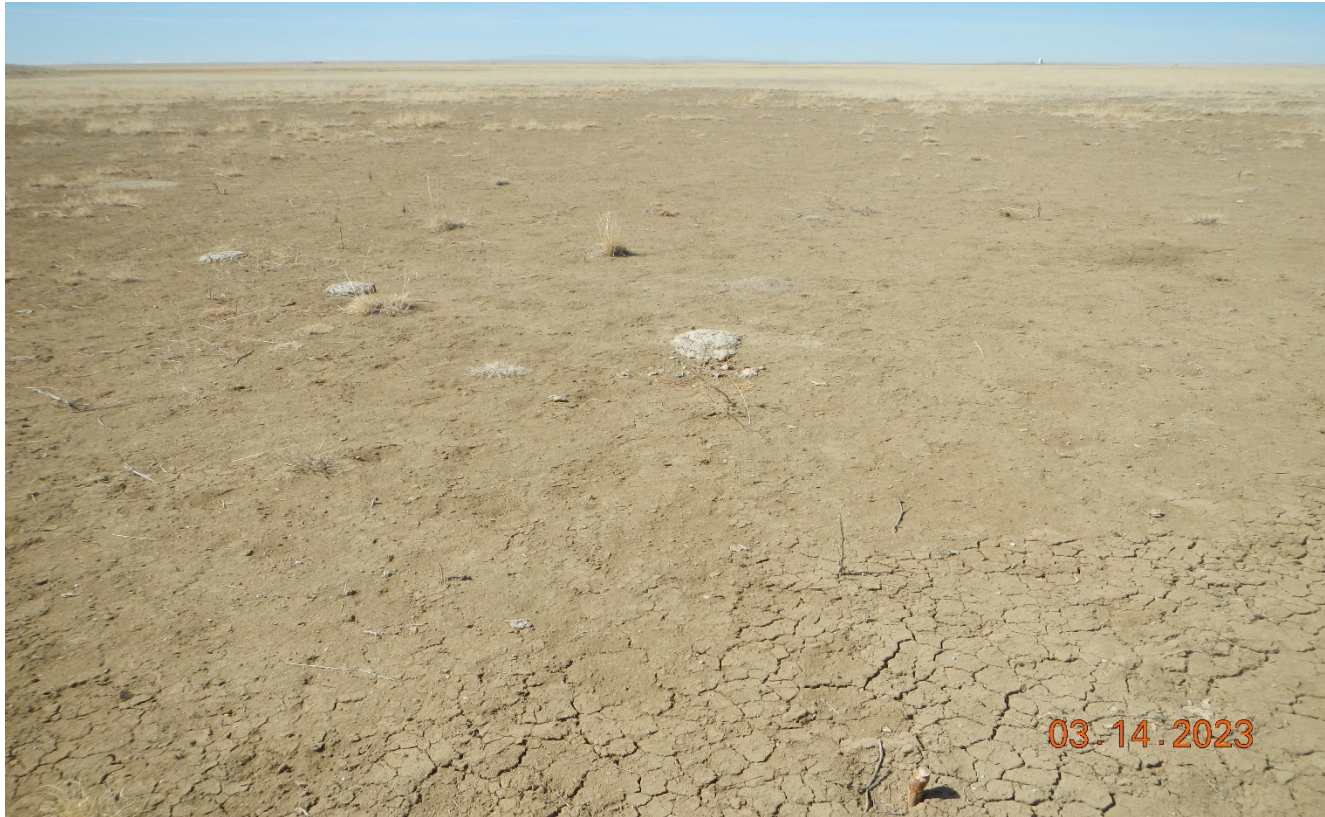
**Photo 5.** North side of the location facing west. The northern portion of the location is mostly devoid of vegetation and needs to be reseeded.

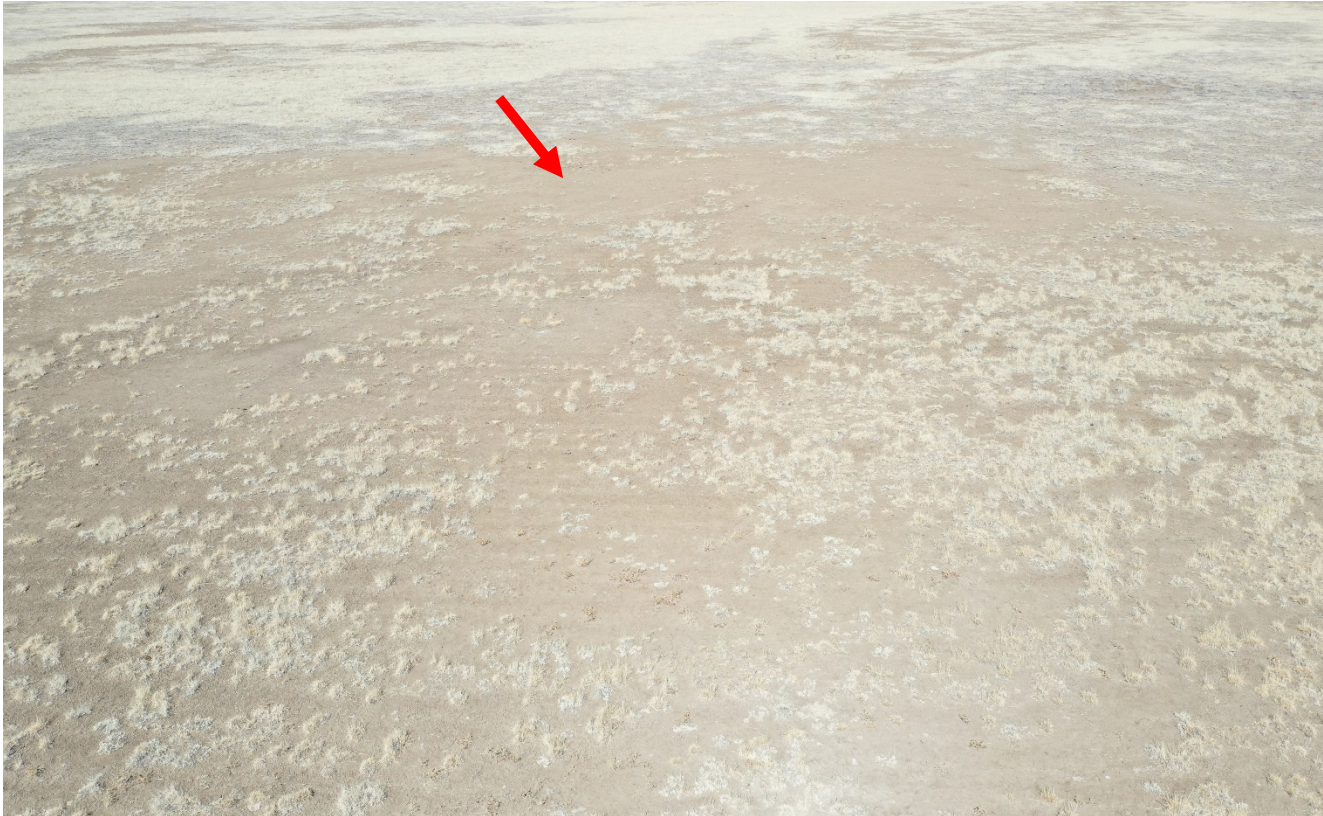
**Photo 6.** Drone aerial photo facing north toward the location. The northern portion of the disturbed location at red arrow is mostly bare soil.

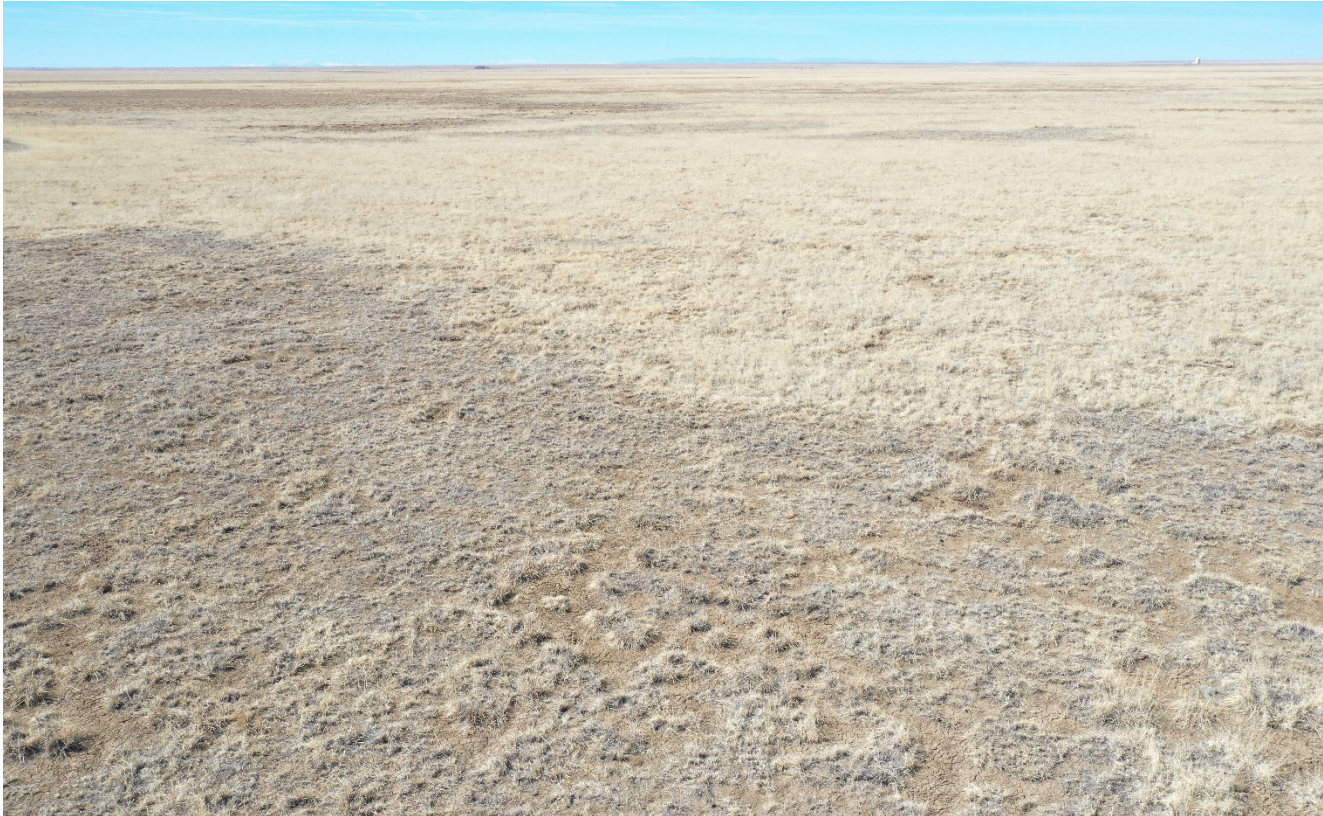
**Photo 7.** Drone aerial image facing west at the surrounding undisturbed uniform vegetation cover.
