TEP  
Miller 10  
Location # 423439

**COLORADO**  
Oil & Gas Conservation  
Commission  
Department of Natural Resources

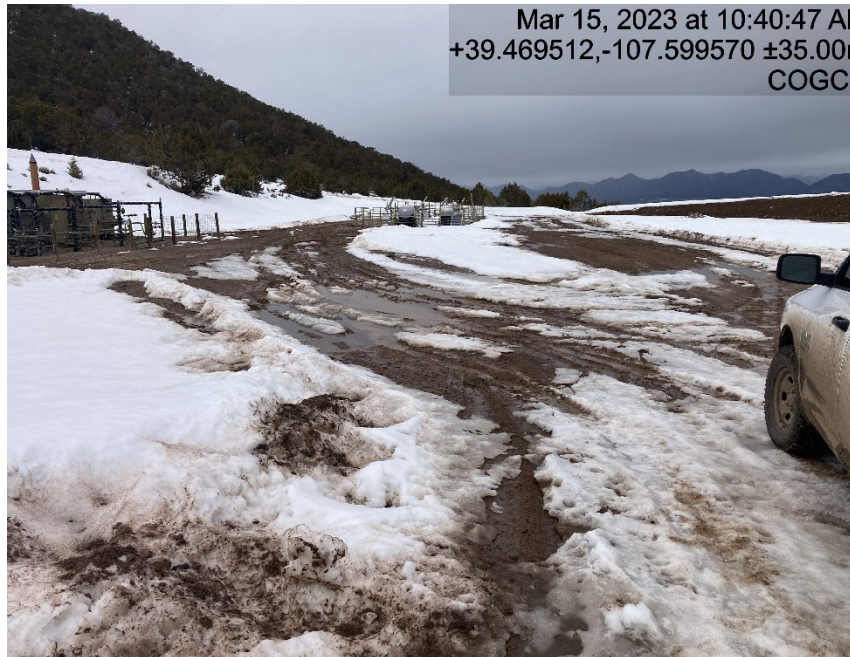
Location and inspector did not drive onto location  
due to muddy conditions

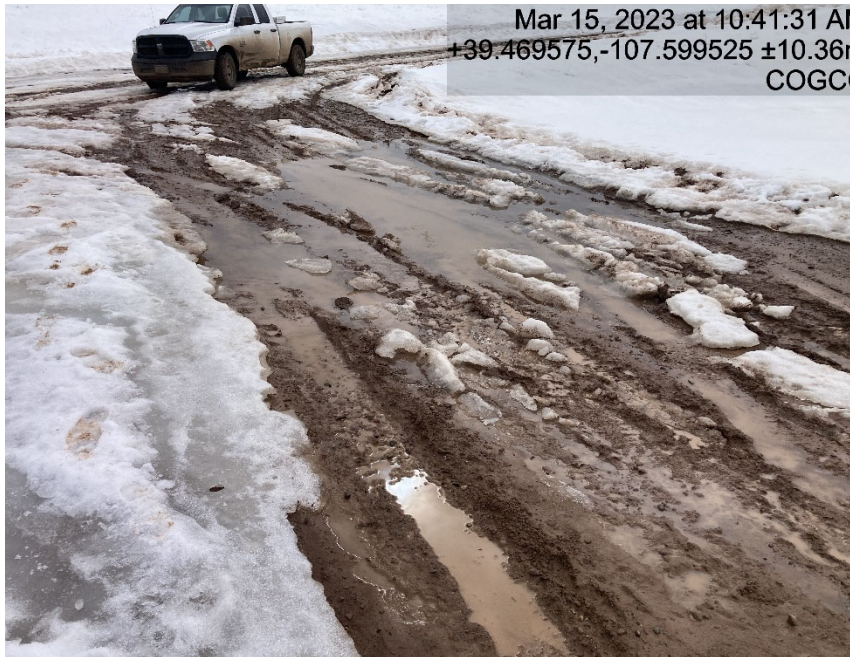
**Lack of stabilization/compaction/no evidence of tracking BMP's**

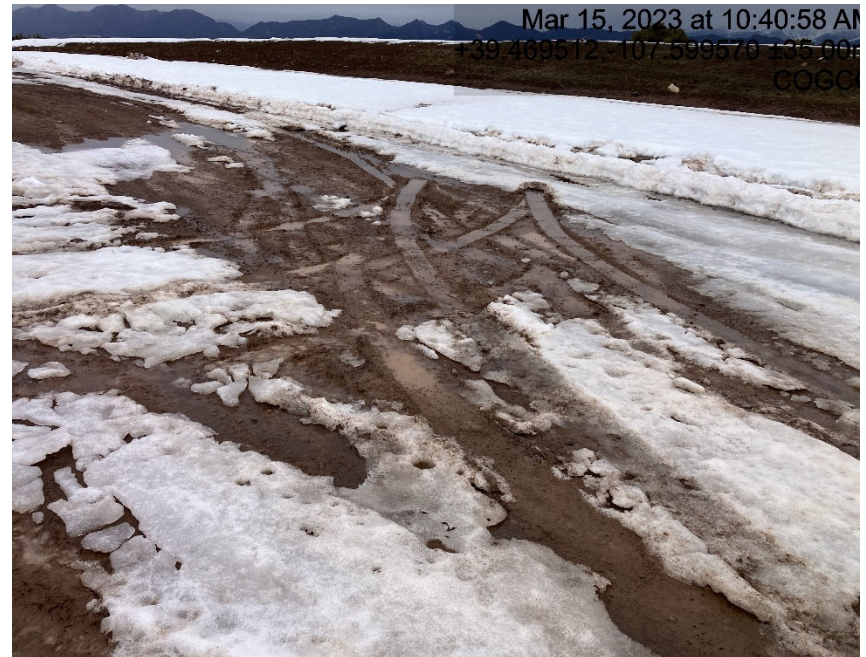
**Lack of stabilization/compaction/no evidence of tracking BMP's**

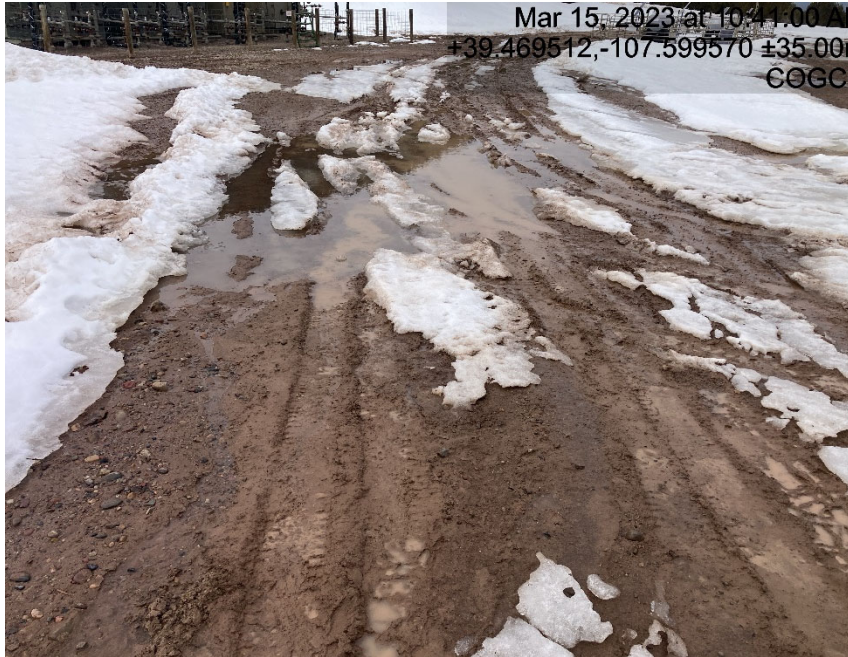
**Lack of stabilization/compaction/no evidence of tracking BMP's**

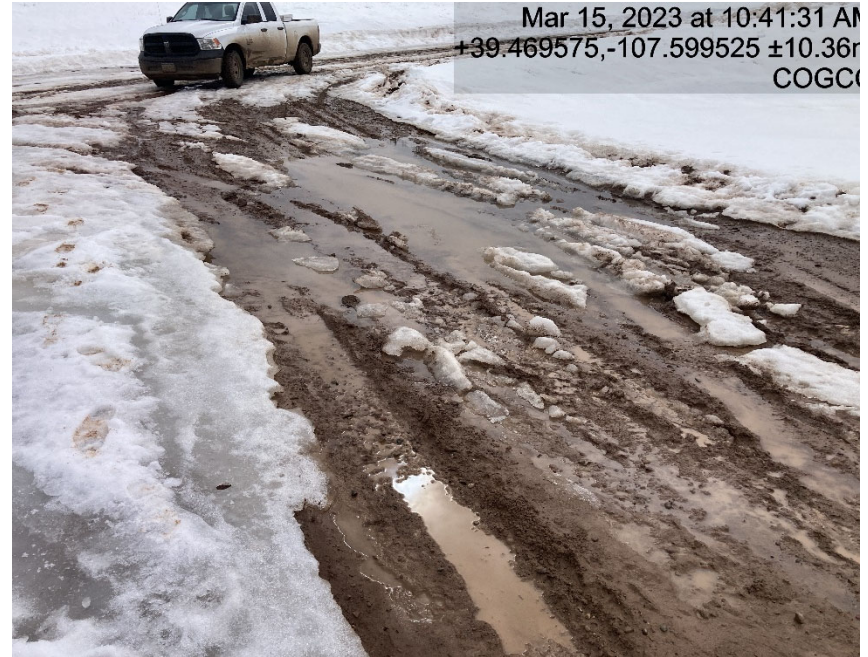
**Lack of stabilization/compaction/no evidence of tracking BMP's**

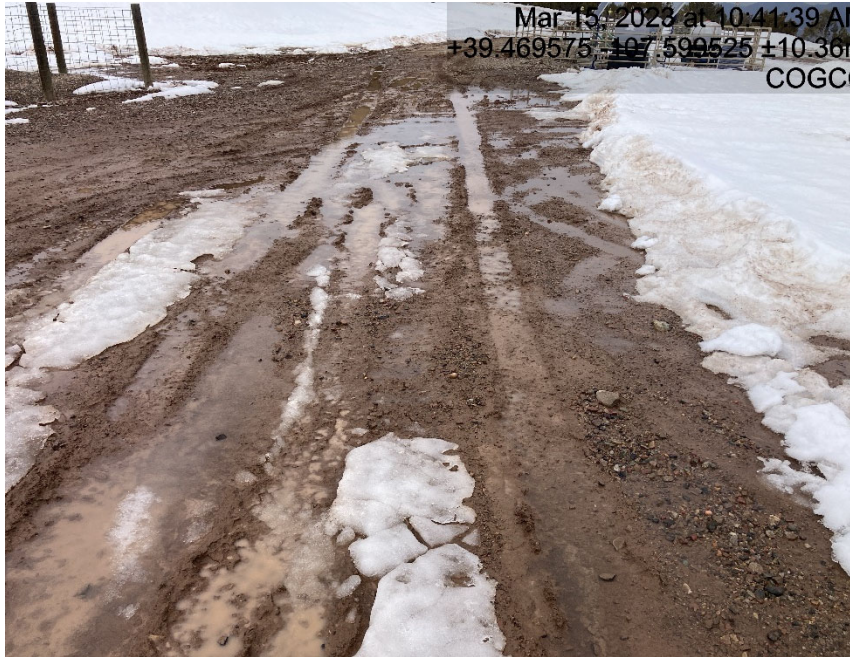
**Lack of stabilization/compaction/no evidence of tracking BMP's**

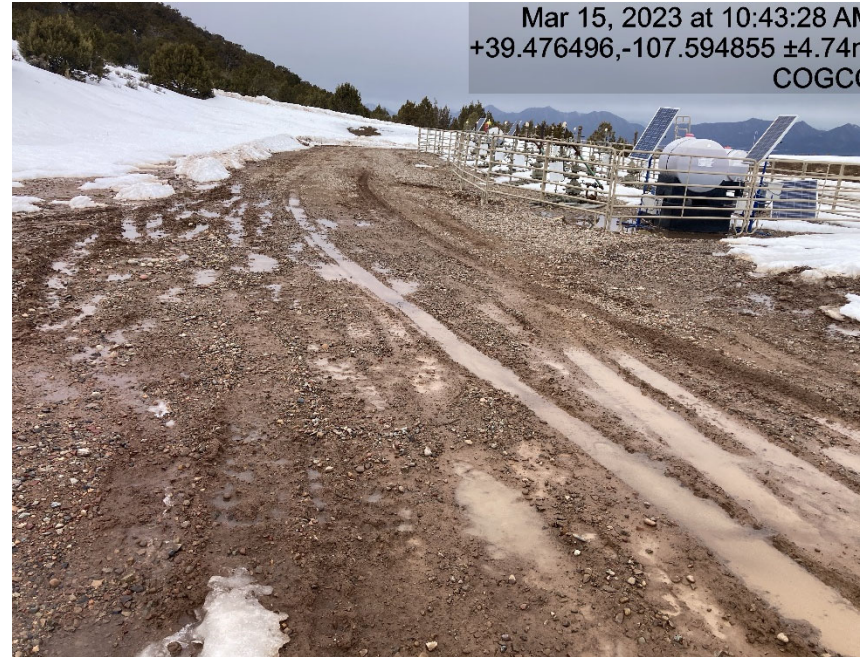
**Lack of stabilization/compaction/no evidence of tracking BMP's**

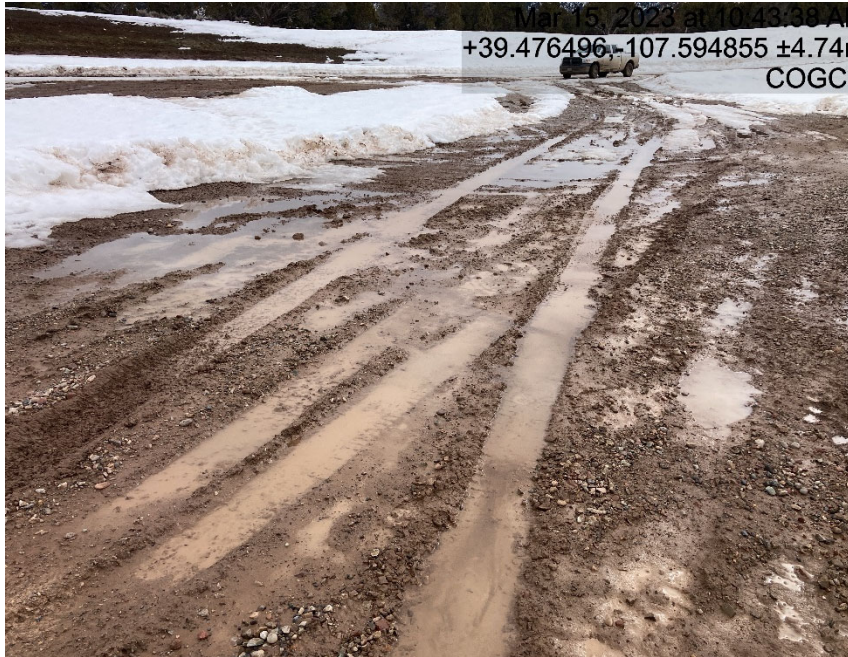
**Lack of stabilization/compaction/no evidence of tracking BMP's**

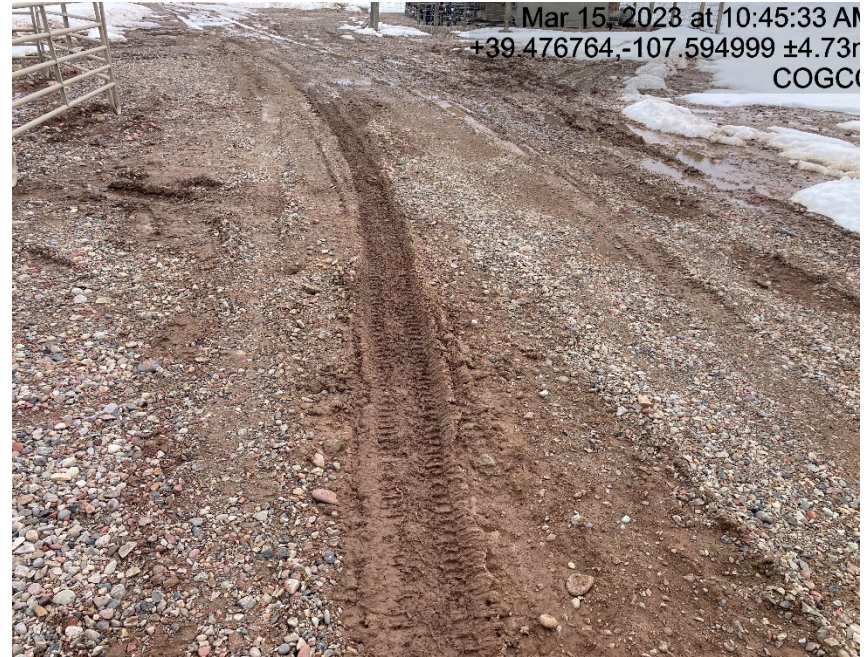
**Lack of stabilization/compaction/no evidence of tracking BMP's**

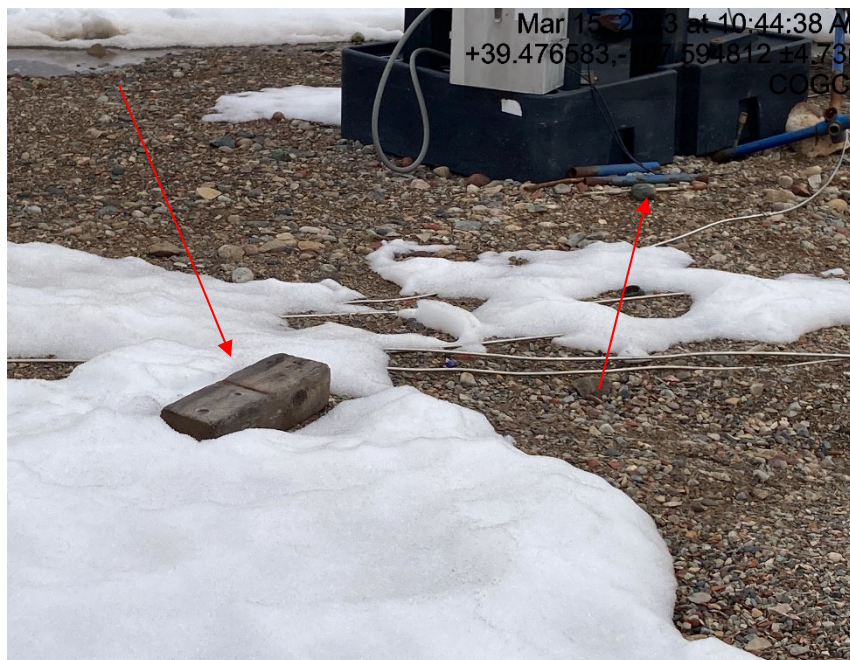
Debris

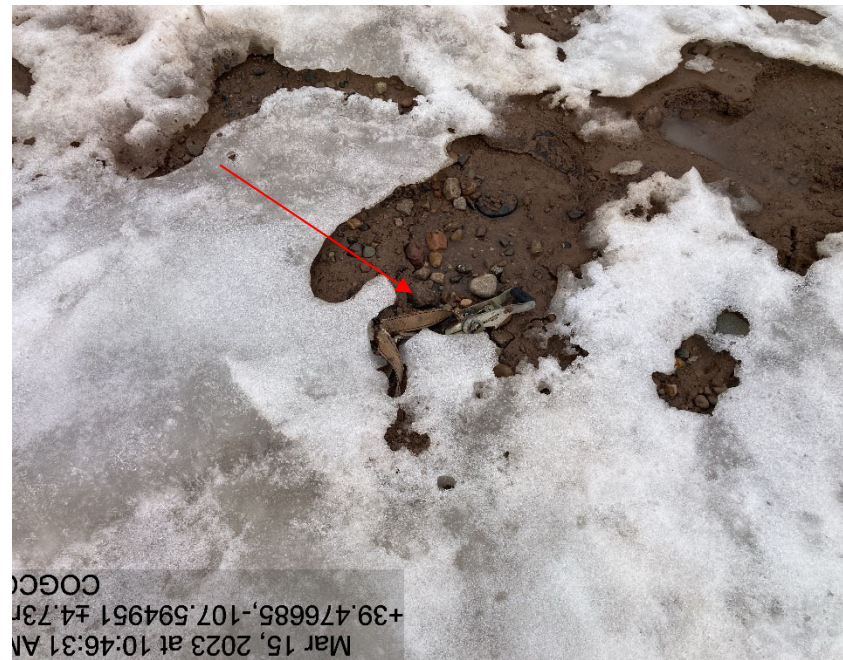
Debris
