Interim Reclamation and Stormwater Inspection

Operator: RED HAWK PETROLEUM LLC - 10503

Location ID: 430662

Inspection Document #: 708200034

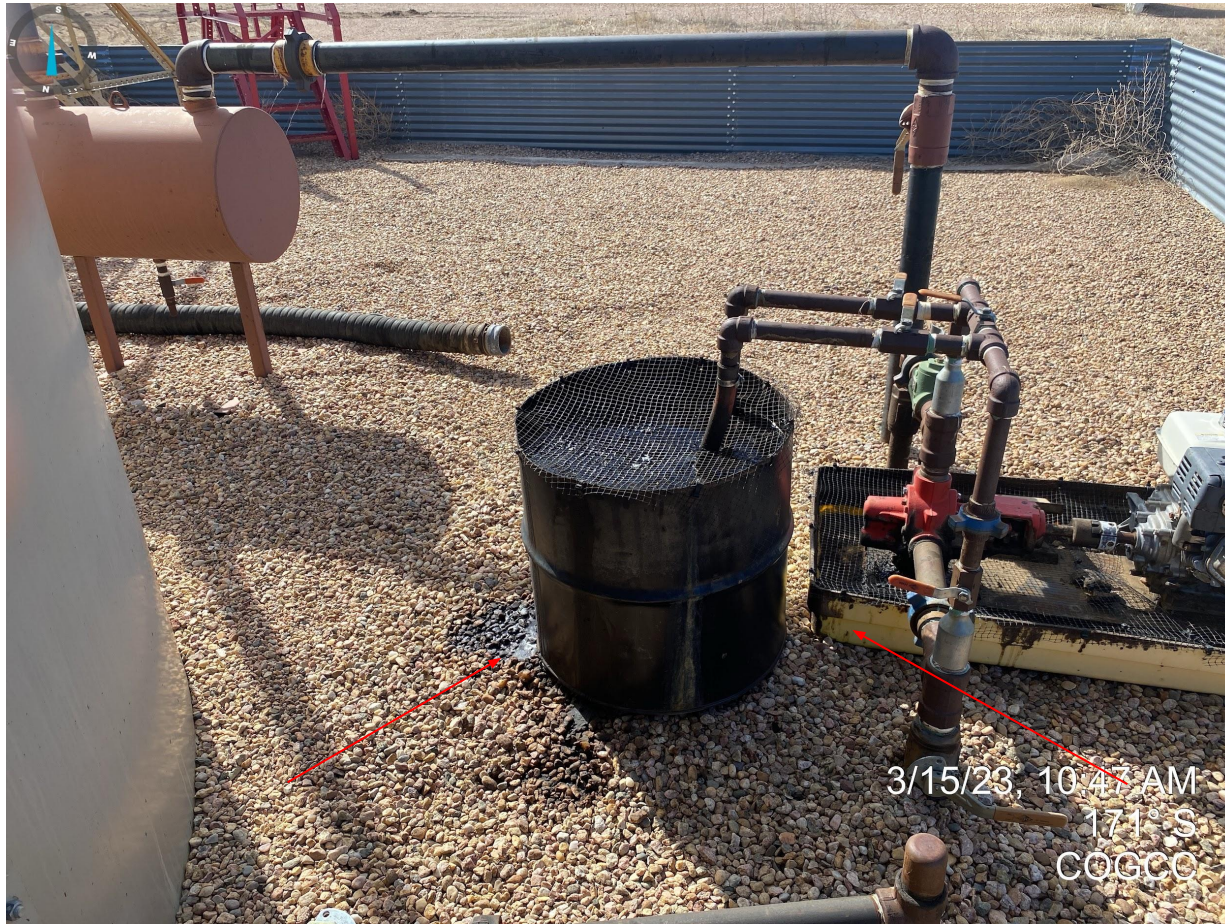
Photo 1. Facing south within secondary containment of battery. Oily waste/stained soil observed around barrel was identified in previous inspection (Doc #696105742) and has not been addressed. The corrective action is being back-dated to when it should have been addressed (see attached report for details).

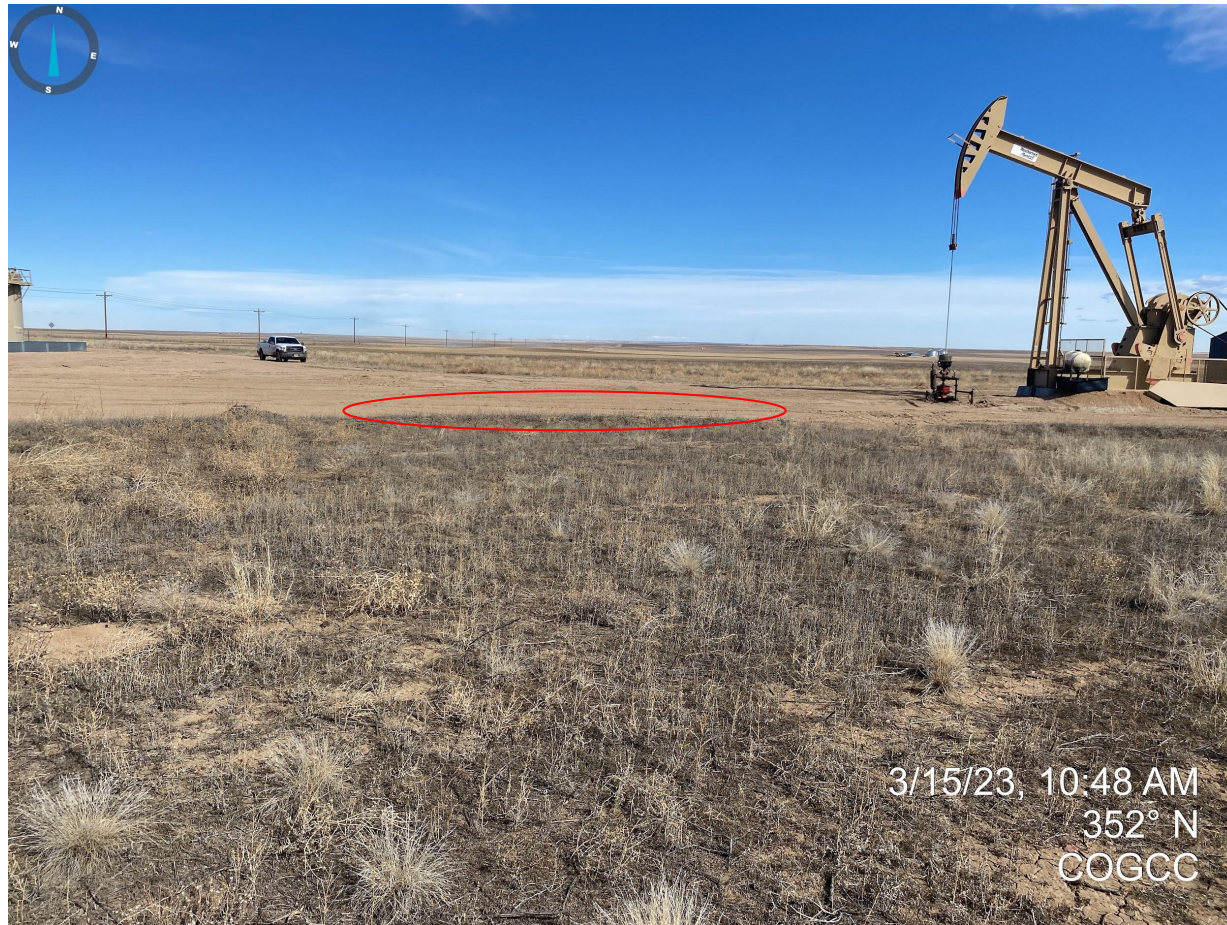
Photo 2. Facing north from interim area. Red outline illustrates location of previously stockpiled, impacted material. It appears the Operator has removed the impacted material off location.

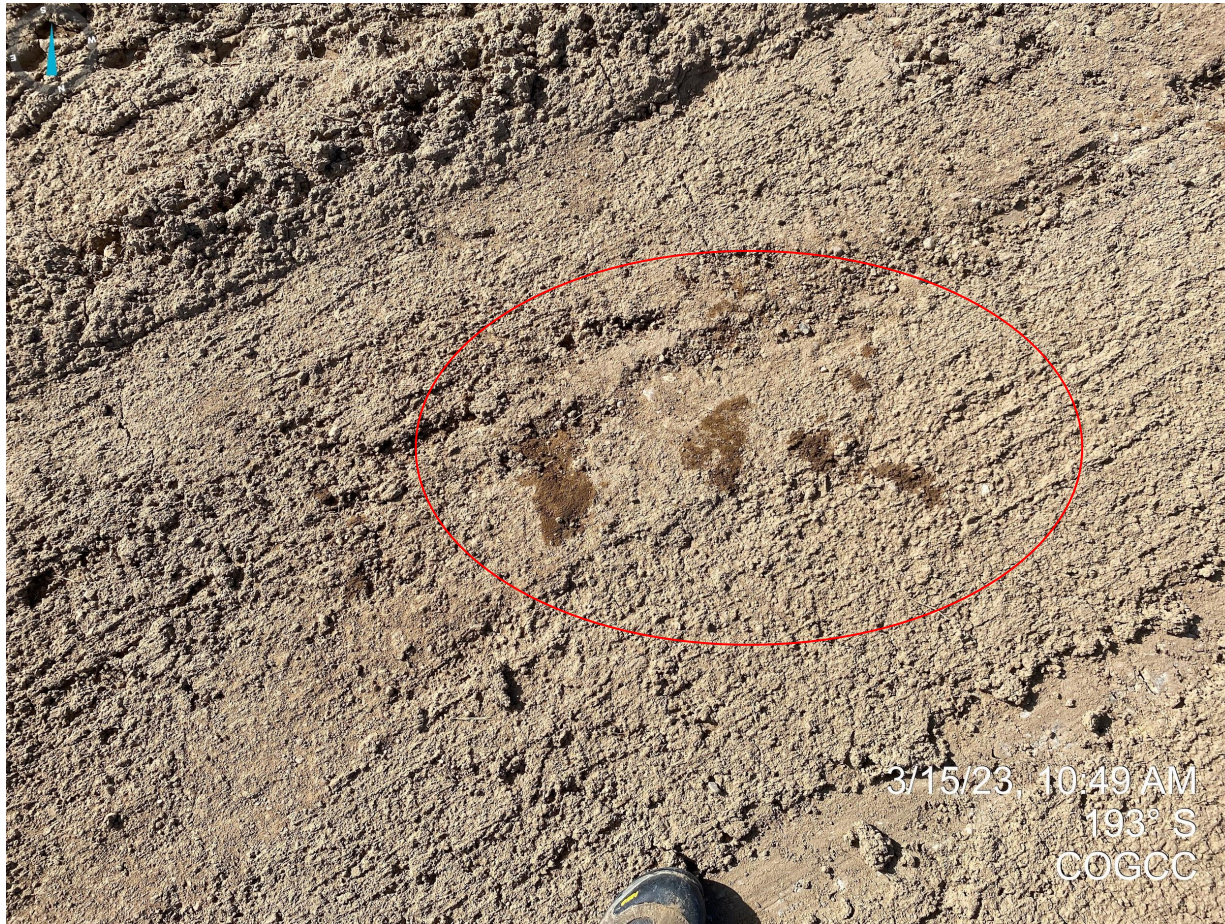
Photo 3. Close up photo of oil stained soil that was near the stockpile material mentioned in Photo 2. This stained soil will need to be properly cleaned up and disposed of per Rule 905.e.

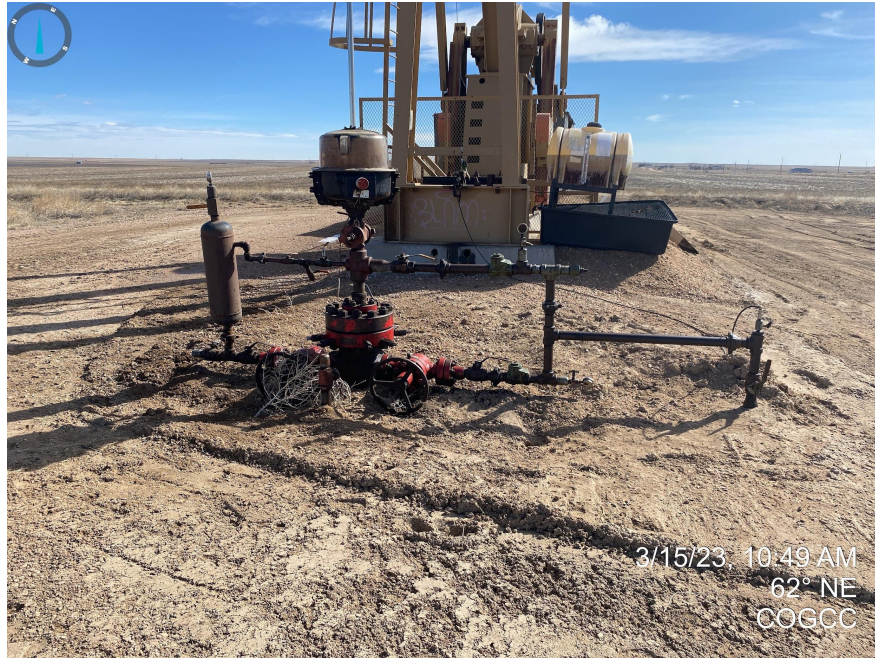
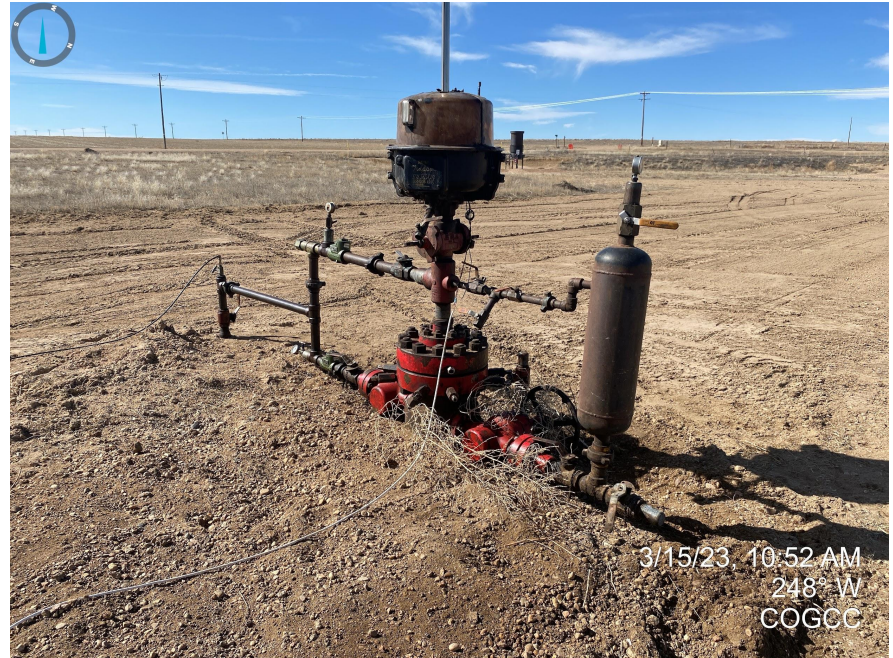
Photos 4 & 5. It appears the Operator has cleaned up the piping, checked equipment, and removed stained soil as identified in previous corrective actions.

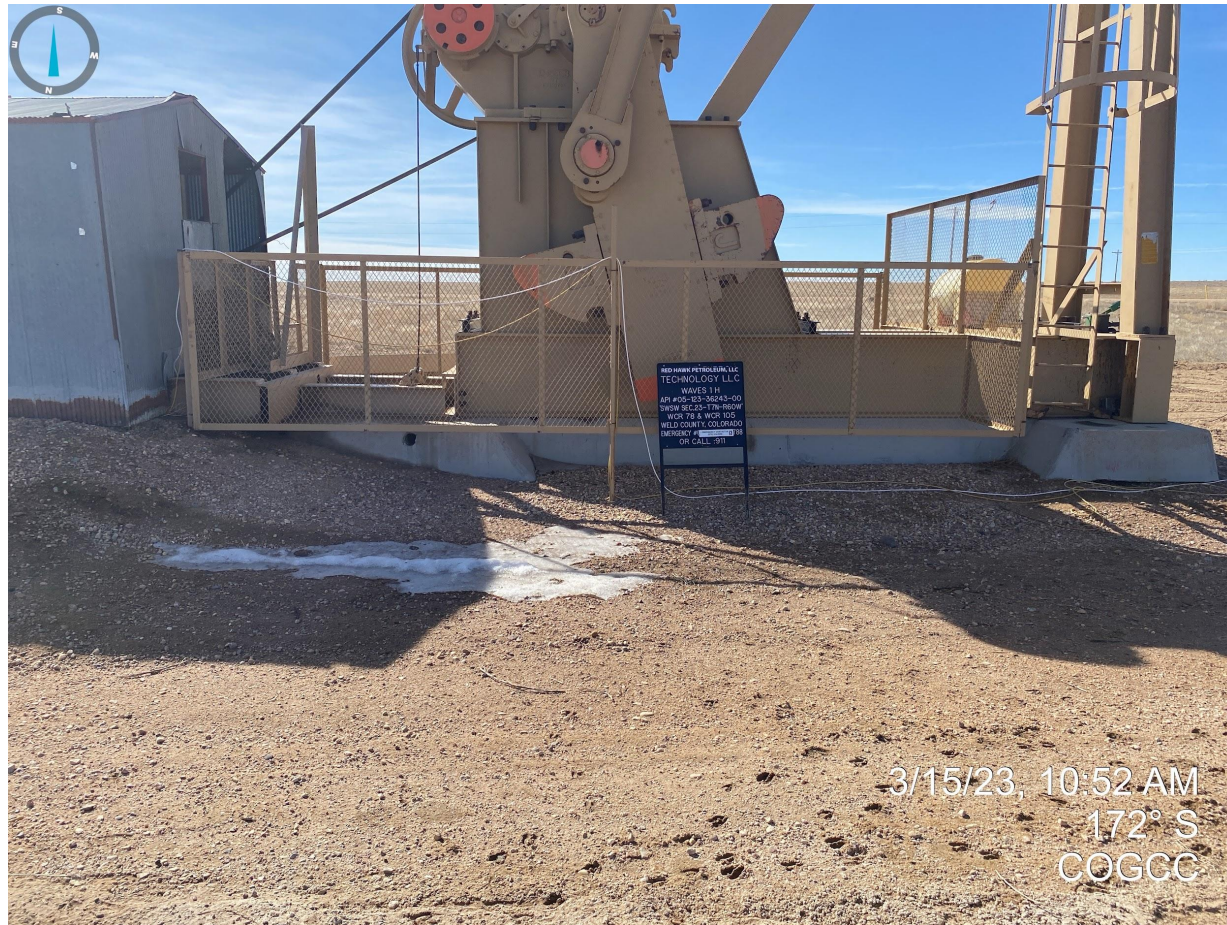
Photo 6. Appears operator has performed the previous corrective actions and removed the tumbleweed accumulations from equipment.

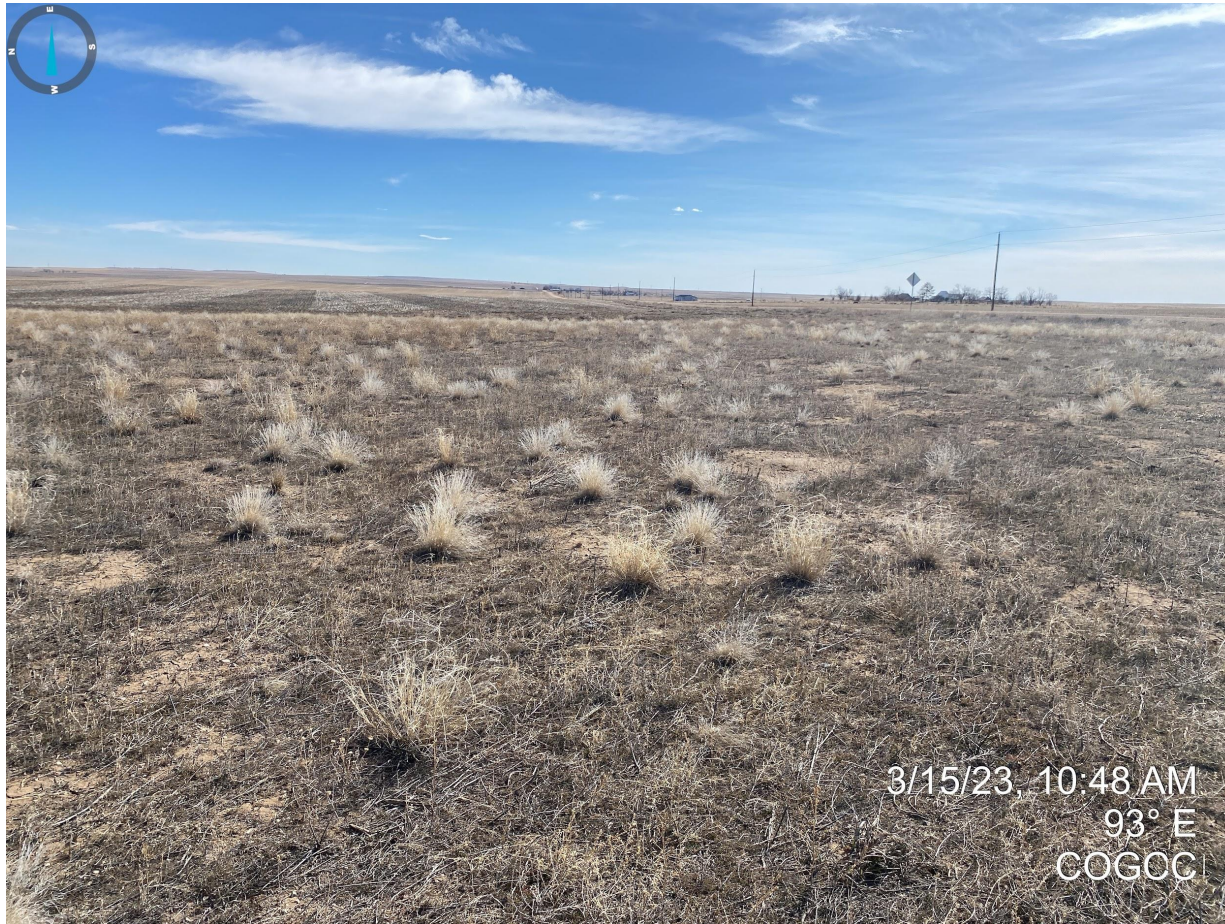
Photo 7. Facing east from the southern portion of the interim area. It appears the operator has performed interim reclamation activities. However, the interim areas are predominantly undesirable vegetation (e.g. russian thistle and kochia) with areas of non-uniform vegetation cover resulting in bare soil. Note: some desirable species were also observed during this inspection (e.g. sand drop seed).

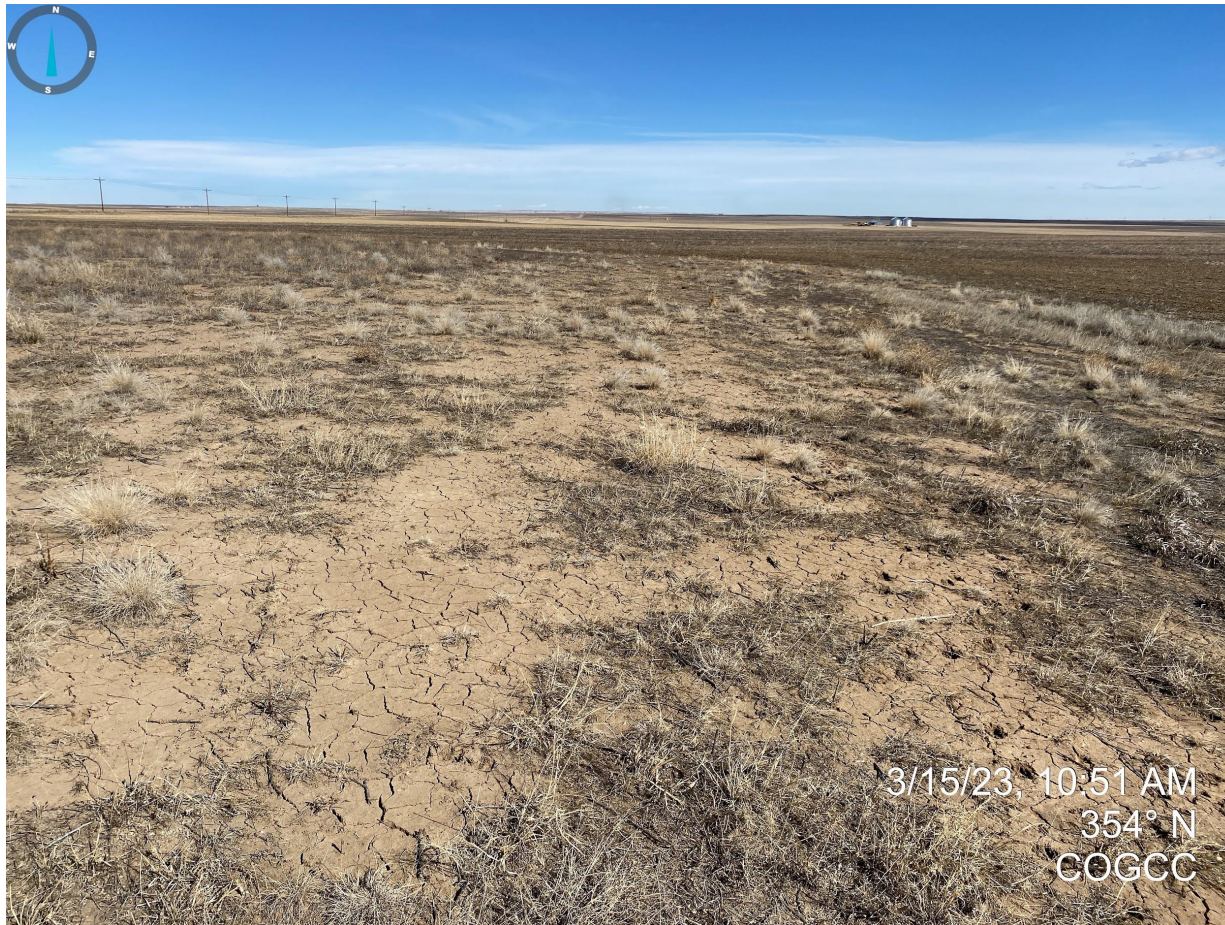
Photo 8. Facing north from the eastern portion of the interim area; see comments in Photo 7.

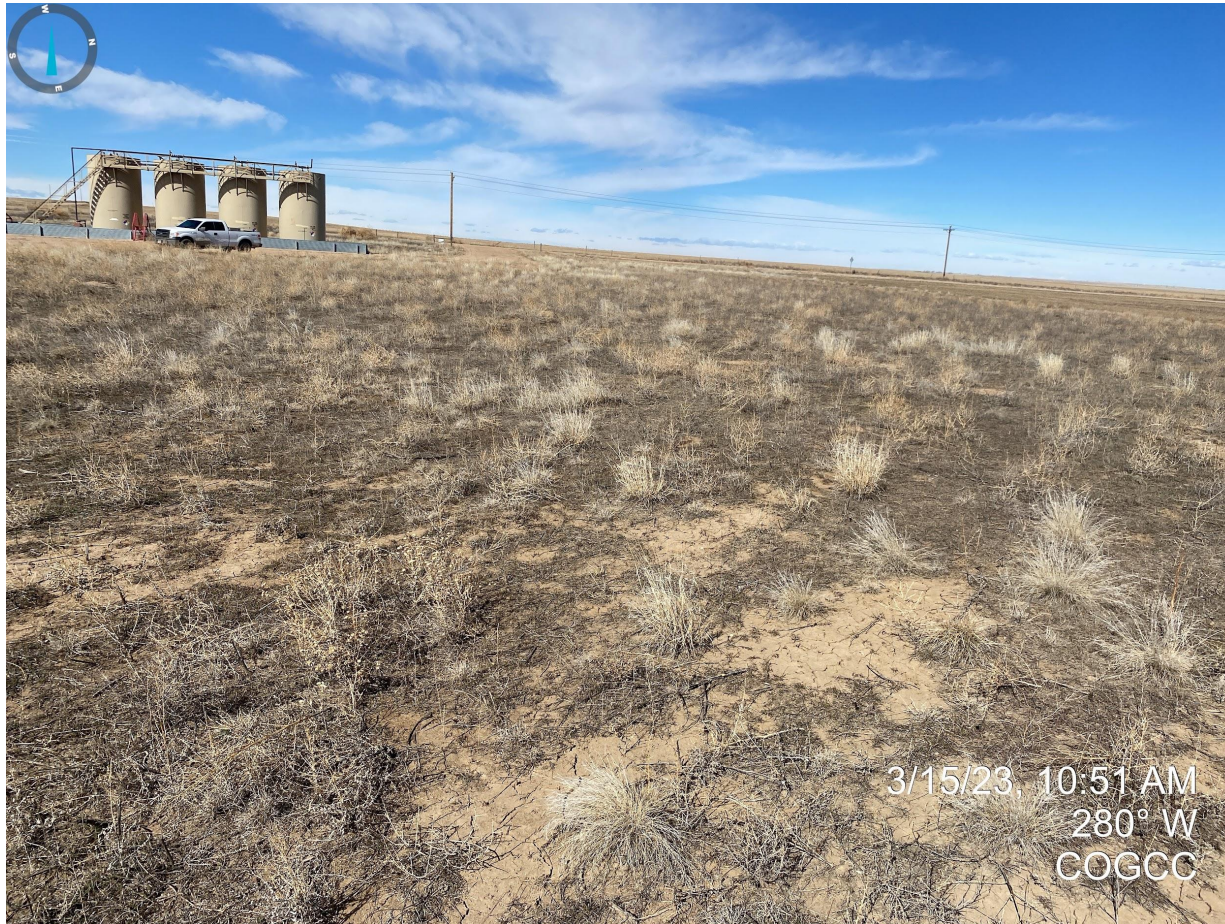
Photo 9. Facing west from the northern portion of the interim area; see comments in Photo 7.

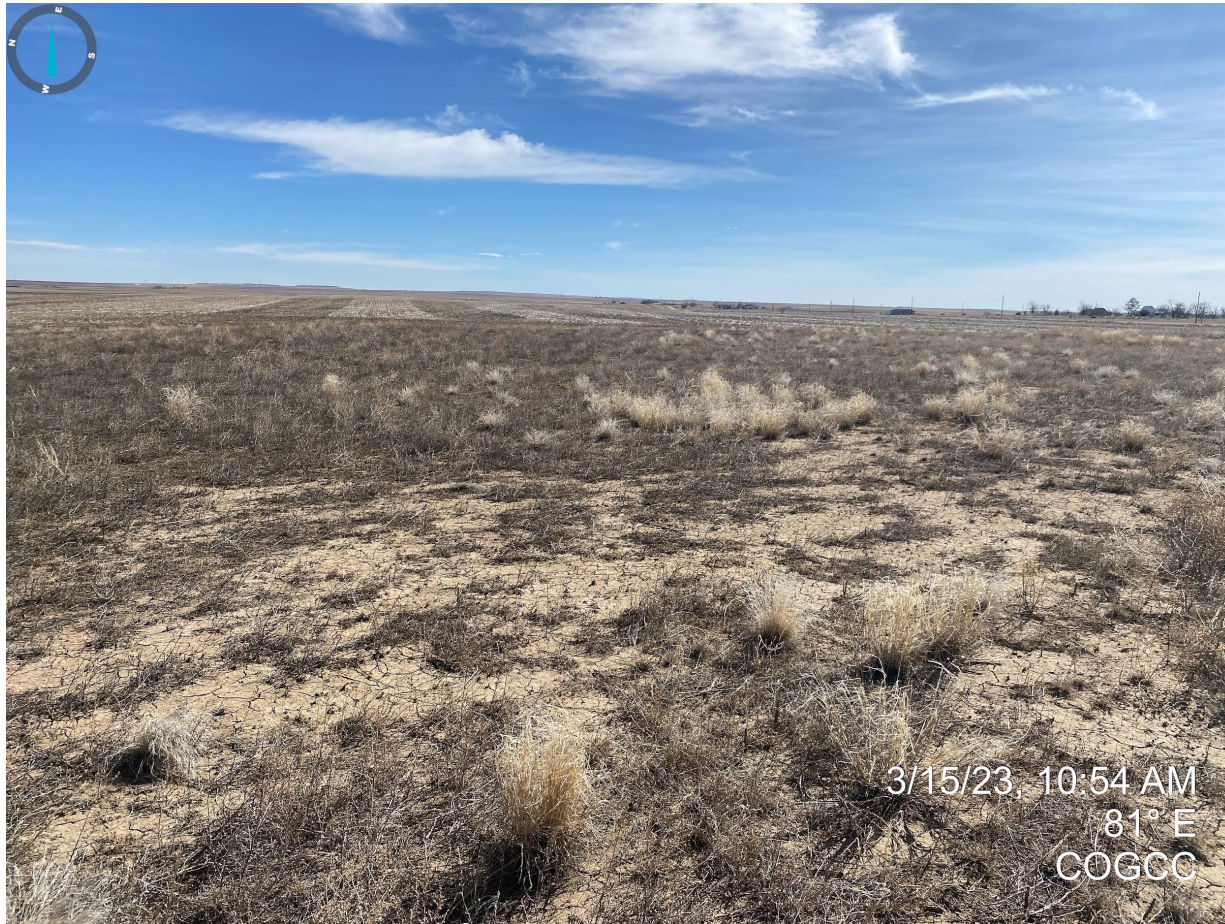
Photo 10. Facing east from the northwestern portion of the interim area; see comments in Photo 7.
